HISTORIC AND DESIGN REVIEW COMMISSION

January 02, 2019

HDRC CASE NO: 2018-580
ADDRESS: 206 CAMARGO
LEGAL DESCRIPTION: NCB 924 BLK 5 LOT N 134 FT OF 2
ZONING: RM-4, H
CITY COUNCIL DIST.: 1
DISTRICT: Lavaca Historic District
APPLICANT: Michael Taritas
OWNER: Michael Taritas
TYPE OF WORK: Exterior modifications, demolition of rear additions, rehabilitation, fenestration modifications, construction of a rear addition, fencing and driveway installation
APPLICATION RECEIVED: December 18, 2018
60-DAY REVIEW: January 16, 2019
REQUEST:

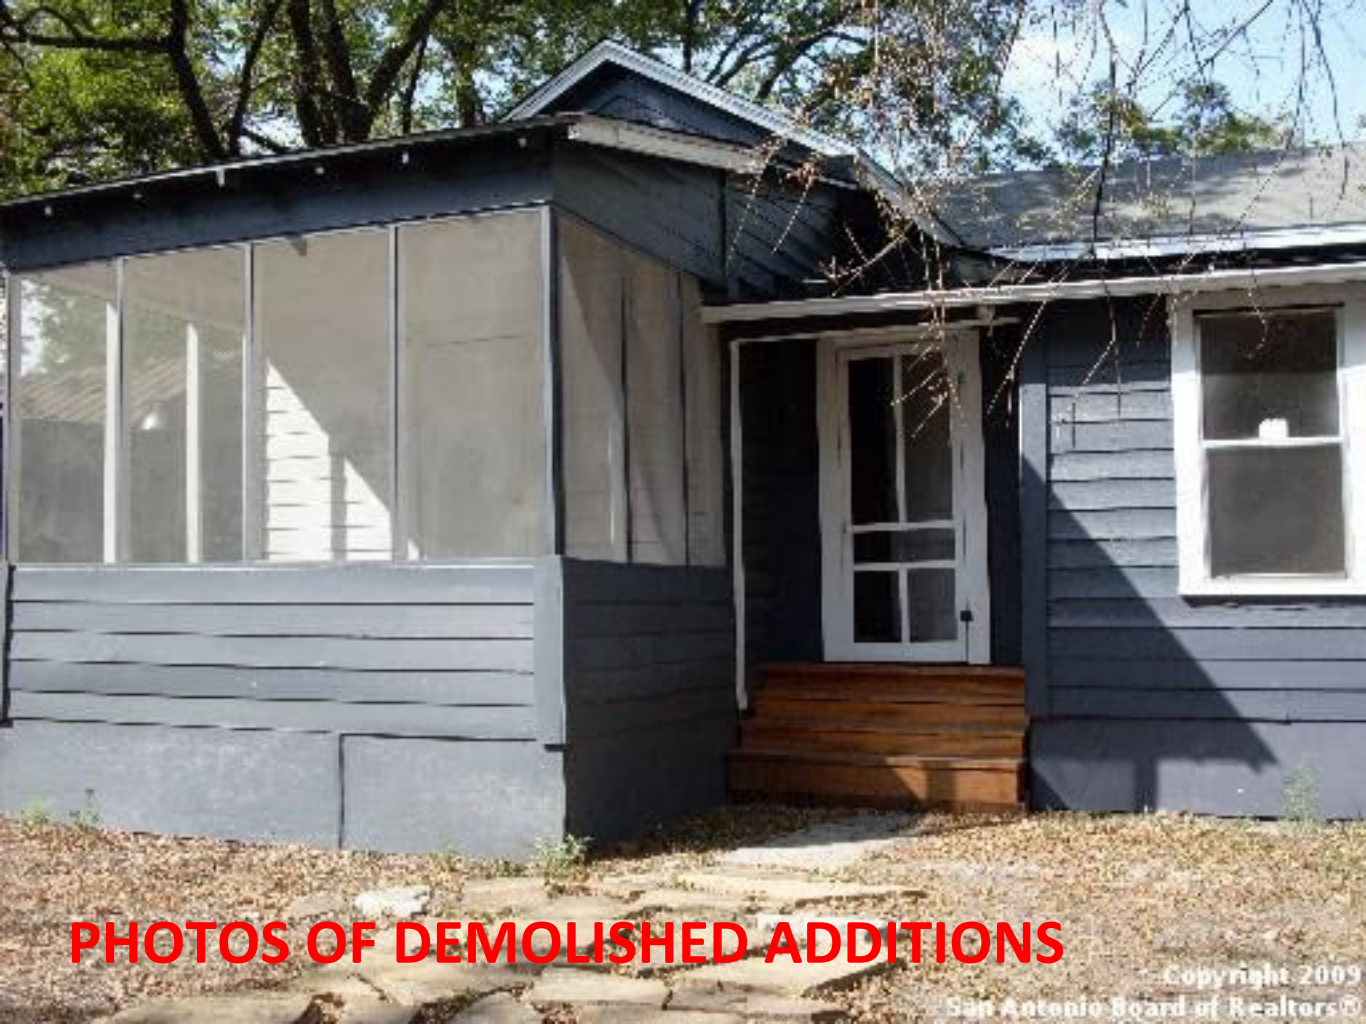
PHOTOS OF DEMOLISHED ADDITIONS

- e. REMOVAL OF ADDITIONS – The applicant has proposed to remove a series of contributing rear additions, including a contributing addition to the rear of the original structure, found on the 1904 Sanborn Map; a contributing addition to the previously noted addition which is found on the 1912 Sanborn Map; and a contributing screened porch addition to the rear of the primary structure rear facing gable which is found on the 1951 Sanborn Map. Staff finds that each of these additions holds historic integrity and does not recommend approval.

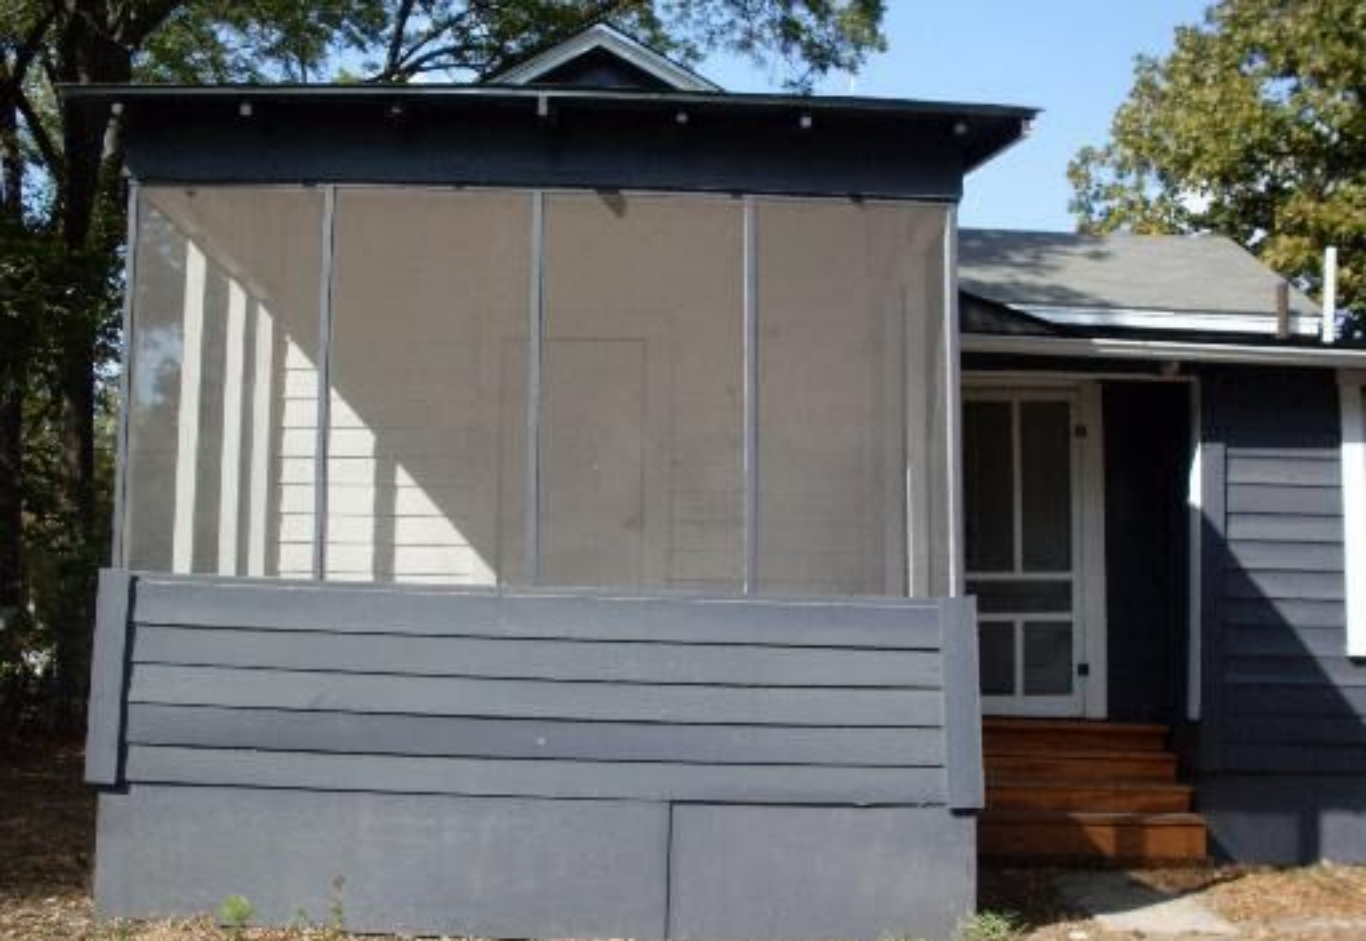
PHOTOS OF DEMOLISHED ADDITIONS

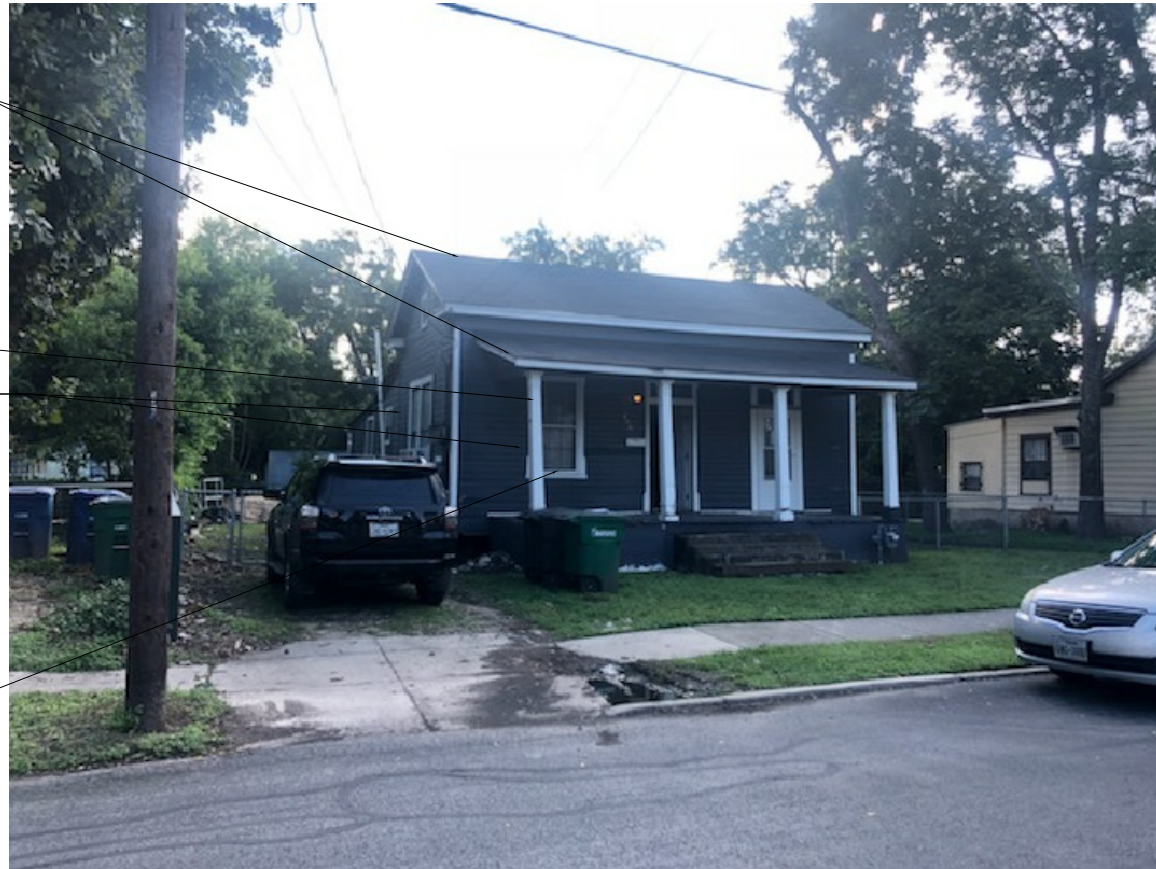
AD.03

EXISTING ROOF TO REMAIN.
REPAIR AS NECESSARY.

EXISTING COLUMNS TO
REMAIN AND REPAIRED AS
NECESSARY. TYPICAL.

EXISTING EXTERIOR SIDING
TO REMAIN. REPAIR AS
NECESSARY. TYPICAL

EXISTING WINDOWS TO
REMAIN. REPAIR AS
NECESSARY.

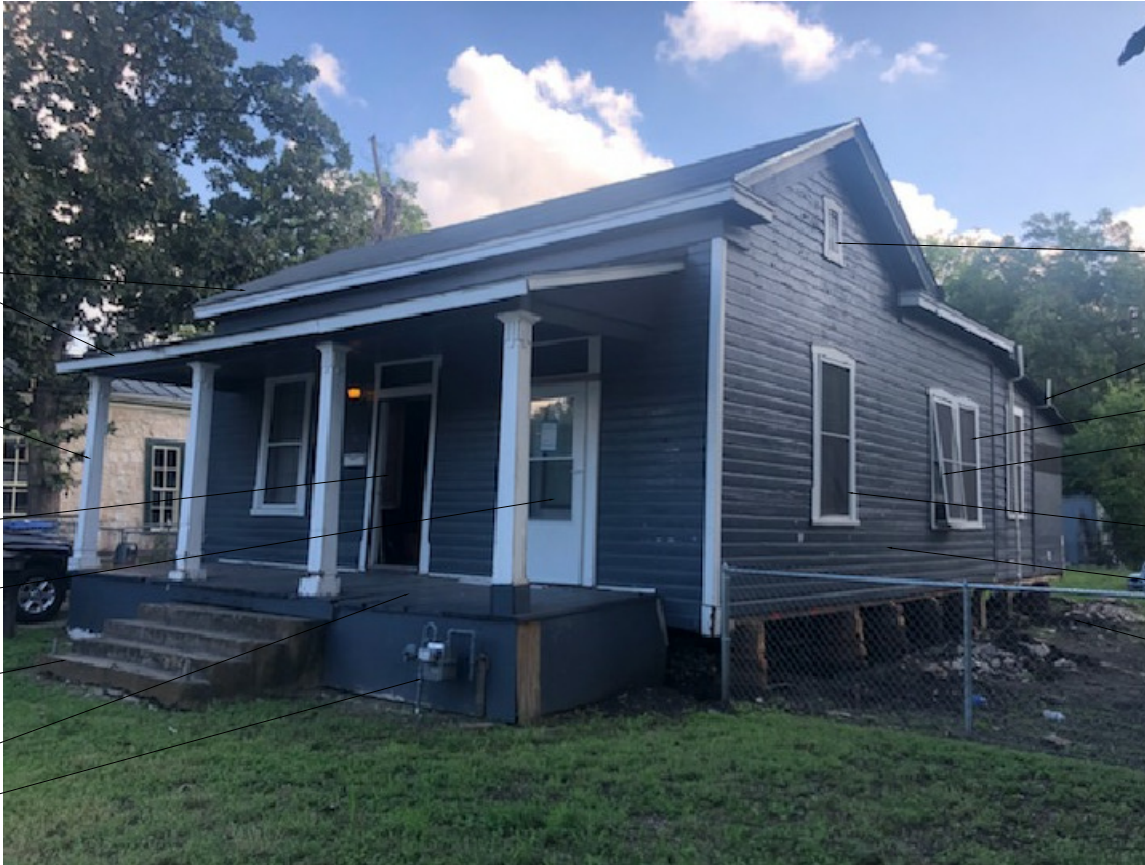
AD.04

EXISTING ROOF TO REMAIN.
REPAIR AS NECESSARY.

EXISTING COLUMNS TO
REMAIN AND REPAIRED AS
NECESSARY. TYPICAL.

EXISTING DOOR TO BE
REPAIRED AS NECESSARY

EXISTING DOOR TO BE
REMOVED AND REPLACED
WITH ORIGINAL WINDOW

EXISTING CONCRETE STEPS
TO REMAIN.

EXISTING PORCH DECK TO
REMAIN. REPAIR AS
NECESSARY

EXISTING GAS METER TO
REMAIN. TYPICAL.

LOUVERED VENT TO REMAIN.
TYPICAL.

EXISTING ROOF TO BE
REMOVED AND REPLACED
WITH NEW ROOF.

EXISTING WINDOW TO
REMAIN

WINDOW TO BE RELOCATED
TO ORIGINAL LOCATION AT
FRONT OF HOUSE

EXISTING WINDOW TO
REMAIN. REPAIR AS
NECESSARY

EXISTING EXTERIOR SIDING
TO REMAIN. REPAIR AS
NECESSARY. TYPICAL.

EXISTING FENCE TO BE
REMOVED.

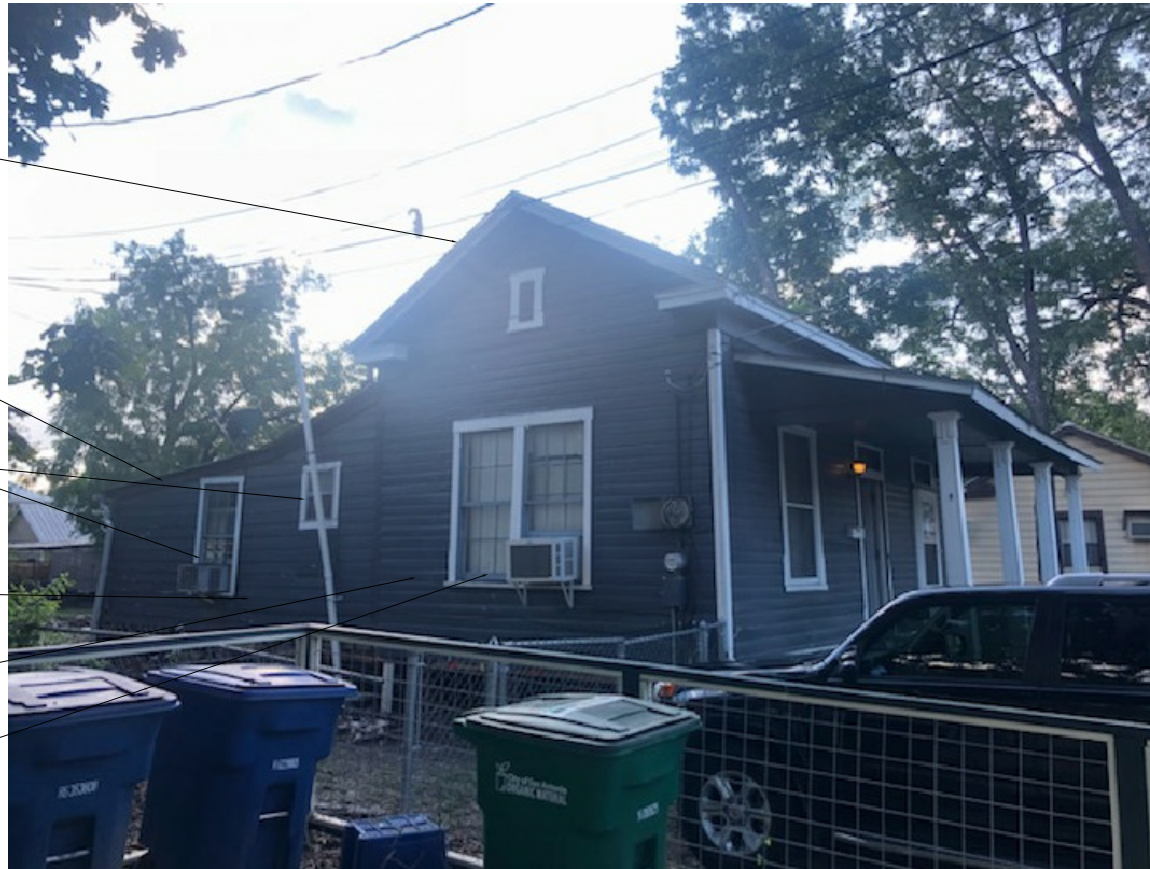
sheet number:
AD.05

EXISTING ROOF TO REMAIN.
REPAIR AS NECESSARY.

EXISTING ROOF TO BE
REMOVED AND REPLACED
WITH NEW ROOF.

EXISTING WINDOWS TO BE
REMOVED.

EXISTING EXTERIOR WALL TO
BE REMOVED. REFER TO
DEMOLITION PLAN

EXISTING EXTERIOR SIDING
TO REMAIN. REPAIR AS
NECESSARY. TYPICAL

EXISTING WINDOWS TO
REMAIN. REPAIR AS
NECESSARY.

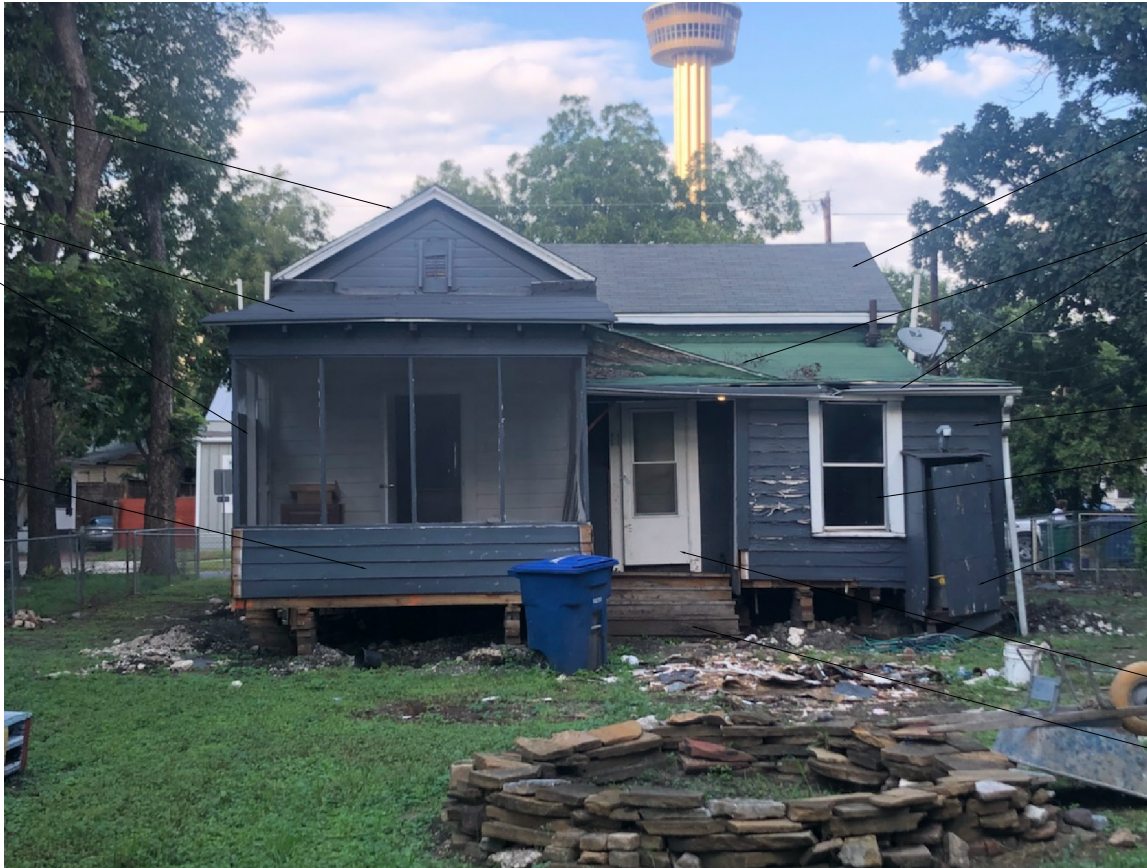
AD.06

EXISTING ROOF TO REMAIN
REPAIR AS NECESSARY

EXISTING ROOF TO BE
REMOVED AND REPLACED
WITH NEW ROOF.

EXISTING SCREENED PORCH
TO BE REMOVED.

EXISTING SIDING TO BE
REMOVED.

EXISTING ROOF TO REMAIN.
REPAIR AS NECESSARY.

EXISTING EXTERIOR WALL TO
BE REMOVED.

EXISTING EXTERIOR WINDOW
TO BE REMOVED.

EXISTING WATER HEATER
CLOSET TO BE REMOVED.

EXISTING DOORS TO BE
REMOVED.

EXISTING WOOD STEPS TO BE
REMOVED.

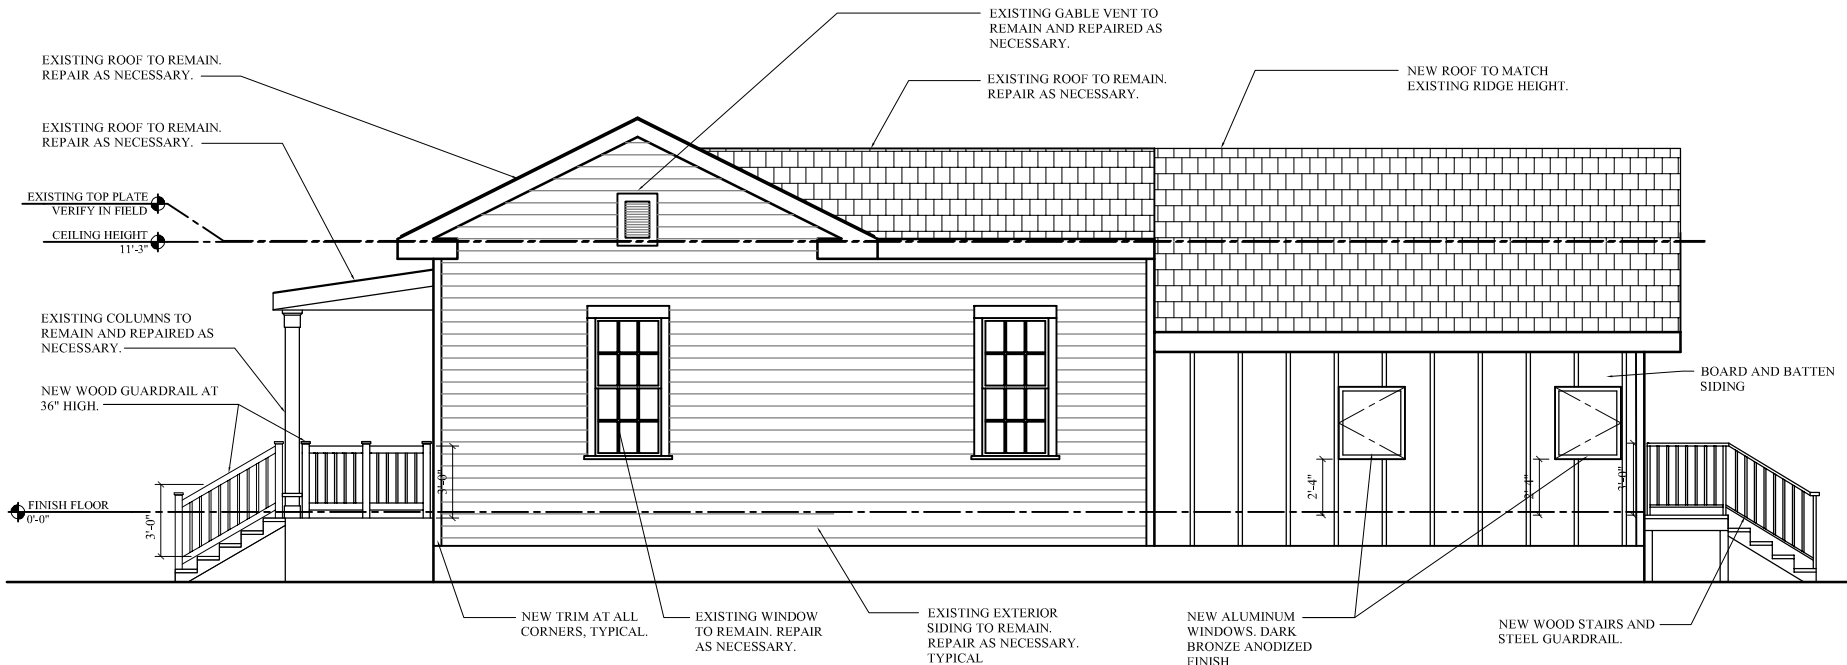
2 West Elevation
1/8"=1'-0"

- h. ARCHITECTURAL DETAILS (Addition) – The applicant has proposed a number of architectural details for the proposed addition that are generally consistent with the Guidelines; however, the applicant has proposed picture windows on the west elevation that feature a profile that is not comparable to those of the historic structure. Staff finds that the applicant should incorporate more traditionally sized windows on this elevation that feature sashes. On the rear façade, the applicant has proposed aluminum storefront windows in the living space. Staff finds that the proposed fenestration is not consistent with the Guidelines. Staff finds that an elevation that is consistent with the Guidelines should be proposed.

- iii. That the addition’s proposed rear façade feature fenestration patterns that are complementary of the historic structure and feature window proportions and materials that are consistent with the Guidelines, as noted in findings h and j.
