HISTORIC AND DESIGN REVIEW COMMISSION February 06, 2019

HDRC CASE NO: 2019-018

ADDRESS: 1507 FULTON AVE

TYPE OF WORK: Rear Addition, Historic Tax Certification

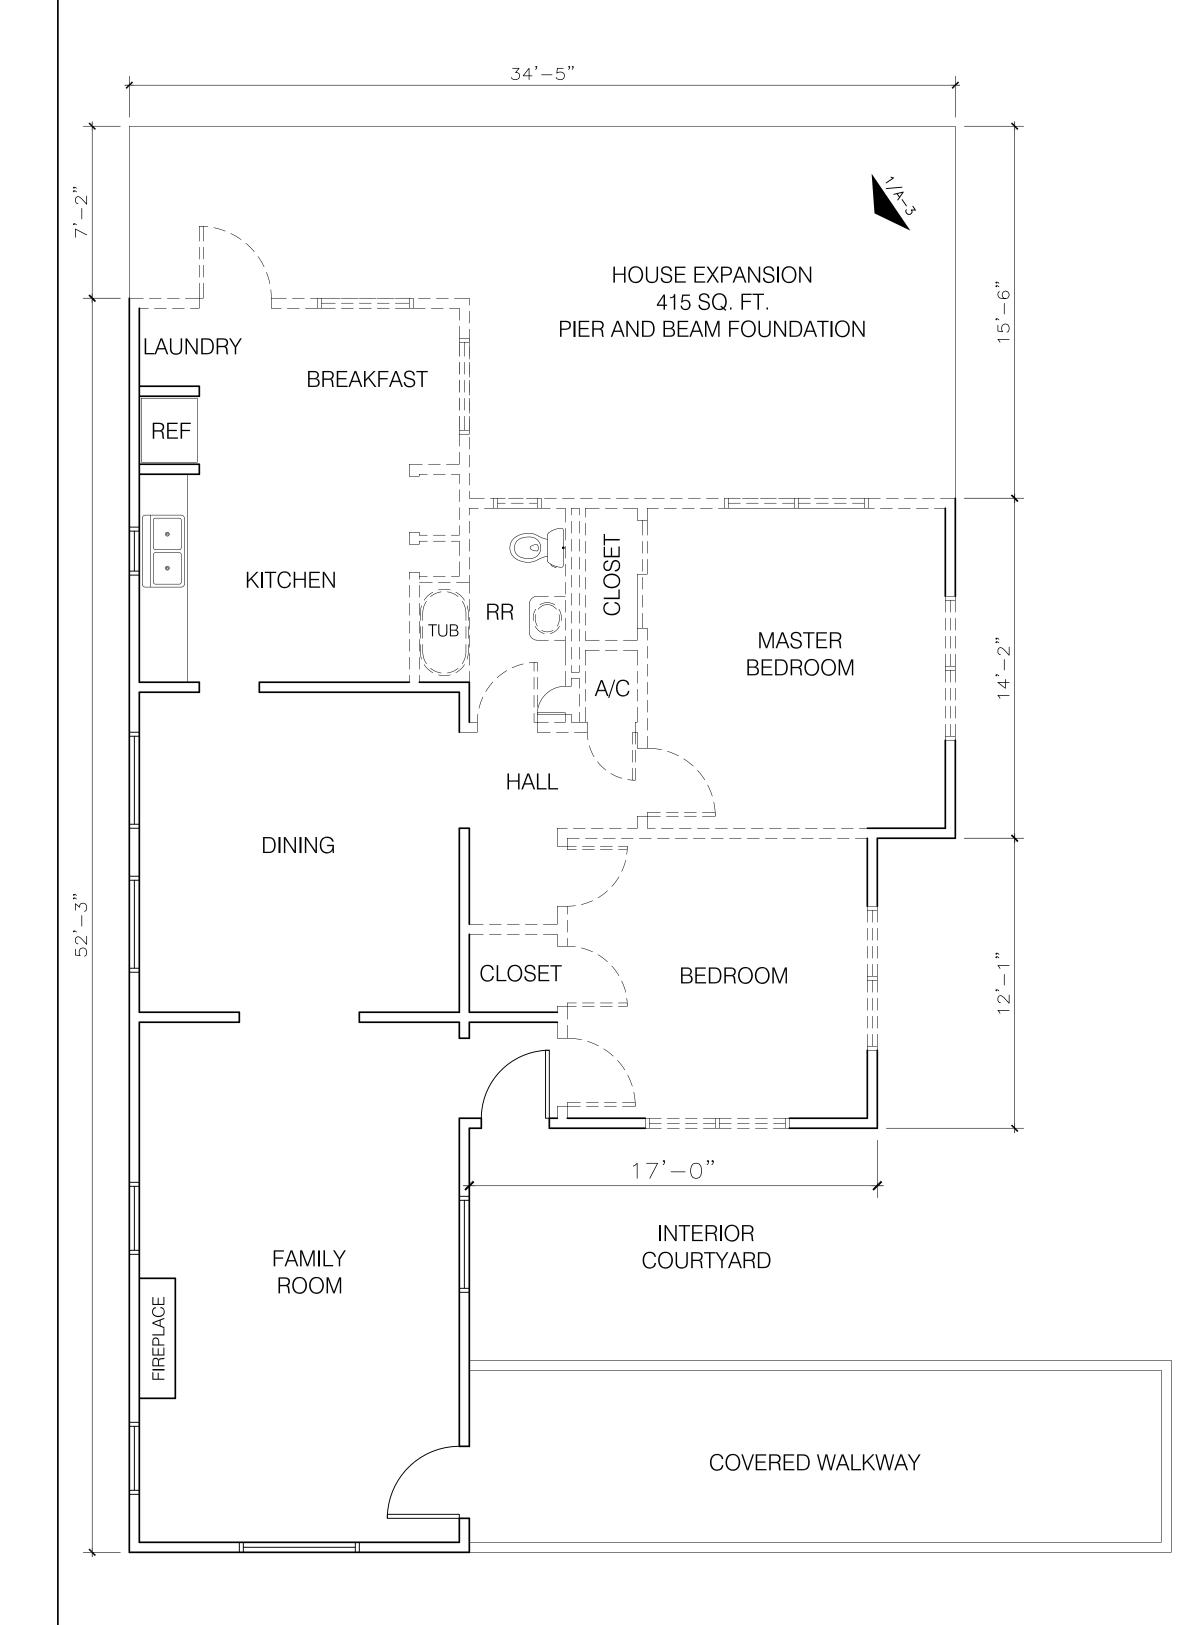
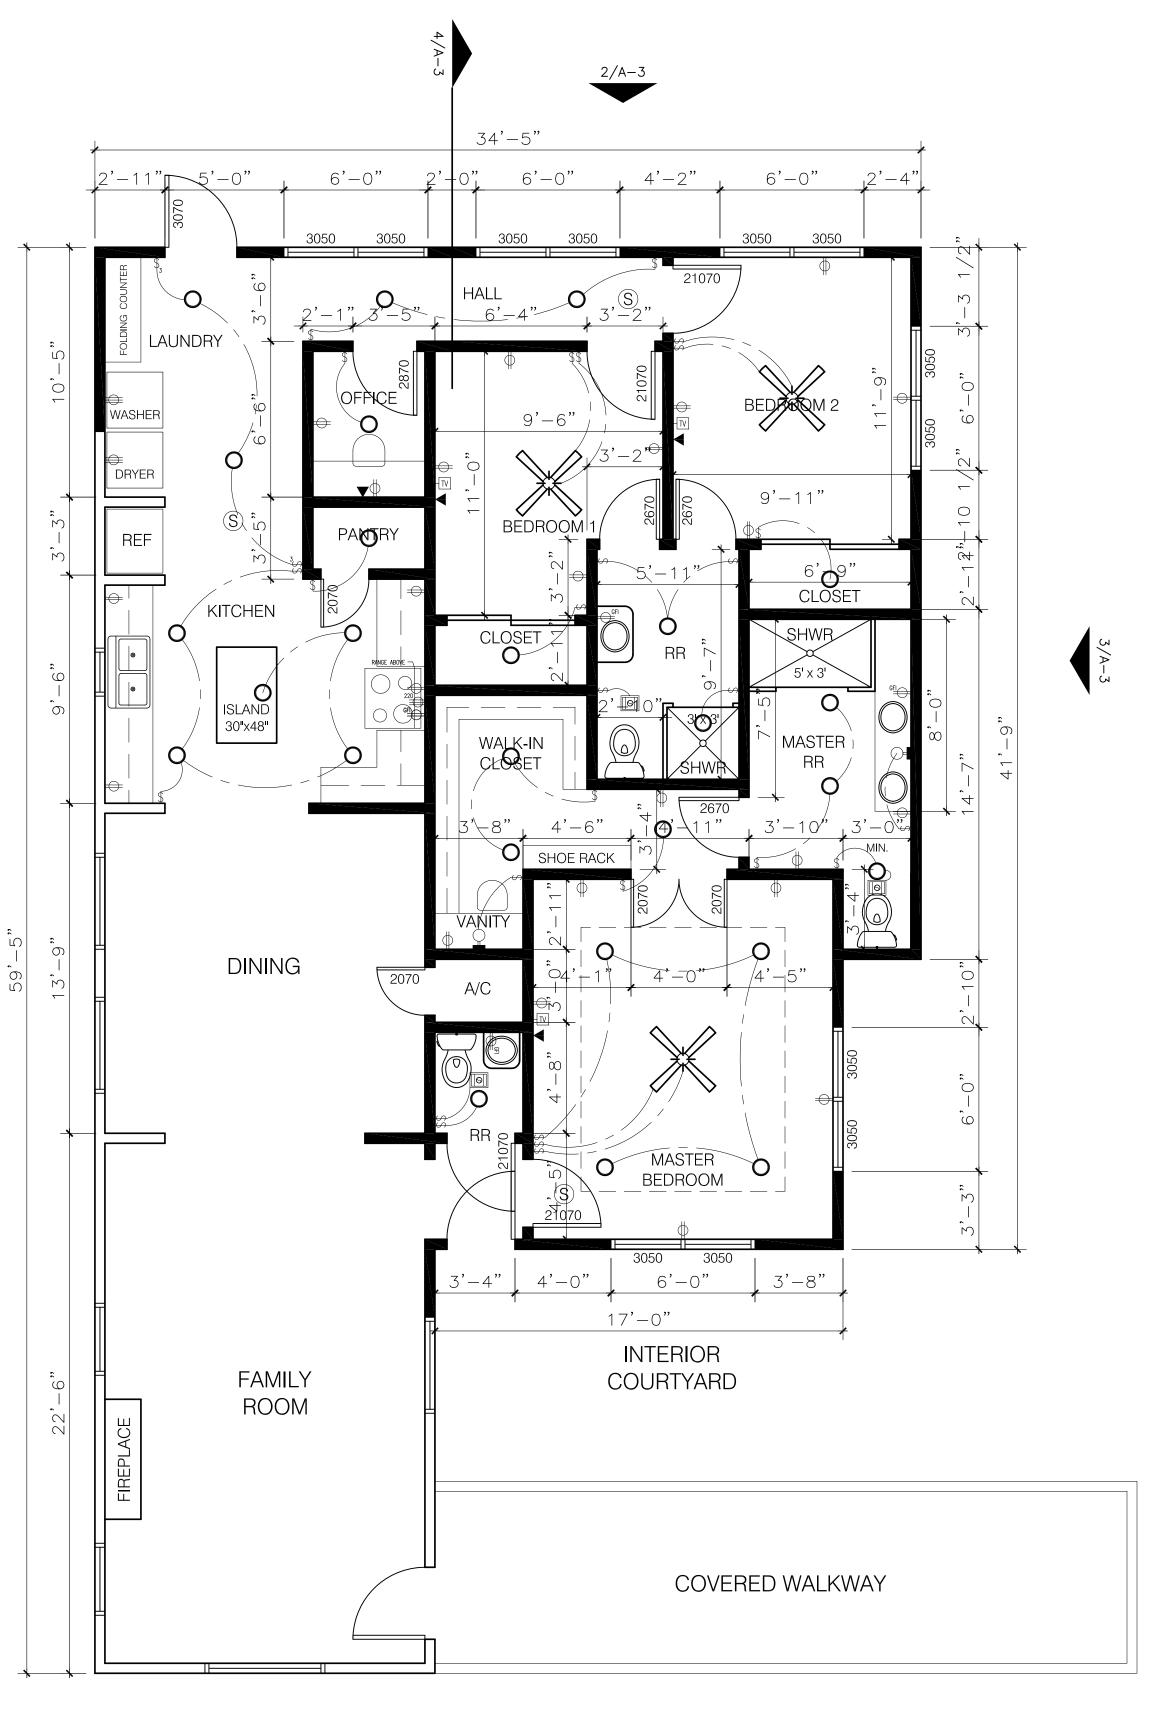
FLOOR PLAN — DEMOLITION

2 FLOOR PLAN — NEW WORK
SCALE: 1/4"=1'-0"

- c. ADDITION The applicant has proposed to install a rear addition featuring 415 square feet with matching windows, stucco walls, and wood framing.
- d. FOOTPRINT The proposed rear addition is to feature 415 square feet, which is less than half of the existing square footage of the primary historic structure. Staff finds that the proposed footprint is consistent with the Guidelines for Additions 1.B.iv.

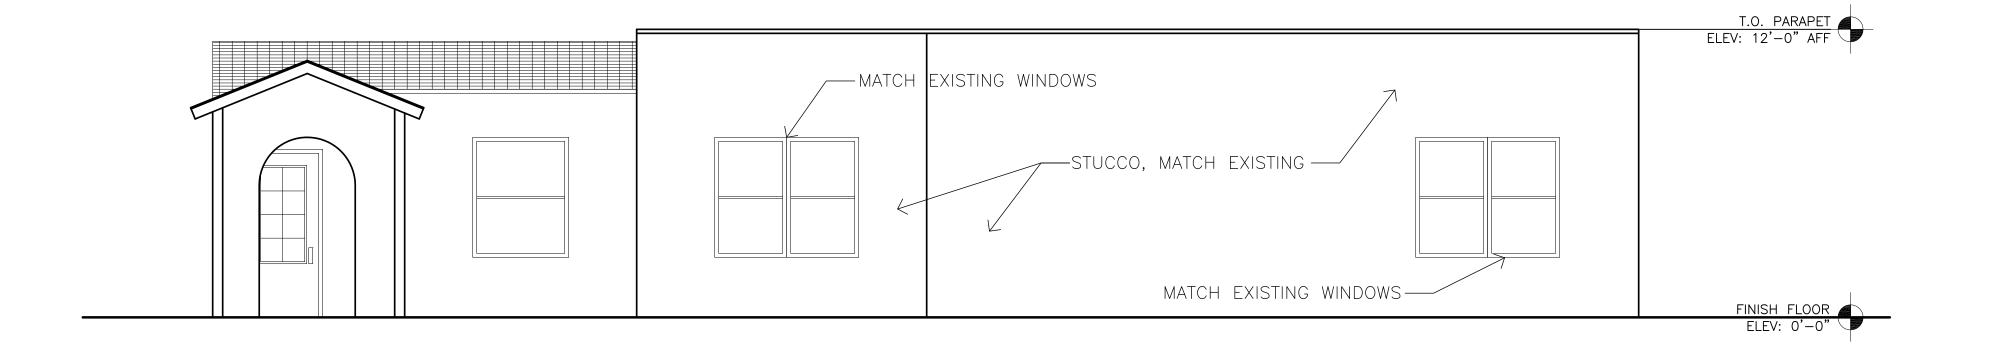
EXTERIOR WALL SECTION

2×6 FRAMING AT ∕R-19 BATT INSUL. STUCCO -CEILING AND ROOF /___I/2" PLYWOOD METAL LATH-—R−19 BATT INSUL. -1/2" GYP.BD.; STUCCO & PAINT VAPOR BARRIER -METAL LATH -2x6 WD FRAMING AT 16" O.C. STUCCO -—R−11 BATT INSUL. 1/2" SHEATHING -—SEALANT AT SOLE PLATE TREATED 2x -SOLE PLATE, CONCRETE FLOORING FINISH GRADE

- g. MATERIALS The proposed rear addition features matching materials to the primary historic structure including stucco over wood framing, and wood trim and wood windows. Staff finds that the proposed materials are consistent with the Guidelines 3.A.i.

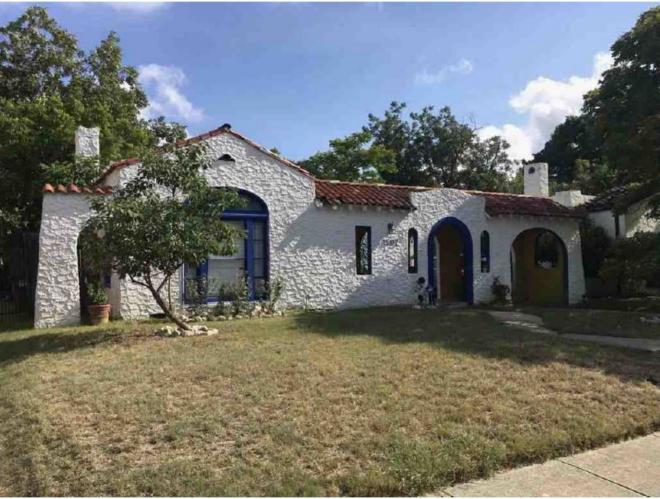
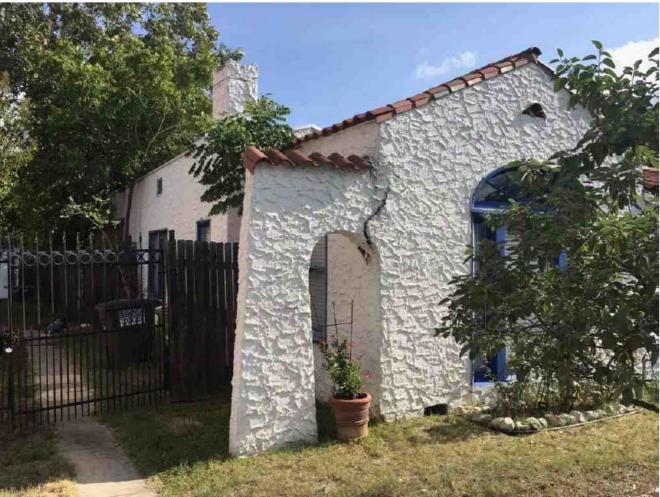
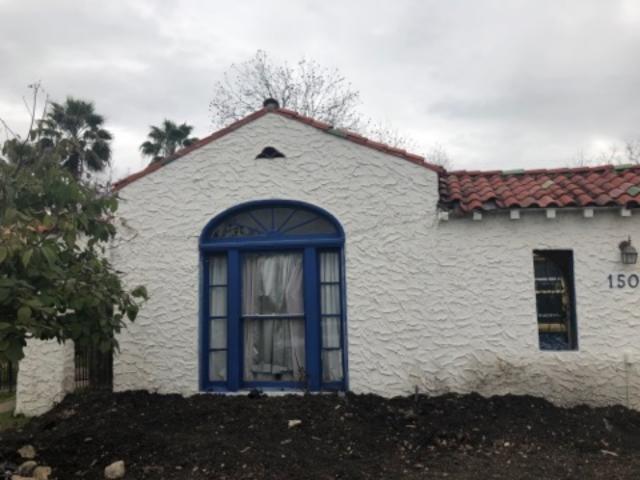
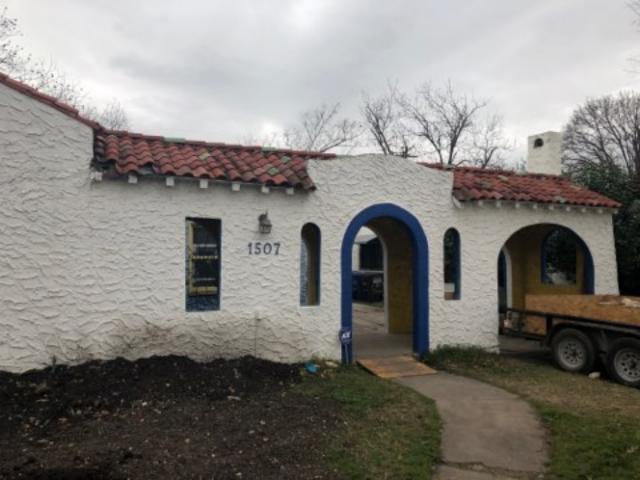
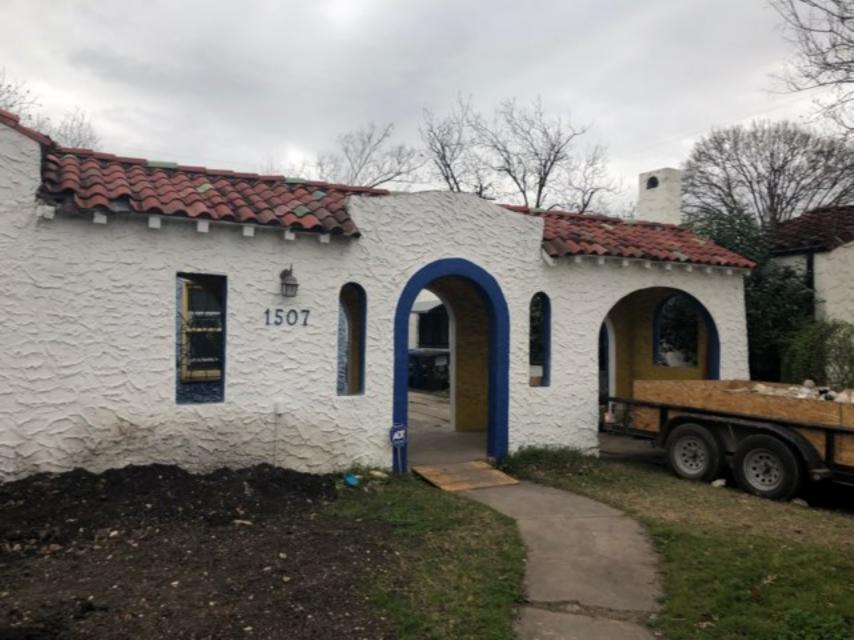
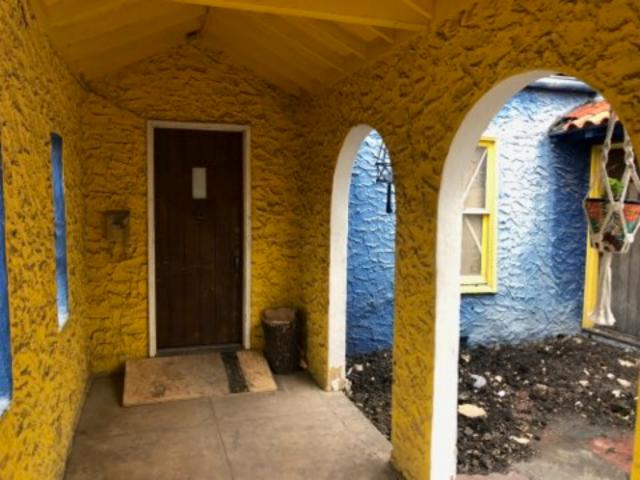
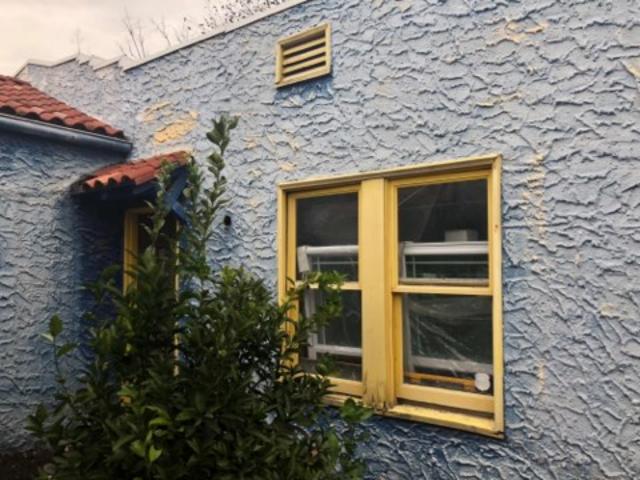
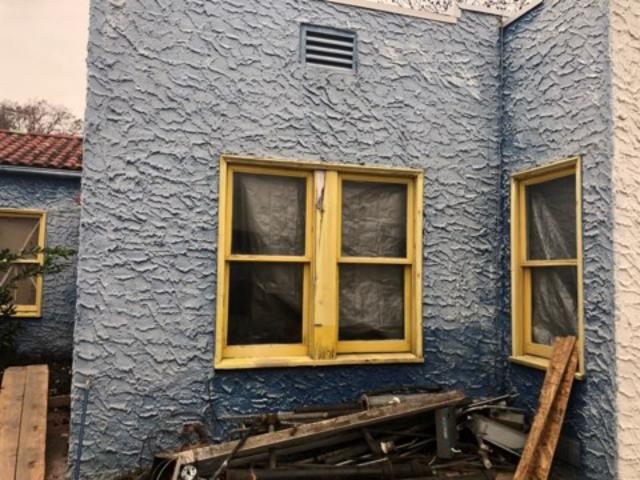
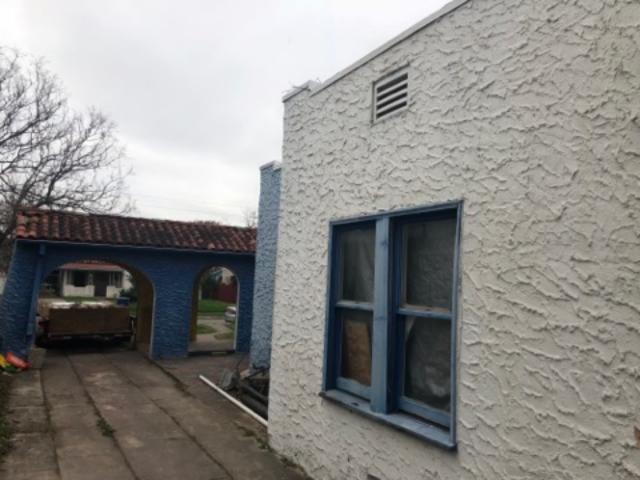
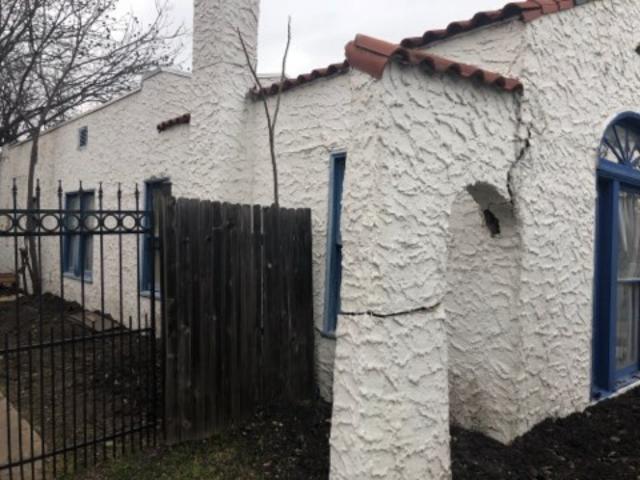
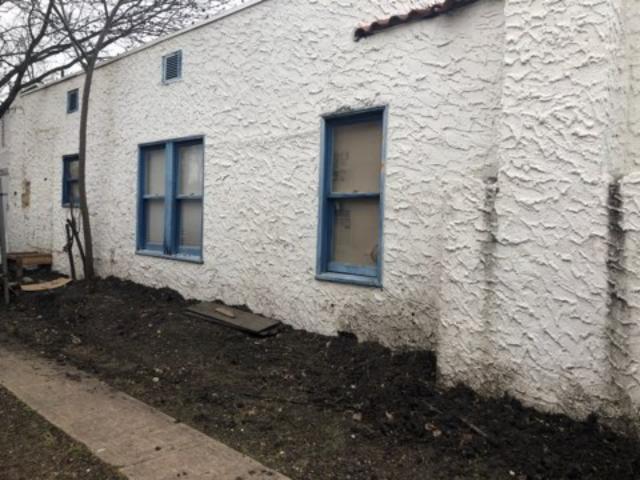
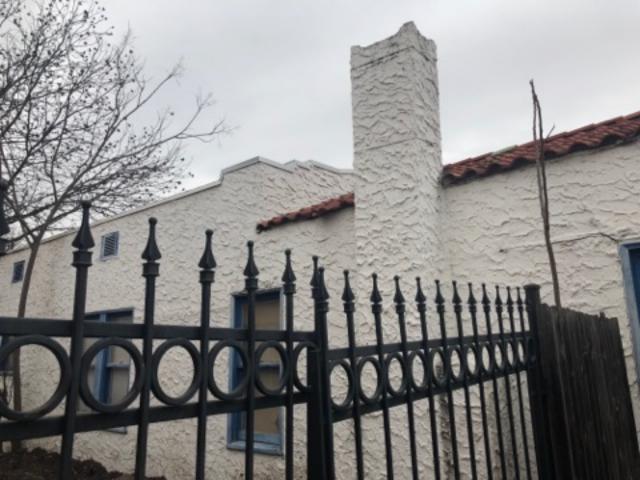
SILE VISIL	
Date	01/11/2019
Time	02:17 PM (-6 GMT)
Context	drive-by
Present Staff	Huy Pham, Other
Present Individuals	Contractor(s)
Present Companies	Unidentified individual
Types of Work Observed	Additions
Amount of Work Completed	25%
Description of work	Removal of rear historic wall planes in rear and imitation of wood framing for a rear addition
Description of interaction	The on-site contractor was generally cooperative and called the owner Aaron to speak to staff. The homeowner was not able to speak to staff but relayed the message to the contractor to not allow anyone into the property. Staff took photos from the public right of way.

Violation Type	No Certificate of Appropriateness (Code 35-451a)
OHP Action	Spoke with contractor(s) and/or crew
Deadline to contact office	01/11/2019
Will post-work application fee apply?	Yes
