## HISTORIC AND DESIGN REVIEW COMMISSION

February 20, 2019

**HDRC CASE NO:** 2019-050  
**ADDRESS:** 315 DEVINE ST  
**LEGAL DESCRIPTION:** NCB 725 BLK 7 LOT 9  
**ZONING:** R-6, H  
**CITY COUNCIL DIST.:** 1  
**DISTRICT:** Lavaca Historic District  
**APPLICANT:** Rodrigo Lillo/Lillo Investment Inc  
**OWNER:** Lillo Investment Inc  
**TYPE OF WORK:** Demo and Porch Repair  
**APPLICATION RECEIVED:** January 24, 2019  
**60-DAY REVIEW:** March 24, 2019  
**REQUEST:**

The applicant is requesting a Certificate of Appropriateness at 315 Devine to:

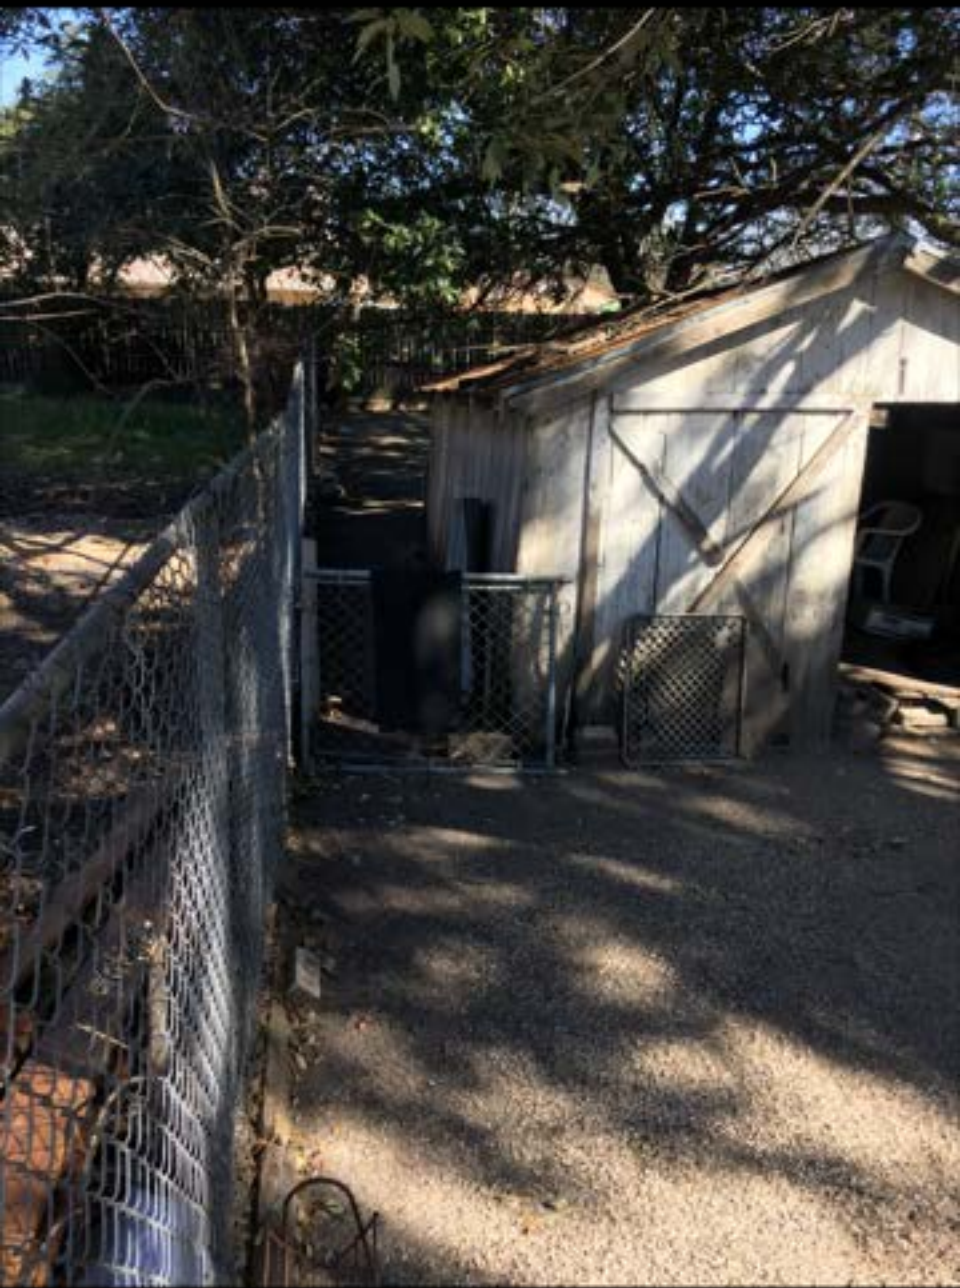
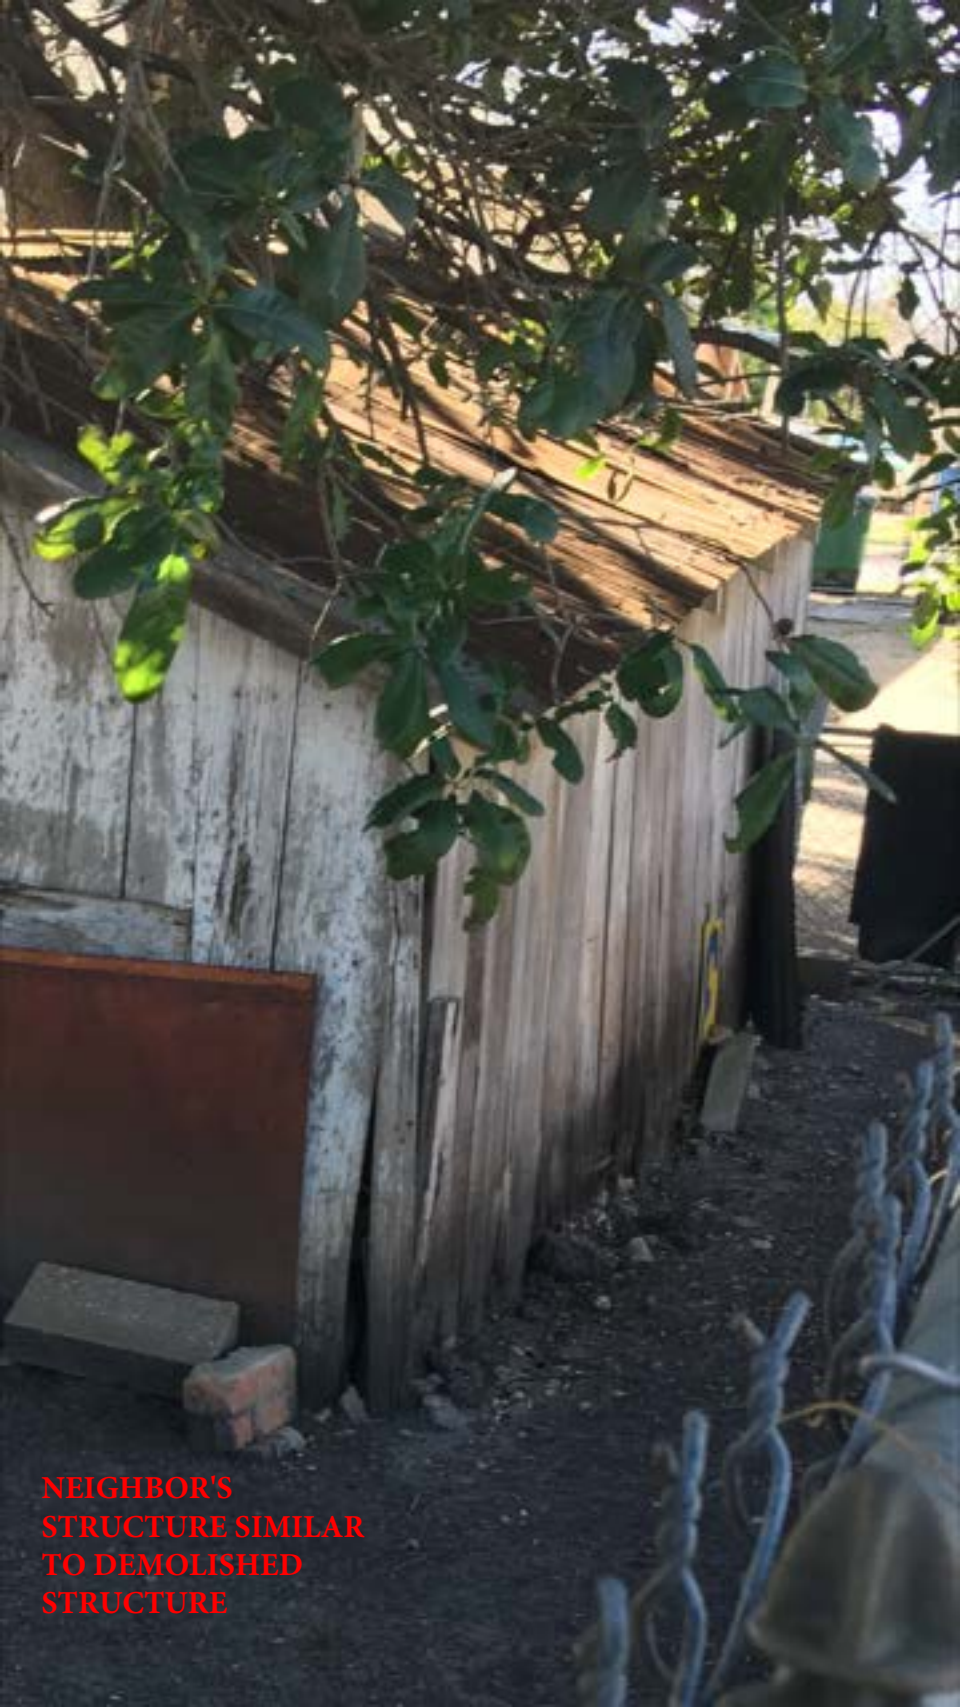
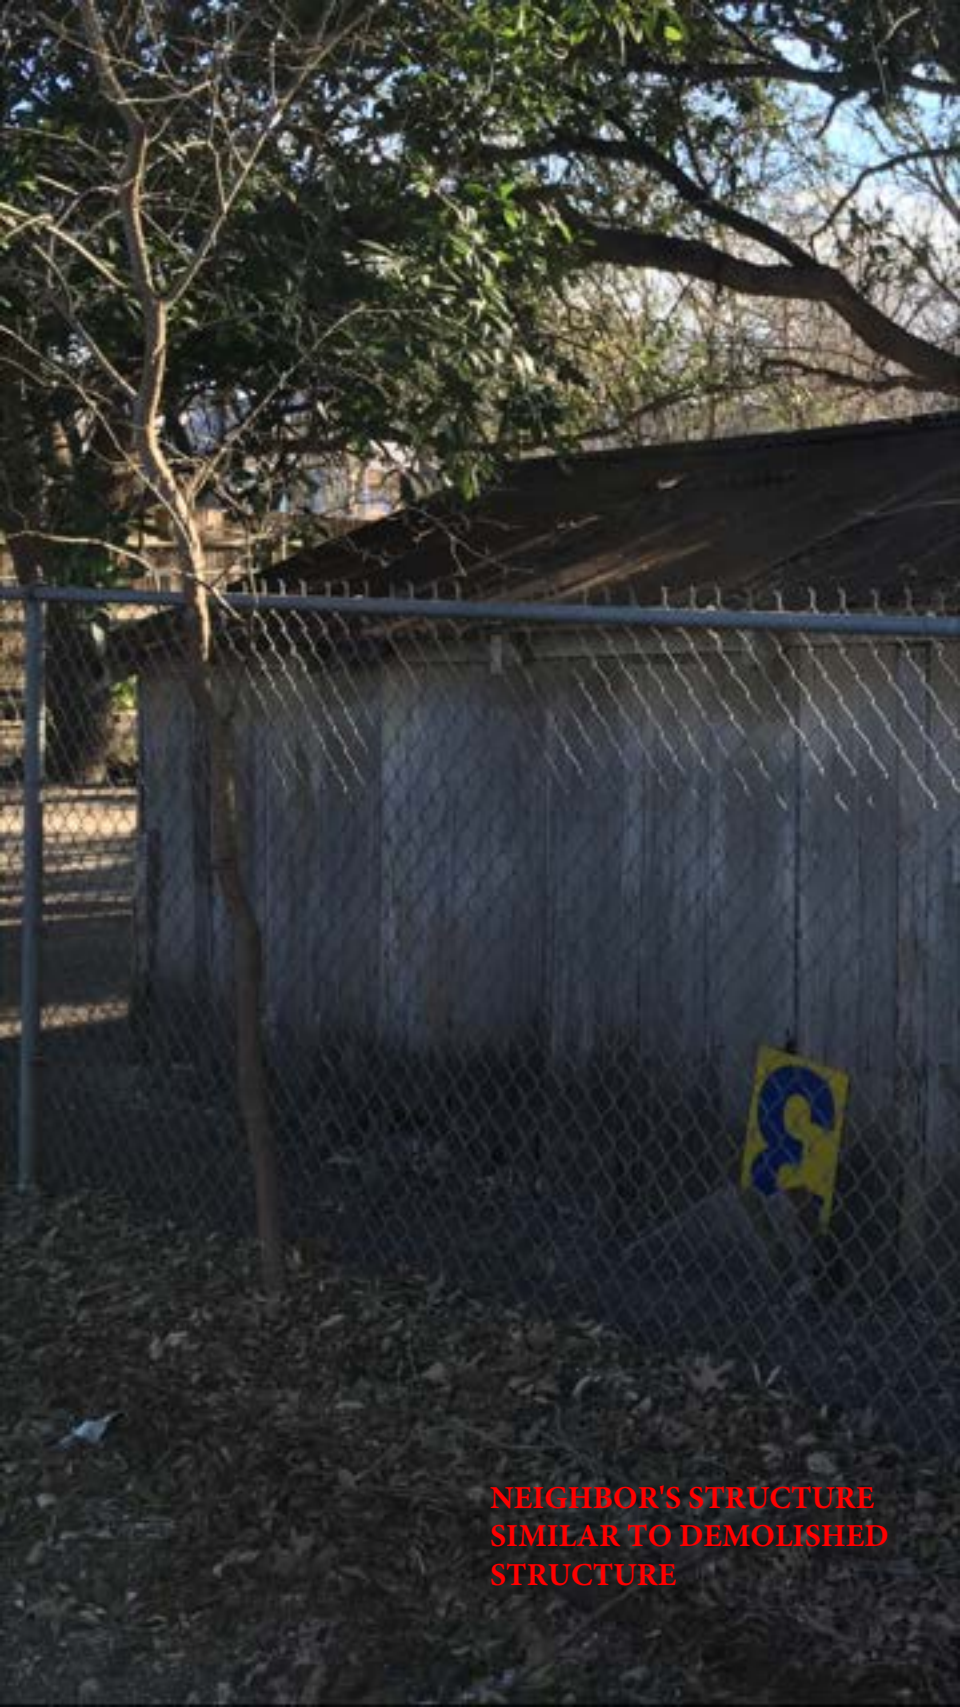
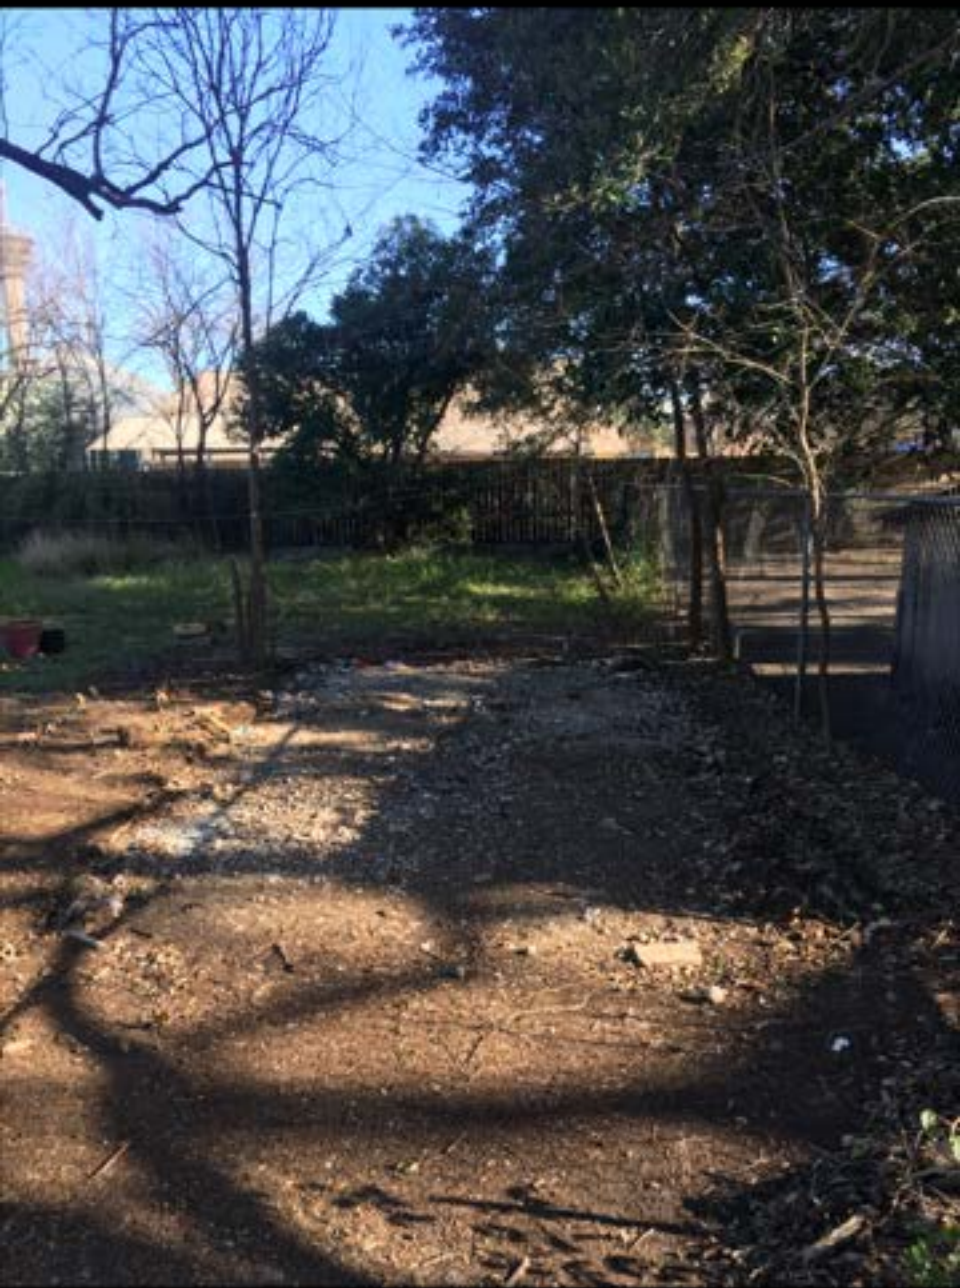
A photograph of a small, weathered wooden shed with a gabled roof. The shed is constructed of vertical wooden planks. The door, which features a lattice pattern, is leaning against the left side of the structure. The interior of the shed is dark and cluttered with various items, including a white plastic chair and a bag. The shed is situated on a gravel surface, and a large tree is visible in the background.

**NEIGHBOR'S  
STRUCTURE SIMILAR  
TO DEMOLISHED  
STRUCTURE**

**NEIGHBOR'S STRUCTURE  
SIMILAR TO DEMOLISHED  
STRUCTURE**

NEIGHBOR'S  
STRUCTURE SIMILAR  
TO DEMOLISHED  
STRUCTURE

- c. REAR ACCESSORY STRUCTURE – The applicant is requesting to demolish a rear accessory structure. The applicant could not provide photos of the structure before it was demolished but references a neighboring property’s accessory structure as matching to the one at 315 Devine, in the same configuration but in a more deteriorated condition.

- a. CONTRIBUTING STATUS – The referenced accessory structure features vertical wood siding, a lack of a foundation, and a sheet metal roof. While the applicant has stated that the structure was rapidly deteriorating, staff finds the structure is still contributing to the district based on photos provided by the applicant of the referenced structure and the 1951 Sanborn map.
