HISTORIC AND DESIGN REVIEW COMMISSION

HDRC CASE NO: 2019-071
ADDRESS: 1839 E HOUSTON ST
LEGAL DESCRIPTION: NCB 1370 BLK 2 LOT 28 E 10 FT OF 27
ZONING: RM-4
CITY COUNCIL DIST.: 2
DISTRICT: Dignowity Hill Historic District
APPLICANT: Gaspar Rivera/Poma Properties LLC
OWNER: Poma Properties LLC
TYPE OF WORK: Historic Tax Certification, door replacement
APPLICATION RECEIVED: February 13, 2019
60-DAY REVIEW: April 12, 2019
REQUEST:

1839 E Houston St San Antonio TX. 78202

Scope of Work includes:

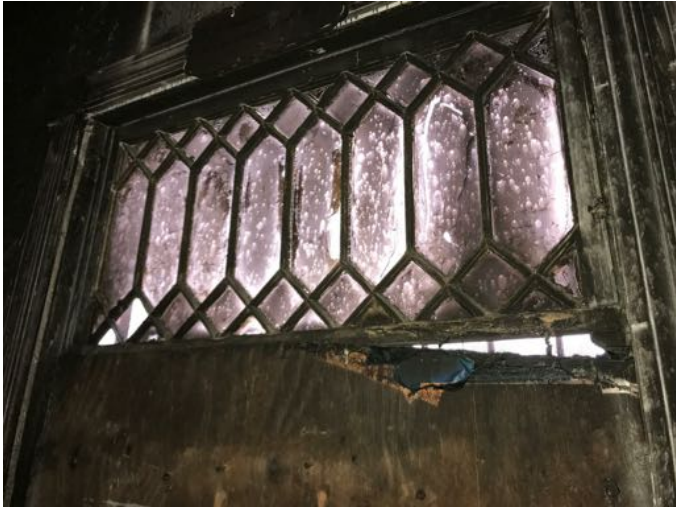
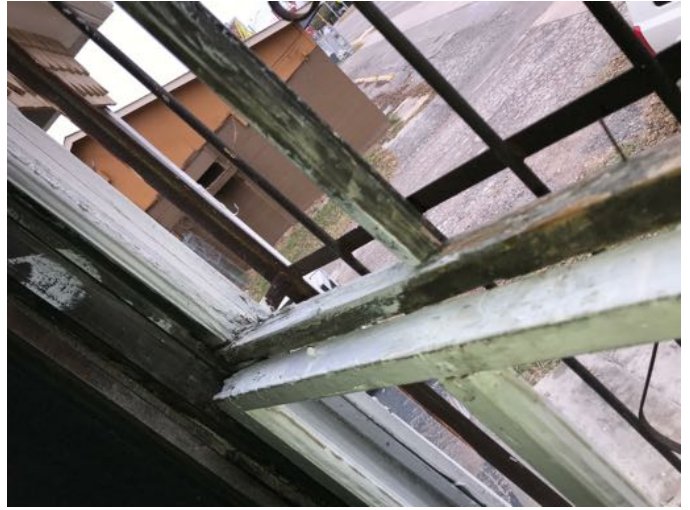
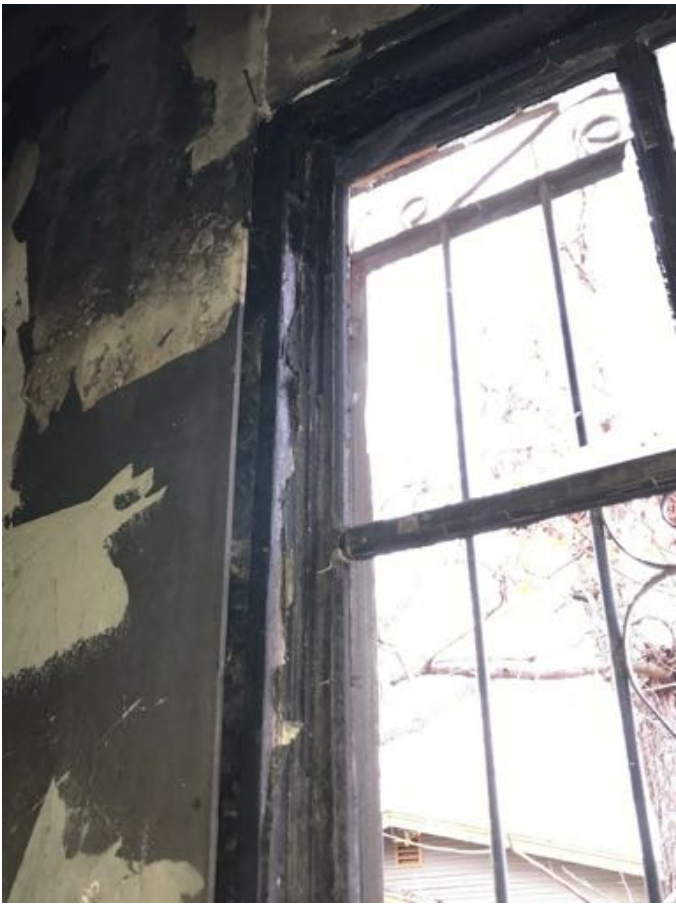
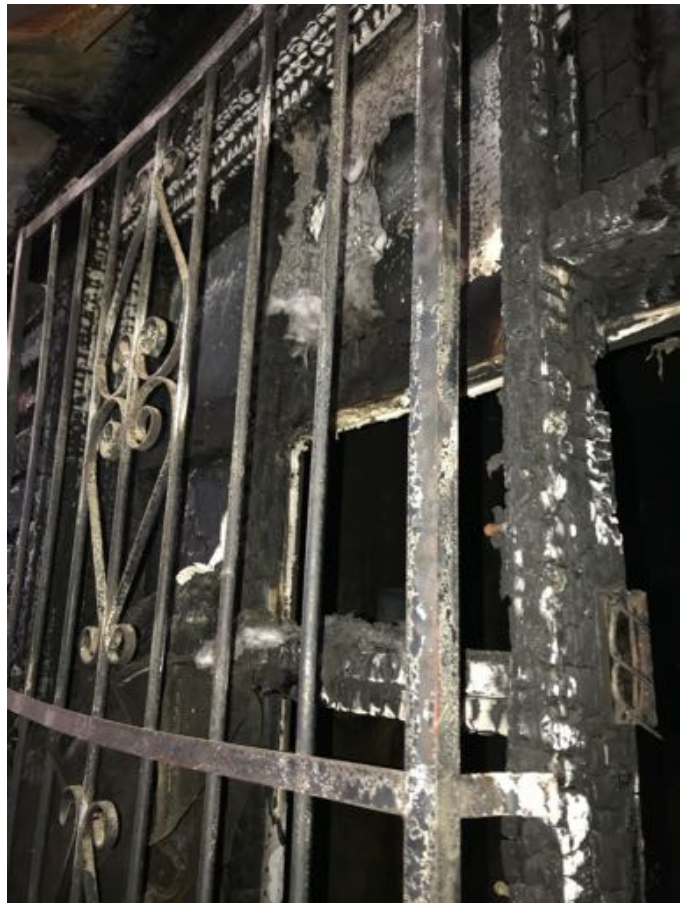
Existing damage to wood windows

1. Restore original wood siding.
2. Remove window security bars
3. Remove fence at south of property (facing Houston St)
4. Restore salvageable existing wood windows,
otherwise replace with new JELD-WEN wood windows.
5. Replace secondary door at front porch with wood window.
6. Install missing wood columns at front porch.
7. Restore roof shingles as necessary. New roof to match existing.
8. Intall new privacy wood fence. Refer to site for fence location.
9. Replace skirting with Hardie Board.
10. Replace concrete steps with wood steps at entry porch.
11. New wood deck at north side of house.
12. New addition of master suite at north side of house.
Addition to have board & batten siding.
13. Paint exterior.
14. Renovation of interior spaces. (As shown in drawings.)
