### HISTORIC AND DESIGN REVIEW COMMISSION March 20, 2019

**HDRC CASE NO:** 2019-110

**ADDRESS:** 1201 E CROCKETT ST

**TYPE OF WORK:** Addition of a dormer on rear roof slope

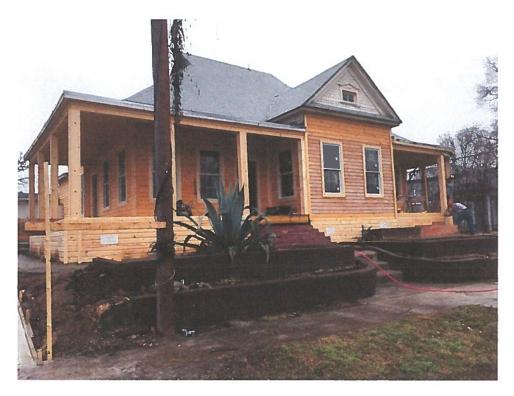
Front Elevation (Facing Pine)

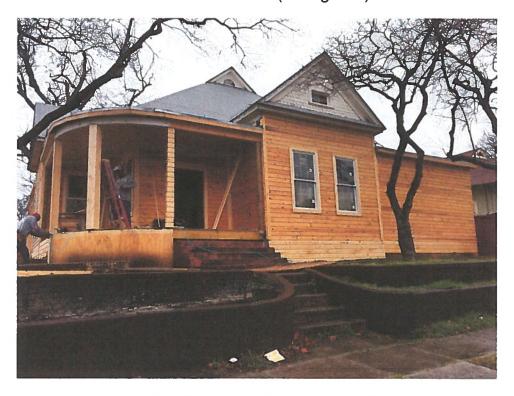
Side Elevation (Facing Crockett)

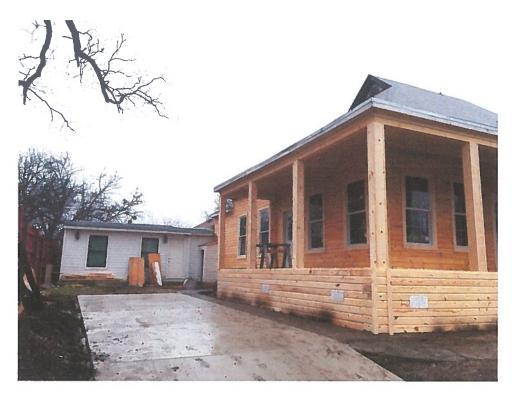
Side Elevation

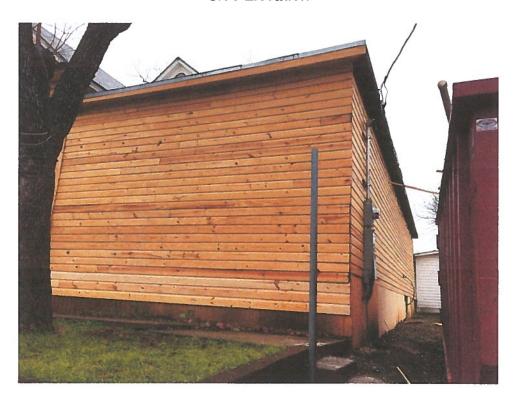
Rear Elevation

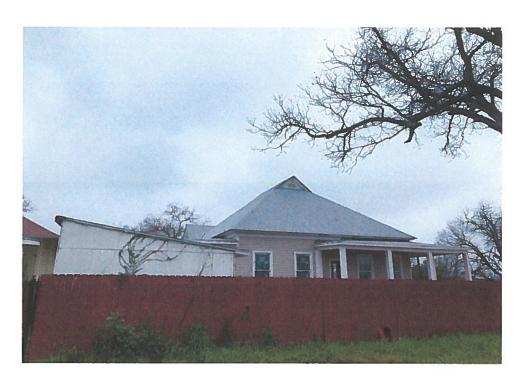
North (Side) Elevation Showing Rear of Roof

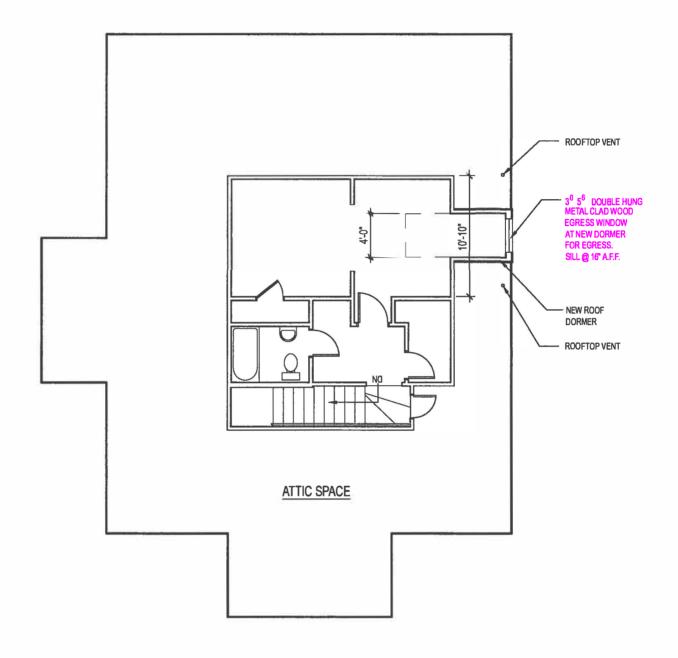
1201 EAST CROCKETT PARTIAL PLAN - STAIRS (2ND FLOOR)

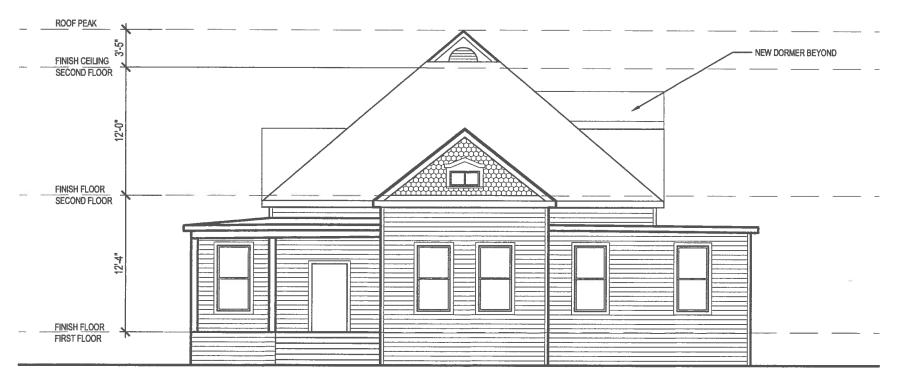
1201 EAST CROCKETT - SOUTH ELEVATION (CROCKETT)

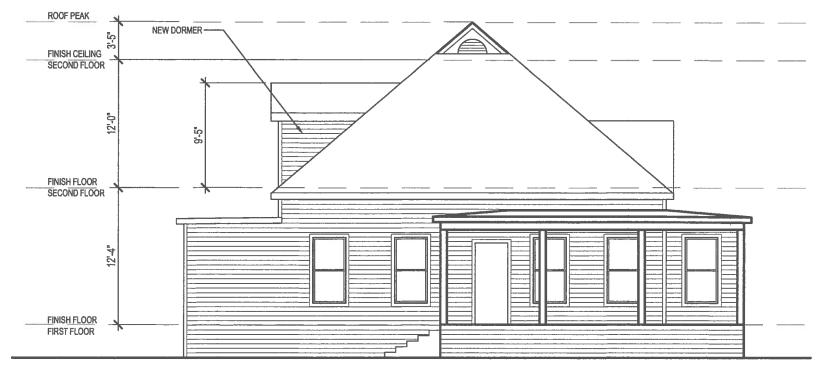
1201 EAST CROCKETT - NORTH ELEVATION (SIDE)

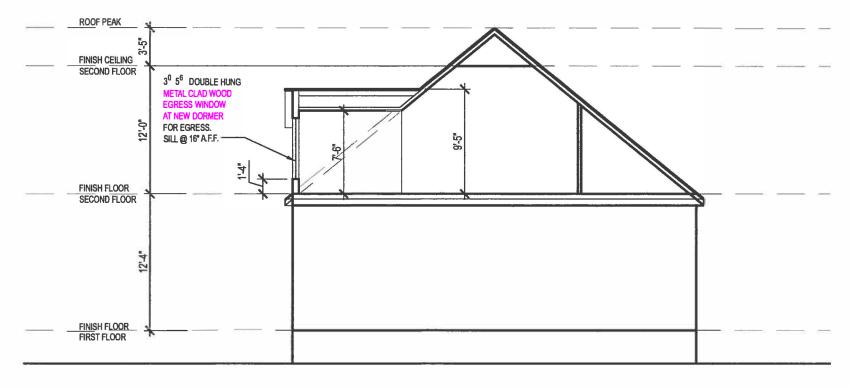
# 1201 EAST CROCKETT HOUSE SECTION THRU DORMER

façade. This request was proposed in pursuit of compliance of the fire code that requires egress for an attic bedroom. Per the Guidelines for Additions 3.1.B.iii notes that dormers should be compatible in size, scale, proportion, placement, and detail with the style of the house. Additionally, the Guidelines note to locate dormers only on non-primary facades (those not facing the public right-of-way) if not historically found within the district. Staff finds that the proposed dormer is consistent with the Guidelines.

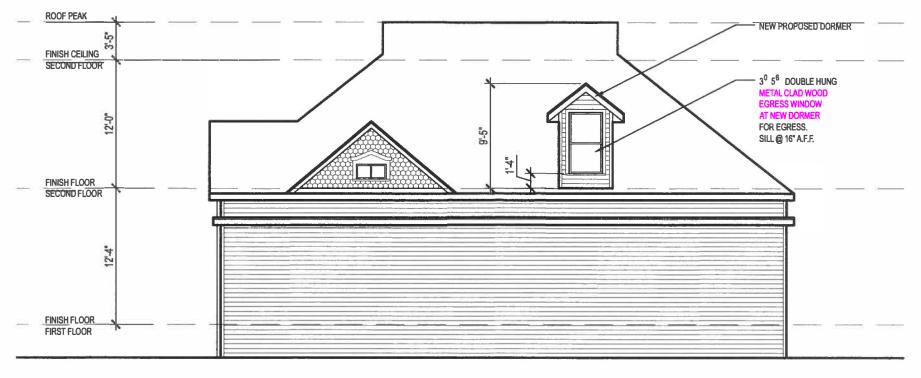
1201 EAST CROCKETT - EAST ELEVATION (REAR)

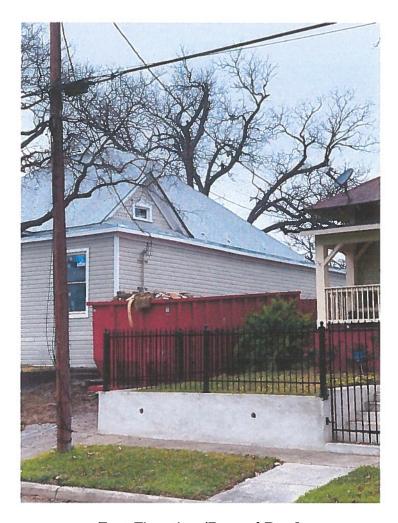
East Elevation (Rear of Roof)
