HISTORIC AND DESIGN REVIEW COMMISSION

April 03, 2019

HDRC CASE NO: 2019-142
ADDRESS: 311 W HUISACHE AVE
LEGAL DESCRIPTION: NCB 3001 BLK 3 LOT 20
ZONING: R-4,H
CITY COUNCIL DIST.: 1
DISTRICT: Monte Vista Historic District
APPLICANT: OCG Austin, LLC
OWNER: OCG Austin, LLC
TYPE OF WORK: Historic Tax Certification
APPLICATION RECEIVED: March 14, 2019
60-DAY REVIEW: May 13, 2019
CASE MANAGER: Adam Rajper
REQUEST:

The applicant is requesting Historic Tax Certification for the property at 311 W Huisache.

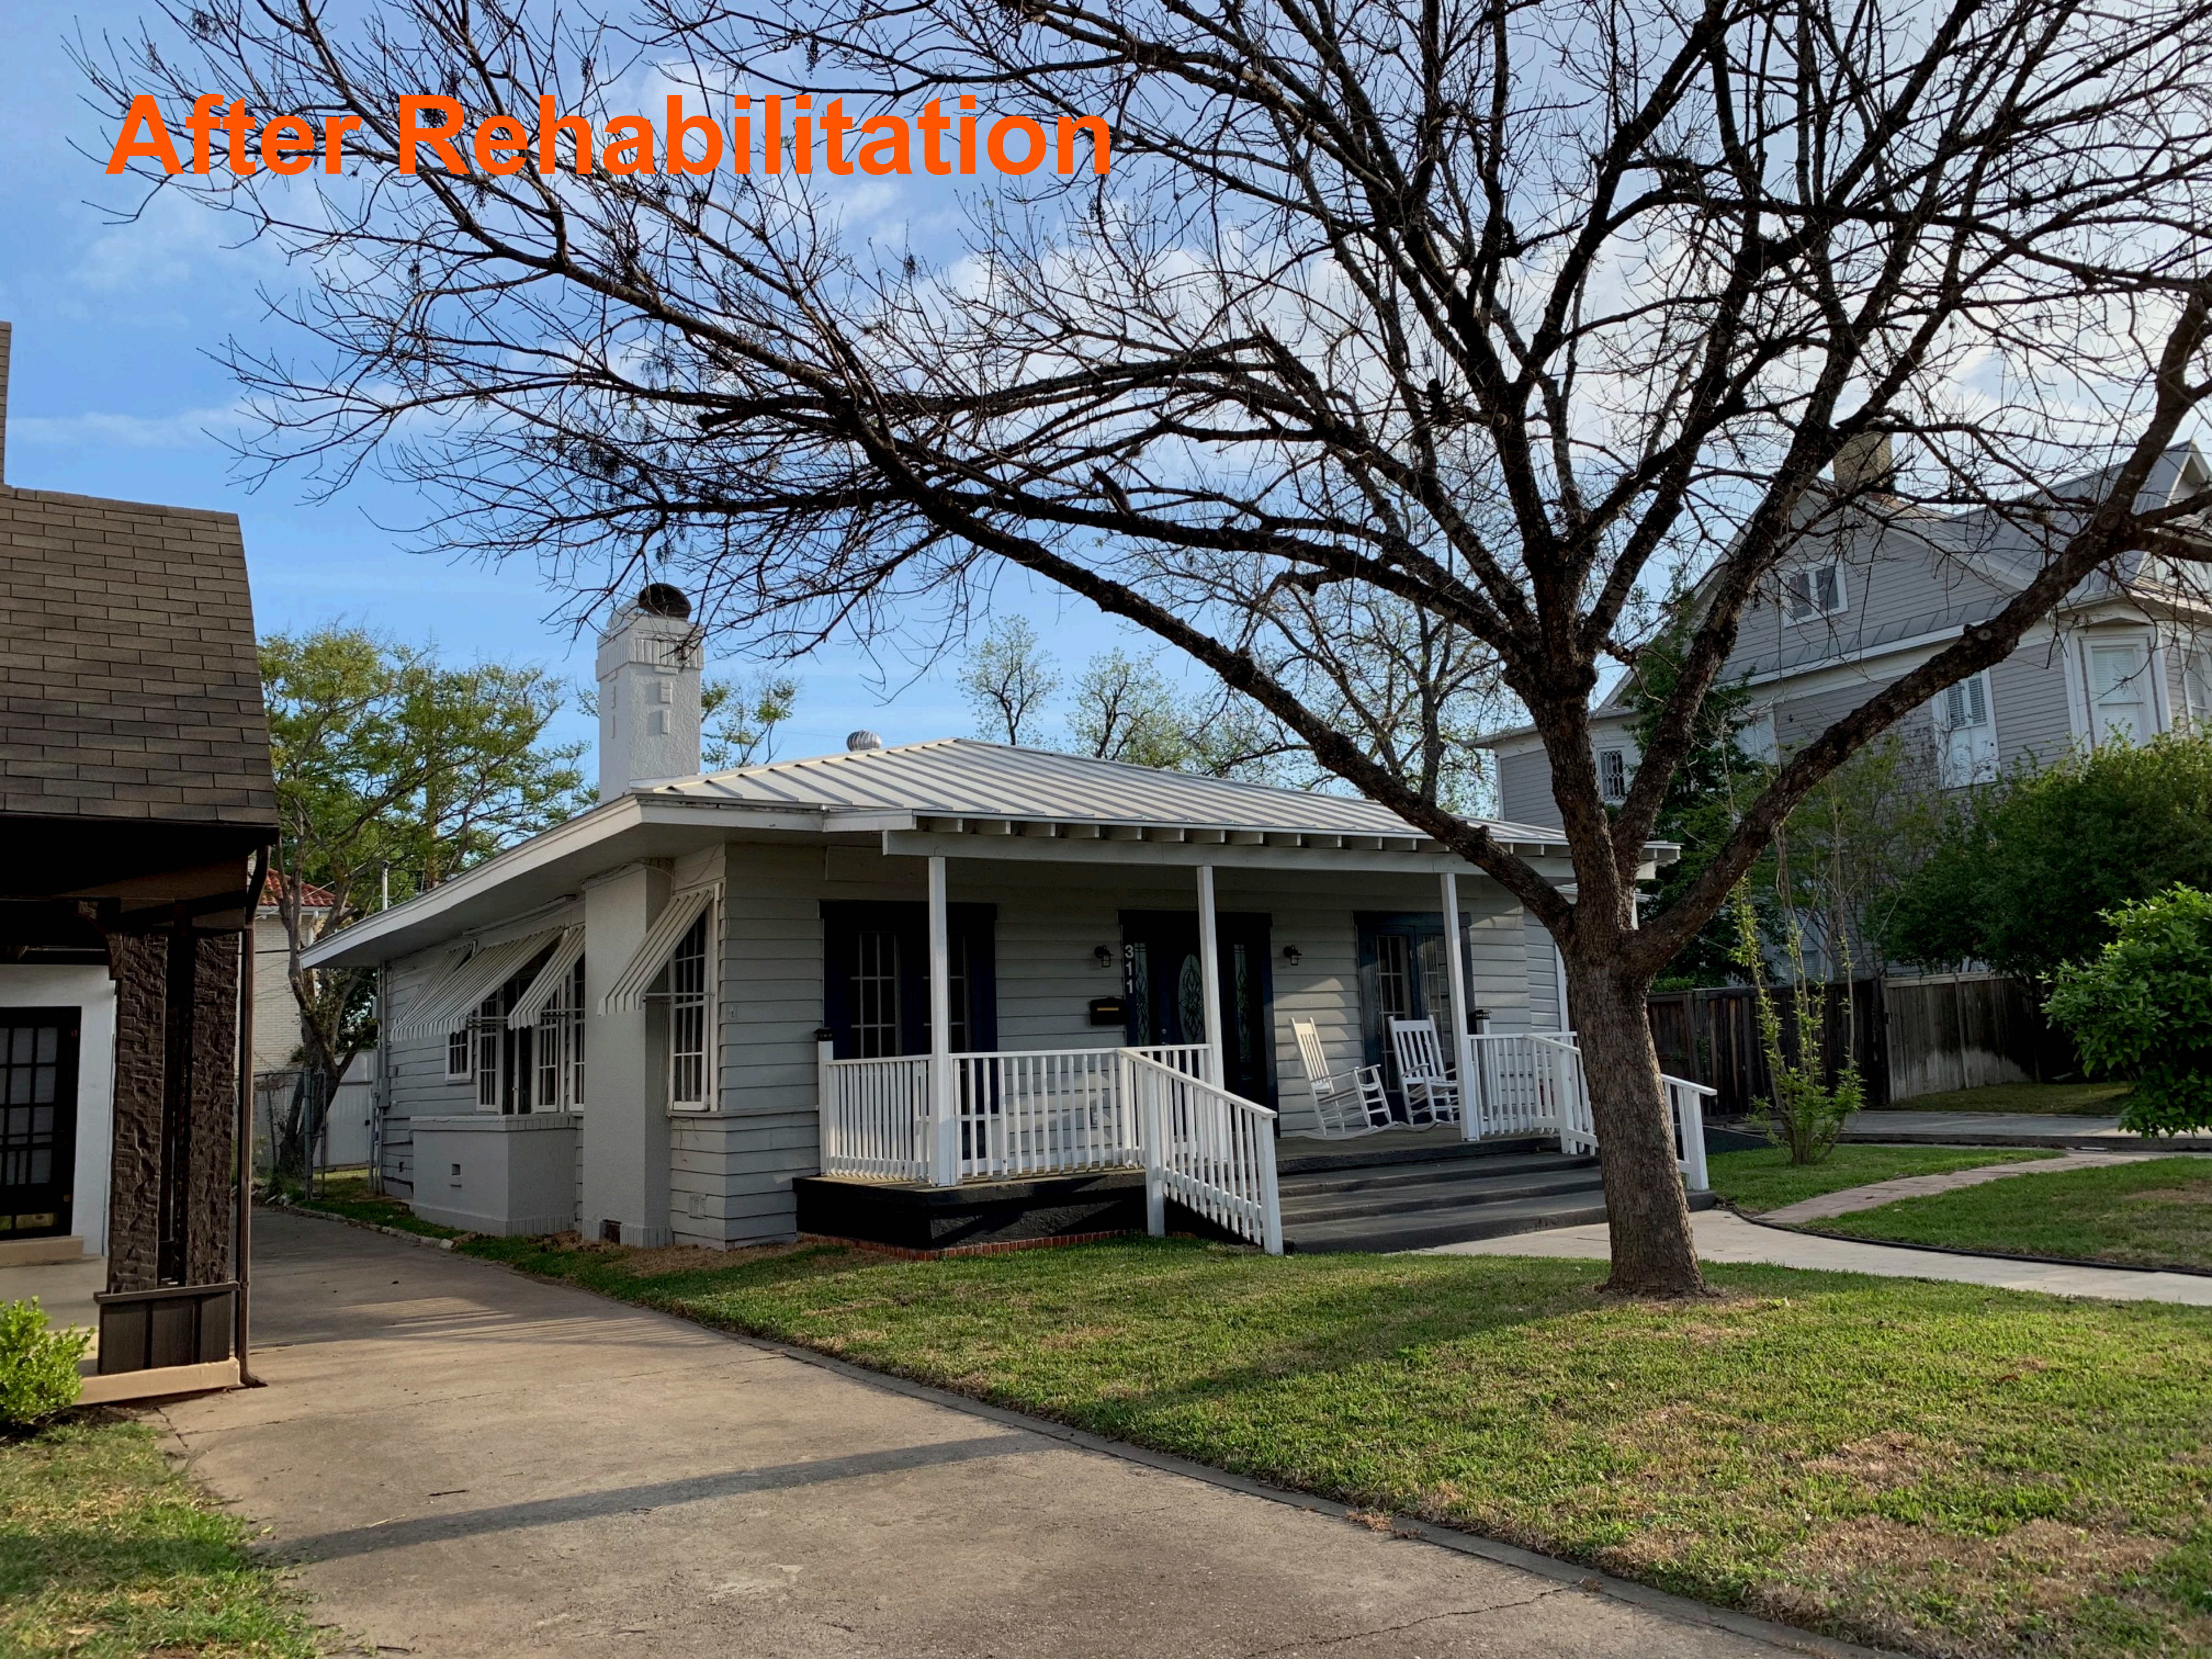
After Rehabilitation

- e. A number of interior and exterior rehabilitative scopes of work have been completed. Exterior work includes enclosure of a street-facing door, modifications to the porch railing, and replacement of a non-original metal awning with a metal shed roof on the front porch. Staff finds that the applicant has enclosed the front-facing door without satisfying staff stipulations or receiving a Certificate of Appropriateness. The applicant has also not satisfied staff stipulations or obtained a Certificate of Appropriateness for the two porch modifications. The property is not eligible for Historic Tax Certification or Historic Tax Verification until these items are resolved with approval, reversal, or correction.

- f. The applicant began work in August 2018. Staff conducted a site visit on March 26, 2019 to examine the exterior conditions of the property. During the site visit, staff confirmed that the exterior work has been completed.

- i. Reverse the unapproved work on the primary façade or comply with the previous staff stipulation dated November 7, 2018 requiring the installation of a window on the street-facing portion of the side addition that is consistent with the size, proportions, configuration, inset, and detailing as those on the original structure or similar to those in the district. The applicant is required to submit a window specification and updated elevation to staff for review and approval prior to receiving a Certificate of Appropriateness.
- ii. That the applicant submit final dimensioned drawings for the front porch railing and new front porch roof to staff for review and approval prior to receiving a Certificate of Appropriateness.

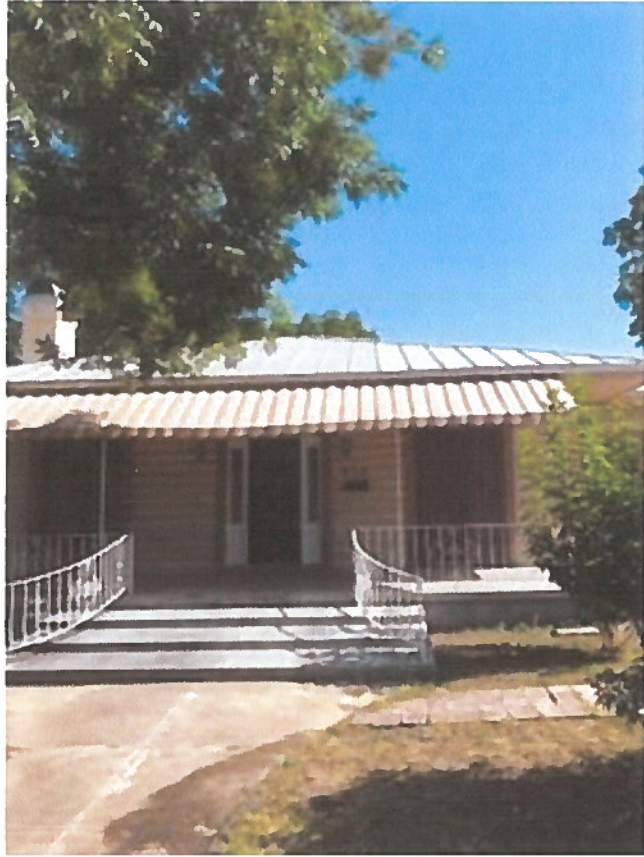
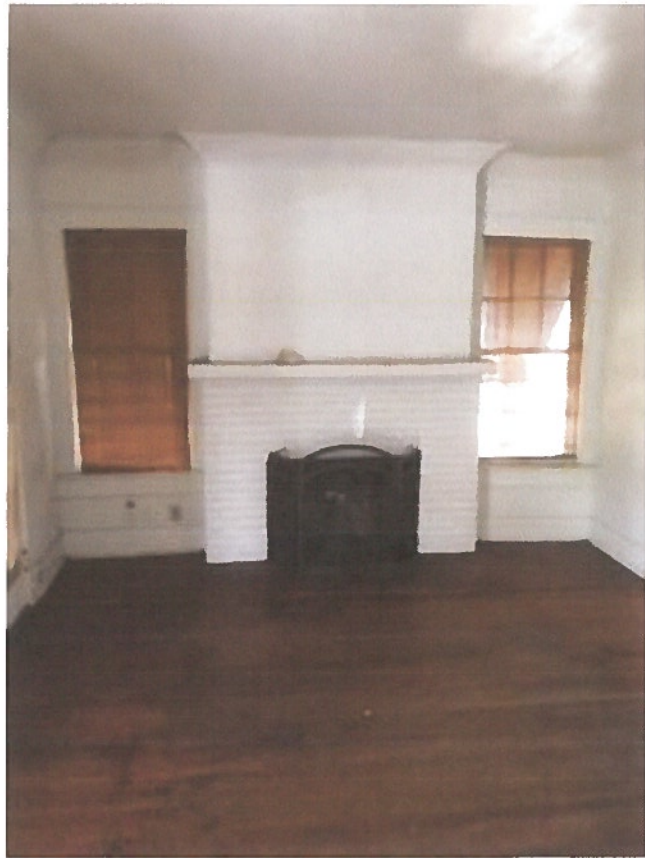
Before Rehabilitation

- a. The primary structure at 311 W Huisache is a one-story single-family Craftsman-style residence constructed in c. 1920. The structure features a primary hipped roof, a stucco chimney, and two pairs of French doors flanking the front entrance. Later modifications include the enclosure of an original porch on the east side of the home, modifications to the front door configuration, and the installation of new siding. The structure is contributing to the Monte Vista Historic District.
