### HISTORIC AND DESIGN REVIEW COMMISSION

May 01, 2019

HDRC CASE NO:	2019-223
ADDRESS:	517 E HOUSTON ST
LEGAL DESCRIPTION:	NCB 422 BLK 26 W 26 FT OF 5 ARB A2
ZONING:	D, H, HS
CITY COUNCIL DIST.:	1
DISTRICT:	Alamo Plaza Historic District
LANDMARK:	Rosenberg, Frank Building
APPLICANT:	Michael Litofsky
OWNER:	Michael Litofsky
TYPE OF WORK:	Front Facade Reconstruction, including removal of ClearBoarding for compliance
OWNER:	Michael Litofsky

The applicant is requesting a Certificate of Appropriateness for approval to construct the storefront at 517 E Houston in accordance with plans approved by the HDRC on May 20, 2015 and a timeline of compliance. This request is a result of a municipal court case filed for the installation of ClearBoarding prior to approval.

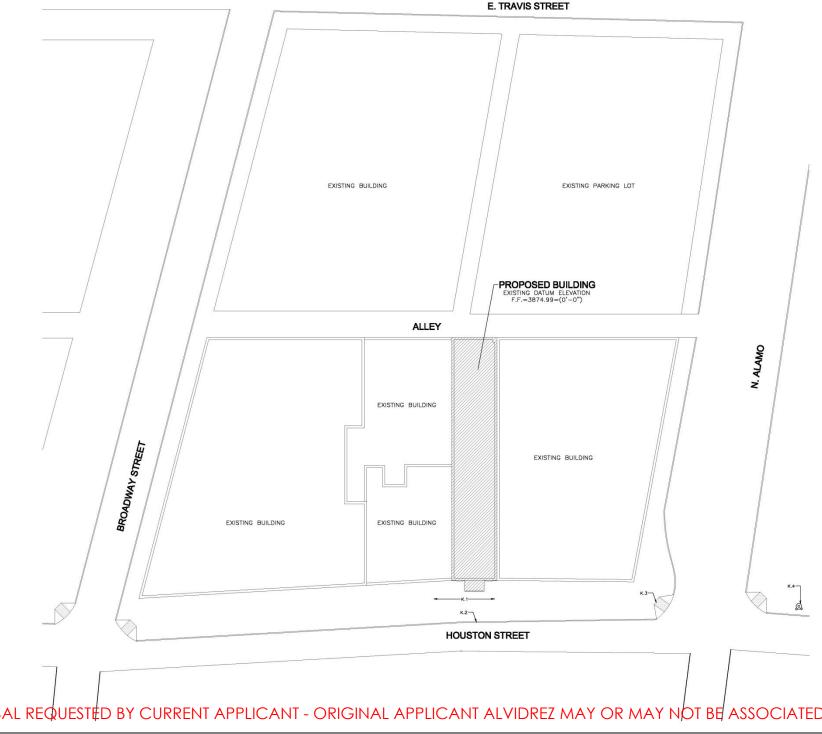
**GROUND LEVEL FLOOR PLAN**

# NO \* 17'-11" 4'-0' 9'-2" STEPS DN 23'-5" 21'-11"

- 1. STOREFRONT While currently covered by plywood, the storefront façade at 517 E Houston features a recessed storefront entrance. Other storefront entrances on E Houston do not feature entrances nearly as deep as this one, which leads staff to believe that 517 E Houston's storefront entrance is not an original element of the building's

design. The applicant has proposed to alter the storefront entrance to become more consistent with other storefront setbacks along E Houston. Staff finds that this request appropriate.

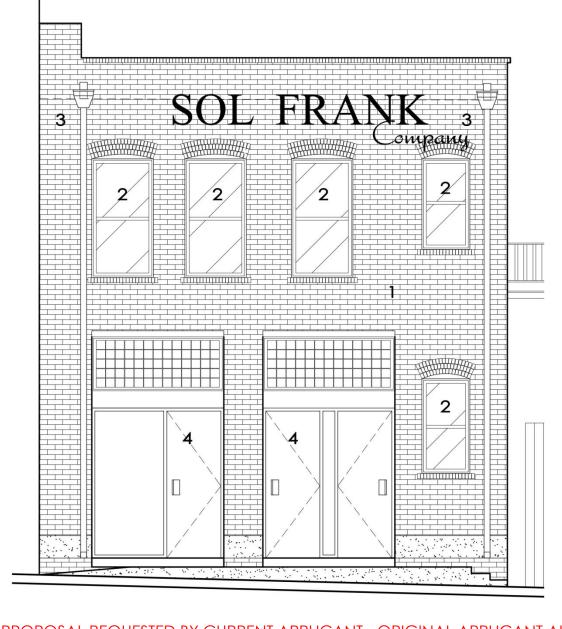
## NORTH ELEVATION

CLEAN AND RESTORE EXISTING BRICK

**RESTORE SCUPPER, DOWNSPOUT**

2 **REPLACE WINDOWS**

**NEW DOORS**

AND DOWN LEADER

- a. FAÇADE MATERIAL RESTORATION The applicant has proposed to restore the existing plaster façade which fronts E Houston as well as to restore the existing rear brick façade which fronts Peacock Alley. This is consistent with the Guidelines for Exterior Maintenance and Alterations 2. A. and 2.B. and 10.B.ii.

- i. GUTTER SYSTEM The applicant has proposed to restore the scuppers, downspouts and down leaders of the existing gutter system. While those that are currently on the façade are not historic, their repair is consistent with the Guidelines for Exterior Maintenance and Alterations 4.A.

- m. NEW WINDOWS According to the Guidelines for Exterior Maintenance and Alterations, new windows that match the historic windows of a structure should be installed when the existing windows are missing or deteriorated beyond repair. The applicant has proposed to install new one over one wood windows on the Peacock Alley (rear) façade of the structure. This is consistent with the Guidelines for Exterior Maintenance and Alterations 6.B.iv.

- n. NEW DOORS The applicant has proposed to install two (2) new doors on the Peacock Alley façade. While this is the rear of the building, in this instance the rear is proposed to be treated as the front also. The Guidelines for Exterior Maintenance and Alterations 6.A.i. does not recommend that new entrances be created where visible from the public right of way. This proposal is not consistent with the Guidelines. Staff recommends that the applicant keep the existing door openings and widths.
