# HISTORIC AND DESIGN REVIEW COMMISSION June 05, 2019

HDRC CASE NO: 2019-273

**ADDRESS:** 1434 FULTON AVE **LEGAL DESCRIPTION:** NCB 2752 BLK 58 LOT 4

**TYPE OF WORK:** Demolition of a rear accessory structure

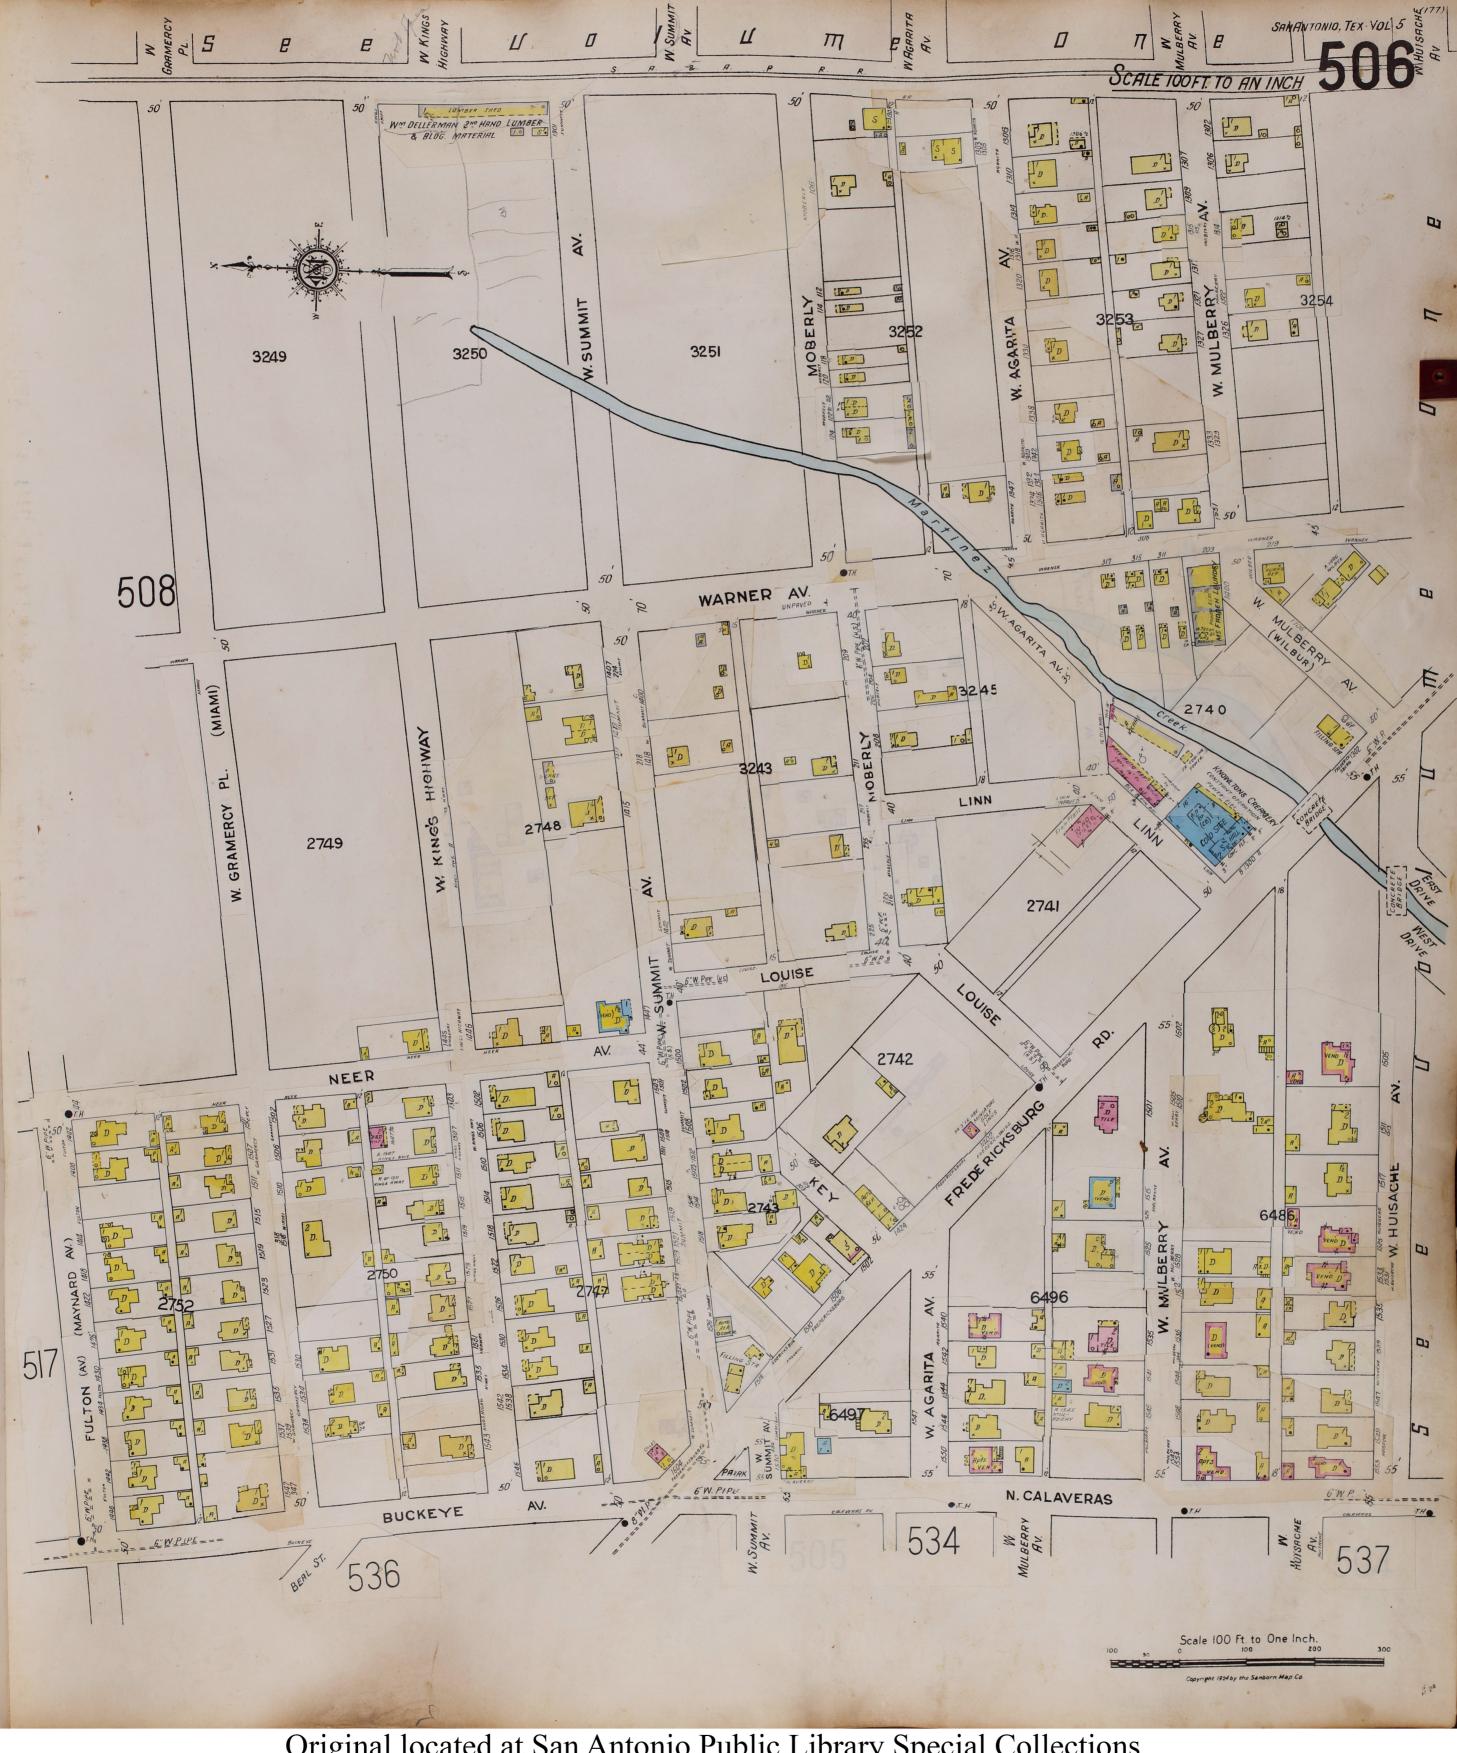
Original located at San Antonio Public Library Special Collections

The subject structure first appears on the 1938 Sanborn map.<sup>5</sup> The map shows a development pattern of single-family residences with L-plan garages on every parcel that shares a block with the subject structure, and accessory structures are common throughout the neighborhood. The parapet likely marks the original entrance to the garage from the alley that runs along the east side of the parcel. There are what appear to be reversible additions to the original structure, but the parapet and rooflines of the original structure are intact and visible. Modifications over time are common among historic structures; modern additions or changes to the garage such as the French doors visible on the south façade do not impact its relationship to the primary structure or its contribution to the historic fabric of the Fulton Avenue historic district.

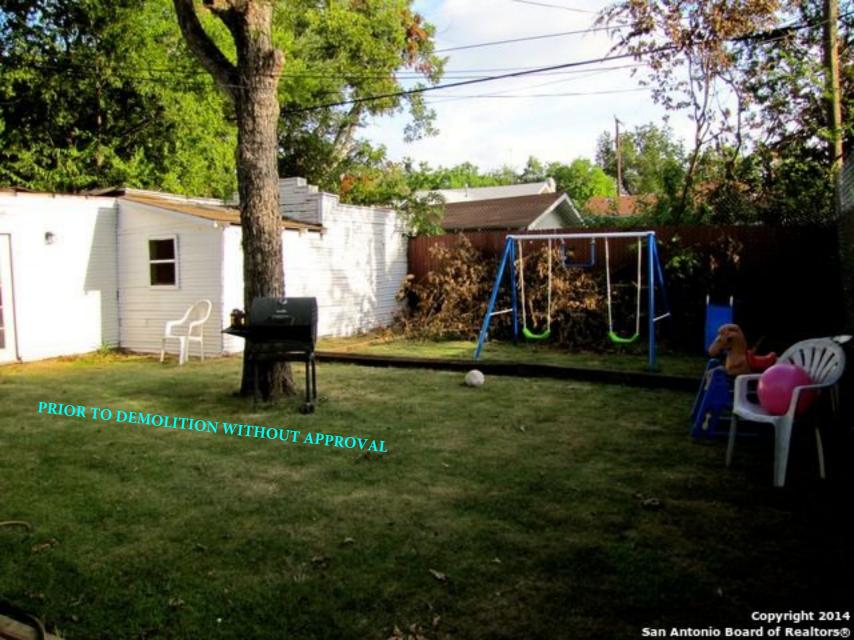
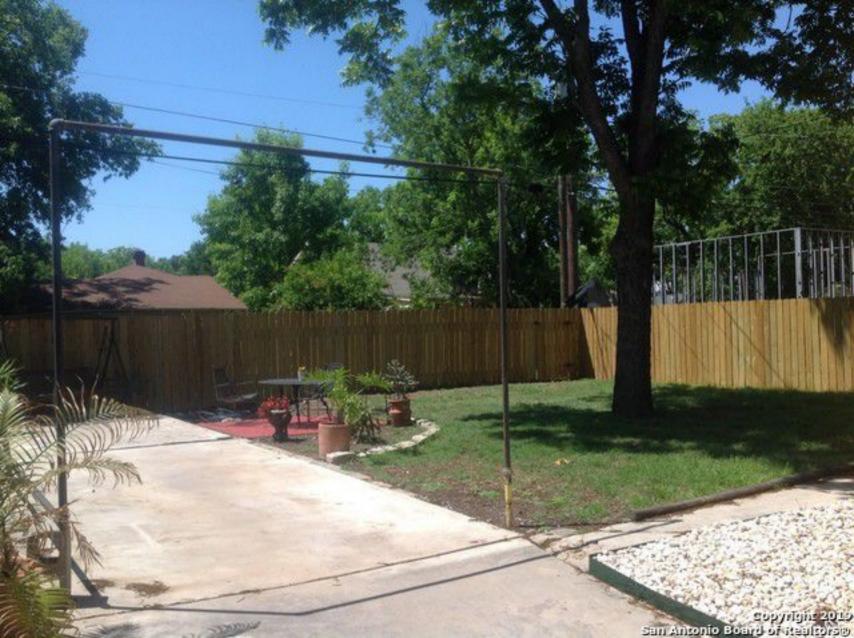
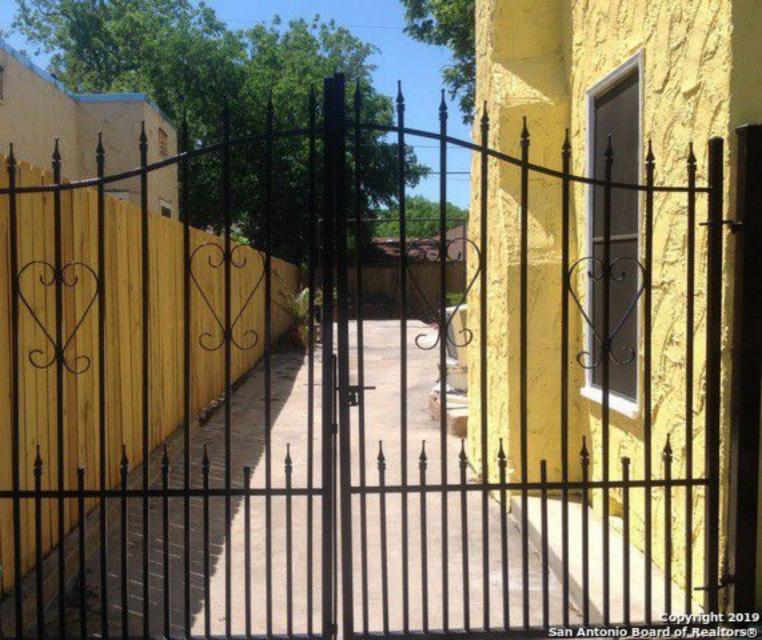
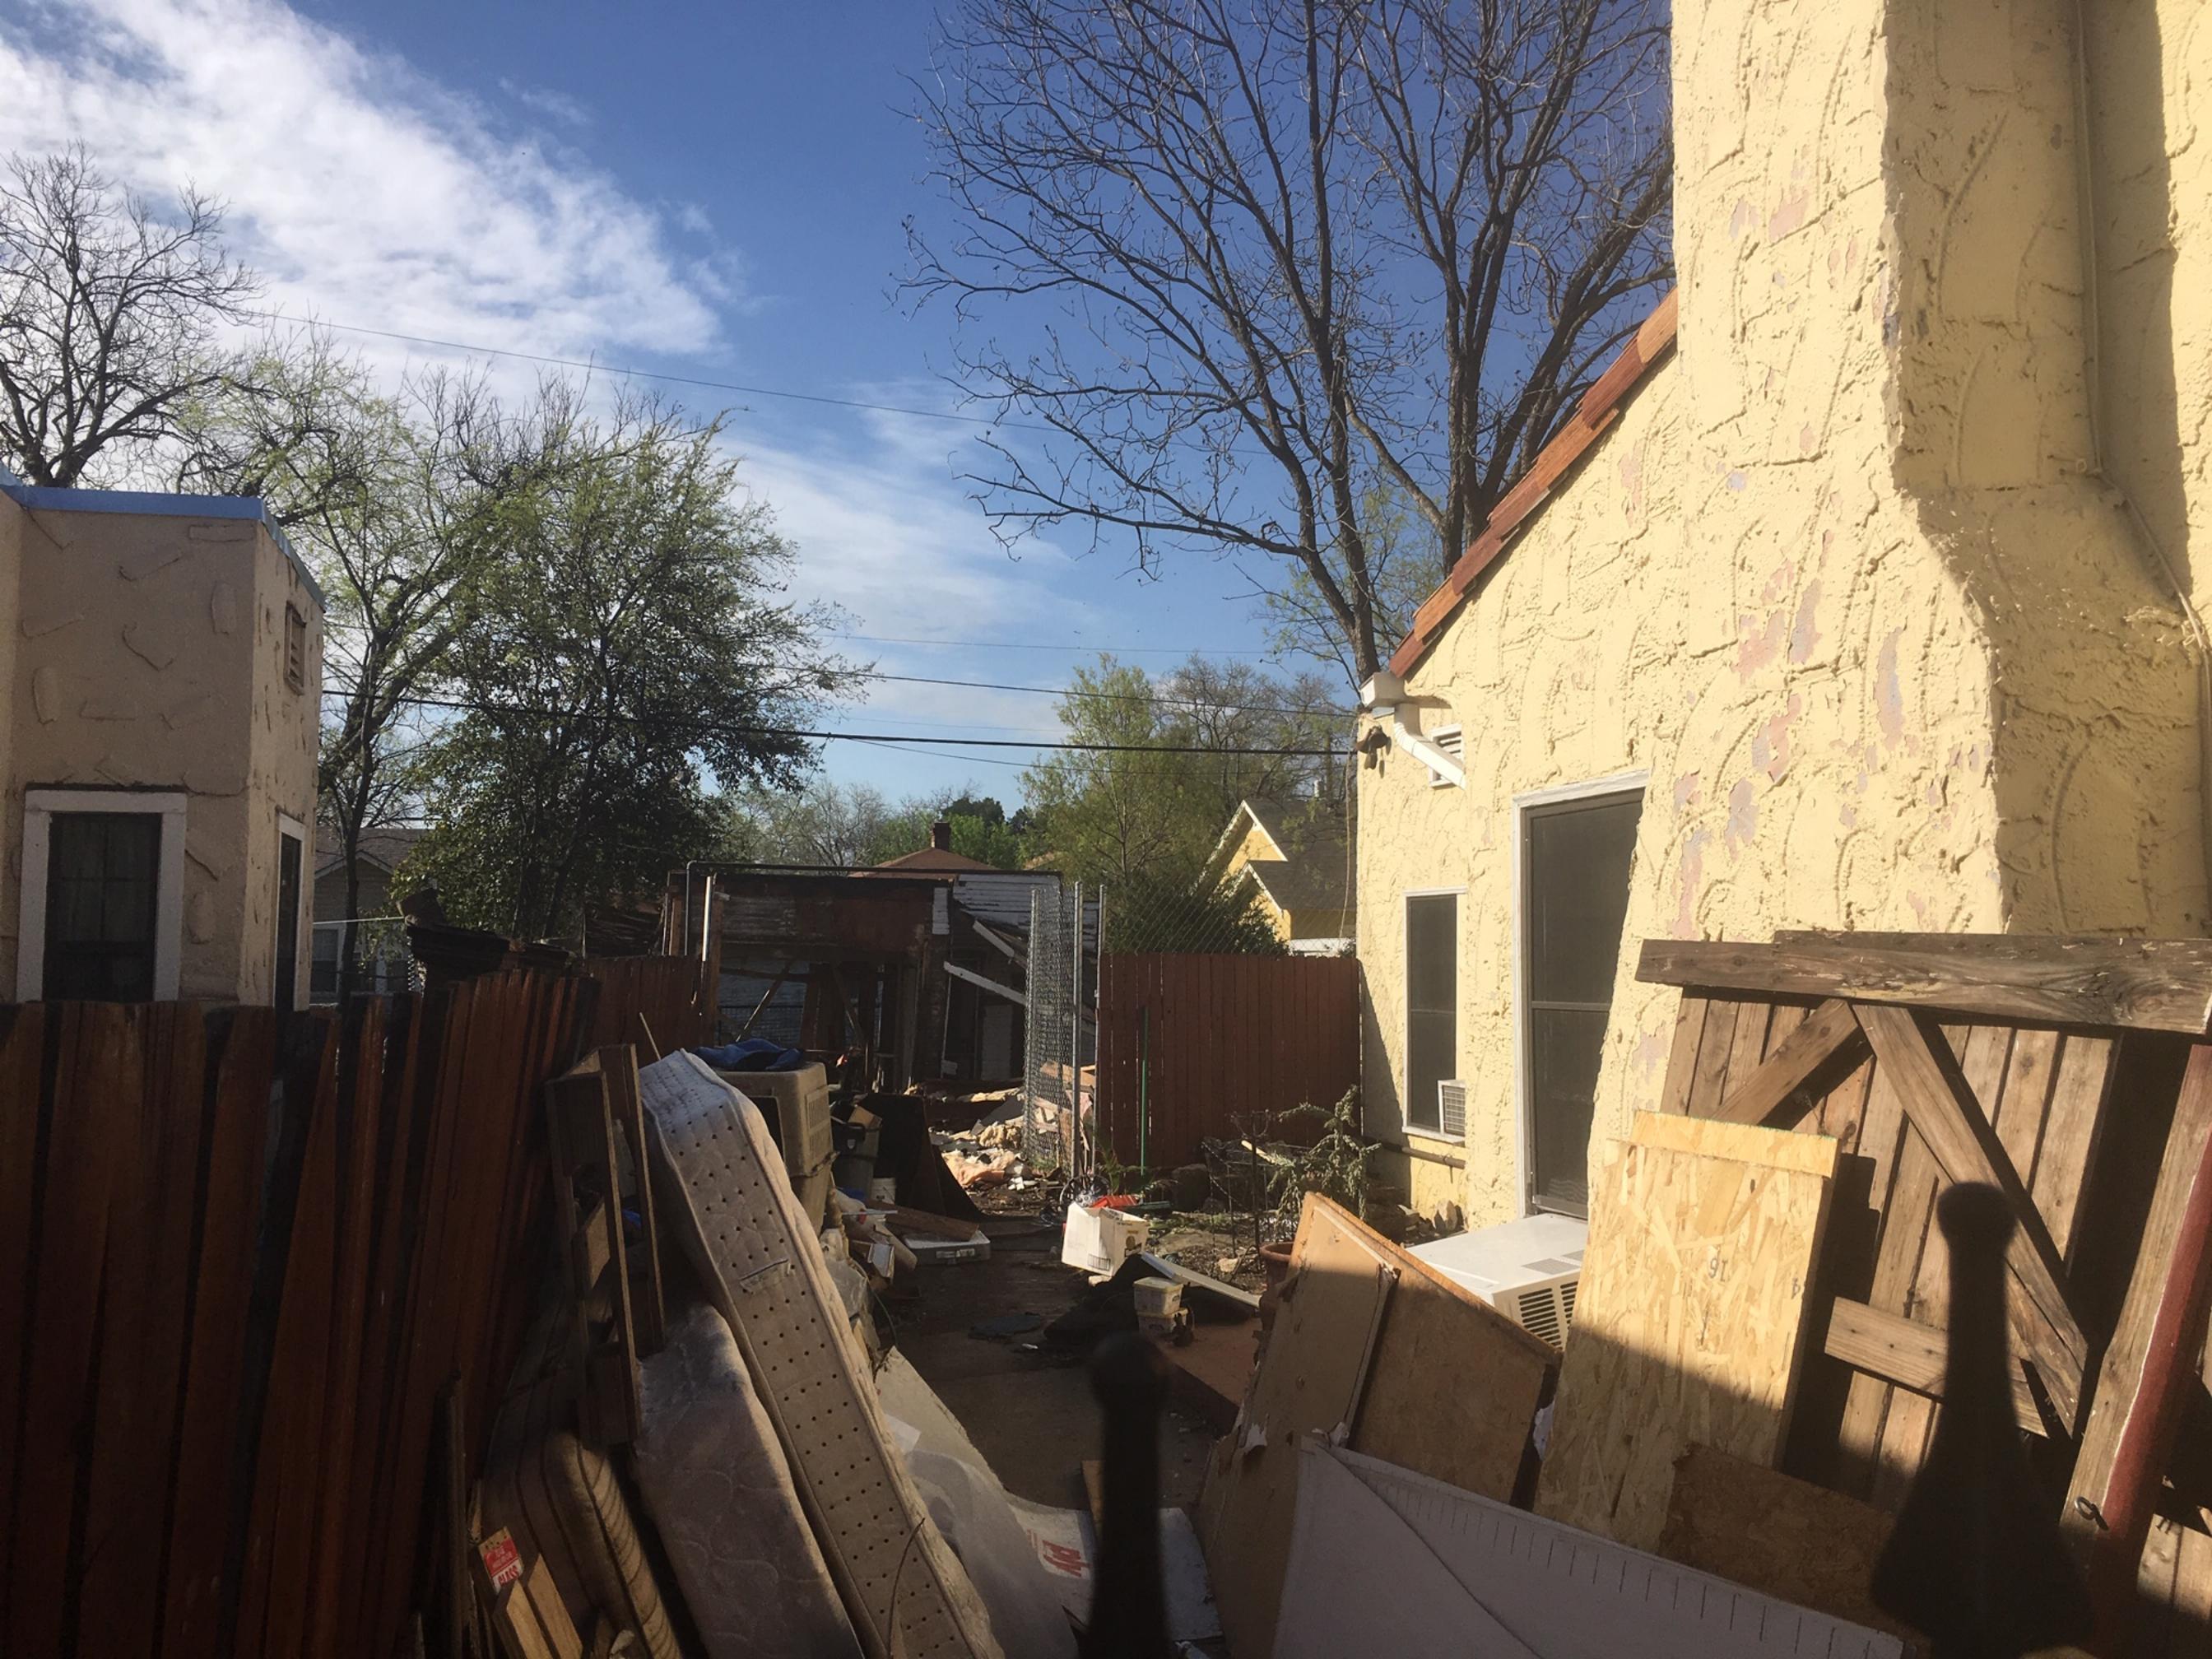
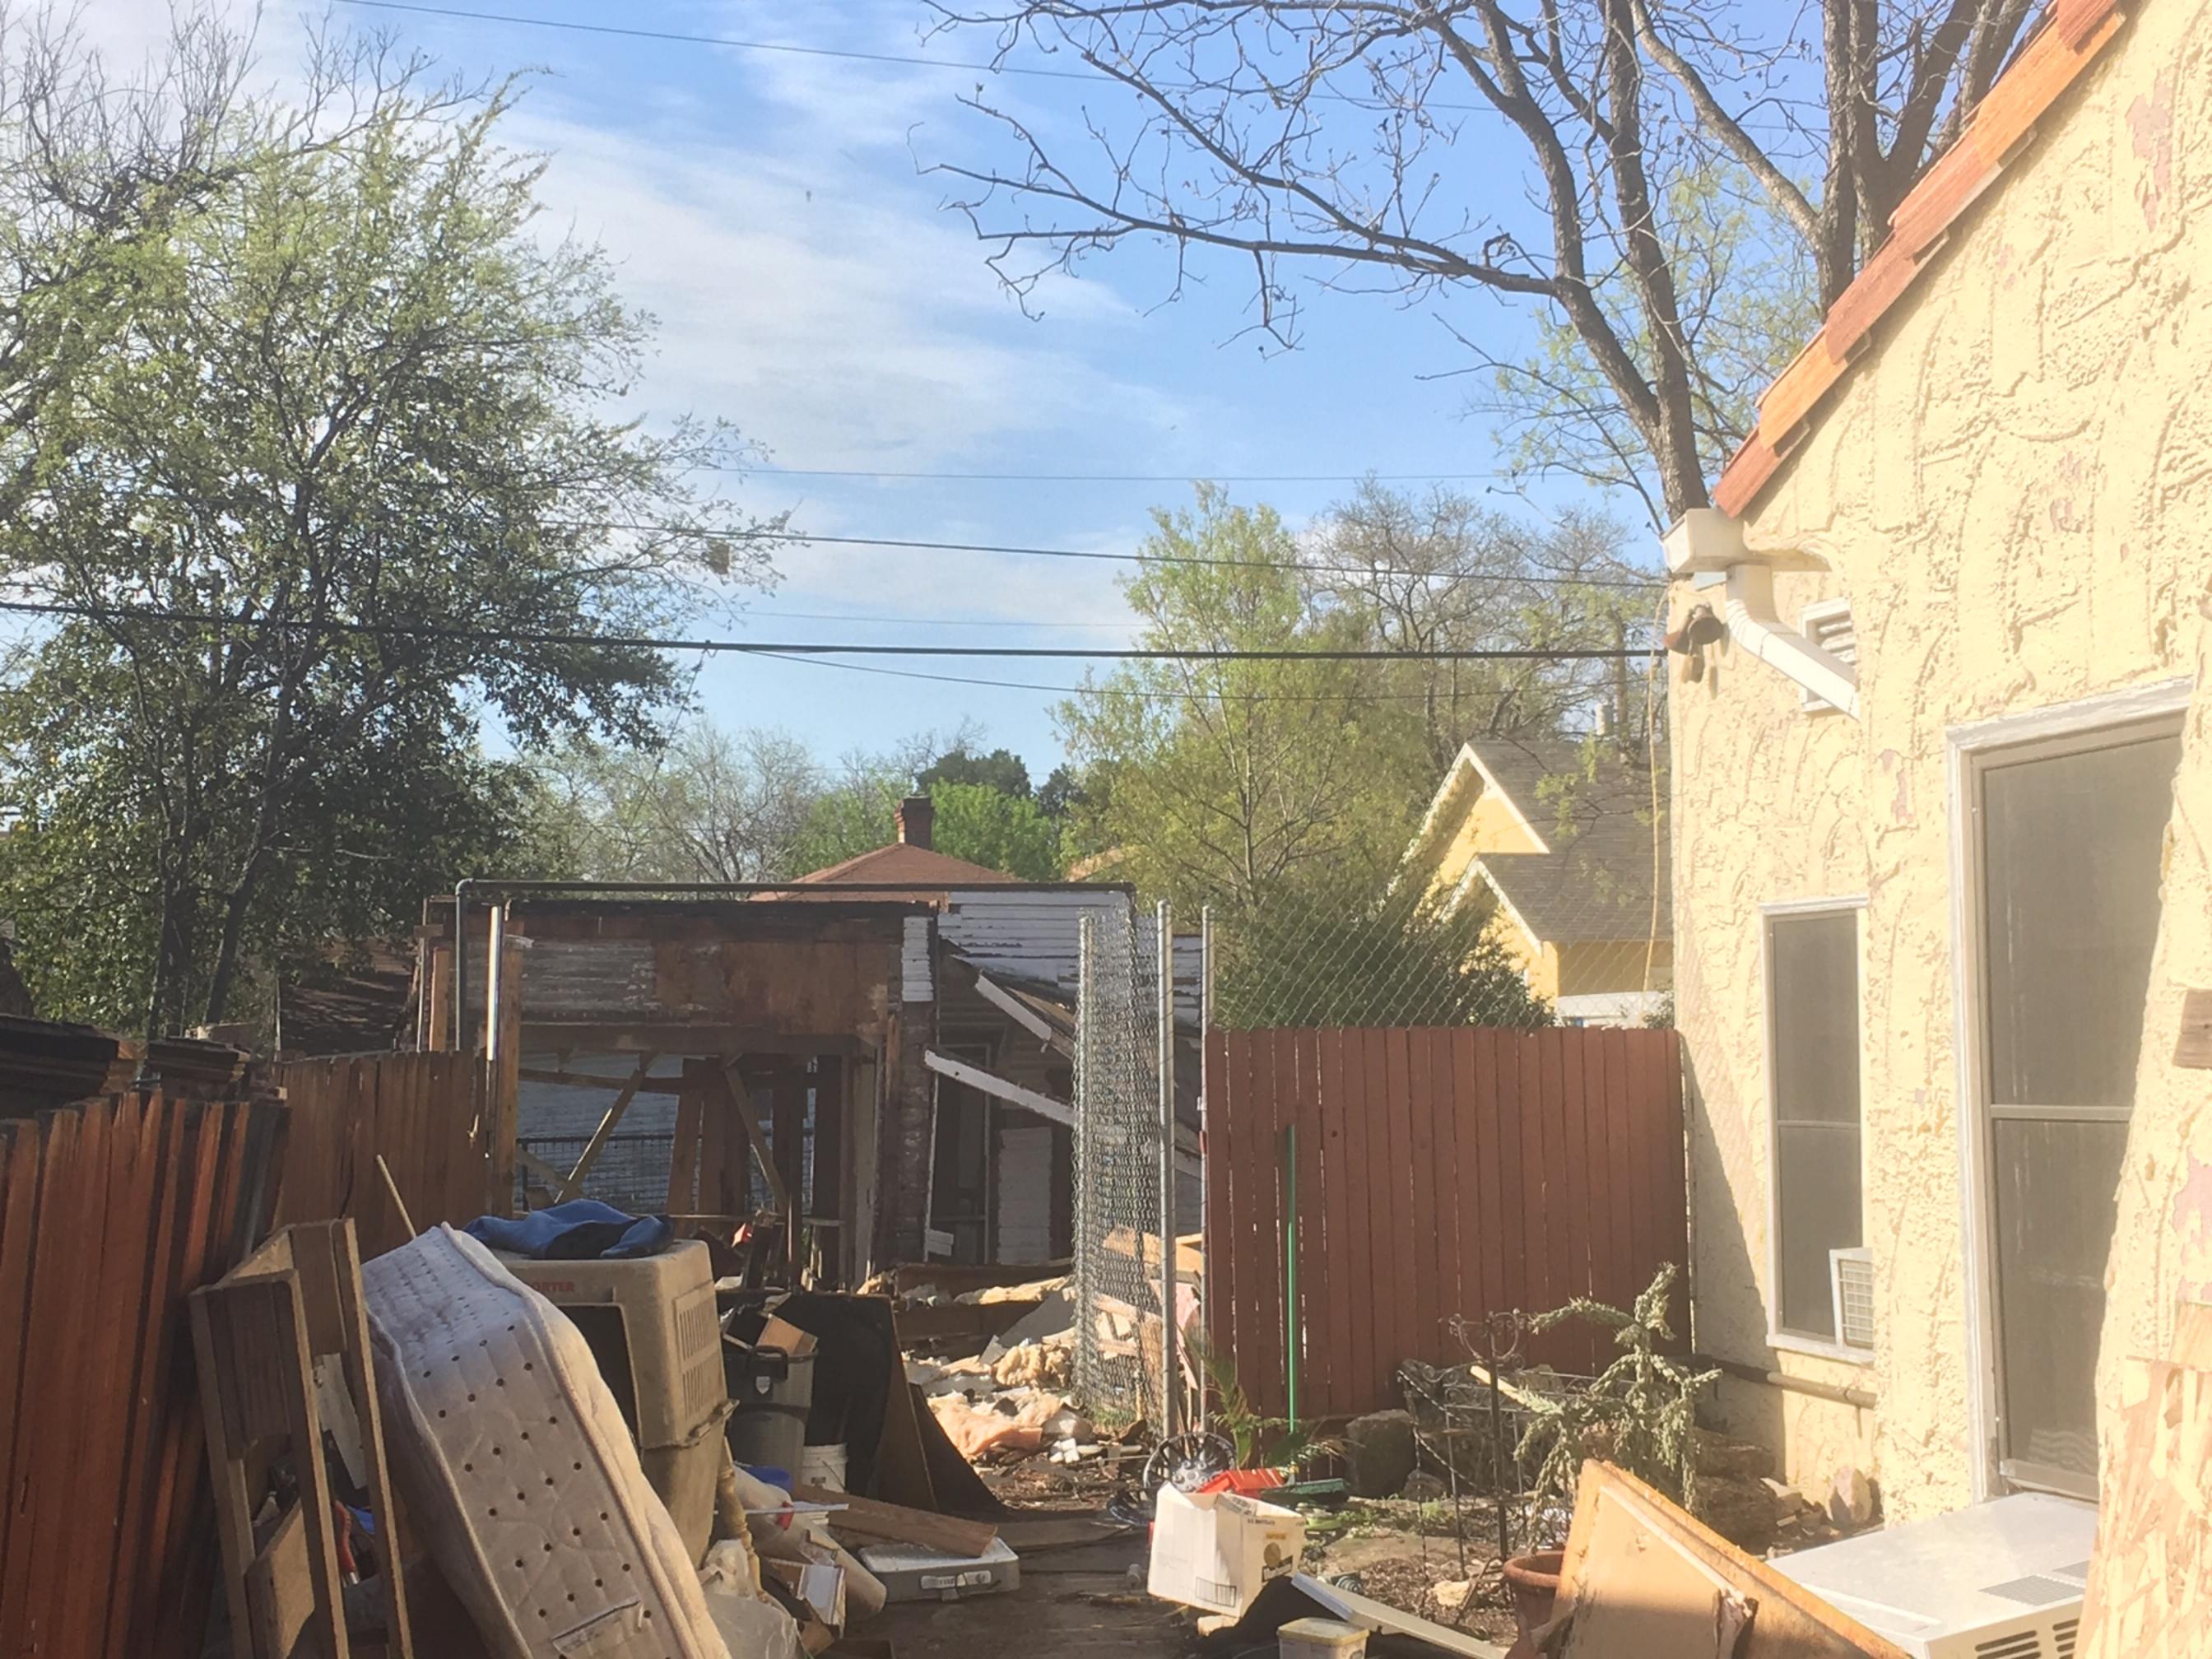
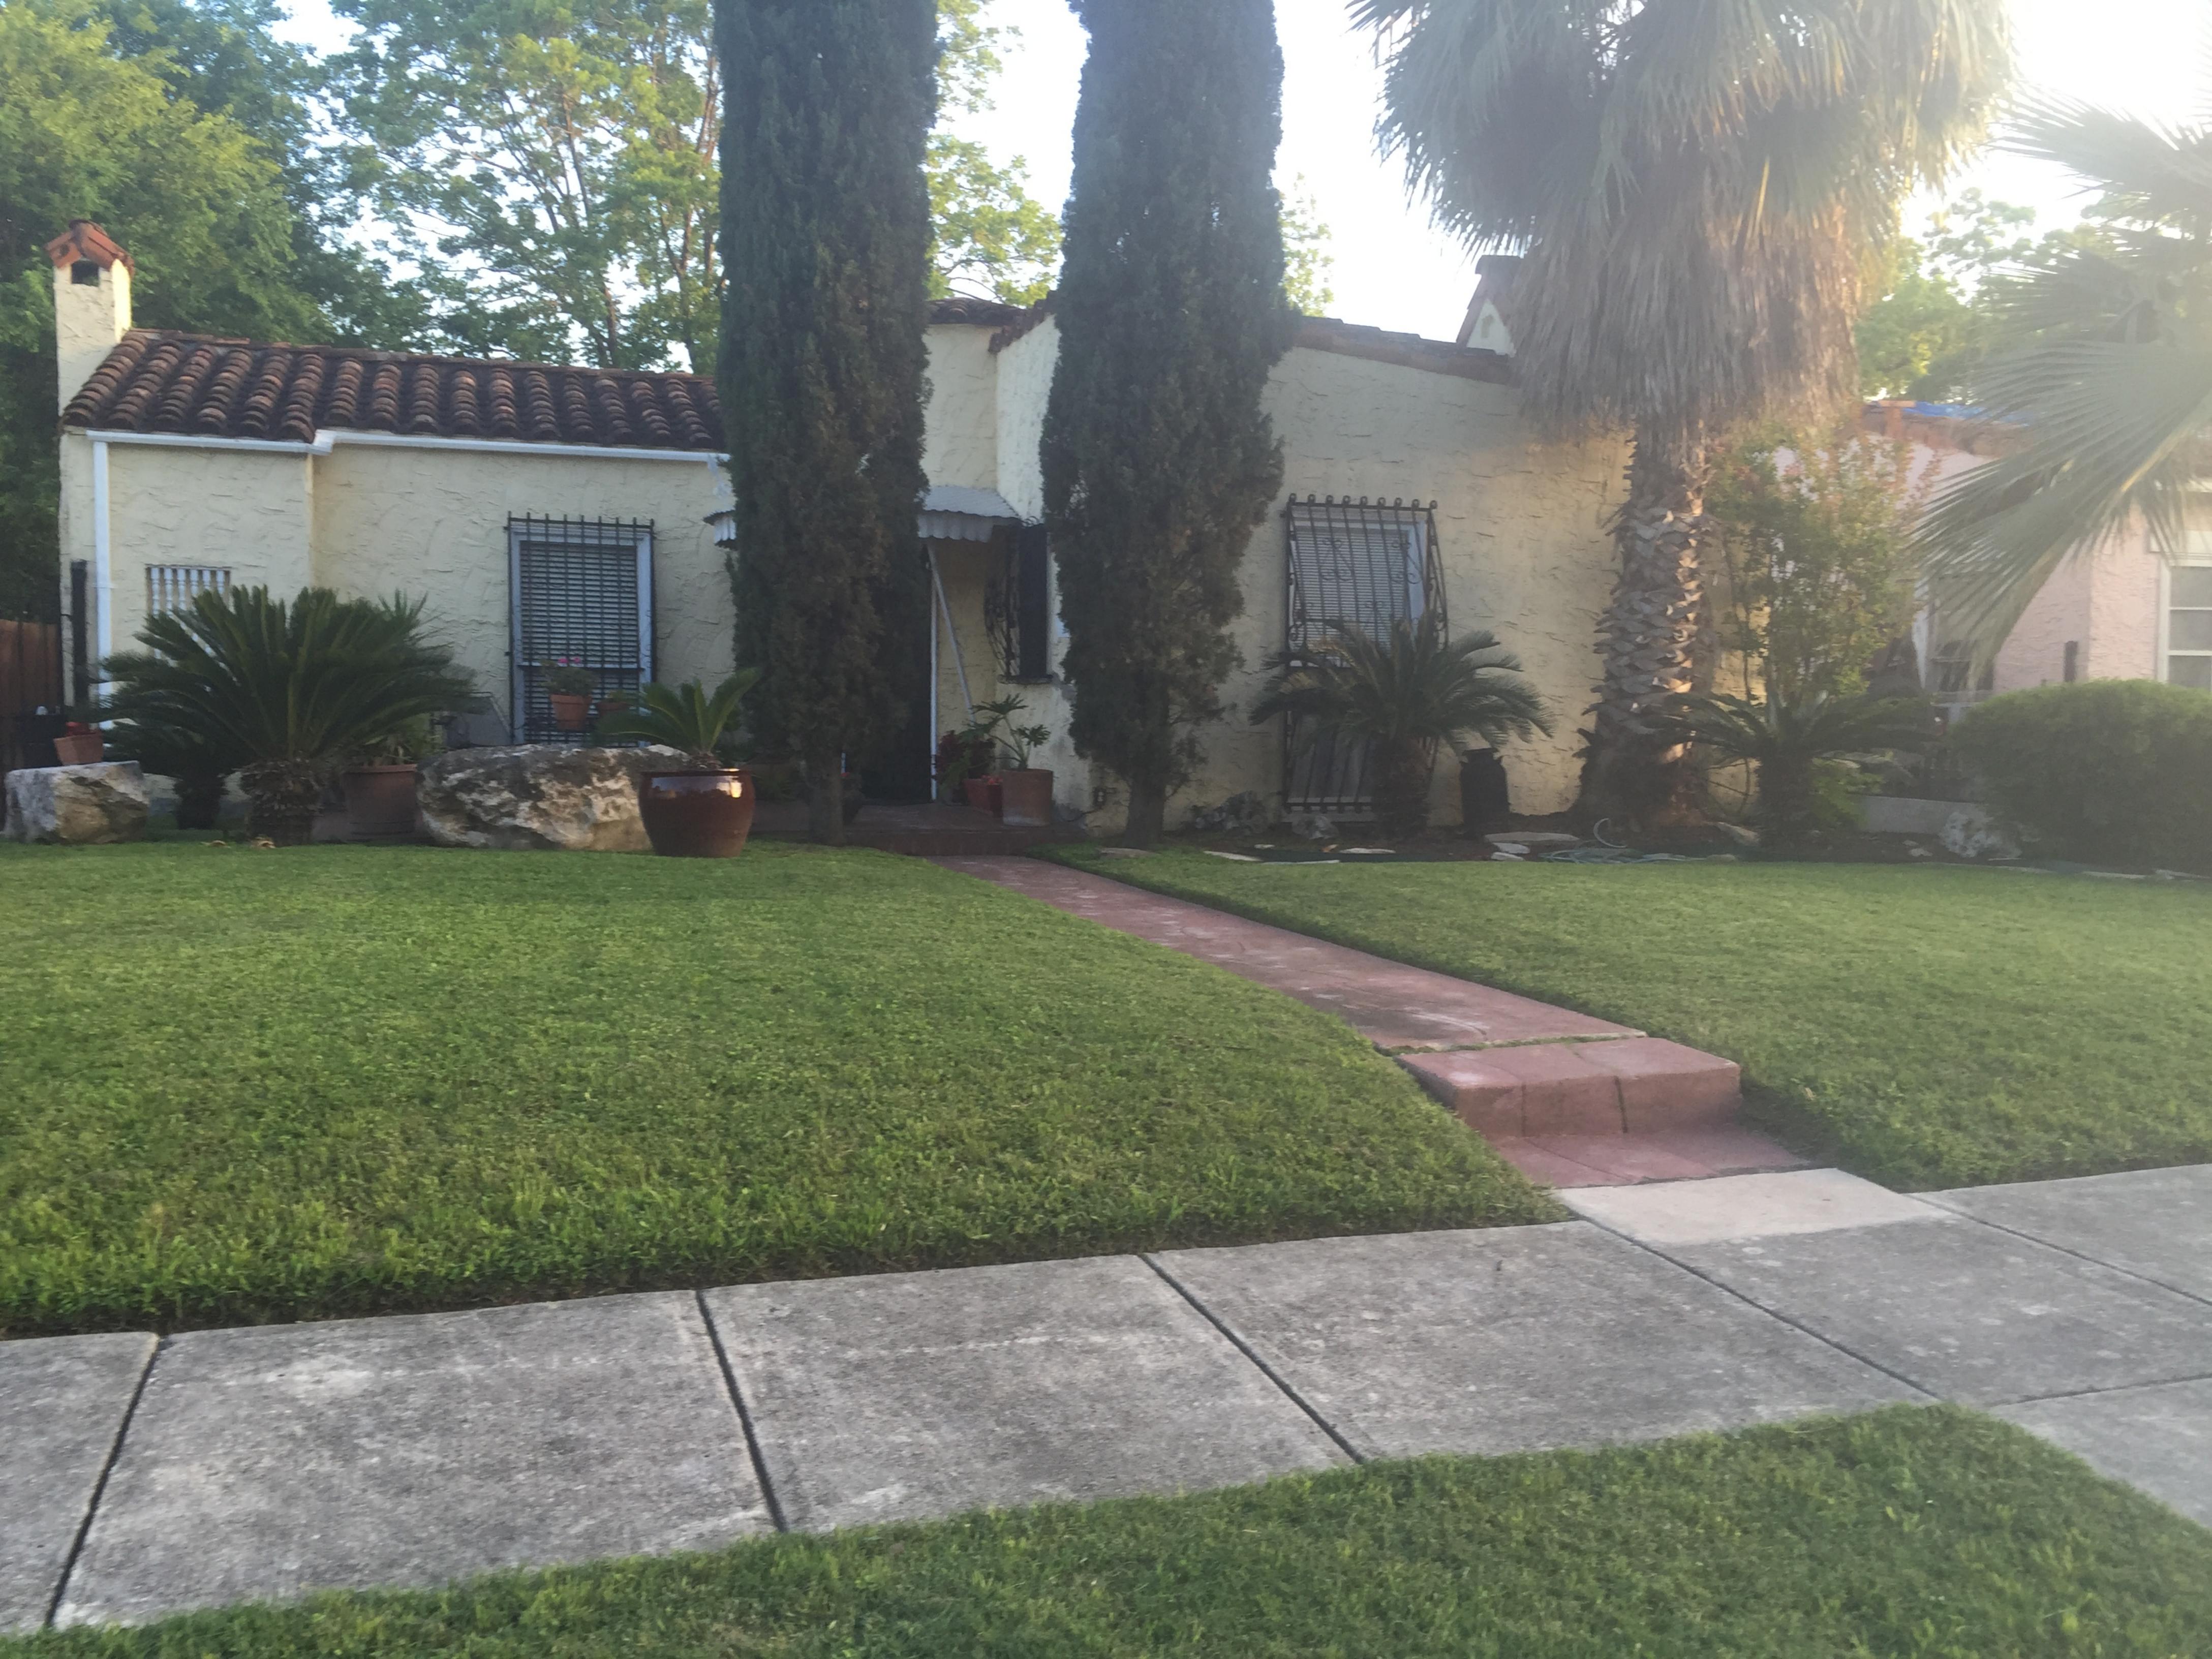
*Images provided by the applicant.*

The garage at 1434 Fulton is a single-story Spanish Eclectic structure with wood clapboard siding situated at the northeast corner of the parcel. There is a stepped parapet on the east side of the structure with an endgable composite shingle roof behind with exposed rafter tails. The structure is slab-on-grade and has a oneover-one window visible on the west side that appears to be vinyl. An addition to the structure is also single

story and slab-on-grade and features a pair of modern French doors on the south elevation that open to the backyard.

Character-defining features of the detached garage at 1434 Fulton Ave include:

- Stepped parapet
- Clapboard siding
- Exposed rafter tails
- Orientation to the alley
