HISTORIC AND DESIGN REVIEW COMMISSION

HDRC CASE NO: 2019-307
ADDRESS: 123 CROFTON
LEGAL DESCRIPTION: NCB 941 BLK 4 LOT E IRR 195 FT OF 10 & E IRR 182.1 FT OF N 1/2 OF 11
ZONING: RM-4,HS
CITY COUNCIL DIST.: 1
DISTRICT: King William Historic District
APPLICANT: John Chesser
OWNER: Linda Couch/NSHE TX DEVINE LLC
TYPE OF WORK: Front porch railings
APPLICATION RECEIVED: May 09, 2019
60-DAY REVIEW: July 08, 2019
CASE MANAGER: Adam Rajper
REQUEST:

The applicant is requesting a Certificate of Appropriateness for approval to add a balustrade to the existing front porch.

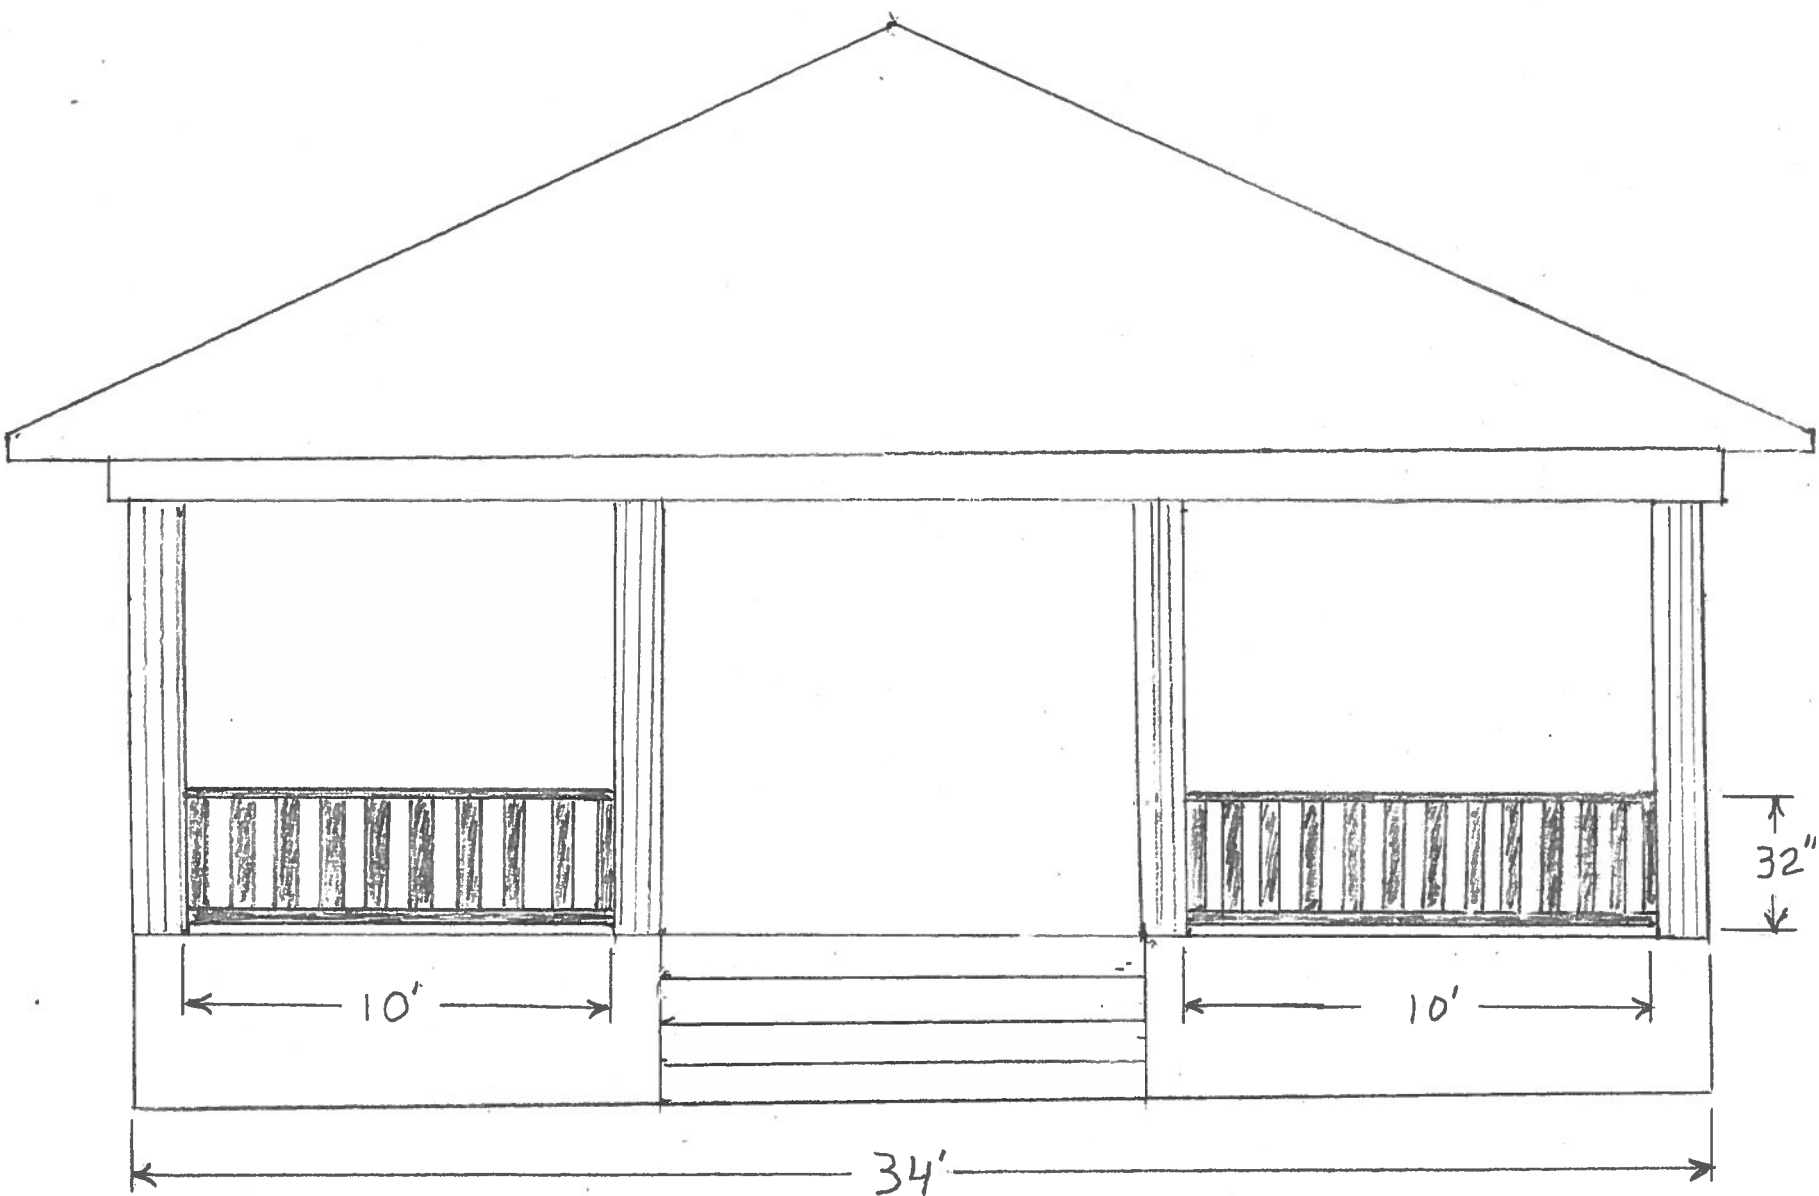
123 CROFTON

- c. **BALUSTRADE DESIGN** – The applicant has proposed to add a wood balustrade to the front porch. The applicant has also indicated that wood balusters with a Classical design will be incorporated, but has not provided baluster details. According to Guideline 7.B.iv for Exterior Maintenance and Alterations, new porch elements should be simple so as to not distract from the historic character of the building and create a false historic appearance. Staff finds that the proposed balustrade’s design is simple and appropriate for the Folk Victorian style of the home. Staff finds the proposal consistent with the Guidelines with the stipulations listed in the recommendation.

FRONT ELEVATION

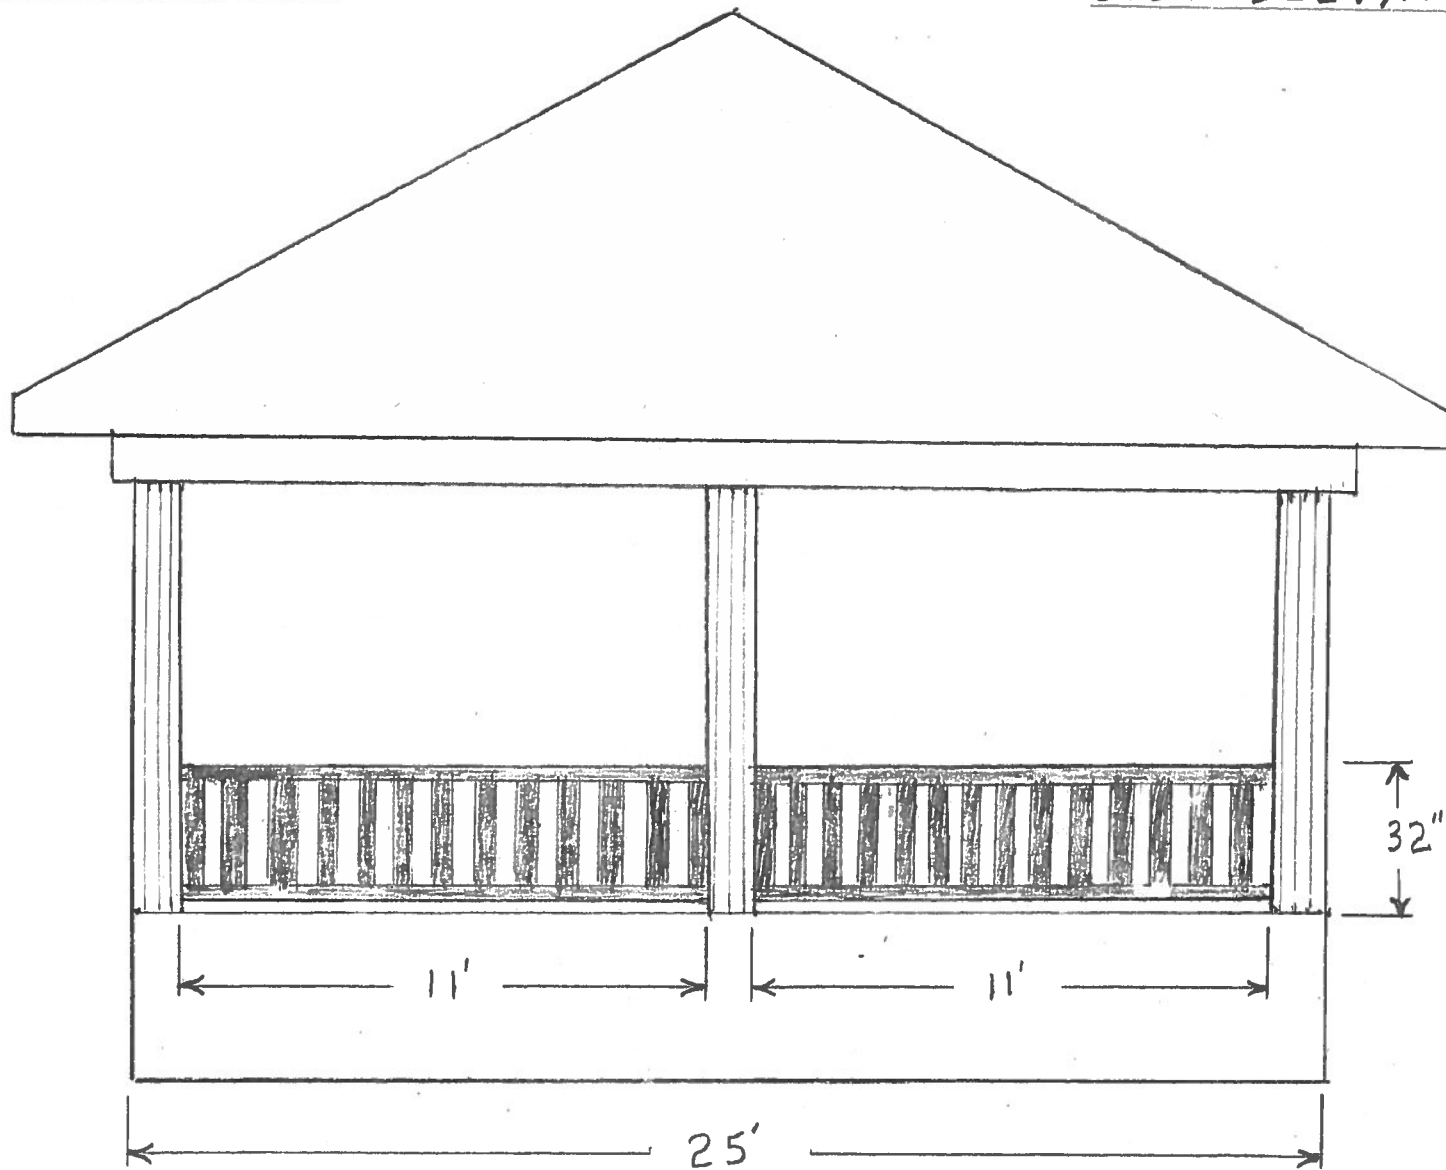
123 CROFTON

SIDE ELEVATION
