HISTORIC AND DESIGN REVIEW COMMISSION

HDRC CASE NO: 2019-365
ADDRESS: 517 E HOUSTON ST
LEGAL DESCRIPTION: NCB 422 BLK 26 W 26 FT OF 5 ARB A2
ZONING: D,HS, H
CITY COUNCIL DIST.: 1
DISTRICT: Alamo Plaza Historic District
LANDMARK: Rosenberg, Frank Building
APPLICANT: Michael Litofsky
OWNER: Michael Litofsky
TYPE OF WORK: Storefront Modification
APPLICATION RECEIVED: June 24, 2019
60-DAY REVIEW: August 23, 2019
CASE MANAGER: Huy Pham
REQUEST:

The applicant is requesting a Certificate of Appropriateness for approval to modify a previously approved design to include a glass storefront on the E Houston Street side.

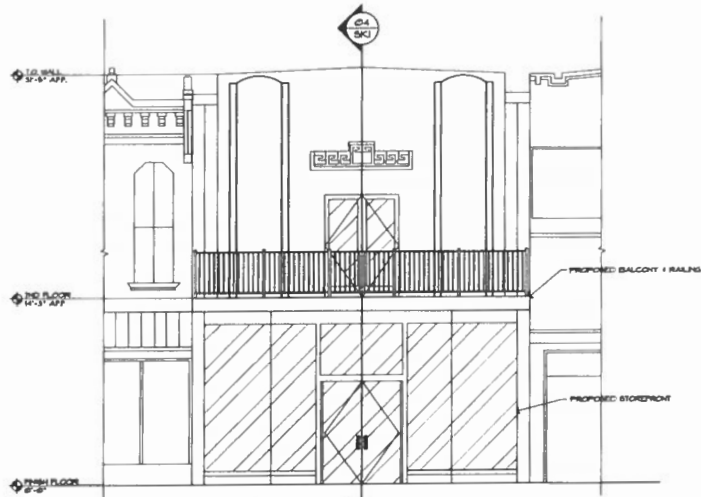
01 PROPOSED ELEVATION
SCALE: 1/8"=1'-0"

- c. **DESIGN AMENDMENT** – The applicant has proposed to install a full-glazing first-floor storefront and a

second-floor balcony with railing and centered entry. Staff finds that the proposed design would create condition where the first-floor storefront does not relate to the second-floor façade and that the proposed balcony with railing is disruptive to the Art Moderne rhyme of the flanking pilasters. Staff finds that the proposed design amendments are inconsistent with the Guidelines for Exterior Maintenance and Alterations 10.A.i and 10.B.i. and that the previously approved design is a more sensitive and appropriate treatment of the structure.

Staff does not recommend approval of the design amendment based on finding c. The applicant may submit another design that is consistent with the Guidelines or based on historic photographic evidence to be submitted for review – or continue with the design approved in May 2015 and again in May 2019.

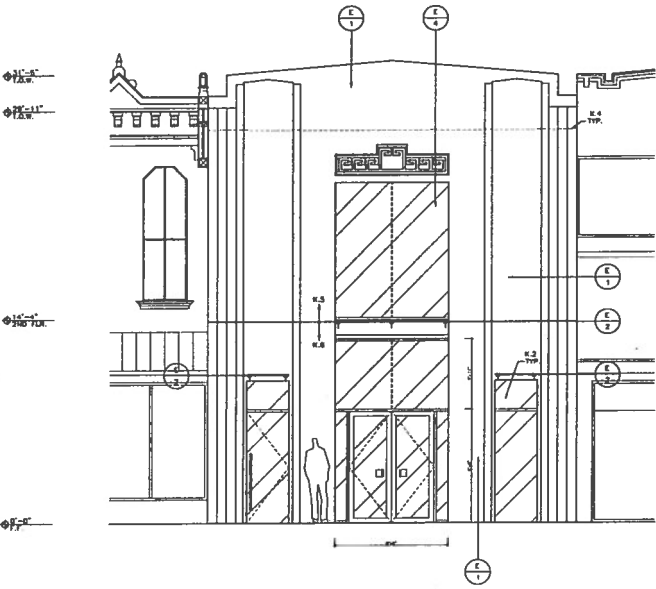
1.A2.1 SOUTH ELEVATION
SCALE: 1/8" = 1'-0"

- KEYED NOTES:
- N.1 EXISTING FOUNDATION WALLS
 - N.2 EXISTING BRICKWORK TO BE RESTORED TO ORIGINAL. COMMON BRICK LIME MORTAR.
 - N.3 EXISTING ROOF TO BE RESTORED TO ORIGINAL. COMMON LIME MORTAR.
 - N.4 ROOF LINE ADJUST TO FOLLOW EXISTING STRUCTURE.
 - N.5 IMPROVED ROOF.
 - N.6 NEW CONSTRUCTION.

- i. SECOND FLOOR WINDOW - The applicant has proposed to install clear glass on the Houston Street façade where a second level clear storefront glass would have once been located. The Guidelines for Exterior Maintenance and Alterations 10.A.iii. states that missing features should be replaced in to match the style of the building and the period in which it was designed. Staff finds that the applicant's proposal is appropriate and consistent with the Guidelines.

- j. CANOPY - Per a photograph dated October 2007, the Houston Street façade at 517 Houston featured a canopy which projected approximately eight (8) feet out over the sidewalk, which has since been removed. The applicant has proposed to install a projecting steel and glass canopy which is to extend over the sidewalk approximately five (5) feet and feature three (3) sections to correspond with the entrance way and the proposed new clear glass. While the profile and materials are not alike in materials to the original historic façade, staff finds that the light appearance of the thin steel and glass canopy does not distract from the historic façade and is appropriate in this instance.

- k. STOREFRONT - While currently covered by plywood, the storefront façade at 517 E Houston features a recessed storefront entrance. Other storefront entrances on E Houston do not feature entrances nearly as deep as this one, which leads staff to believe that 517 E Houston's storefront entrance is not an original element of the building's design. The applicant has proposed to alter the storefront entrance to become more consistent with other storefront setbacks along E Houston. Staff finds that this request appropriate.
