## HISTORIC AND DESIGN REVIEW COMMISSION

**HDRC CASE NO:** 2019-396  
**ADDRESS:** 420 E HOUSTON ST  
**LEGAL DESCRIPTION:** NCB 416 BLK 23 LOT 7 OR A9  
**ZONING:** D, H, RIO-3  
**CITY COUNCIL DIST.:** 1  
**DISTRICT:** Alamo Plaza Historic District  
**APPLICANT:** Aaron Selinkoff/Mad Dogs Group  
**OWNER:** TSP 420 LLC  
**TYPE OF WORK:** Signage and exterior paint  
**APPLICATION RECEIVED:** July 08, 2019  
**60-DAY REVIEW:** September 6, 2019  
**CASE MANAGER:** Edward Hall  
**REQUEST:**

The applicant is requesting a Certificate of Appropriateness for approval to paint the existing historic structure a dark green color, "Garden Cucumber".

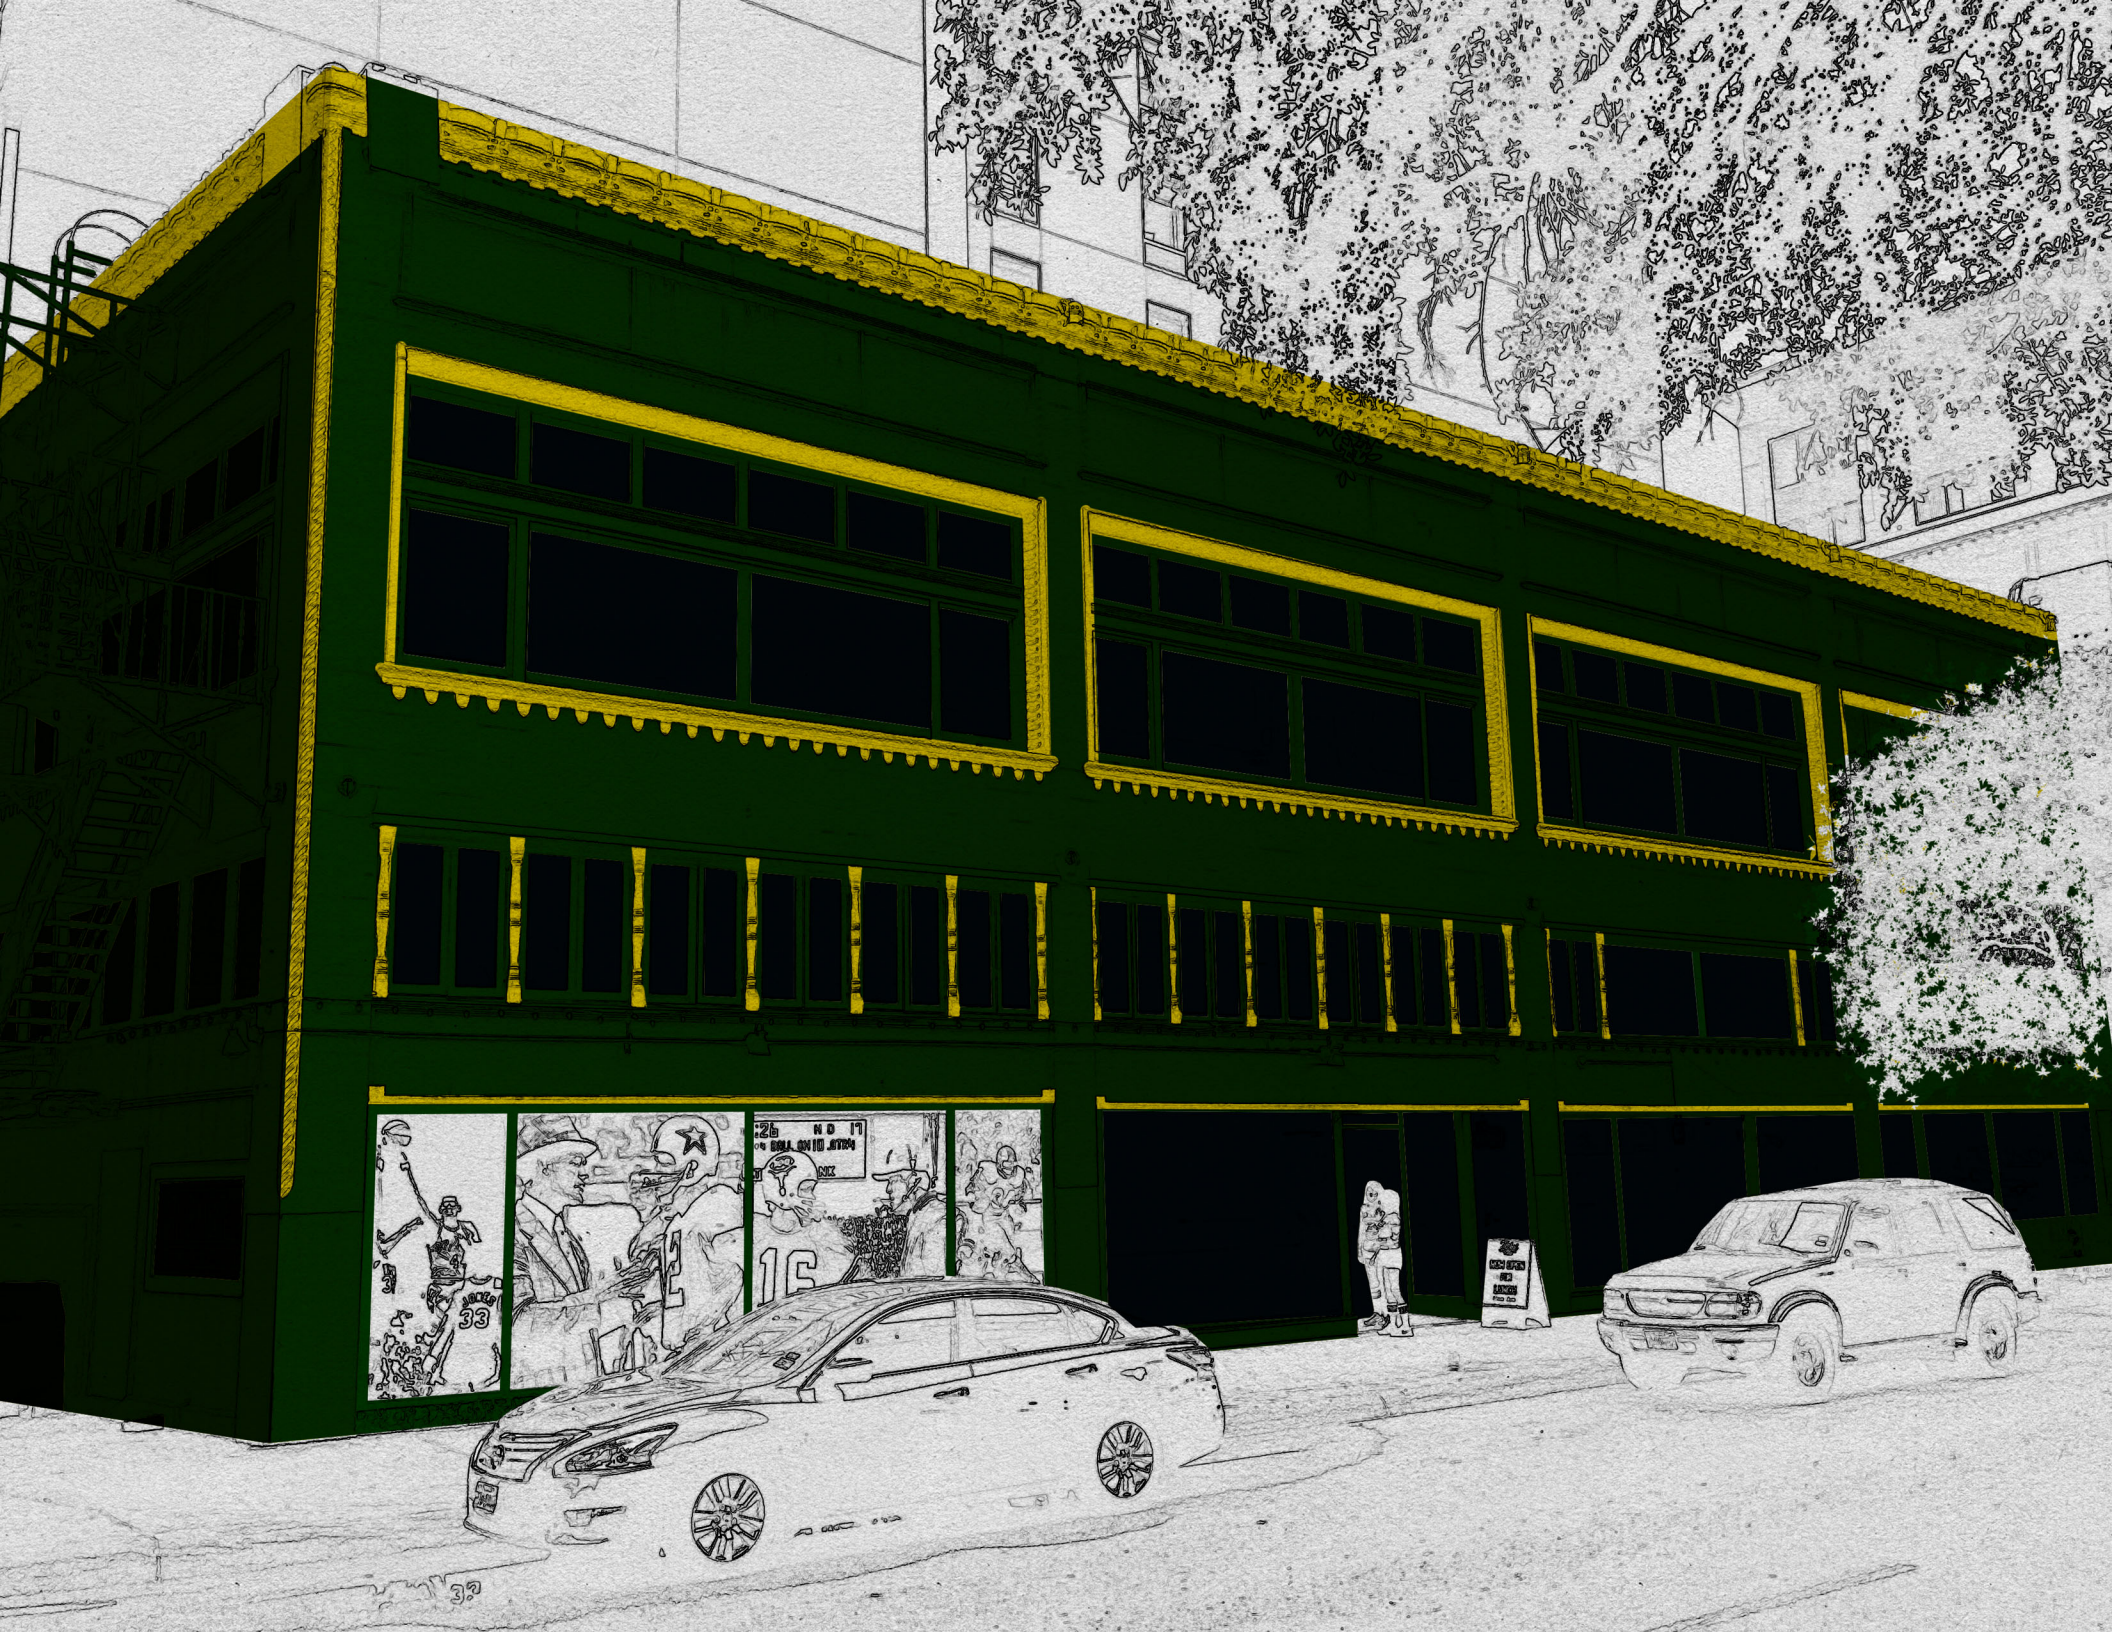
M400B

M400-4<sup>th</sup>  
Brookview  
Vue sur ruisseau

M400-5<sup>th</sup>  
Baby Spinach  
Jaune épinard

M400-6<sup>th</sup>  
Légumes variés  
Mixed vegetables

M400-7<sup>th</sup>  
Garden Cucumber  
Concombre de jardin

- b. PAINTING – The applicant has proposed to paint the existing historic structure a dark green color, “Garden Cucumber”. The Guidelines for Exterior Maintenance and Alterations 10.B.ii. notes that the scale, design, materials, color and texture of proposed modifications to historic structures are compatible with the historic structure. Additionally, the Guidelines for Exterior Maintenance and Alterations 10.A.i. notes that character defining features of a structure should be preserved to contribute to the character of a building.

- c. Staff does not find the proposed paint color to be appropriate. Staff finds that there is neither precedent, nor historic examples of dark green within the Alamo Plaza Historic District as a primary color for a commercial historic structure. Staff finds that an earth toned green may be more appropriate; similar to the tones found on the Maverick Building’s entry awning or the limestone found at 603 Navarro.
