## HISTORIC AND DESIGN REVIEW COMMISSION

**HDRC CASE NO:** 2019-397  
**COMMON NAME:** 202 WEAVER  
**LEGAL DESCRIPTION:** NCB 6517 BLK 6 LOT 44 (MISSION GROVE)  
**ZONING:** H  
**CITY COUNCIL DIST.:** 3  
**DISTRICT:** Mission Historic District  
**APPLICANT:** Office of Historic Preservation  
**TYPE OF WORK:** Recommendation to the Building Standards Board  
**APPLICATION RECEIVED:** July 16, 2019  
**60-DAY REVIEW:** September 14, 2019  
**CASE MANAGER:** Edward Hall  
**REQUEST:**

The applicant is requesting a recommendation to the Building Standards Board for the primary historic structure located at 202 Weaver Street, located within the Mission Historic District.

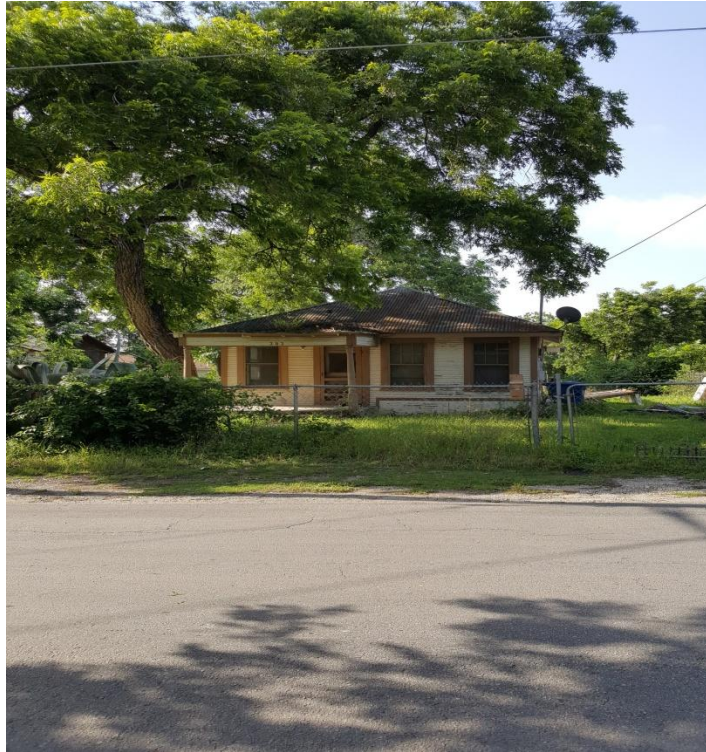
202 Weaver  
Case  
#23268836

- b. According to Development Services Department Code Enforcement staff, the primary historic structure features damage to the roof structure, siding, foundation, front and rear porches. The City's Code Enforcement Division inspected the property and determined it to be eligible for repair. The Historic Design Guidelines for Exterior Maintenance and Alterations note that historic exterior elements should be preserved where they remain or replaced or reconstructed in-kind of damaged. When new materials are needed, they should match the existing materials in color, configuration, durability, and texture. The repair and replacement of wood siding, wood trim, wooden porch elements, and roofing elements is eligible for administrative approval.

Staff recommends repair of the primary historic structure based on findings a and b. The Certificate of Appropriateness for repair of this structure is eligible for administrative approval. No exterior work should commence prior to the issuance of a COA.
