HISTORIC AND DESIGN REVIEW COMMISSION

HDRC CASE NO: 2019-493
ADDRESS: 619 BARBE ST
LEGAL DESCRIPTION: NCB 2877 BLK 2 LOT 14
ZONING: RM-4
CITY COUNCIL DIST.: 1
DISTRICT: King William Historic District
APPLICANT: henry rodriguez/Queta Construction Group, LLC
OWNER: NEW HORIZONS ARC LLC
TYPE OF WORK: Amendment to previously-approved roofing
APPLICATION RECEIVED: August 16, 2019
60-DAY REVIEW: October 15, 2019
CASE MANAGER: Stephanie Phillips
REQUEST:

The applicant is requesting a Certificate of Appropriateness to install a ridge cap on the newly-installed standing seam metal roof on the primary structure at 619 Barbe St. The crimped ridge seam was installed incorrectly and the requested ridge cap is proposed in an effort to aesthetically mitigate the seam.

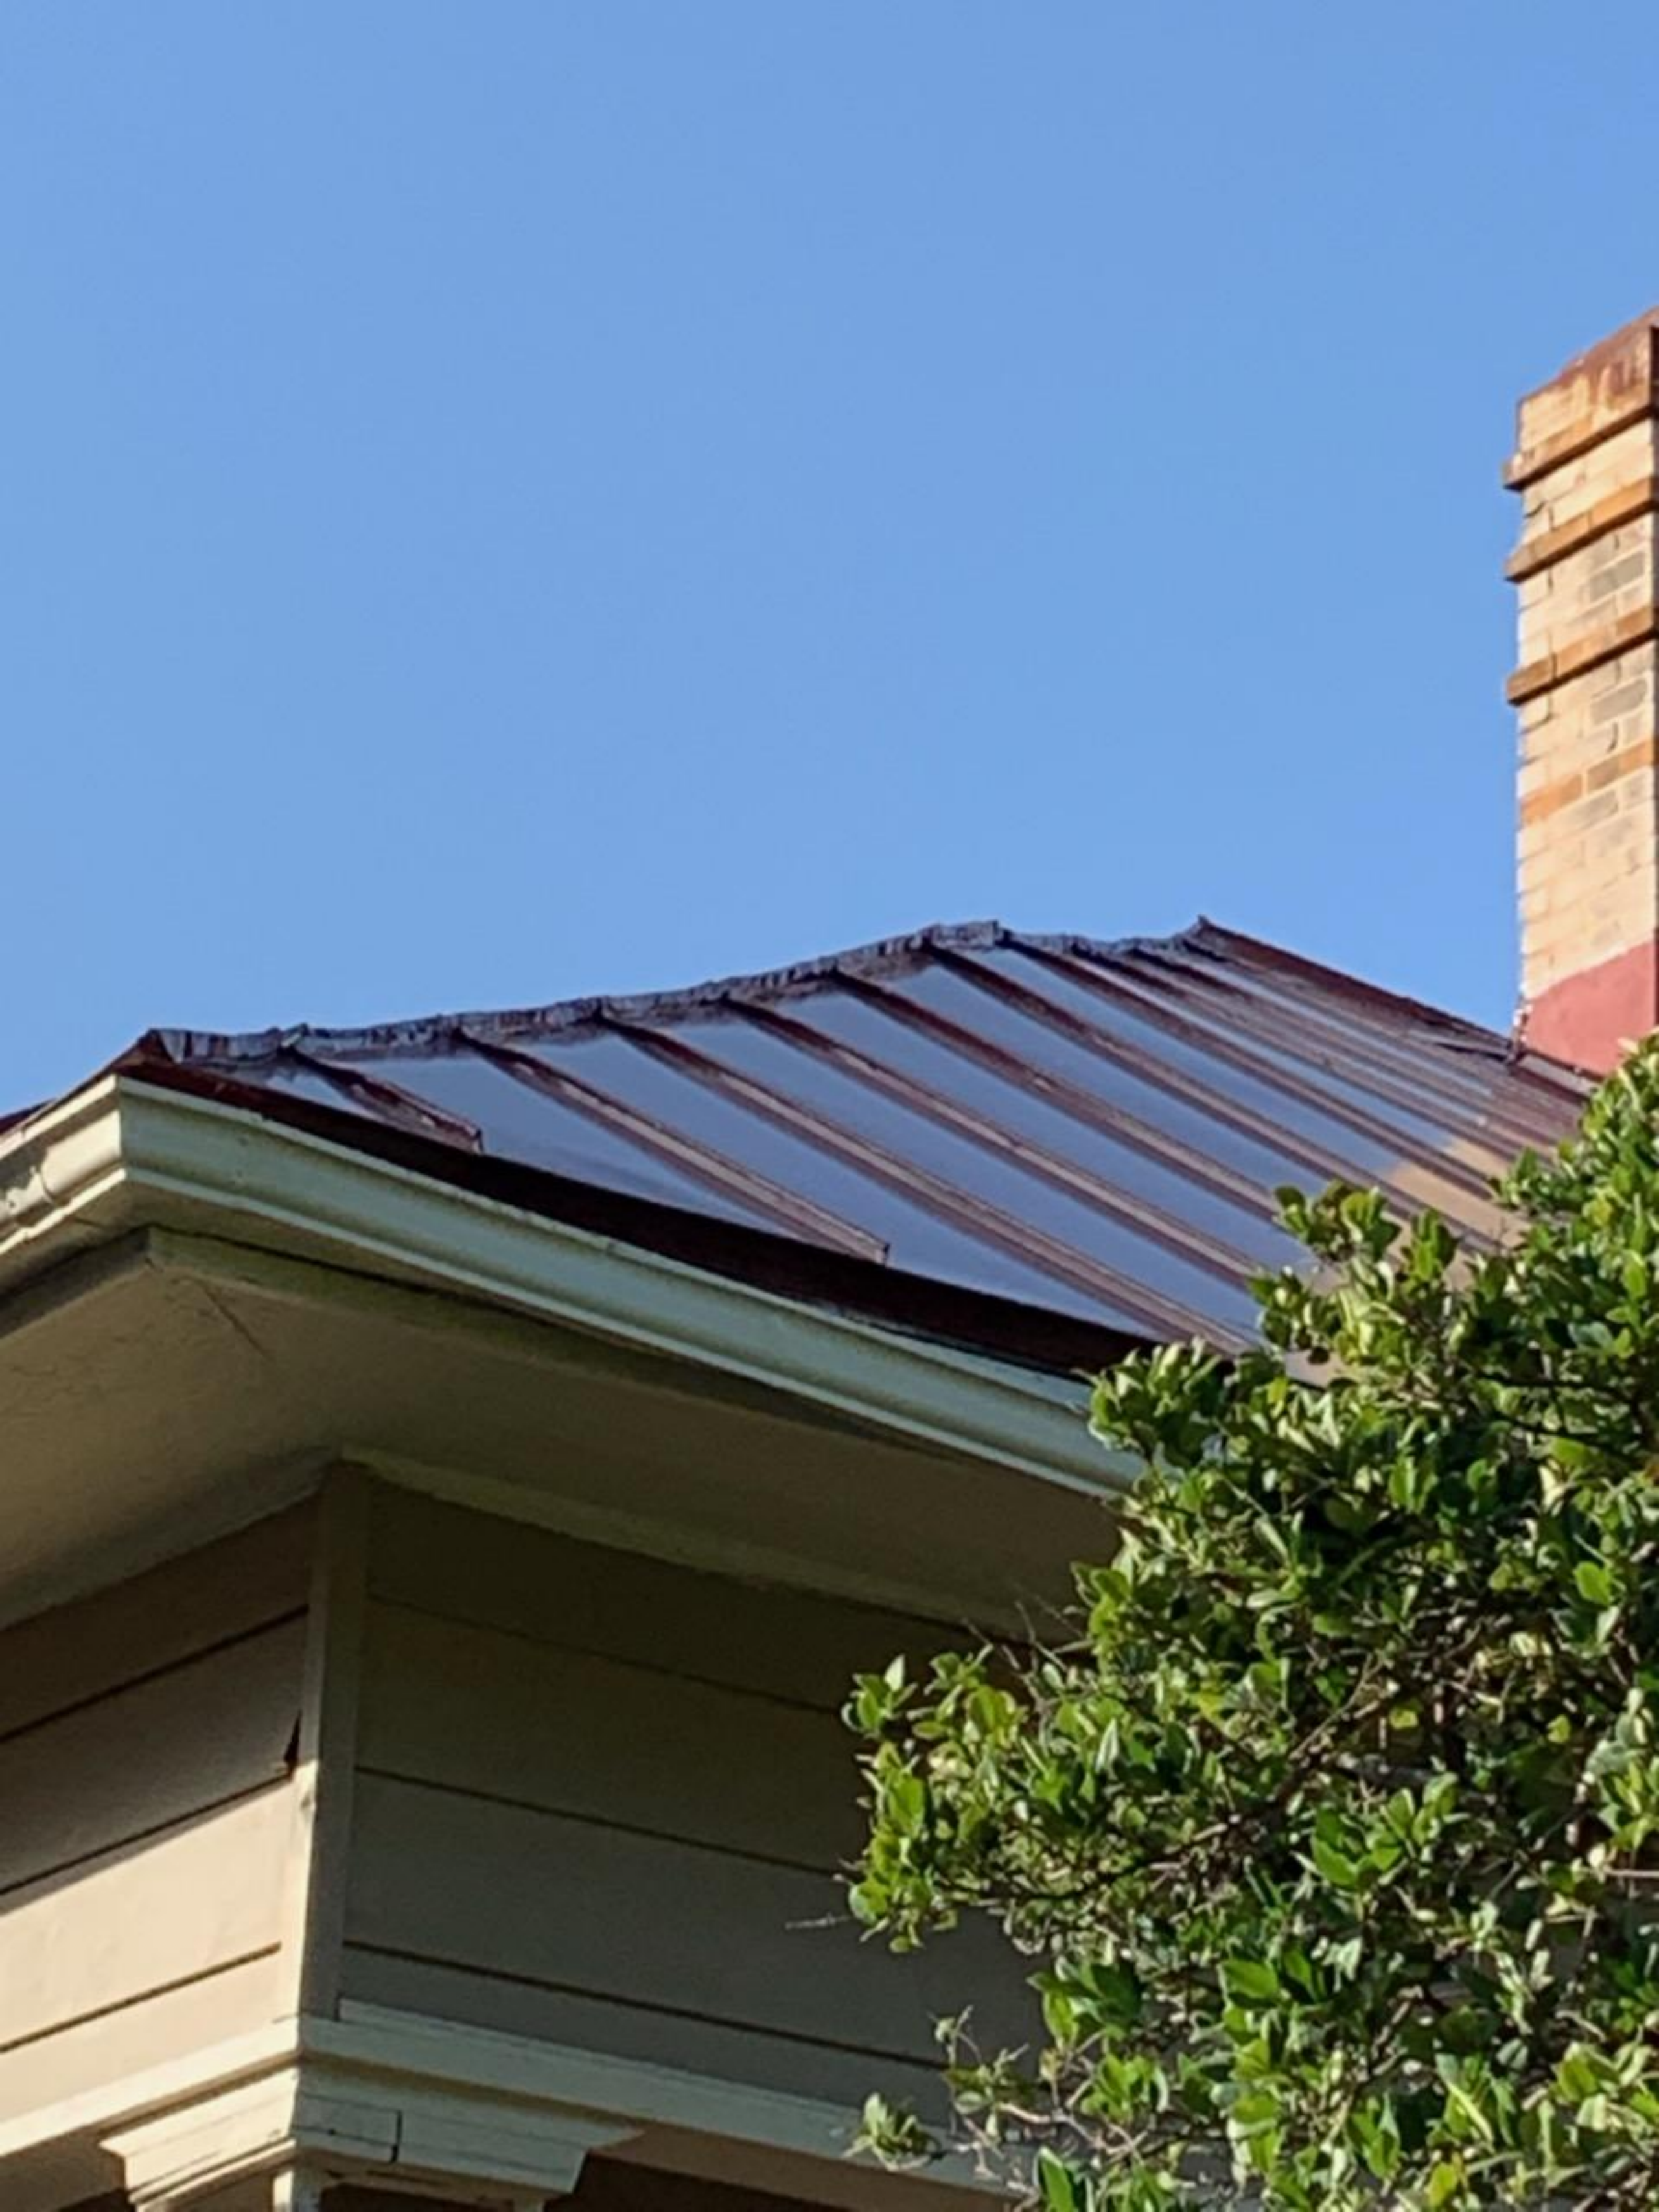
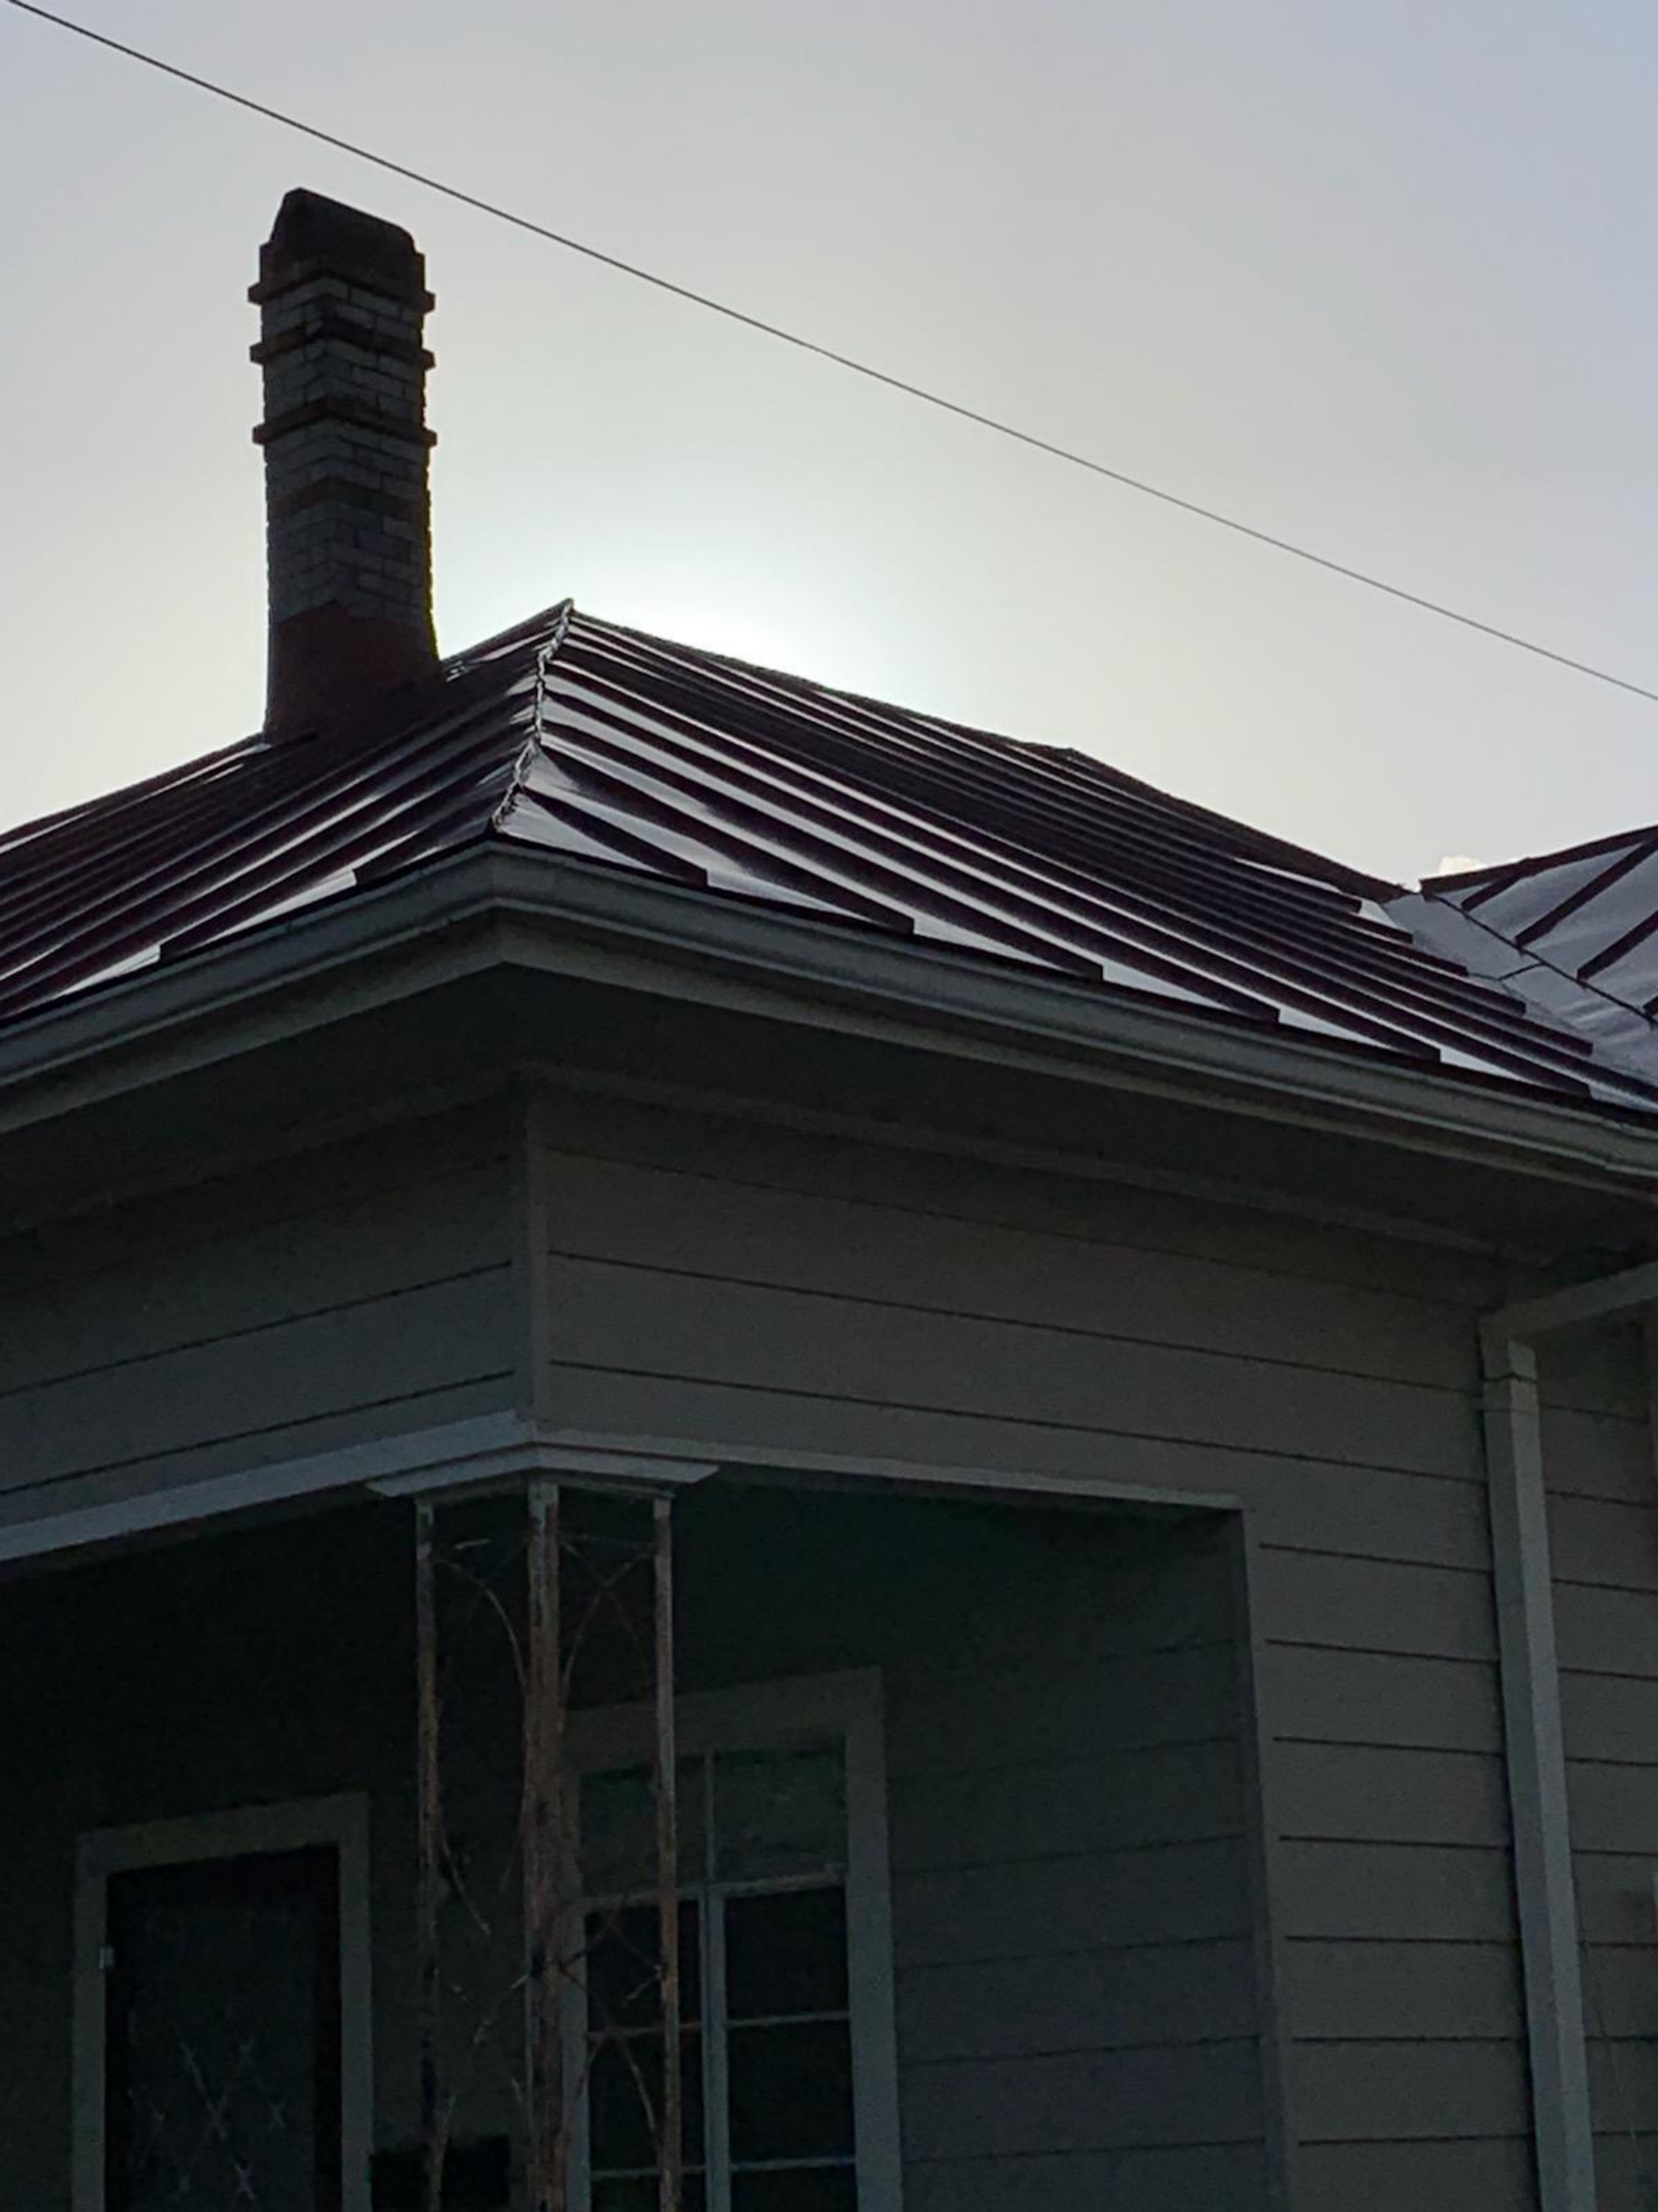
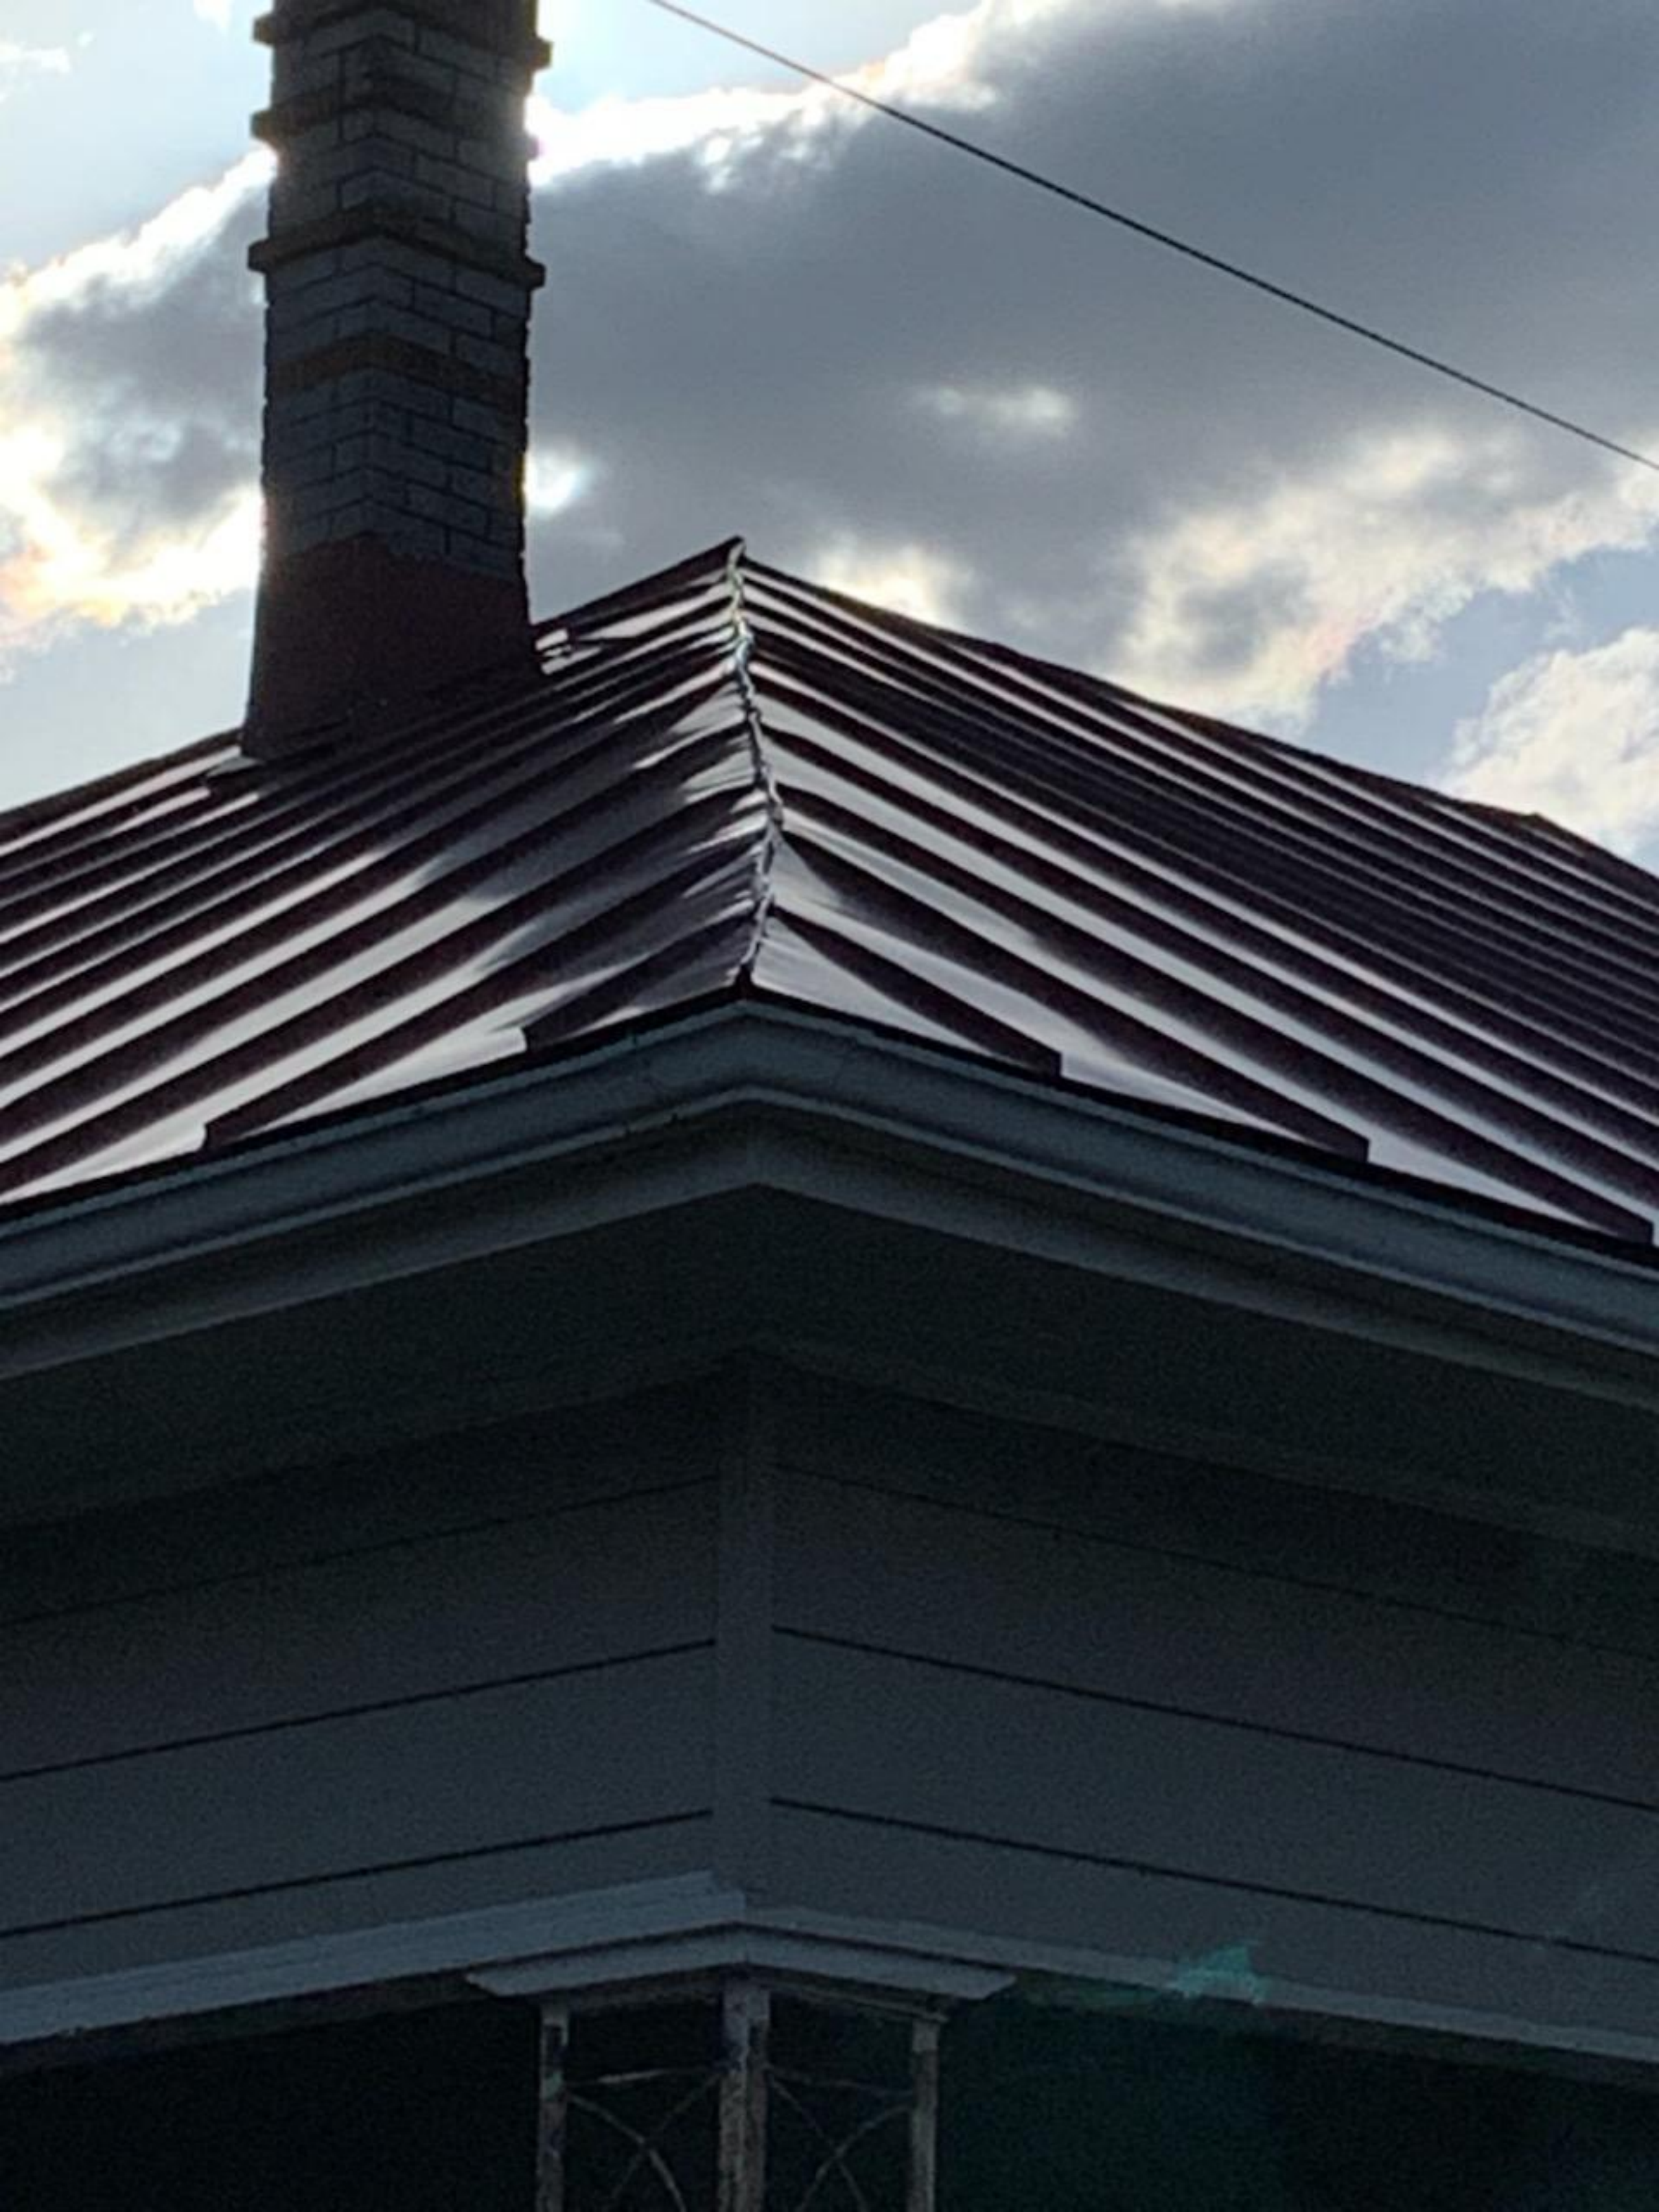
- b. ROOF AMENDMENT – The applicant is requesting approval to install a ridge cap on the primary structure. Administrative approval was granted on May 20, 2019, to replace the standing seam metal roofing in-kind. The approval included the following stipulations: panels should be 18-21 inches wide; seams should be 1-2 inches tall; a crimped ridge seam should be used; and a ridge cap is not permitted. The applicant has stated that the crimped ridge seam was installed incorrectly and is seeking approval to install a ridge cap to cover the irregular seams. The property also received approval for Historic Tax Certification on June 24, 2019. According to the Historic Design Guidelines and OHP standing seam metal roof policy, ridge caps should not be used. Staff finds that the applicant should correct the ill-installed crimped ridge seam in lieu of proposing a non-functional ridge cap to cover the seam.

Staff does not recommend approval based on findings a and b. Staff finds that the applicant should correct the ill-installed crimped ridge seam in lieu of proposing a non-functional ridge cap to cover the seam.
