HISTORIC AND DESIGN REVIEW COMMISSION

HDRC CASE NO: 2019-485
ADDRESS: 912 E CROCKETT ST
914 E CROCKETT ST
916 E CROCKETT ST
LEGAL DESCRIPTION: NCB 583 BLK 8 LOT 6
NCB 583 BLK 8 LOT 5
ZONING: RM-4
CITY COUNCIL DIST.: 2
DISTRICT: Dignowity Hill Historic District
APPLICANT: Office of Historic Preservation
OWNER: Estate of Dorothy Hunter Sapenter
TYPE OF WORK: Recommendation to the Building Standards Board
APPLICATION RECEIVED: August 20, 2019
60-DAY REVIEW: October 19, 2019
CASE MANAGER: Katie Totman

The Office of Historic Preservation is requesting a recommendation to the Building Standards Board (BSB) regarding the rear accessory structure at 912/914/916 E Crockett.

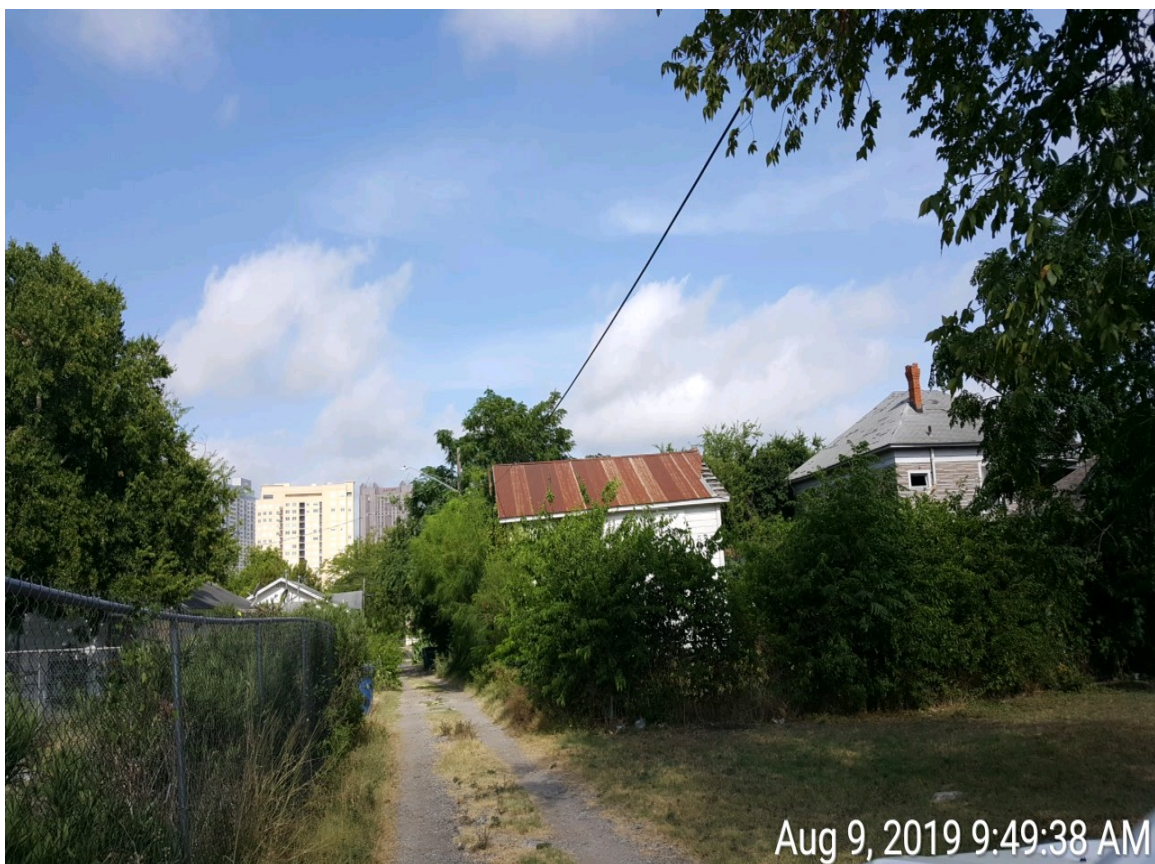
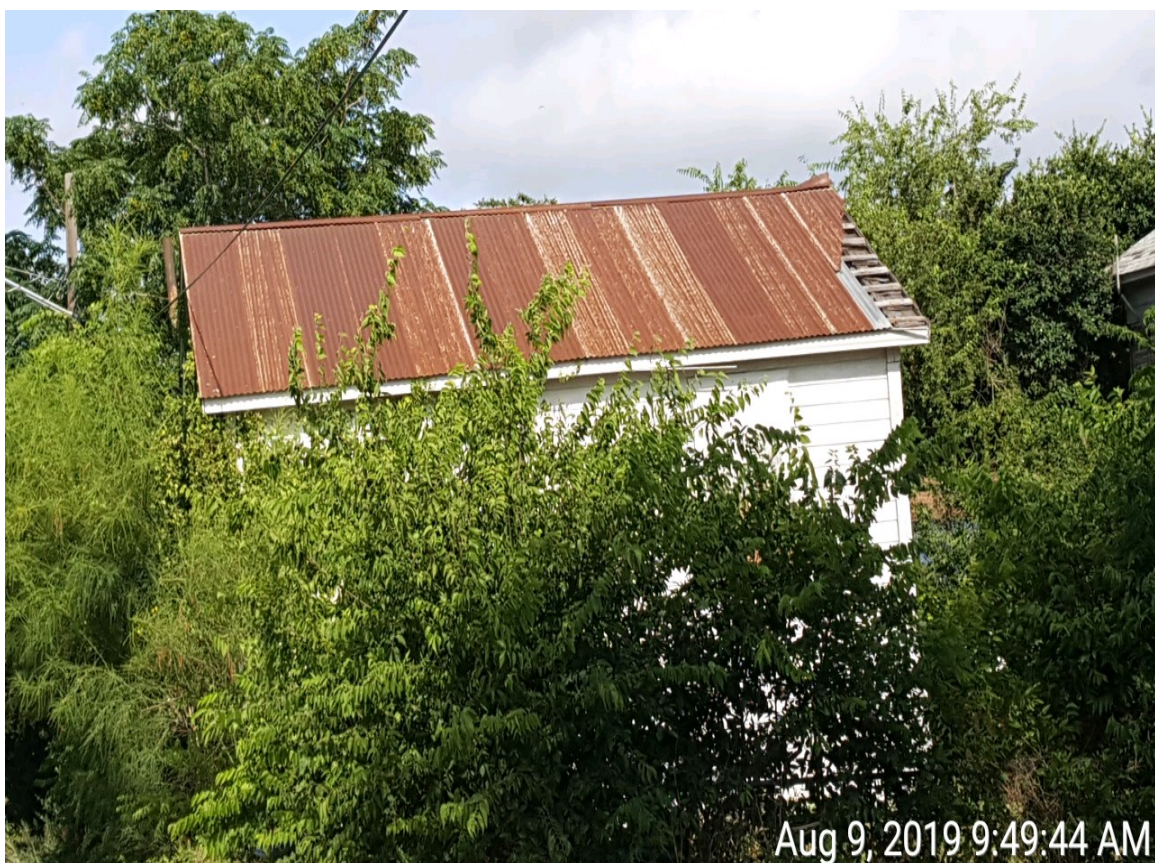
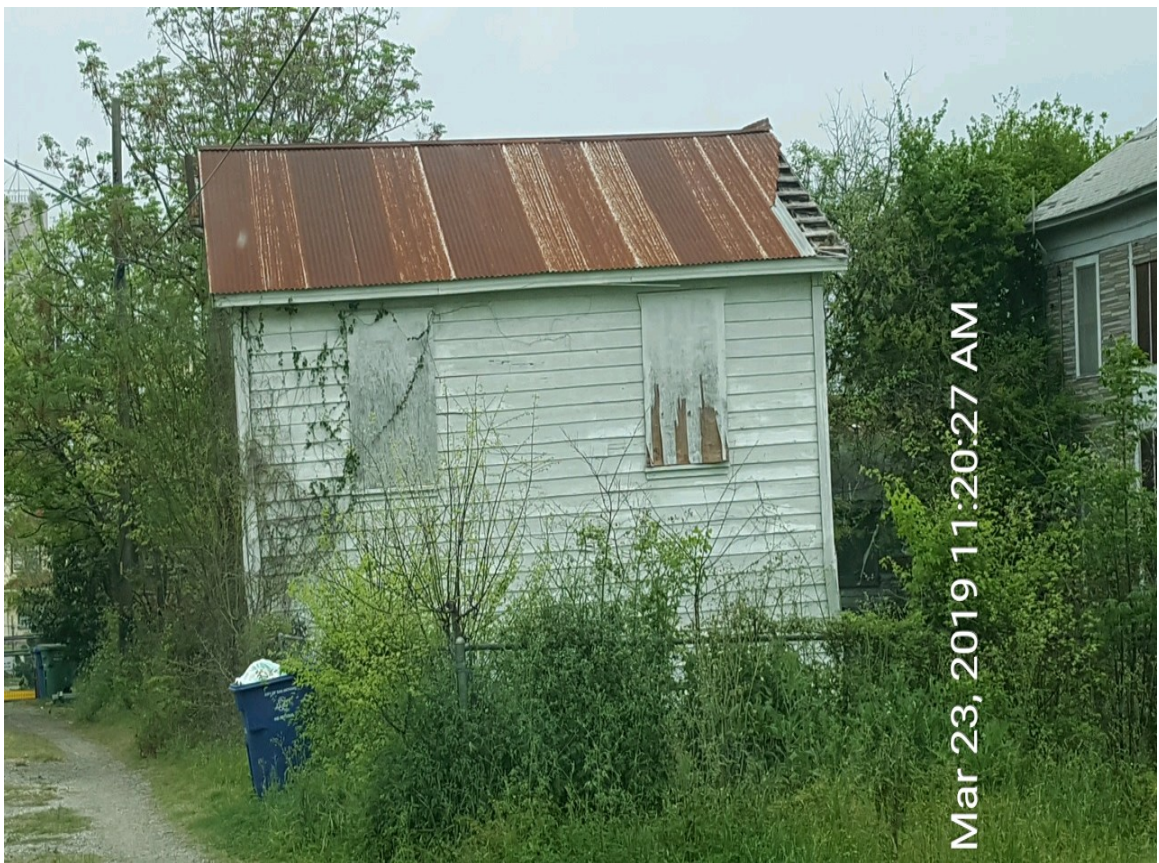
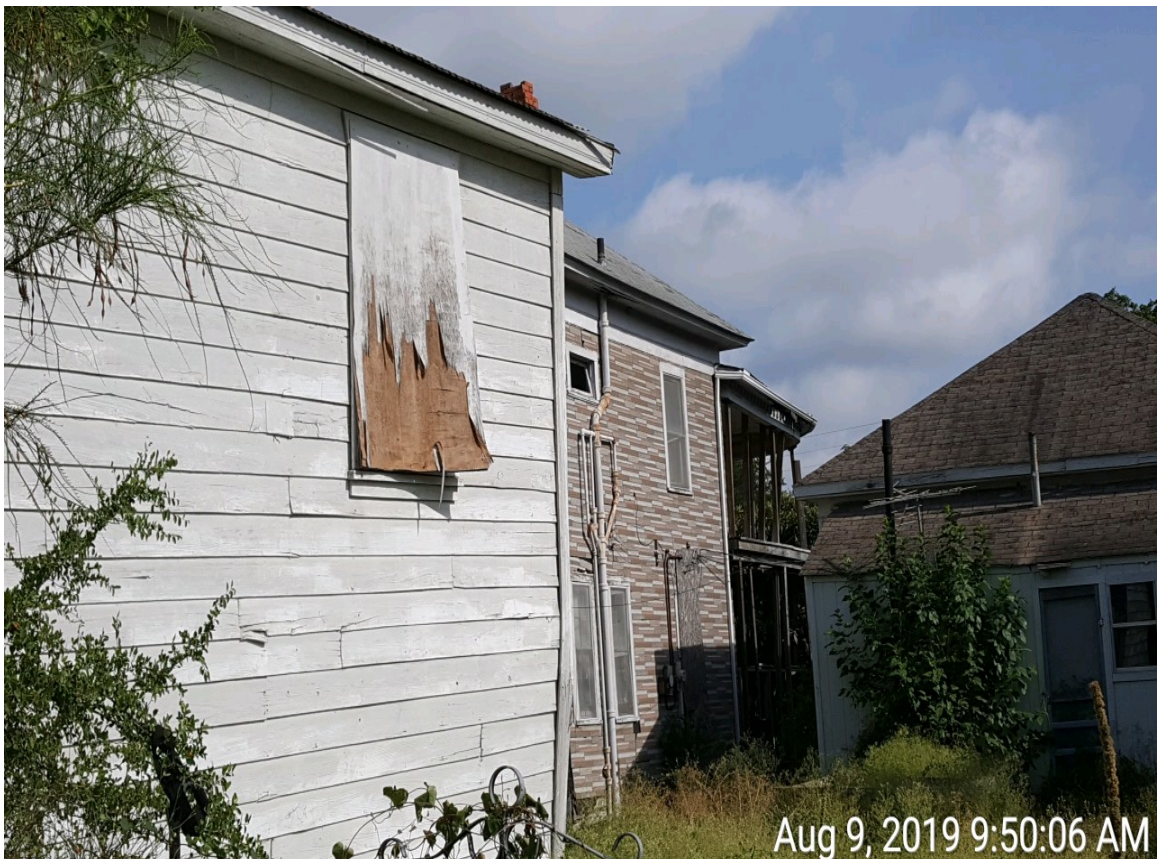
912 E. Crockett St

- b. The City's Code Enforcement Division has determined that the rear accessory structure at this address has deteriorated beyond repair and is recommending demolition of the structure per Chapter 6-156, subsections 7, 8, 11, 12, 17, and 18. The pictures provided by code enforcement show the structure significantly leaning to one side and partial roof and siding damage.

Staff recommends that the HDRC concur with code enforcement's recommendation to demolish the structure based on findings b and c.
