HISTORIC AND DESIGN REVIEW COMMISSION

HDRC CASE NO: 2019-458
ADDRESS: 1301 E COMMERCE ST
LEGAL DESCRIPTION: NCB 590 BLK 3 LOT 13, 14 E 60.16' OF 12, & E 183.1' OF 7 & 9
ZONING: AE-1 S, H
CITY COUNCIL DIST.: 2
DISTRICT: Dignowity Hill Historic District
APPLICANT: Alonzo Alston/Sol Studio Architects
OWNER: Store Space
TYPE OF WORK: Exterior modifications
APPLICATION RECEIVED: September 09, 2019
60-DAY REVIEW: November 08, 2019
REQUEST:

The applicant is requesting a Certificate of Appropriateness for approval to perform exterior modifications the existing structure at 1301 E Commerce. Within the proposed scope of work, the applicant has proposed the following:

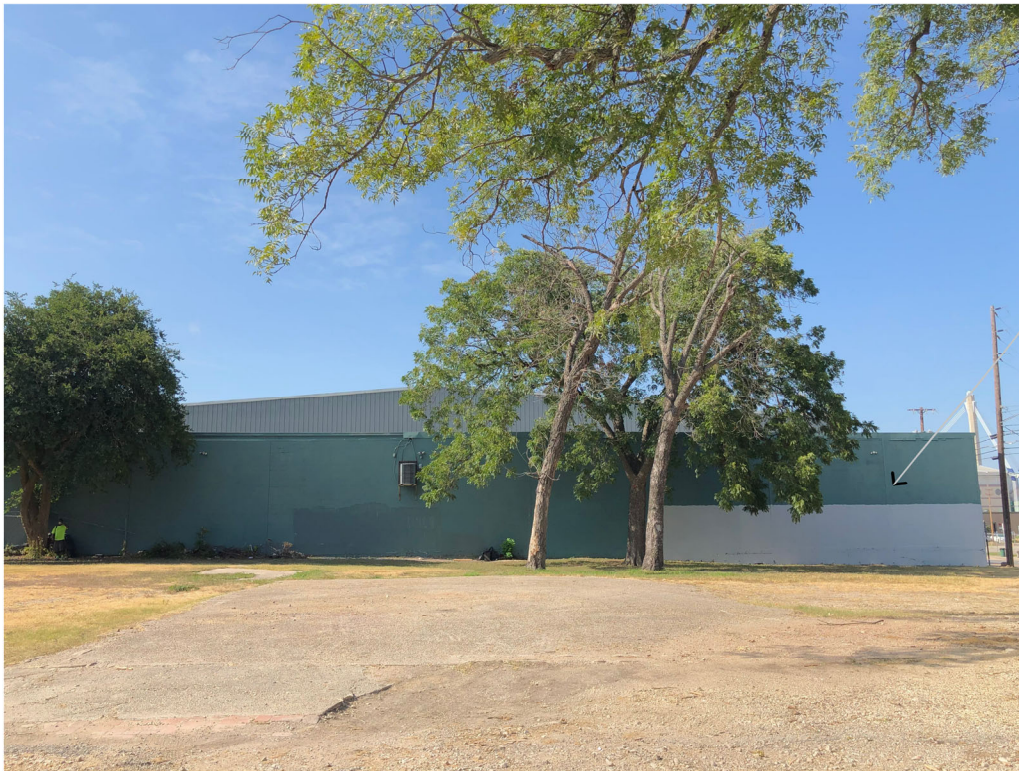
NORTH FACADE - EXISTING

EXISTING WALL TO BE PAINTED

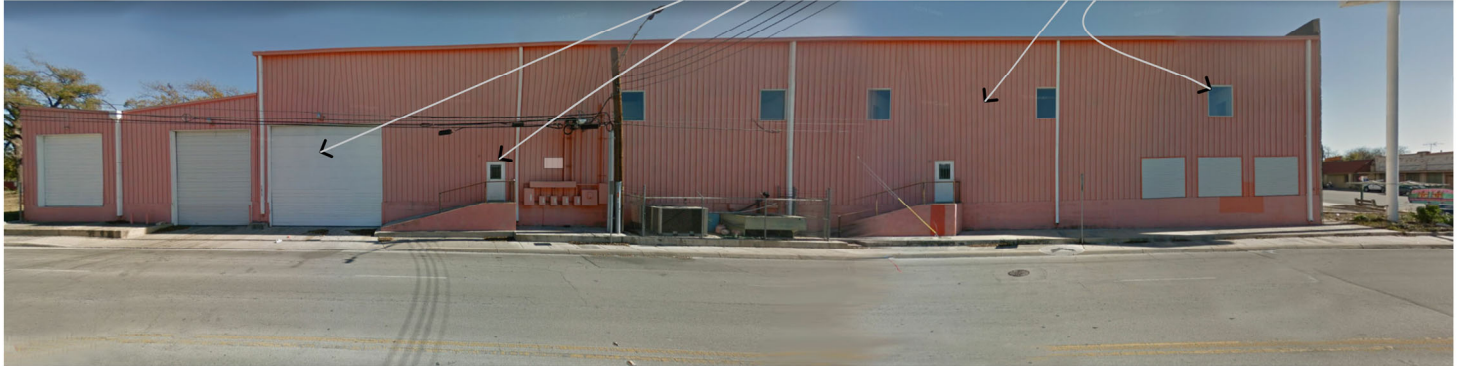
NORTH FACADE - EXISTING

EXISTING WALL TO BE PAINTED
 EXISTING DOORS TO BE PAINTED
 EXISTING WALL TO BE PAINTED
 EXISTING WINDOWS TO REMAIN

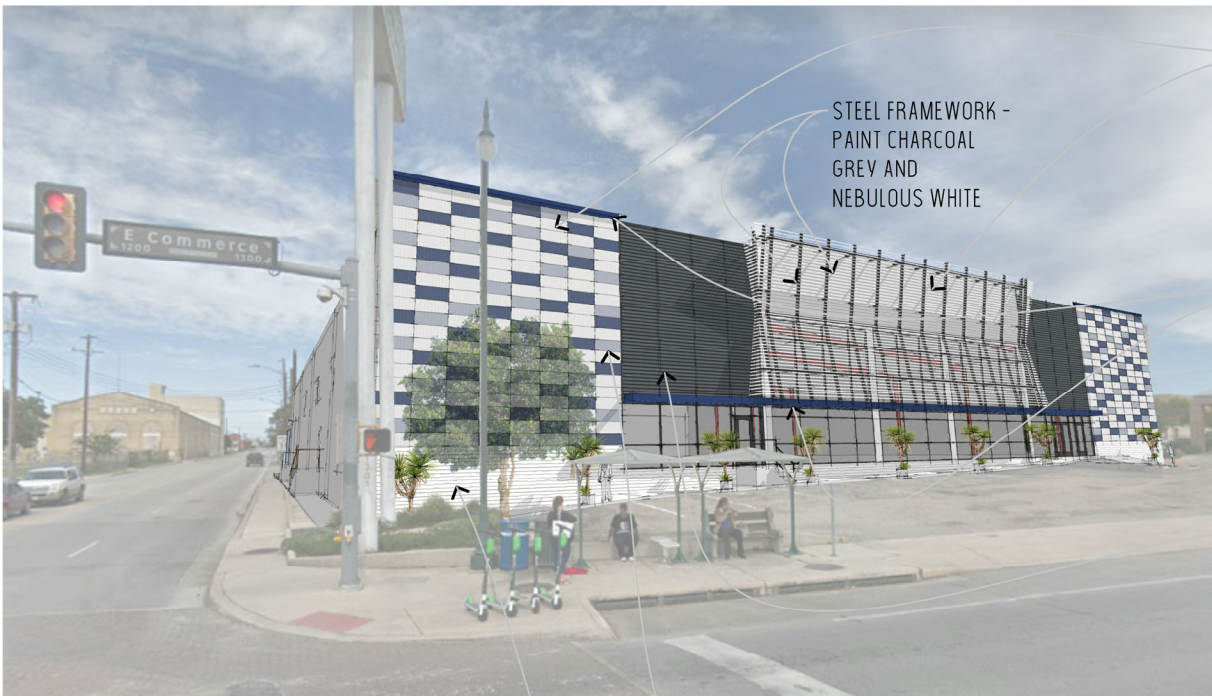
PROPOSED

STUCCO-SHERWIN
WILLIAMS PAINT -
NEBULOUS WHITE

PARAPET AND STEEL
AWNINGS-SHERWIN
WILLIAMS PAINT -
DISTANCE

MBCI CORRUGATED
PANEL -
CHARCOAL GREY

STUCCO - SHERWIN
WILLIAMS PAINT -
STORM CLOUD

DRY STACKED STONE
- ARCHITECTURAL
STACKED STONE CO.

EXTERIOR PERSPECTIVE - SOUTH FACADE

- c. **FAÇADE MODIFICATIONS** – The applicant has proposed to remove the existing stone veneer, and existing canopy and replace them with stucco and a dry stack stone system, and a new steel awning. Generally, staff finds that the existing stone façade provides architectural integrity and façade depth and separation. The proposed modifications introduce forms and materials that are not found historically in the district, including the additional storefront and new canopy frame system, and are contemporary in nature. While staff finds that modifications to the exterior may be appropriate, staff finds that existing materials should remain, or that stone or a modular masonry material be installed. Staff does not find the use of metal siding to be appropriate in place of the mansard roof canopy. Additionally, staff does not find the use of stucco to be appropriate.

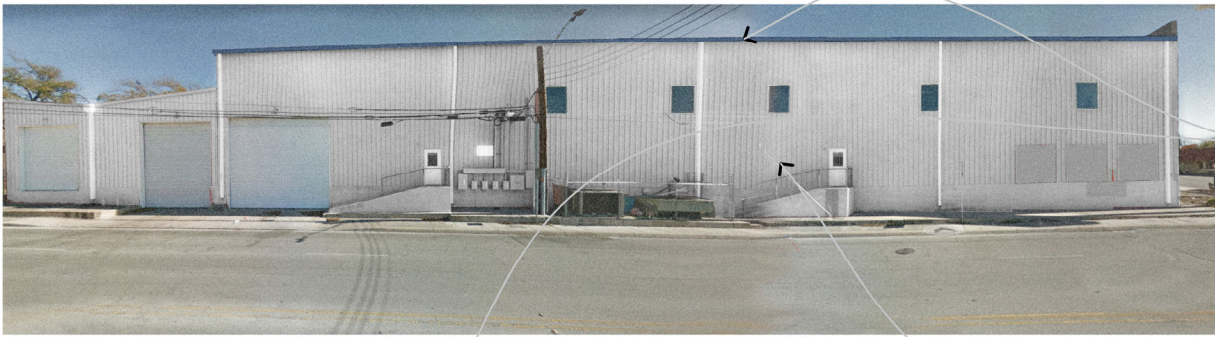
PROPOSED WEST FACADE

PARAPET-SHERWIN
WILLIAMS PAINT -
DISTANCE

STUCCO-SHERWIN
WILLIAMS PAINT -
ASH GREY
