HISTORIC AND DESIGN REVIEW COMMISSION

HDRC CASE NO: 2019-426

ADDRESS: 229 W HOLLYWOOD AVE

DISTRICT: Monte Vista Historic District
APPLICANT: Matt Murray/Pella Windows
OWNER: MURRAY KATHRYN A
TYPE OF WORK: Window replacement

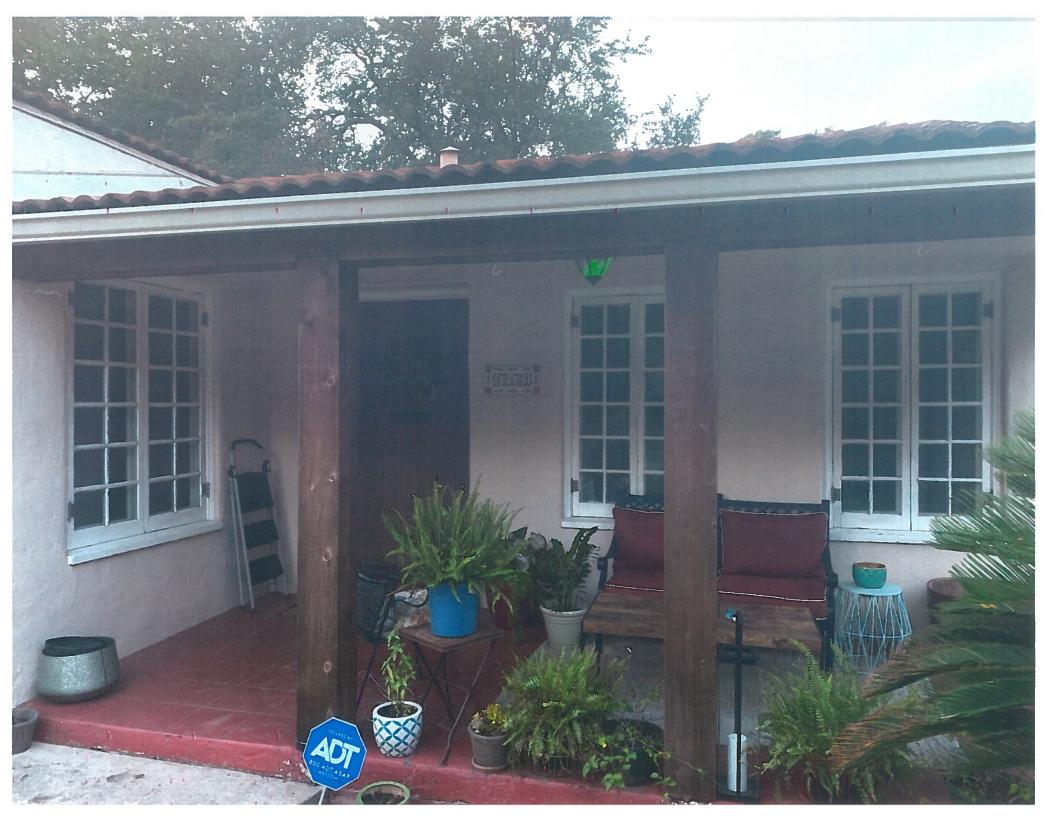
Line Number: 10 Quote Qty: 1 Scaling: 1/2" = 1'

Description: Architect Reserve, 2-Wide Casement, 50 X 65

Rough Opening: 50.75" X 66.875"

Room Location: Front Elevation Left

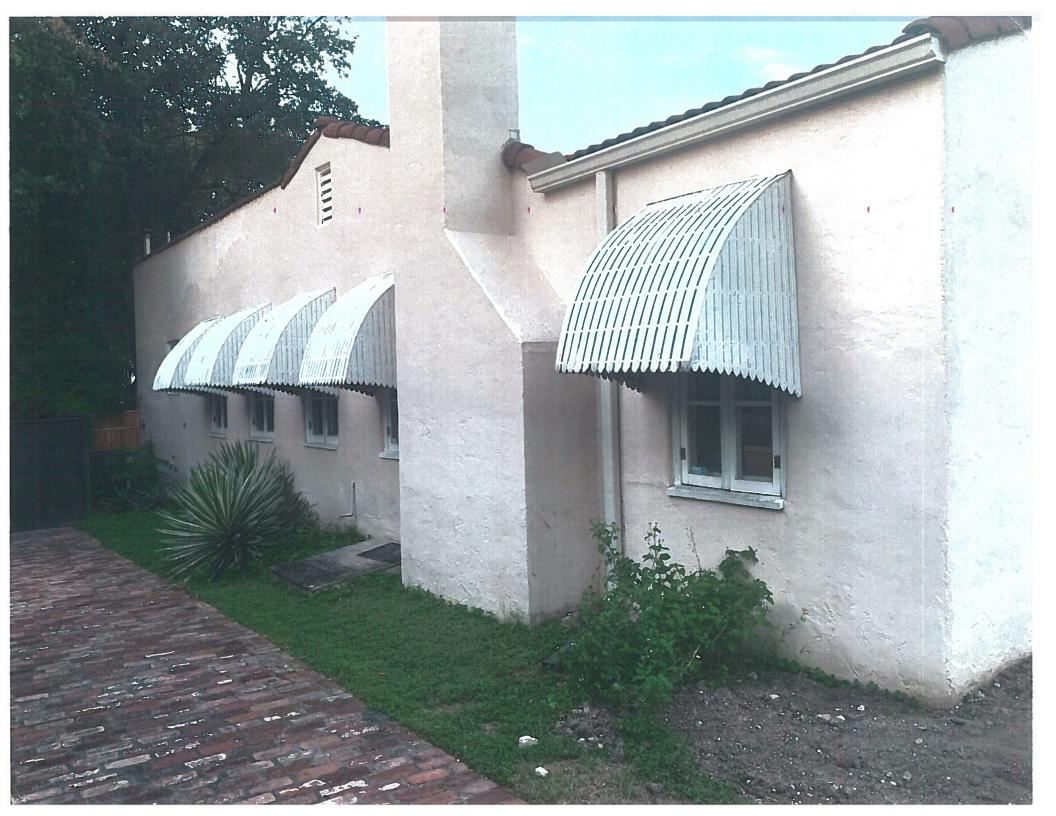
Line Number: 15 Quote Qty: 1 Scaling: 1/2" = 1'

Description: Architect Reserve, 2-Wide Casement, 50 X 65

Rough Opening: 50.75" X 66.875"

Room Location: Patio @ Entry

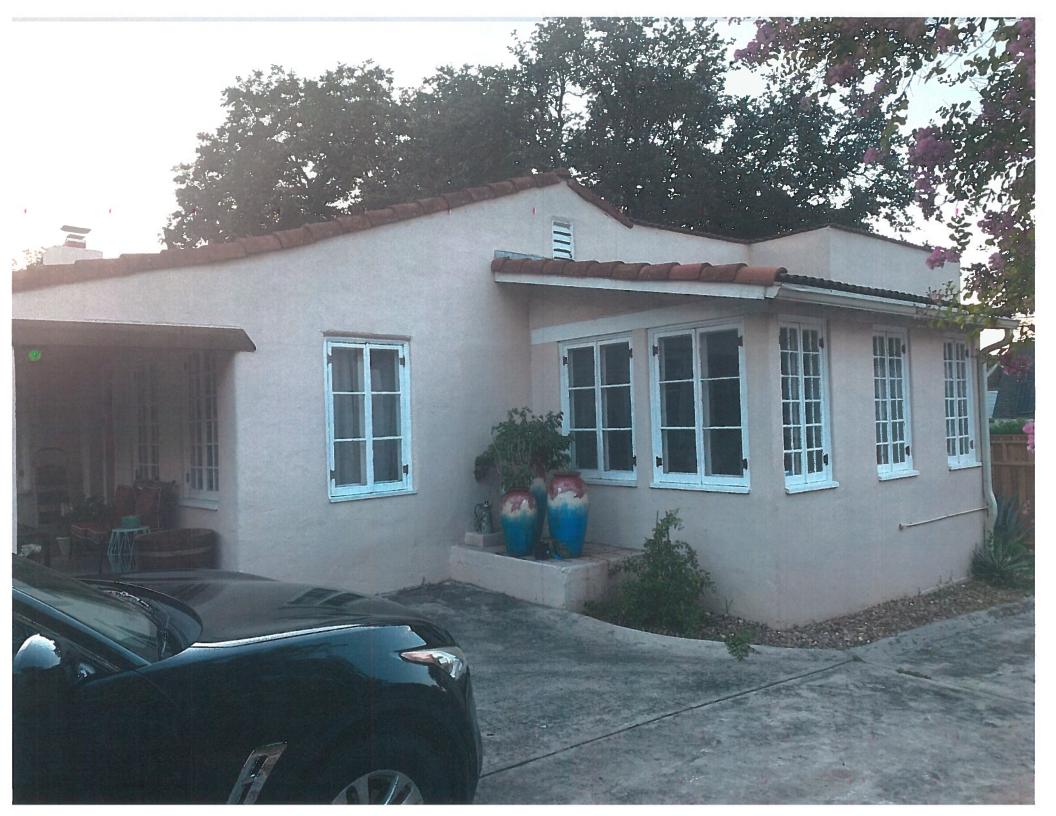
Line Number: 40 Quote Qty: 1 Scaling: 1/2" = 1'

Description: Architect Reserve, Casement Left, 38 X 65

Rough Opening: 38.75" X 66.875"

Room Location: Patio @ Entry

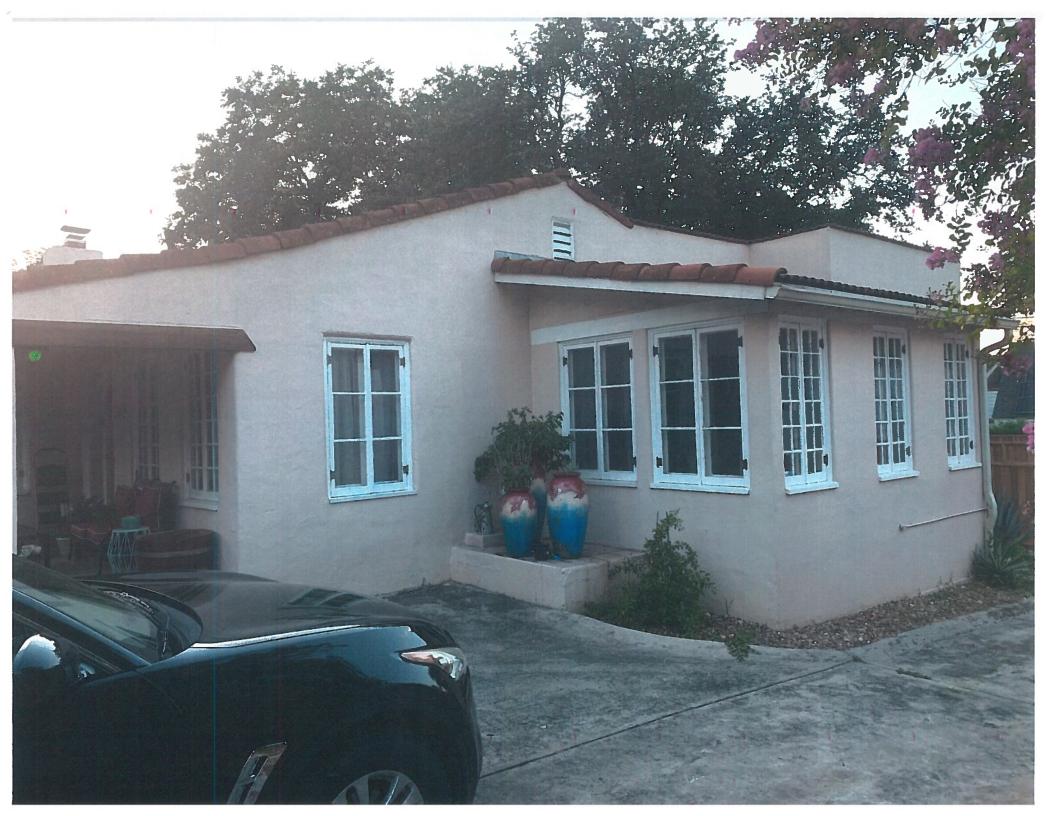
Line Number: 45 Quote Qty: 1 Scaling: 1/2" = 1'

Description: Architect Reserve, Casement Right, 38 X 65

Rough Opening: 38.75" X 66.875"

Room Location: Patio @ Entry

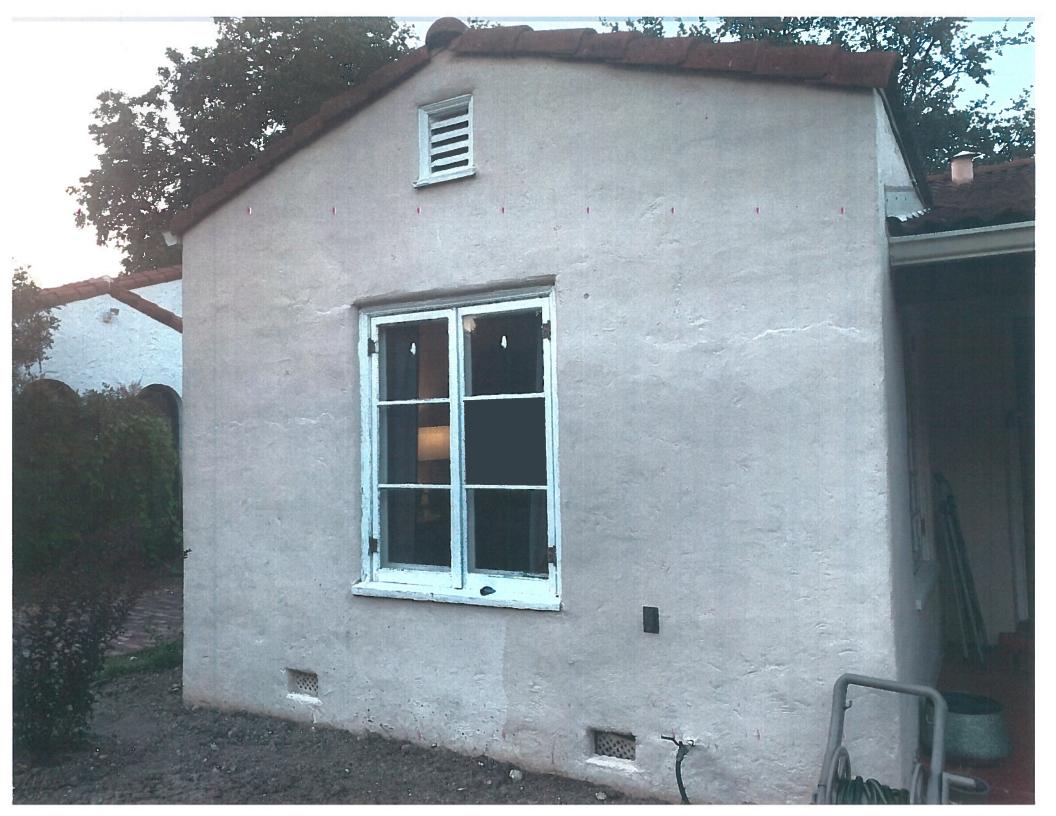
Line Number: 50 Quote Qty: 1 Scaling: 1/2" = 1'

Description: Architect Reserve, Casement Right, 38 X 65

Rough Opening: 38.75" X 66.875"

Room Location: Right Elevation

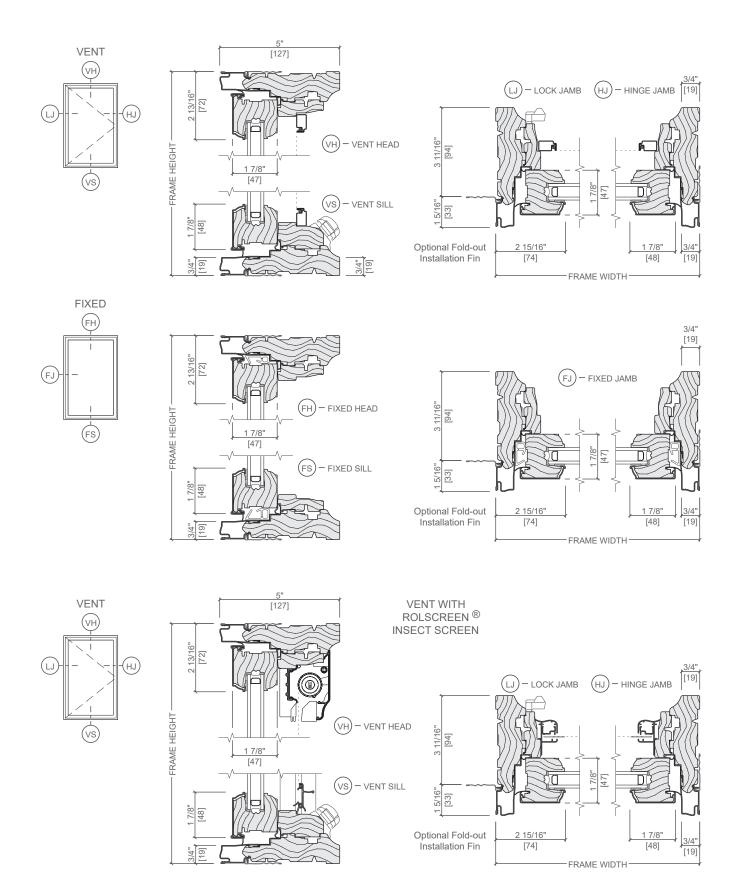
Unit Sections - Aluminum-Clad Exterior, Ogee Exterior Profile

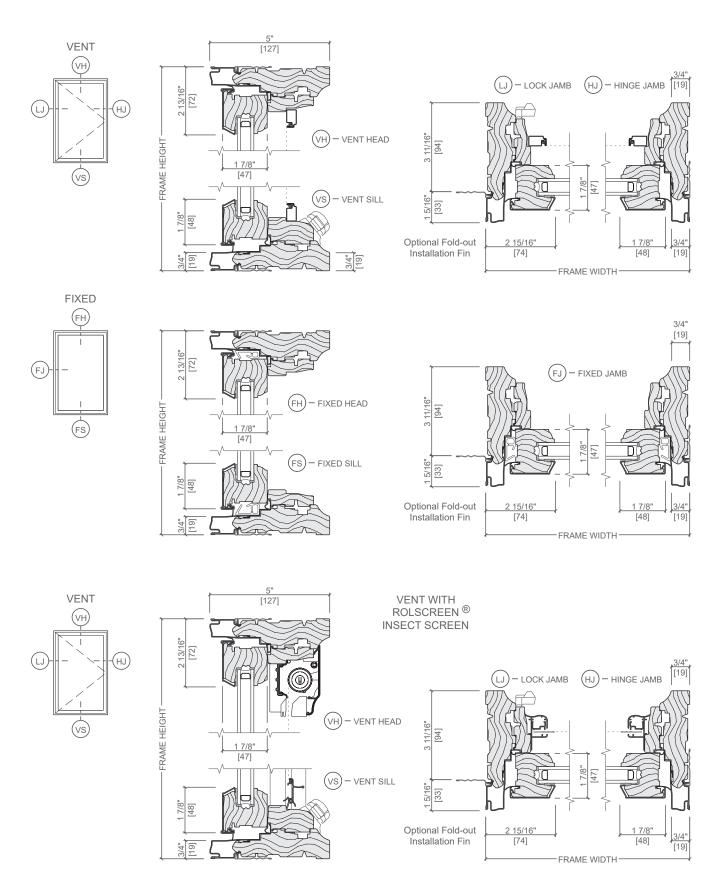
Unit Sections - Aluminum-Clad Exterior, Putty Glaze Exterior Profile

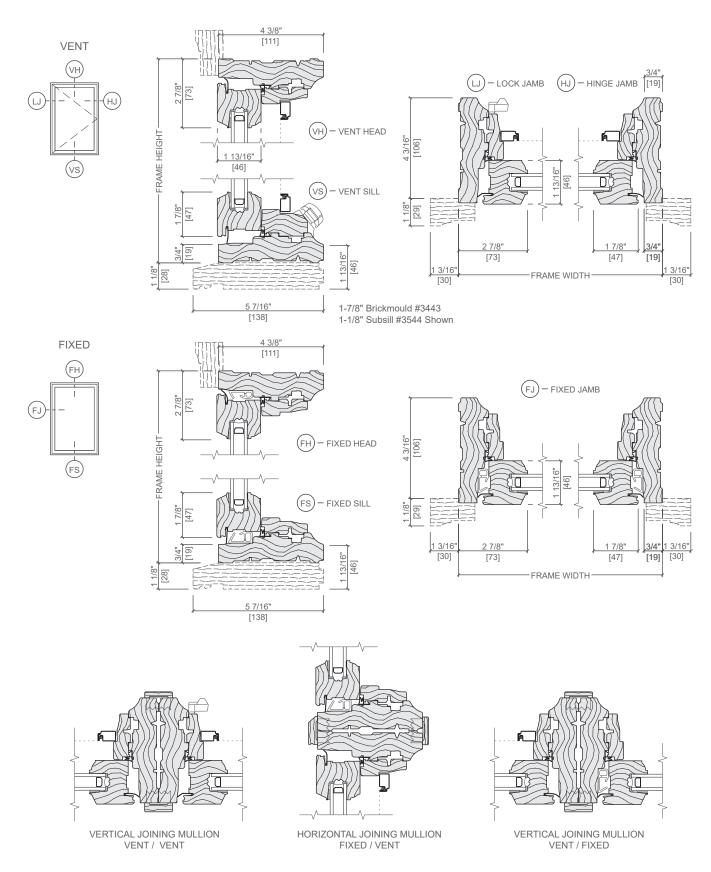
Unit Sections - Wood Exterior, Putty Glaze Exterior Profile

Scale 3" = 1' 0" All dimensions are approximate.
