HISTORIC AND DESIGN REVIEW COMMISSION

September 18, 2019

HDRC CASE NO: 2019-543
ADDRESS: 223 E CAROLINA ST
LEGAL DESCRIPTION: NCB 3010 BLK 8 LOT 15
ZONING: RM-4,H
CITY COUNCIL DIST.: 1
DISTRICT: Lavaca Historic District
APPLICANT: Alan Yoshida
OWNER: T & T CONTRACTORS LLC
TYPE OF WORK: Demolition of rear accessory structure, installation of rear shipping container structure
APPLICATION RECEIVED: August 09, 2019
60-DAY REVIEW: October 08, 2019
CASE MANAGER: Stephanie Phillips
REQUEST:

1. Demolish a contributing rear accessory structure.
2. Construct a 1-story shipping container-style rear structure.

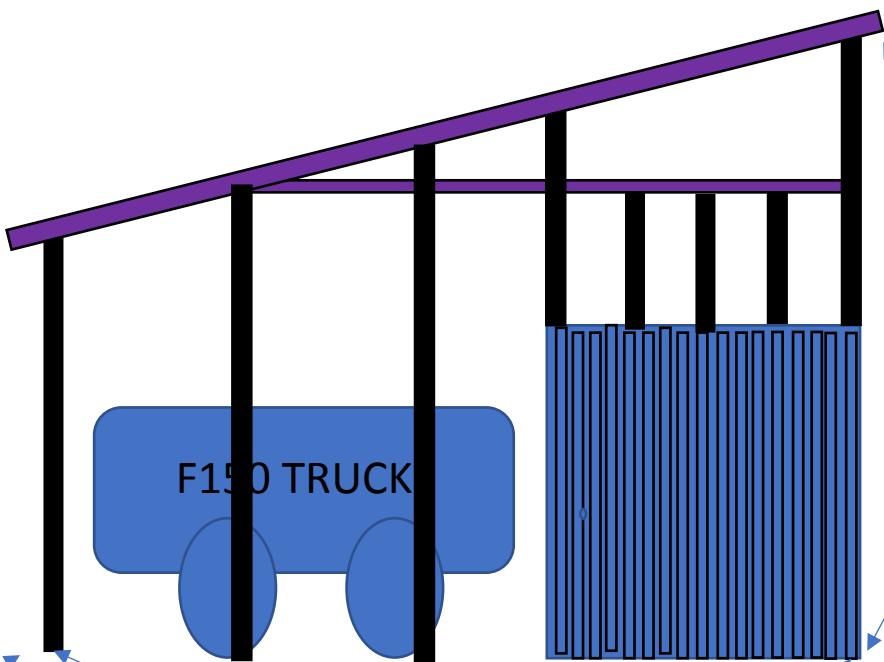
ELEVATION LEFT

16'-6" TALL

7'

HALF COVERED CONTAINER
