HISTORIC AND DESIGN REVIEW COMMISSION

HDRC CASE NO: 2019-567
ADDRESS: 301 W MAGNOLIA AVE
LEGAL DESCRIPTION: NCB 2952 BLK 1 LOT 19, 20, 21, 22, & E 38 FT OF 18
ZONING: MF-33
CITY COUNCIL DIST.: 1
DISTRICT: Monte Vista Historic District
APPLICANT: Office of Historic Preservation
OWNER: Magnolia Vertical LTD
TYPE OF WORK: Recommendation to the Building Standards Board
APPLICATION RECEIVED: September 20, 2019
60-DAY REVIEW: November 19, 2019
CASE MANAGER: Katie Totman

The Office of Historic Preservation is requesting a recommendation to the Building Standards Board (BSB) for the repair of building 1 located at 301 W Magnolia.

Building Standards Board - Structural Condition

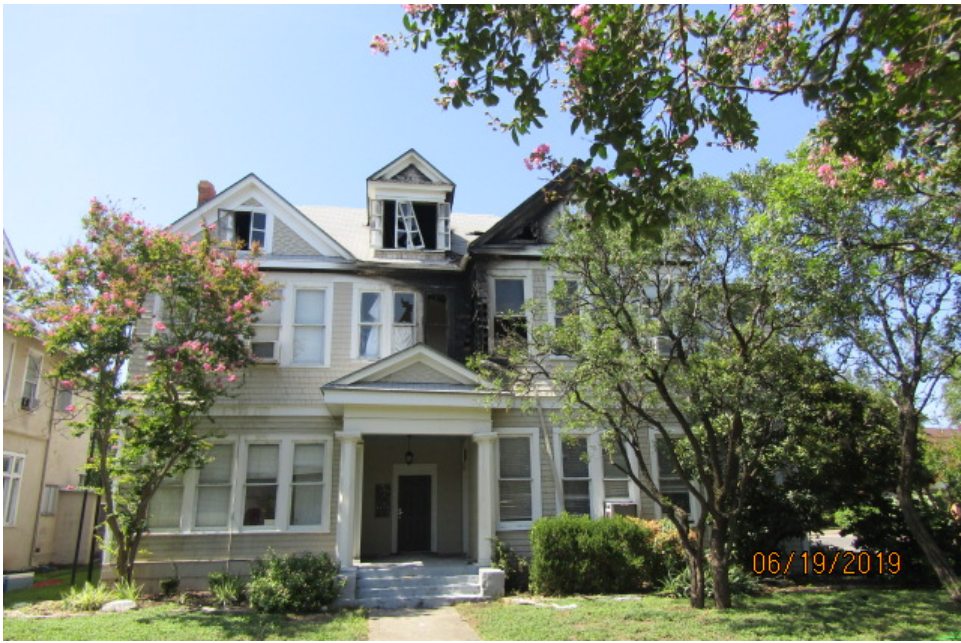
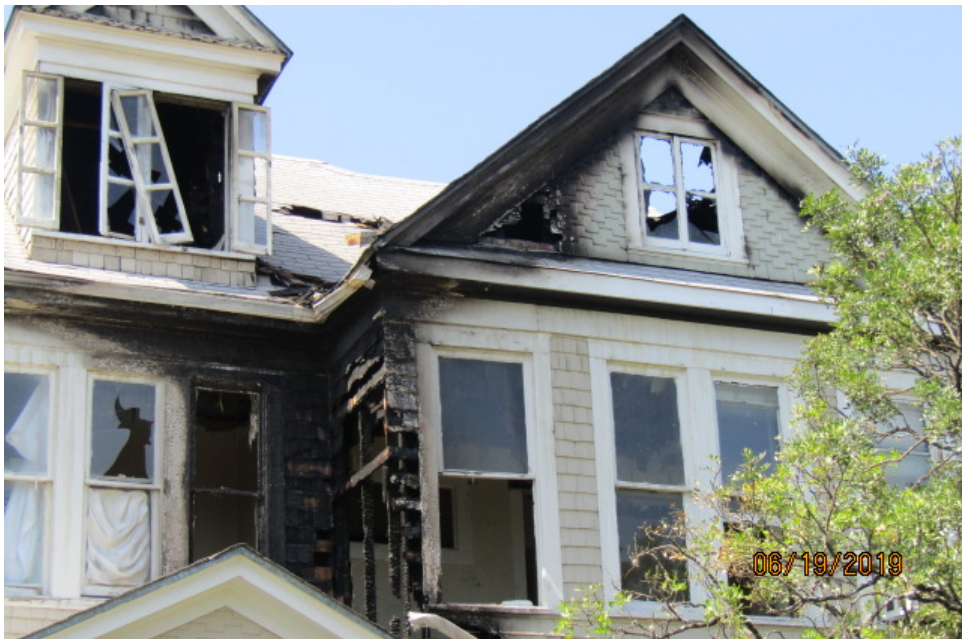
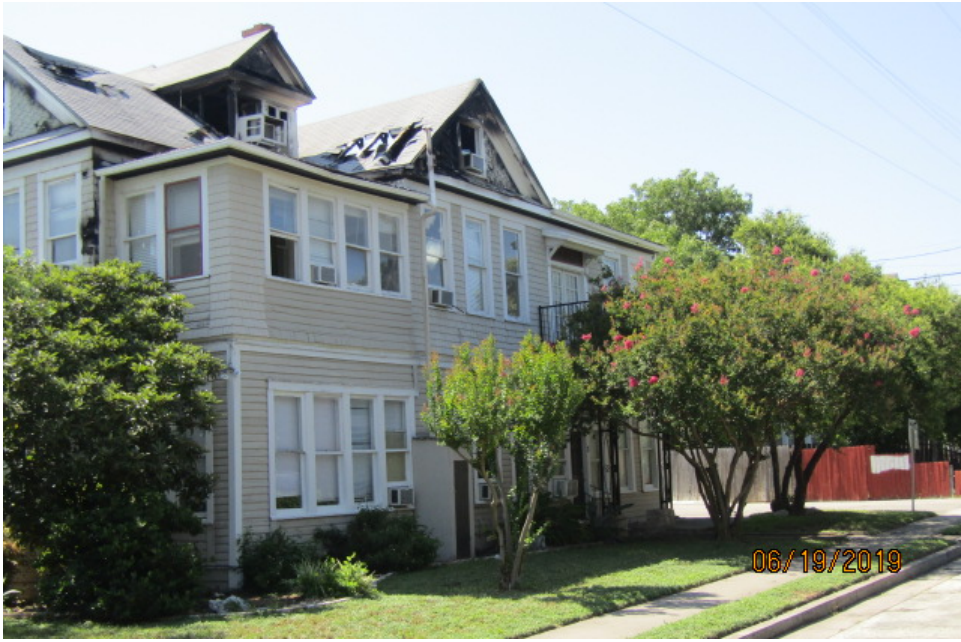
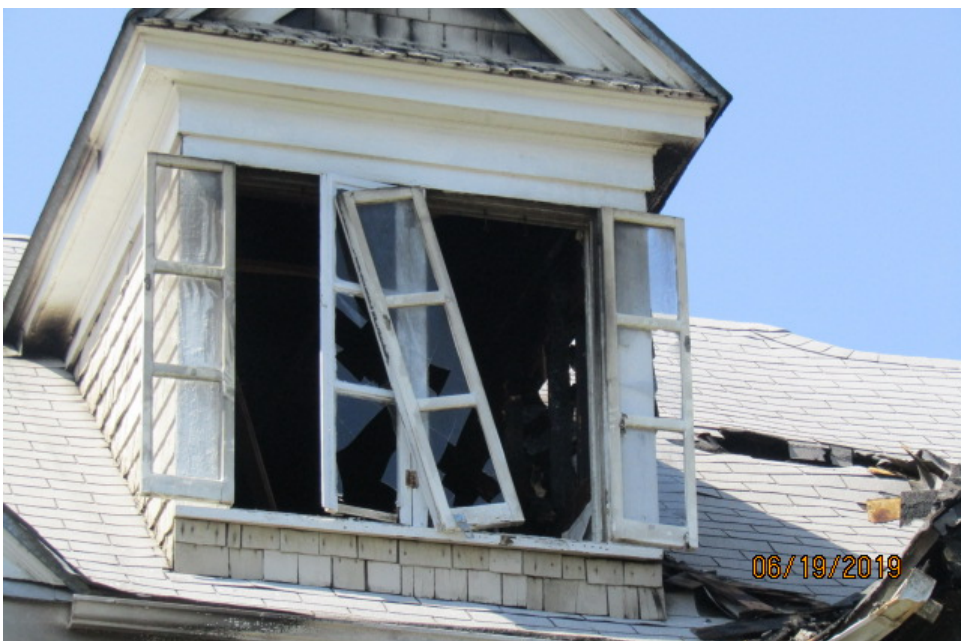
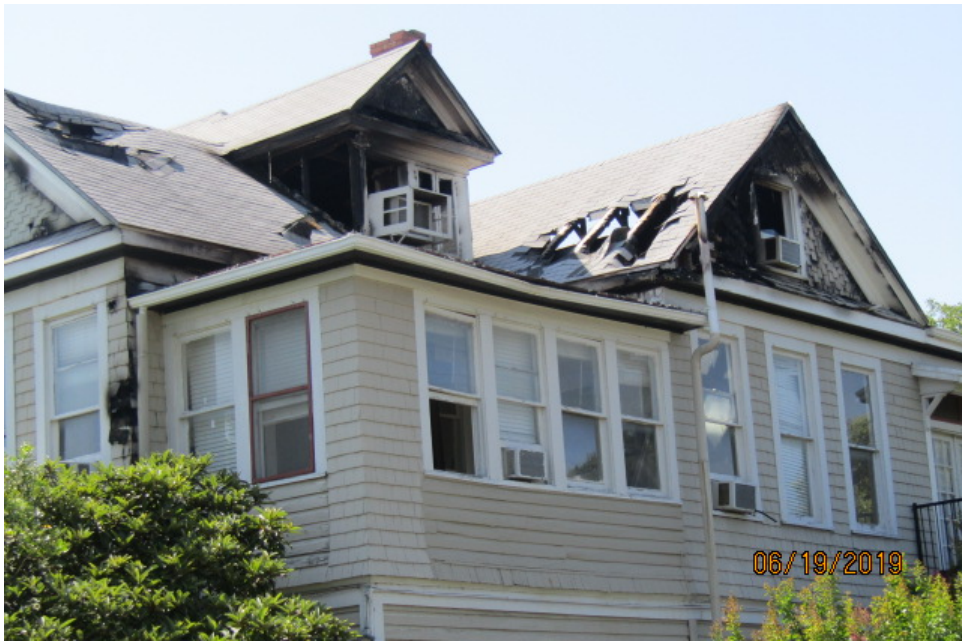
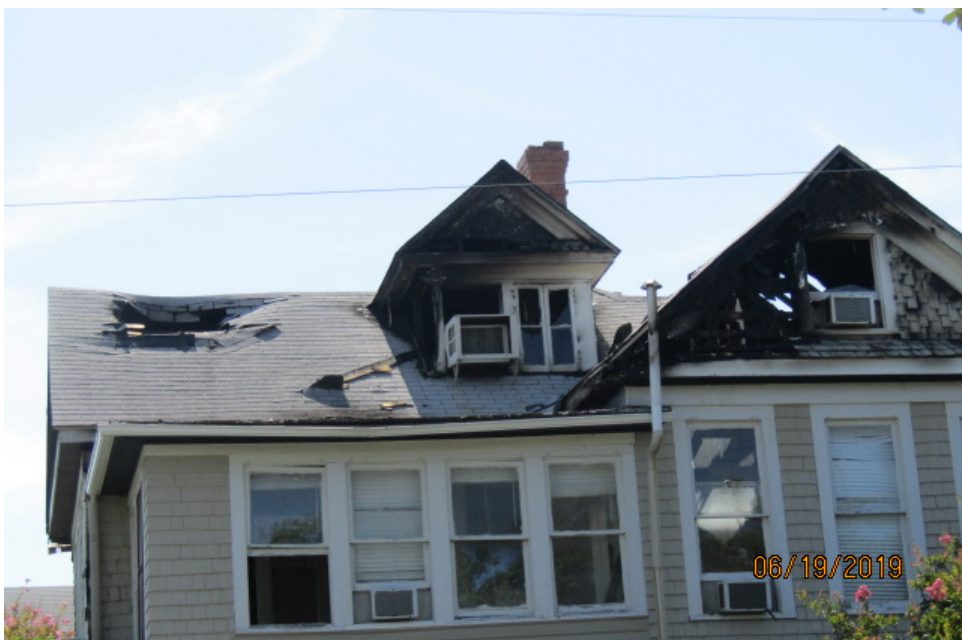
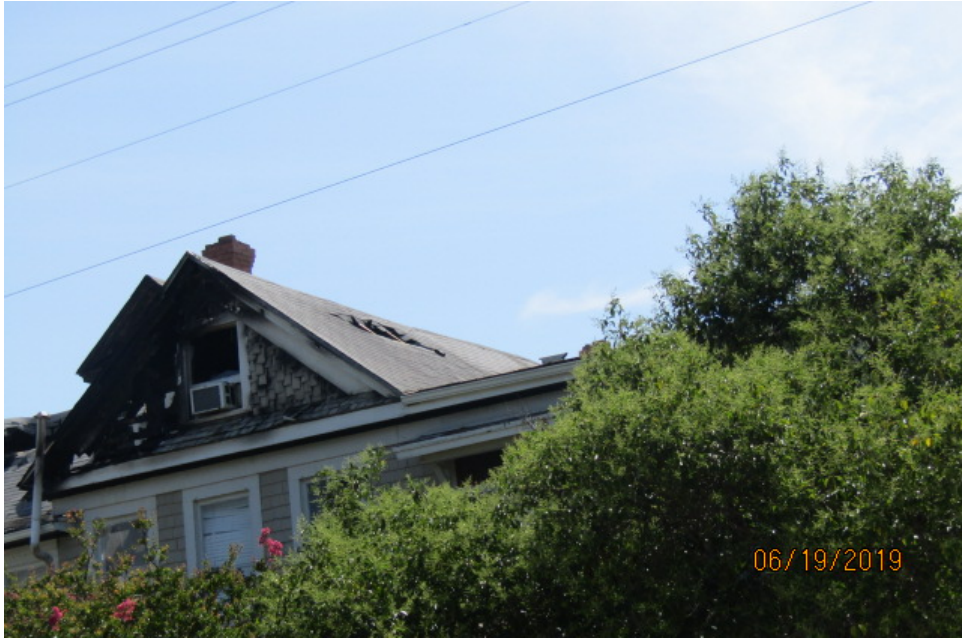
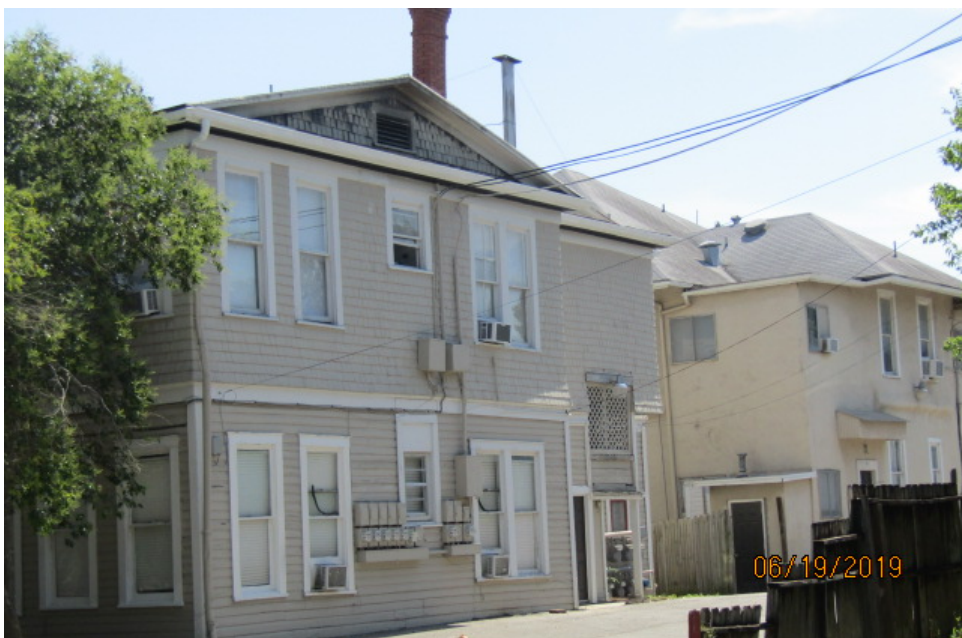
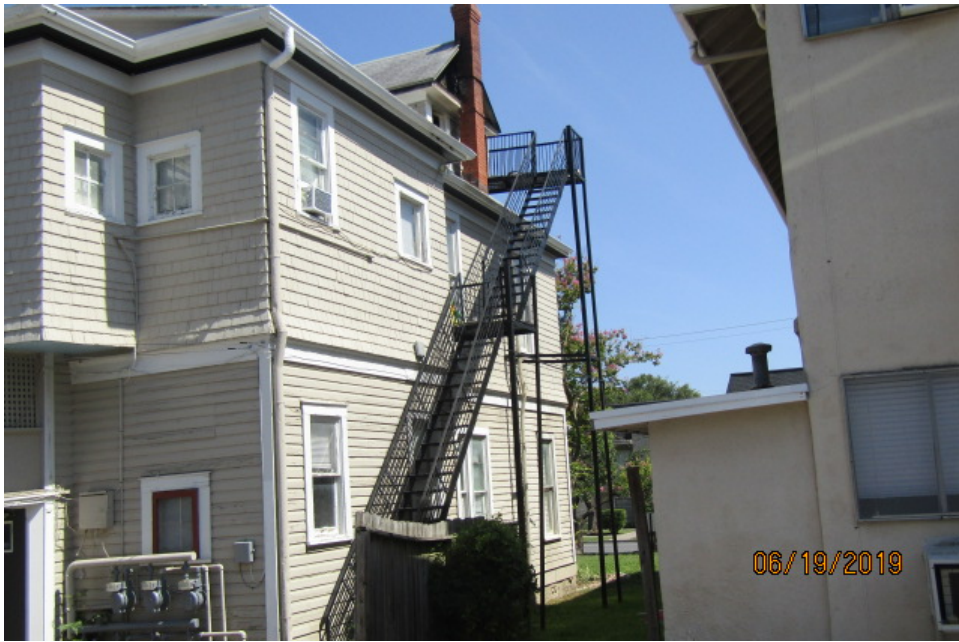
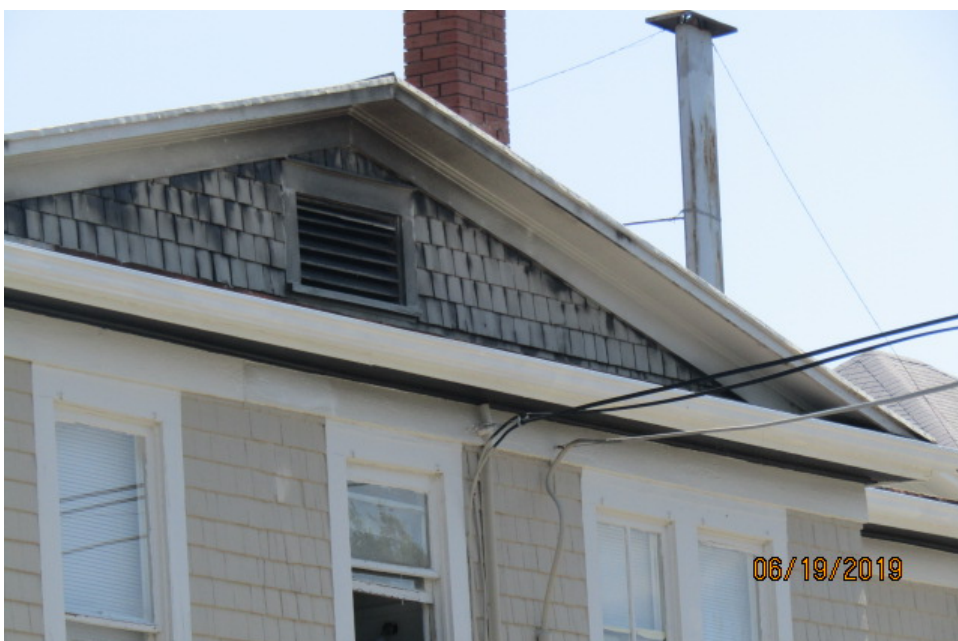
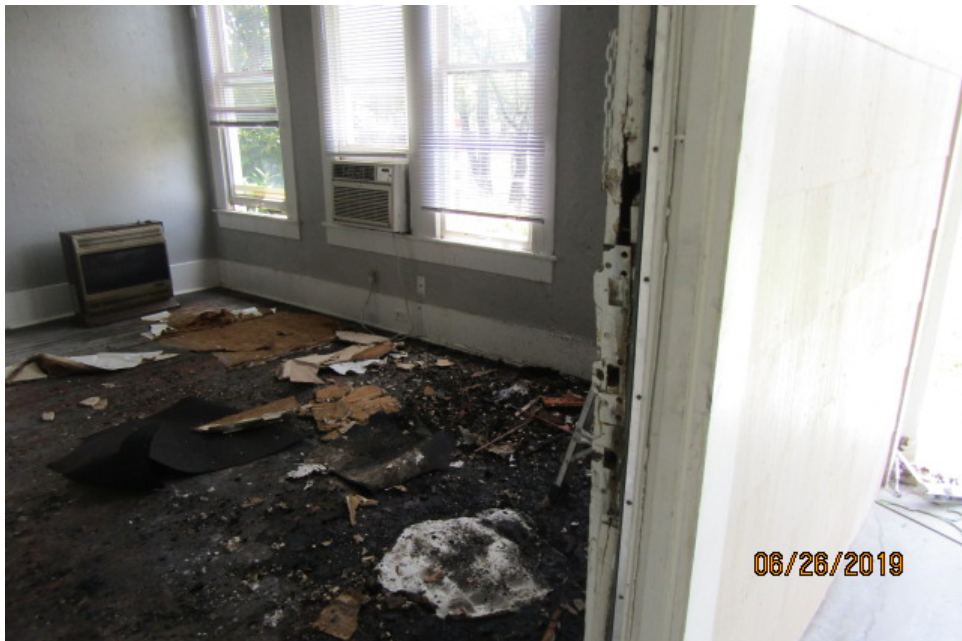
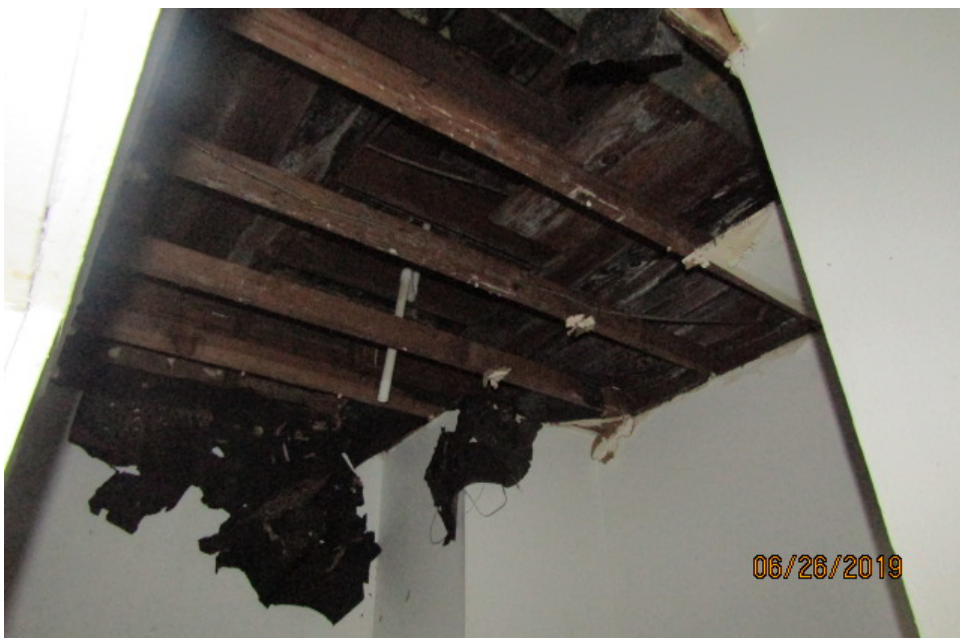
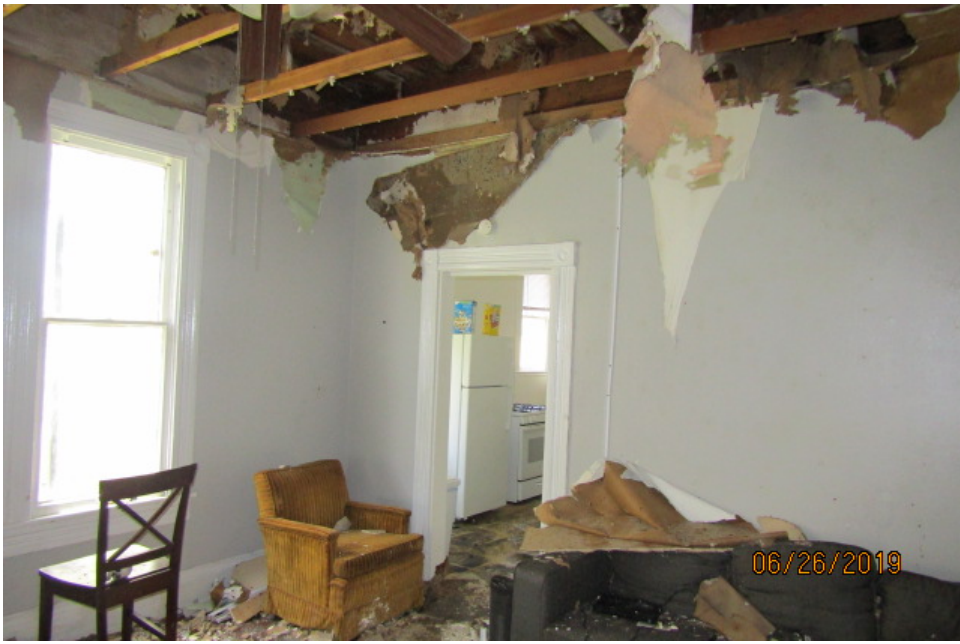
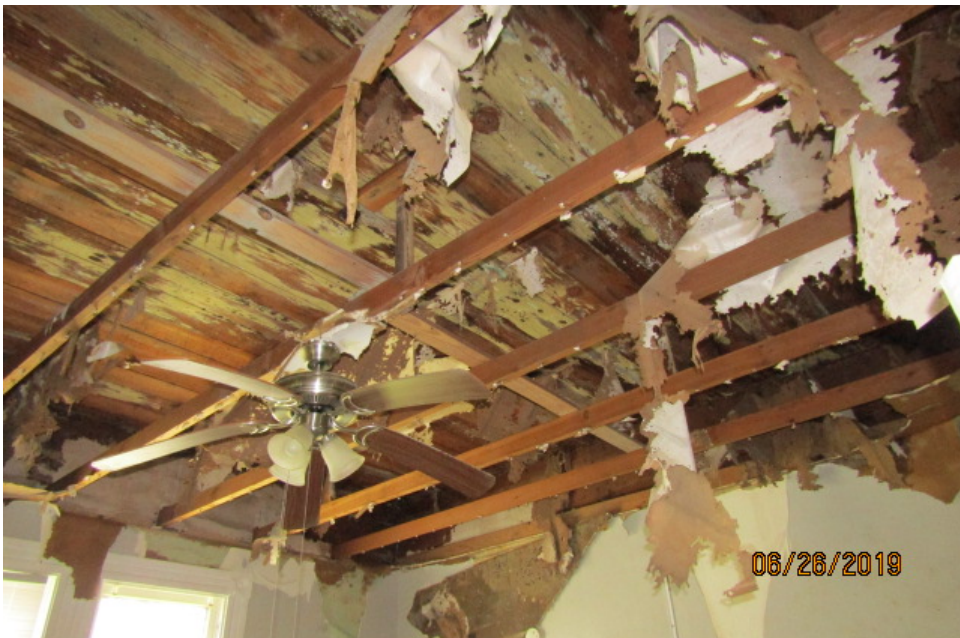
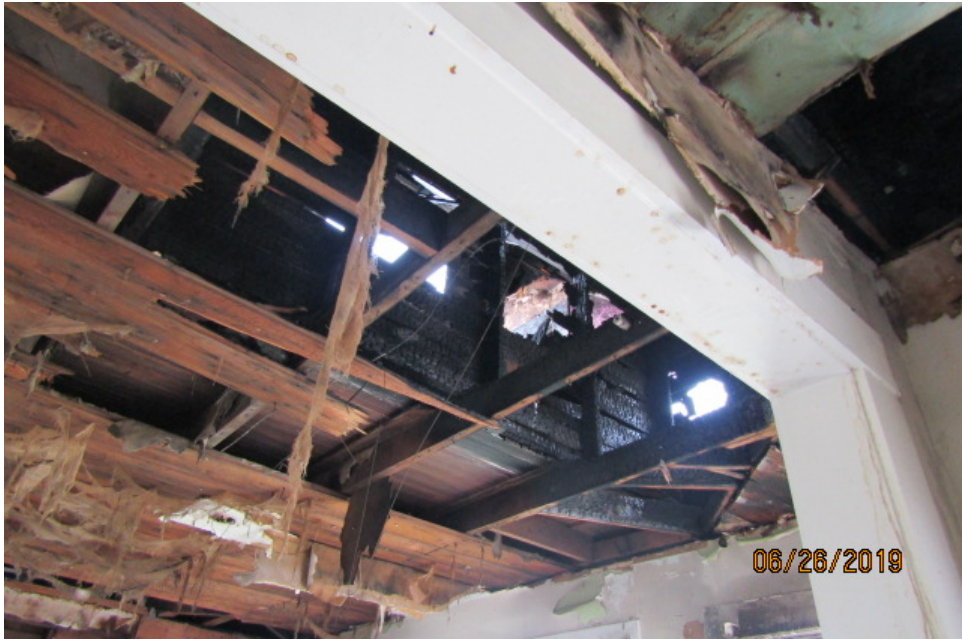
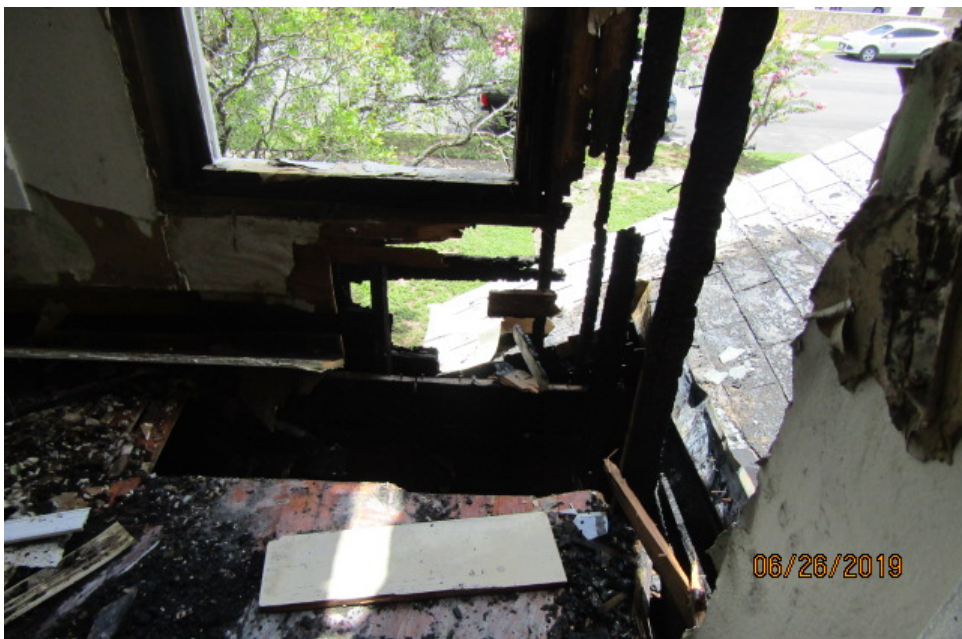
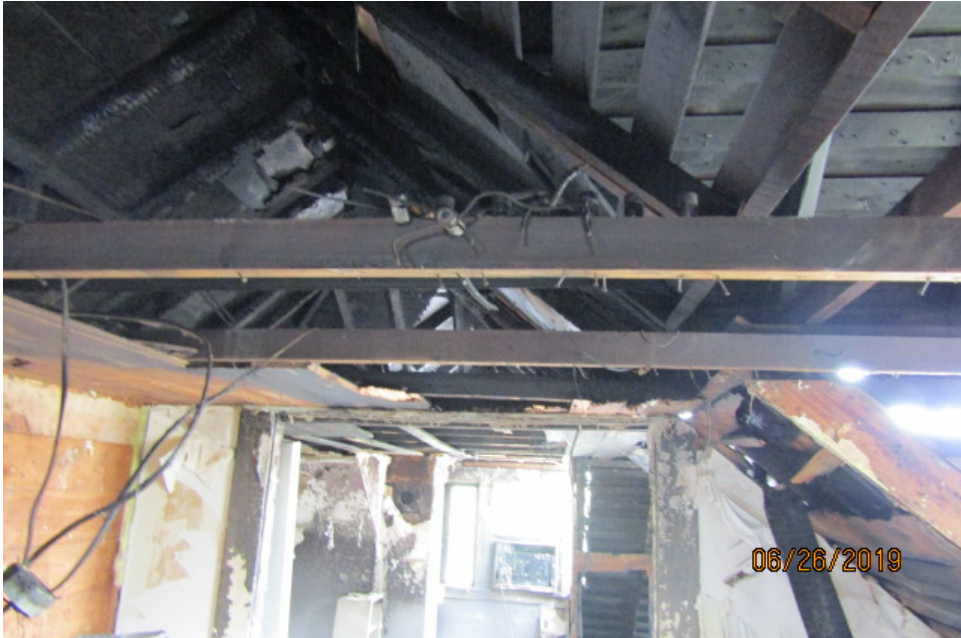
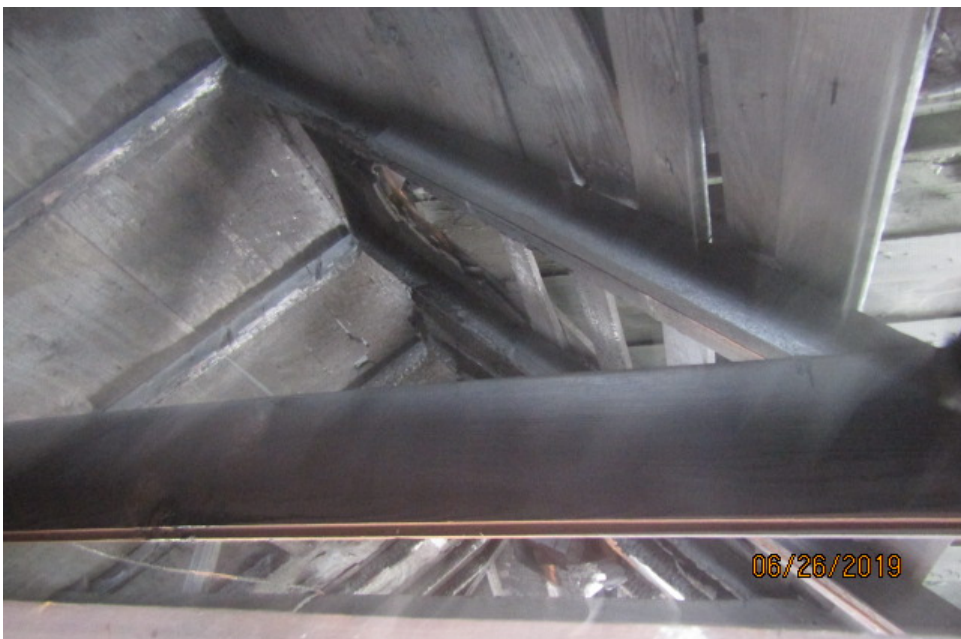
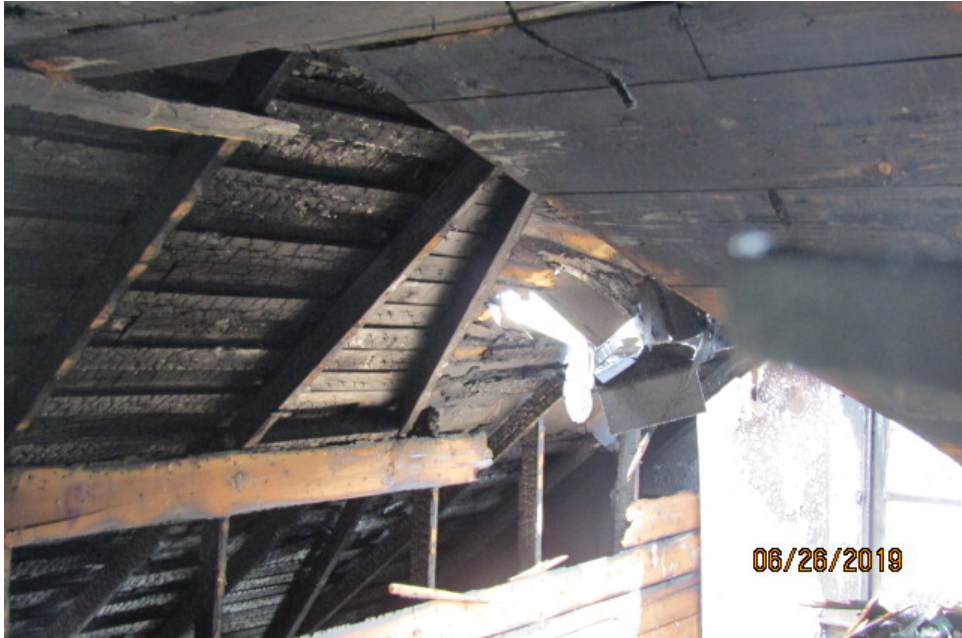
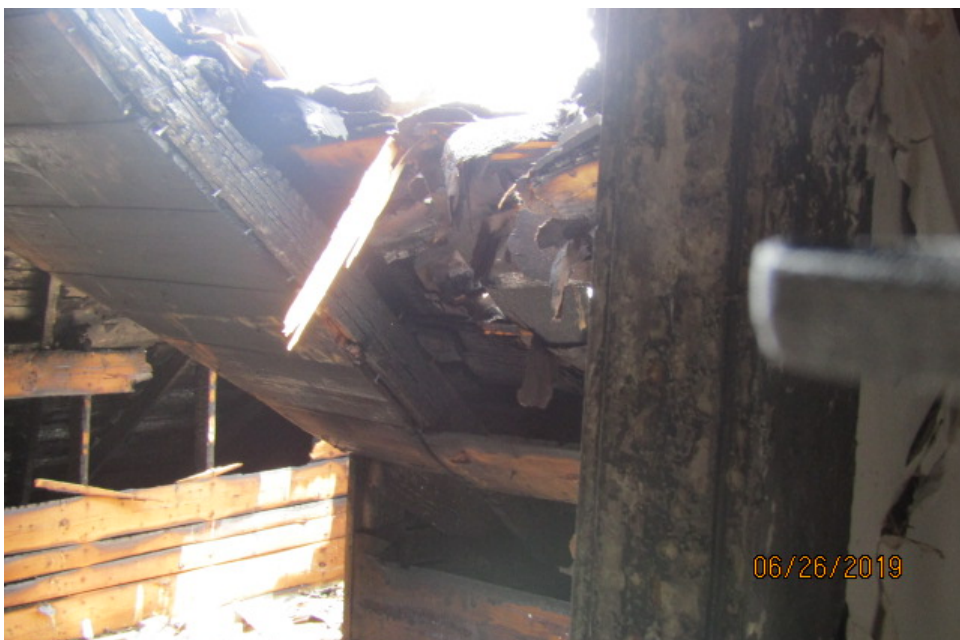
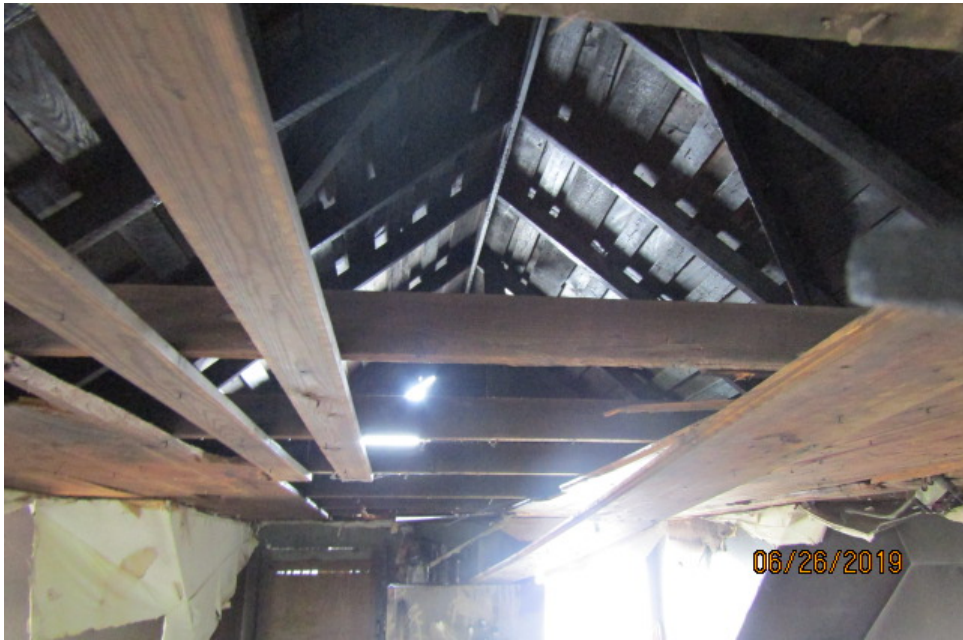
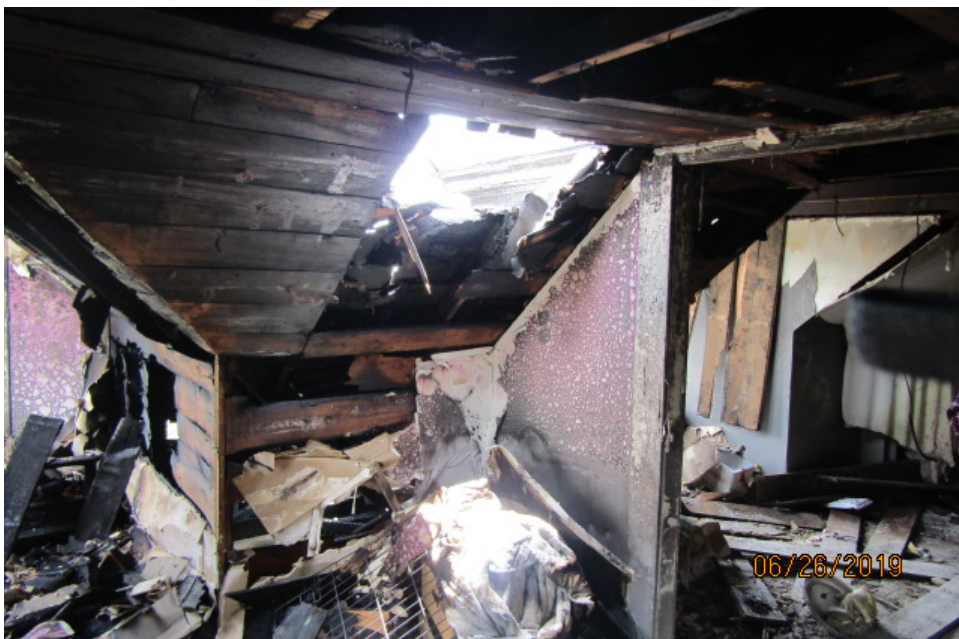
301 W Magnolia Ave #23234628

| <input type="checkbox"/> Roof sagging | <input type="checkbox"/> Roof structure dilapidated | <input checked="" type="checkbox"/> Roof Sheathing rotted/damaged |
| <input checked="" type="checkbox"/> Roof holes/ collapsed | <input type="checkbox"/> Missing flashing | <input type="checkbox"/> Overhang deteriorated/rotted |

| <input checked="" type="checkbox"/> Exterior Inspection | <input checked="" type="checkbox"/> Interior Inspection | <input checked="" type="checkbox"/> Floors |
| <input checked="" type="checkbox"/> Fire damage walls | <input type="checkbox"/> Ceiling not at required height | <input type="checkbox"/> Floor trusses rotted/damaged |
| <input type="checkbox"/> Siding damaged/deteriorated | <input type="checkbox"/> Ceiling severely deflected | <input checked="" type="checkbox"/> Floor has holes |
| <input checked="" type="checkbox"/> Windows damaged/broken | <input checked="" type="checkbox"/> Sheetrock damaged/missing | <input type="checkbox"/> Floor joists rotten/damaged |
| <input type="checkbox"/> Brick veneer damaged | <input type="checkbox"/> Studs rotted/leaning | <input checked="" type="checkbox"/> Floor covering damaged |
| <input type="checkbox"/> Structure is listing | <input type="checkbox"/> Bottom plated rotted/damaged | <input checked="" type="checkbox"/> Fire Damage-Floors |
| <input type="checkbox"/> Lack of Weather Protection | <input checked="" type="checkbox"/> Interior walls vandalized | |

Recommendation: Repair: Bldg 1
