## HISTORIC AND DESIGN REVIEW COMMISSION

**HDRC CASE NO:** 2019-573  
**ADDRESS:** 119 ADAMS ST  
**LEGAL DESCRIPTION:** NCB 931 BLK LOT 17 AND 18  
**ZONING:** RM-4,HS, H  
**CITY COUNCIL DIST.:** 1  
**DISTRICT:** King William Historic District  
**LANDMARK:** Koehler House  
**APPLICANT:** Nicole Corwin/Tatanka  
**OWNER:** Jarod and Celeste Oliver  
**TYPE OF WORK:** Historic Tax Certification  
**APPLICATION RECEIVED:** September 20, 2019  
**60-DAY REVIEW:** November 19, 2019  
**CASE MANAGER:** Huy Pham  
**REQUEST:**

The applicant is requesting Historic Tax Certification for the property at 119 Adams St.

## Rehabilitation Narrative & List of work performed

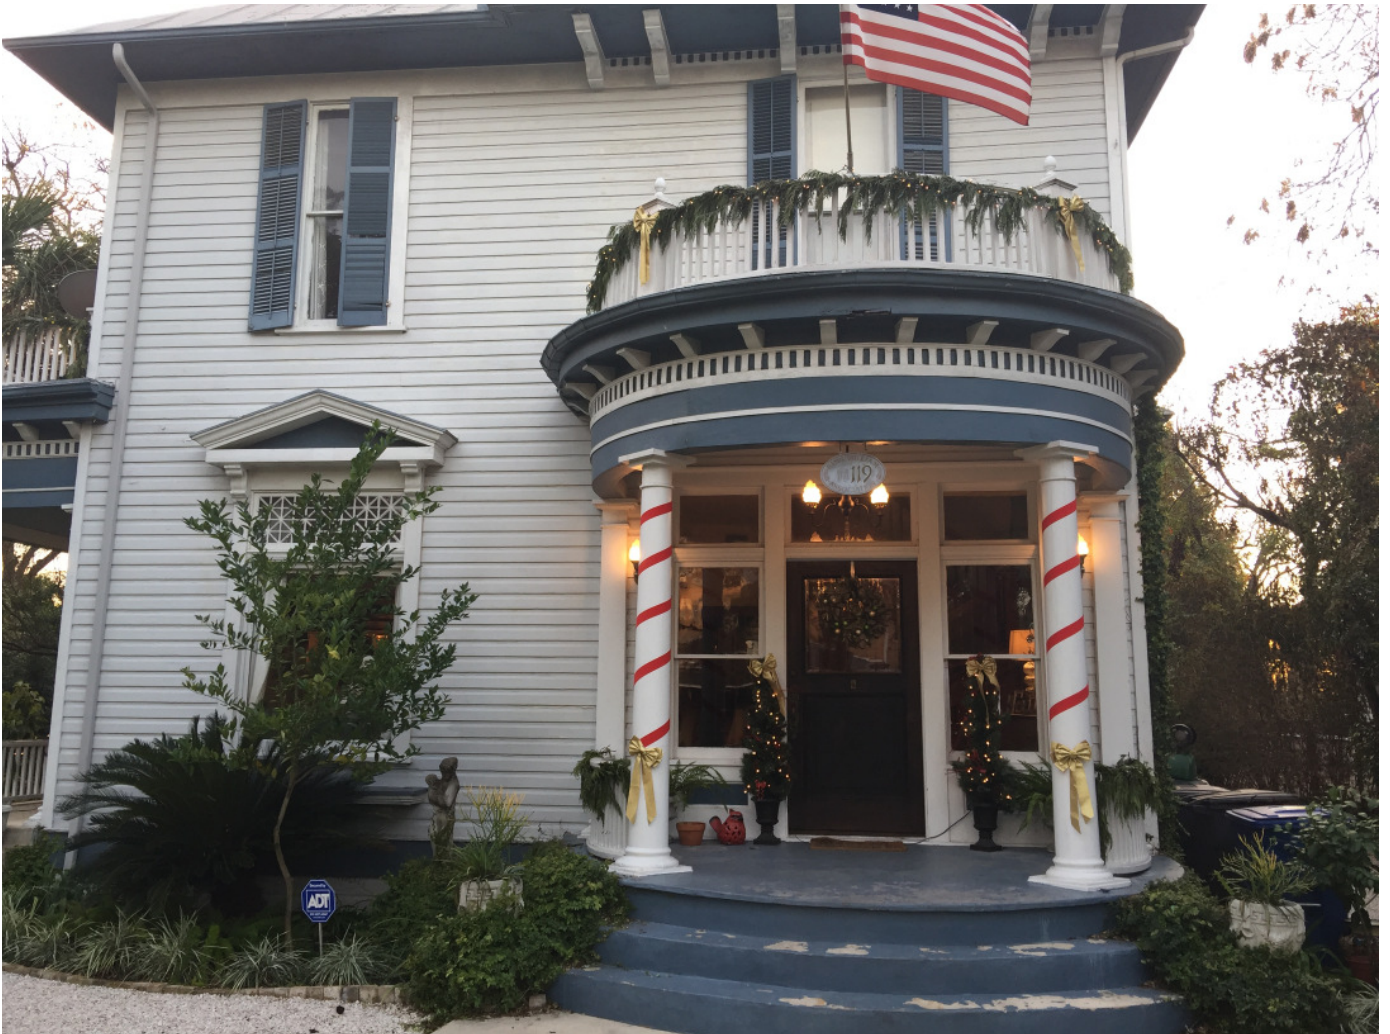
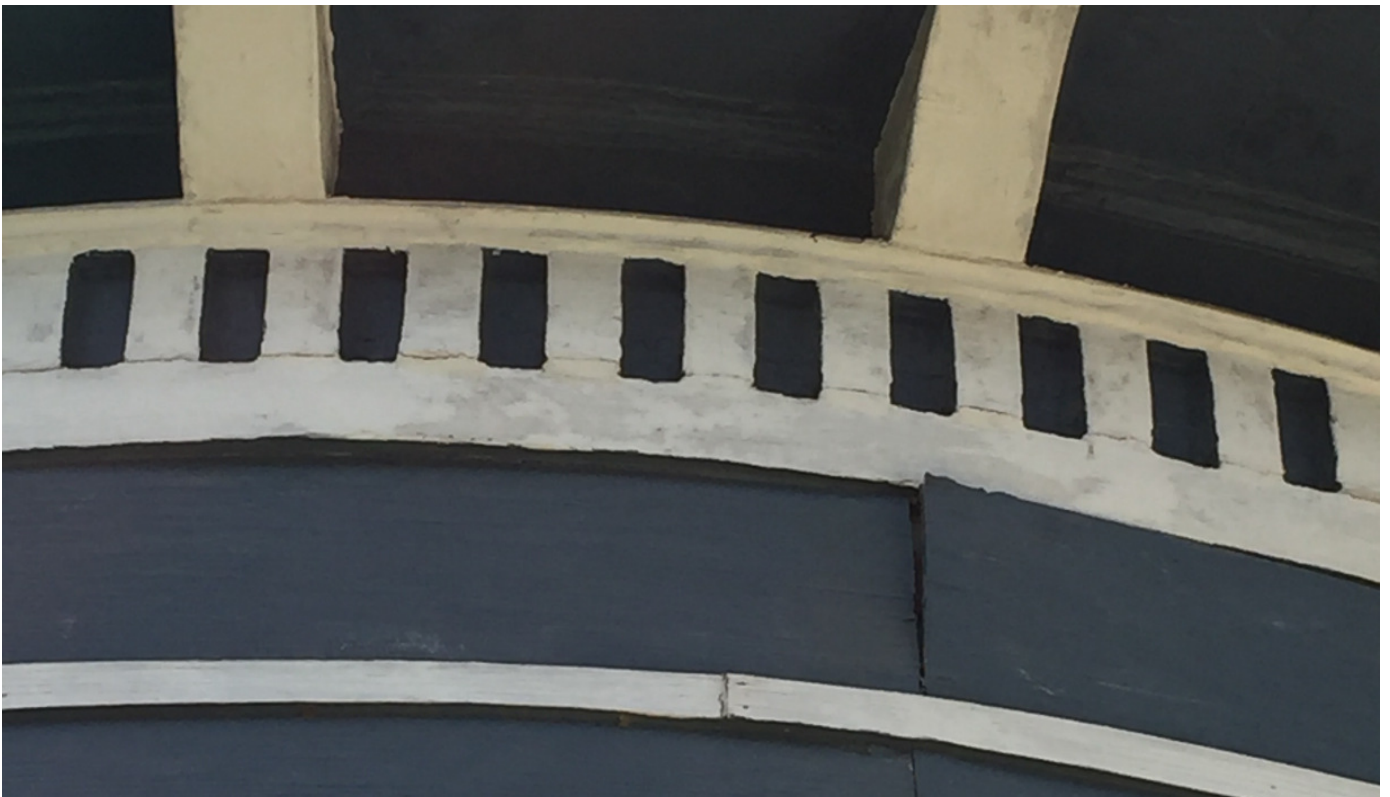
**Pre-Remodel Exterior, Front**  
wood shutters to be repaired and replaces as needed, new paint throughout, wood railing & detailing to be repaired

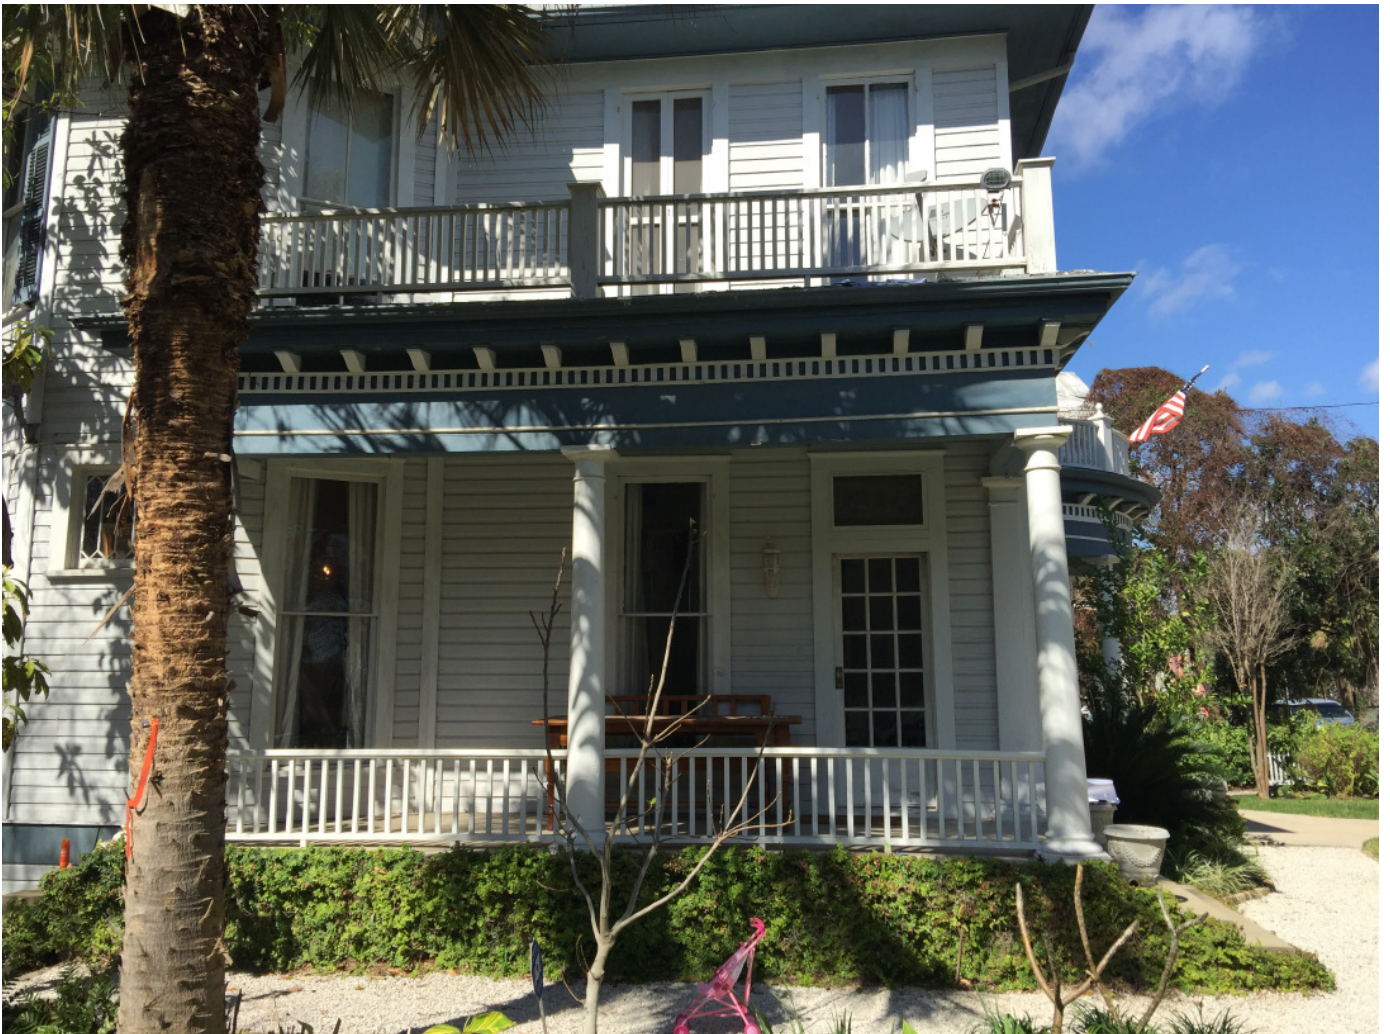
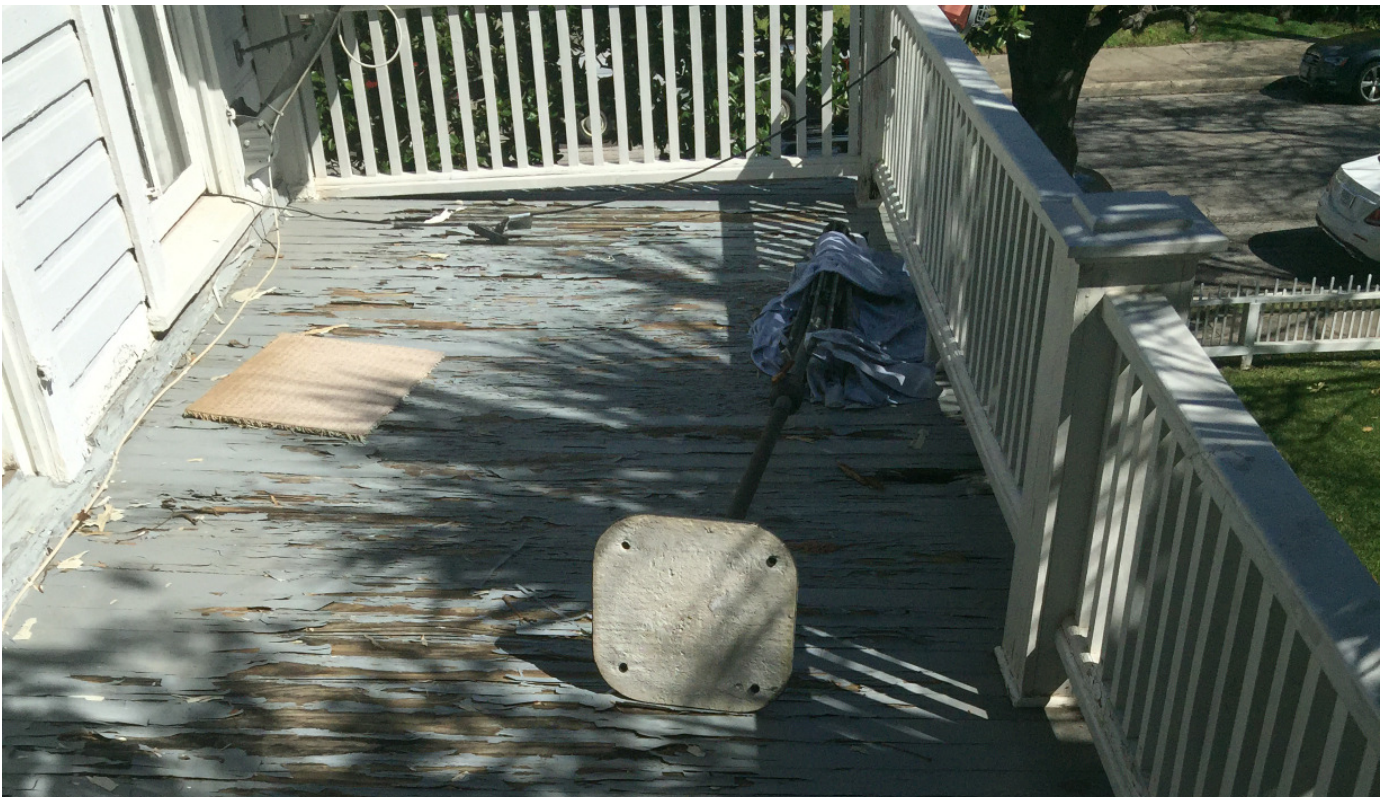
**Pre-Remodel Exterior, Northwest Corner**  
wood shutters to be repaired and replaces as needed, new paint throughout, wood railing & deck to be repaired

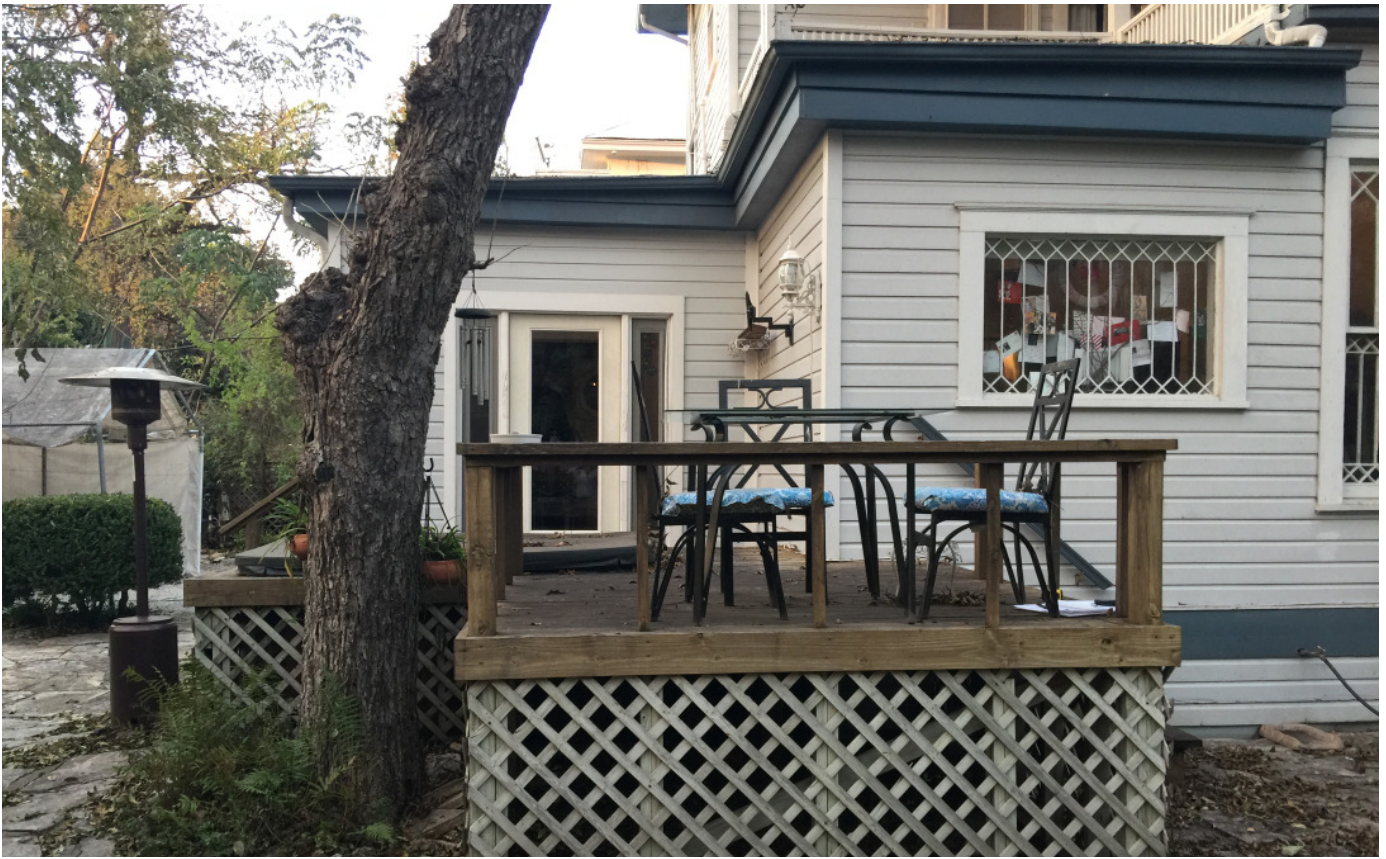
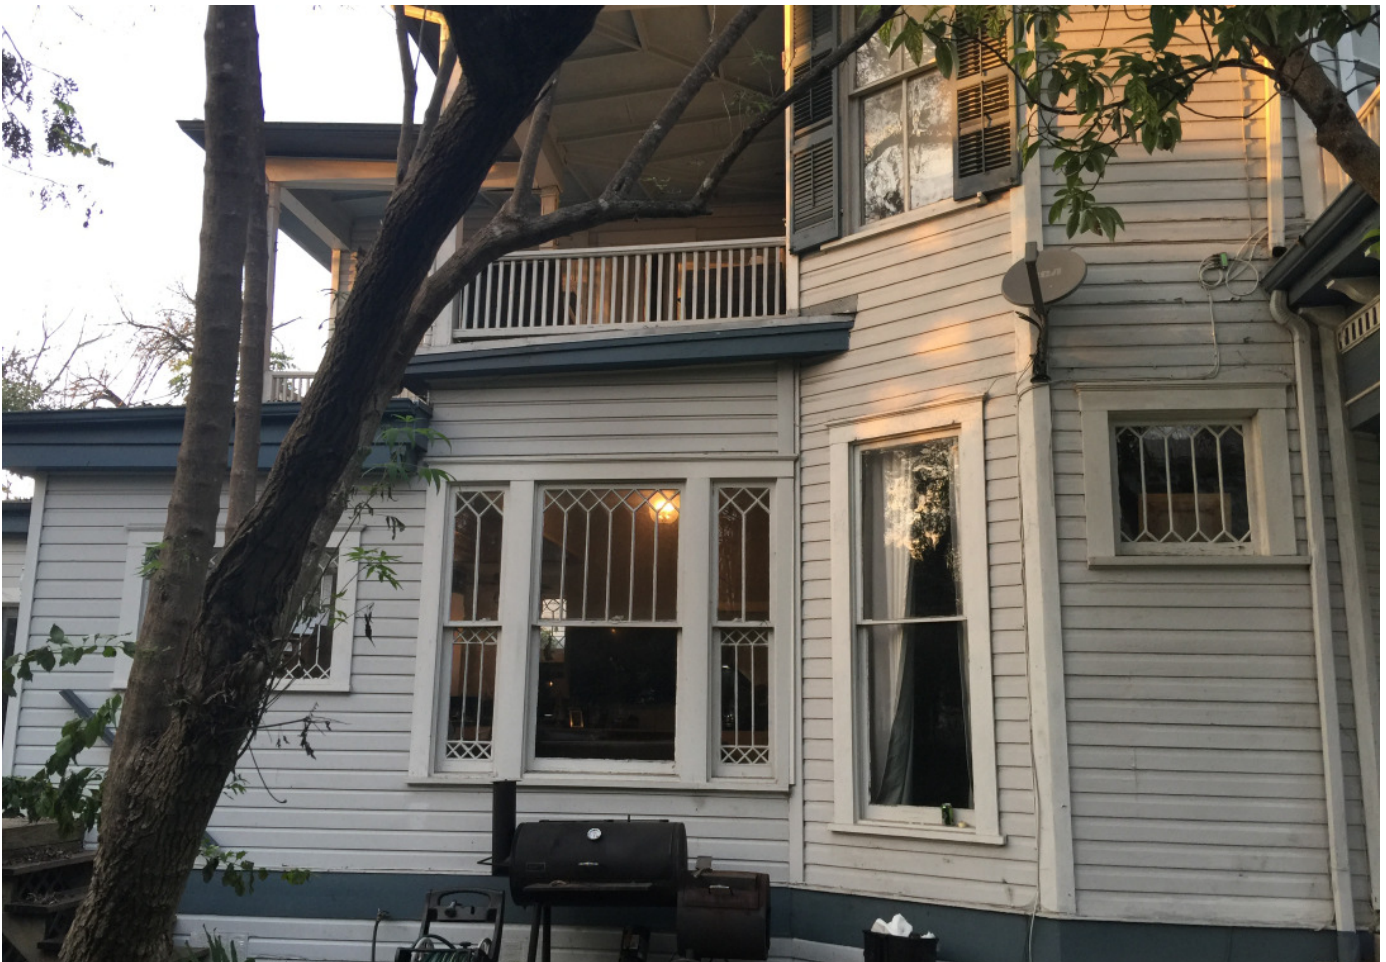
**Pre-Remodel Exterior, Southwest Corner**

Wood deck and spa to be removed, 2nd floor to be added onto and balcony relocated. Leaded glass windows to be relocated..

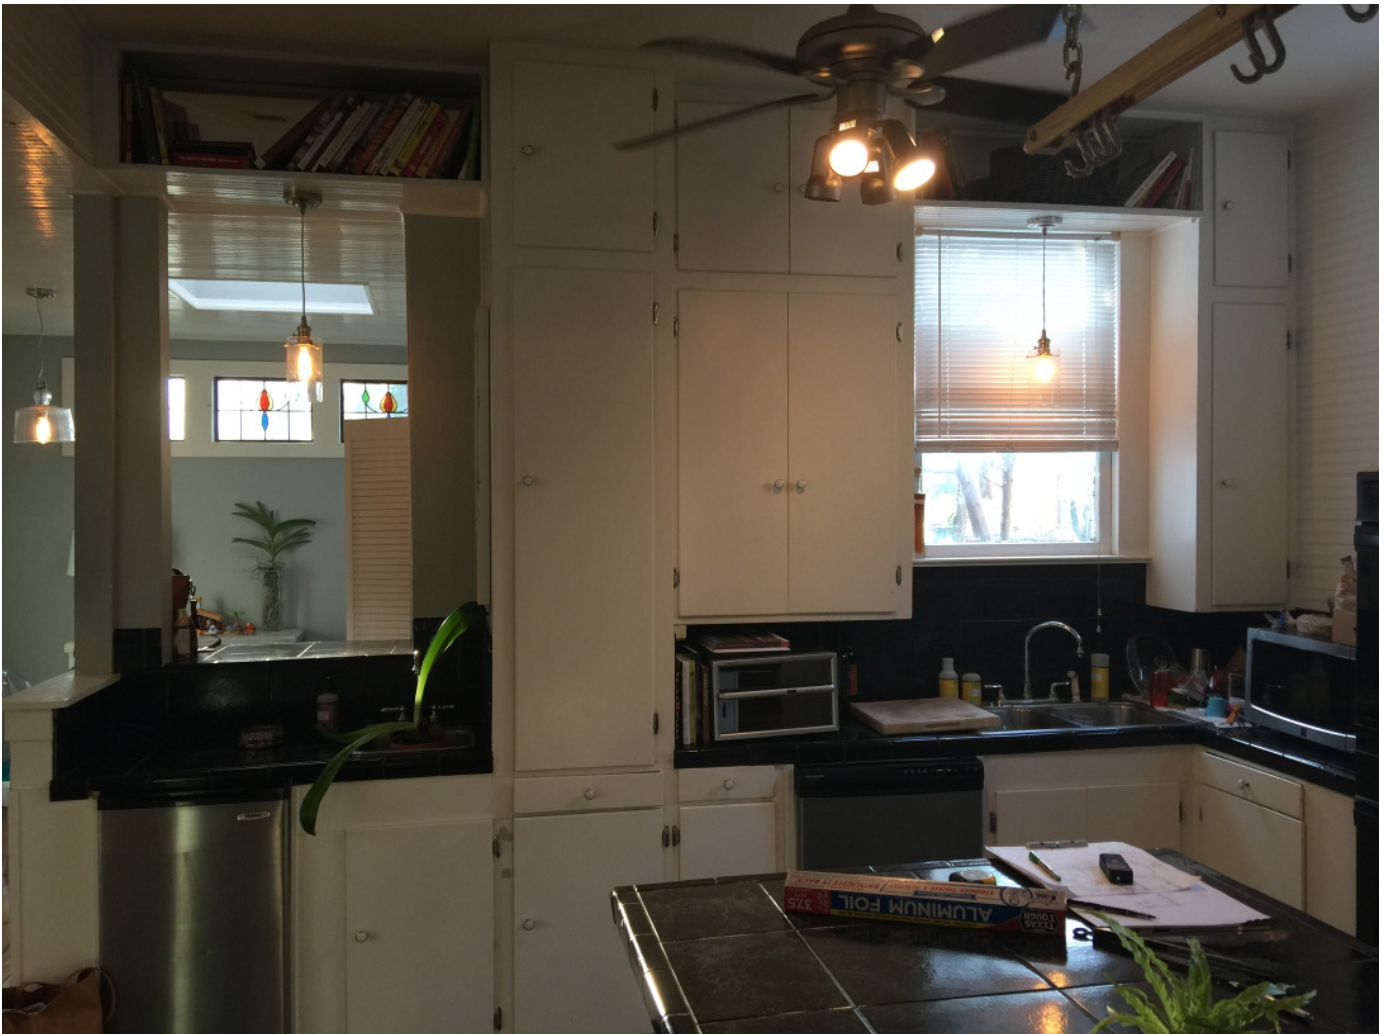
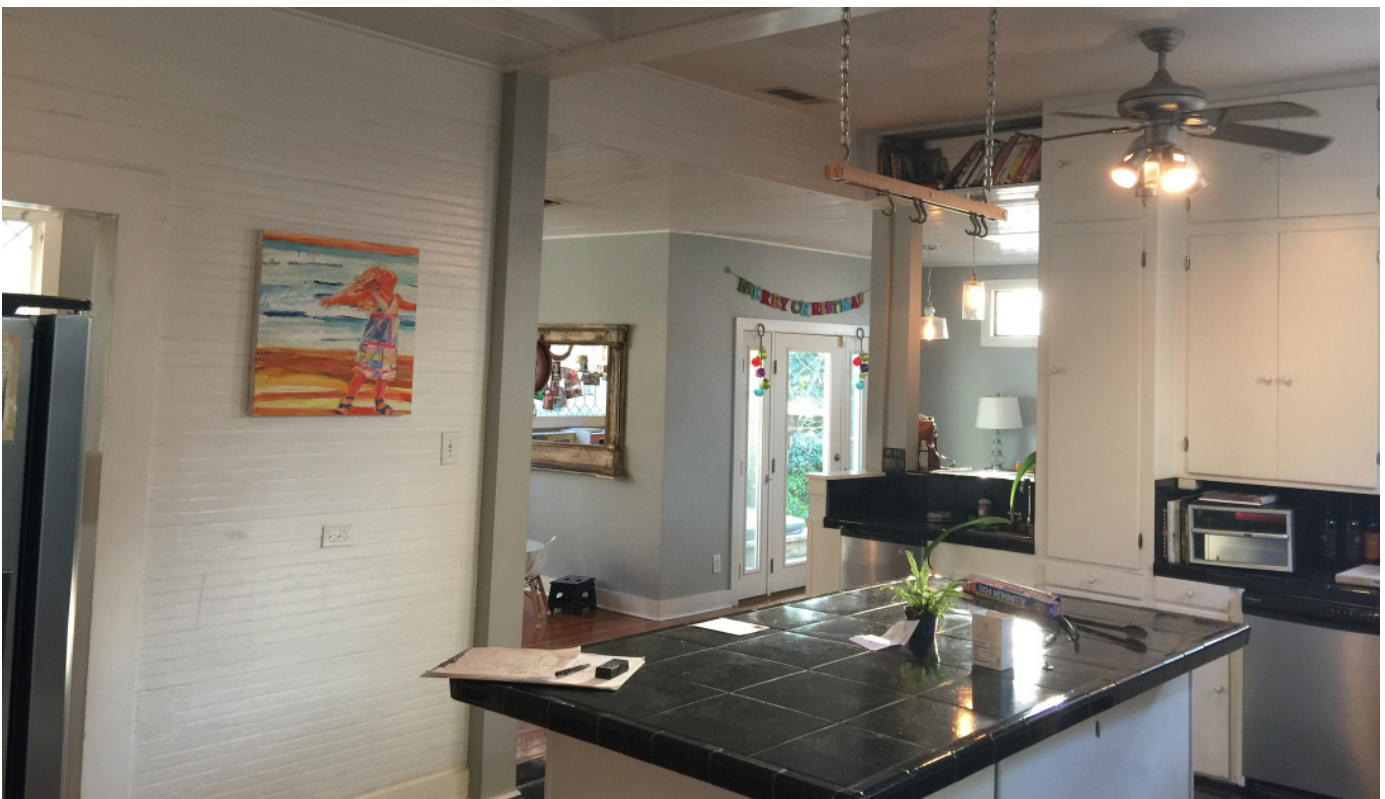
**Pre-Remodel 1st Kitchen**  
wall dividing kitchen from living to be removed, all new kitchen finishes, fixtures and cabinets.

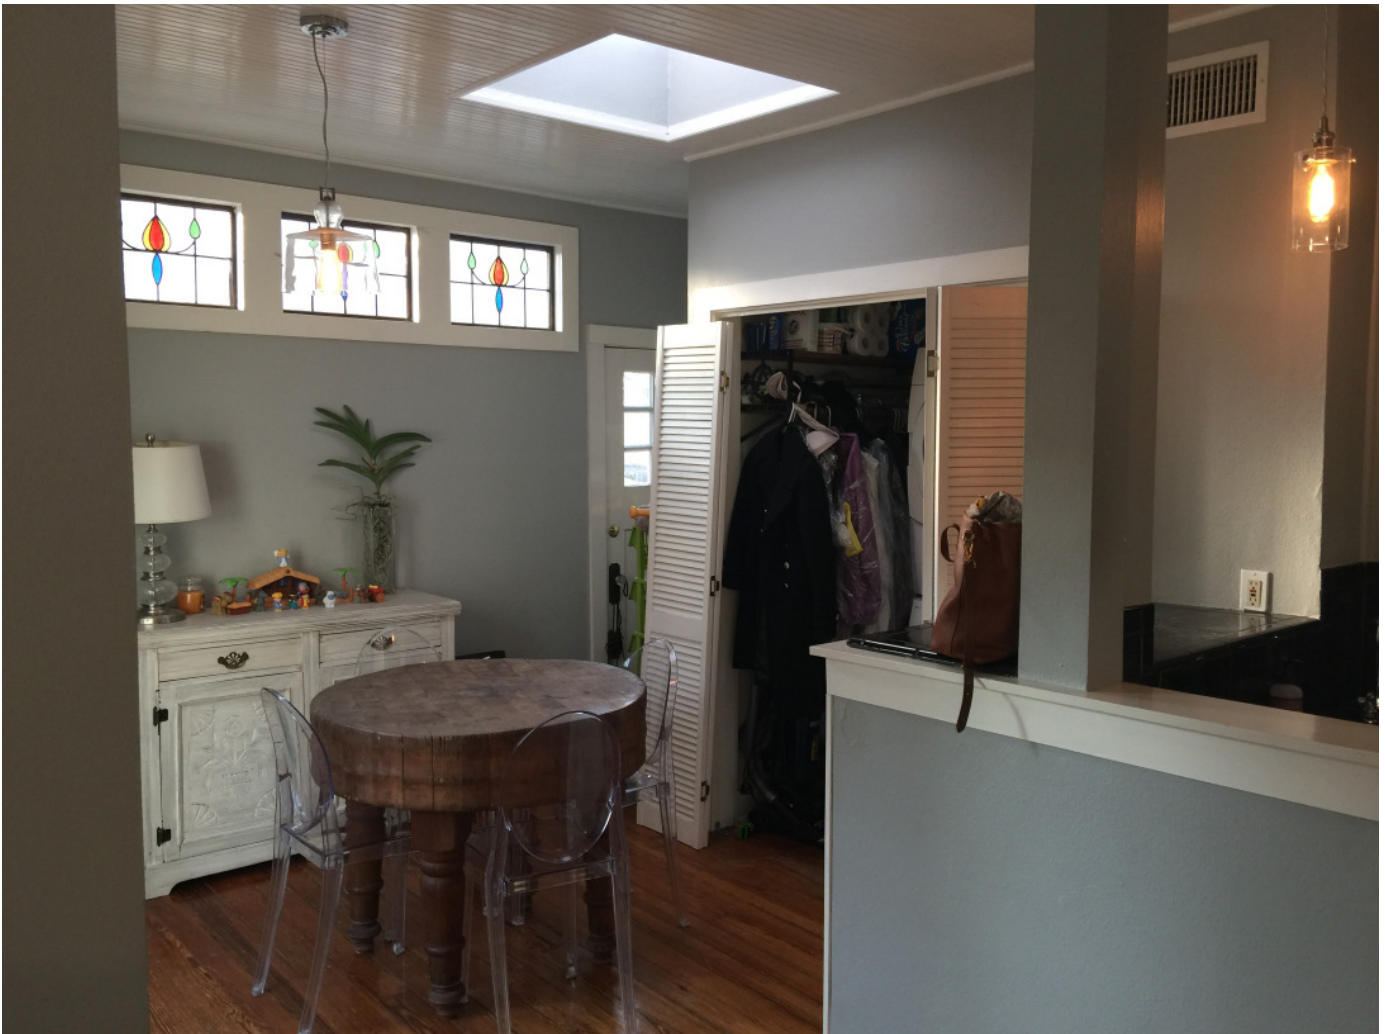
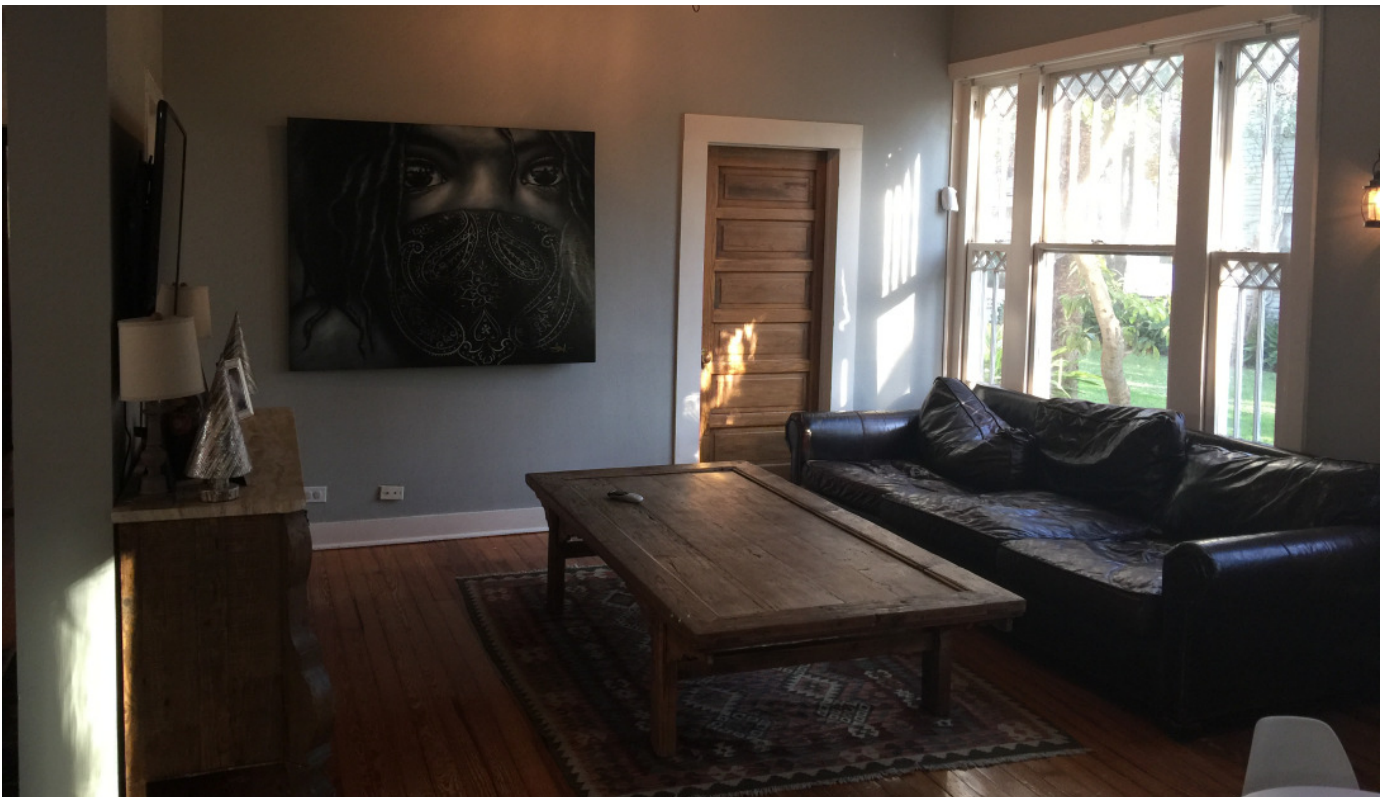
**Pre-Remodel 1st Mudroom/Laundry & Living**

reconfigure mudroom & laundry relocated, door to dining rm relocated & new cased opening to dining, relocated leaded windows.

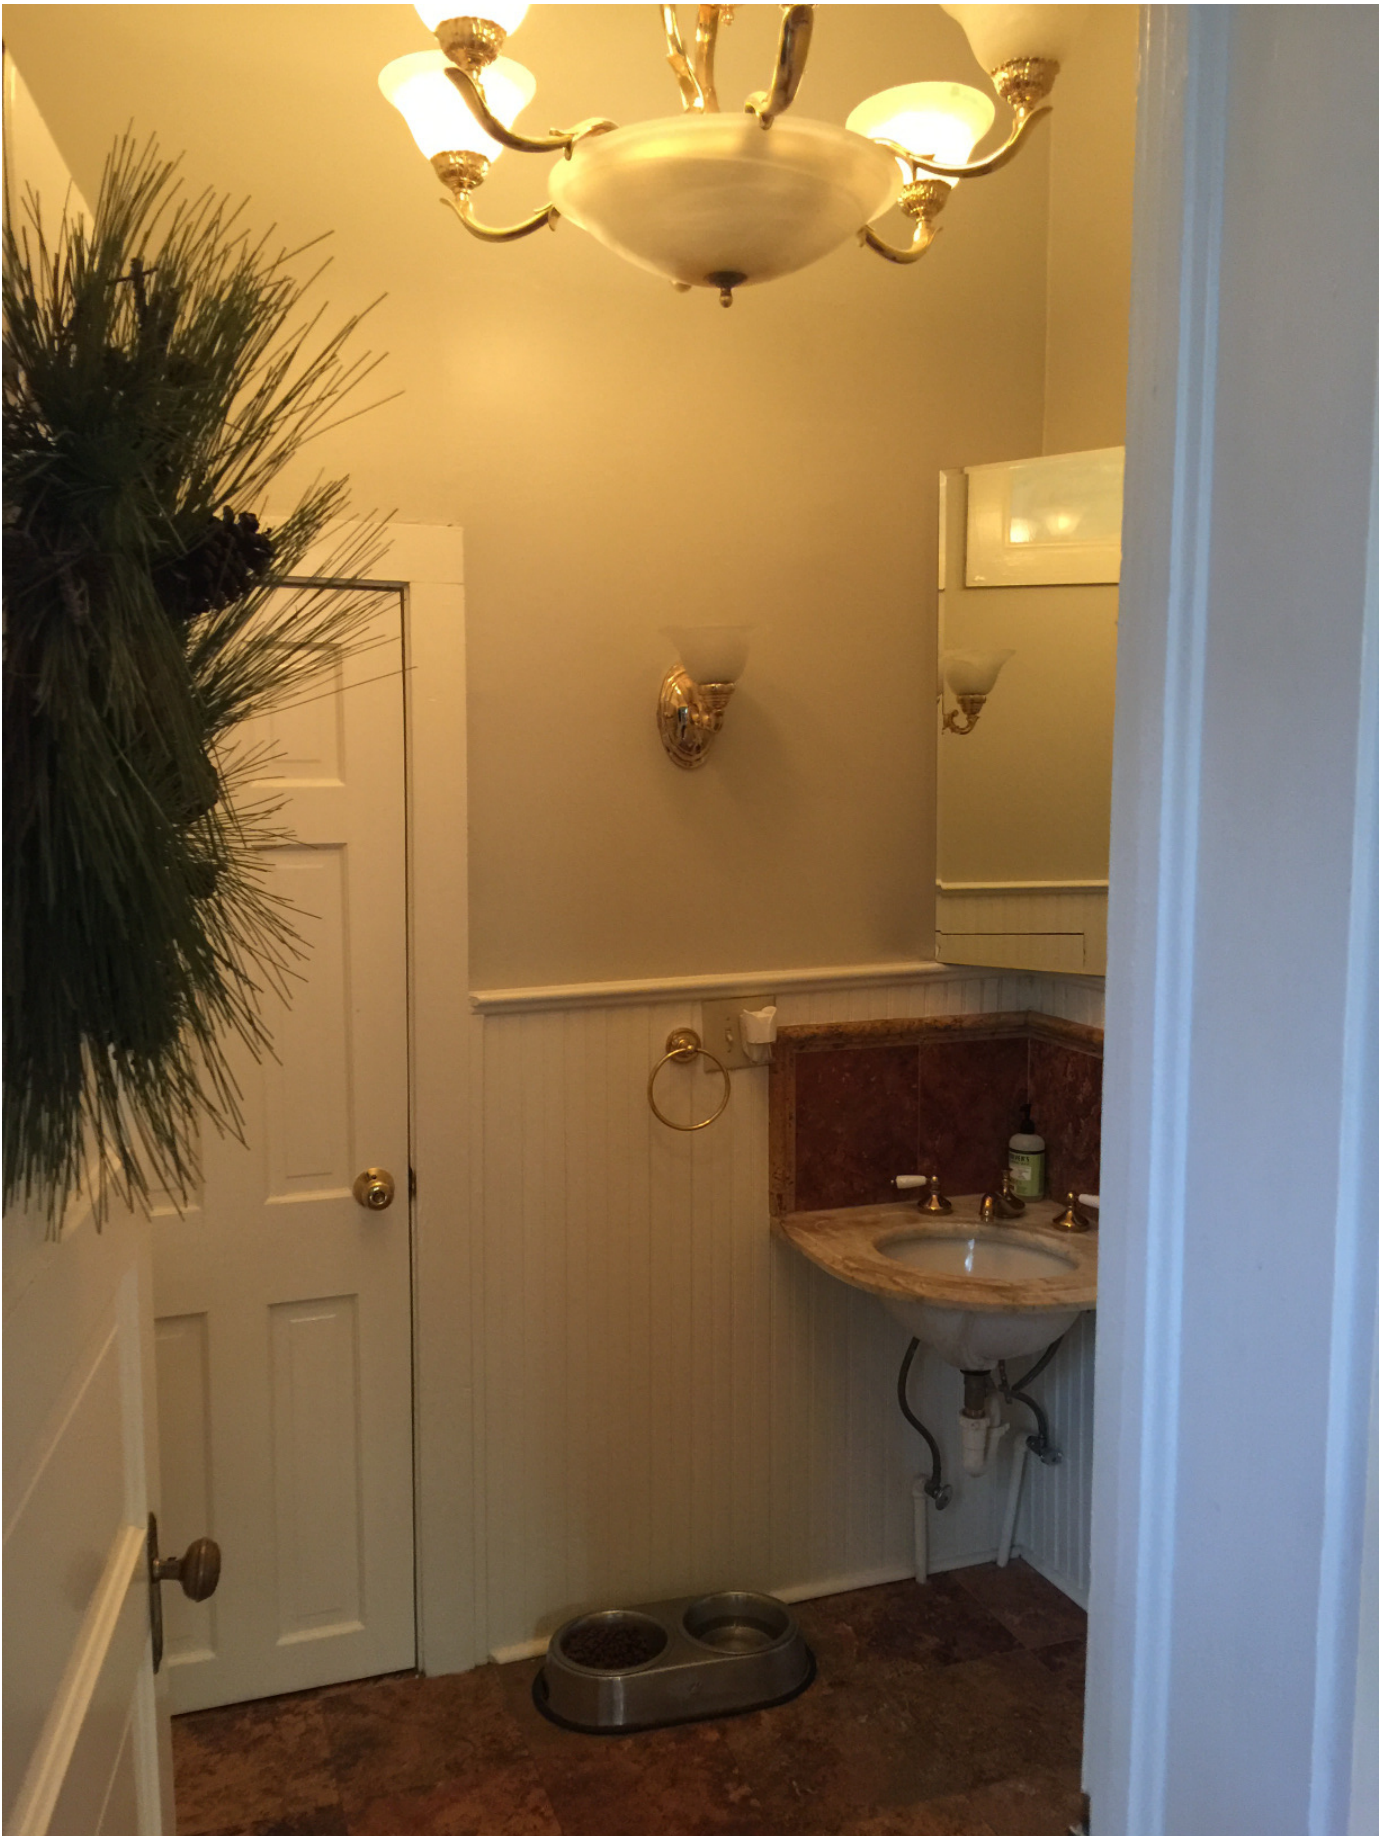
**Pre-Remodel 1st Powder Room**  
to be reconfigured . all new finishes and fixtures

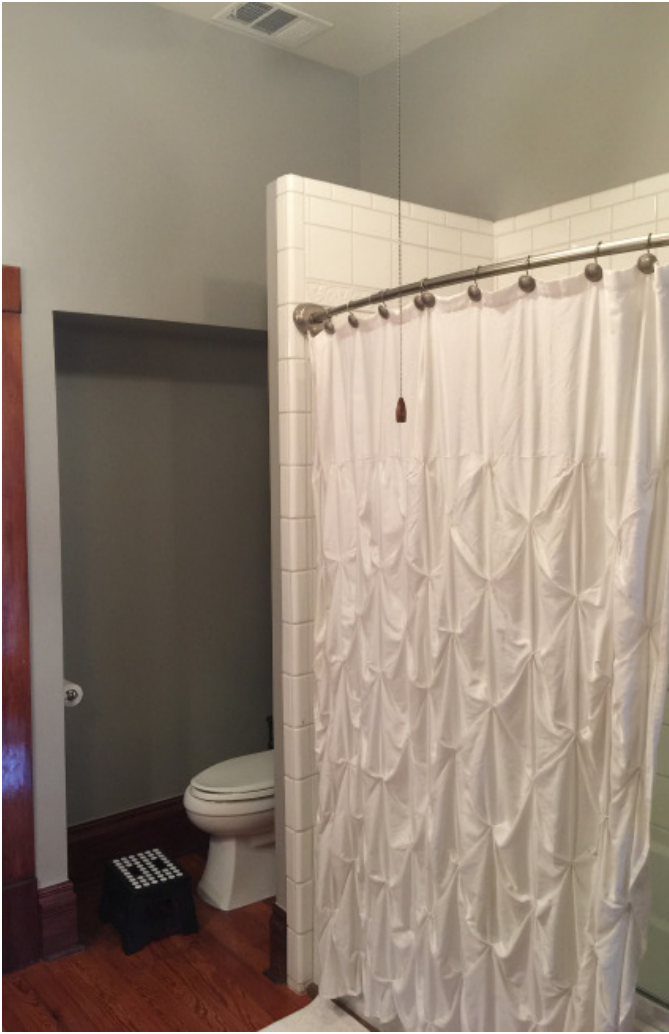
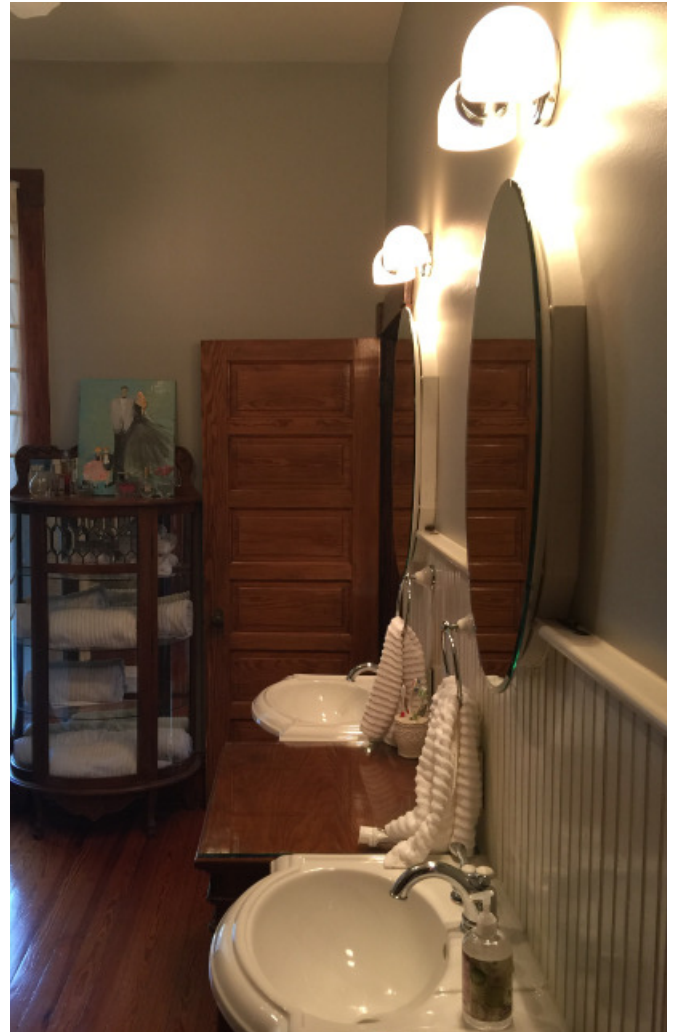
**Pre-Remodel 2nd Floor Guest Bathroom A**  
to be reconfigured into guest bath and laundry room, all new finishes and fixtures.

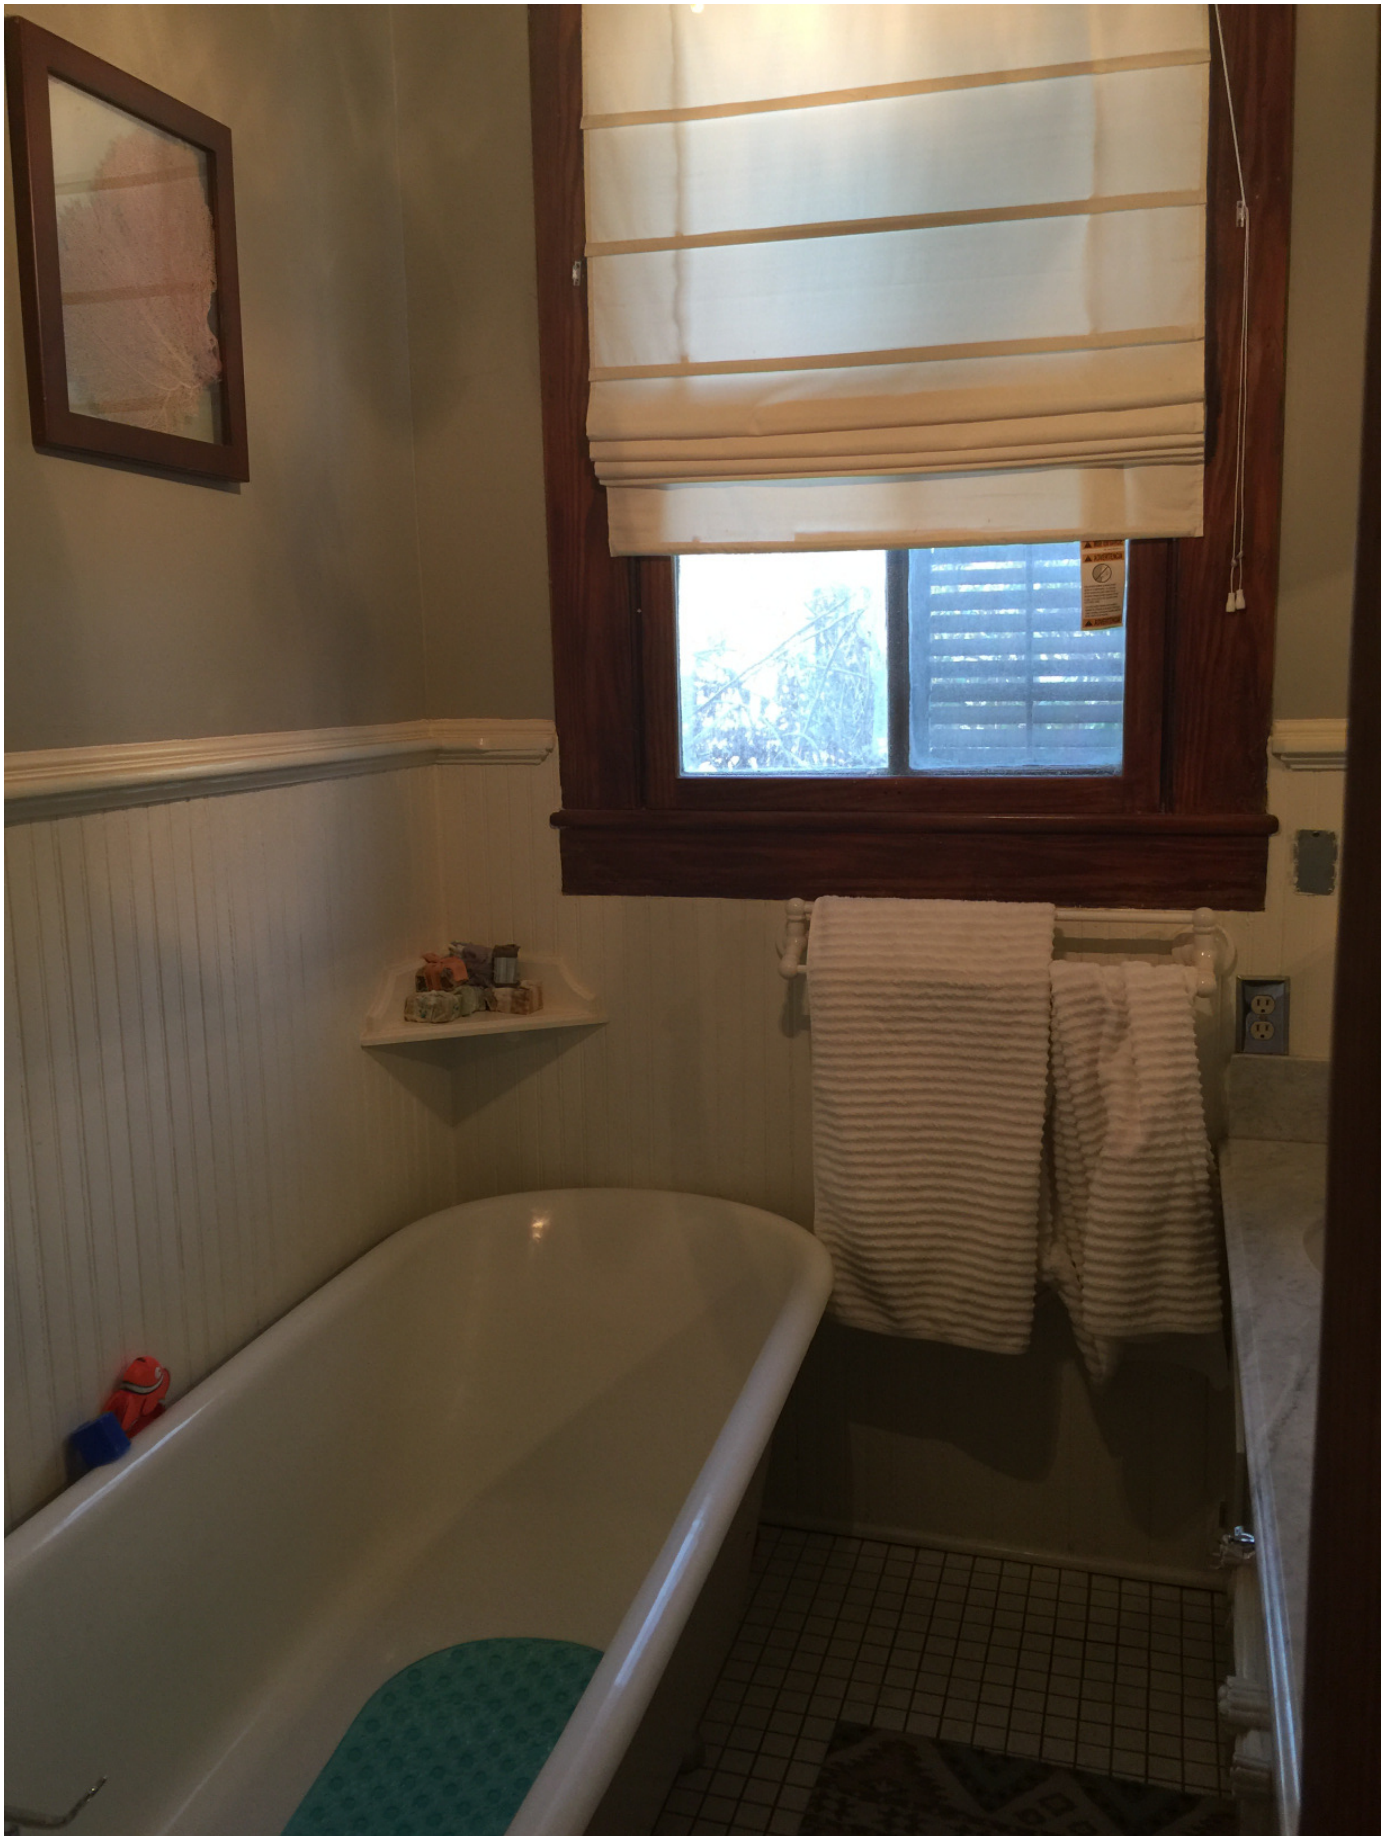
**Pre-Remodel 2nd Floor Guest Bathroom B**  
to receive new flooring and paint, restored and repair fixtures

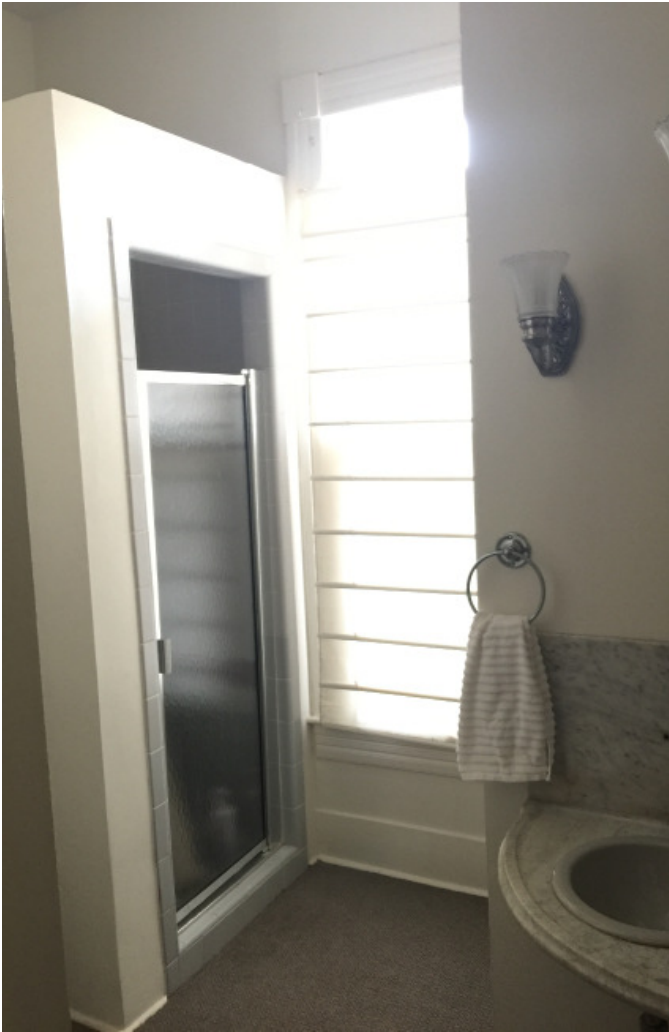
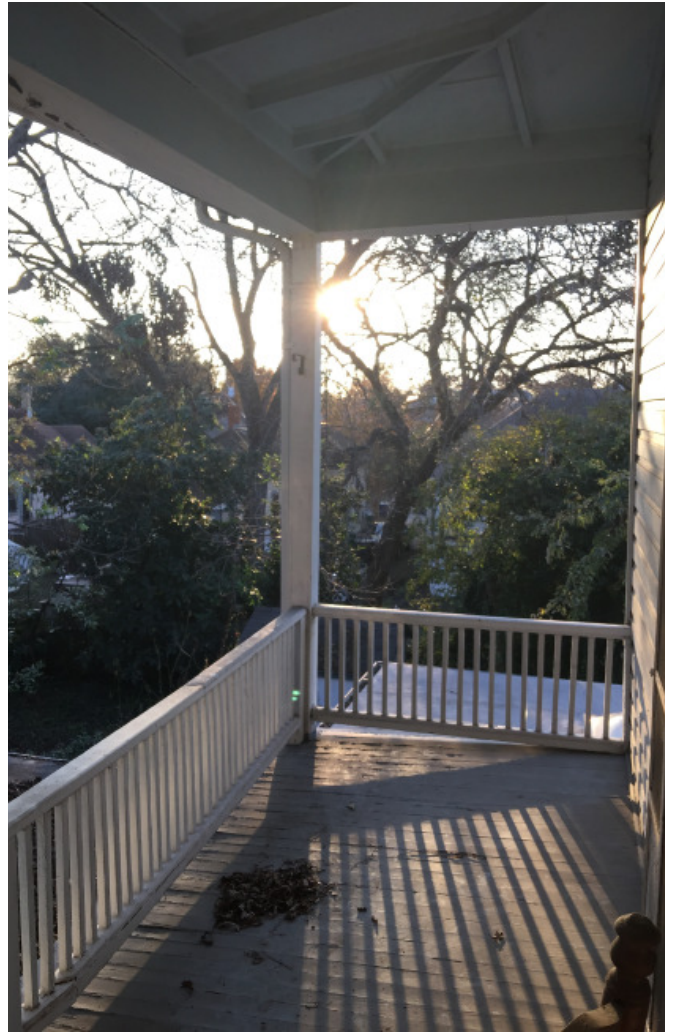
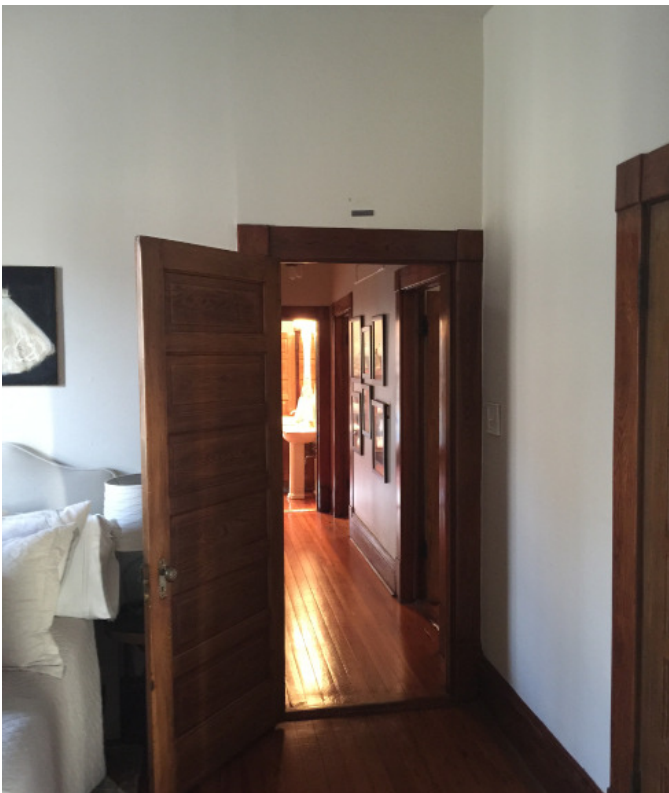
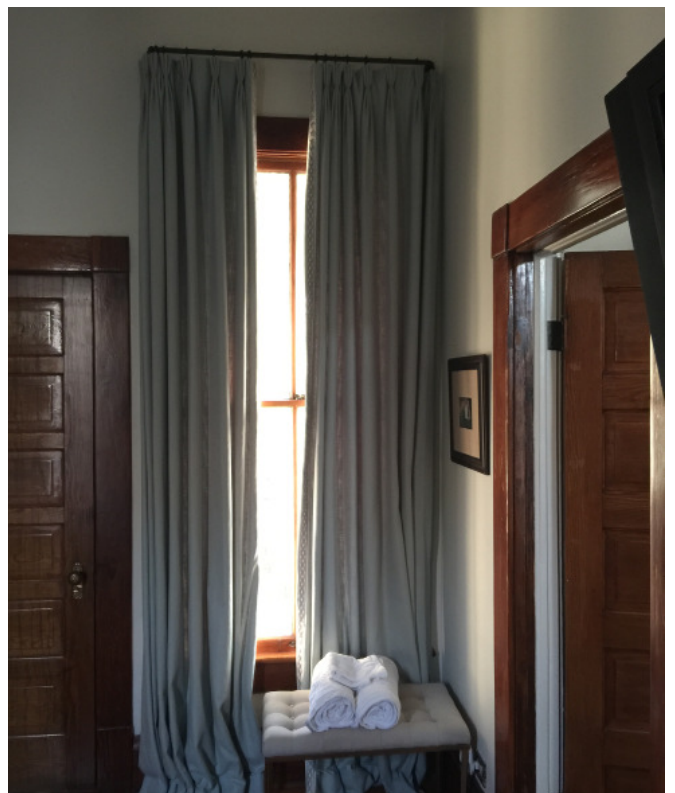
**Pre-Remodel Master Suite & Balcony**  
New layout and all new finishes and fixtures, doors to be reused

- iii** The southwest balcony location was reoriented over the structure below to increase the 2<sup>nd</sup> floor master suite interior square footage. The modified balcony included new doors, new painted wood columns, railing, wood siding, wood decking with TPO underlayment and new electrical fixtures.
