# HISTORIC AND DESIGN REVIEW COMMISSION

**HDRC CASE NO:** 2019-648  
**ADDRESS:** 115 QUEENS CRESCENT  
**LEGAL DESCRIPTION:** NCB 3087 BLK 3 LOT S IRR 99.22 FT OF 17 0.235 AC  
**ZONING:** MF-33, H  
**CITY COUNCIL DIST.:** 1  
**DISTRICT:** Monte Vista Historic District  
**APPLICANT:** Angela Blake/BLAKE ANGELA LUTHI & TIMOTHY LEE  
**OWNER:** Angela Blake/BLAKE ANGELA LUTHI & TIMOTHY LEE  
**TYPE OF WORK:** Addition, window replacement, exterior repairs  
**APPLICATION RECEIVED:** October 24, 2019  
**60-DAY REVIEW:** December 23, 2019  
**CASE MANAGER:** Huy Pham  
**REQUEST:**

# 115 Queens Crescent

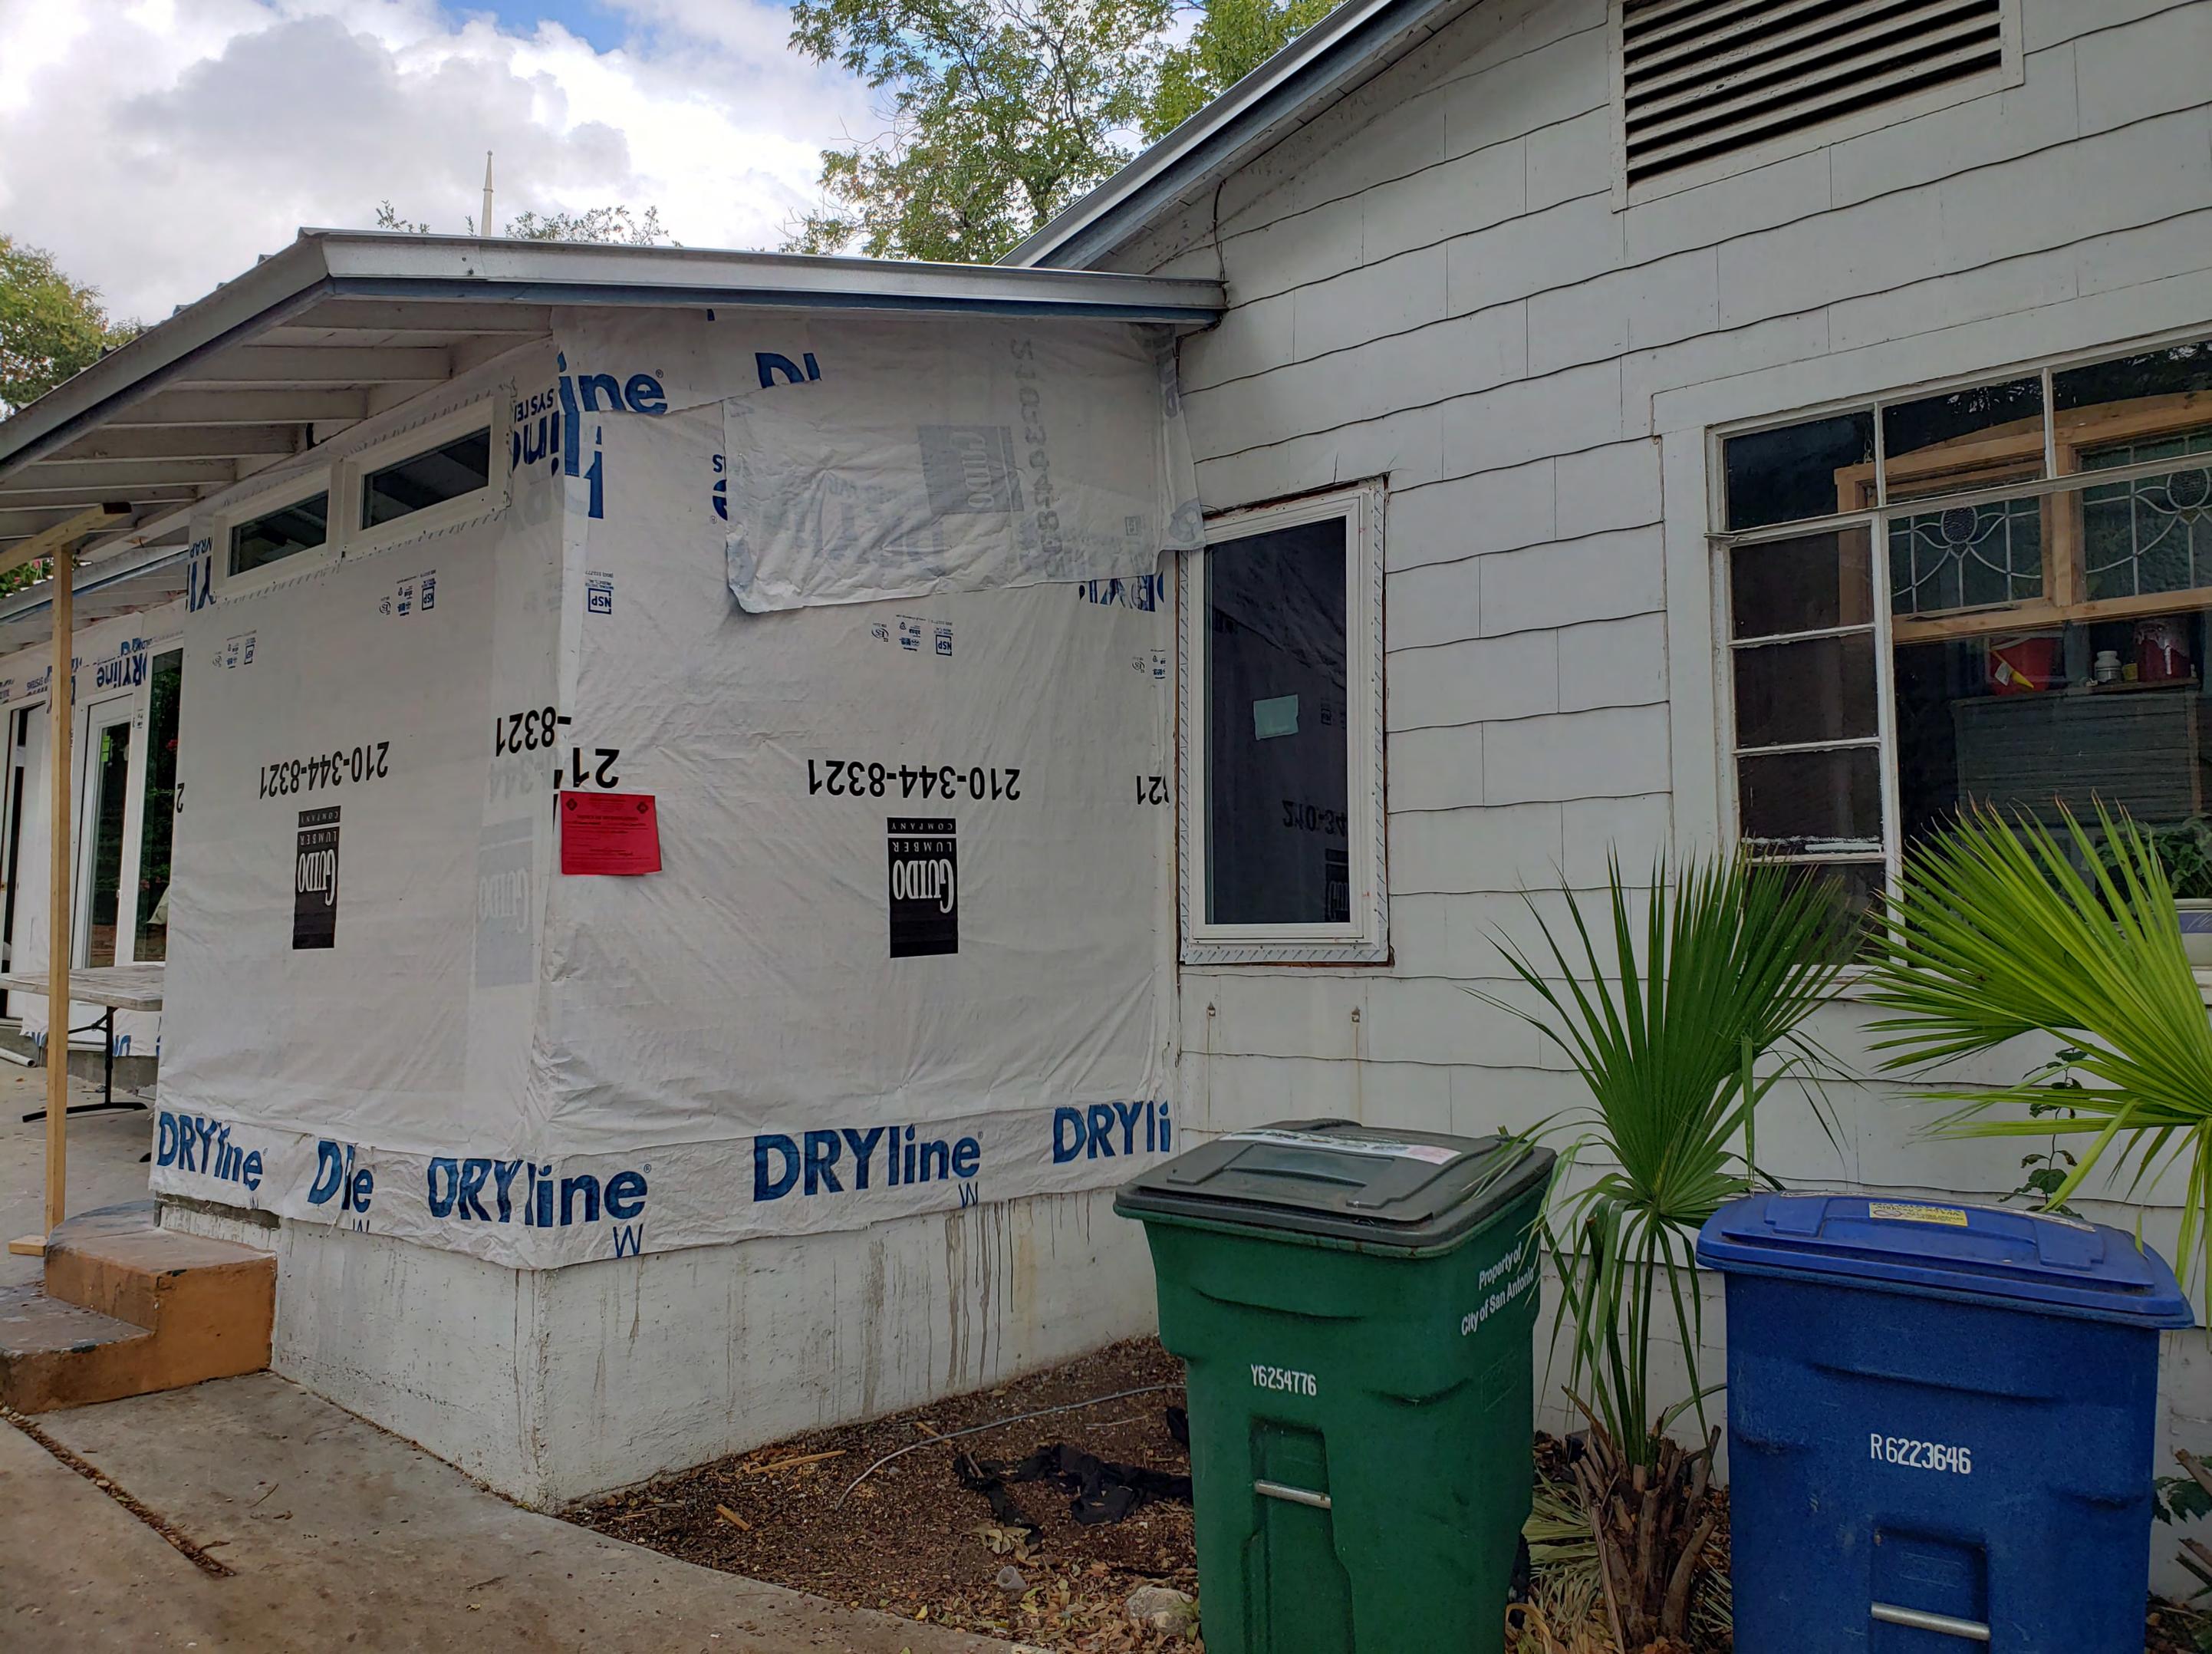
Red notice or sign attached to the plastic sheeting.

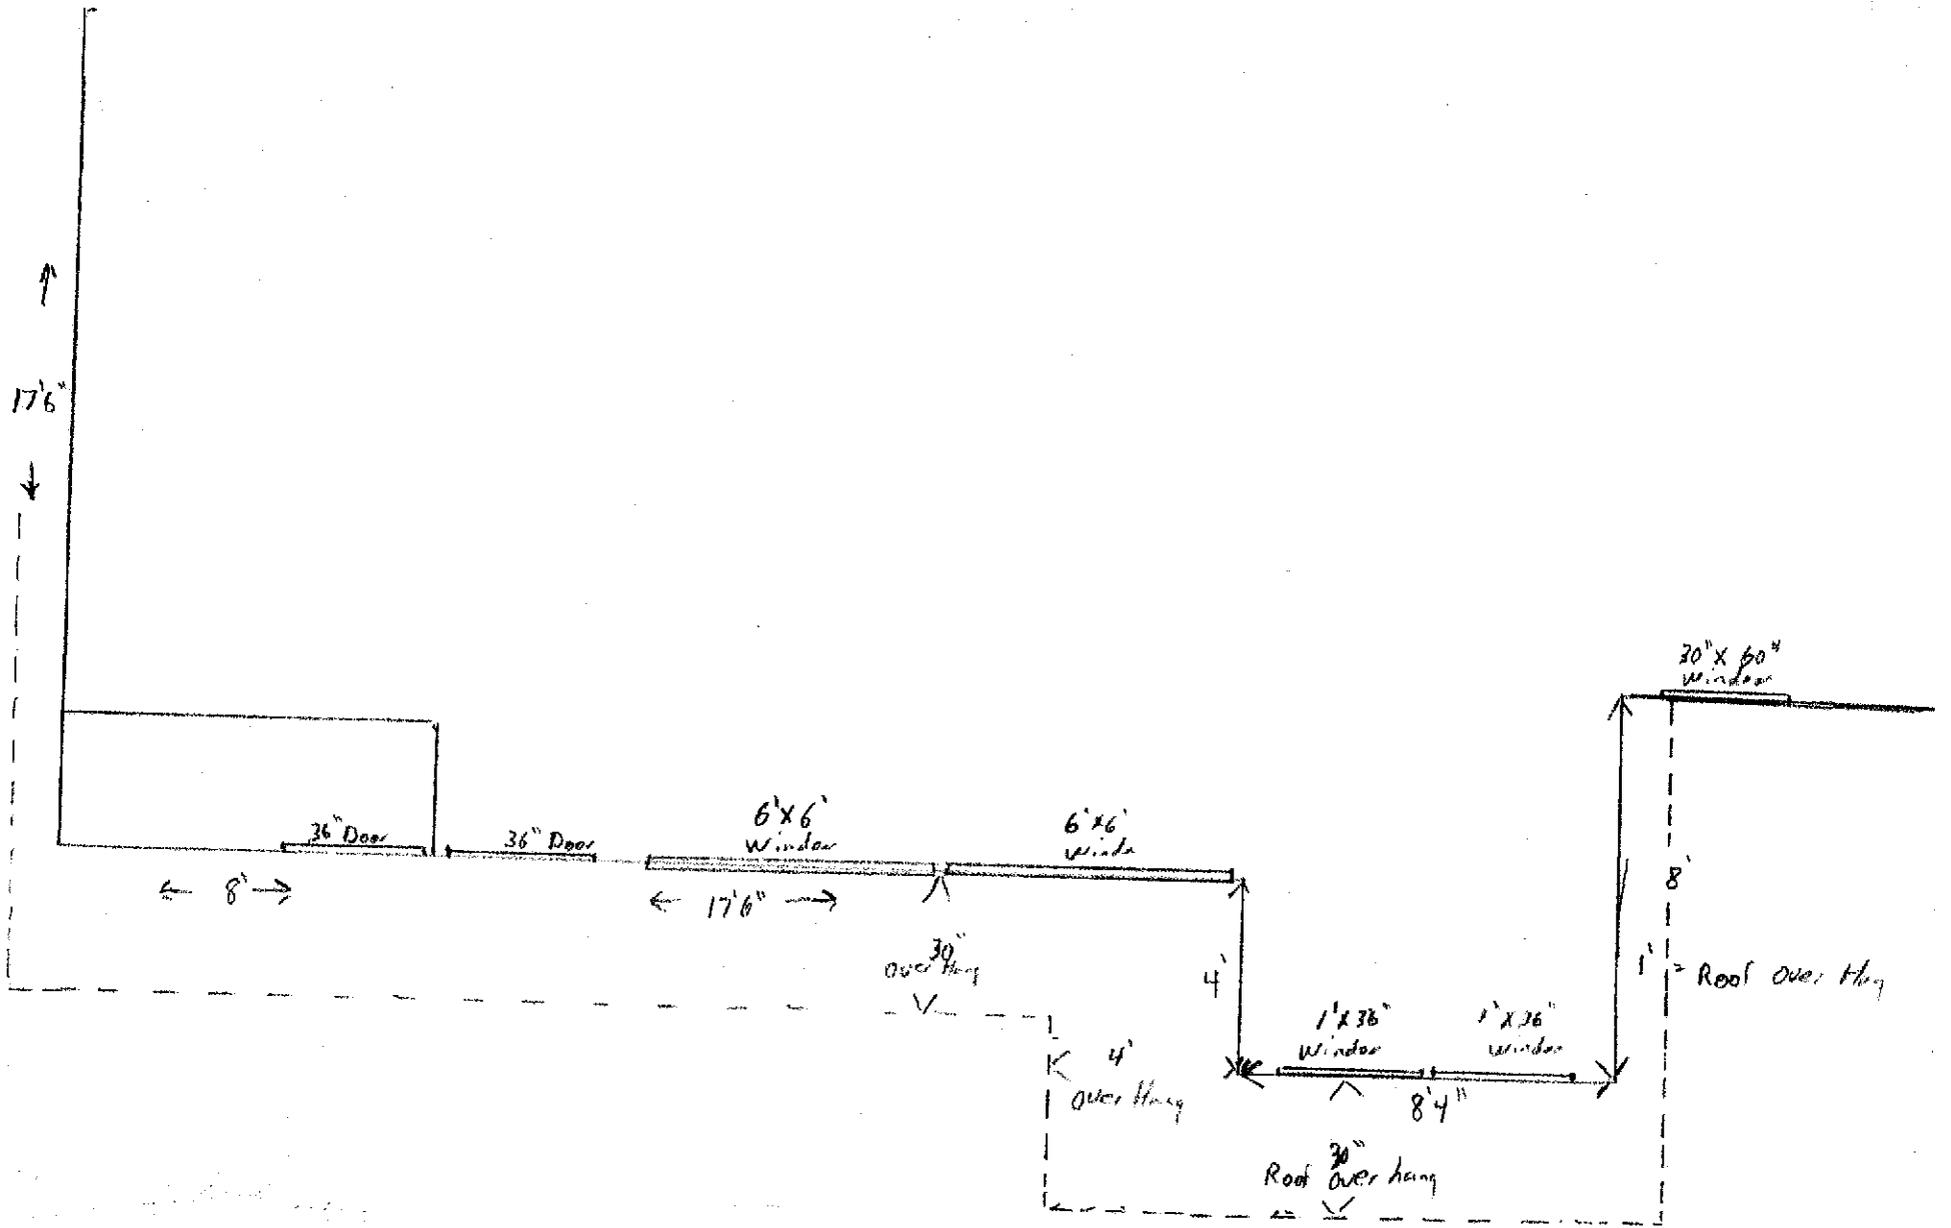
Front of  
Carport

Siding and Paint Colors  
to match existing

- k. REAR CAPORT ENCLOSURE - That a vertical trim piece is used to distinguish the between the original inset wall and the new addition
- l. WINDOW REPLACEMENT - That the new window should relate to the original metal casement windows with divided lights of the historic structure or be an improvement from the wood sash window; the fixed vinyl window is inconsistent with the Guidelines for Exterior Maintenance and Alterations.

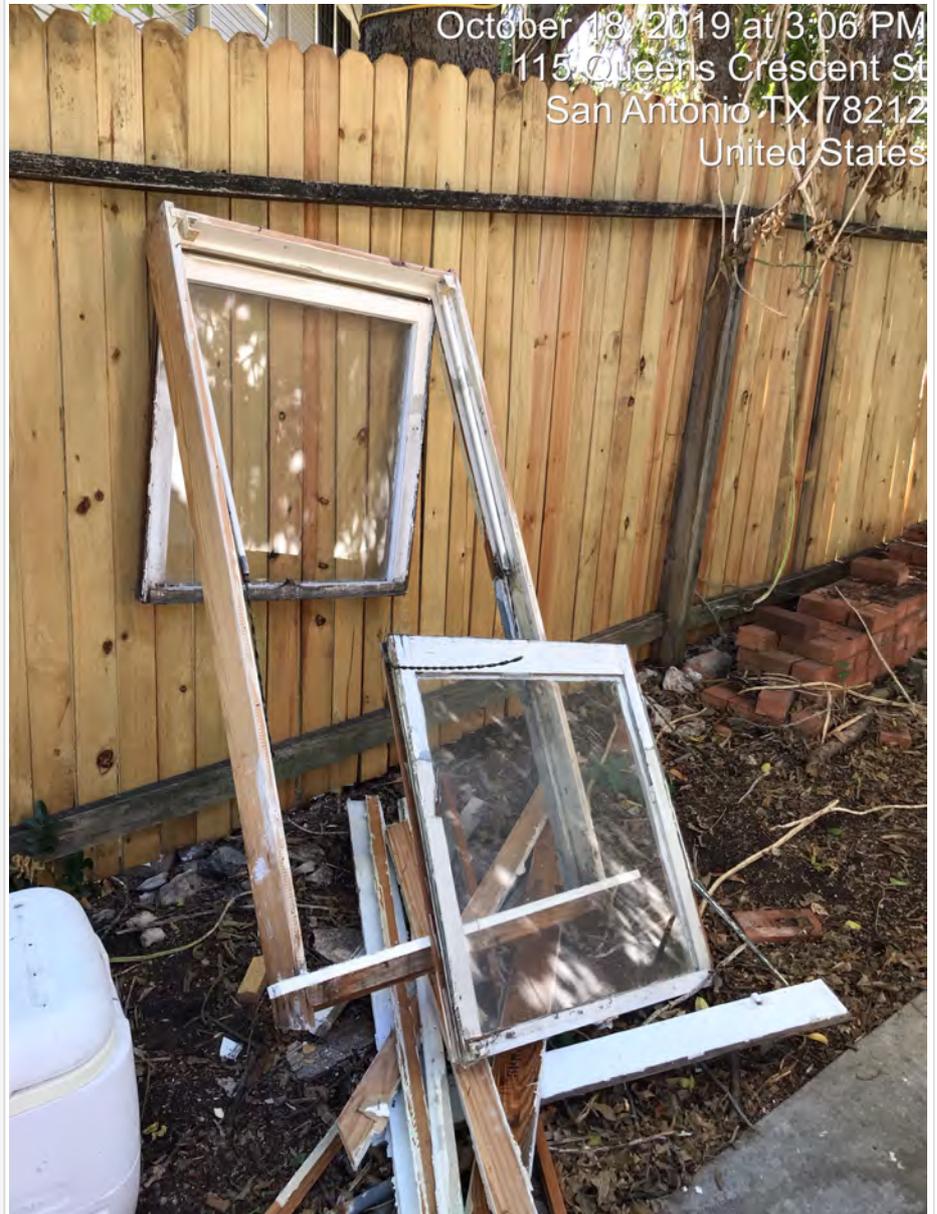
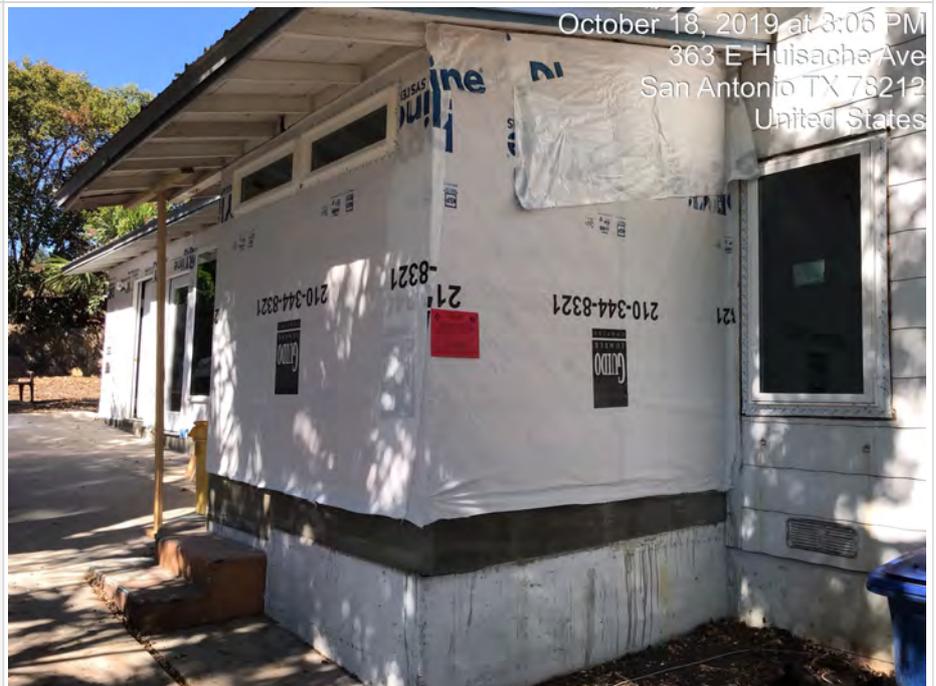
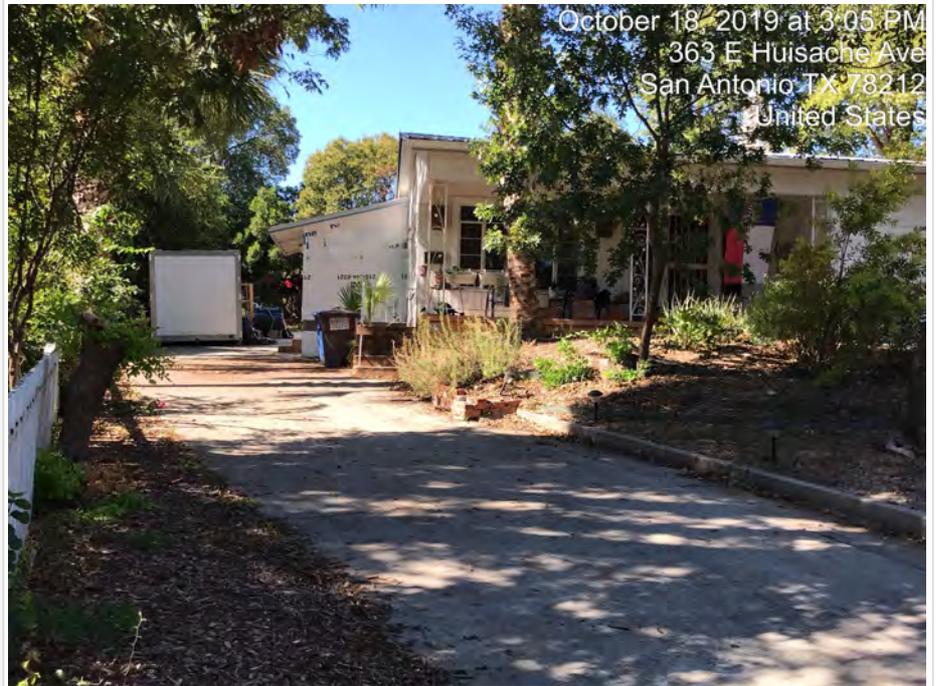
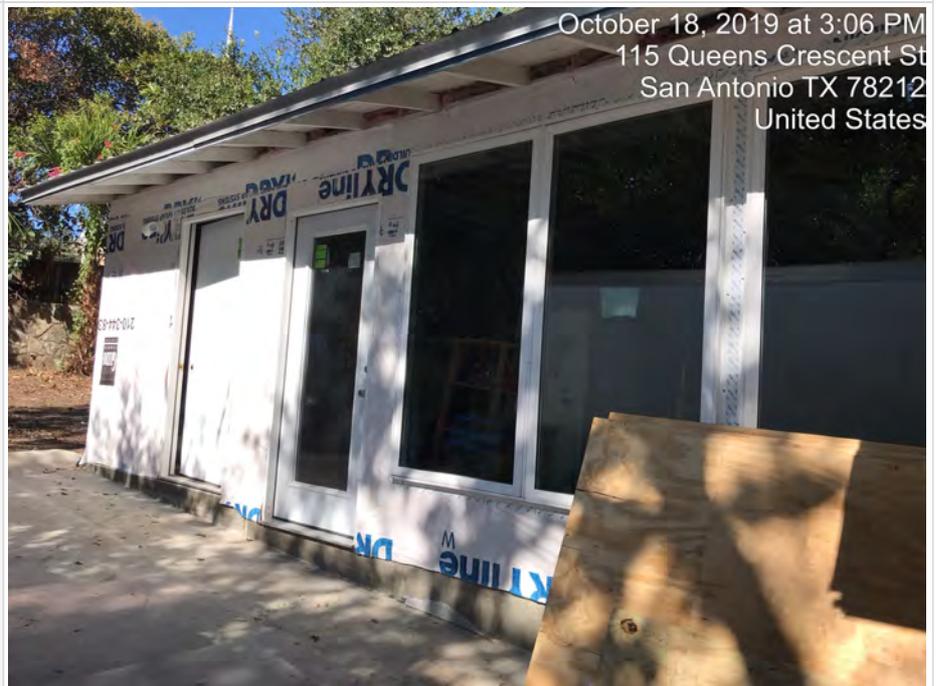
#### Photographs

Date	10/18/2019
Time	03:08 PM (-5 GMT)
Context	citizen report
Present Staff	Huy Pham, Edward Hall
Present Individuals	None
Types of Work Observed	Exterior Maintenance and Alterations, Additions
Amount of Work Completed	75%
Description of work	Construction of a side addition and window replacement

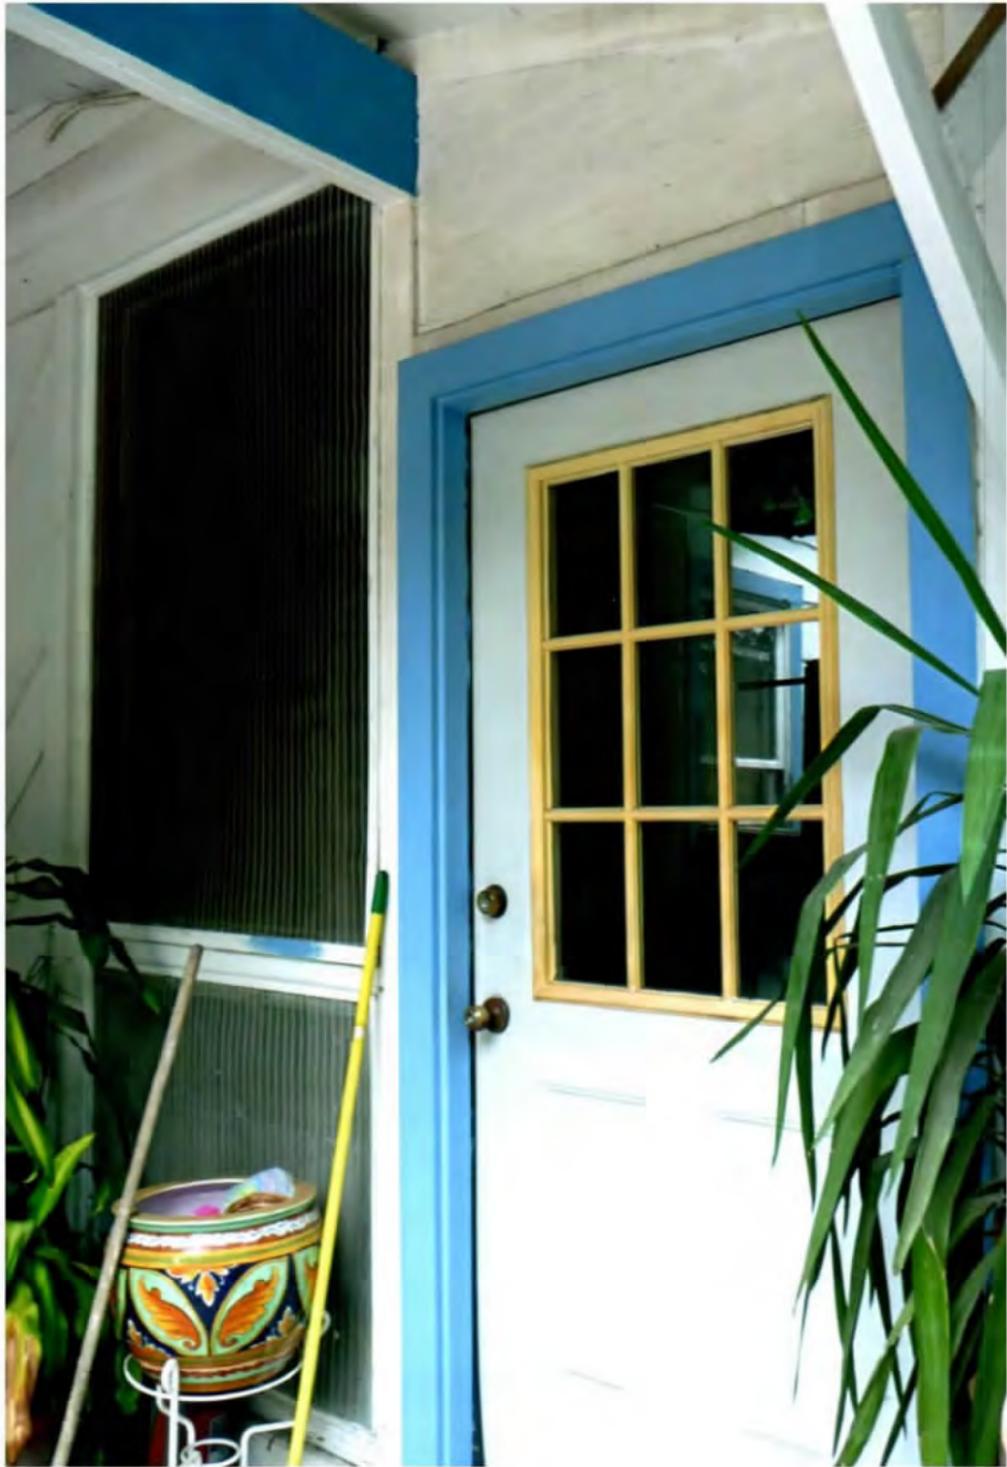
The first pic is the rear entrance, unseen from the road, and into what my husband and I called the vestibule. The door is a steel door, definitely not 1948 materials.

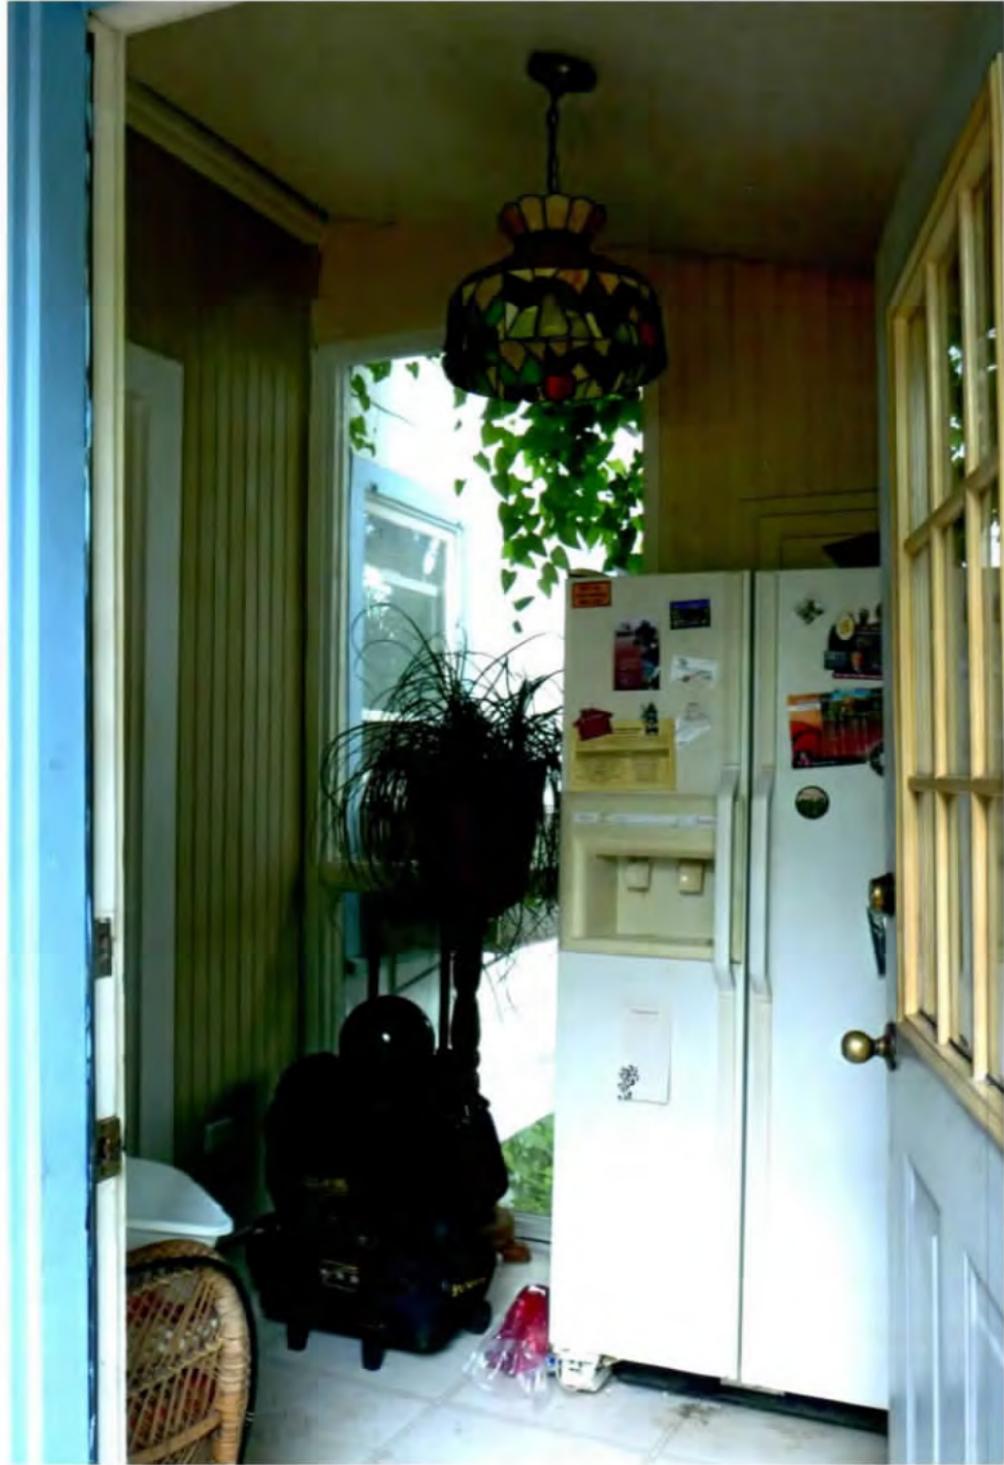
The second pic – where the fridge was. You can see the very cheaply done glass part there to the left of the fridge. To the left of that is what looks to me like the outside of the original structure, built in 1948.

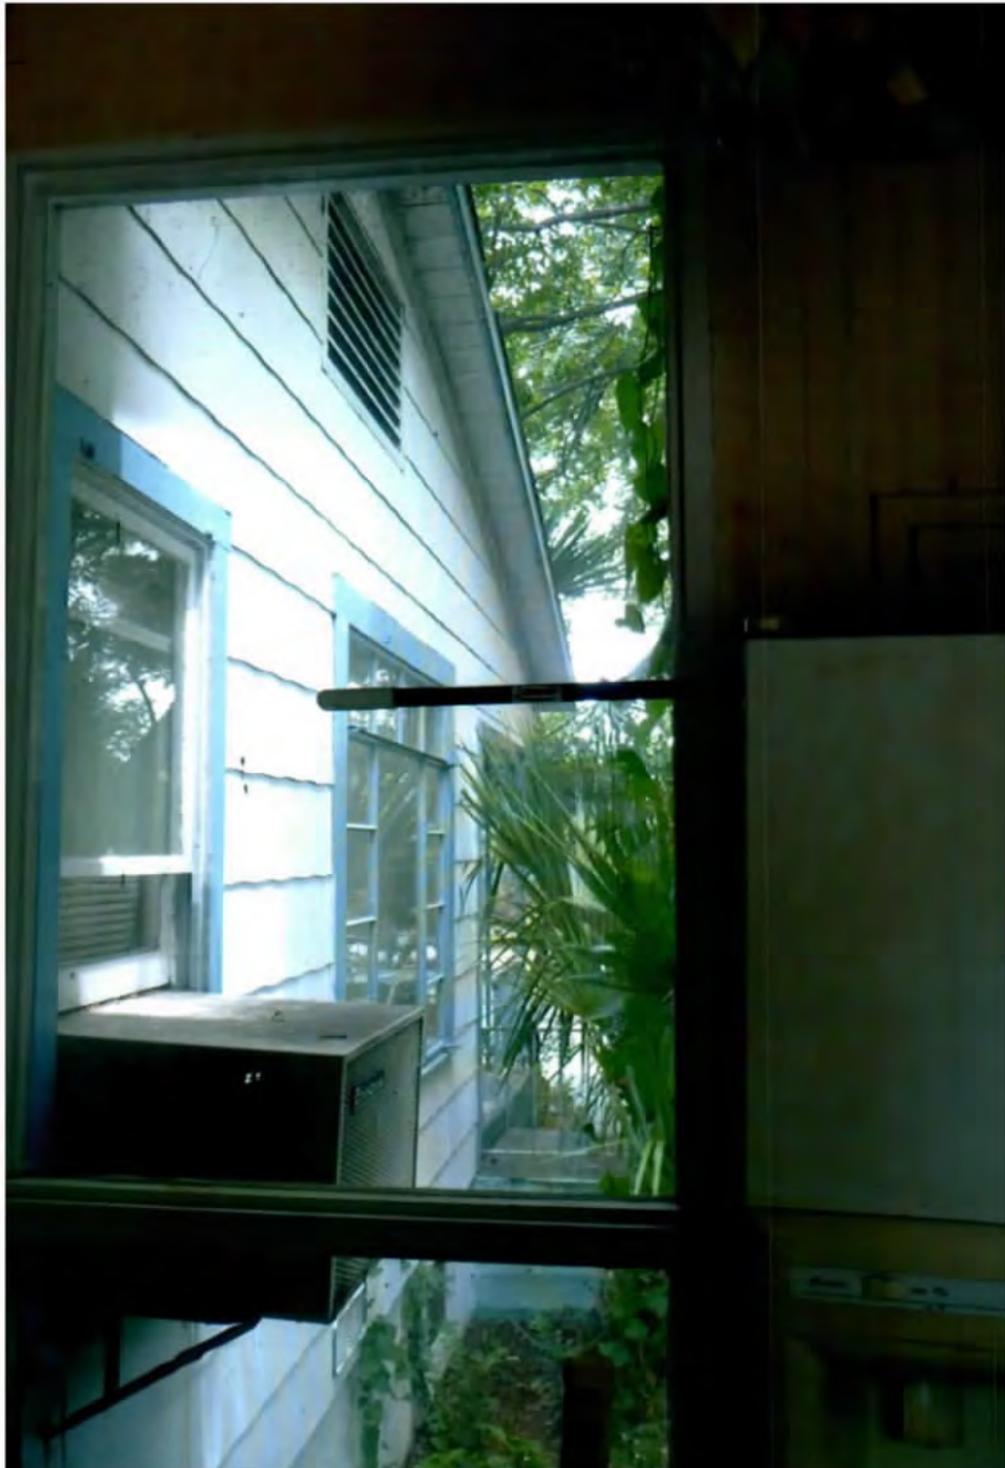
The third pic – you can see the window unit which is the wood-framed window. I think that was probably put in to house the window unit. It doesn't match the metal-framed picture window beside it.

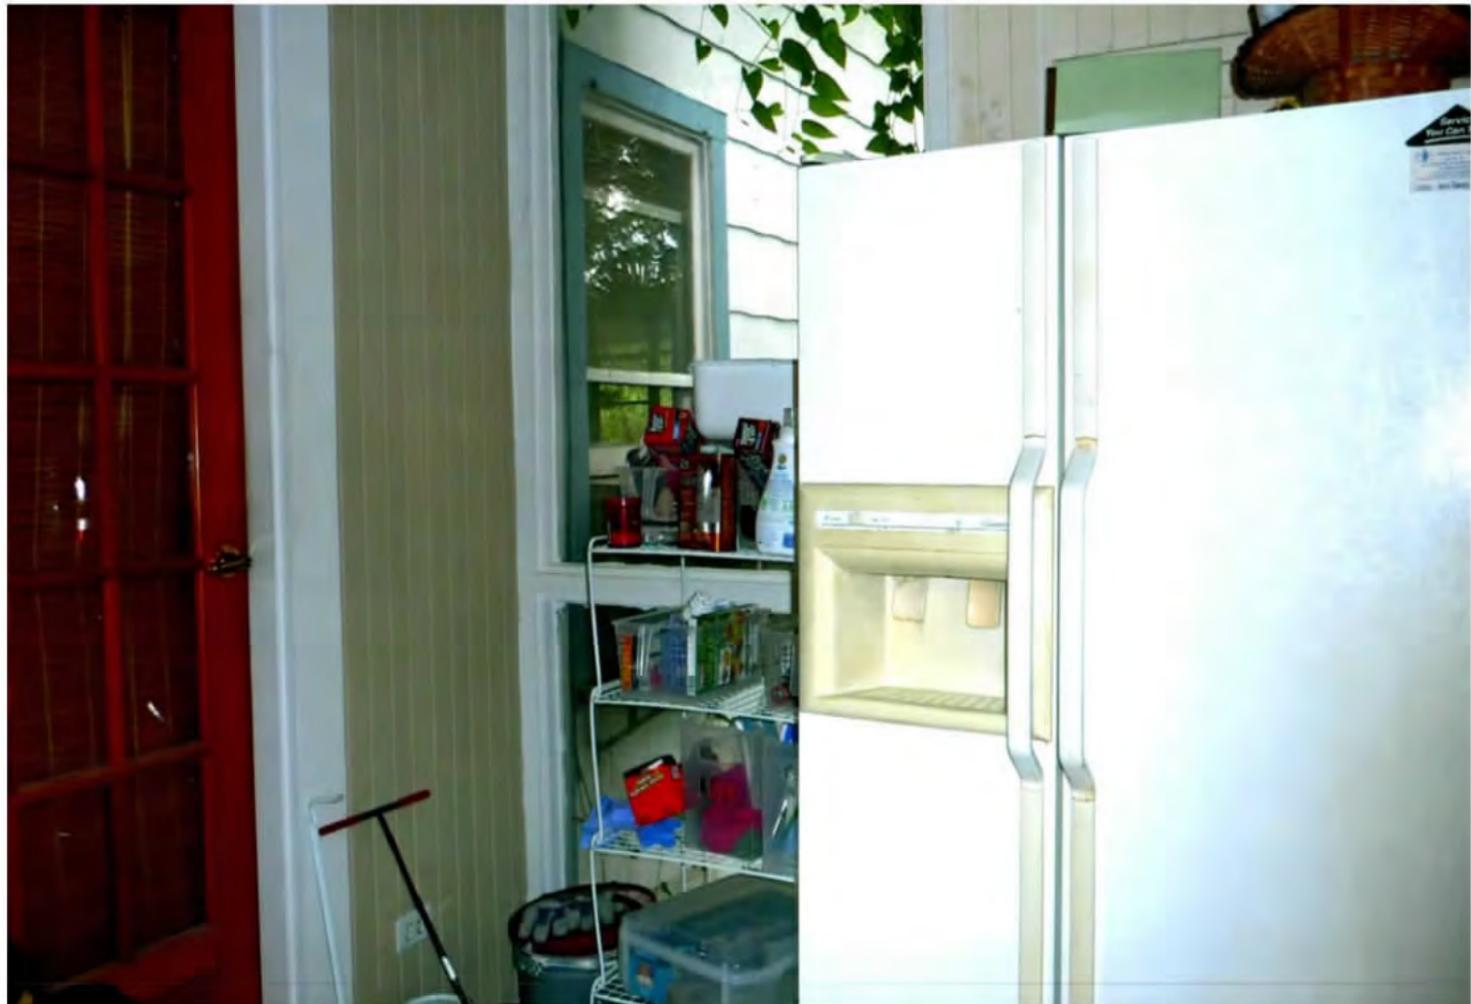
The fourth pic – more of the same, outside part of the house.

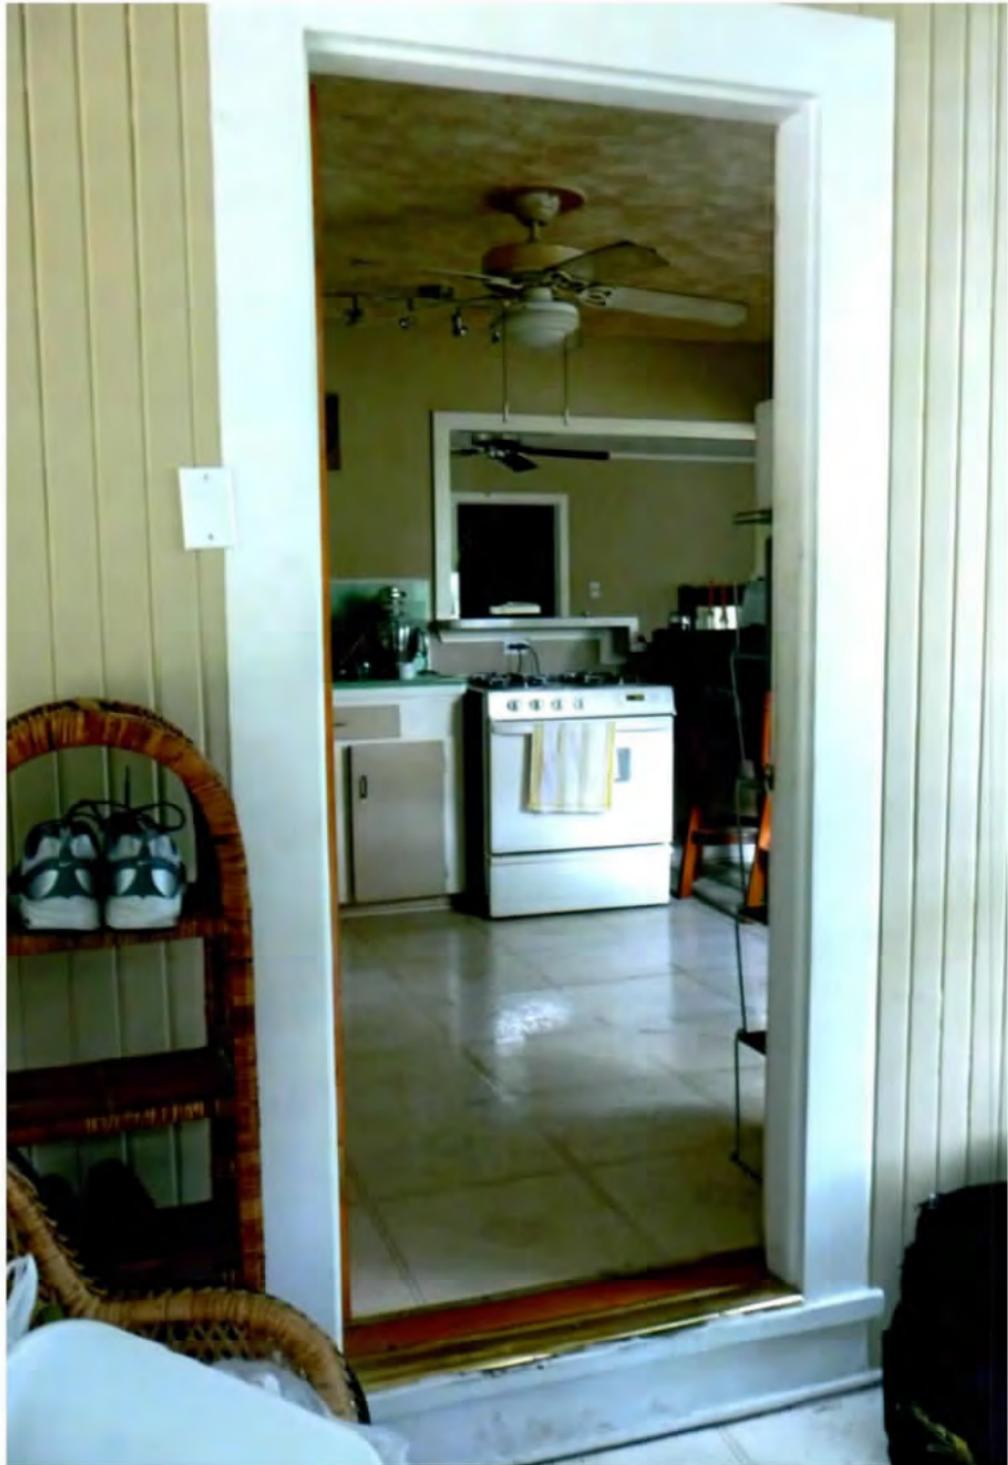
The fifth pic – the original entrance to the house, into the kitchen.

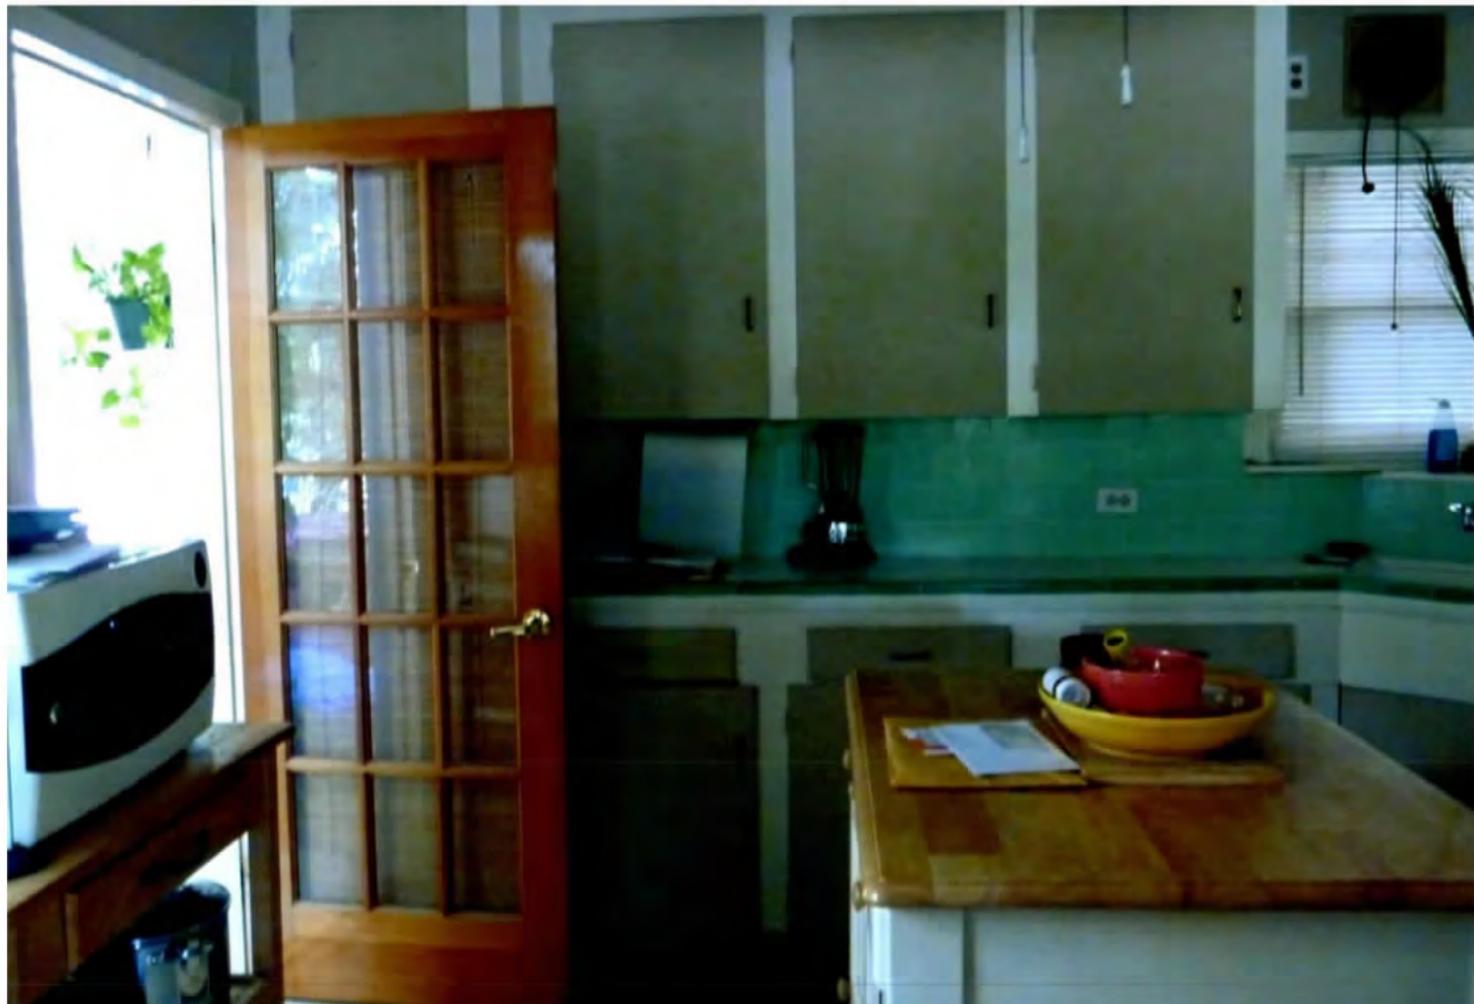
The sixth pic – from inside the kitchen, looking at the door that was installed into the vestibule.

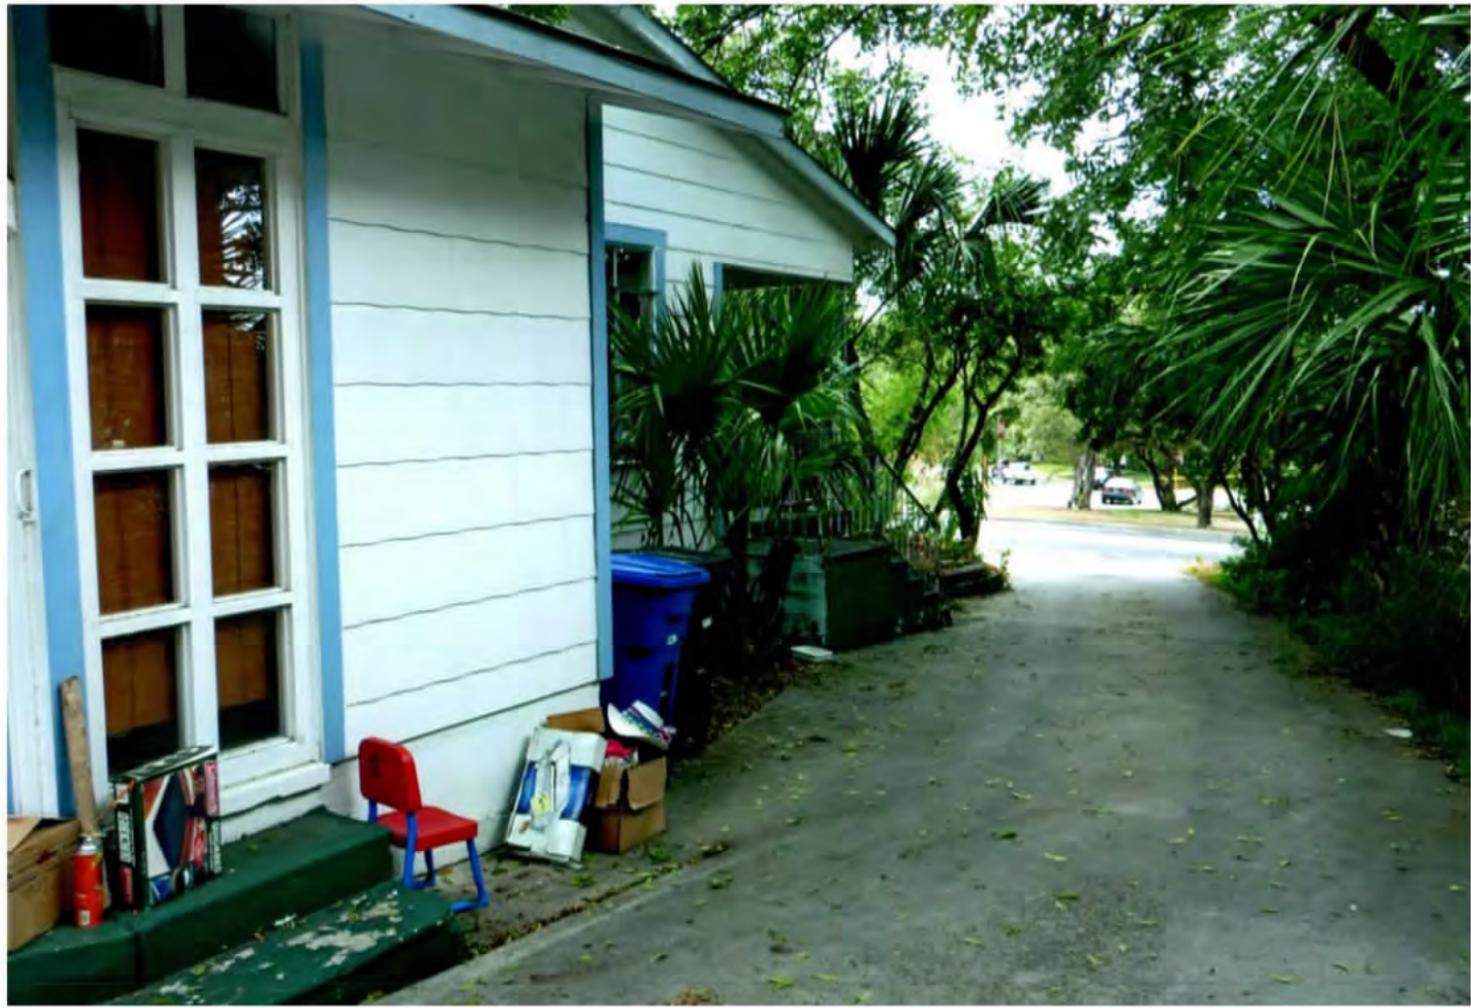
The seventh pic – you can see where a door used to be, with the green steps, and what it looks like down the drive to the street, along with the siding.

- m. SIDING REPLACEMENT - That the siding on the non-original addition may be replaced if the new siding relates to, but does not have to match, the asbestos siding on the rest of the historic structure in exposure height and lap configuration. Siding specifications shall be submitted to staff prior to approval.

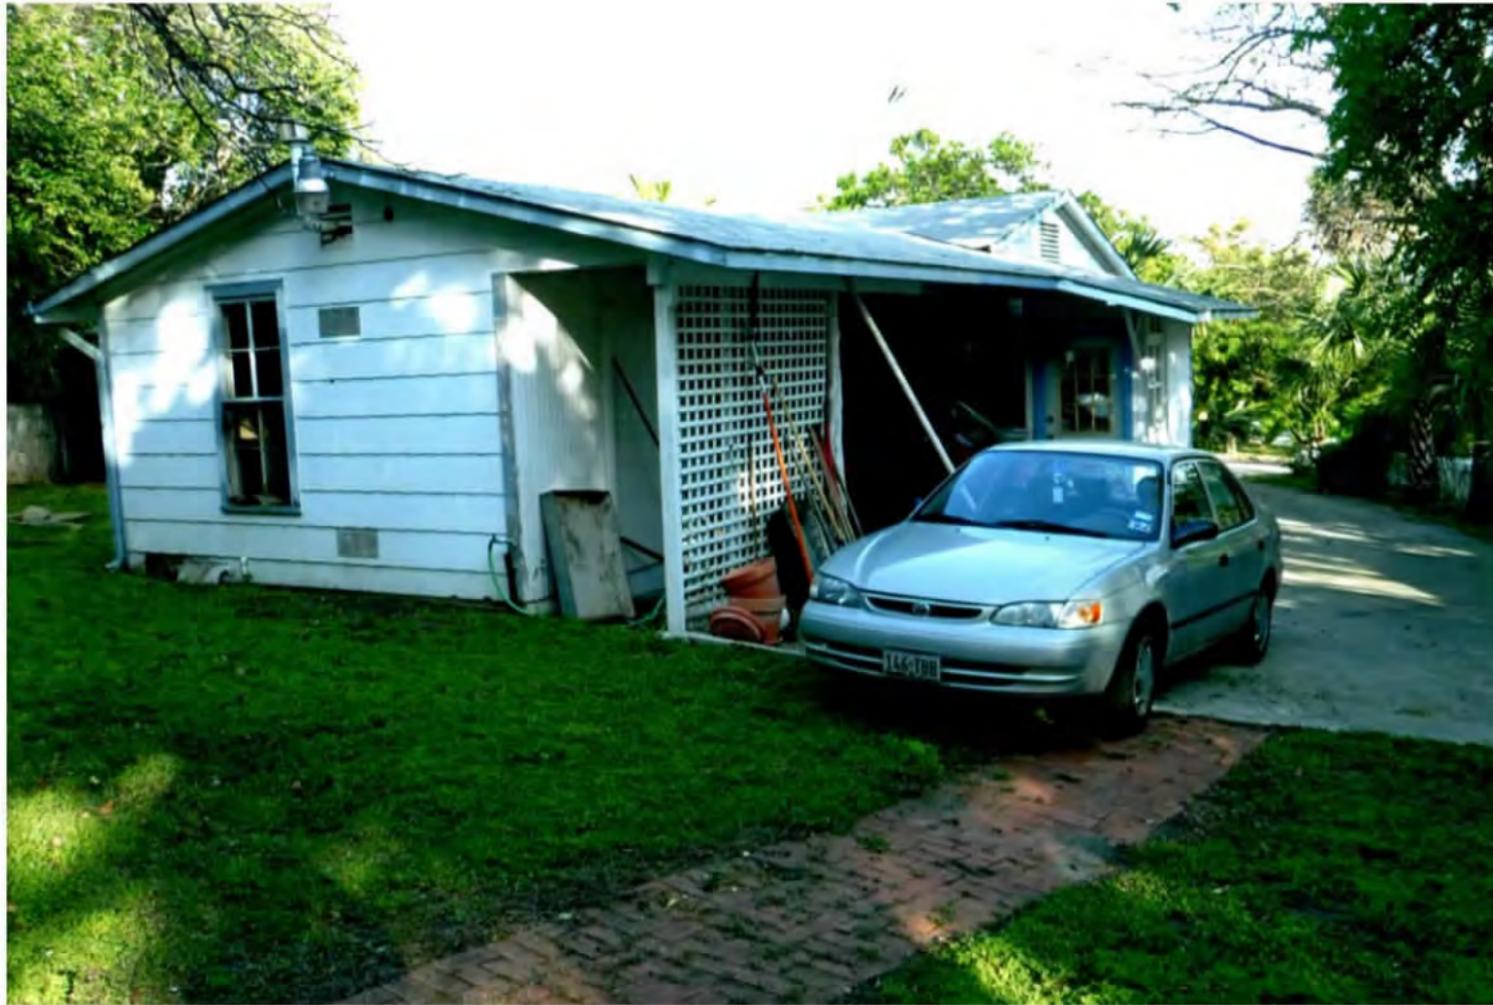
The eighth pic – you can see what the entire back part of the house looked like. My contractor thinks the carport is an add-on too, not part of the original structure. You can see that there's a window in the kitchen into the carport.
