HISTORIC AND DESIGN REVIEW COMMISSION

February 05, 2020

HDRC CASE NO: 2020-020
ADDRESS: 1112 E CROCKETT ST
LEGAL DESCRIPTION: NCB 585 BLK 2 LOT 3
ZONING: RM-4, H
CITY COUNCIL DIST.: 2
DISTRICT: Dignowity Hill Historic District
APPLICANT: Anthony Segura II/The Window Source of San Antonio
OWNER: Ricardo Gonzales/GONZALES RICARDO S
TYPE OF WORK: Window replacement
APPLICATION RECEIVED: January 16, 2020
60-DAY REVIEW: March 15, 2020
CASE MANAGER: Huy Pham

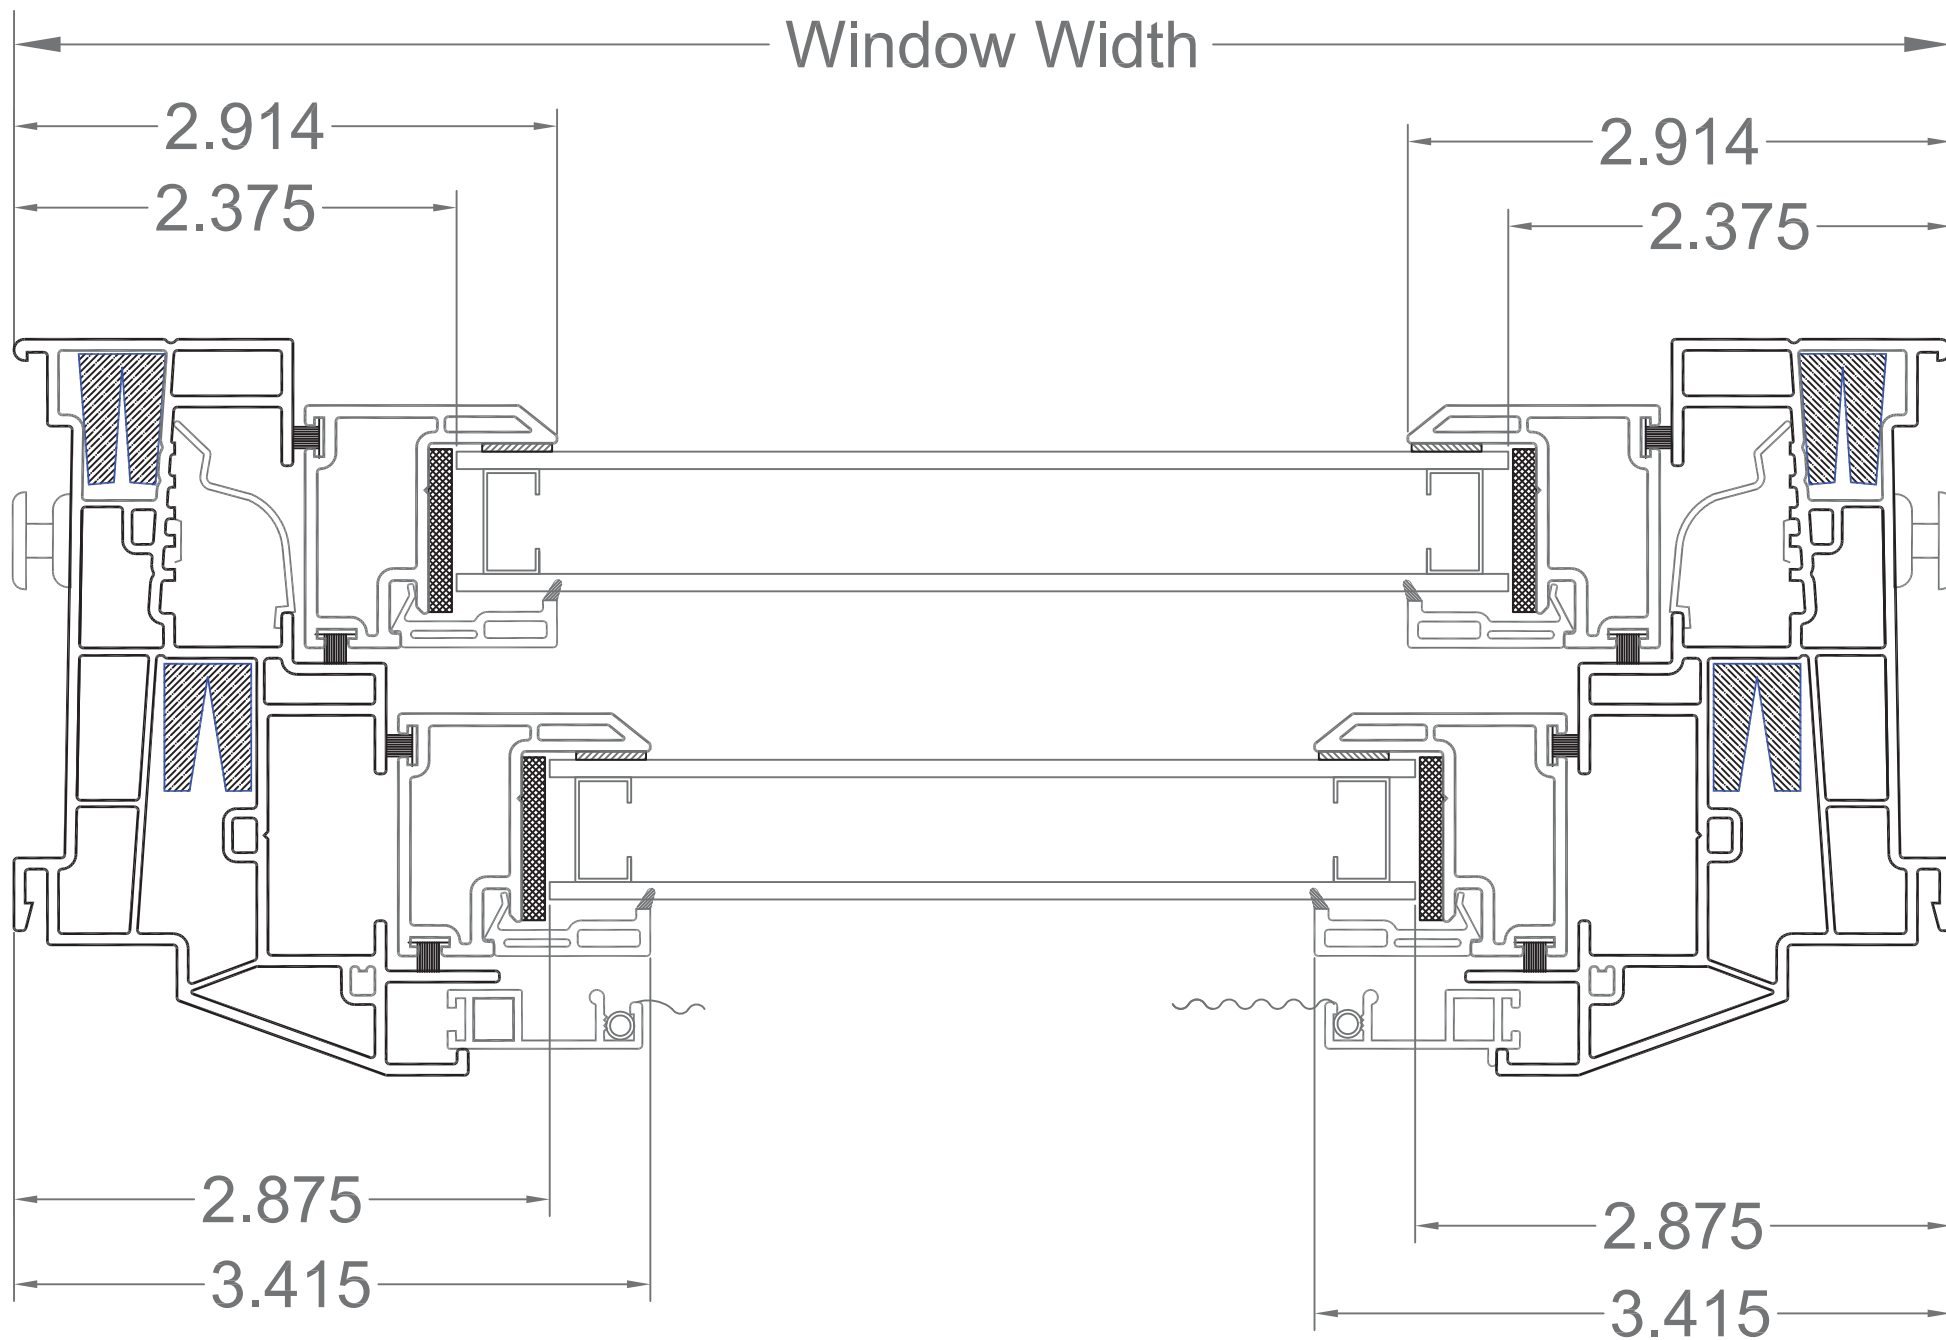
Model 3A01 Double Hung

- c. **ADDITION WINDOWS** – The applicant has proposed to replace four vinyl windows on the rear addition with new vinyl windows (Alside 3A01). The applicant has included the use of faux divided lights on two windows to match their existing configuration. Staff finds the existing vinyl windows are not original to the historic structure, and are eligible for replacement if the new windows are an improvement upon the overall quality and conformity to the historic structure, which excludes the continued use of faux divided lights or nailing fin installations. Staff finds that the proposed windows should otherwise meet the Standard Specifications for Windows in Additions and New Construction.

- i. That the new windows exclude faux divided lights and nailing fins, and otherwise adhere to the *Standard Specifications for Windows in Additions and New Construction*.
- ii. That the new glass on the picture and transom windows are plain and clear, and that there will be no alterations to the existing wood window frames.
- iii. That all unapproved work within the last two years are remedied with approval or reversal including:
 - a. Restoring the front door to feature a Folk Victorian style door.
 - b. Restoring the decorative gable returns on the front-facing and turned gabled roofs.
