HISTORIC AND DESIGN REVIEW COMMISSION

HDRC CASE NO: 2020-154
ADDRESS: 126 WICKES
LEGAL DESCRIPTION: NCB 931 BLK LOT 28 RM-4, H
ZONING: 1
CITY COUNCIL DIST.: King William Historic District
DISTRICT: GARZA BENJAMIN S & MARGARITA
APPLICANT: GARZA BENJAMIN S & MARGARITA
OWNER: Roof replacement
TYPE OF WORK: March 18, 2020
APPLICATION RECEIVED: Not applicable due to City Council Emergency Orders
60-DAY REVIEW: Huy Pham
CASE MANAGER:

The applicant is requesting a Certificate of Appropriateness for approval to reroof the structure including:

1. Modification of the roof form
2. Removal of two brick chimneys

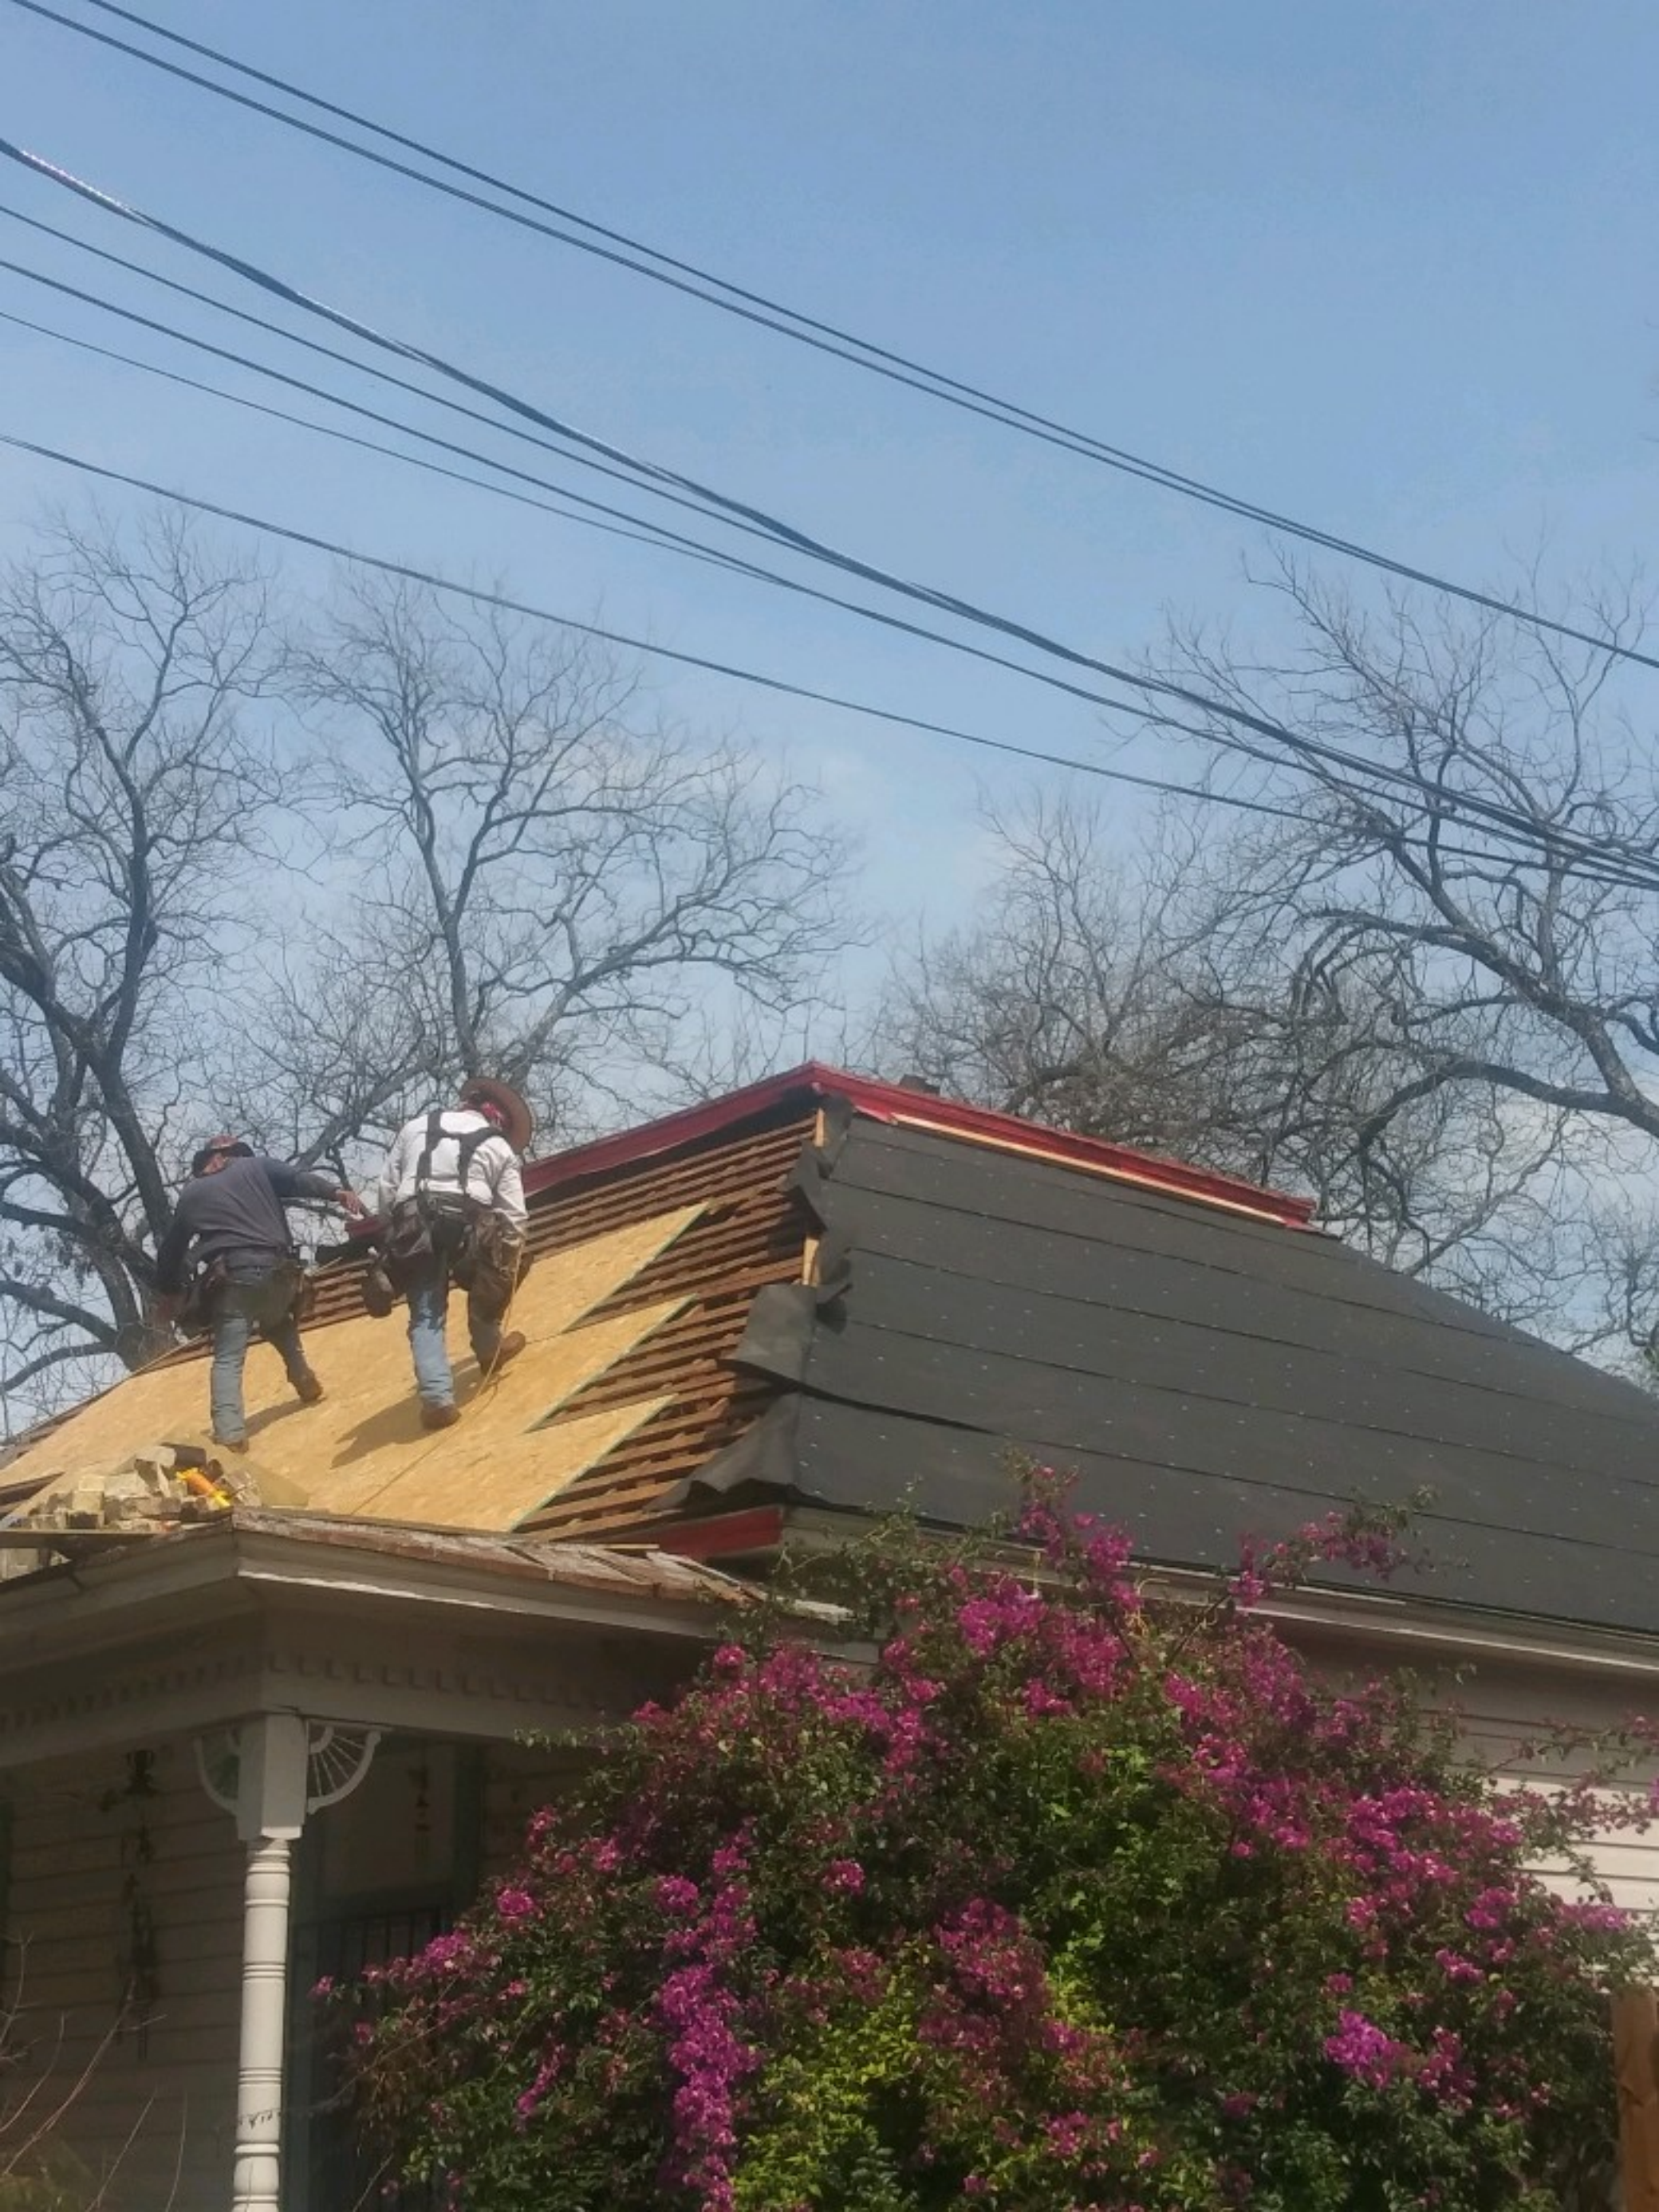
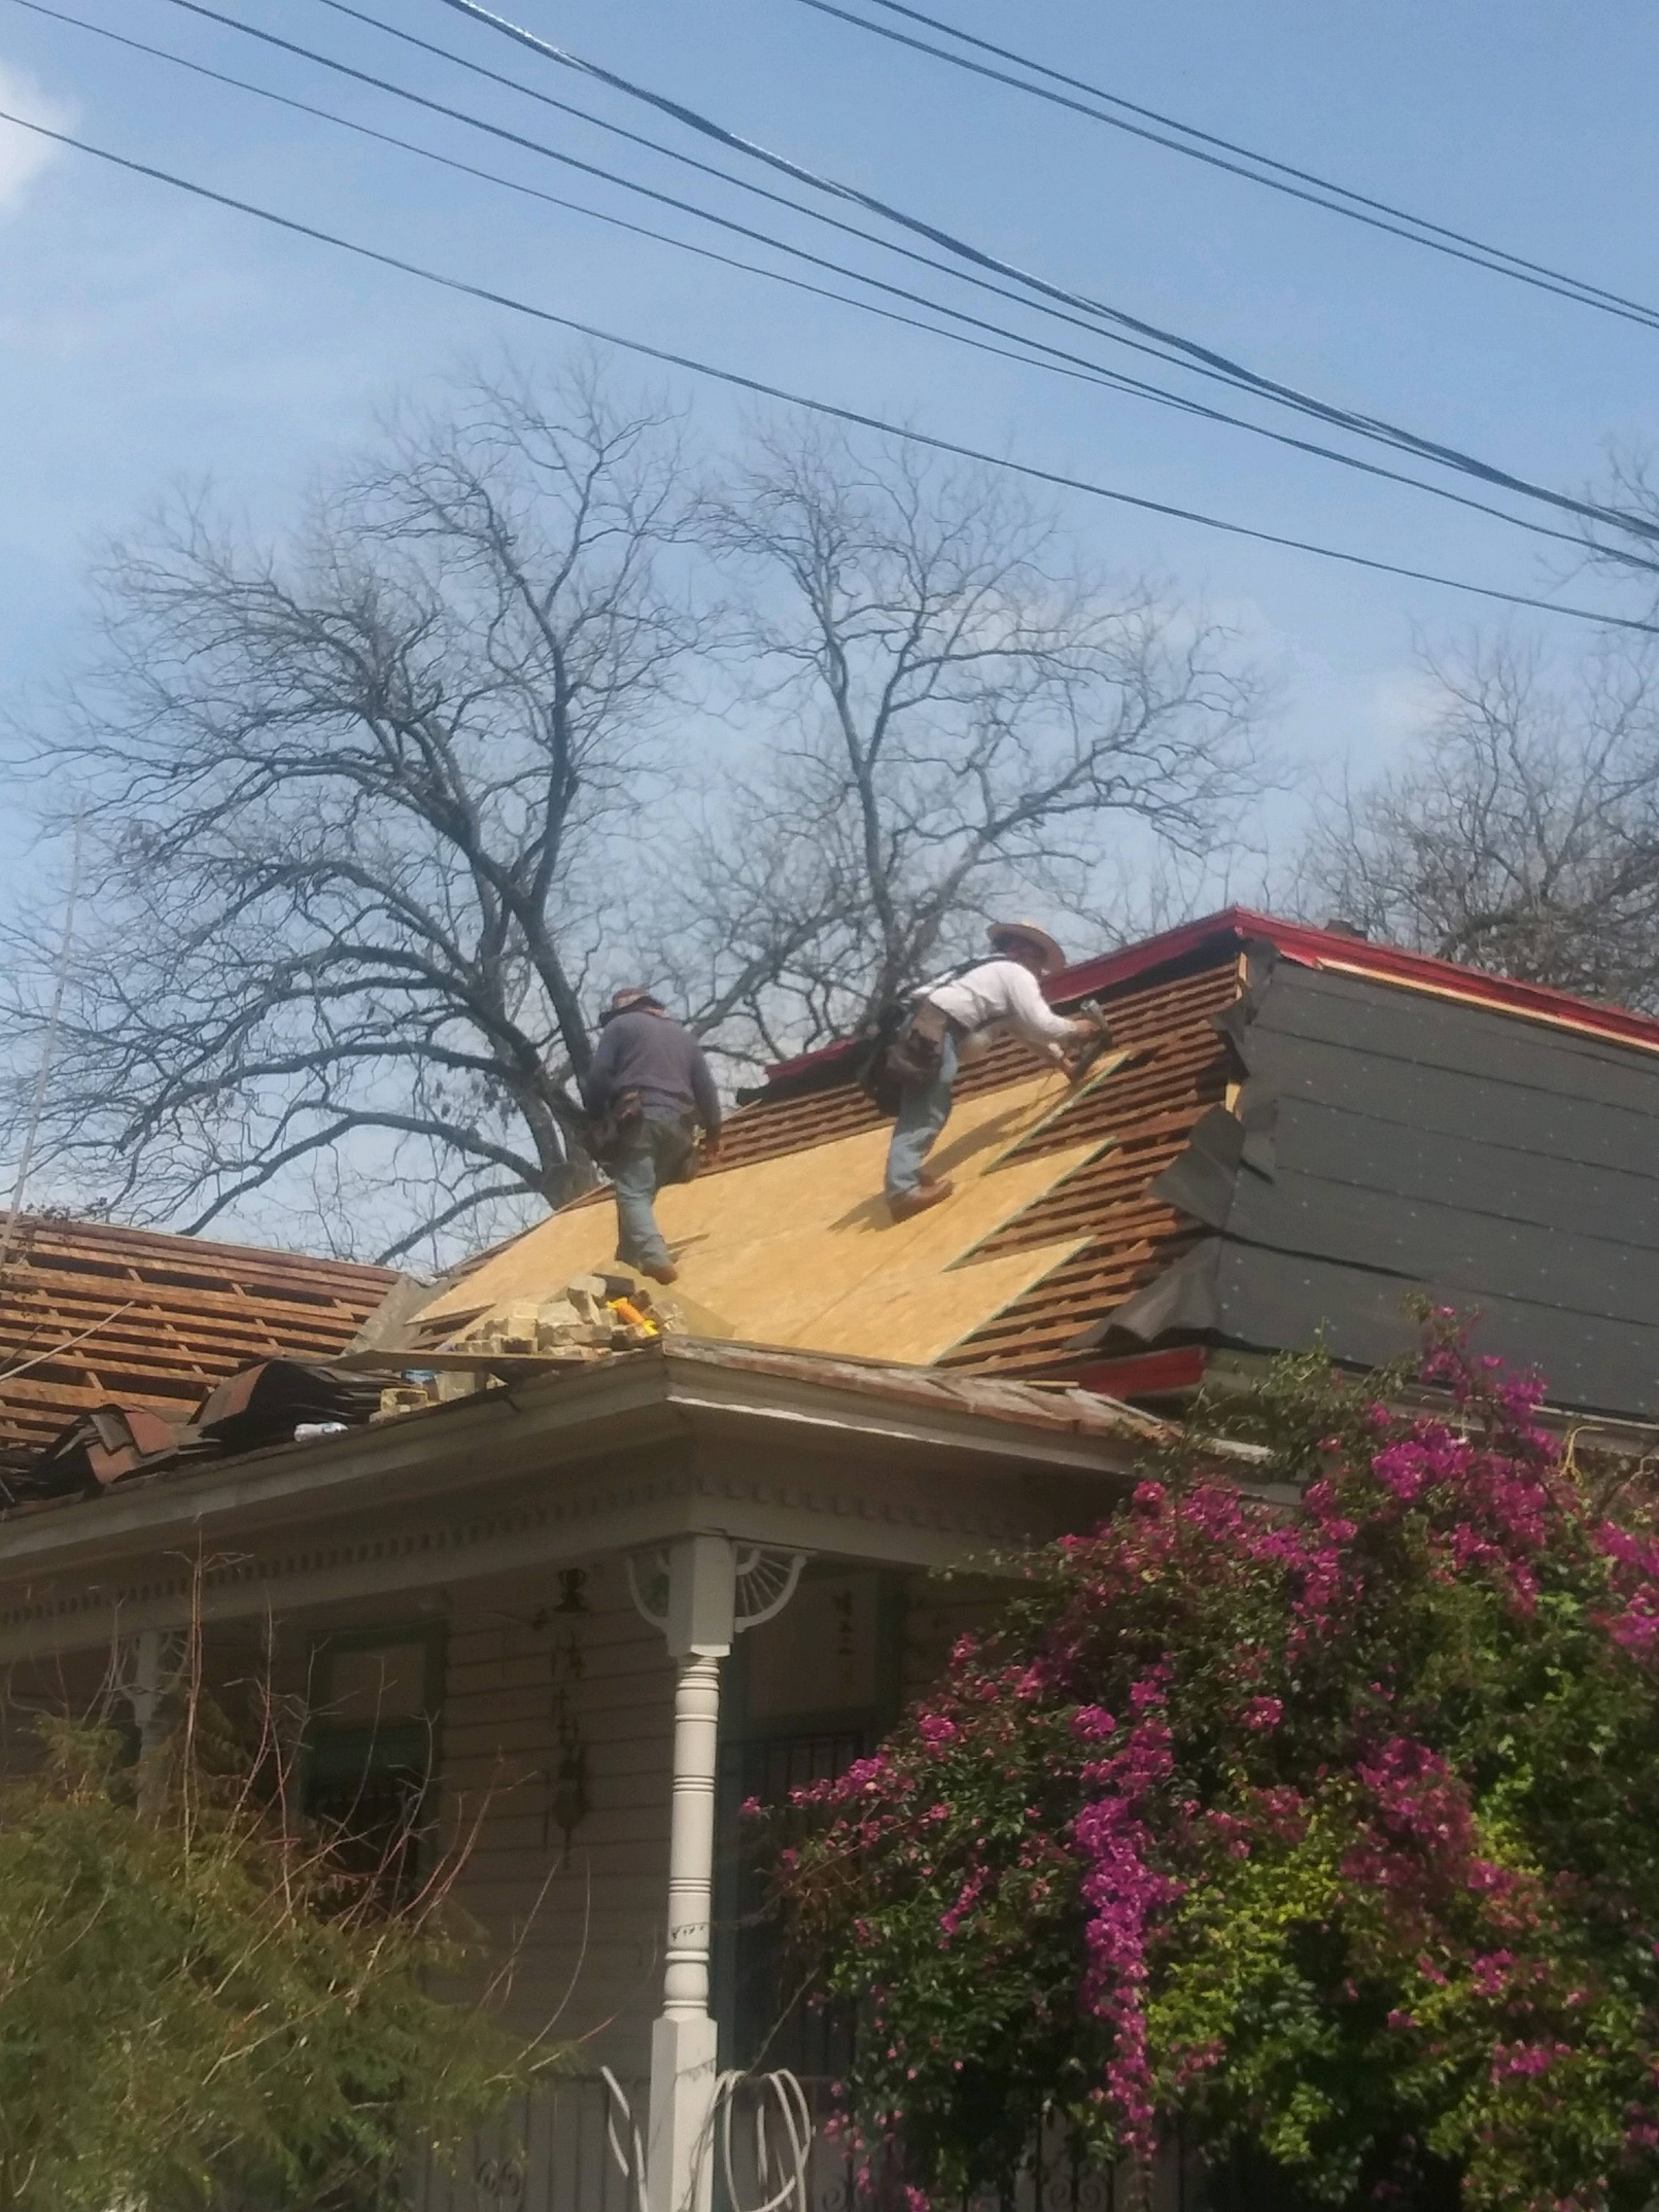
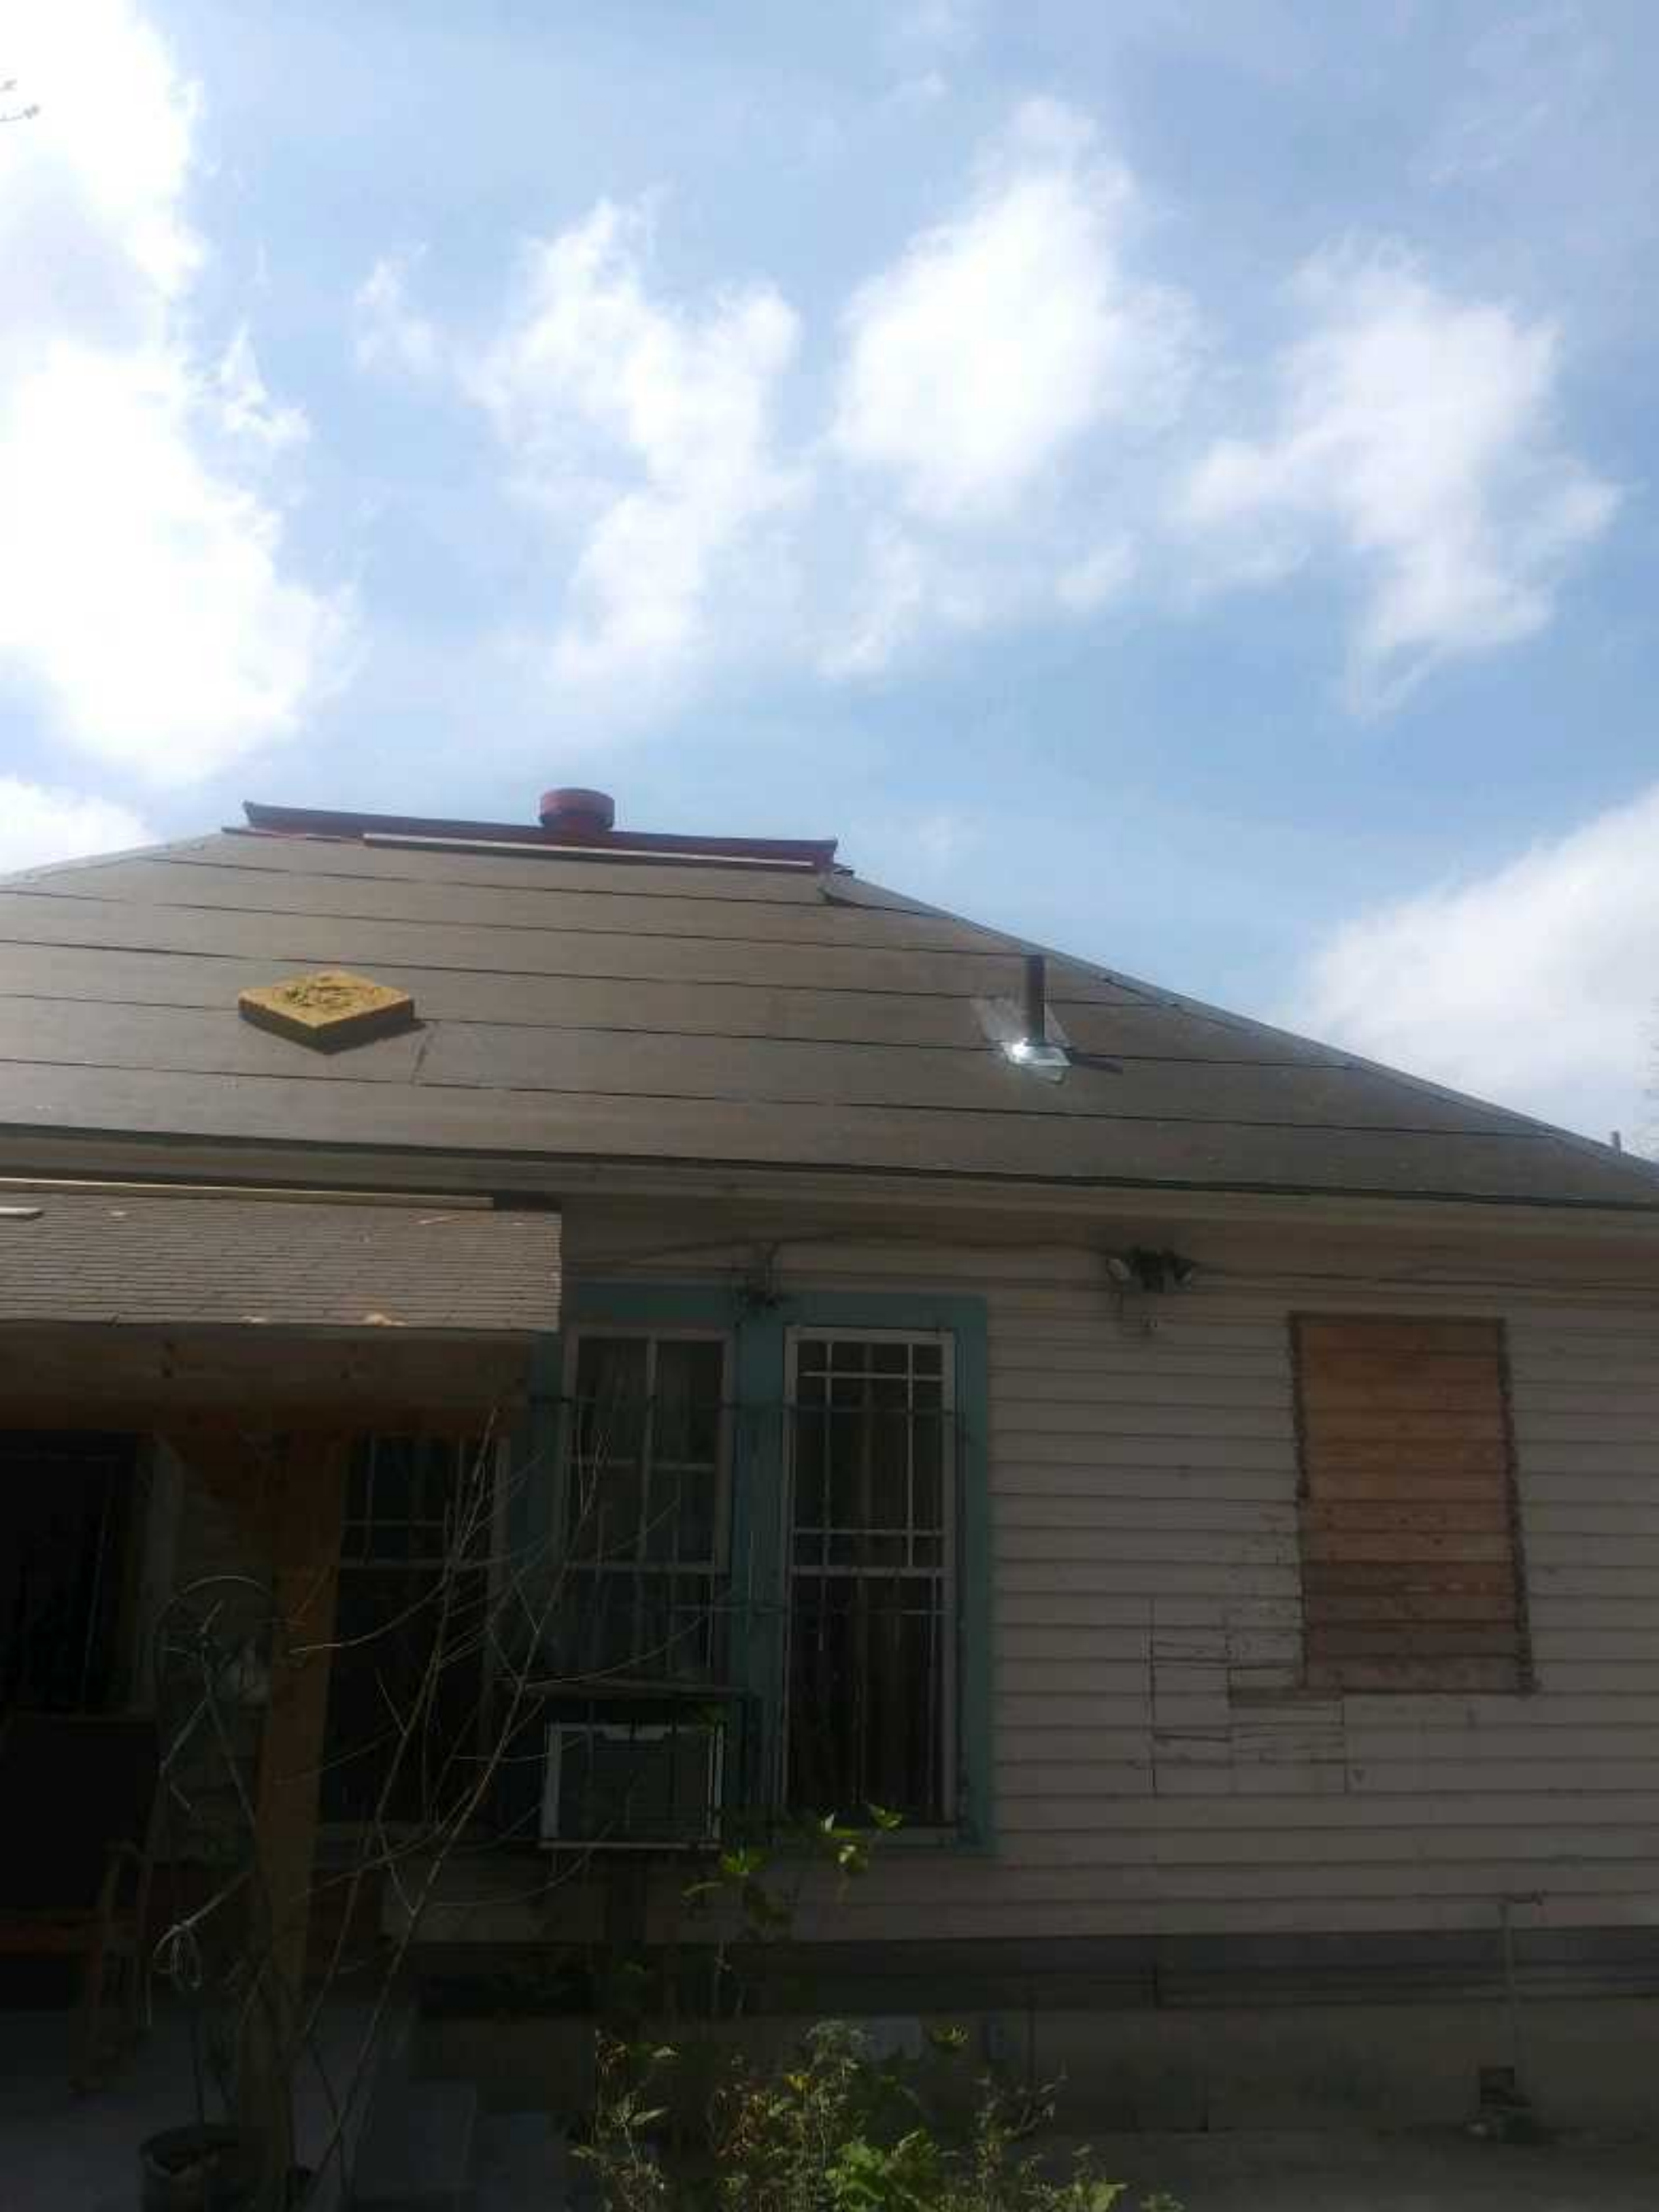
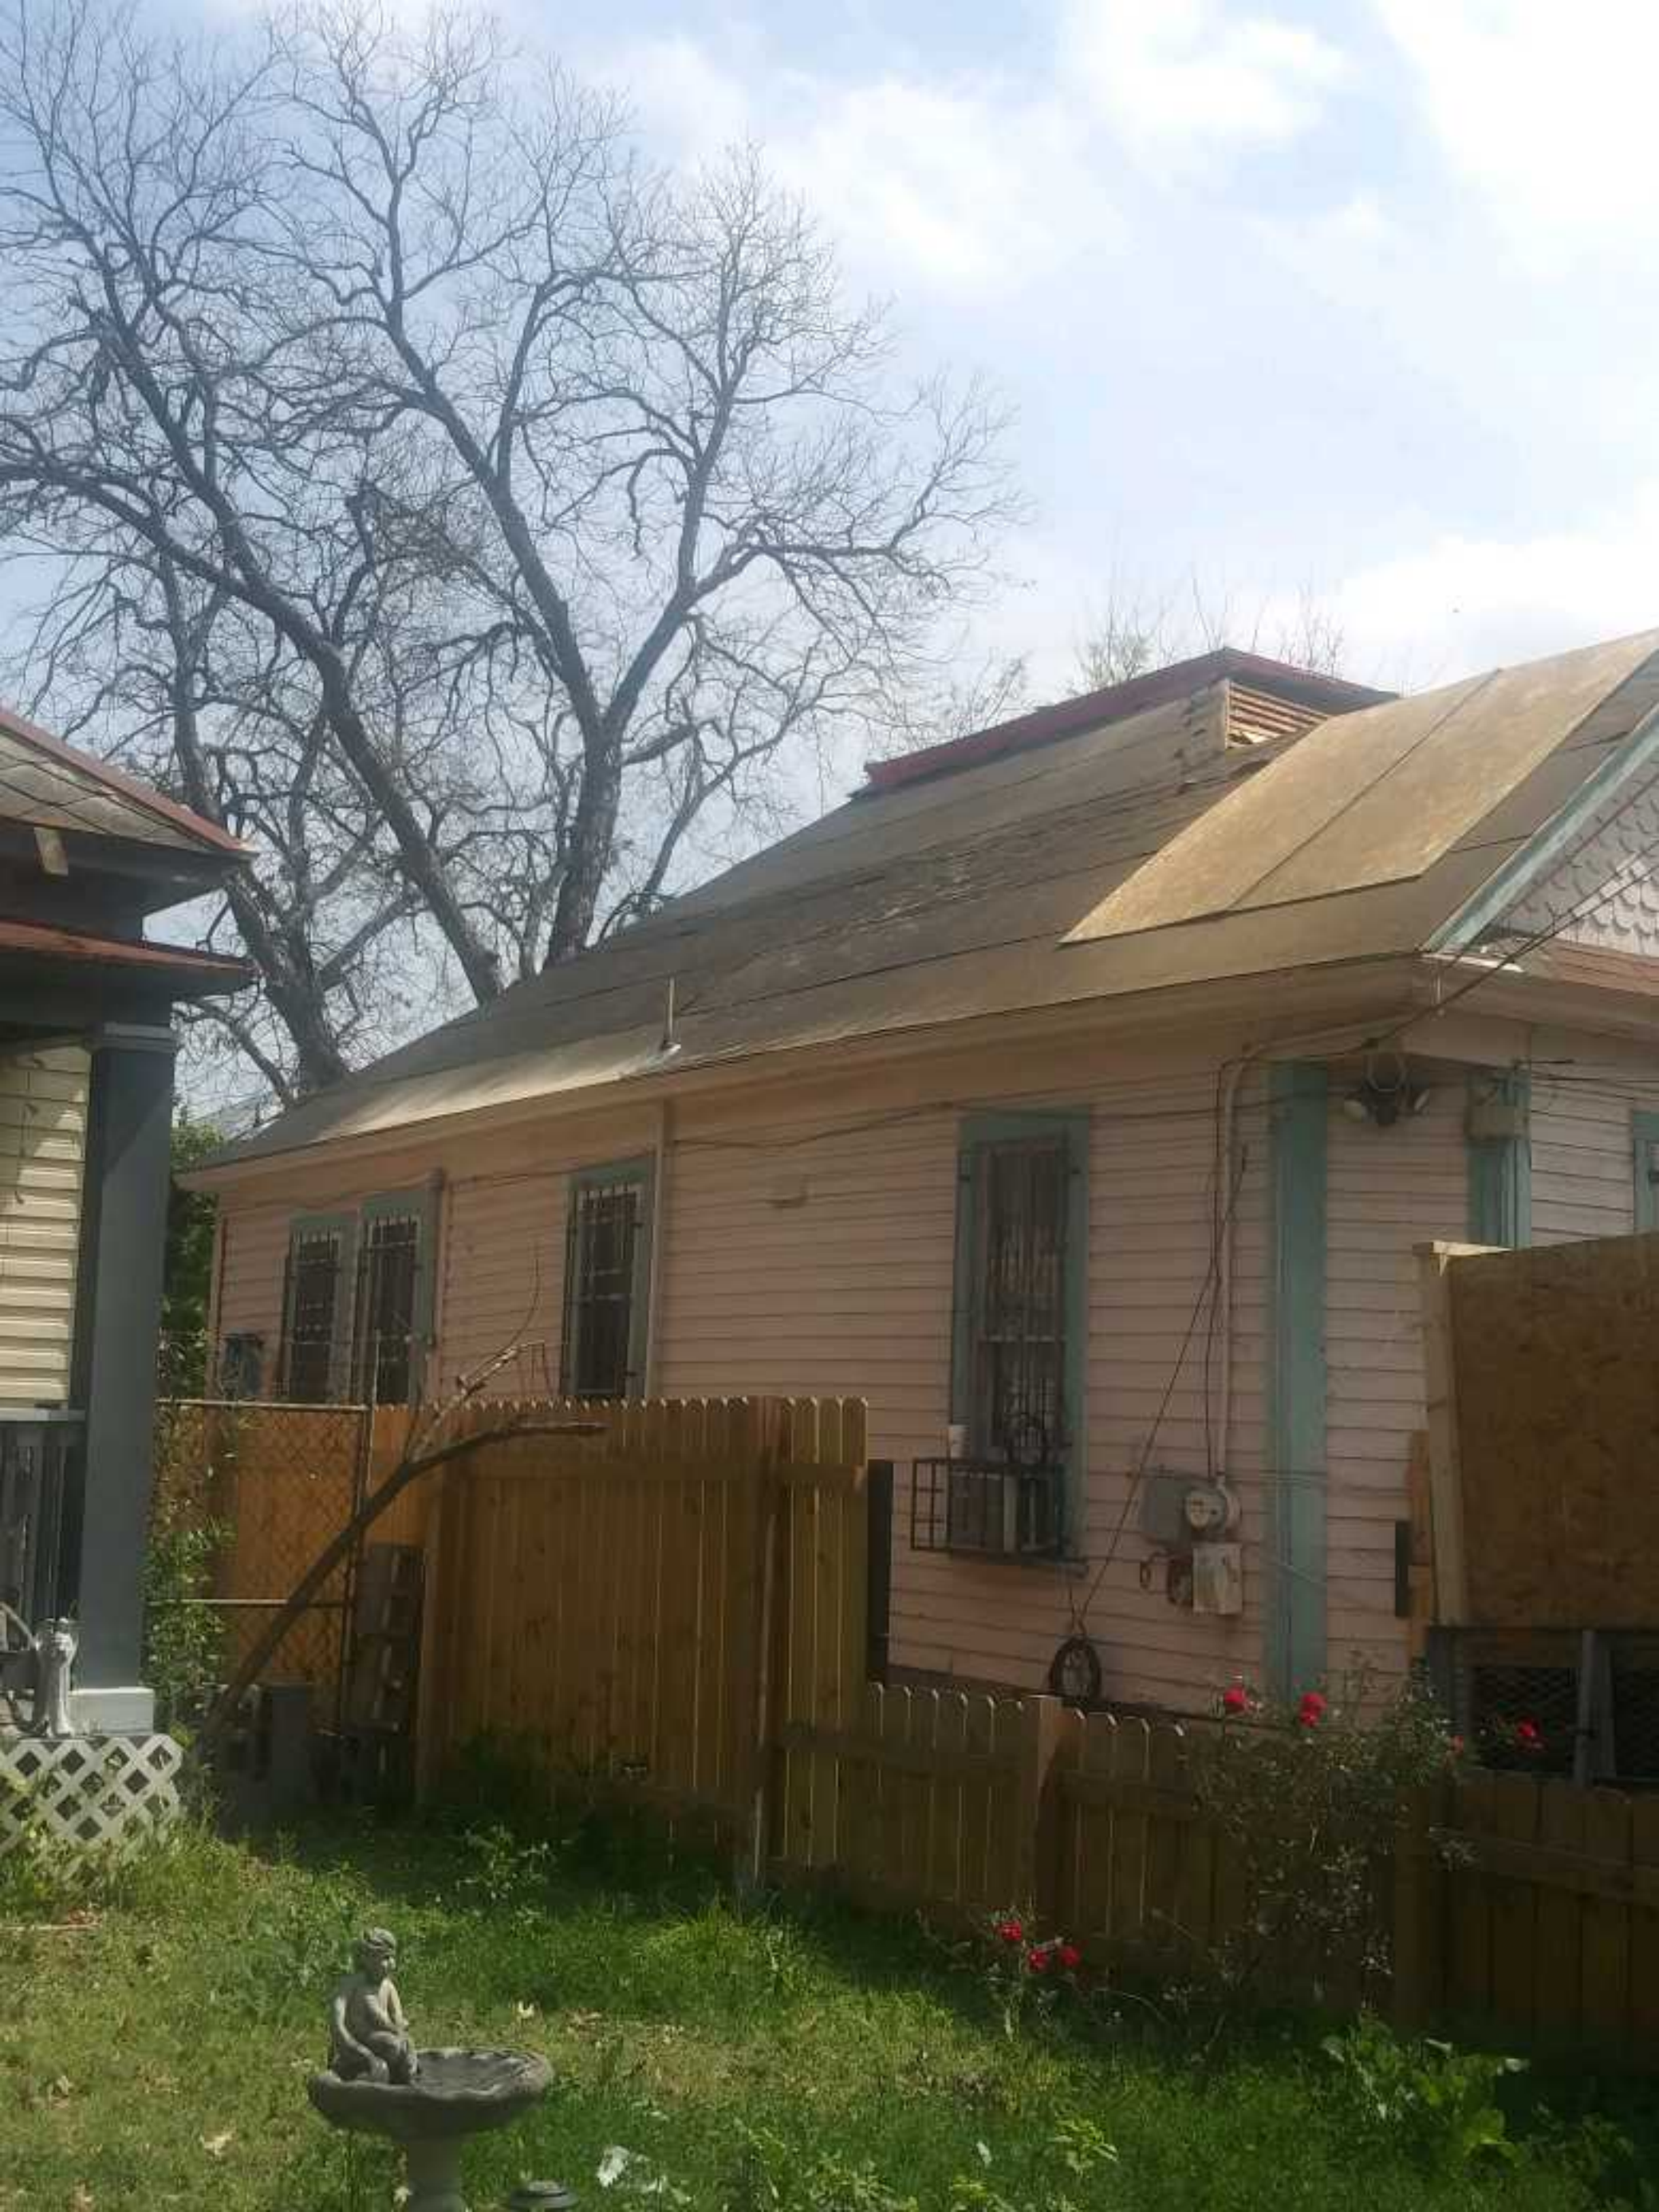
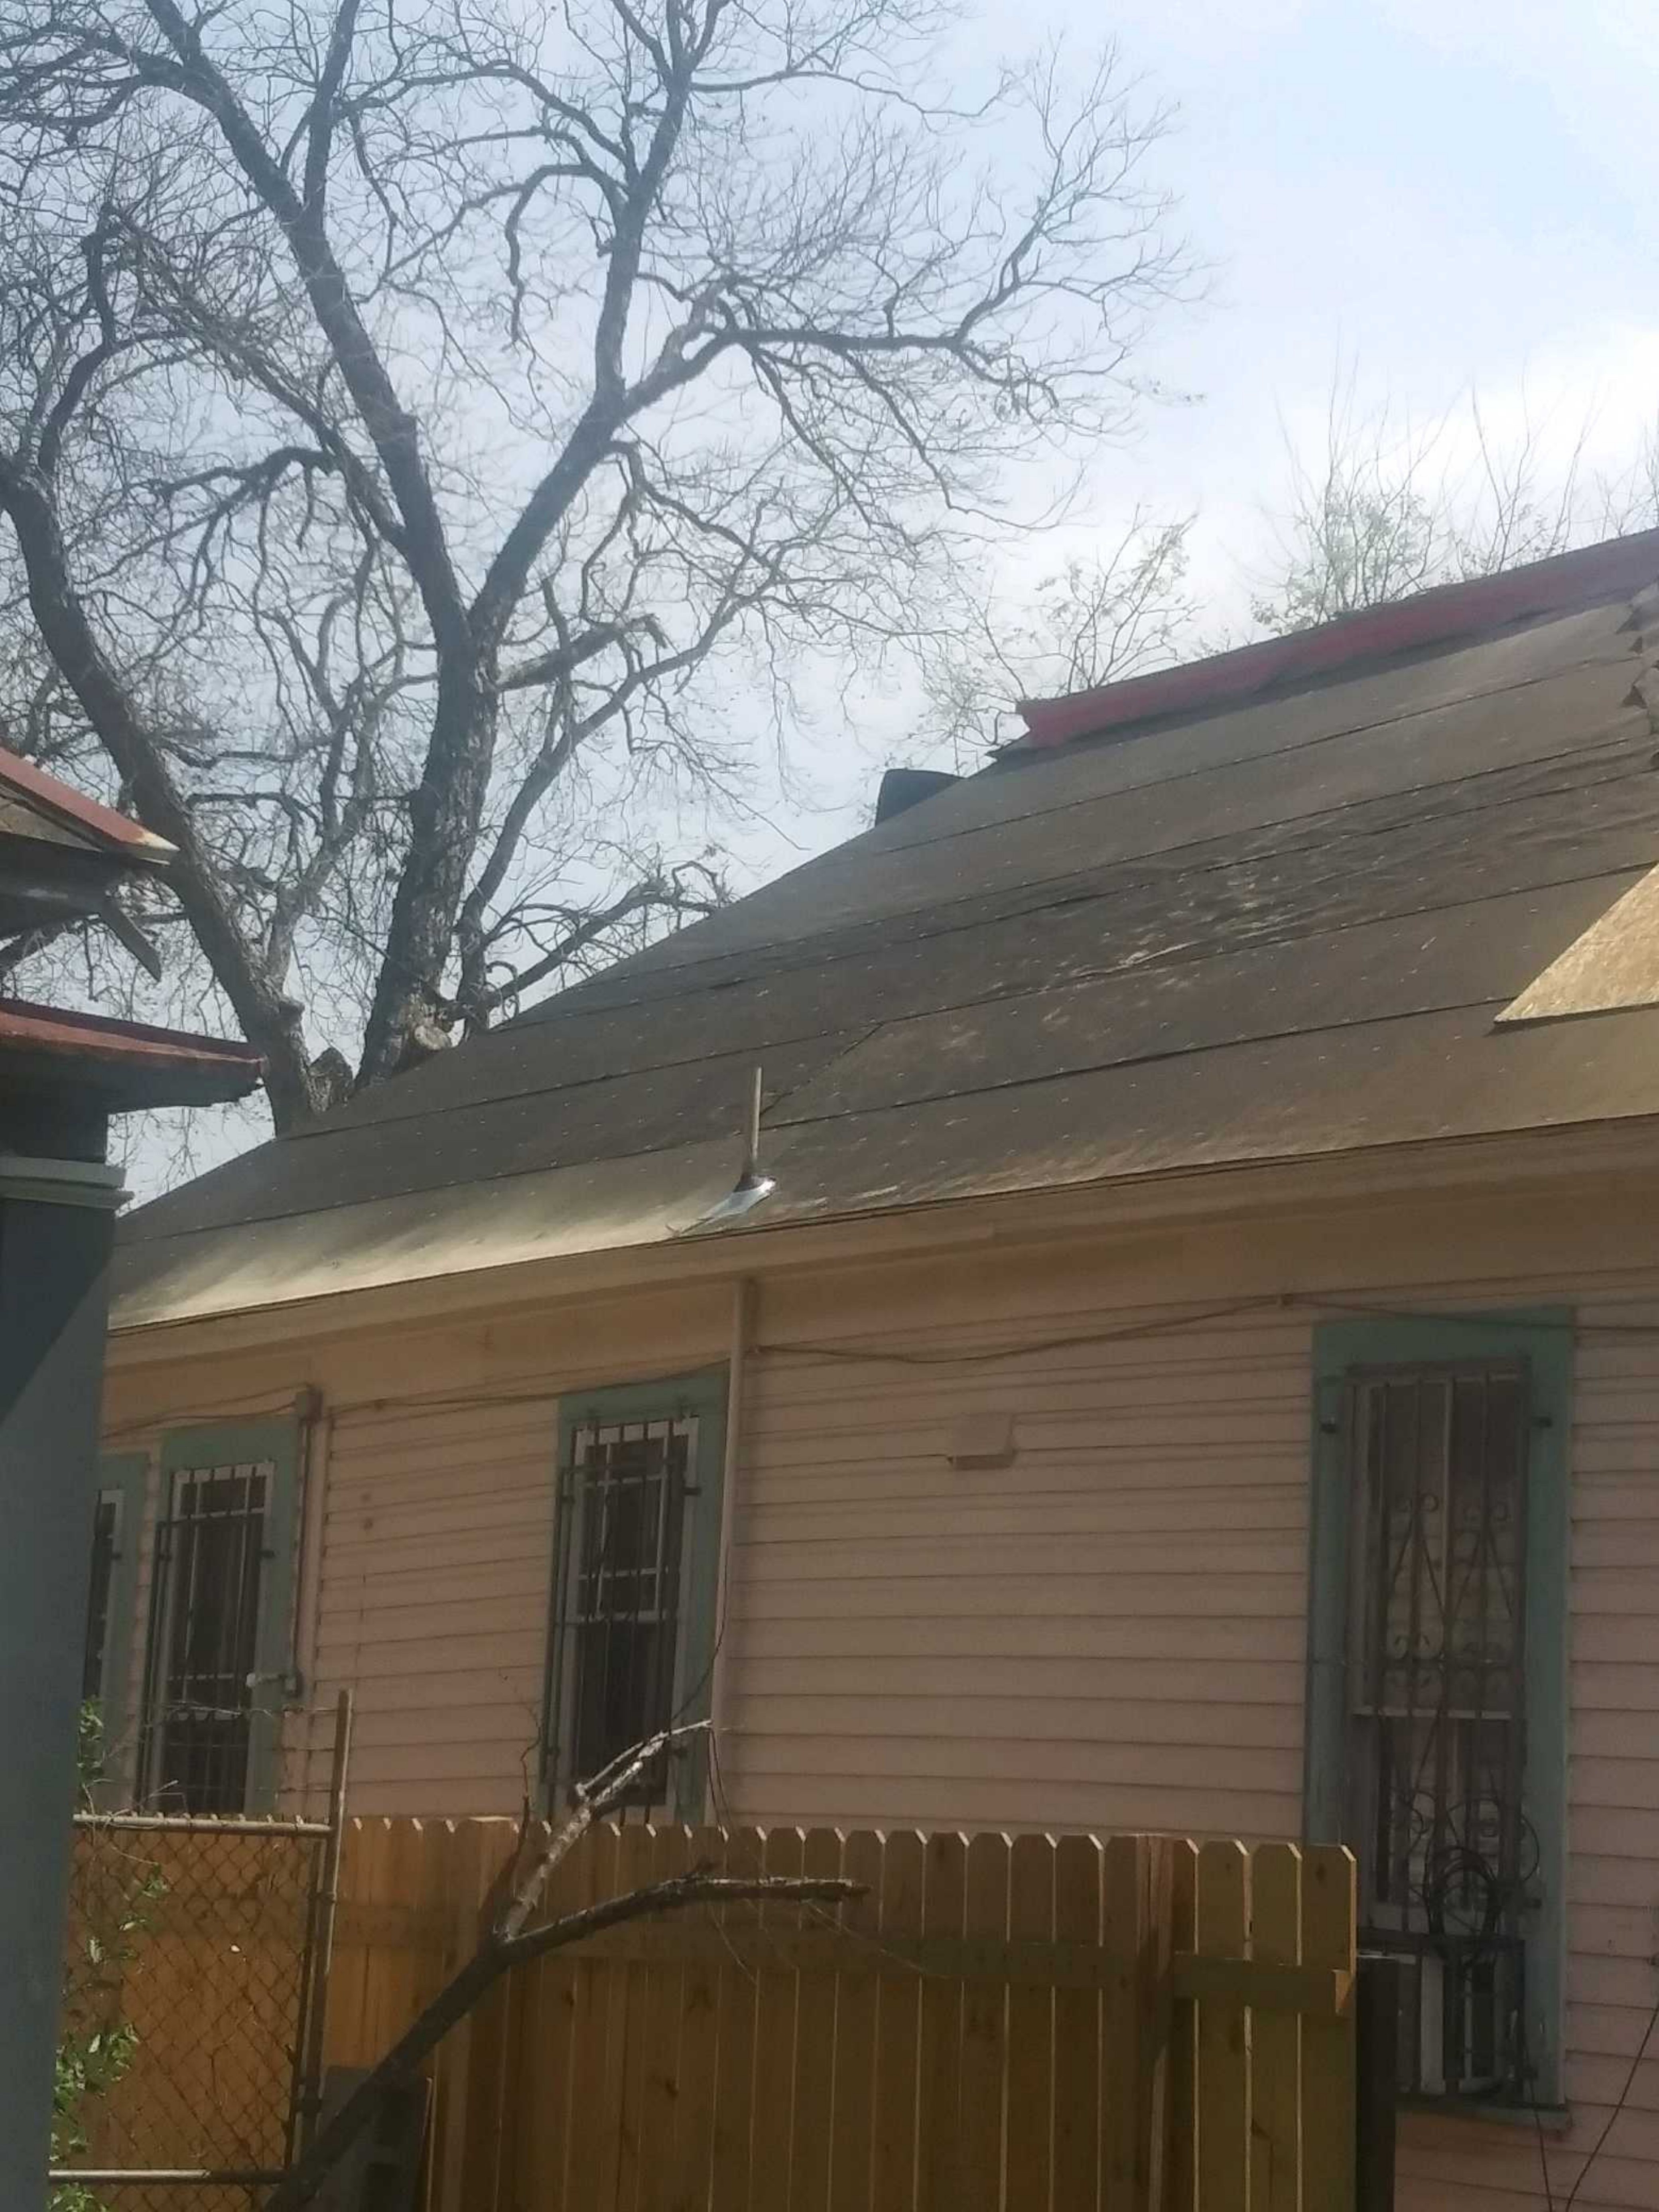
- c. **EXISTING ROOF** – Prior to work without approval, the roof at 126 Wickes a featured primary hipped roof with composition shingles, with a flat roof portion with standing seam metal and metal cresting. The structure also featured two brick chimneys flanking each side of the flat roof portion.

- d. **ROOF FORM** – The applicant has proposed to eliminate the flat roof portion of the hipped roof to instead feature a pyramidal roof with a single point. Per the Guidelines for Exterior Maintenance and Alterations 3.B.ii., applicants should preserve the original shape, line, pitch, and overhang of historic roofs when replacement is necessary. Staff finds that the original roof form should be restored including the flat roof portion, standing seam metal material, and metal cresting.

- e. **CHIMNEY** – The applicant has proposed to remove the two chimneys. Per the Guidelines for Exterior Maintenance and Alterations 3.B.iii., applicants p reserve and repair distinctive roof features such as cornices, parapets, dormers, open eaves with exposed rafters and decorative or plain rafter tails, flared eaves or decorative purlins, and brackets with shaped ends. While the applicant has verbally agreed to restore the chimneys, no measured drawings or photo documentation that supports a good faith effort towards compliance has been submitted. Staff finds that the chimneys should be restored to their original location and design, features as much original brick material as possible, and that a measured drawing is submitted to staff prior to any further work.

Staff does not recommend approval of item 1 and 2 based on finding b through e. Staff finds that the original roof form should be restored including the flat roof portion, standing seam metal material, and metal cresting. The chimneys should be restored to their original location and design, feature as much original brick material as possible, and that a measured drawing is submitted to staff prior to any further work.
