HISTORIC AND DESIGN REVIEW COMMISSION

HDRC CASE NO: 2020-154
ADDRESS: 126 WICKES
LEGAL DESCRIPTION: NCB 931 BLK LOT 28 RM-4, H
ZONING: 1
CITY COUNCIL DIST.: King William Historic District
DISTRICT: GARZA BENJAMIN S & MARGARITA
APPLICANT: GARZA BENJAMIN S & MARGARITA
OWNER: Roof replacement
TYPE OF WORK: March 18, 2020
APPLICATION RECEIVED: Not applicable due to City Council Emergency Orders
60-DAY REVIEW: Huy Pham
CASE MANAGER:

The applicant is requesting a Certificate of Appropriateness for approval to reroof the structure including:

1. Modification of the roof form
2. Removal of two brick chimneys

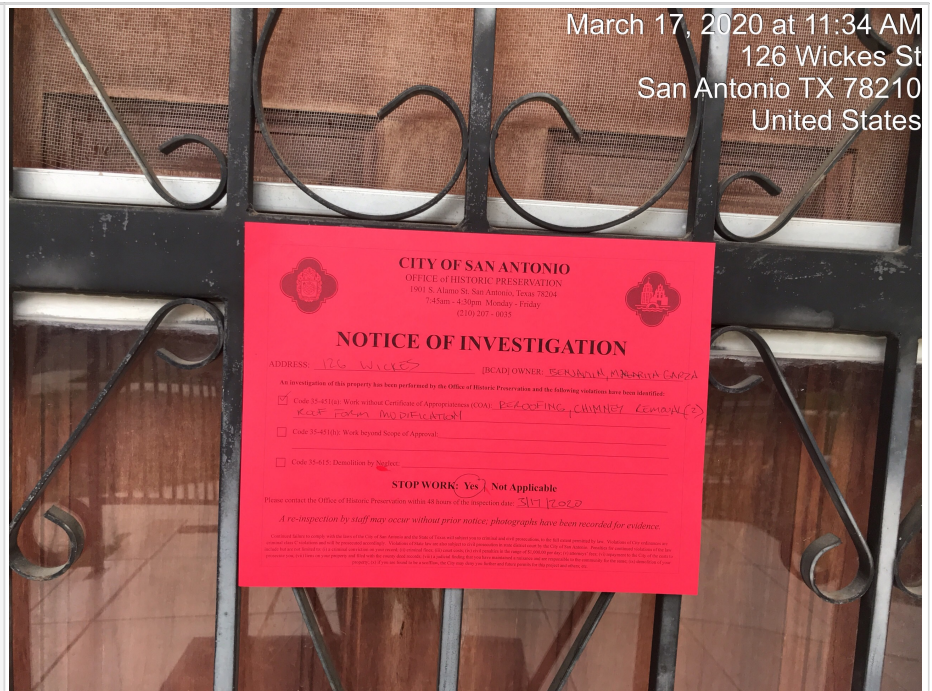
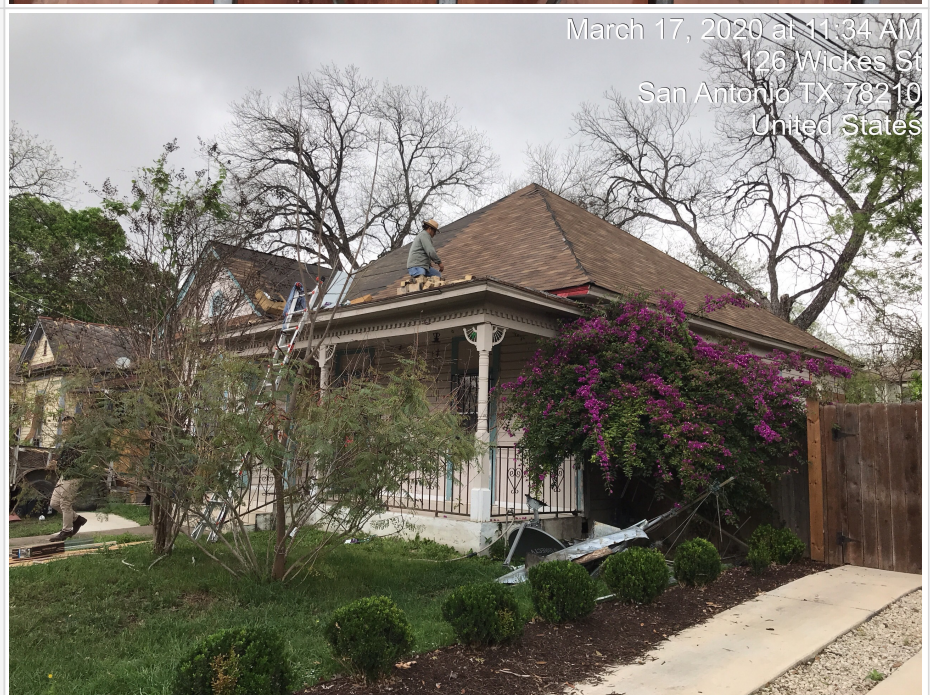
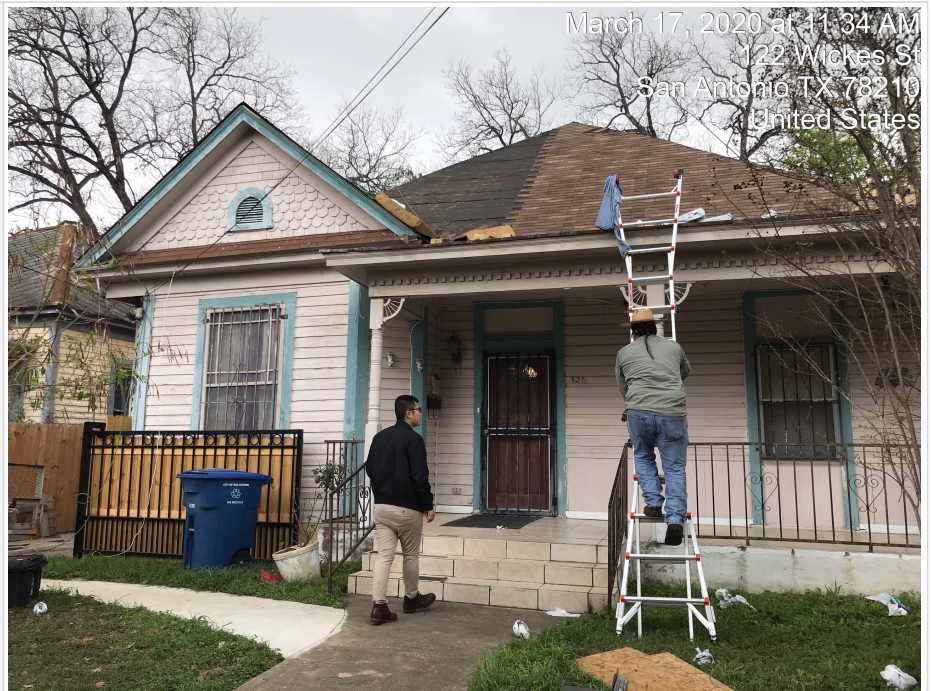
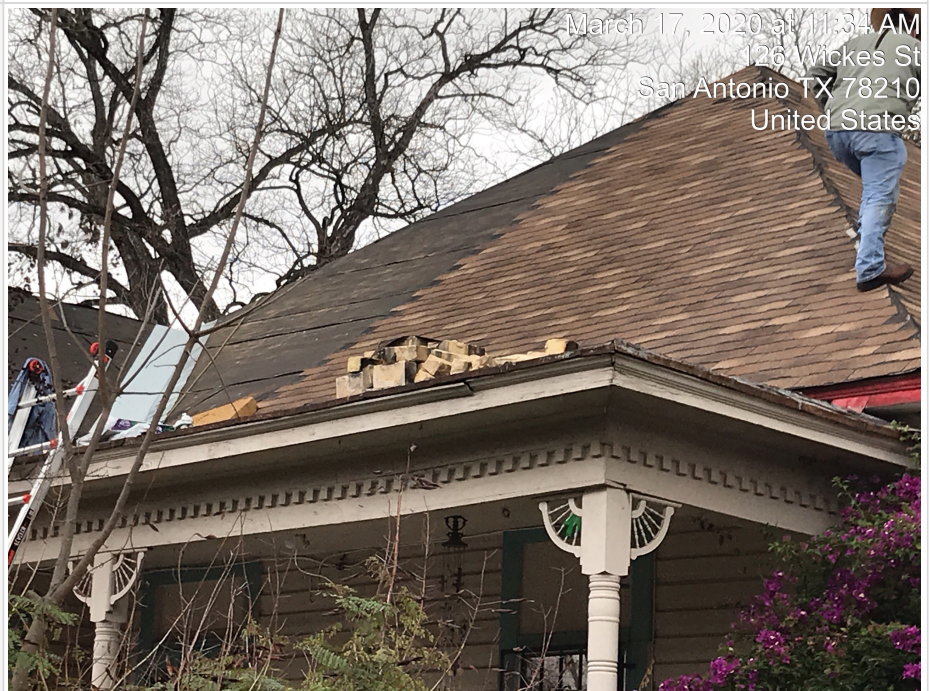
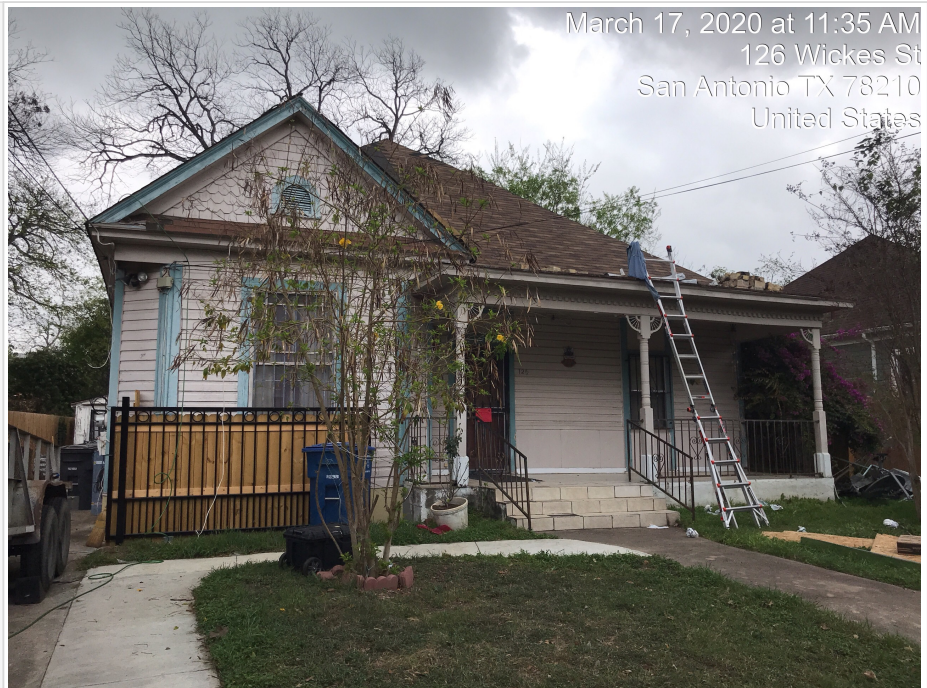
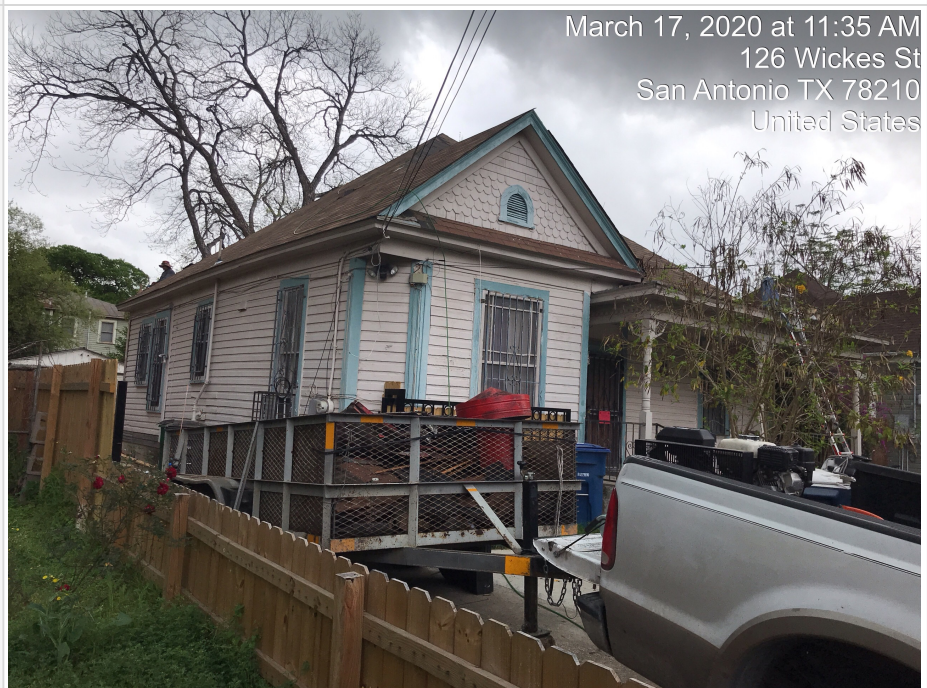
Photographs

Date	03/17/2020
Time	11:35 AM (-5 GMT)
Context	citizen report
Present Staff	Huy Pham, Edward Hall
Present Individuals	Contractor(s)
Types of Work Observed	Exterior Maintenance and Alterations
Amount of Work Completed	75%
Description of work	Reroofing, removal of 2 brick chimneys, roof form modification
Description of interaction	Staff spoke with two subcontractors who said their project manager obtain approvals. Staff advised that a COA or permit had not been issued and all work should stop.

Staff does not recommend approval of item 1 and 2 based on finding b through e. Staff finds that the original roof form should be restored including the flat roof portion, standing seam metal material, and metal cresting. The chimneys should be restored to their original location and design, feature as much original brick material as possible, and that a measured drawing is submitted to staff prior to any further work.
