### ADMINISTRATIVE EXCEPTION/VARIANCE REQUEST APPLICATION

| <b>Project Name:</b> | SA BigHaus Development |
| <b>A/P # /PPR # /Plat #</b> | LAND-PLAT-20-11800047 |

**Reference: SA BigHaus LAND-PLAT-20-11800047 Section UDC 35-F124 - Allowable Development Within the Regulatory Floodplain**

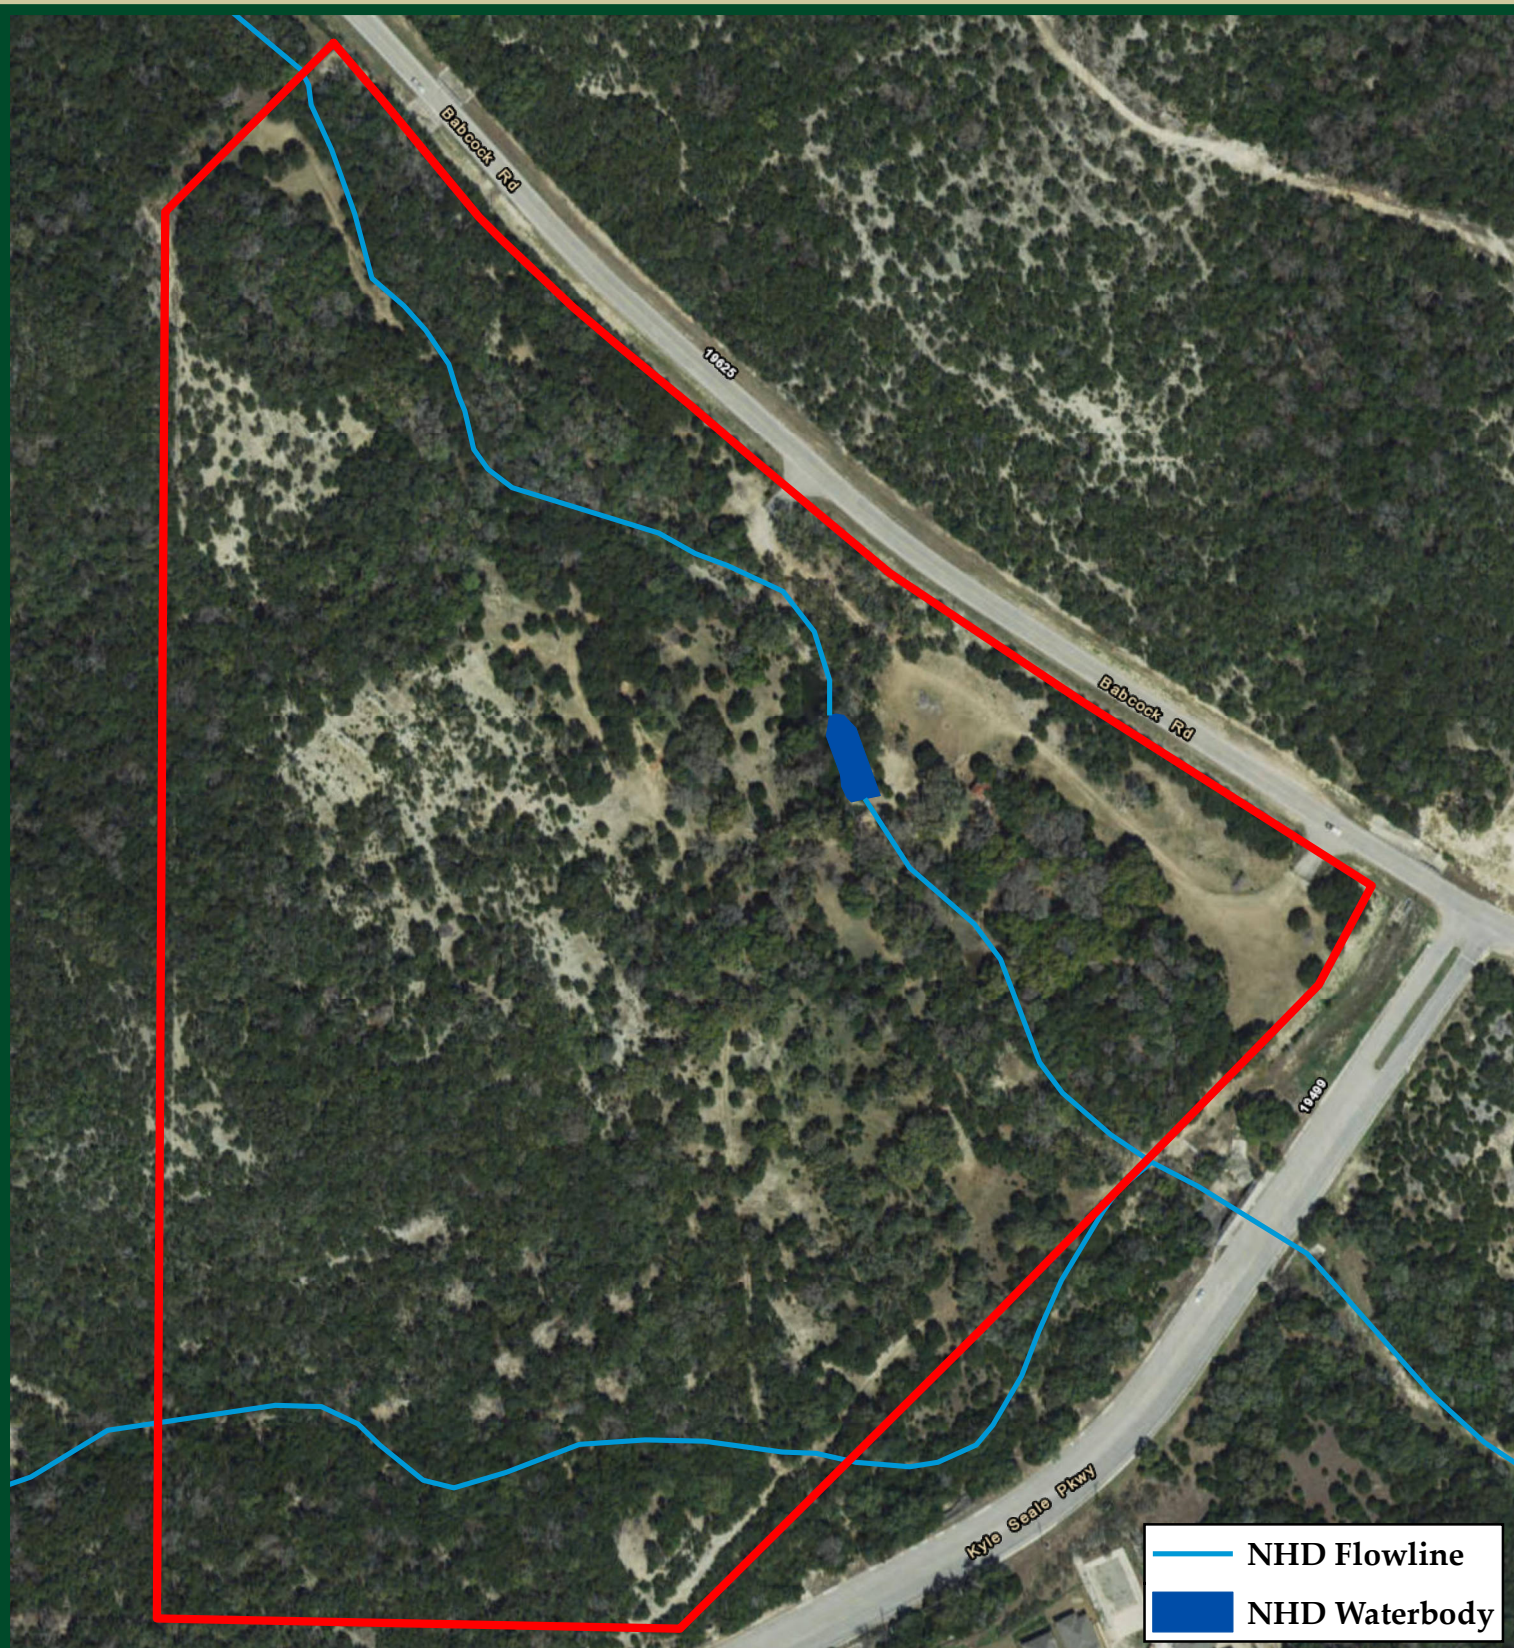
According to the Federal Emergency Management Agency (FEMA) (2018), the subject area intersects the “1% Annual Chance of Flood Hazard” (100-year flood zone) and “Future Conditions 1% Annual Chance Flood Hazard” zones (Figure 8).

| Figure 8: FEMA Flood Hazard Zones ..... | 14 |

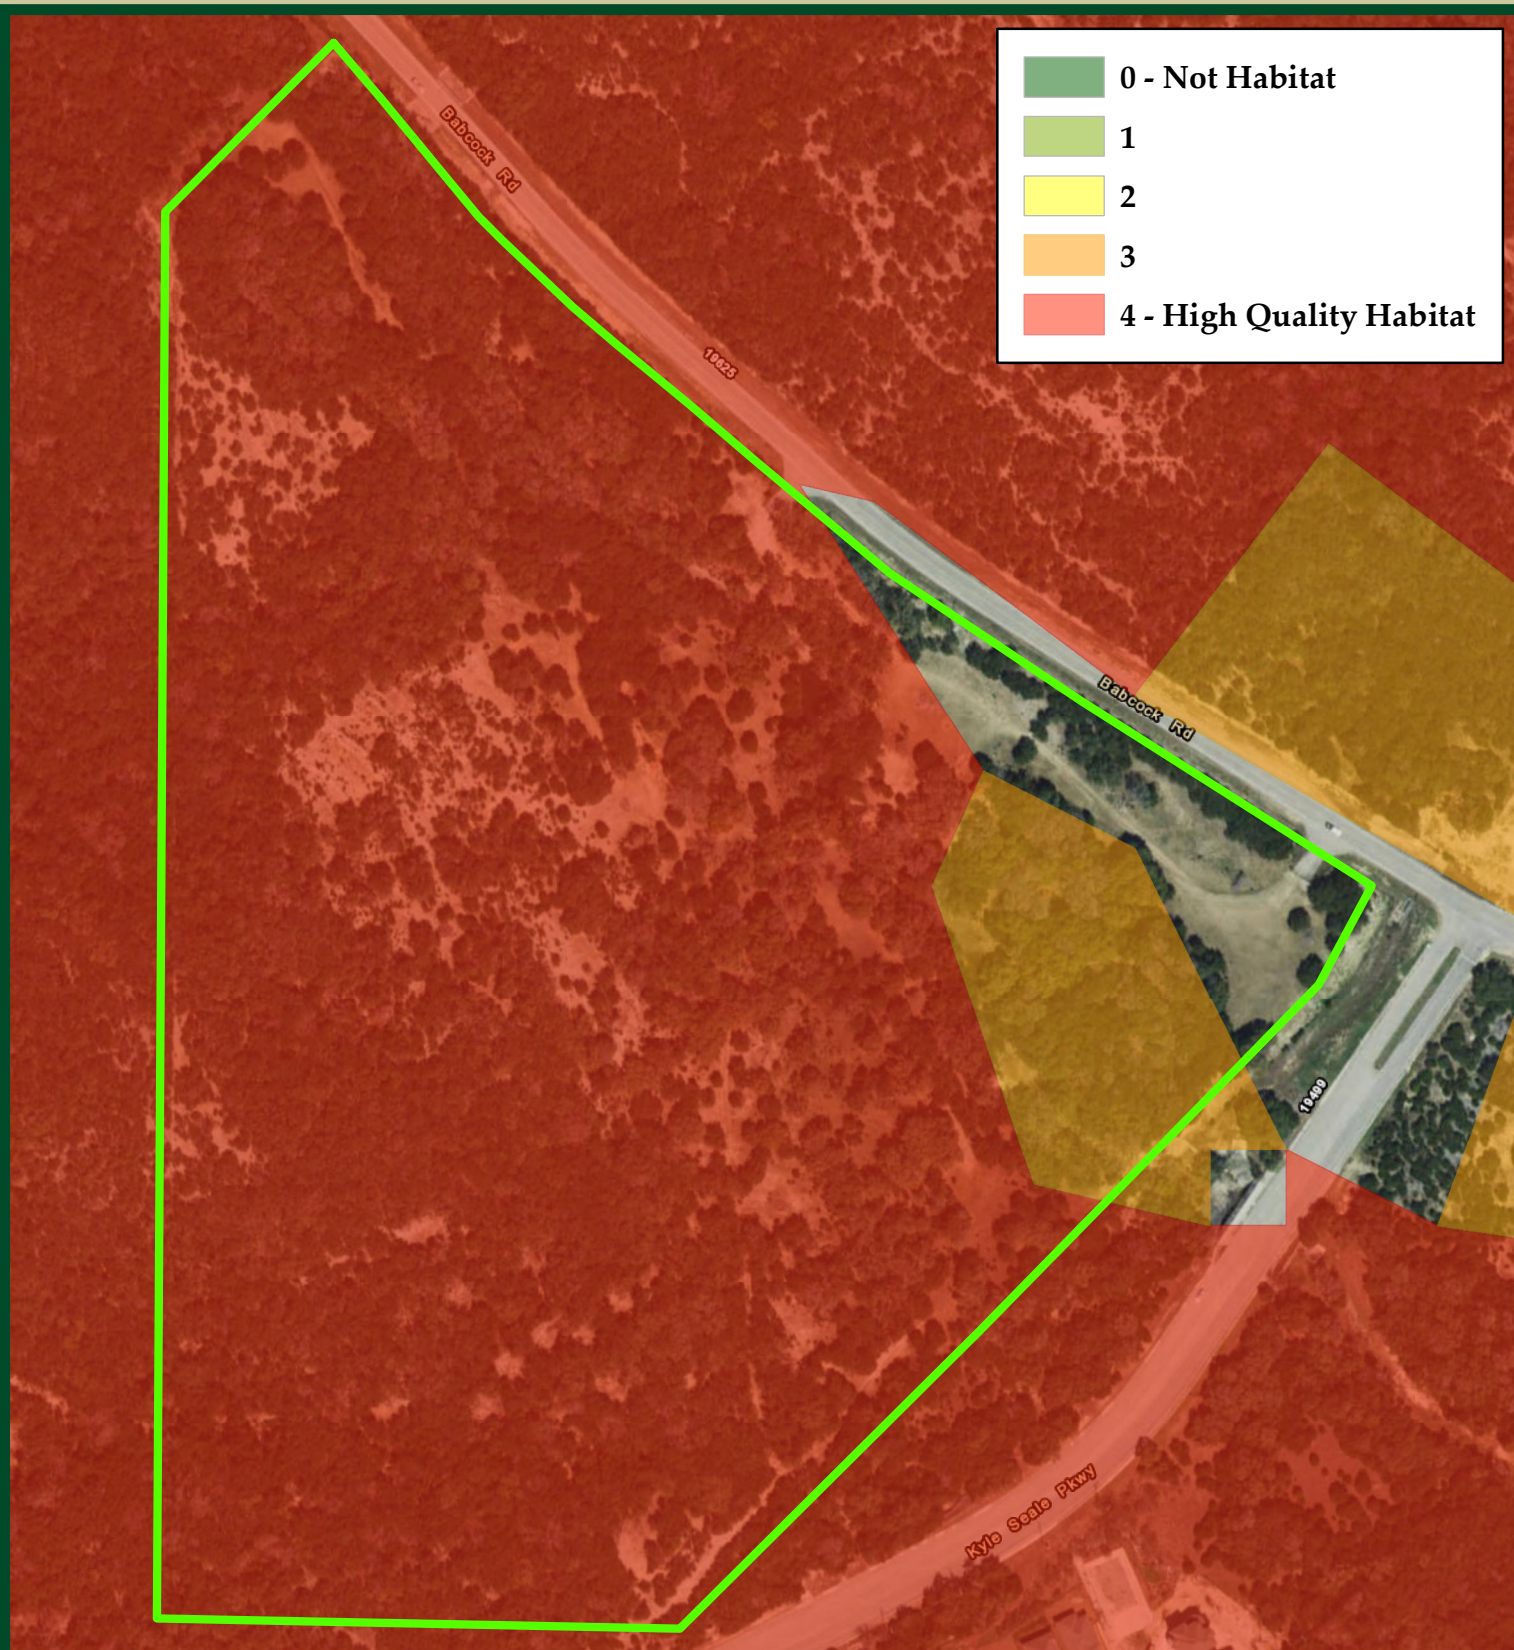
The Loomis Model assumes that any large area of dense to moderately dense woodland is potential habitat. It does not account for species composition, age, canopy height or other potentially relevant variables associated with GCWA habitat (Loomis 2008). The Loomis Model classified habitat into three classes:

- Class 0 - Not Likely Habitat;
- Class 1 - Potential Low Quality GCWA Habitat;
- Class 2 - Potential Medium Quality GCWA Habitat; and
- Class 3 - Potentially High Quality Habitat.
