HISTORIC AND DESIGN REVIEW COMMISSION

HDRC CASE NO: 2020-338
ADDRESS: 333 SADIE ST

TYPE OF WORK: Fenestration modifications to rear accessory structure, front yard fence

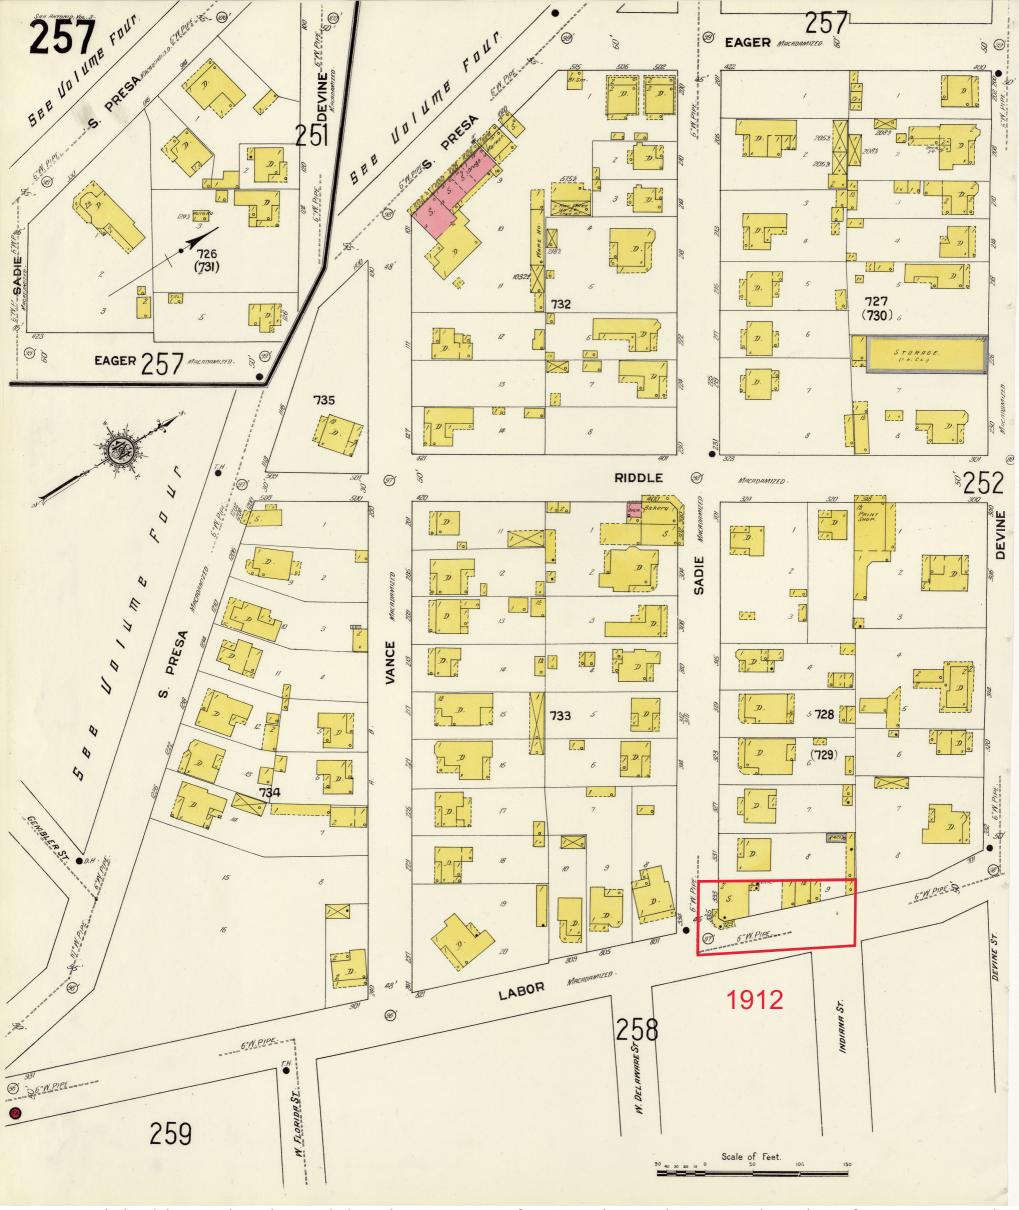
333 Sadie - Sanborn Maps

1931, v.3, p. 257 – separate building for auto repair at rear of main store.

- b. FENESTRATION MODIFICATIONS The applicant has proposed to install two carriage-style garage doors on the street facing elevation. Two wood-framed windows currently exist on this elevation. The existing fenestration pattern on the rear accessory structure is not original. Guideline 6.B.ii for Exterior Maintenance and Alterations states that new entrances are compatible in size, scale, shape, proportion, material, and massing with historic entrances. The structure was previously used as an auto repair shop per the 1931 Sanborn Map and as a dry cleaner per the 1951 Sanborn Map. Staff finds the installation of garage doors appropriate.

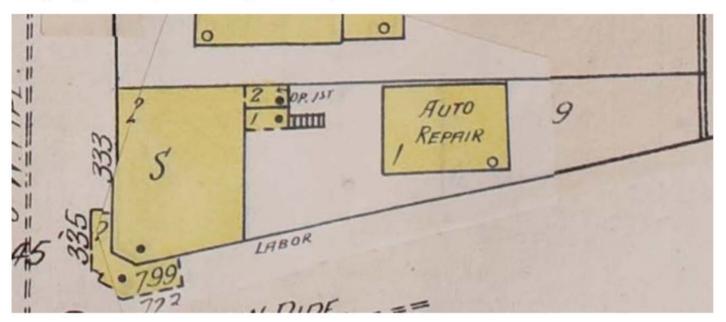
1938, v.3, p. 257 – shows a separate dry cleaners' at the rear of main store. Unclear whether auto repair

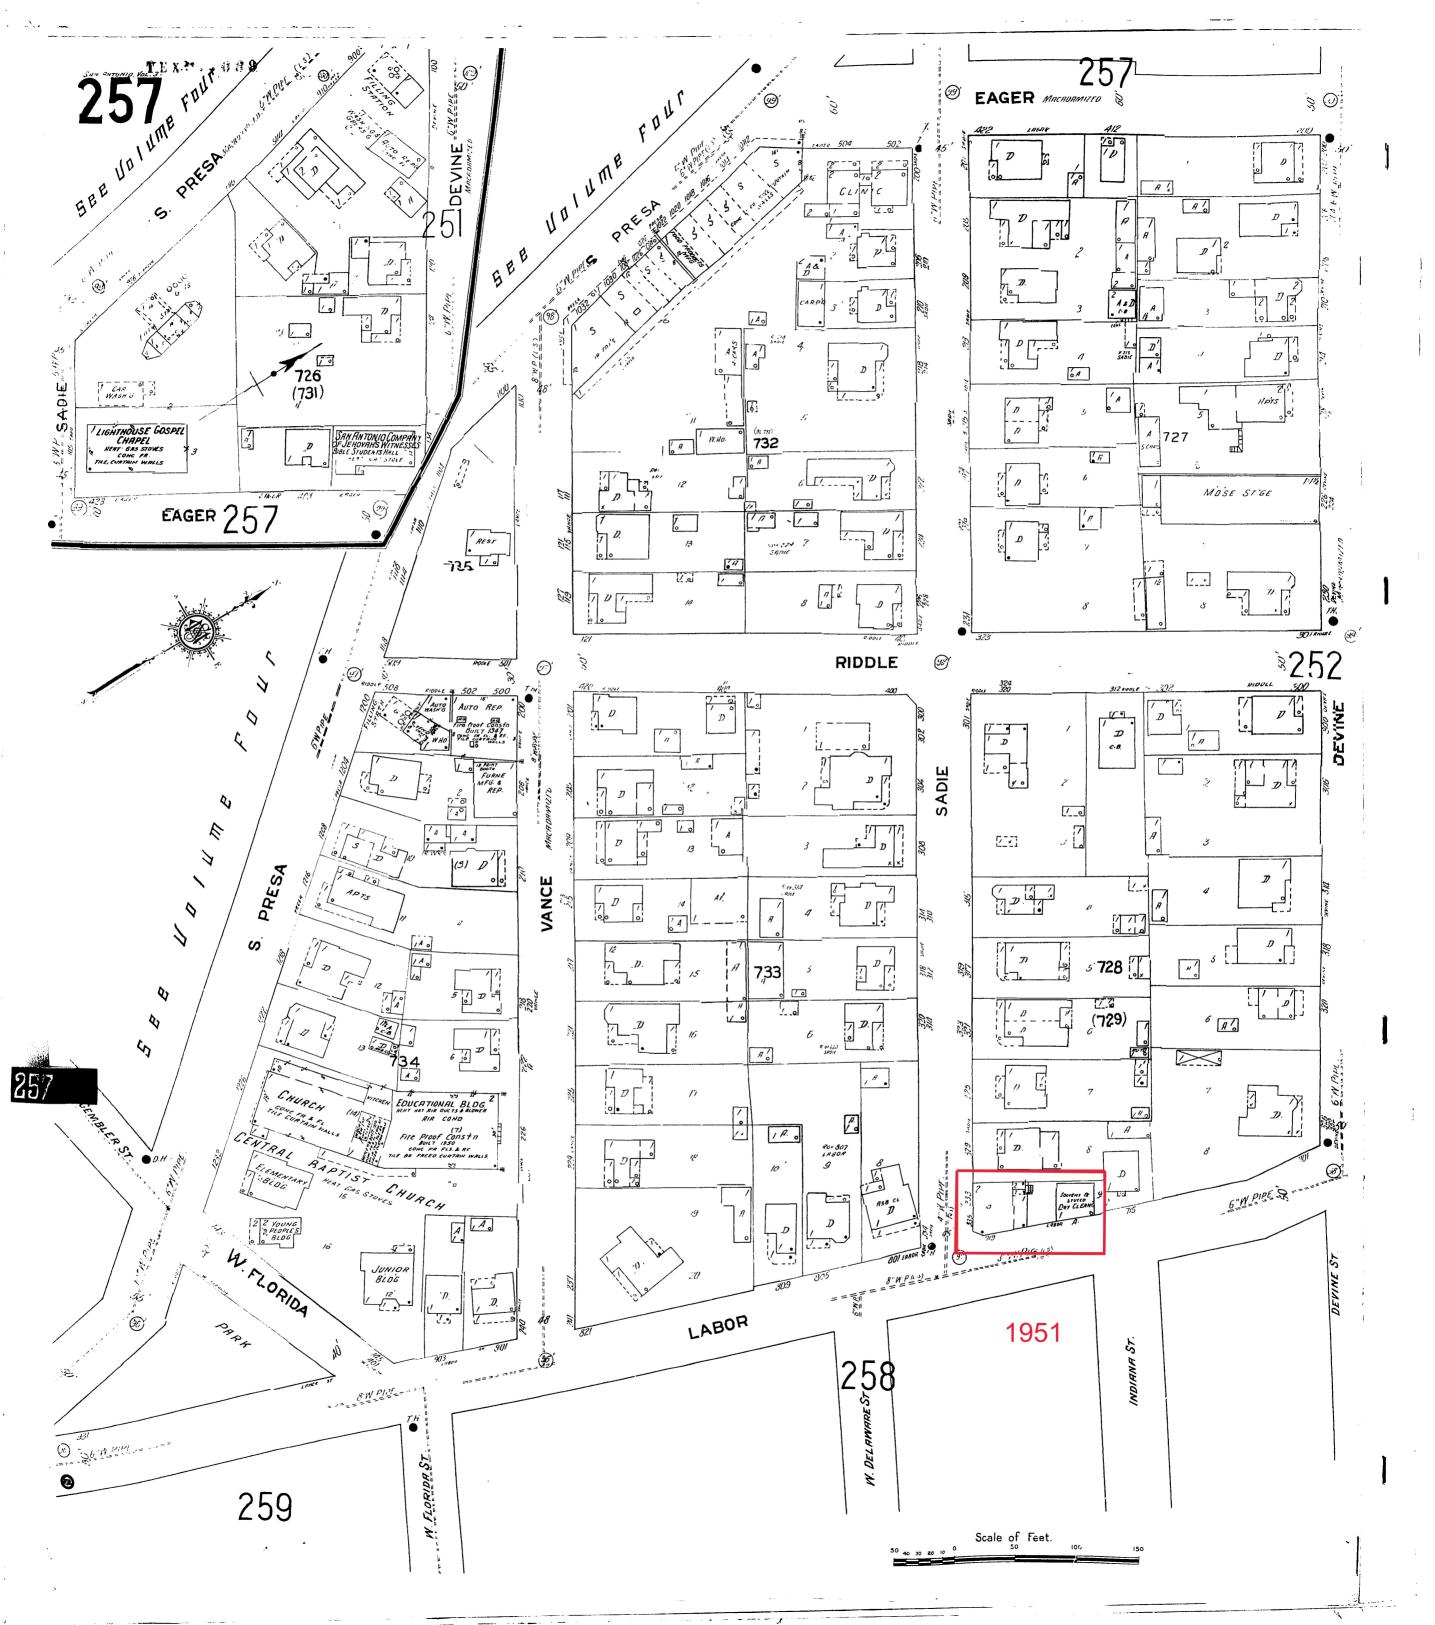
Existing structure - 333 SADIE (facing Labor St)

- a. The primary structure located at 333 Sadie is a 2-story structure constructed circa 1910. The property first appears on the Sanborn Maps in 1912 as a commercial structure. The structure features a flat roof, composition siding, one-over-one windows, and an entryway oriented to the corner of Sadie and Labor Streets. The property features a rear accessory structure that is not original to the property and does not appear on the Sanborn Maps until 1951. The rear accessory structure features a flat roof, stucco cladding, and two wood-framed windows facing Labor street. The property is contributing to the Lavaca Historic District.
