# HISTORIC AND DESIGN REVIEW COMMISSION

September 16, 2020

**HDRC CASE NO:** 2020-400  
**ADDRESS:** 422 E GUENTHER ST  
**LEGAL DESCRIPTION:** NCB 937 BLK 2 LOT 10  
**ZONING:** RM-4,H  
**CITY COUNCIL DIST.:** 1  
**DISTRICT:** King William Historic District  
**APPLICANT:** Kurt Lehr/Lehrco  
**OWNER:** STEWART PATTI S  
**TYPE OF WORK:** Exterior alterations  
**APPLICATION RECEIVED:** August 26, 2020  
**60-DAY REVIEW:** Not applicable due to City Council Emergency Orders  
**CASE MANAGER:** Stephanie Phillips

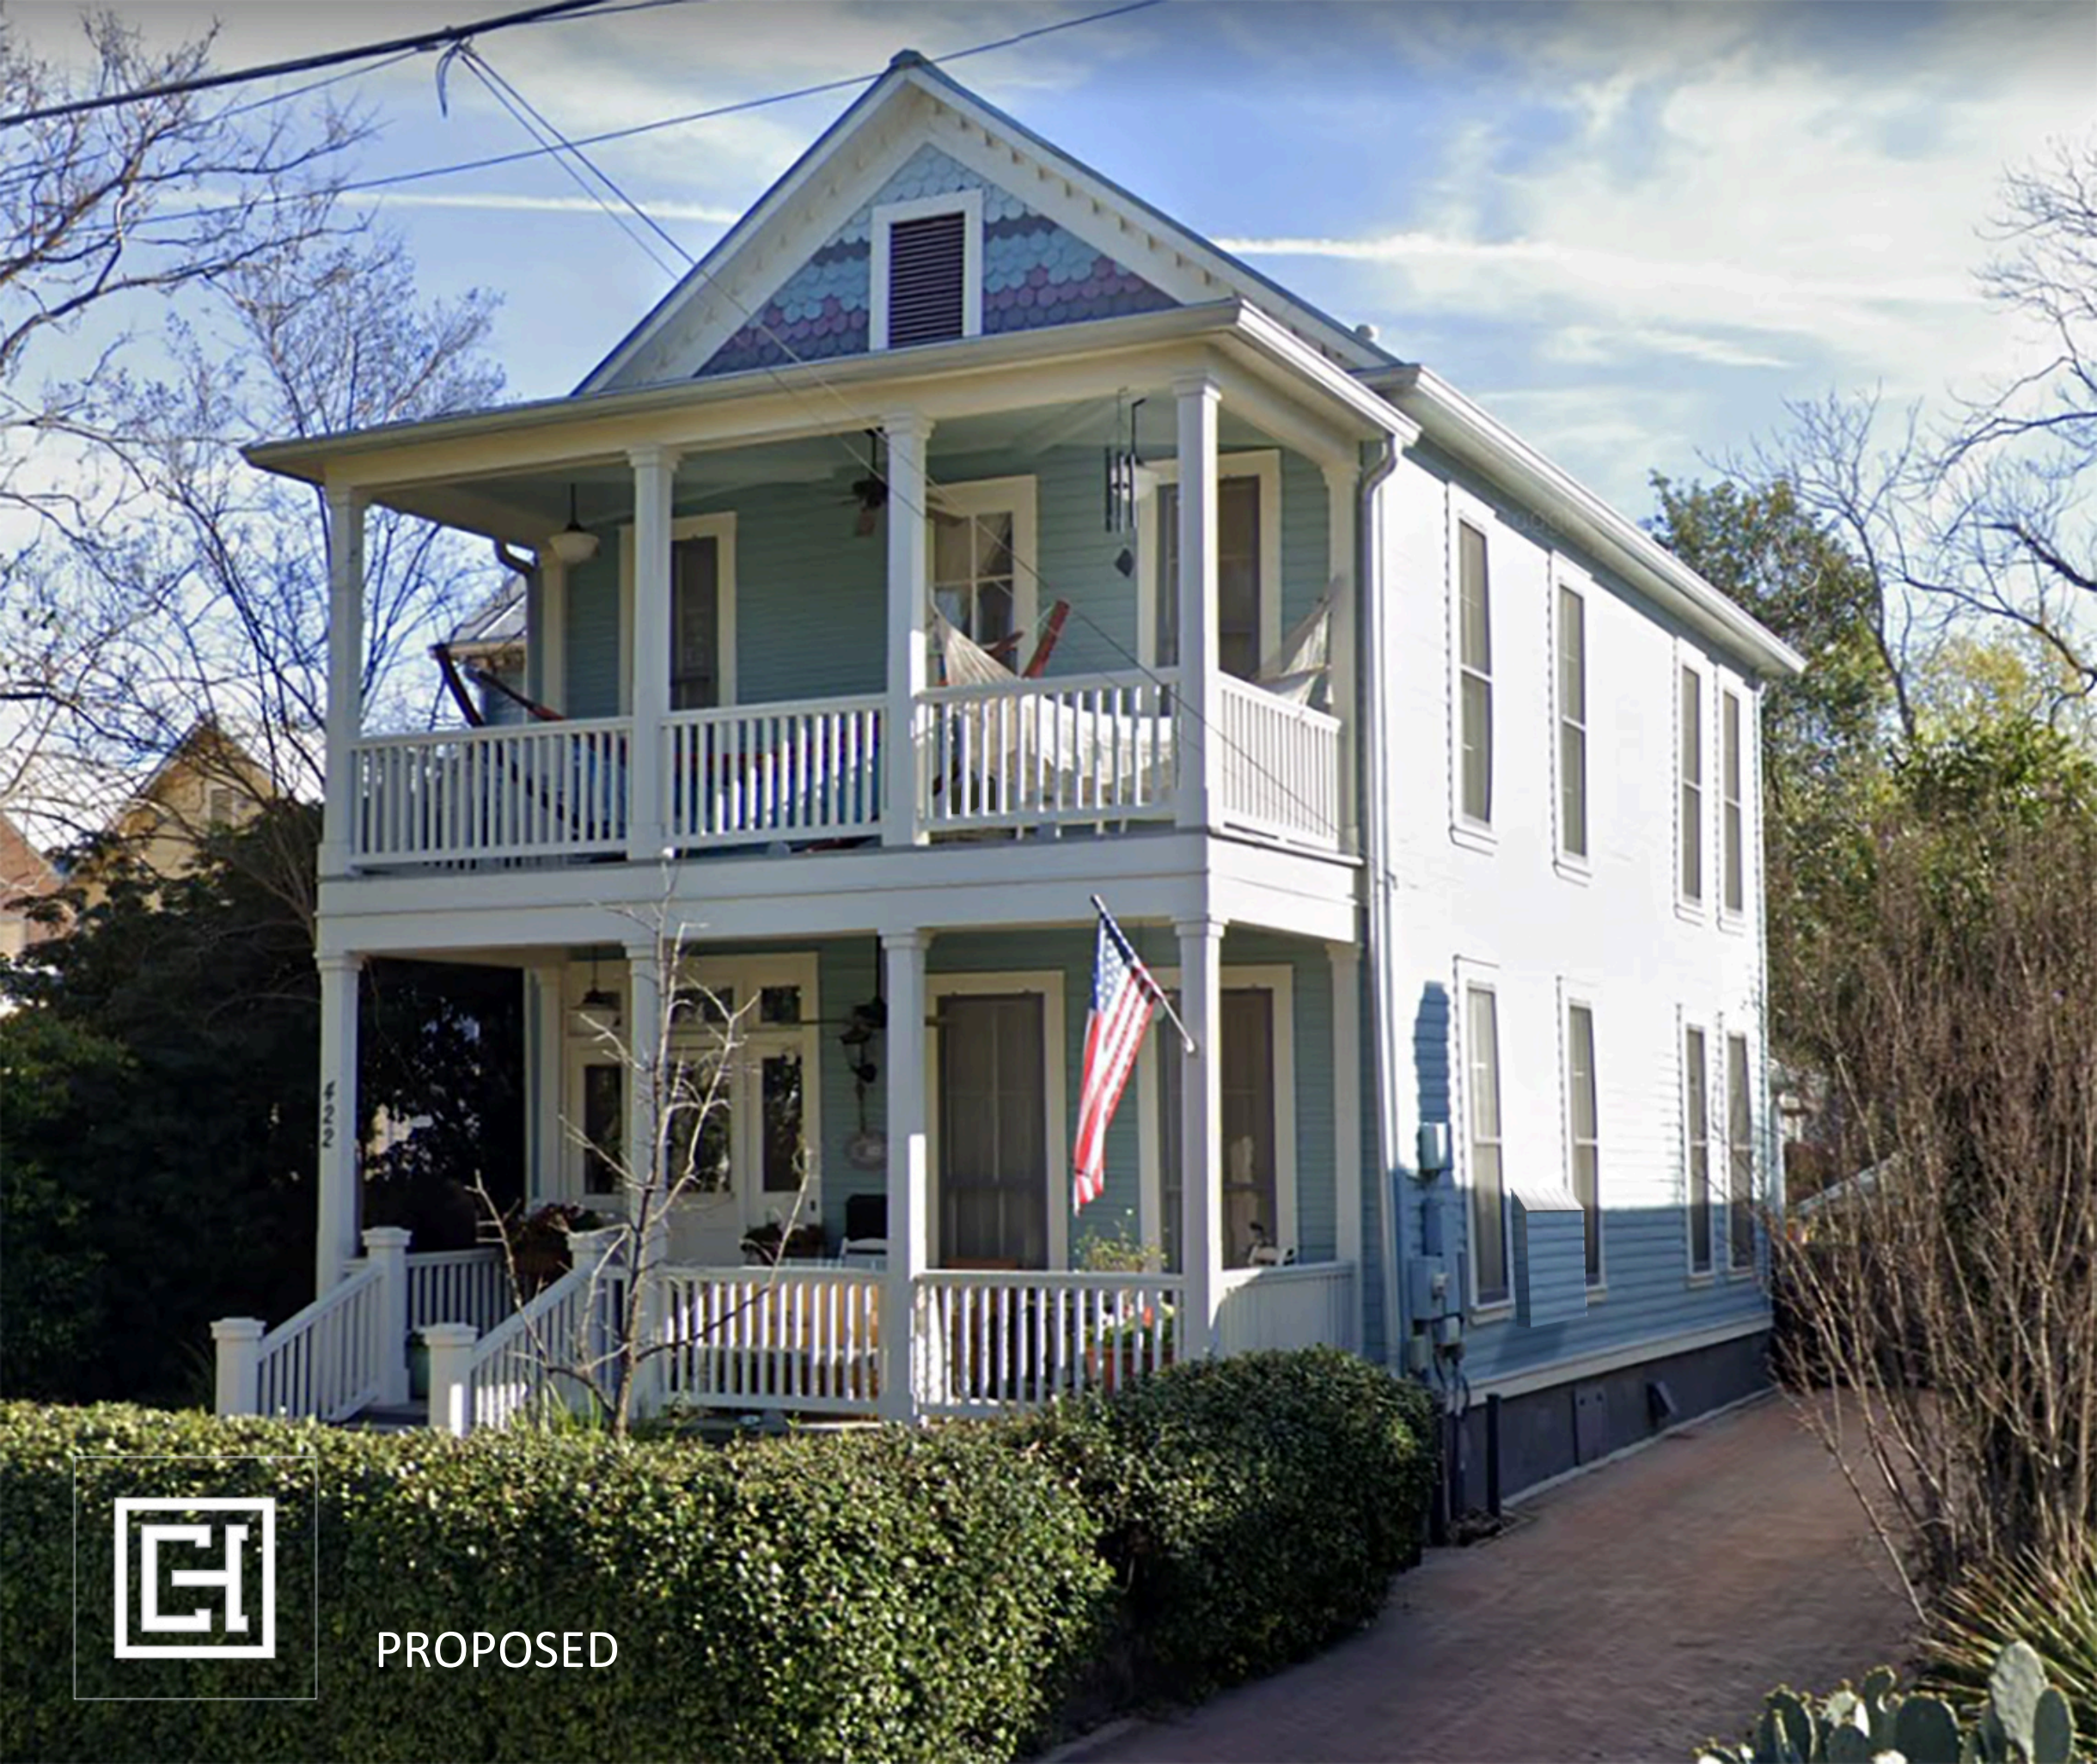
PROPOSED

1. Install a gas fireplace on the side of the structure, to include a small bump-out measuring approximately 30" wide, 38" tall, with a projection (depth) of about 10-12". The bump-out will be clad in siding to match the existing and will be covered with a small metal roof.
2. Add an exterior balcony door.
3. Replace the existing front door.

- b. GAS FIREPLACE – The applicant has proposed to install a gas fireplace on the southeastern corner of the home, adjacent to the driveway. The fireplace will require the construction of a bump-out along this façade, measuring approximately 30" wide, 38" tall, with a projection (depth) of about 10-12". The bump-out will be clad in siding to match the existing and will be covered with a small metal roof. The fireplace will be located near the corner of the front and side facades, near existing equipment, and will be partially visible from the public right-of-way. Based on the minimal size and compatible cladding proposed, staff finds the request acceptable.

Item 1, Staff recommends approval of the exterior gas fireplace enclosure based on finding b with the stipulation that the siding match the existing on the historic structure in dimension, profile, and finish.

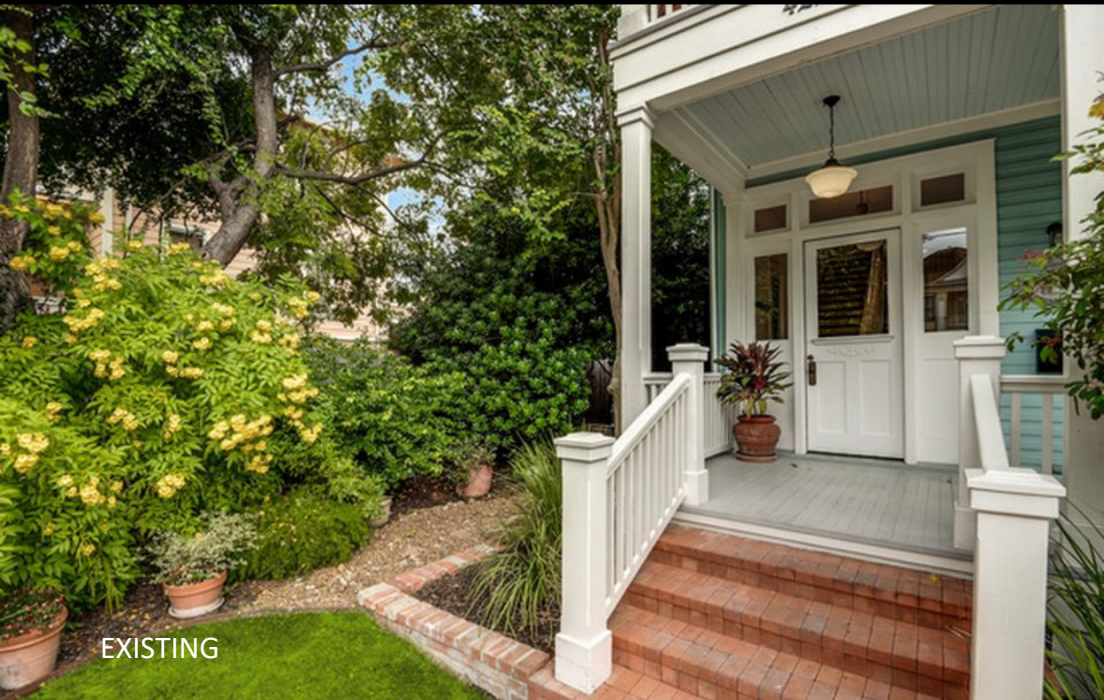
EXISTING

- d. FRONT DOOR MODIFICATIONS – The applicant has proposed to modify the existing front door, to include changing the swing, hardware, and altering the design. The existing door features a half-lite configuration,

which matches the adjacent side lites. While the door does not appear to be original, the door is stylistically compatible with the historic structure. While staff finds the swing and hardware change acceptable, staff finds that the existing Neoclassical detailing should remain, in lieu of the new Craftsman-style detailing, which is inconsistent with the style of the home.

Item 3, Staff recommends approval of the front door modifications based on finding d with the stipulation that the existing Neoclassical-style detailing remain, or that the applicant proposes alternative design modifications that are Neoclassical in style.
