HISTORIC AND DESIGN REVIEW COMMISSION

November 04, 2020

HDRC CASE NO: 2020-481
ADDRESS: 135 W ROSEWOOD AVE
LEGAL DESCRIPTION: NCB 6534 BLK 14 LOT 1&2
ZONING: R-5,H
CITY COUNCIL DIST.: 1
DISTRICT: Monte Vista Historic District
APPLICANT: Kristy Kosub
OWNER: Kristy Kosub
TYPE OF WORK: Front walkway replacement
APPLICATION RECEIVED: October 01, 2020
60-DAY REVIEW: Not applicable due to City Council Emergency Orders
CASE MANAGER: Stephanie Phillips

The applicant is requesting a Certificate of Appropriateness to replace the existing front concrete walkway with a new gray brick walkway. The walkway width is requested to be retained at five feet.

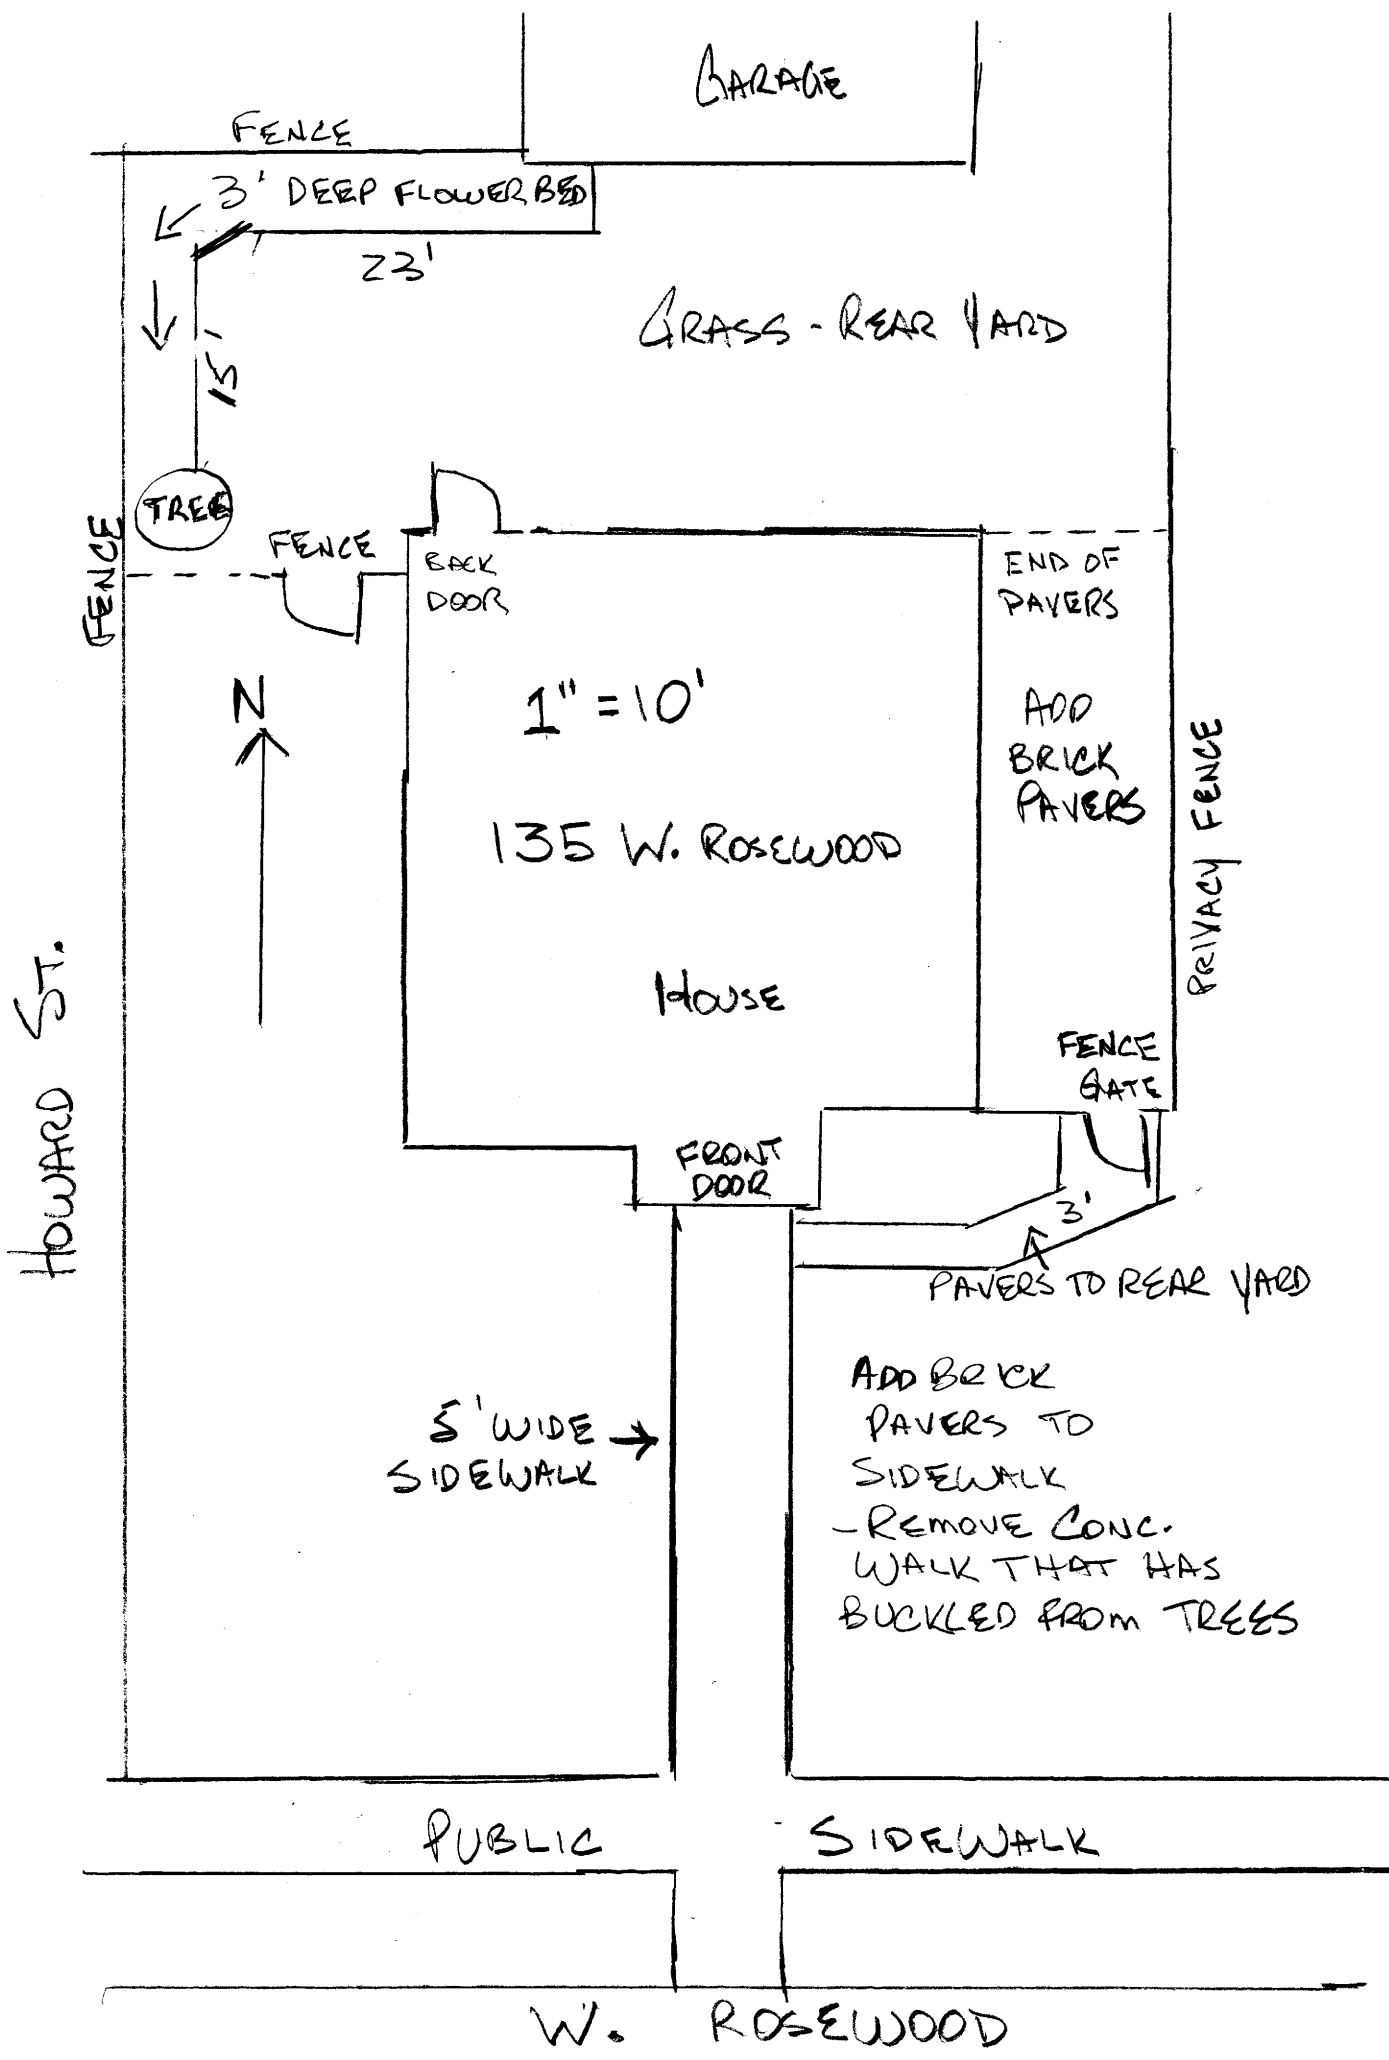
135 W. ROSEWOOD

END OF PAVERS

ADD BRICK PAVERS

PAVERS TO REAR YARD

5' WIDE SIDEWALK

ADD BRICK PAVERS TO SIDEWALK
- REMOVE CONC. WALK THAT HAS BUCKLED FROM TREES

- b. **WALKWAY** – The applicant is proposing to remove the existing continuous concrete walkway leading from the street to the porch with a walkway constructed of individual gray bricks. Per the applicant, the existing walkway is sinking and in need of replacement. According to the Historic Design Guidelines, walkways should be replaced in-kind and follow the historic alignment, configuration, and width of those historically found in the district. The historic width, alignment, or design should only be altered where absolutely necessary to accommodate the preservation of a significant tree. Staff does not find the proposal consistent with the Guidelines.

- c. **ADMINISTRATIVE APPROVAL** - The submitted request also includes adding a 3 foot wide secondary walkway of gray bricks from the existing walkway to the side fence line, near the front facade of the house, as well as bricks in a portion of the rear yard behind the privacy fence. Based on the width and location, staff finds this portion of the request eligible for administrative approval.
