HISTORIC AND DESIGN REVIEW COMMISSION
November 4, 2020

HDRC CASE NO: 2020-469
ADDRESS: 118 LOTUS ST
LEGAL DESCRIPTION: NCB 3097 BLK 2 LOT 7
ZONING: RM-4, NCD-1
CITY COUNCIL DIST.: 1
APPLICANT: Cherise Rohr-Allegrini, Lavaca Neighborhood Association
OWNER: Alamo City Housebuyer Inc
TYPE OF WORK: Request for review of historic significance
180-DAY REVIEW: Not applicable due to City Council Emergency Orders
CASE MANAGER: Jessica Anderson

A request for review by the HDRC regarding eligibility of the property located at 118 Lotus for landmark designation.

Statement of Significance

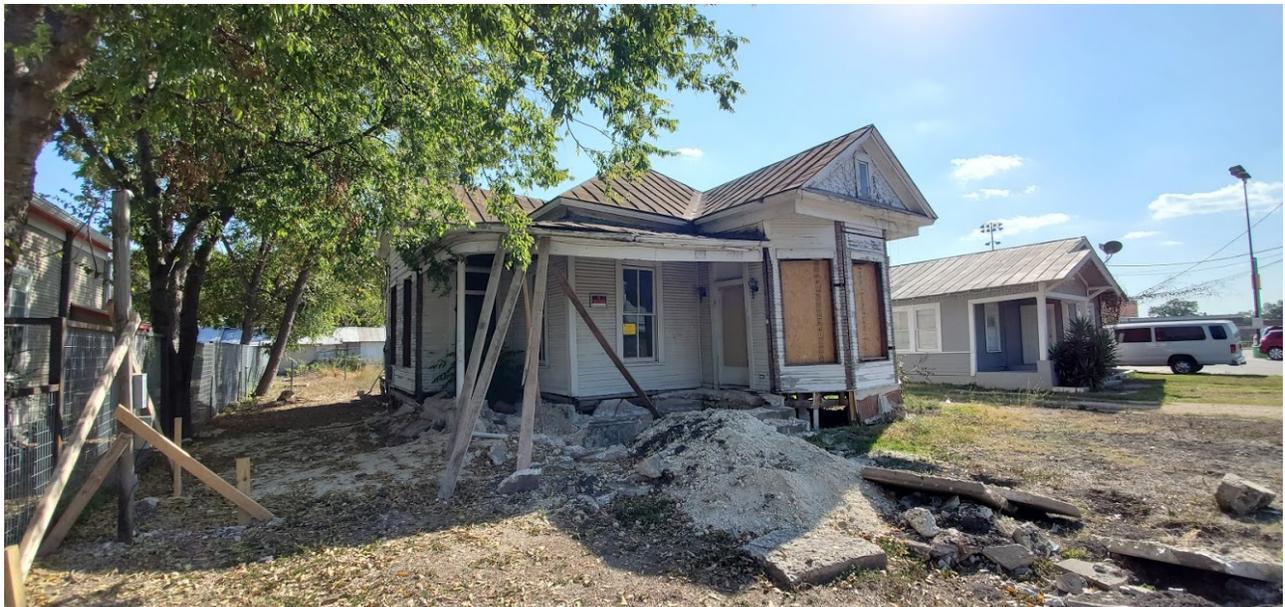
Northeast oblique

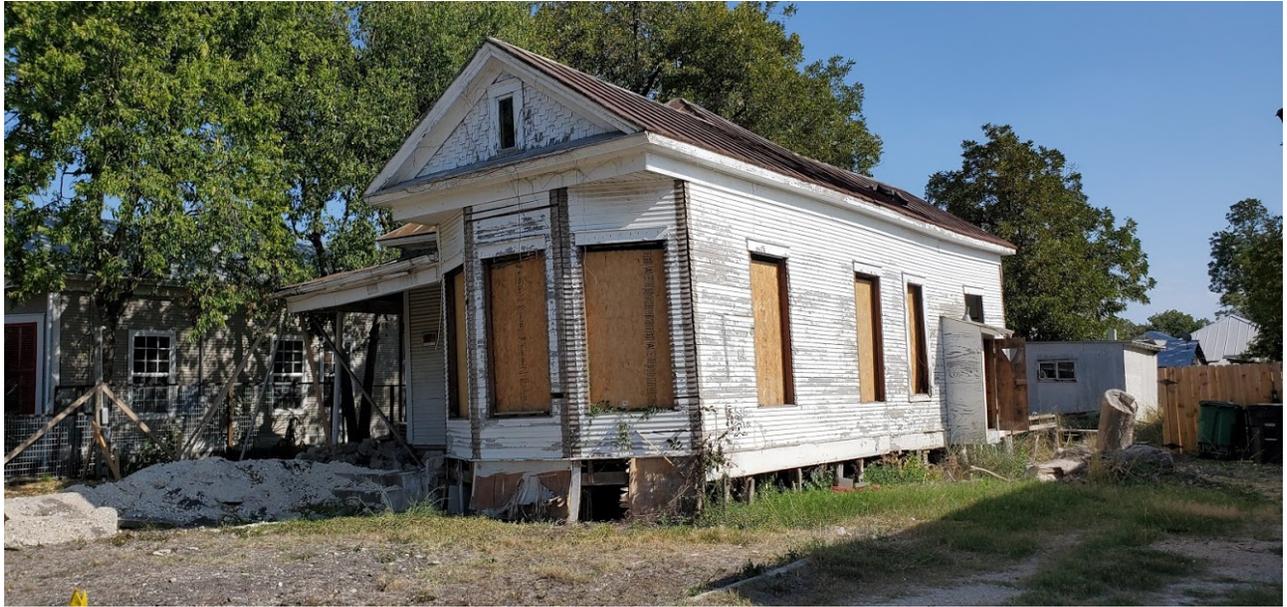
Northwest oblique

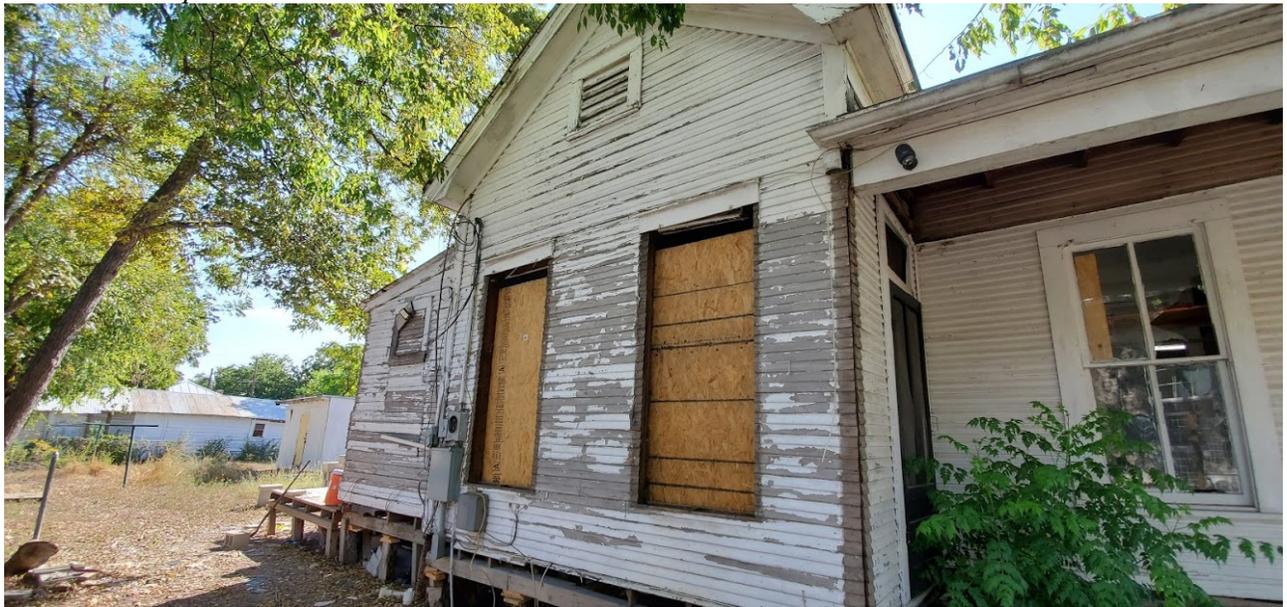
East elevation

The property has a gravel ribbon driveway that runs along the east side of the house and has a full concrete apron. The divorced sidewalk is only a couple feet from the right-of-way and has a grass easement; a concrete path leads from the sidewalk to the front porch of the home, but has been largely demolished, as has the concrete porch that wrapped around the northeast corner of the house.

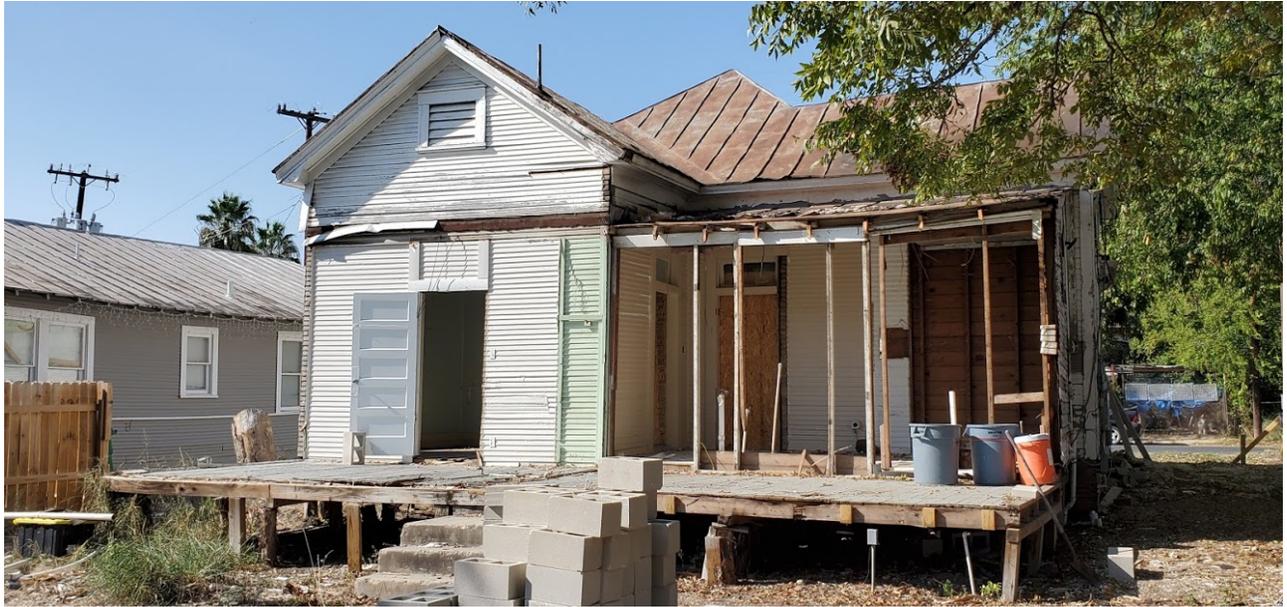
Rear/south elevation

There is a full-length wood porch on the south side of the house; the south gable is open with a vent at center. The southeast corner of the house is open, though the studs and flat roof remain. Both clapboard siding and wood shiplap appear on the exterior wall under the flat roof. There is a detached rear flat-roofed structure with exposed rafter tails, clad in plywood.

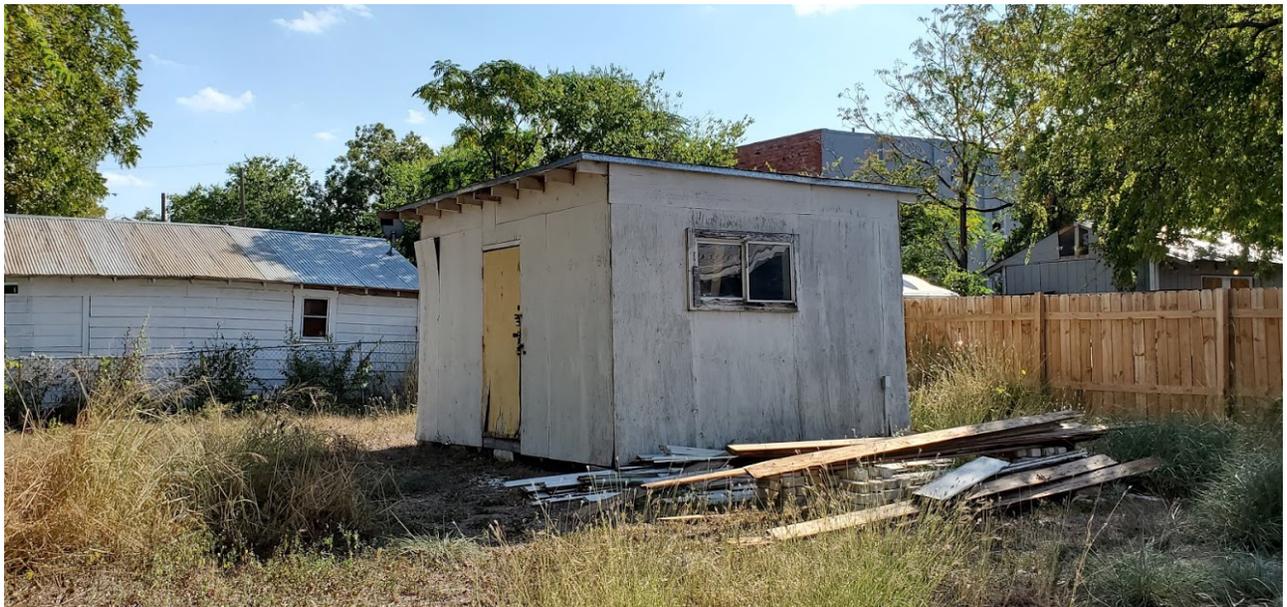
Detached shed

The rear addition to the property appears between 1966 and 1973 on historic aerials; staff was unable to determine the approximate build date of the detached structure in the backyard due to tree coverage in historic aerials. It is in a different location than detached structure included on Sanborns from 1912-1952, indicating it is not original to the 1910 primary structure.

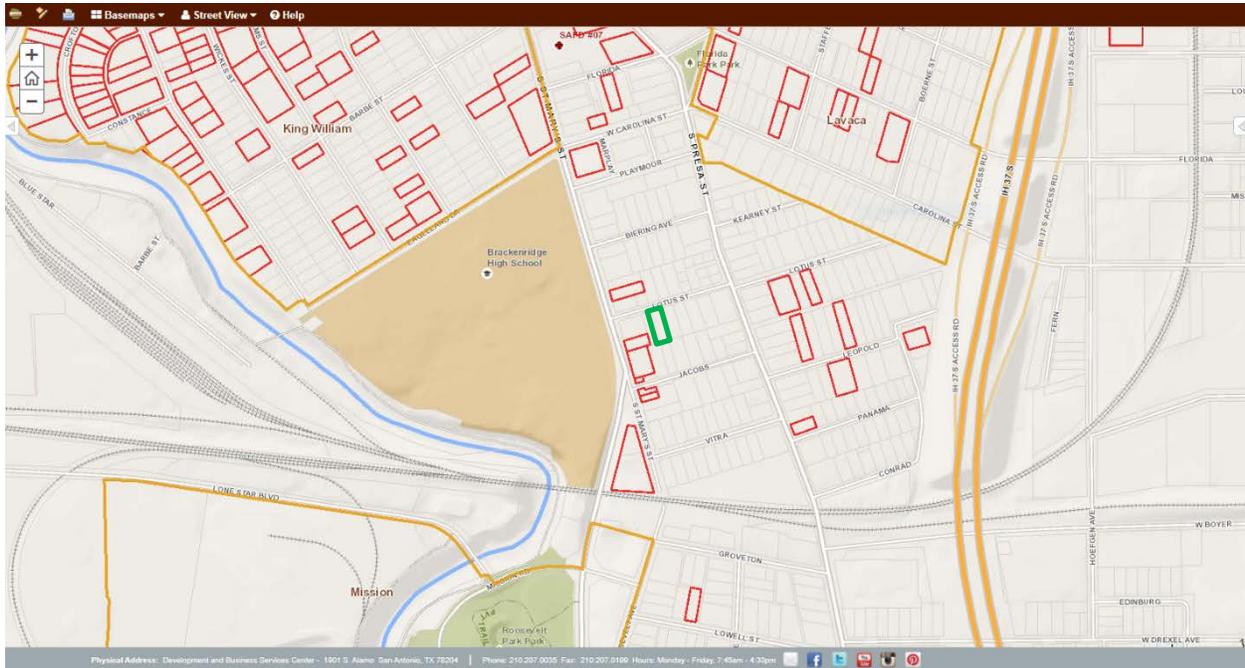
118 Lotus is outlined in green near the center of image. The red boxes indicate individual local landmarks. The orange border above and to the right of 118 Lotus is the Lavaca Historic District; above to the left is the King William Historic District; below to the left is the Mission Historic District.

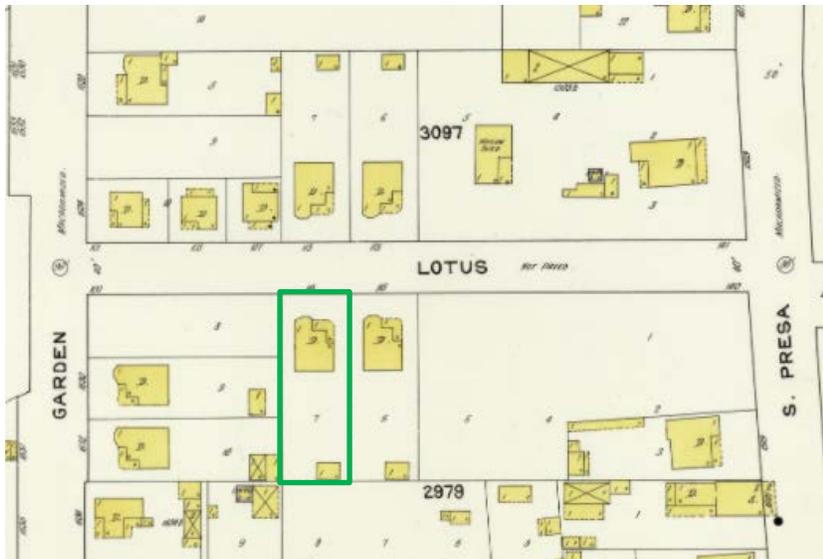
Sanborn Fire Insurance Map, 1912, vol. 4, sheet 364. 118 Lotus in green.

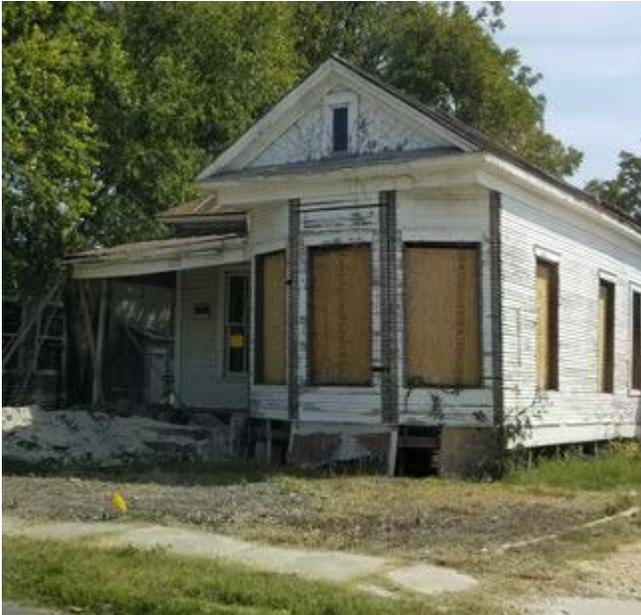
Primary elevation

The standing-seam metal roof is pyramidal in form with intersecting gables and a flat roof over the front and rear porches. The house is clad in wood clapboard with wood trim and decorative shingles in a closed gable that projects from the northwest side of the main elevation. The main entrance with transom is located on the east side of the bay mass, tucked below a porch roof that curves around the northeast corner of the house. The porch roof is supported by one round column and pieces of lumber wedged against the fascia at the curved corner. There is a second door with wood-frame screen door and transom on the southeast end of the porch. The projecting gable is over a bay with windows removed and boarded with plywood. Single two-over-two wood windows are found on the north and east elevations; all other windows are removed and boarded with plywood. A cedar pier-and-beam foundation is visible where the skirt has been removed. There is a water-heater closet on the west elevation.
