# HISTORIC AND DESIGN REVIEW COMMISSION

**HDRC CASE NO:** 2020-505  
**ADDRESS:** 120 CALLAGHAN AVE  
**LEGAL DESCRIPTION:** NCB 719 BLK 1 LOT N 1-2 OF 5  
**ZONING:** RM-4,H  
**CITY COUNCIL DIST.:** 1  
**DISTRICT:** Lavaca Historic District  
**APPLICANT:** Jim Ferrell/FT Builder Sevices  
**OWNER:** MENDIOLA MARIO J  
**TYPE OF WORK:** Window replacement  
**APPLICATION RECEIVED:** October 29, 2020  
**60-DAY REVIEW:** Not applicable due to City Council Emergency Orders  
**CASE MANAGER:** Stephanie Phillips

The applicant is requesting a Certificate of Appropriateness for approval to replace all of the original wood windows on the primary structure with new Jeld Wen wood windows.

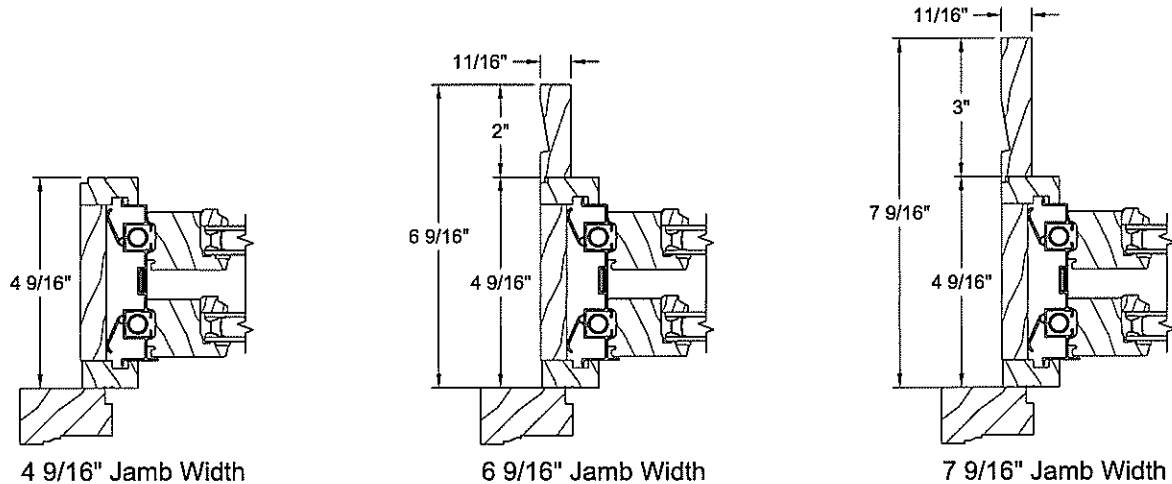
## JAMB EXTENDER & PREP FOR STOOL OPTIONS

### Return Kerf:

Generally located from first visible interior frame line. Kerfed option available on all jamb extender sizes.

4/4 Jamb Typ.

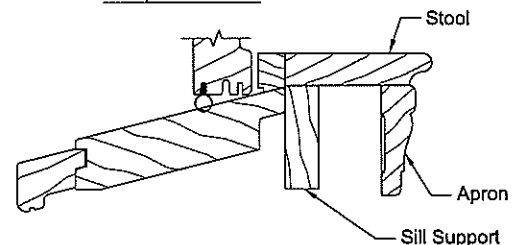
### Prep for Stool

Note: Stool, apron, and sill support are applied by trim carpenter after window is installed and are not provided by JELD-WEN. Unit is shipped without sill jamb extenders.

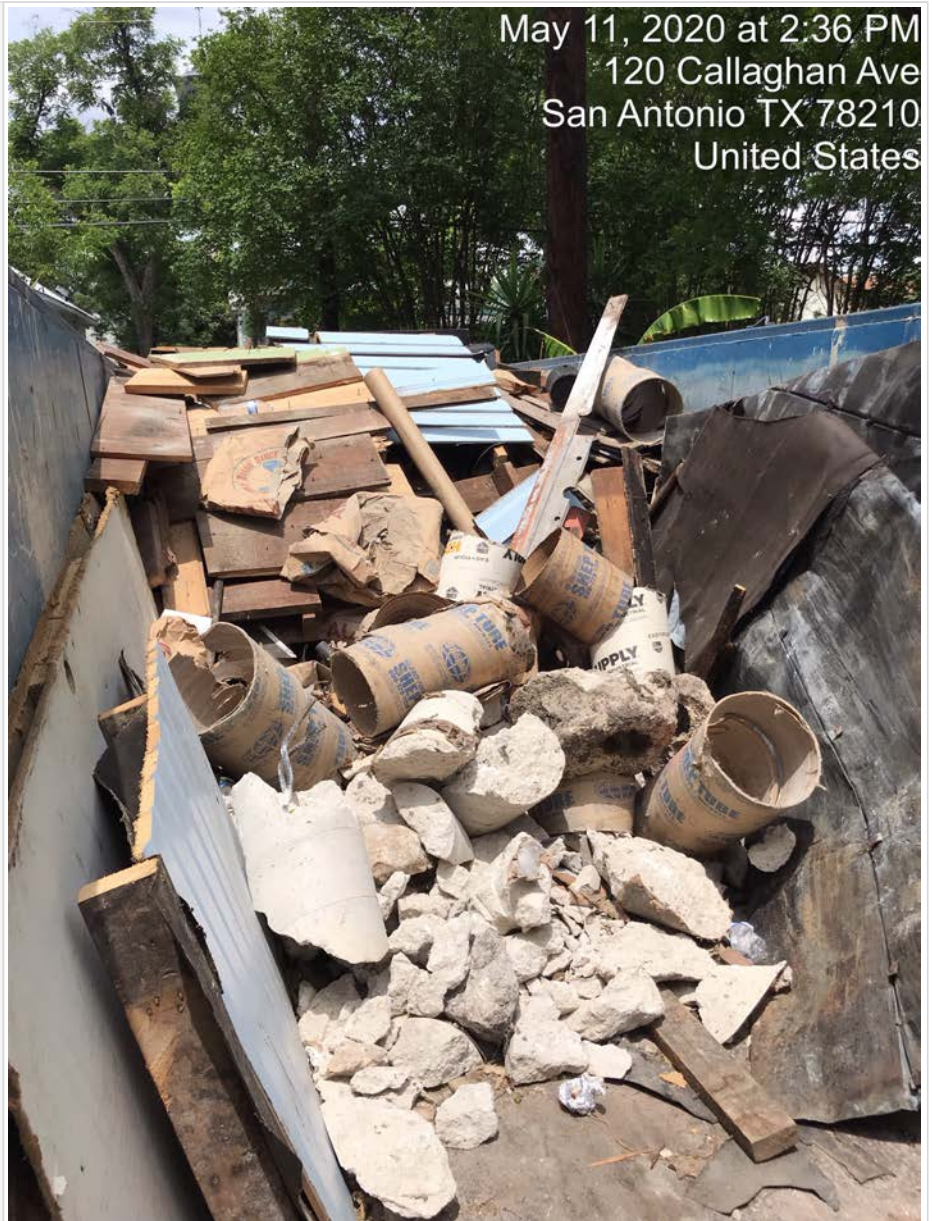
Date	05/11/2020
Time	02:43 PM (-5 GMT)
Context	citizen report
Present Staff	Huy Pham, Edward Hall
Present Individuals	Other
Types of Work Observed	Exterior Maintenance and Alterations, Demolition
Amount of Work Completed	75%
Description of work	Demolition of historic facades and materials beyond the scope of approval for construction of a rear addition
