CITY OF SAN ANTONIO
**OFFICE OF HISTORIC
PRESERVATION**

BOA-20-10300109

4007 S Flores St – Individual Landmark

Request: An appeal of the Historic Preservation Officer's denial of the demolition of the historic landmark at 4007 S Flores St and the conceptual approval of a new car wash.

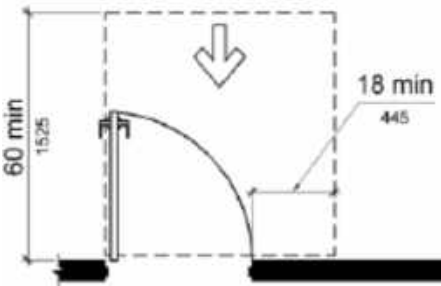
| <p>404 Doors, Doorways, and Gates</p> | <p>1. The clearance in front of the main entry doors does currently comply. However, the ramp in front of the main entry doors will need to be removed and replaced (reference comments in section 405). The door clearance in front of the main entry doors (for at least one door) shall comply with Figure (c) below once any modifications are completed.</p> <p>(a) front approach, pull side</p> |

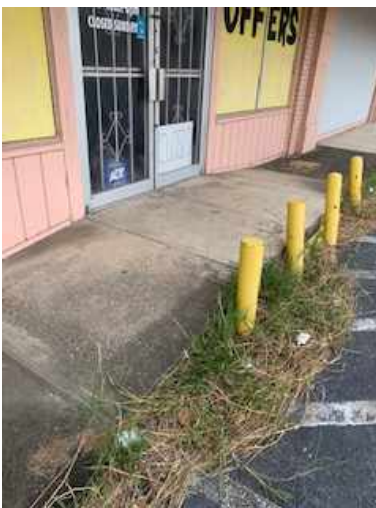
| <p>405 Ramps</p> | <p>1. The exterior ramps on both sides of the main entry door have the deficiencies listed below.</p> <ul style="list-style-type: none"> - Both ramps have a slope of 11% - 12%, which does not comply. The slope shall be 8.3% maximum. If the slope is 5% or less, the ramps will not require handrails on both sides. - The ramps do not have handrails. If the new ramps have a slope greater than 5%, they will require handrails complying with section 505 on both sides. <p>2. When the existing ramps are removed and replaced, they shall fully comply with the requirements of section 405 below.</p> <p>405.1 General. Ramps on accessible routes shall comply with 405.</p> <p>405.2 Slope. Ramp runs shall have a running slope not steeper than 1:12.</p> <p>EXCEPTION: In existing sites, buildings, and facilities, ramps shall be permitted to have running slopes steeper than 1:12 where such slopes are necessary due to space limitations.</p> <p>Slope vs. Maximum Rise</p> <p>Steeper than 1:10 but not steeper than 1:8 - 3 inches (75 mm) Steeper than 1:12 but not steeper than 1:10 - 6 inches (150 mm)</p> <p>1. A slope steeper than 1:8 is prohibited.</p> <p>405.3 Cross Slope. Cross slope of ramp runs shall not be steeper than 1:48.</p> <p>405.4 Floor or Ground Surfaces. Floor or ground surfaces of ramp runs shall comply with 302. Changes in level other than the running slope and cross slope are not permitted on ramp runs.</p> <p>405.5 Clear Width. The clear width of a ramp run and, where handrails are provided, the clear width between handrails shall be 36 inches (915 mm) minimum.</p> <p>405.6 Rise. The rise for any ramp run shall be 30 inches (760 mm) maximum.</p> <p>405.7 Landings. Ramps shall have landings at the top and the bottom of each ramp run. Landings shall comply with 405.7.</p> <p>405.7.1 Slope. Landings shall comply with 302. Changes in level are not permitted.</p> <p>EXCEPTION: Slopes not steeper than 1:48 shall be permitted.</p> <p>405.7.2 Width. The landing clear width shall be at least as wide as the widest ramp run leading to the landing.</p> |

405.7.3 Length. The landing clear length shall be 60 inches (1525 mm) long minimum.

405.7.4 Change in Direction. Ramps that change direction between runs at landings shall have a clear landing 60 inches (1525 mm) minimum by 60 inches (1525 mm) minimum.

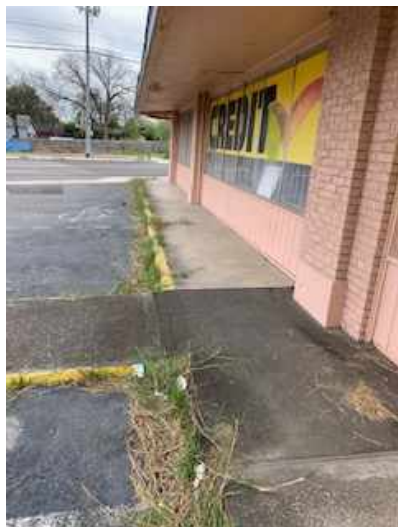
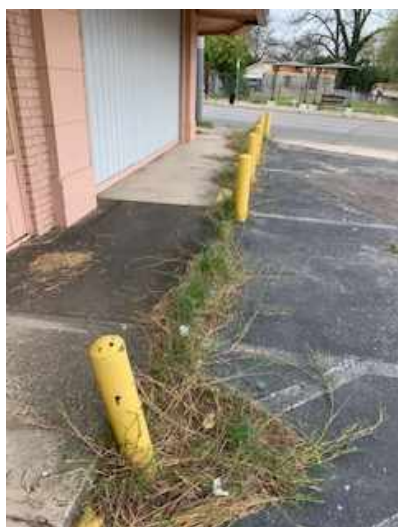
406 Curb Ramps

1. No curb ramps are provided for access to the building sidewalk. Once the accessible parking spaces are provided, a curb ramp(s) complying with section 406 shall be provided connecting the accessible parking access aisle to the sidewalk.

406.2 Counter Slope. Counter slopes of adjoining gutters and road surfaces immediately adjacent to the curb ramp shall not be steeper than 1:20. The adjacent surfaces at transitions at curb ramps to walks, gutters, and streets shall be at the same level.
