### HISTORIC AND DESIGN REVIEW COMMISSION

HDRC CASE NO:	2021-028
ADDRESS:	1829 N NEW BRAUNFELS AVE
LEGAL DESCRIPTION:	NCB: 1268 BLK: 4 LOT: 9 KITCHEN SUBDIVISION
ZONING:	C-2 IDZ, H
<b>CITY COUNCIL DIST.:</b>	2
DISTRICT:	Government Hill Historic District
APPLICANT:	Pam Carpenter/Seventh Generation Design, Inc.
<b>OWNER:</b>	GOVERNMENT HILL SQUARE
TYPE OF WORK:	Removal of existing, historic blade sign
<b>APPLICATION RECEIVED:</b>	January 15, 2021
60-DAY REVIEW:	Not applicable due to City Council Emergency Orders
CASE MANAGER:	Edward Hall

### **REQUEST:**

RE: 1829 N. New Braunfels Ave., Weilbacher Building Rehabilitation, Request for Sign Removal (SGD Project No. 1622)

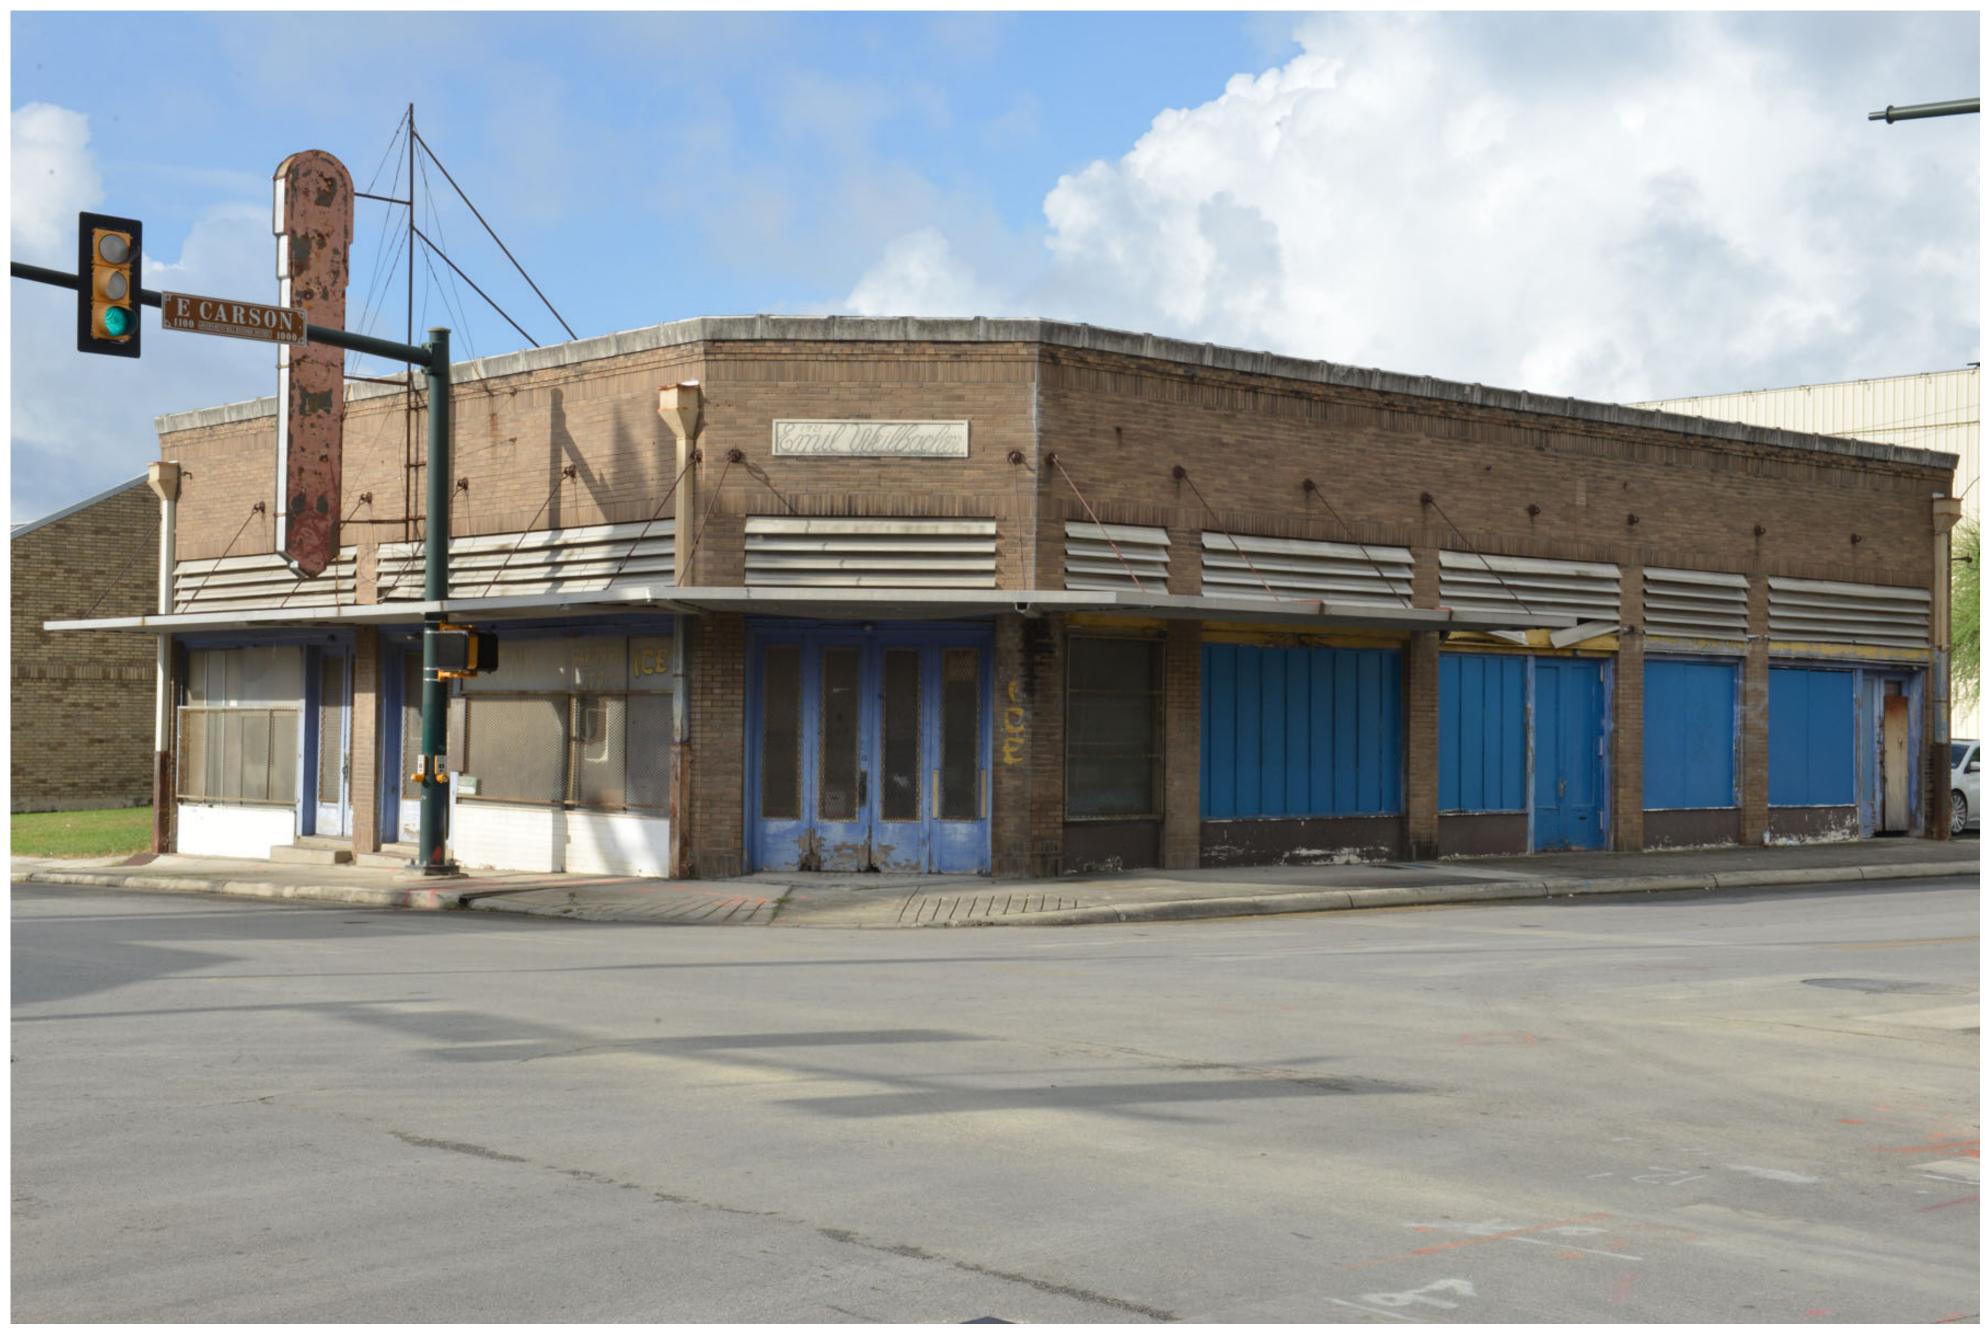
EXISTING BUILDING TO BE REHABILITATED

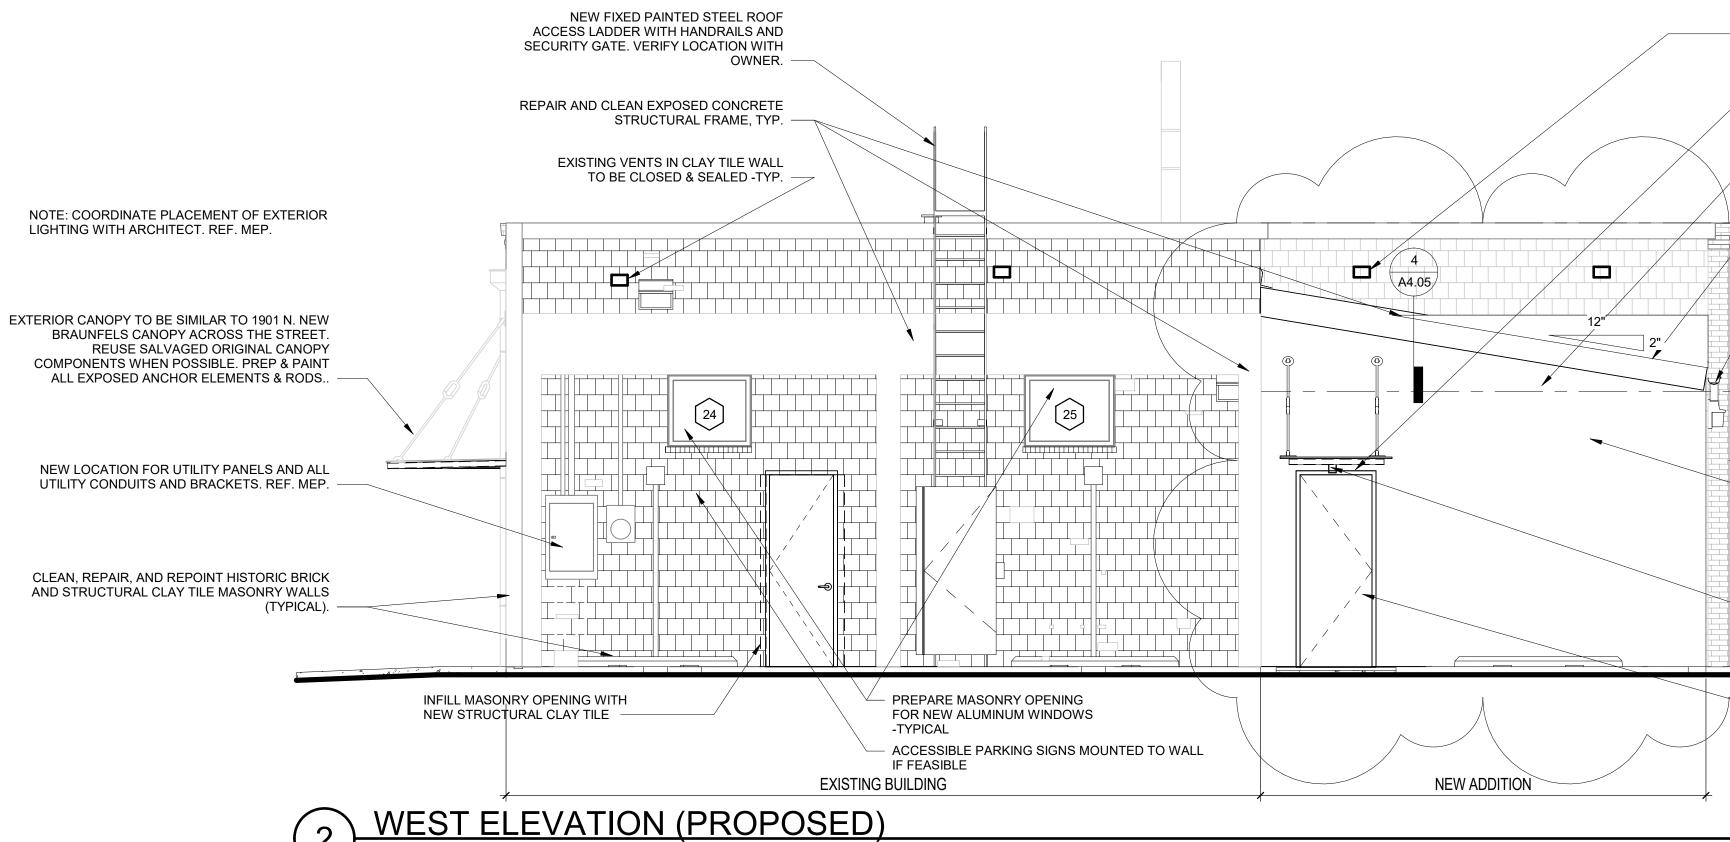
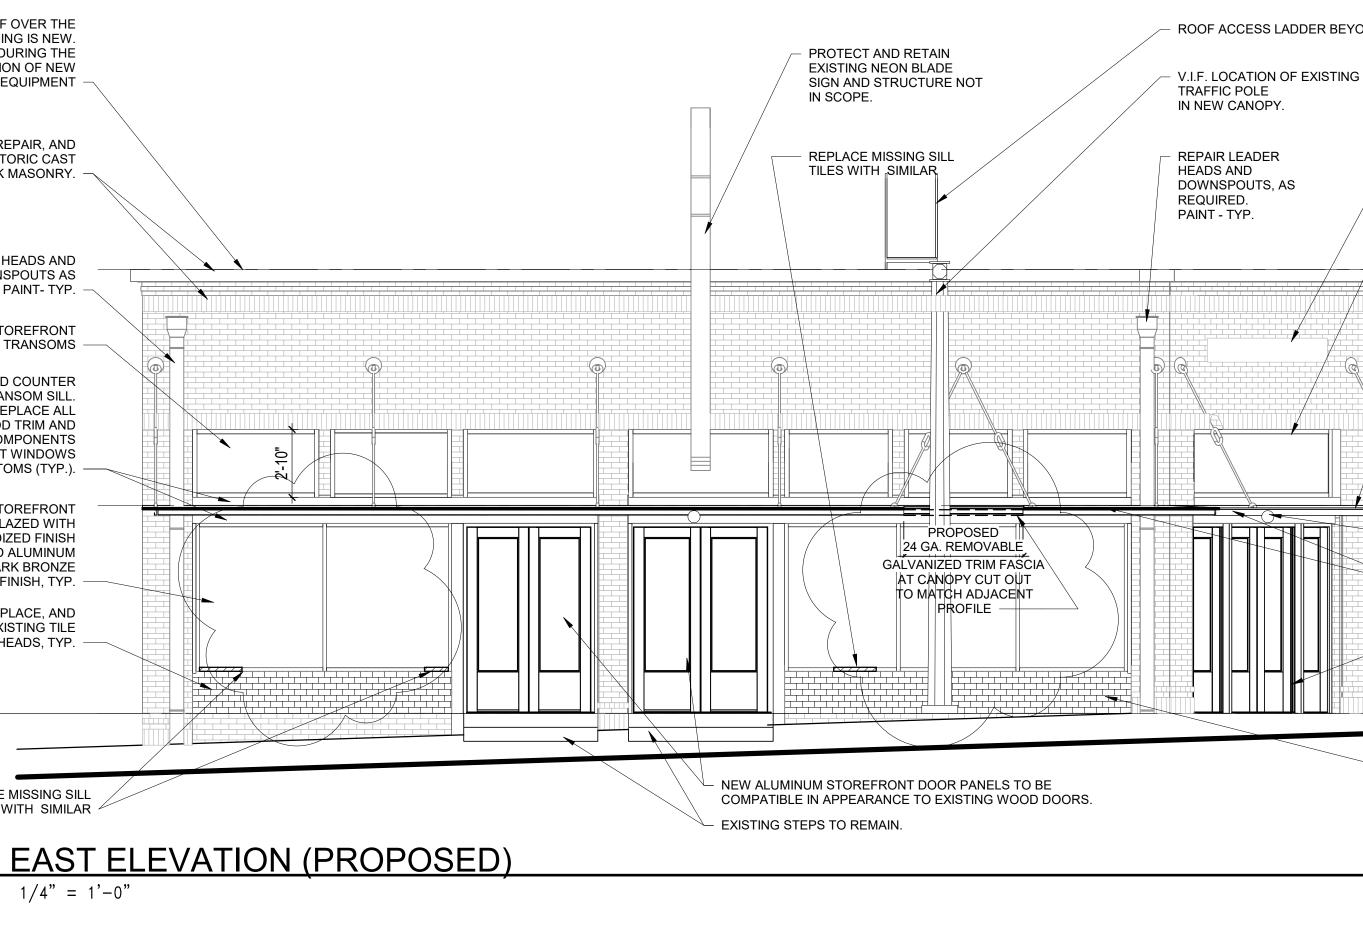
> CLEAN, REPAIR, AND REPOINT HISTORIC CAST STONE & BRICK MASONRY.

NEW FLASHING AND COUNTER FLASHING AT TRANSOM SILL. REPAIR OR REPLACE ALL DETERIORATED WOOD TRIM AND STRUCTURAL COMPONENTS BETWEEN STOREFRONT WINDOWS AND TRANSTOMS (TYP.).

> CLEAN, REPLACE, AND REPAIR EXISTING TILE BULKHEADS, TYP.

REPLACE MISSING SILL TILES WITH SIMILAR

BEYOND.	
TING CLEAN & PROTECT HISTORIC STONE INSCRIPTION.	
REPAIR AND REASSEMBLE FRESNEL PANELS     IN NEW FRAMES TO BE INSTALLED ON THE     EXTERIOR OF THE NEW ALUMINUM     STOREFRONT TRANSOMS.	ARC
EXTERIOR CANOPY TO BE SIMILAR TO 1901 N. NEW BRAUNFELS CANOPY ACROSS THE STREET. REUSE SALVAGED ORIGINAL CANOPY COMPONENTS WHEN POSSIBLE. PREP & PAINT ALL EXPOSED ANCHOR ELEMENTS & RODS.	G
	STRUC
8'-8" NEW LIGHT FIXTURE TO BE INSTALLED - TYPICAL	106
NEW WOOD TRIM ABOVE STORE FRONT SYSTEM, PAINTED, TYP.	MEP Er
EXTERIOR ALUMINUM STOREFRONT DOORS TO PROVIDE ADA CONFIGURATION AT NORTHEAST CORNER ENTRANCE.	
01 FLOOR PLAN 0"	EI BI
CLEAN, REPLACE, AND REPAIR EXISTING TILE BULKHEADS, TYP.	R
	182 SA
	No. 1 2 3 6
EXISTING VENTS IN CLAY TILE WALL TO BE CLOSED & SEALED WITH PAINTED REAR MOUNTED METAL PLATE -TYP.	
<ul> <li>PAINTED METAL CANOPY AT DOOR OVERHANG TO MATCH MAIN CANOPY WITH GUTTER OR DIVERTER</li> </ul>	
LIGHT FIXTURE RE: ELECTRICAL DRAWINGS - TYPICAL

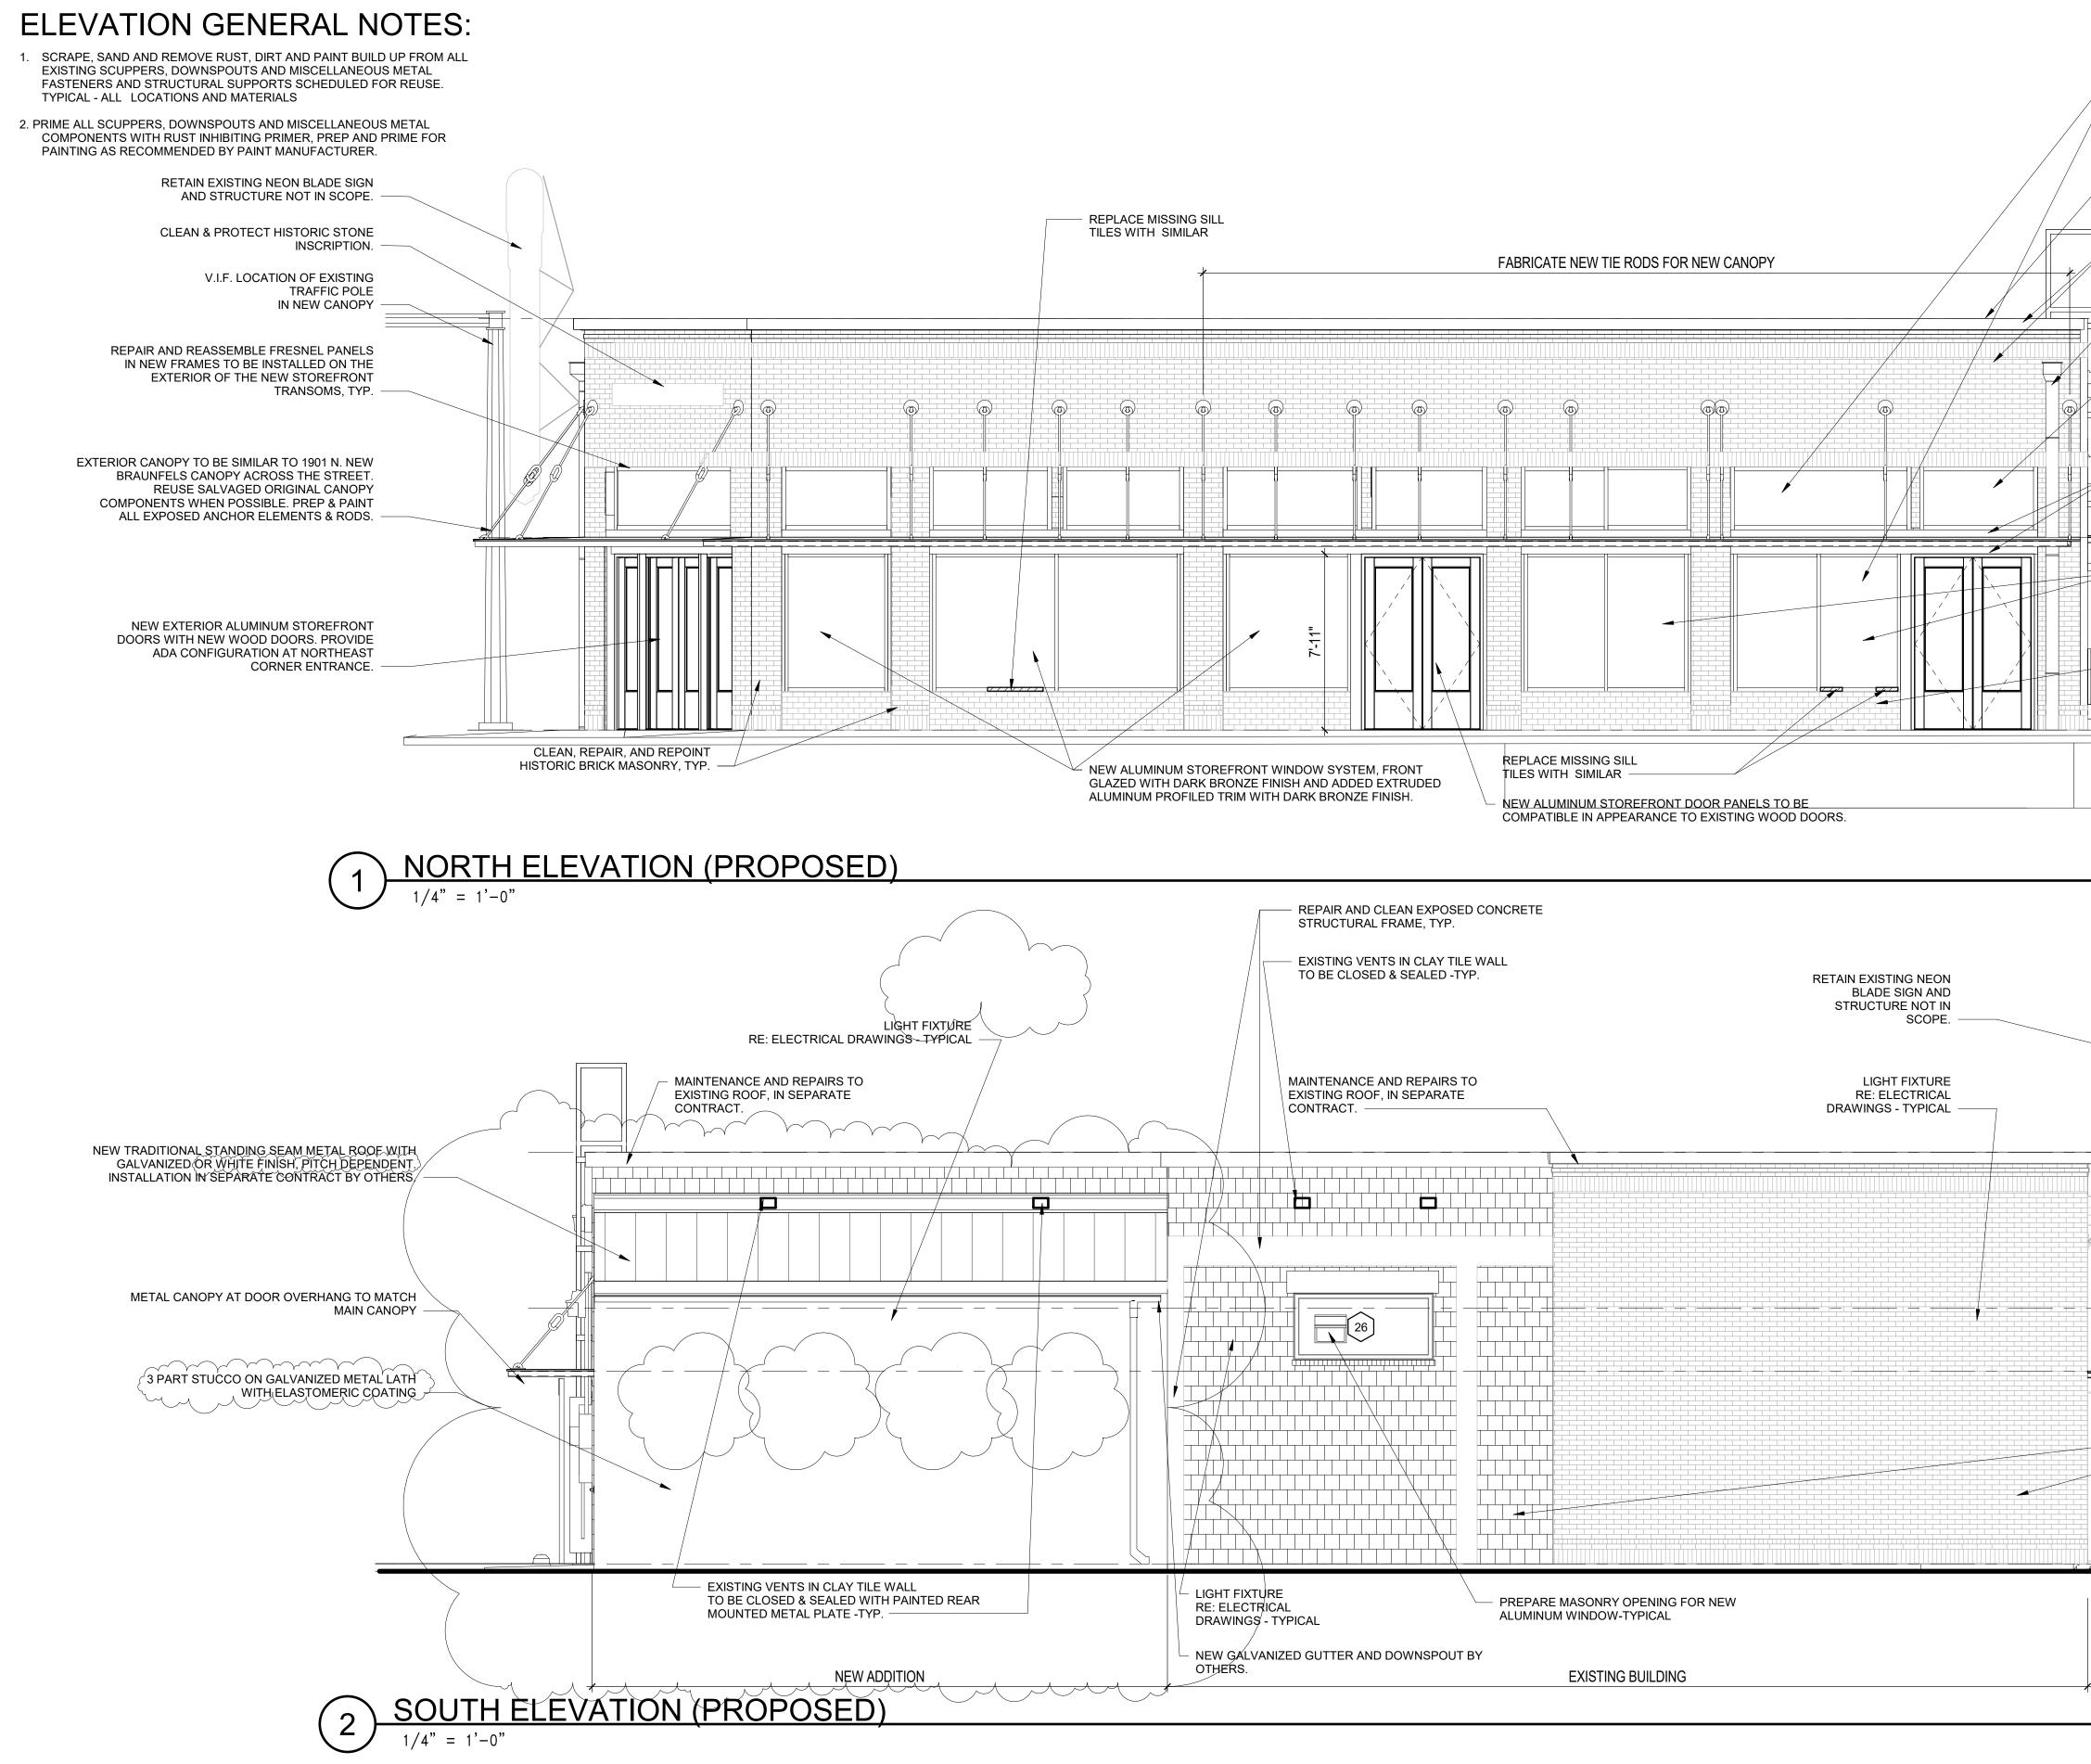
*		Project number1622Date11/13/2018Drawn by
		Checked by A3.02
		Scale 1/4" = 1'-0"

NEW WINDOW SYSTEM AND FRAMING, TYPICAL	
	MAINTENANCE AND REPAIRS TO EXISTING ROOF, IN SEPARATE CONTRACT.	Seventh Generation
	CLEAN, REPAIR, AND REPOINT HISTORIC CAST STONE AND BRICK MASONRY, TYP.	DESIGN
	REPAIR LEADER HEADS TOP OF PARAPET AND DOWNSPOUTS, AS 18'-6"	118 Broadway, Suite 519 San Antonio, Texas 78205 TEL (210) 262-6161 TEL (210) 241-7490 OWNER:
	NEW ALUMINUM STOREFRONT SYSTEM AT TRANSOMS BEHIND FRESNEL PANEL, FRONT GLAZED WITH DARK BRONZE FINISH AND ADDED EXTRUDED ALUMINUM PROFILED TRIM WITH DARK BRONZE FINISH TO MATCH STOREFRONT WINDOWS BELOW.	Government Hill Square Properties, LP. 209 East Riverside Drive Austin, Texas 78704 TEL (210) 227-2724
	NEW FLASHING AND COUNTER FLASHING AT TRANSOM SILL. REPAIR OR REPLACE ALL DETERIORATED WOOD TRIM AND STRUCTURAL COMPONENTS BETWEEN STOREFRONT WINDOWS AND TRANSTOMS	CIVIL ENGINEER: SA Engineering Co. 12703 Spectrum Drive, Suite 101 San Antonio, Texas 78249 TEL (210) 561-0808

(TYP.). 	STRUCTURAL ENGINEER: Alpha Consulting Engineers 10609 W. Interstate Highway 10, Suite 203
	NEW ALUMINUM STOREFRONT WINDOW SYSTEM, FRONT GLAZED WITH DARK BRONZE FINISH AND ADDED EXTRUDED ALUMINUM PROFILED TRIM WITH DARK BRONZE FINISH.	San Antonio, Texas 78230 TEL (210) 227-3647 MEP ENGINEER:
	CLEAN AND REPAIR EXISTING TILE BULKHEADS, TYP.	CNG Engineering, PLLC 1917 N. New Braunfels Ave. Suite 201 San Antonio, Texas 78208 TEL (210) 224-8841
	01 FLOOR PLAN 0"	EMIL WEILBACHER BUILDING
		REHABILITATION
		1829 N. NEW BRAUNFELS ST. SAN ANTONIO, TX 78208
		No.DateDescription108-22-201795% Construction Set205-01-2018Draft Permit Set311-13-2018Permit Set608-13-2019Addendum 4 Construction Set
	V.I.F. LOCATION OF EXISTING TRAFFIC POLE IN NEW CANOPY	
	EXTERIOR CANOPY TO BE SIMILAR TO 1901 N. NEW BRAUNFELS CANOPY ACROSS THE STREET. REUSED SALVAGED ORIGINAL CANOPY COMPONENTS WHEN POSSIBLE. PREP & PAINT ALL EXPOSED ANCHOR ELEMENTS & RODS.

ADDITION PLATE HT. 11'-5 3/4"	PROPOSED EXTERIOR
		ELEVATIONS
	CLEAN, REPAIR, AND REPOINT HISTORIC BRICK AND STRUCTURAL CLAY TILE MASONRY WALLS (TYPICAL).	
		STERED ARCHITECT
<u>A</u>	<u>01 FLOOR PLAN</u> 0"	SA 74665 45
		Swff 11/1. Jarpent 11/13/2018

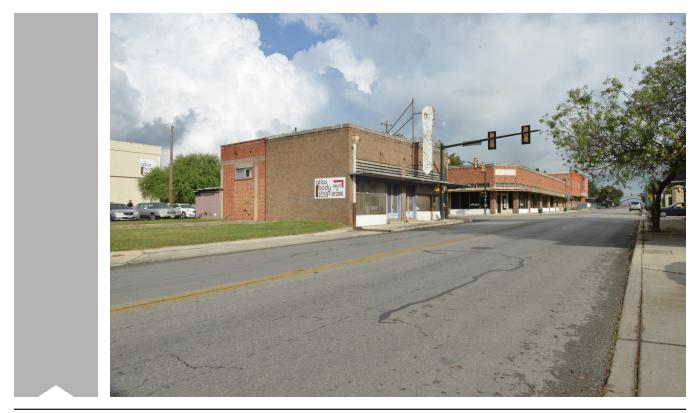
Name: Address: Description: Date: Emil Weilbacher Building Rehabilitation 1829 North New Braunfels Ave., San Antonio, Texas View looking NNW toward southeast corner of building October 7, 2016 (Prior to Rehabilitation)

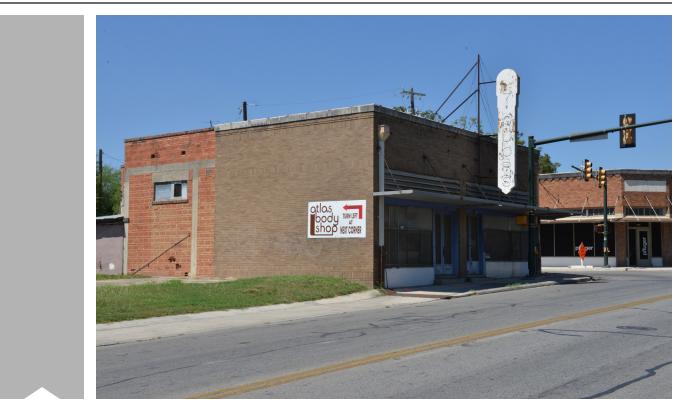
Photograph No.

Name:Emil Weilbacher Building RehabilitationAddress:1829 North New Braunfels Ave., San Antonio, TexasDescription:View looking NNW toward southeast corner of buildingDate:October 7, 2016 (Prior to Rehabilitation)

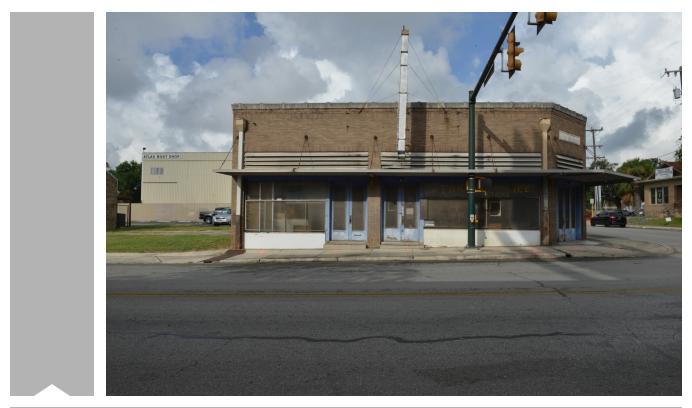
Name:Emil Weilbacher Building RehabilitationPhotograph No.Address:1829 North New Braunfels Ave., San Antonio, TexasBescription:View looking west across New Braunfels Ave. at east facadeDate:October 7, 2016 (Prior to Rehabilitation)GVHL-03

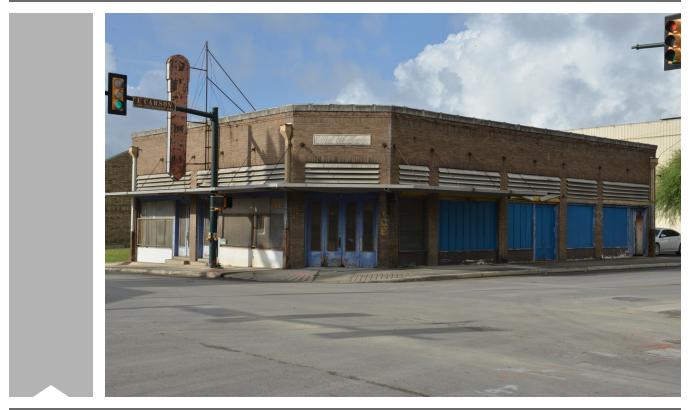
Name:Emil Weilbacher Building RehabilitationAddress:1829 North New Braunfels Ave., San Antonio, TexasDescription:View looking southwest at northeast corner of buildingDate:October 7, 2016 (Prior to Rehabilitation)

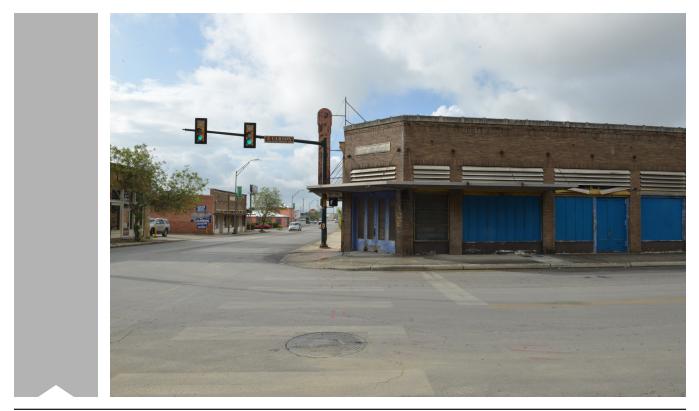
Name:Emil Weilbacher Building RehabilitationAddress:1829 North New Braunfels Ave., San Antonio, TexasDescription:View looking south across Carson St. at north facade of buildingDate:October 7, 2016 (Prior to Rehabilitation)

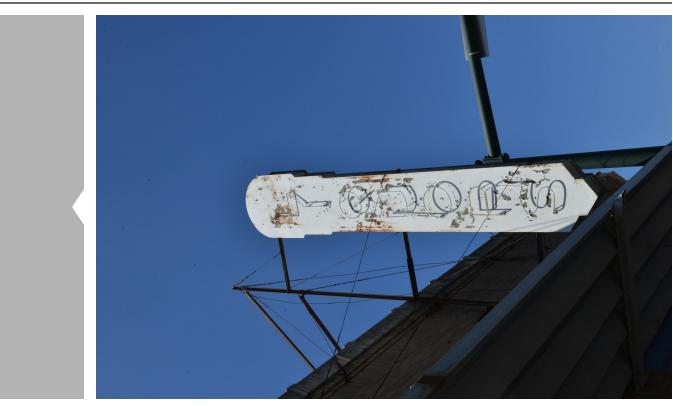
While assumed not original to the Weilbacher Building (built 1921), the existing metal blade sign appears to date from the mid-20<sup>th</sup> century and may be considered a character-defining feature of the primary façade of the building. As a result, the original scope of permitted work for the building included rehabilitation of the sign (see attached architectural drawing sheets and photographic documentation). Years of exposure and lack of maintenance, preceding the current property owner, has deteriorated the paint finish and exposing the metal case of the sign. Most of the original neon lighting tubes are broken or missing. And the structural armature suspending the sign from the building's parapet and façade is requiring substantial repairs or wholesale replacement to secure the sign properly and safely.

Name:Emil Weilbacher Building RehabilitationAddress:1829 North New Braunfels Ave., San Antonio, TexasDescription:Detail view of south face of blade sign on east facadeDate:October 7, 2016 (Prior to Rehabilitation)

A qualified sign contractor provided the property owners with a cost estimate of \$25,0000 to rehabilitate the sign. This exceeds the available contingency funding for the current phase of rehabilitation of the property. This COA request proposes to temporarily remove the sign for safekeeping for rehabilitation during a future phase of the project. Acknowledging the iconic potential for the sign, it is the owners' intention to collaborate with community organizations (e.g., SAGE, Conservation Society of San Antonio, Government Hill neighborhood associations, etc.) to find funding to have the sign possibly restored as a Government Hill District gateway marker.

If the City of San Antonio issues a Certificate of Appropriateness required for removal to remove of the existing blade sign located at 1829 N. New Braunfels Ave., Government Hill Properties will store it until funds are raised to rehabilitate and reinstall the sign. Government Hill Properties will commit to completion of the rehabilitation and reinstallation of the sign within 10 years. The sign will be kept in storage at location(s) known to OHP at all times. Community and District fundraising for the sign's restoration will be pursued to have the sign rehabilitated and reinstalled as soon as possible. In fact, once \$20,000 is raised, work would be authorized by Government Hill Properties to begin the sign's rehabilitation. During the fundraising period, Government Hill Properties will commit and set aside \$2500 annually to go towards the sign's eventual restoration and reinstallation. In other words, without any outside fundraising, Government Hill will set aside \$25,000 during the next ten years and contribute any additional funds needed in the tenth year to have the sign rehabilitated and reinstalled. Government Hill Properties further requests that the City of San Antonio also agrees that Government Hill Properties will retain all rights and the full authority to determine the content and the layout of the original sign faces, subject only to the normal regulations of the UDC's Signage Ordinance.

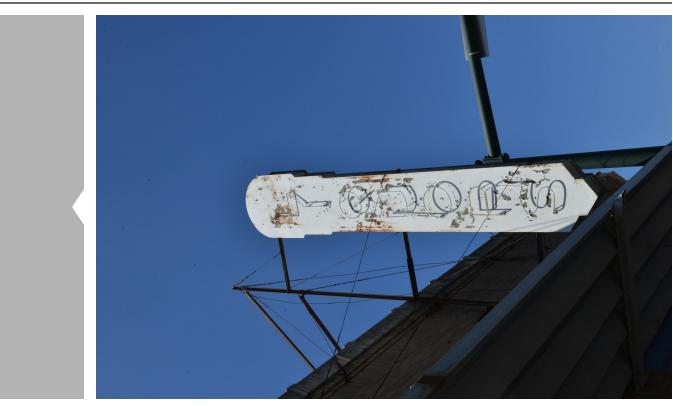
Name:Emil Weilbacher Building RehabilitationAddress:1829 North New Braunfels Ave., San Antonio, TexasDescription:Detail view of south face of blade sign on east facadeDate:October 7, 2016 (Prior to Rehabilitation)
