# HISTORIC AND DESIGN REVIEW COMMISSION

**HDRC CASE NO:** 2021-057  
**ADDRESS:** 1235 E CROCKETT ST  
**LEGAL DESCRIPTION:** NCB 1373 BLK 1 LOT S 125 FT OF 27  
**ZONING:** RM-4, H  
**CITY COUNCIL DIST.:** 2  
**DISTRICT:** Dignowity Hill Historic District  
**APPLICANT:** Kali Tripp/Tripp Flip, LLC  
**OWNER:** Kali Tripp/Tripp Flip, LLC  
**TYPE OF WORK:** Removal of an existing front door  
**APPLICATION RECEIVED:** January 27, 2021  
**60-DAY REVIEW:** Not applicable due to City Council Emergency Orders  
**CASE MANAGER:** Edward Hall

The applicant is requesting a Certificate of Appropriateness for approval to remove the eastern front door opening on the historic structure at 1235 E Crockett, located within the Dignowity Hill Historic District.

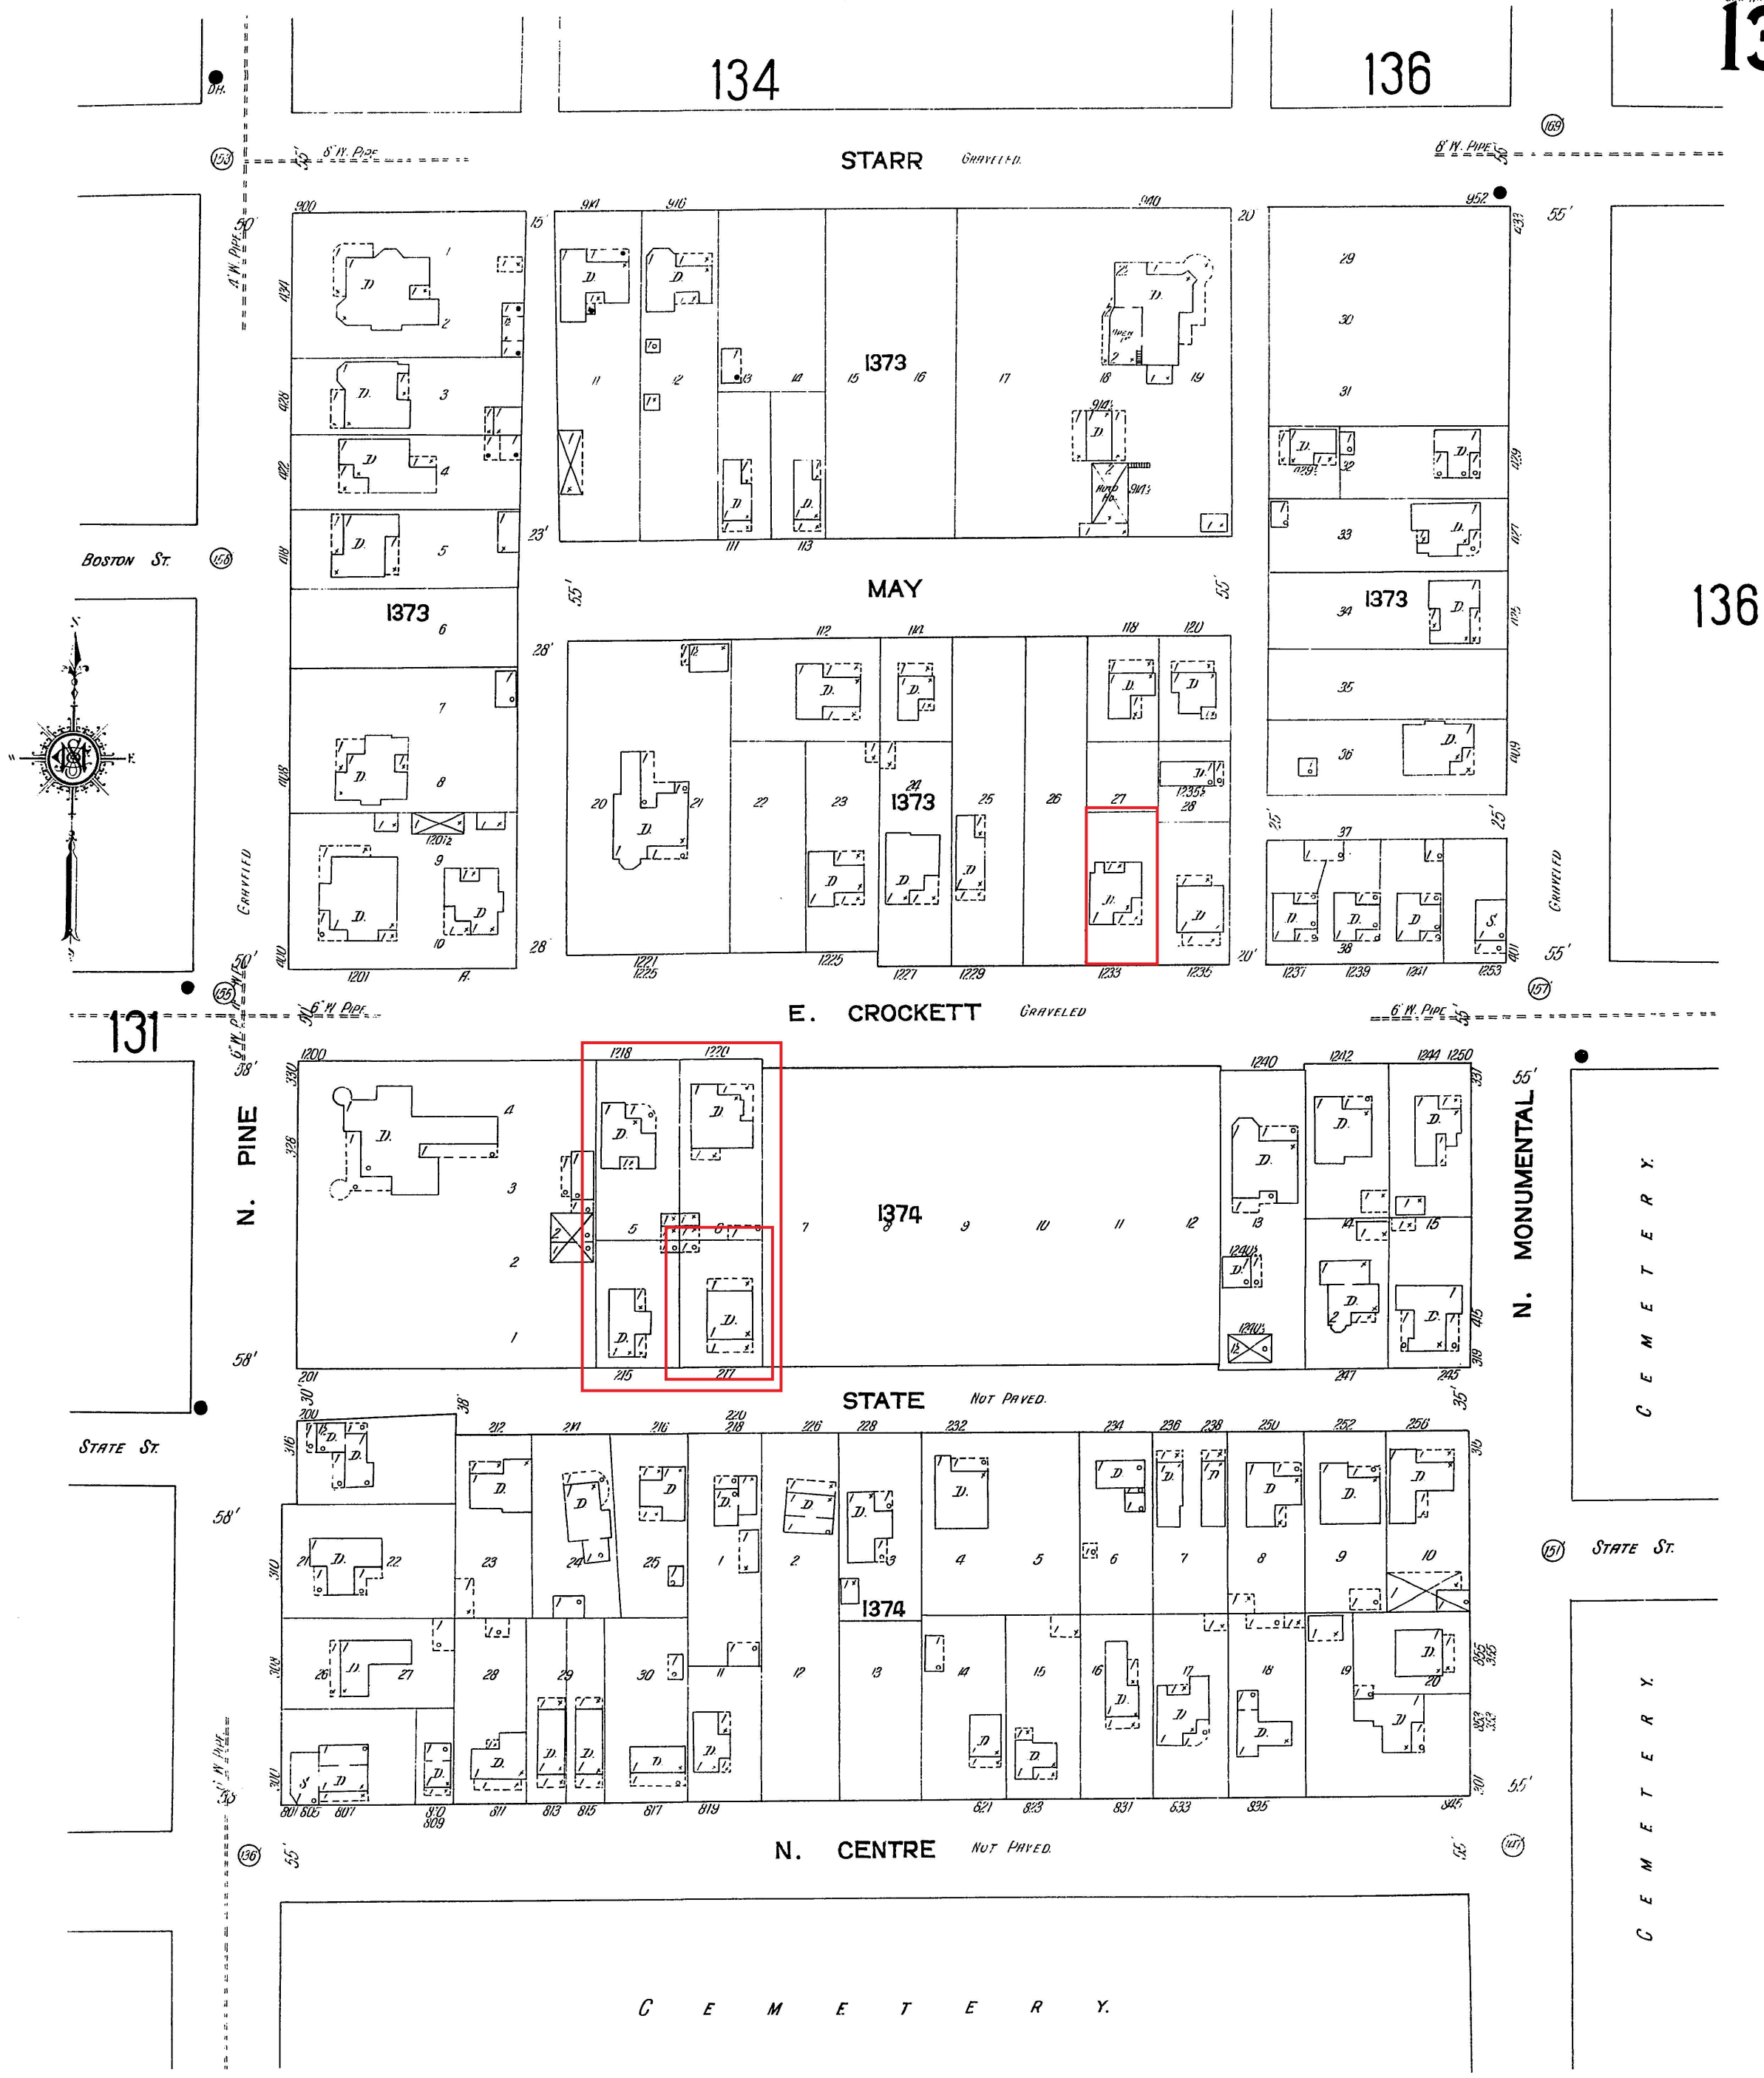
1912 SANBORN MAP

- b. The historic structure located at 1235 E Crockett first appears on aerial photographs at its current location in 1986. The structure was relocated to its current location at an undetermined time; speculatively during the construction of Fairchild Park, where a number of historic structures were removed from their original locations. The original structure located at 1235 E Crockett is noted on the 1931 Sanborn Map as “partly burned” and was no longer present at the lot by 1952. OHP staff has not found a reference to the historic structure in its original location; however, there is a duplex structure found on the 1912 and 1952 Sanborn Map. Interior framing suggests that the structure may have featured a recessed front porch with street facing and side yard facing front doors; however, this has not been verified via Sanborn Maps or other historic information.

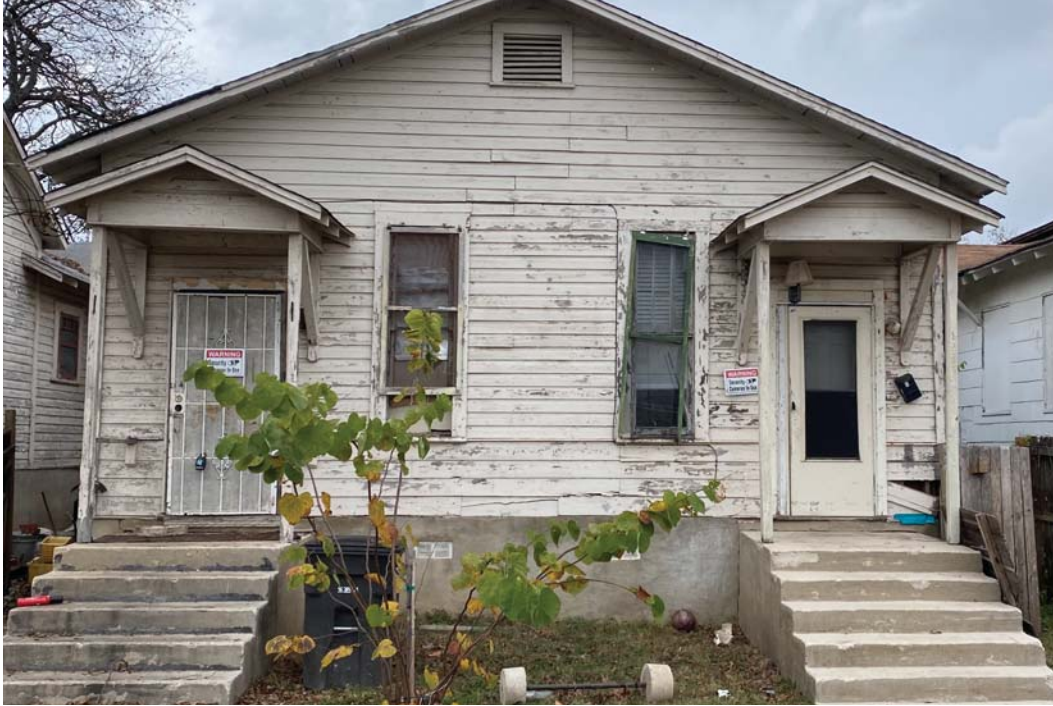
1235 E. Crockett St.  
San Antonio, TX 78202

1. Remove second (east) front door

After demolition of interior of property, it was discovered that the original home was in fact a single-family home.

- Two doorways leading from the separate “units”, or sides, of the home are in the original framing.
- The second door is not original to the home’s framing, but was cut in at a later time.

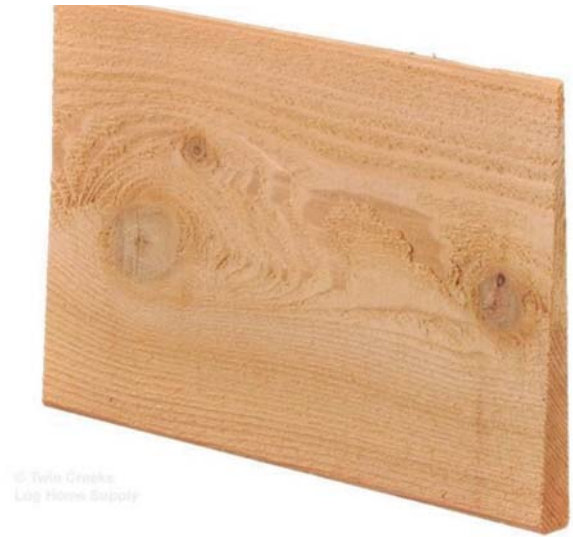
If areas/panels need to be replaced, it will match the existing materials, which are cedar 1x8 panels.

Similar to photo

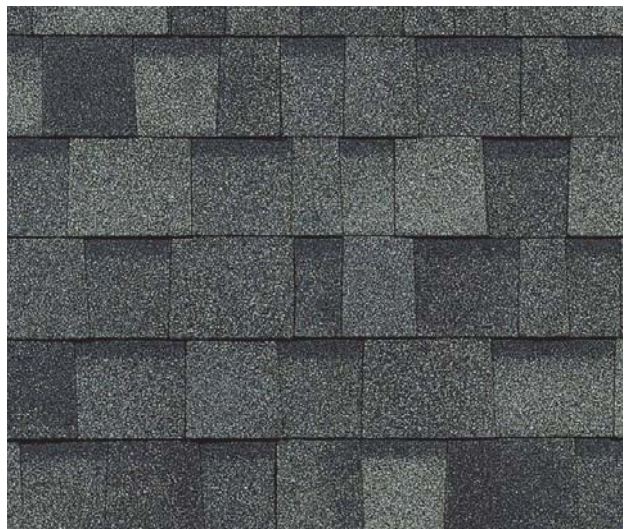
20-year shingle roof in dark gray

Similar to photo

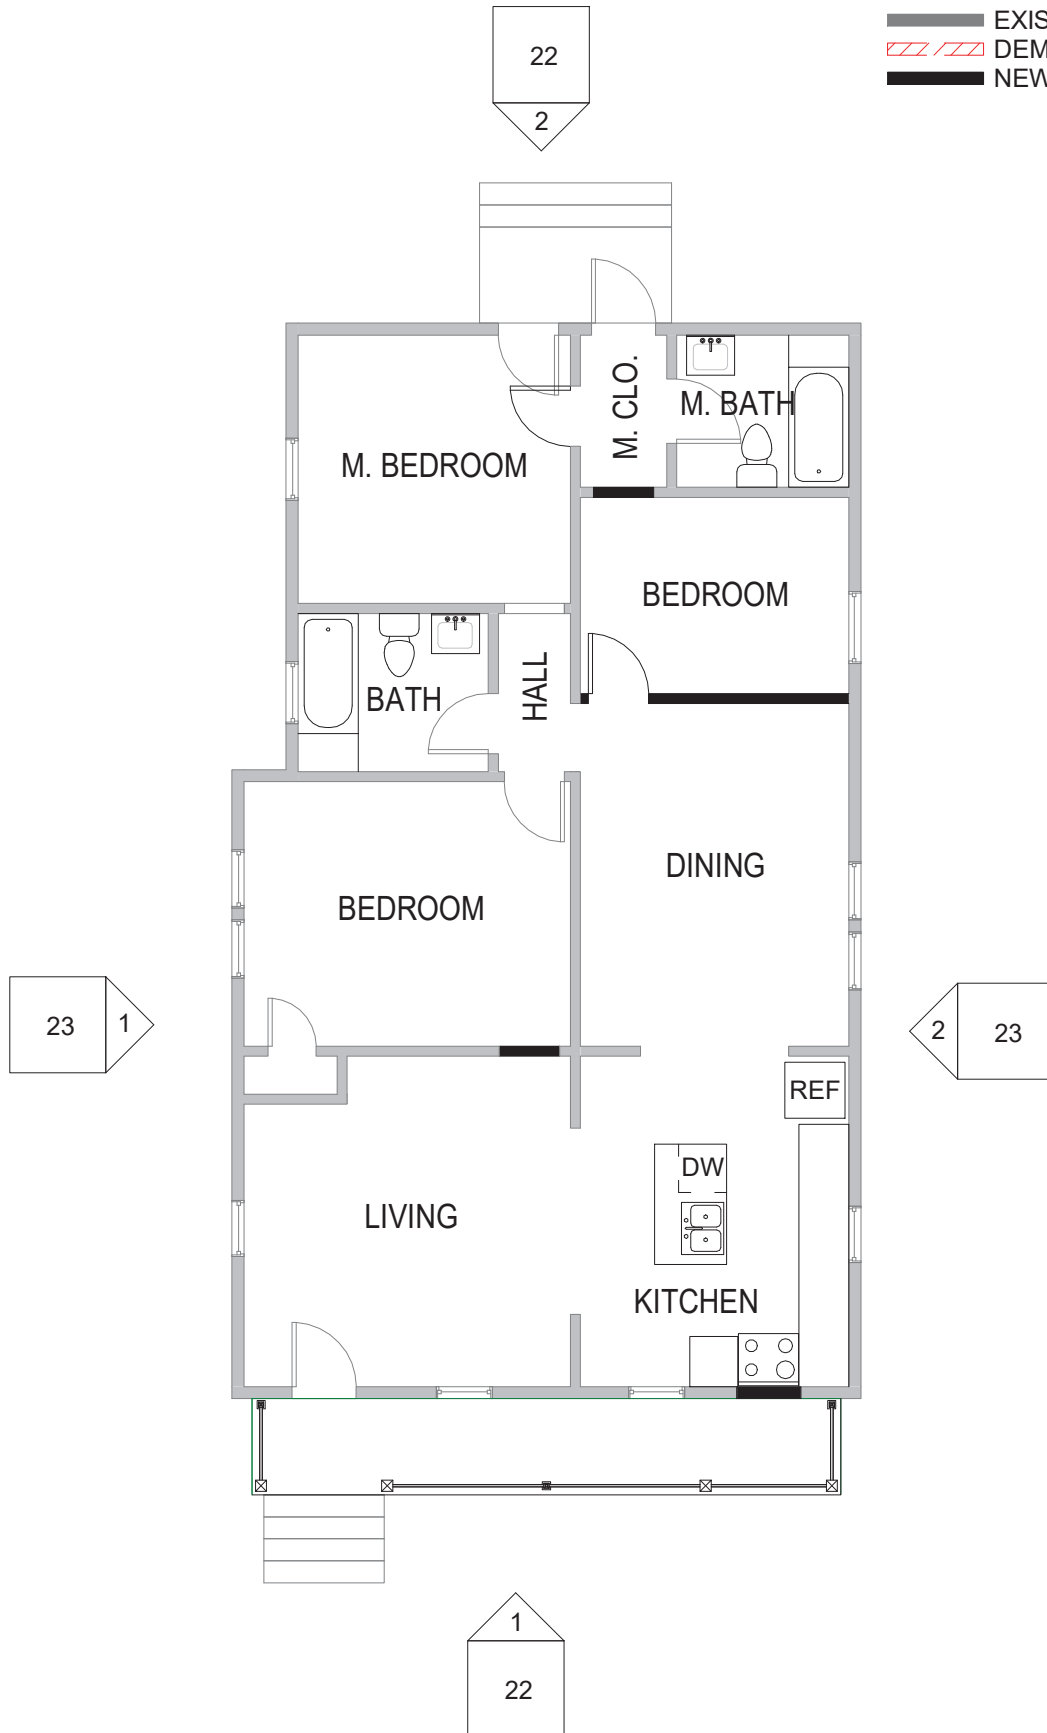
FLOOR PLAN - PROPOSED

EXISTING  
DEMOLITION  
NEW CONSTRUCTION

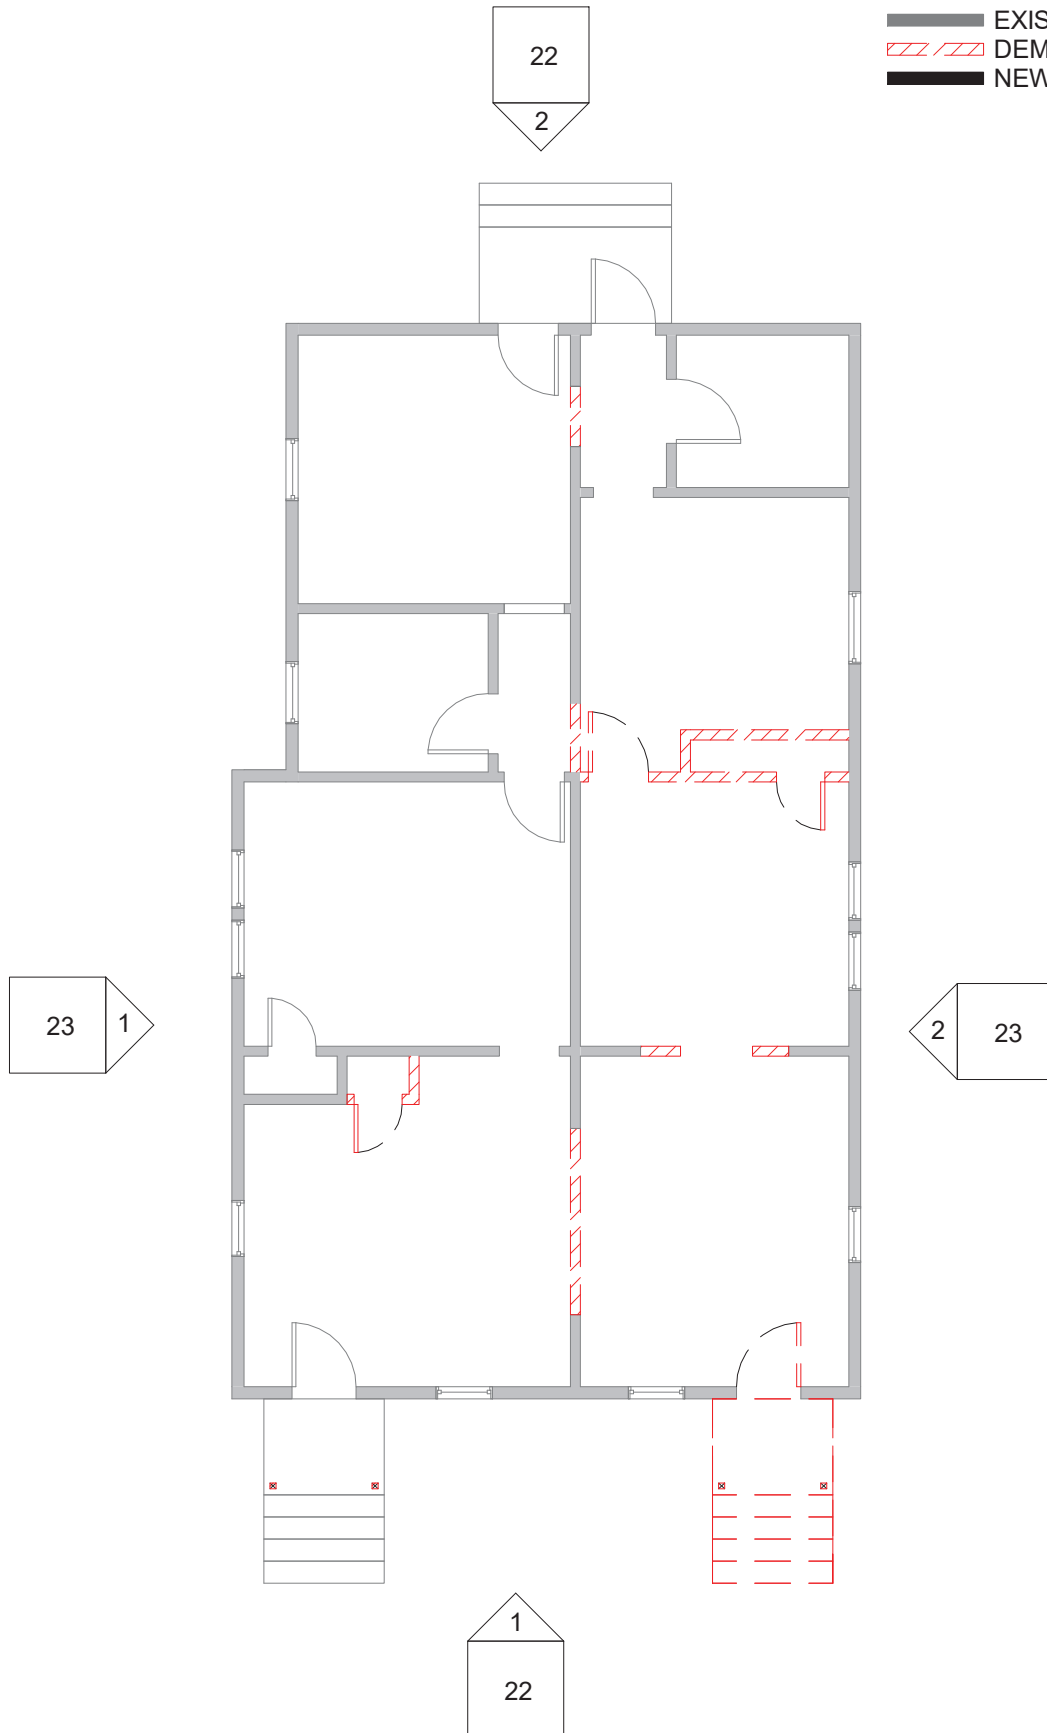
FLOOR PLAN - DEMOLITION

EXISTING  
DEMOLITION  
NEW CONSTRUCTION
