HISTORIC AND DESIGN REVIEW COMMISSION

HDRC CASE NO: 2021-081
ADDRESS: 415 LABOR ST
LEGAL DESCRIPTION: NCB 926 BLK 7 LOT W IRR 90.7 FT OF E IRR 190.85 FT OF 4
ZONING: RM-4, H
CITY COUNCIL DIST.: 1
DISTRICT: Lavaca Historic District
APPLICANT: Lauri Azzaro/Real Life Ministries
OWNER: Sean Azzaro/REAL LIFE MINISTRIES
TYPE OF WORK: Window replacement
APPLICATION RECEIVED: February 10, 2021
60-DAY REVIEW: Not Applicable Due to City Council Emergency Orders
CASE MANAGER: Rachel Rettaliata

The applicant is requesting a Certificate of Appropriateness for approval to replace 8 existing aluminum windows with new vinyl windows.

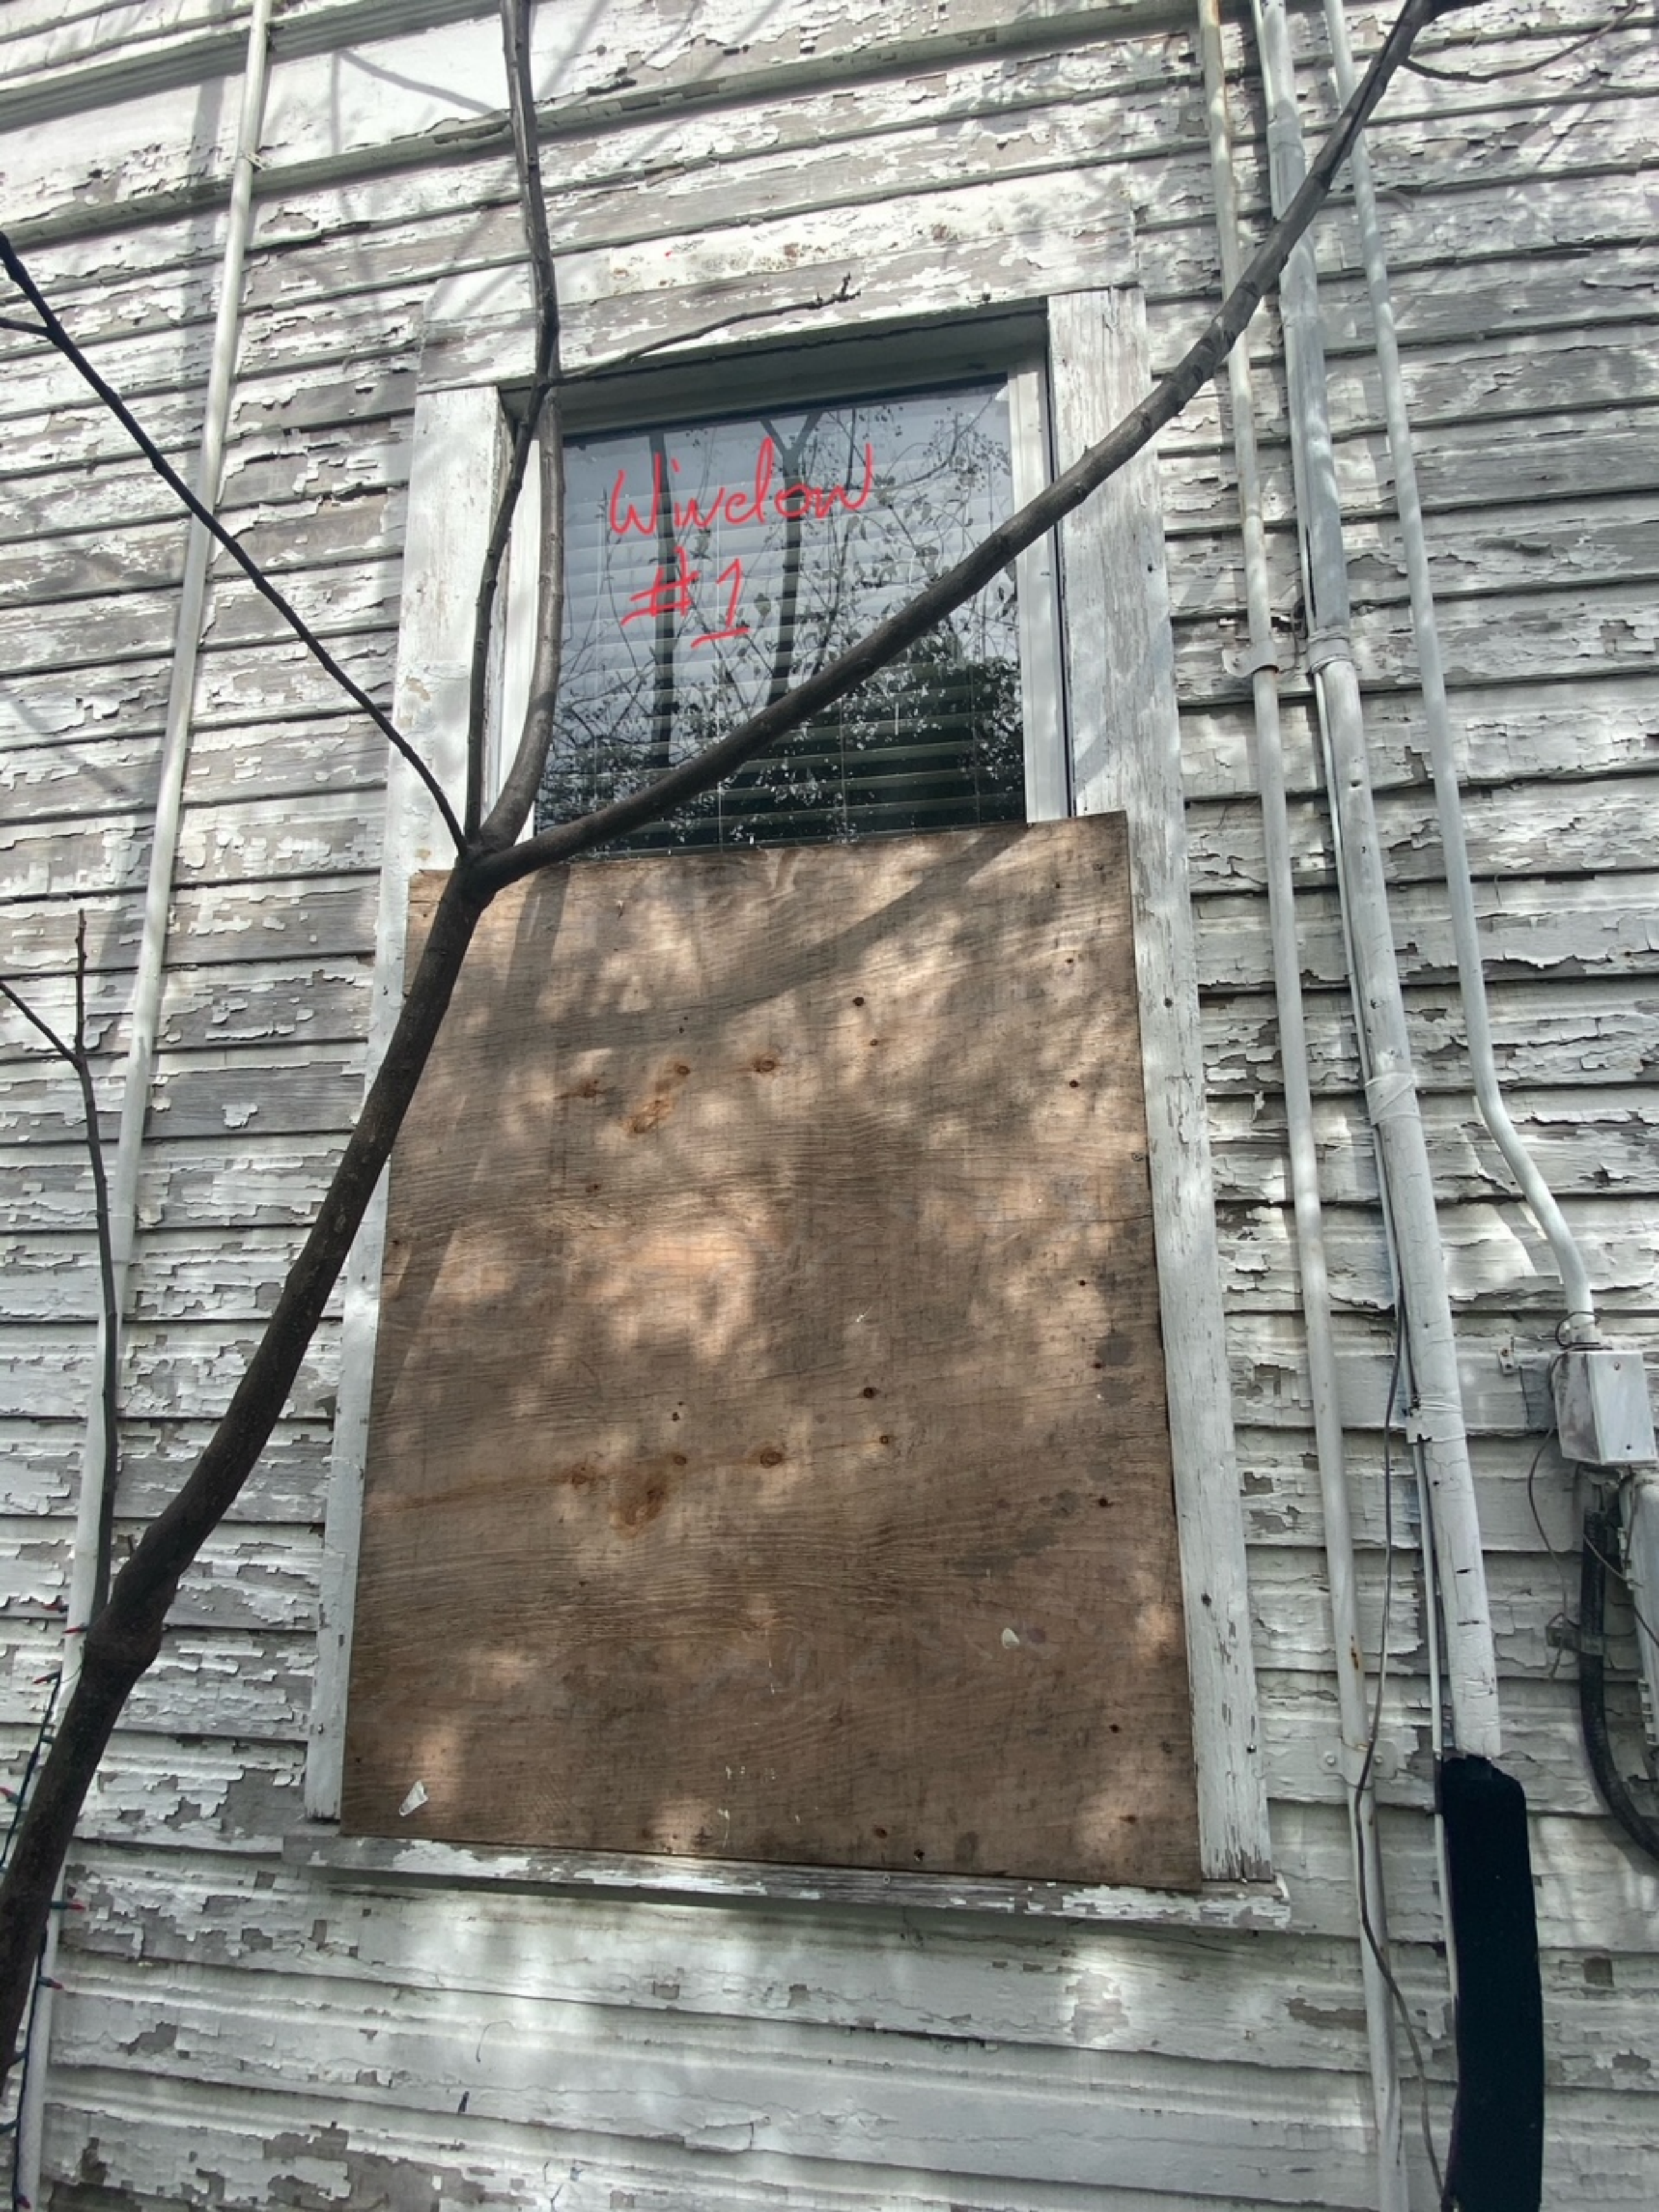
Window
#1

- b. SITE VISIT – Staff conducted a site visit to the property on March 12, 2021. During the site visit staff observed the following damage to the existing aluminum windows: missing sashes or sash elements, cracked or missing glass, and openings without windows. Overall, the windows were found to be in poor condition. Staff finds that the windows proposed for replacement are deteriorated and are an inappropriate window product for the historic structure.

- i. That the applicant installs fully wood windows or aluminum-clad wood windows that meet staff's standard window stipulations and submits updated specifications to staff for review and approval. The windows should feature an inset of two (2) inches within facades and should feature profiles that are found historically within the immediate vicinity. Meeting rails must be no taller than 1.25" and stiles no wider than 2.25". White manufacturer's color is not allowed, and color selection must be presented to staff. There should be a minimum of two inches in depth between the front face of the window trim and the front face of the top window sash. This must be accomplished by recessing the window sufficiently within the opening or with the installation of additional window trim to add thickness. Window trim must feature traditional dimensions and architecturally appropriate sill detail. Window track components must be painted to match the window trim or concealed by a wood window screen set within the opening.

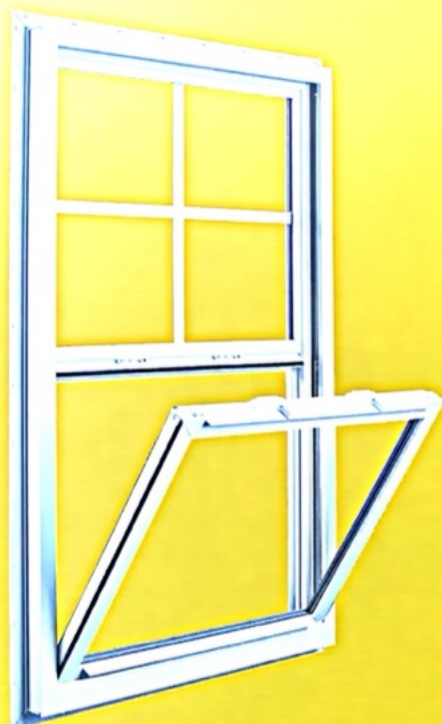
1110 SERIES SINGLE HUNG

- Energy-efficient Warm Edge insulating glass
- Maintenance-free multi-chamber PVC construction
- Fully fusion-welded corners on sash and frame for superior structural strength
- Dual lift rails on bottom sash for easy operation
- Integral nail fin (shown) for simple installation
- Bottom sash tilts in and is removable for easy cleaning
- Flush mounted tilt latches
- Traditional brick mould profile with 2 3/4" frame depth
- Interior glazed top sash, Exterior glazed bottom sash
- Aluminum reinforced meeting rail with cam locks that engage keepers for your security
- Block and tackle balances

- c. WINDOW REPLACEMENT – The applicant has proposed to replace 8 existing aluminum windows with vinyl replacement windows. The existing wood windows on the structure are not included in the request for replacement and will be repaired. Guideline 6.B.vii for Exterior Maintenance and Alterations states that non-historic incompatible windows should be replaced with windows that are typical of the architectural style of the building. Staff finds the proposed vinyl replacement windows inappropriate.
