HISTORIC AND DESIGN REVIEW COMMISSION

HDRC CASE NO: 2021-195
ADDRESS: 1901 N NEW BRAUNFELS AVE
LEGAL DESCRIPTION: NCB 1258 BLK LOT E 57.7 FT OF 17-18-19-20 & 21
ZONING: C-2 IDZ, H
CITY COUNCIL DIST.: 2
DISTRICT: Government Hill Historic District
APPLICANT: Kent Niemann/GOVERNMENT HILL SQUARE PROPERTIES LP
OWNER: Kent Niemann/GOVERNMENT HILL SQUARE PROPERTIES LP
TYPE OF WORK: Replacement of building tile
APPLICATION RECEIVED: April 16, 2021
60-DAY REVIEW: Not applicable due to City Council Emergency Orders
CASE MANAGER: Edward Hall

The applicant is requesting a Certificate of Appropriateness for approval to install new, wainscot tile at 1901 N New Braunfels. In locations where the historic tile still exists, the applicant has proposed to install the new tile on top of the existing, to preserve the existing in place.

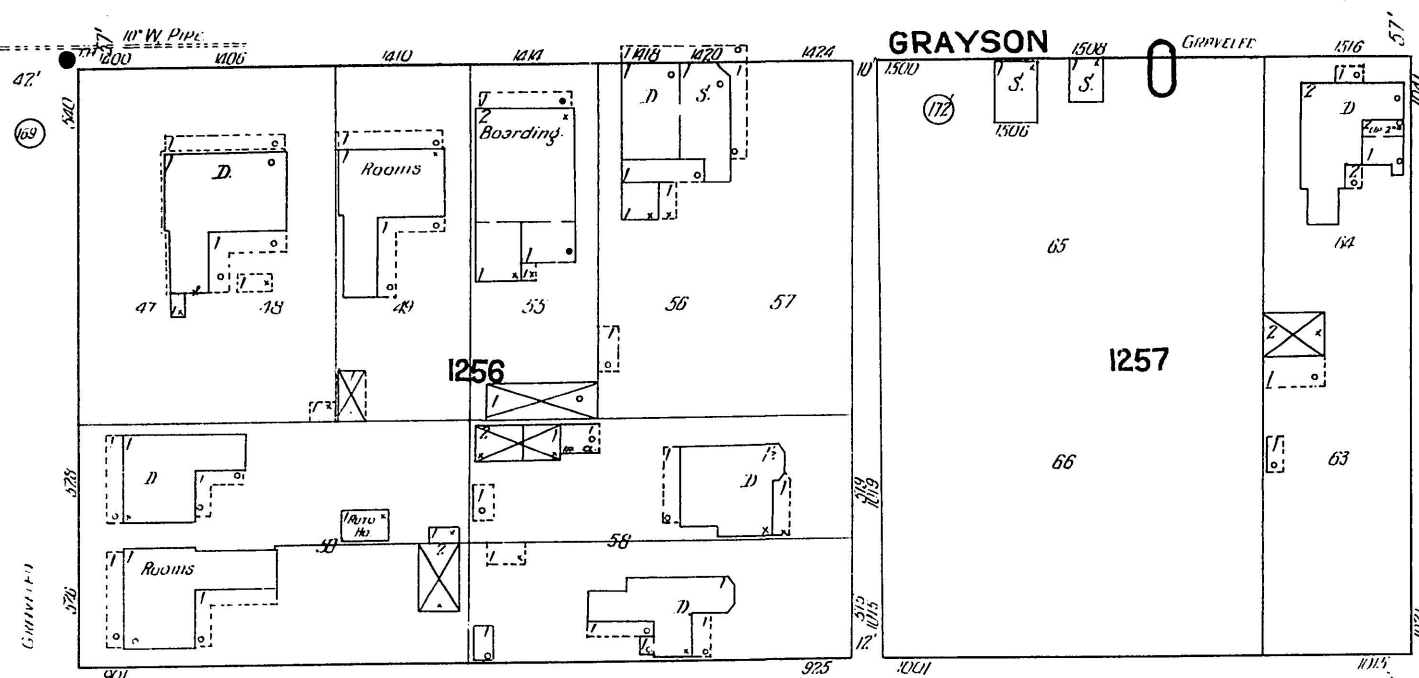
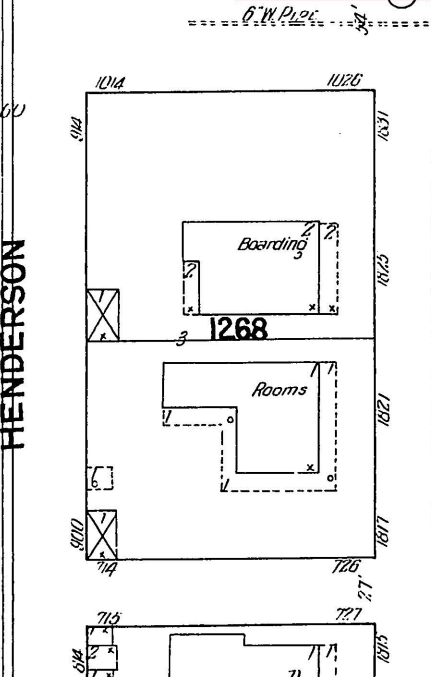
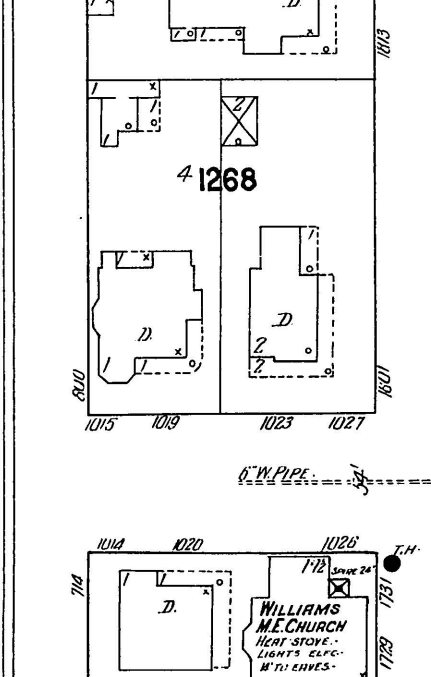
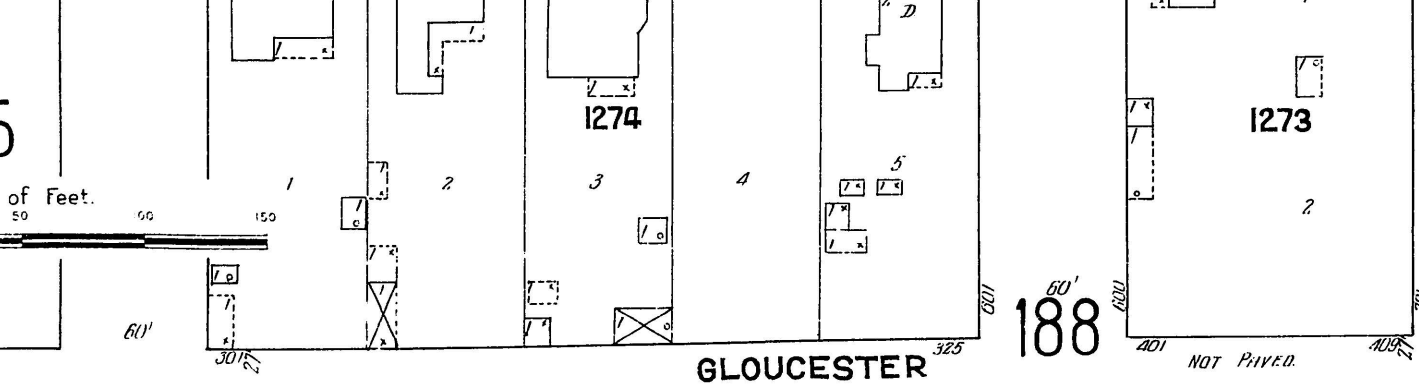
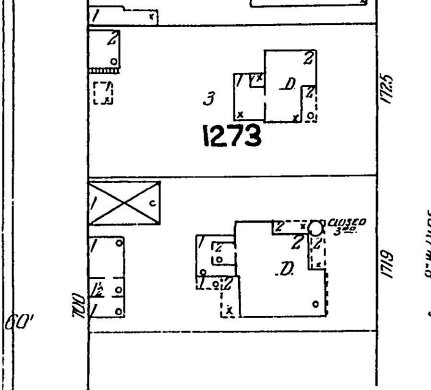
1912 SANBORN MAP

- a. The historic structure at 1901 N New Braunfels was constructed circa 1910 and is first found on the 1912 Sanborn Map. The historic structure features one story in height, a storefront system and sidewalk canopy. The historic structure features historic tile at some locations, which other locations feature replacement tile or no tile.
- b. **TILE REPLACEMENT/INSTALLATION** – The applicant is requesting a Certificate of Appropriateness for approval to install new, wainscot tile at 1901 N New Braunfels. In locations where the historic tile still exists, the applicant has proposed to install the new tile on top of the existing, to preserve the existing in place. Per the Guidelines for Exterior Maintenance and Alterations 10.A.i., applicants are to preserve character defining

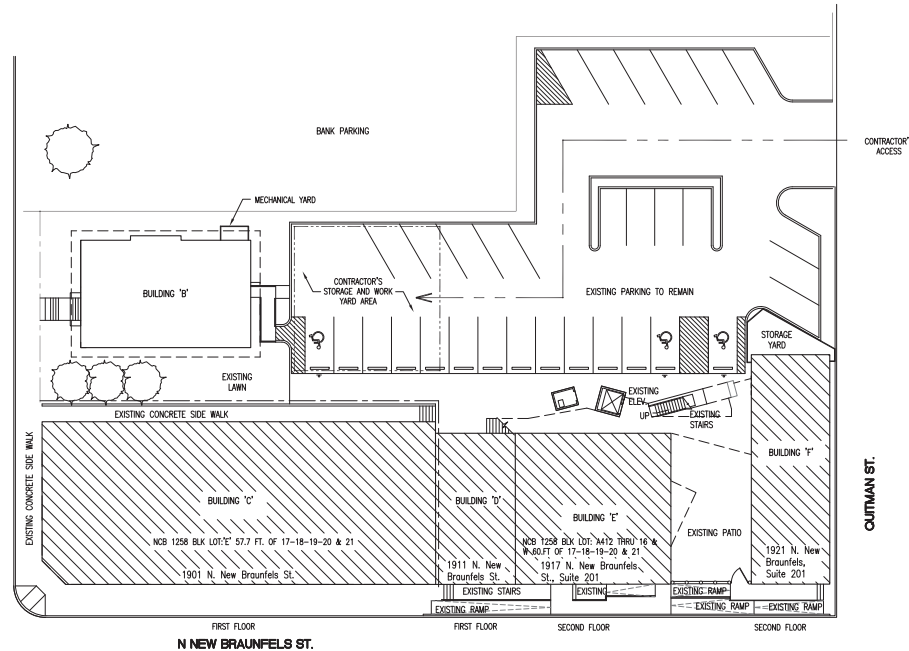
TITLE: SITE PLAN

OVERALL SITE PLAN
