HISTORIC AND DESIGN REVIEW COMMISSION May 05, 2021

HDRC CASE NO:	2021-196
ADDRESS:	1419 W ROSEWOOD AVE
LEGAL DESCRIPTION:	NCB 2766 BLK 71 LOT 20
ZONING:	R-4, H
CITY COUNCIL DIST.:	1
DISTRICT:	Keystone Park Historic District
APPLICANT:	Lionel Contreras/CONTRERAS LIONEL & ISMAEL G HERNANDEZ
OWNER:	Lionel Contreras/CONTRERAS LIONEL & ISMAEL G HERNANDEZ
TYPE OF WORK:	Solar screen installation
APPLICATION RECEIVED:	April 19, 2021
60-DAY REVIEW:	Not applicable due to City Council Emergency Orders
CASE MANACED:	Pachel Pattaliata
60-DAY REVIEW:	Not applicable due to City Council Emergency Orders
CASE MANAGER:	Rachel Rettaliata

The applicant is requesting a Certificate of Appropriateness for approval to install solar screens over the existing windows.

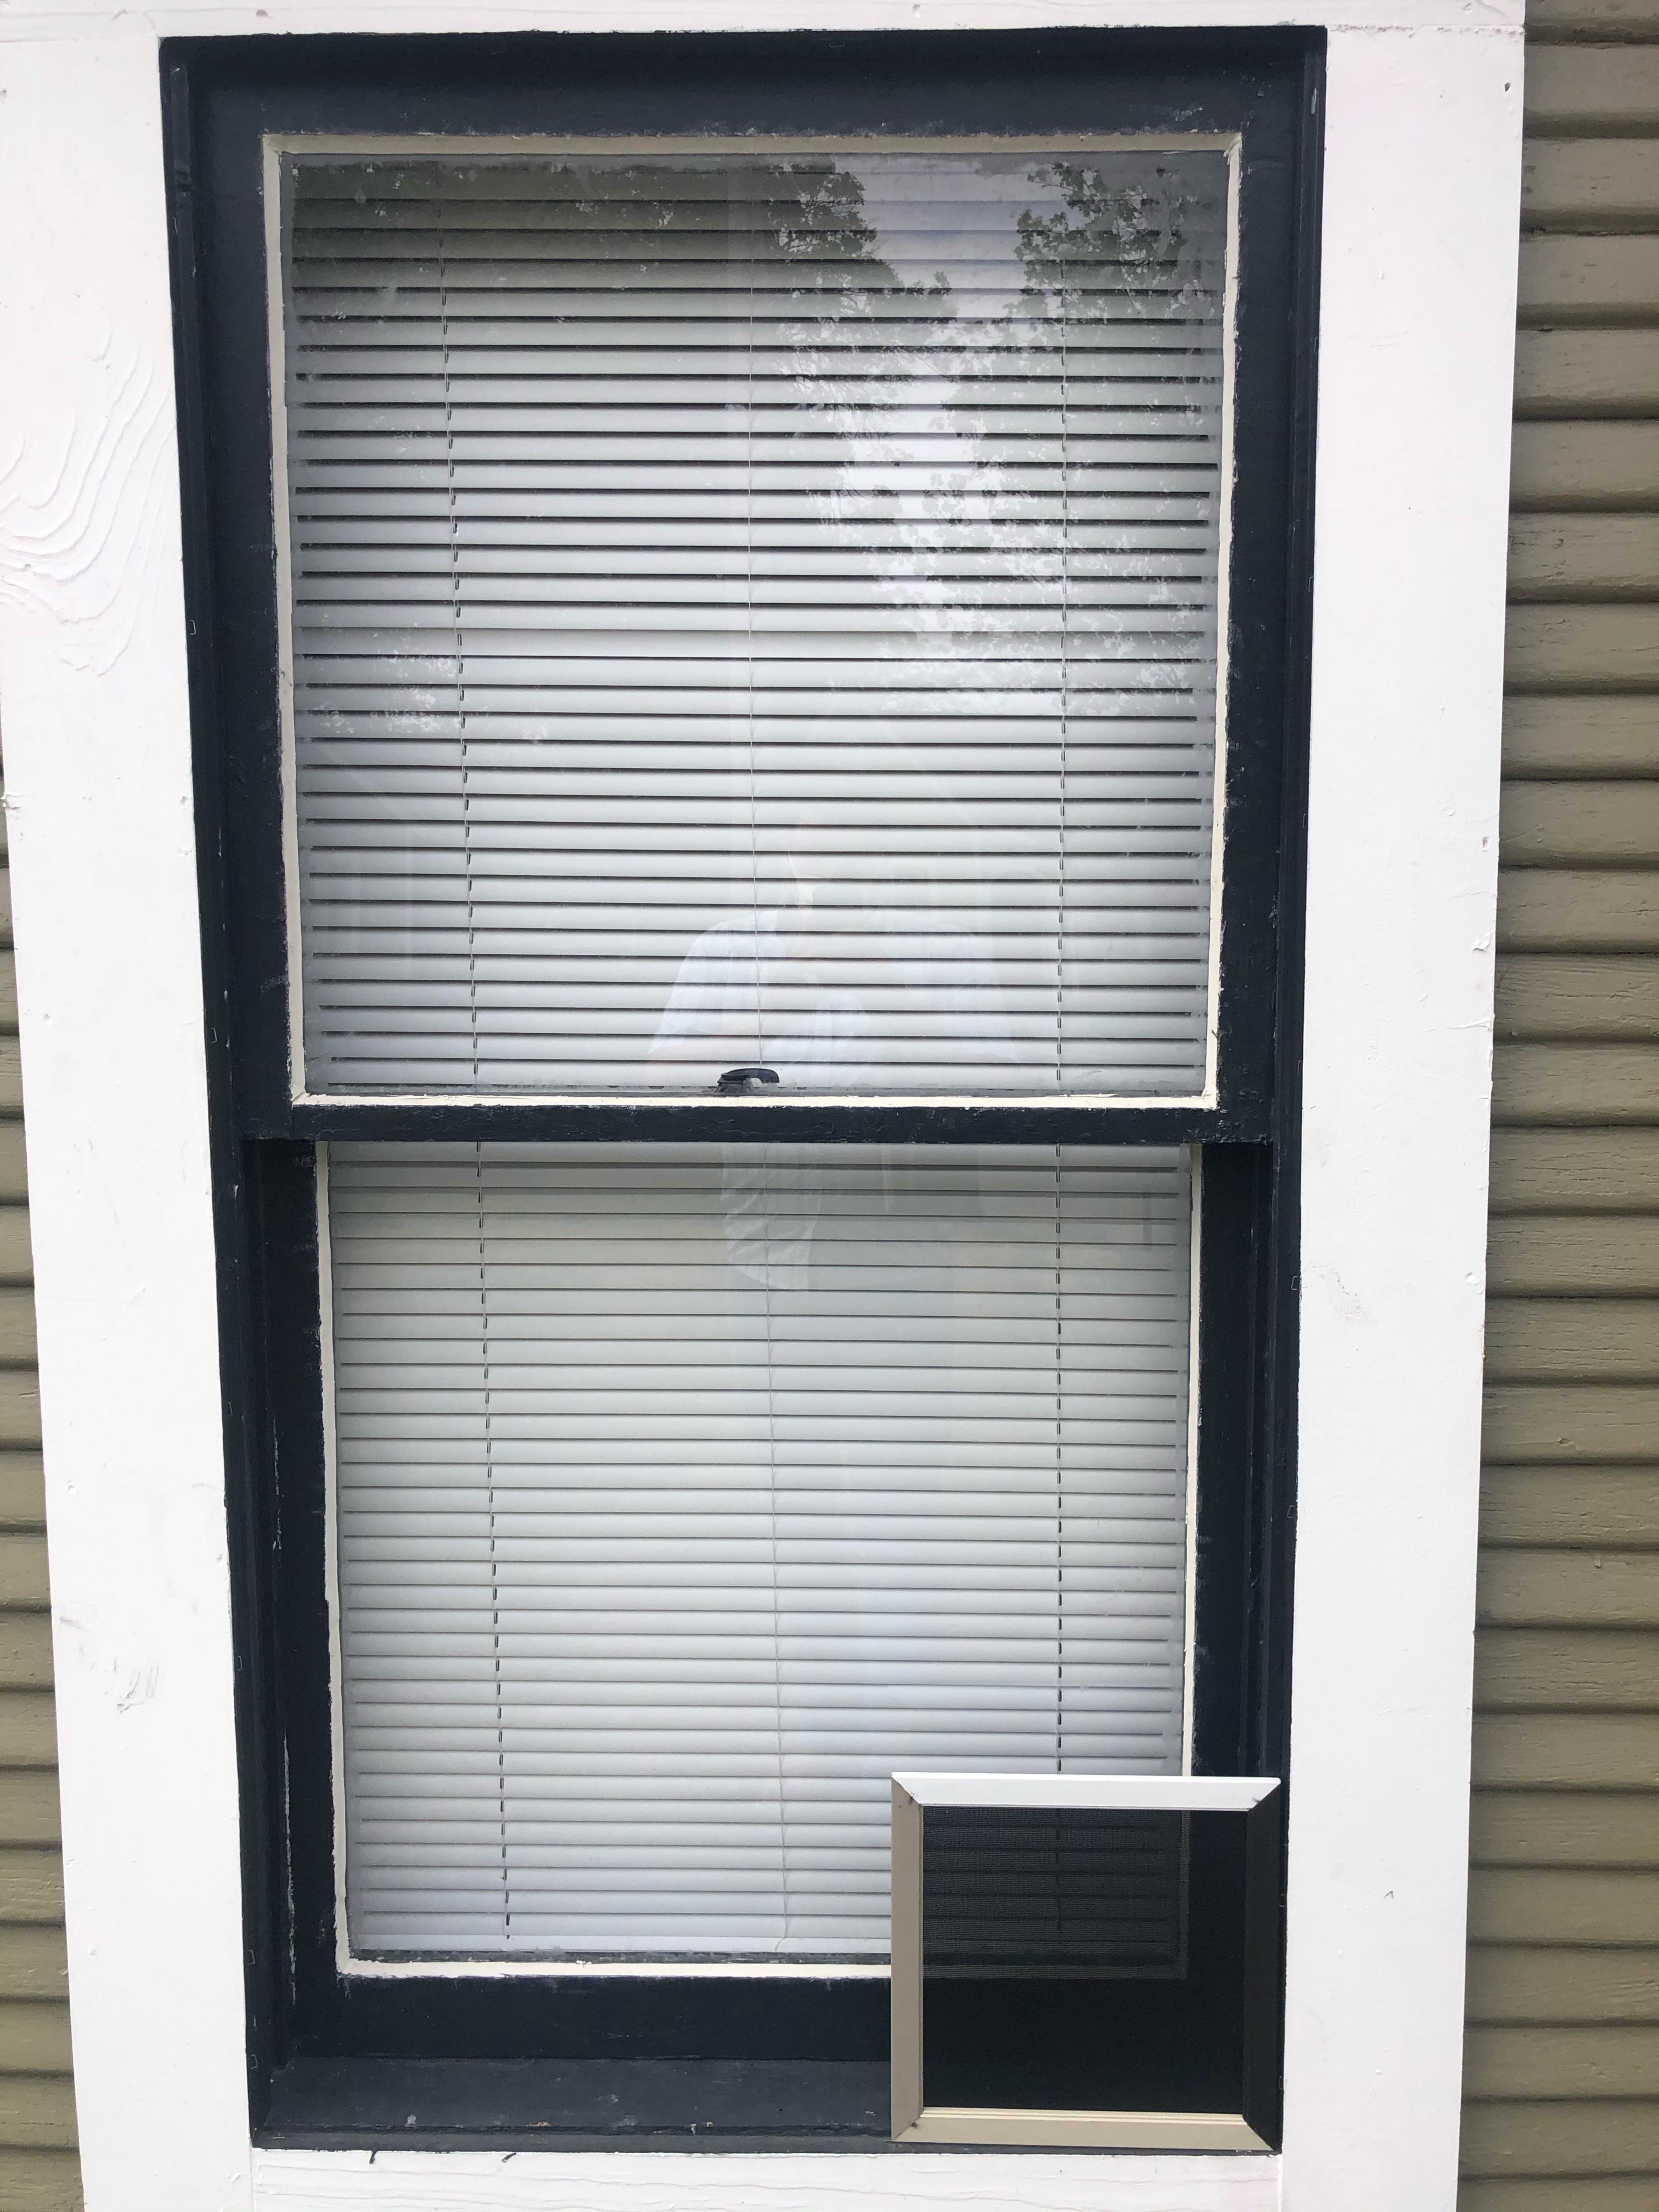
PRAIRIE

- b. SOLAR SCREEN INSTALLATION The applicant has proposed to install solar screens over each of the existing 22 windows. The solar screens will feature aluminum frames, dark mesh screens, and the Prairie grid pattern. According to Guideline 6.B.ix for Exterior Maintenance and Alterations, wood screen window frames should match those historically found in profile, size, and design. Additionally, the Guideline states that the tint of replacement screens should closely match original screens or those used historically. While the property does not feature original window screens, the applicant can use window screens on nearby historic properties as precedent. The applicant should install wood window screens with a screen tint similar to those historically found in the neighborhood or other historic districts in a one-over-one configuration or a style consistent with other Tudor Revival homes. Examples of traditional wood window screens in the Keystone Historic District include the properties at 1442 W Rosewood, 1554 W Lynwood, 1550 W Lynwood, 1543 W Lynwood, and 1523 W Lynwood. Staff finds the installation of window screens appropriate but finds that the screens should be constructed of wood frames with a screen tint that is consistent with the Guidelines.

i. That the screens be fully wood in lieu of the proposed aluminum and feature a tint that closely matches those used historically in the district. The applicant is required to submit an updated product specification to staff for review and approval prior to receiving a Certificate of Appropriateness.
