# HISTORIC AND DESIGN REVIEW COMMISSION

**HDRC CASE NO:** 2021-195  
**ADDRESS:** 1901 N NEW BRAUNFELS AVE  
**LEGAL DESCRIPTION:** NCB 1258 BLK LOT E 57.7 FT OF 17-18-19-20 & 21  
**ZONING:** C-2 IDZ, H  
**CITY COUNCIL DIST.:** 2  
**DISTRICT:** Government Hill Historic District  
**APPLICANT:** Kent Niemann/GOVERNMENT HILL SQUARE PROPERTIES LP  
**OWNER:** Kent Niemann/GOVERNMENT HILL SQUARE PROPERTIES LP  
**TYPE OF WORK:** Replacement of building tile, new building tile installation  
**APPLICATION RECEIVED:** April 16, 2021  
**60-DAY REVIEW:** Not applicable due to City Council Emergency Orders  
**CASE MANAGER:** Edward Hall

## REQUEST:

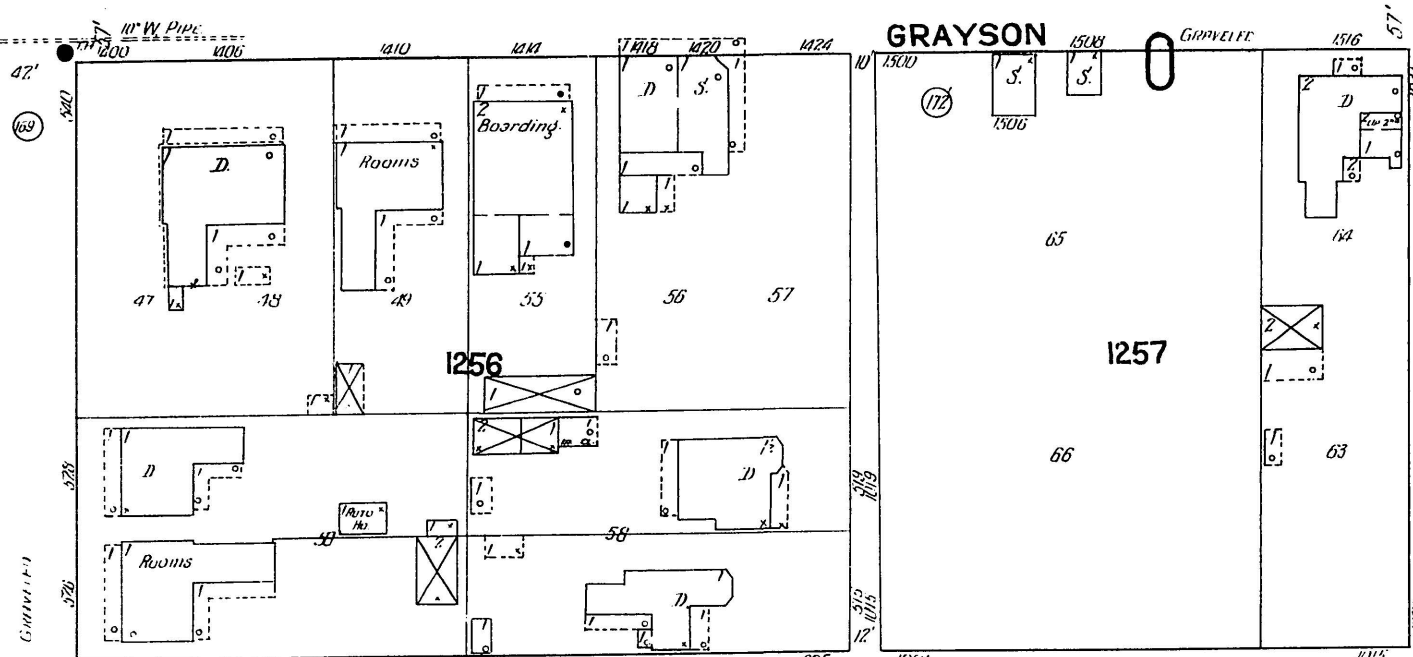
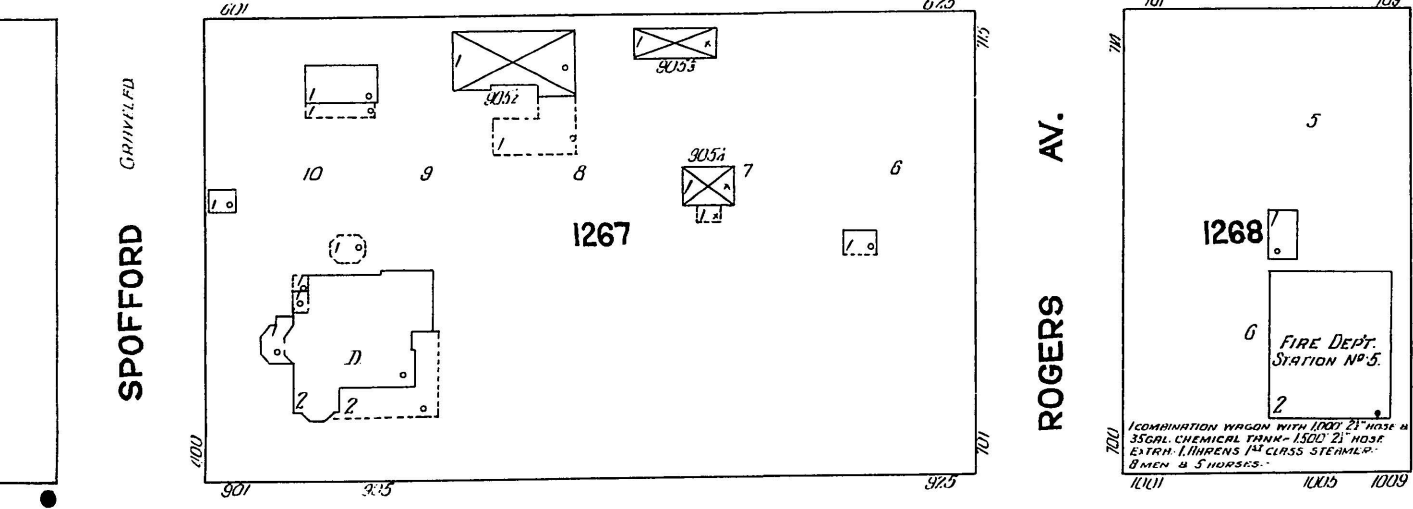
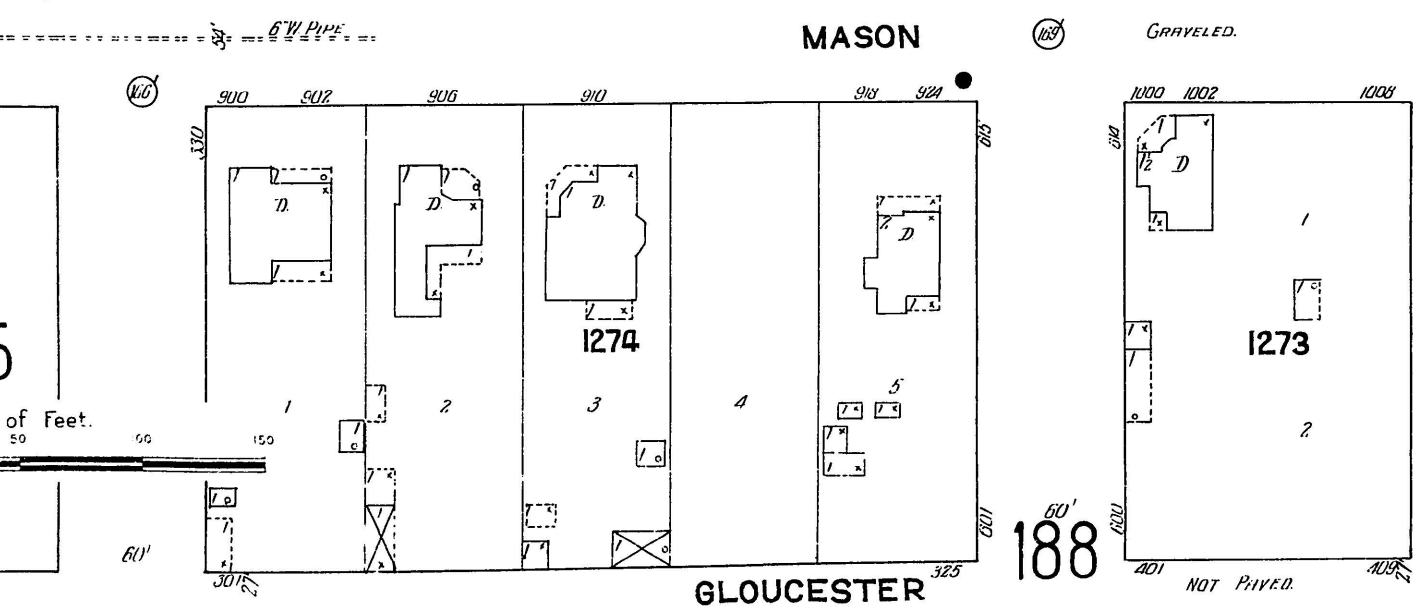
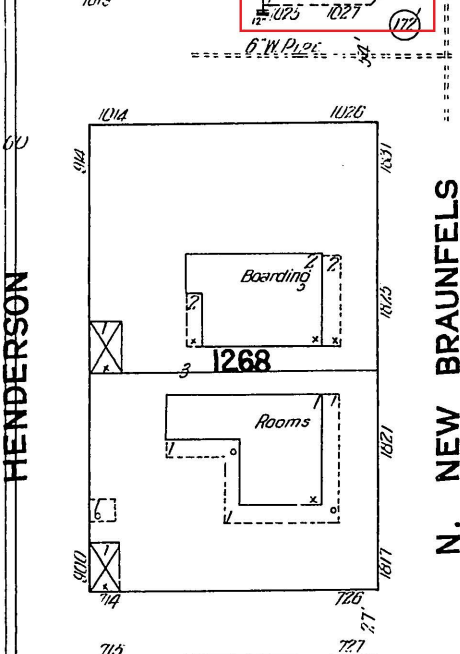
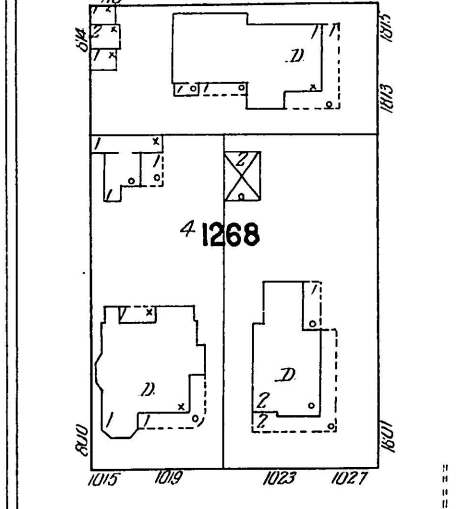
1912 SANBORN MAP

- a. The historic structure at 1901 N New Braunfels was constructed circa 1910 and is first found on the 1912 Sanborn Map. The historic structure features one story in height, a storefront system and sidewalk canopy. The historic structure features historic tile at some locations, which other locations feature replacement tile or no tile.

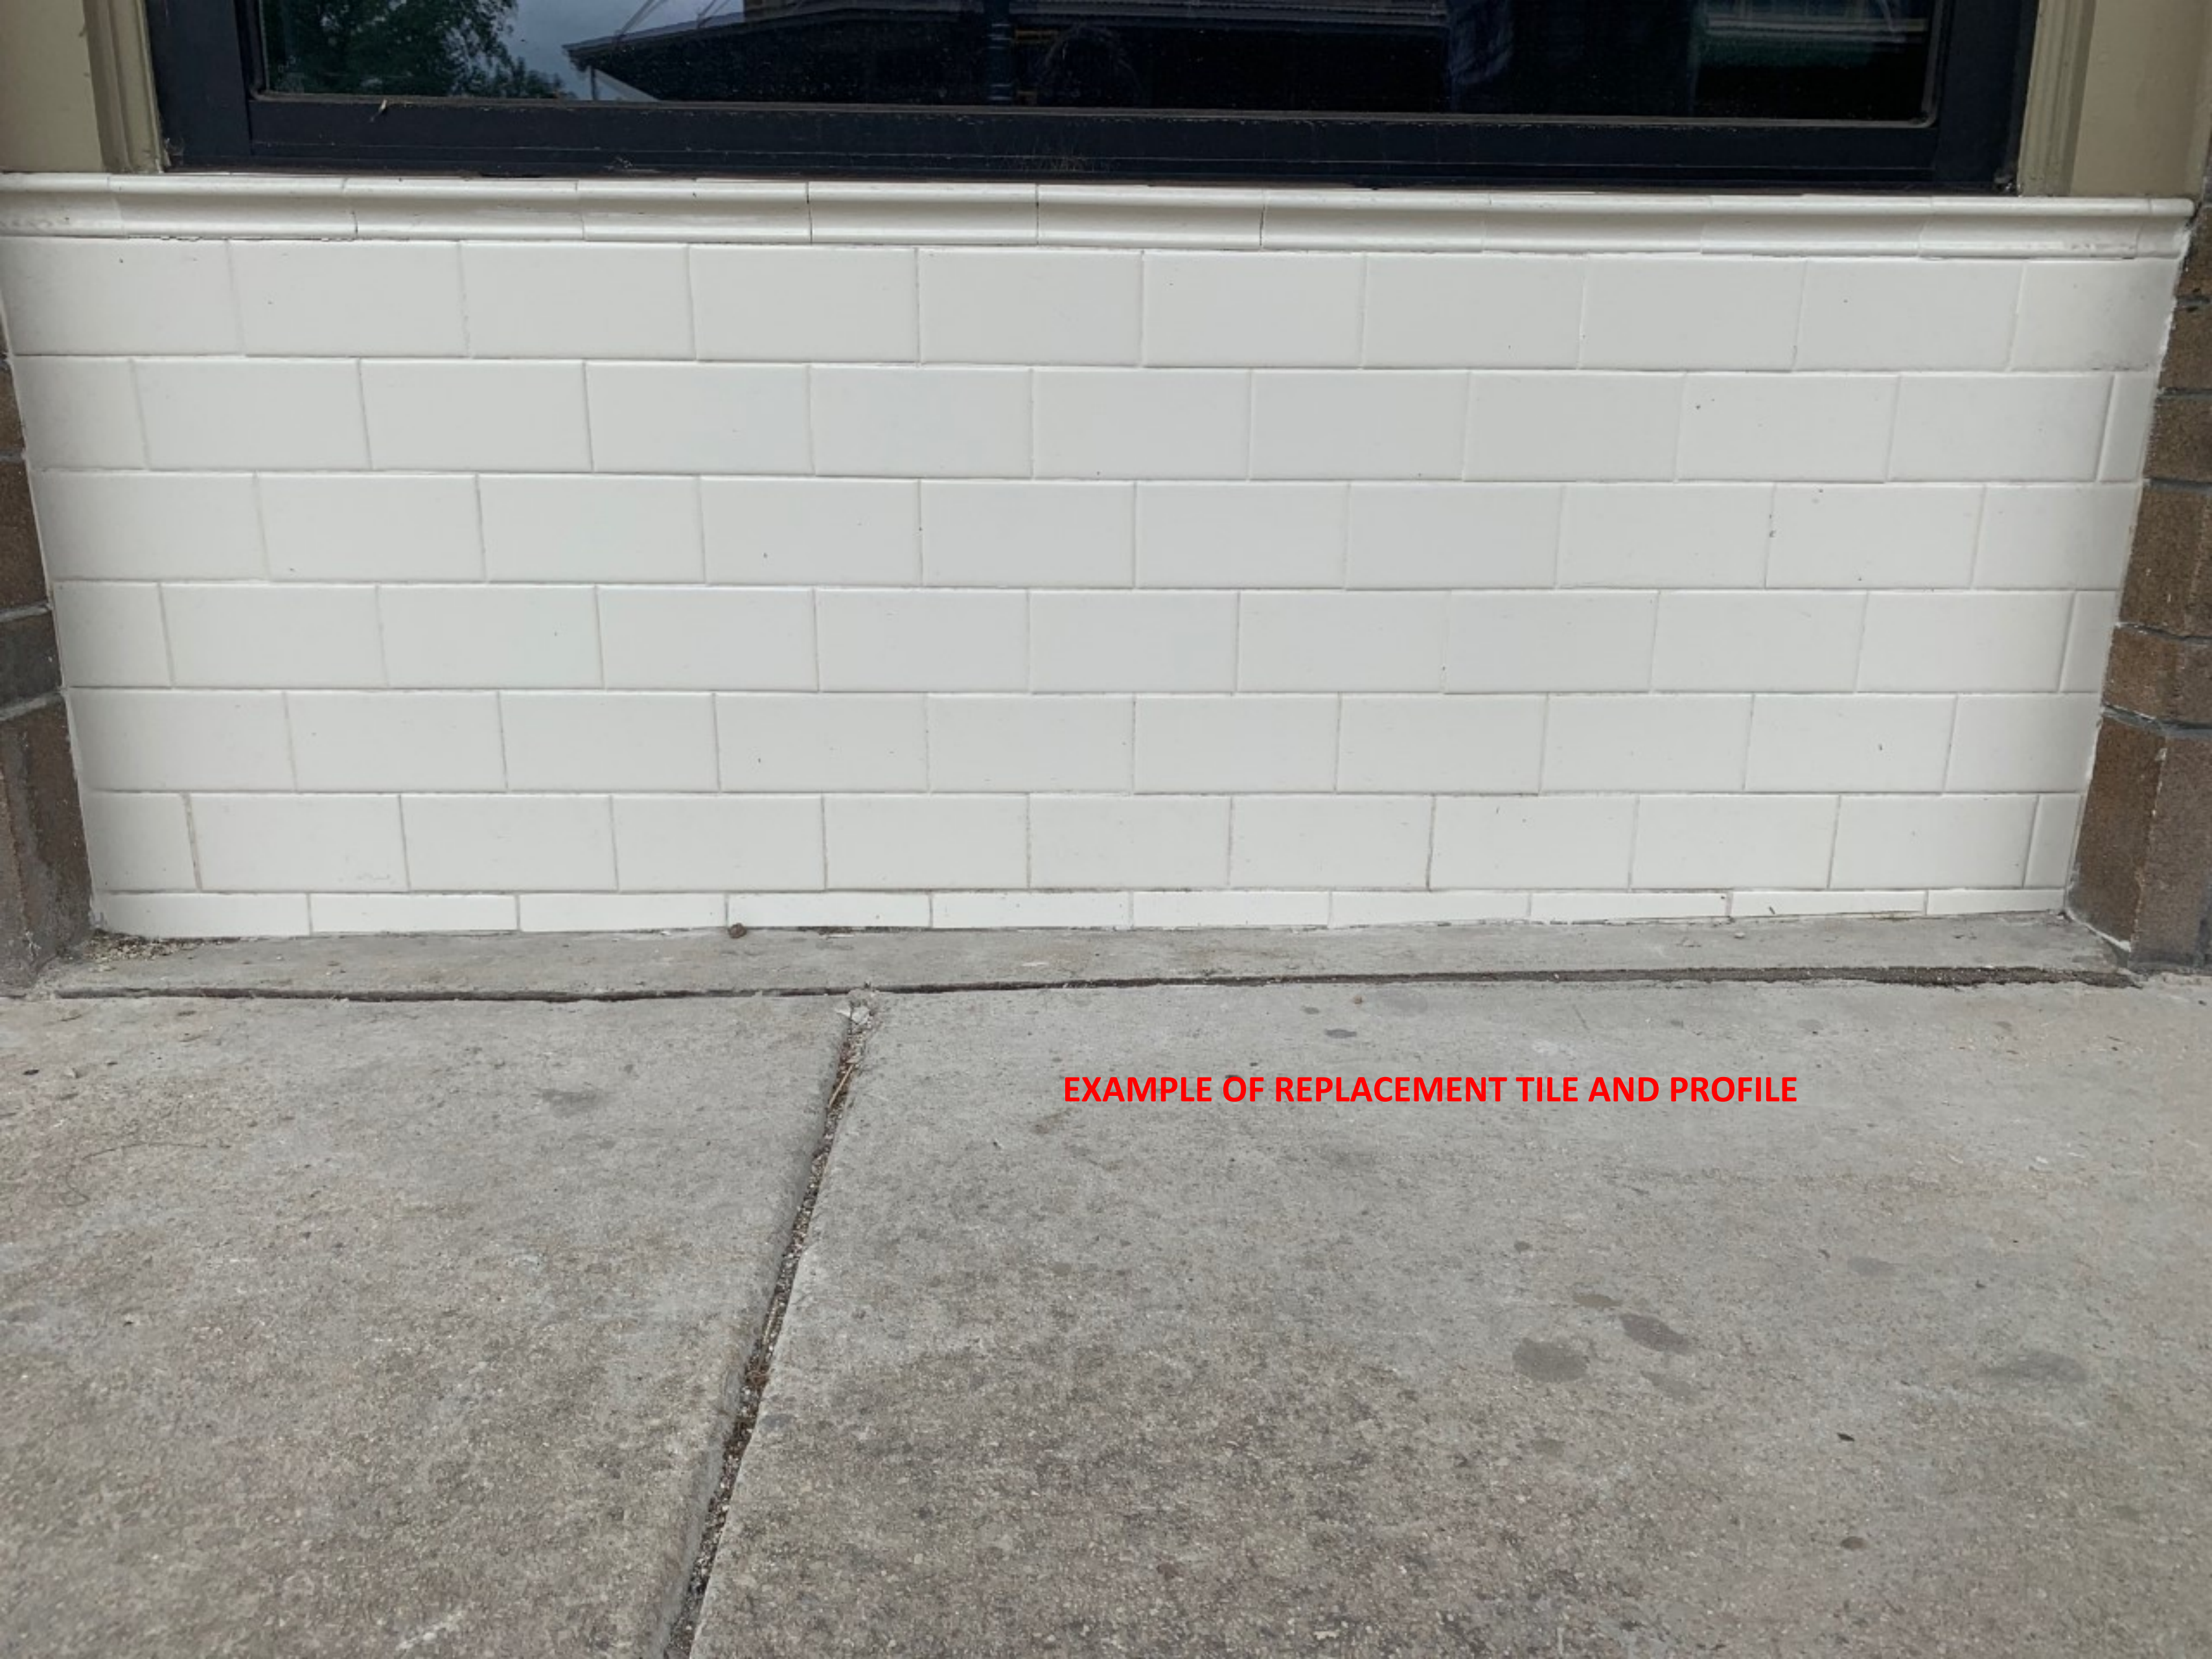
EXAMPLE OF REPLACEMENT TILE AND PROFILE

the applicant has proposed to install the new tile on top of the existing, to preserve the existing in place. Per the Guidelines for Exterior Maintenance and Alterations 10.A.i., applicants are to preserve character defining features such as cornice molding, upper-story windows, transoms, display windows, kickplates, entryways, tiled paving at entryways, parapet walls, bulkheads, and other features that contribute to the character of the building. Additionally, per the Guidelines for Exterior Maintenance and Alterations 10.B.i. applicant should not introduce new facade elements that alter or destroy the historic building character. Staff finds the installation of matching tile where tile does not exist or where tile is non-original to be appropriate and consistent with the Guidelines; however, staff finds the installation of new tile on top of existing, original tile to be inconsistent with the Guidelines. Staff finds that original tile should be repaired.
