# HISTORIC AND DESIGN REVIEW COMMISSION

**HDRC CASE NO:** 2021-206  
**ADDRESS:** 401 NORTH DR  
**LEGAL DESCRIPTION:** NCB 7059 BLK 8 LOT 11  
**ZONING:** R-6,H  
**CITY COUNCIL DIST.:** 7  
**DISTRICT:** Monticello Park Historic District  
**APPLICANT:** Patricia Wathen  
**OWNER:** Patricia Wathen  
**TYPE OF WORK:** Replacement of concrete walkway with flagstone  
**APPLICATION RECEIVED:** April 22, 2021  
**60-DAY REVIEW:** Not applicable due to City Council Emergency Orders  
**CASE MANAGER:** Stephanie Phillips

The applicant is requesting a Certificate of Appropriateness for approval to replace the front concrete walkway with a new flagstone walkway.

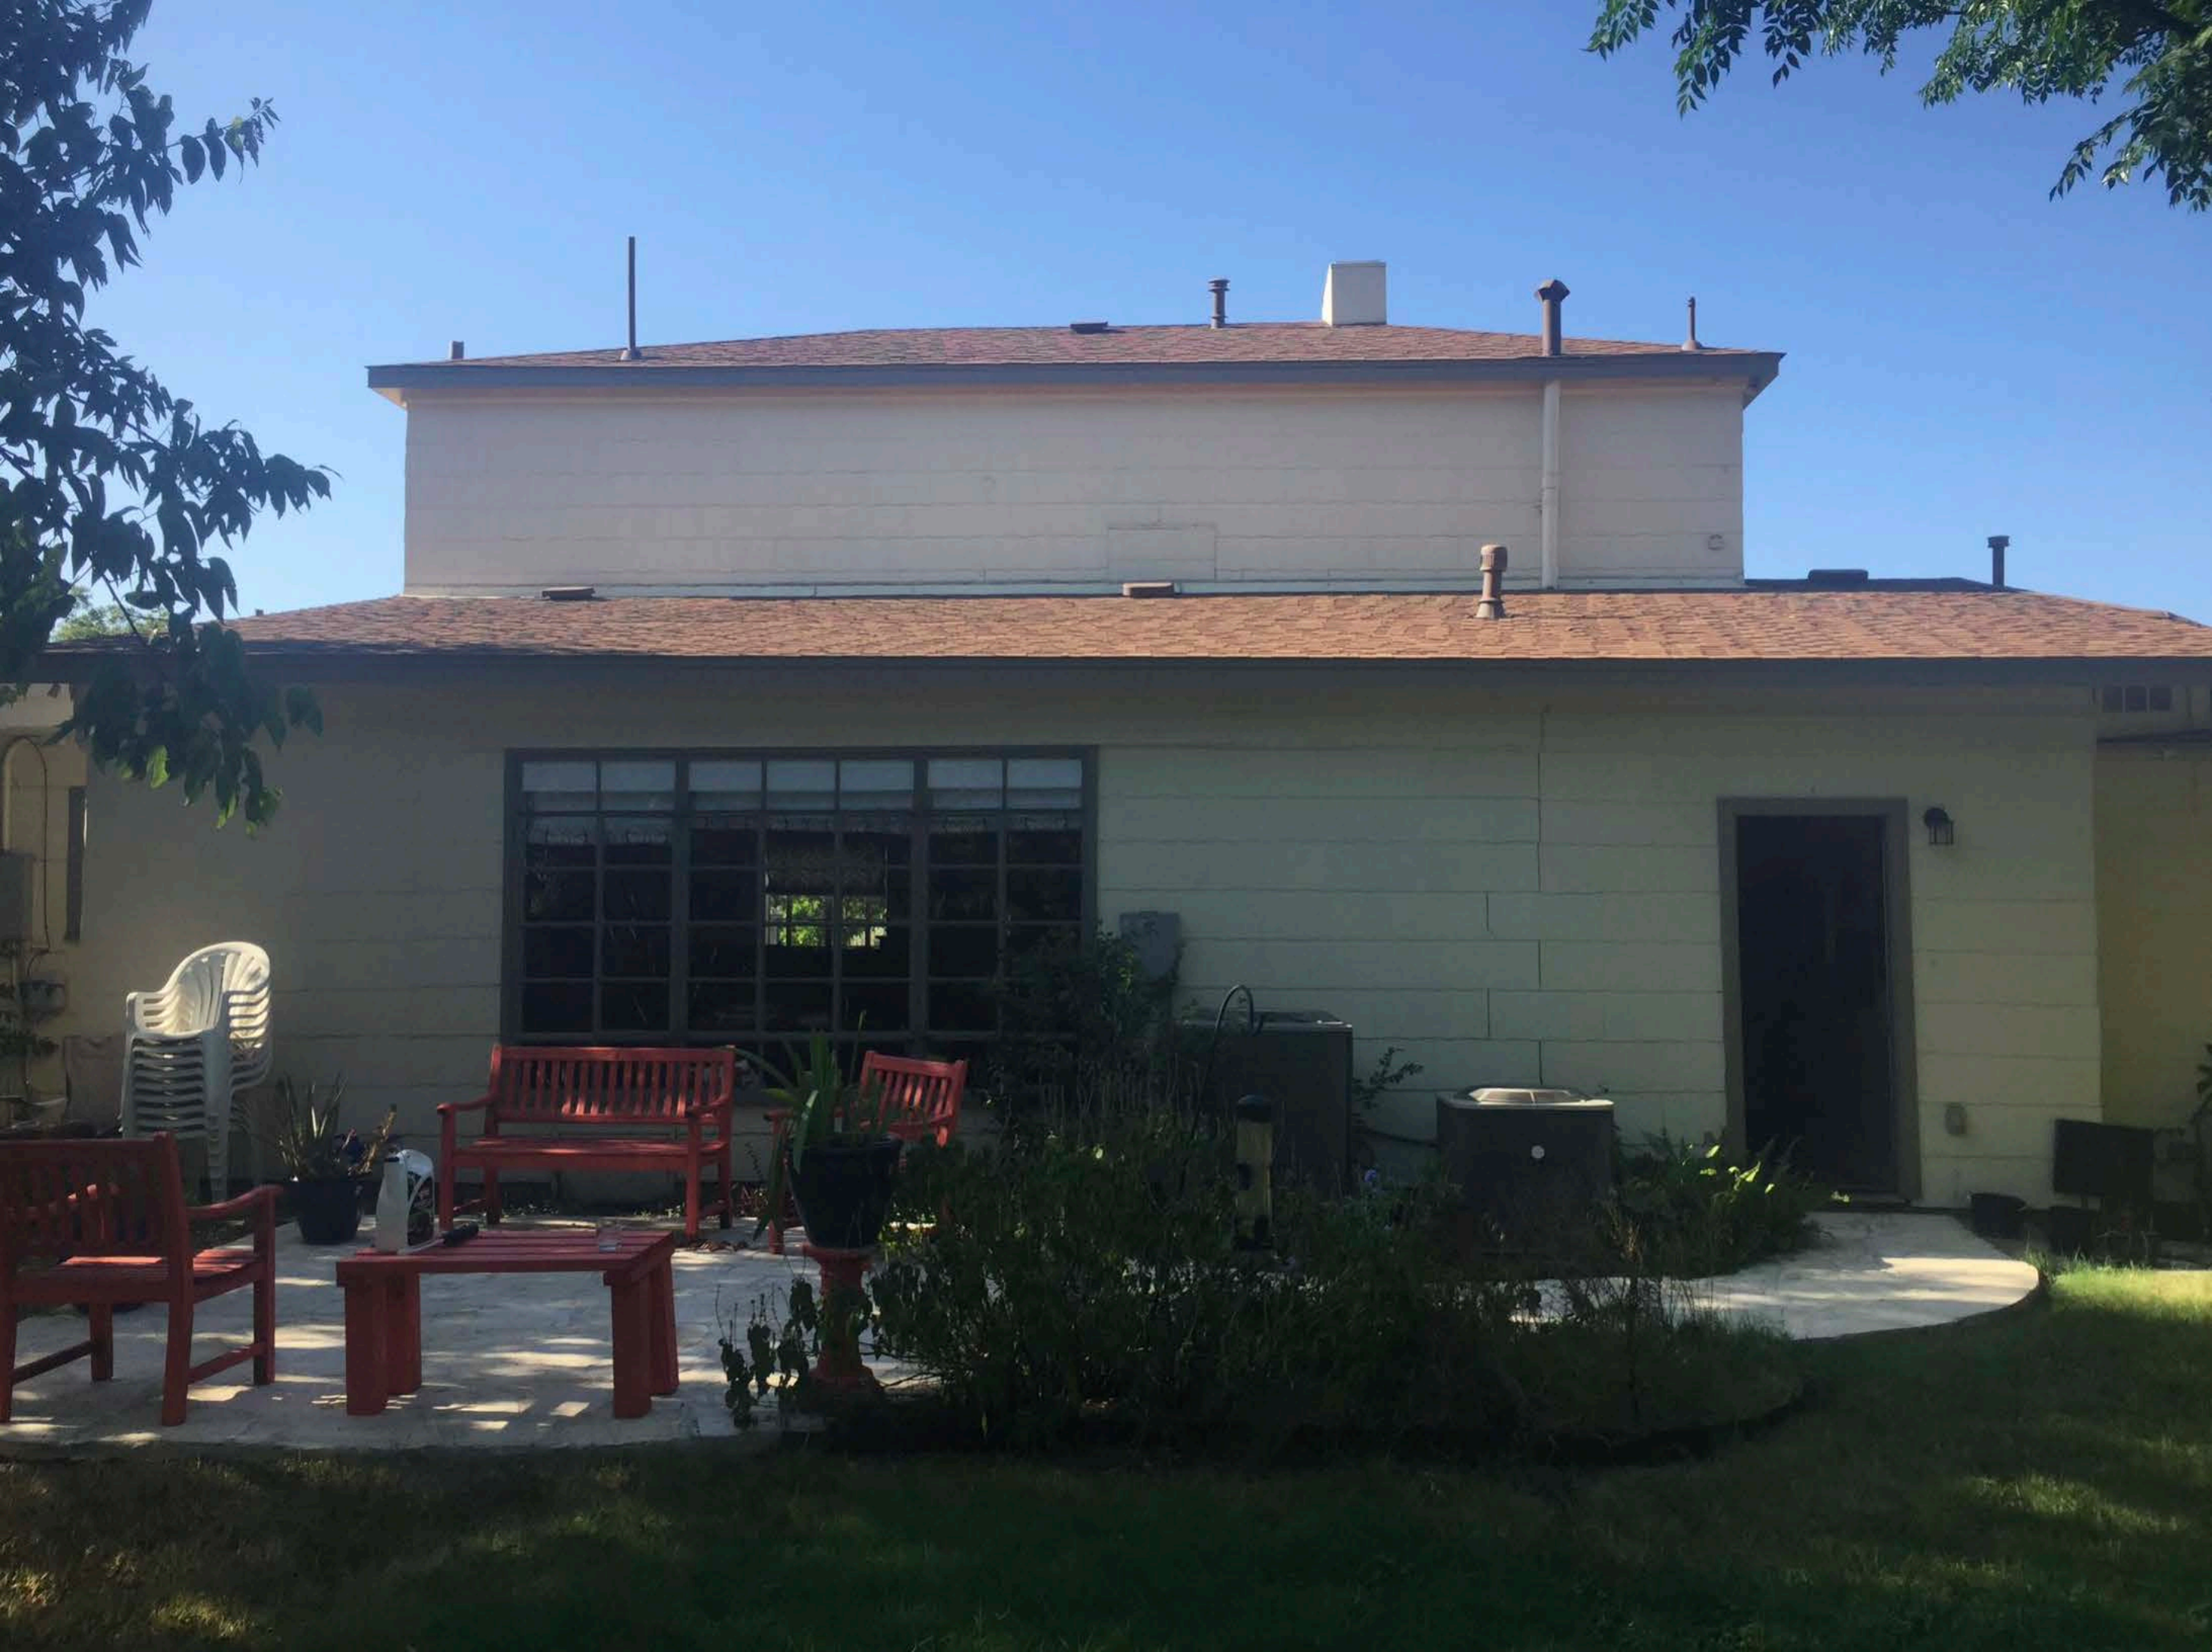
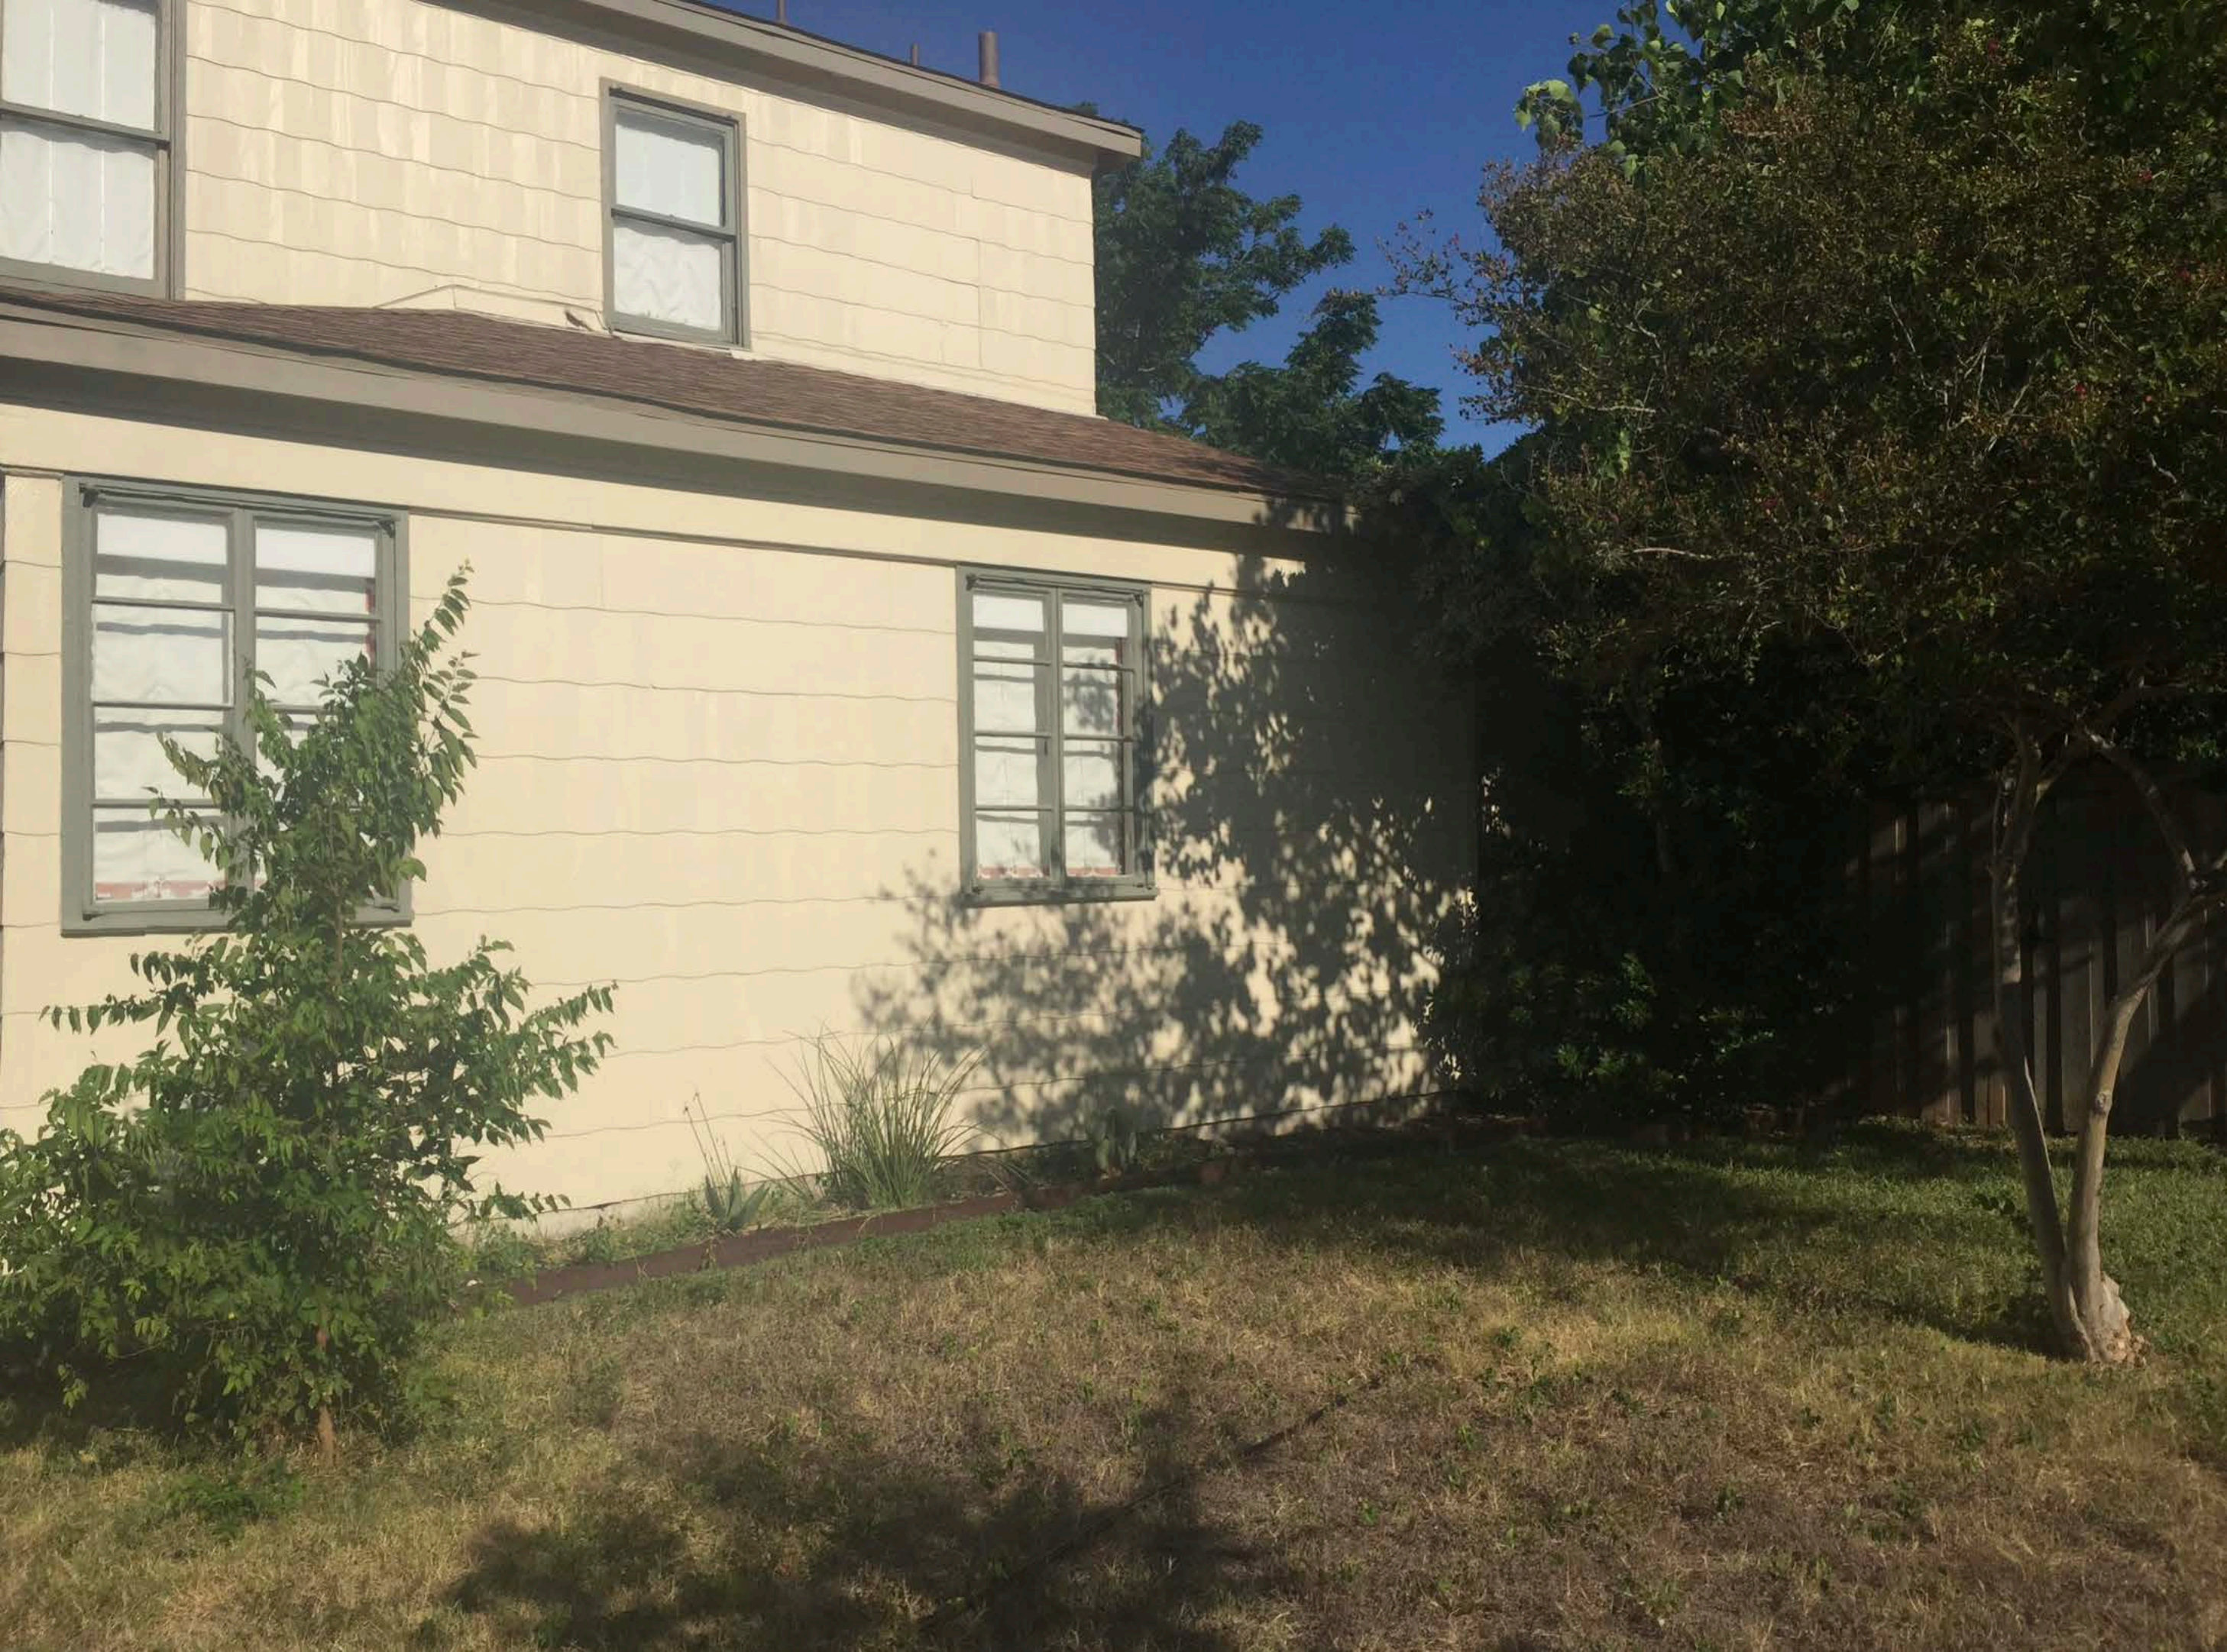
- b. FRONT WALKWAY REPLACEMENT – The applicant has proposed to replace the existing concrete front walkway with limestone pavers. Guideline 5.A.i for Site Elements states that historic sidewalk and walkway paving materials—often brick or concrete—should be retained and repaired in place. According to Guideline 5.A.ii for Site Elements, when replacing those portions of sidewalks or walkways that are deteriorated beyond repair, every effort should be made to match existing sidewalk color and material. North Dr and this area of the district is characterized by gently curving concrete walkways leading from the public sidewalk and street to front doors. Staff finds the proposal inconsistent with the Guidelines.

Staff does not recommend approval of the limestone walkway installation based on finding b. Staff recommends that the applicant repairs and replaces the existing concrete walkway with in-kind material and matches the existing footprint and design.

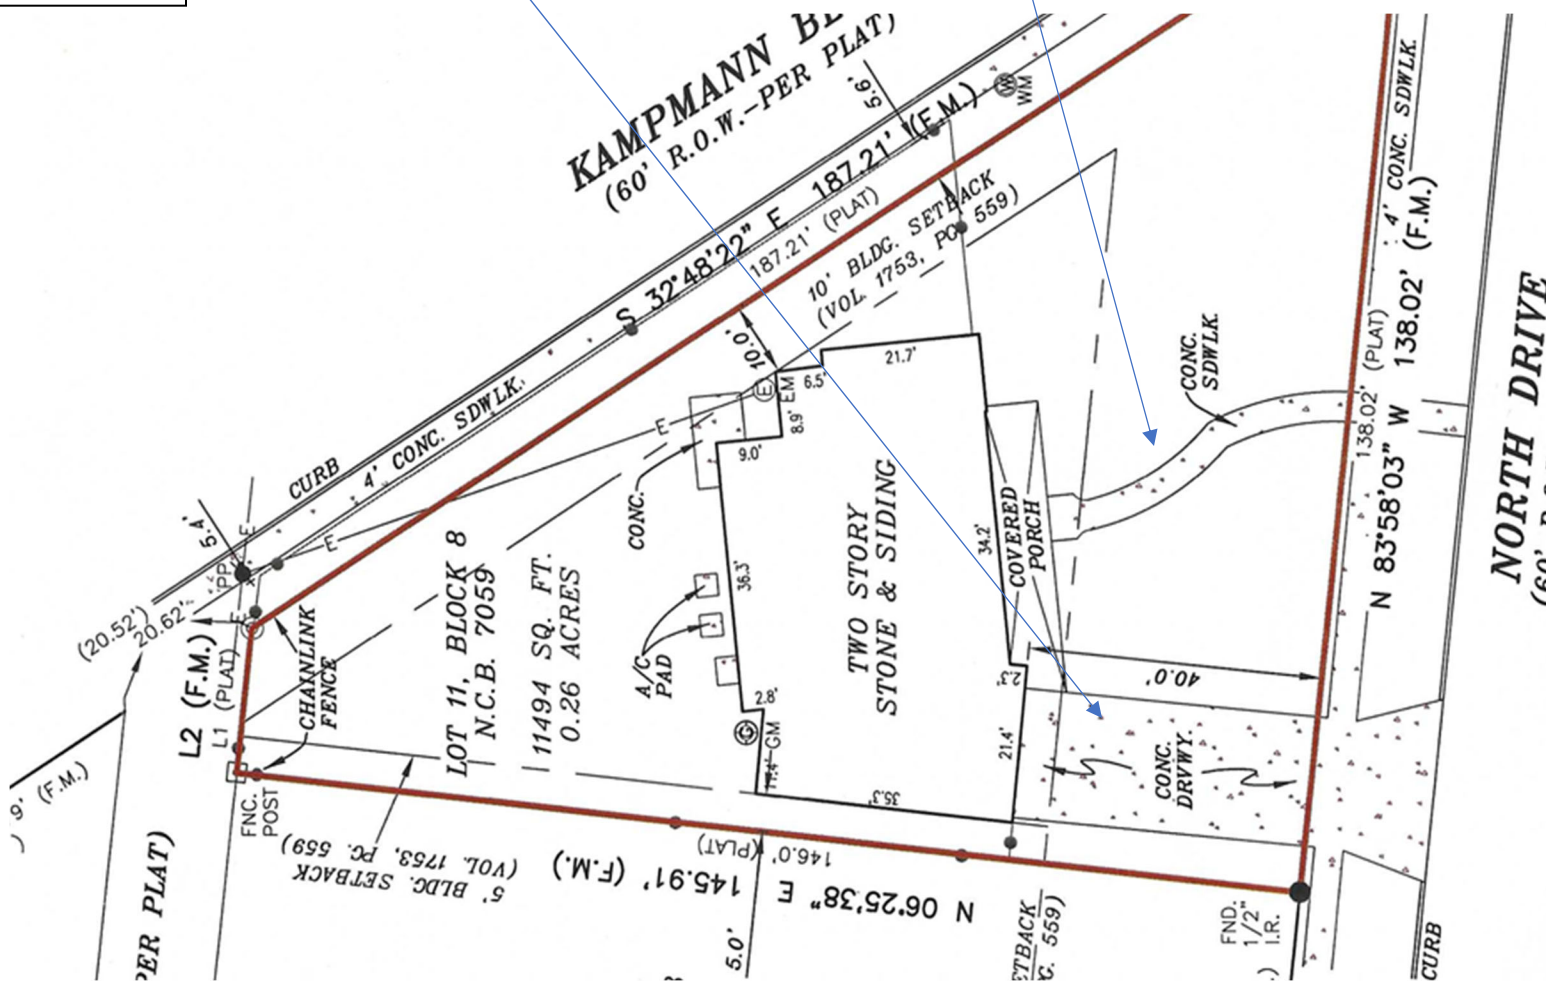
Concrete driveway: 40 ft by 21.4 ft replace cracked and broken concrete with new pour

Walkway: Dimensions 37 feet long, 4 ft wide: Currently concrete (cracked). Proposal is to replace with flagstone walkway
