# HISTORIC AND DESIGN REVIEW COMMISSION

**HDRC CASE NO:** 2021-242  
**ADDRESS:** 134 W MISTLETOE  
**LEGAL DESCRIPTION:** NCB 1837 BLK 15 LOT 1 & W 14.28 FT OF 2  
**ZONING:** R-4, H  
**CITY COUNCIL DIST.:** 1  
**DISTRICT:** Monte Vista Historic District  
**APPLICANT:** Lyndsay Thorn/Thorn Architects  
**OWNER:** ARCHER JOHN CHRISTIAN  
**TYPE OF WORK:** Demolition of a rear accessory structure  
**APPLICATION RECEIVED:** May 07, 2021  
**60-DAY REVIEW:** Not applicable due to City Council Emergency Orders  
**CASE MANAGER:** Rachel Rettaliata

1. Demolish a contributing rear accessory structure.
2. Construct a rear carport.

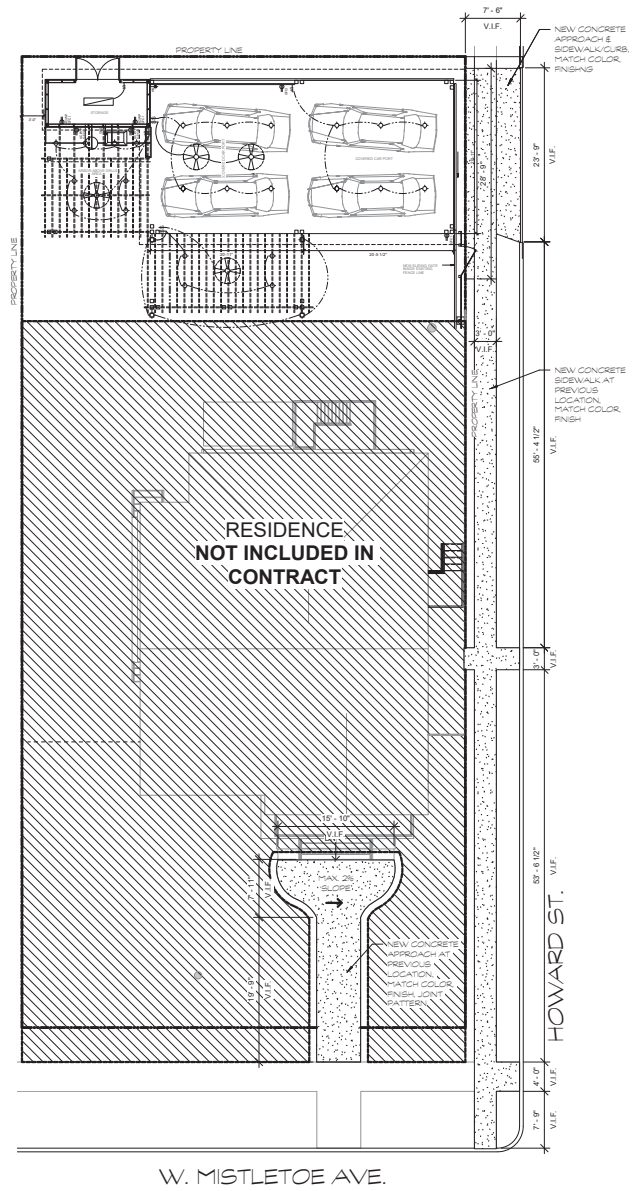
**2** Site - Carport  
 1/8" = 1'-0"

Drawing Title:  
 SITE PLAN - CARPORT

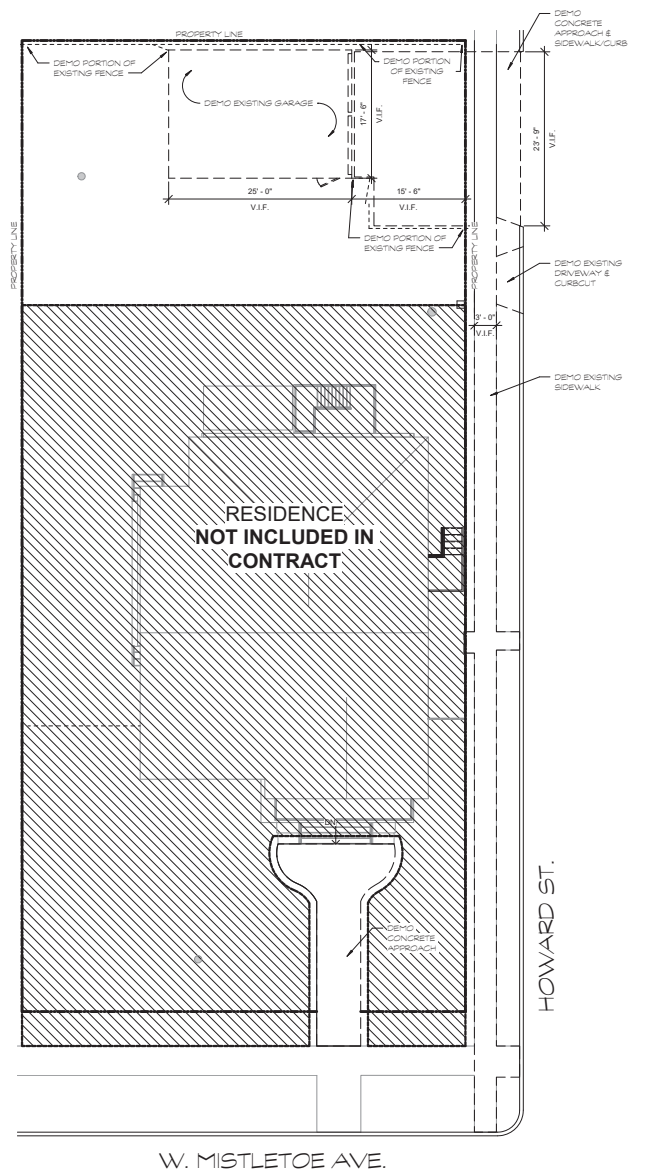
**1** Site - Demo  
 1/8" = 1'-0"

- b. DEMOLITION – The applicant is requesting approval for the demolition of the rear accessory structure only and replace the structure with a rear carport. In general, accessory structures contribute to the character of historic properties and the historical development pattern within a historic district.

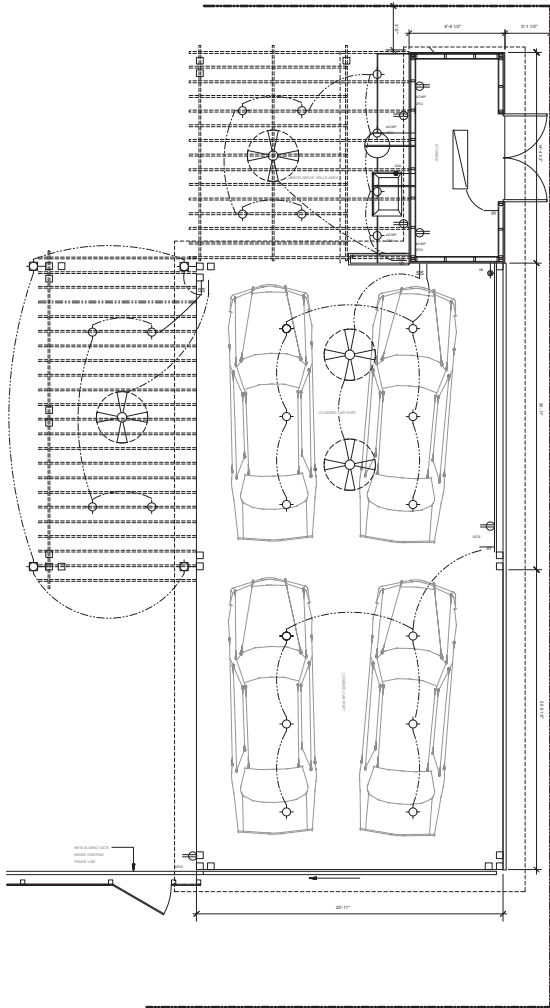
A-1.1 FLOOR PLAN  
Scale: 1/4" = 1'-0"

Drawn: Project No.  
Author: 2037  
Checked: Date: 05/05/21  
Checker:  
Scale: 1/4" = 1'-0"  
Drawing Title:  
PROPOSED FLOOR PLAN  
SECTION AND  
ELEVATIONS

- iii. That the applicant reduces the overall footprint to more closely reflect the footprint of the existing rear accessory structure. An updated site plan and updated elevation drawings must be submitted to staff for review and approval prior to the issuance of a Certificate of Appropriateness.
- iv. That the applicant submits final material specifications to staff for review and approval prior to the issuance of a Certificate of Appropriateness.

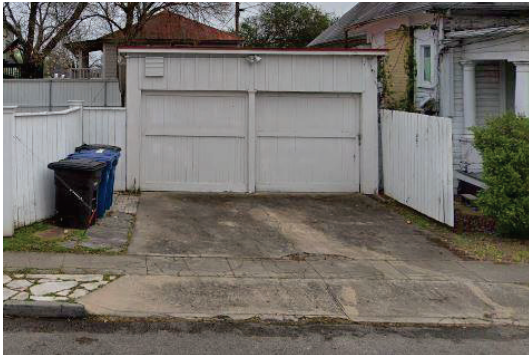
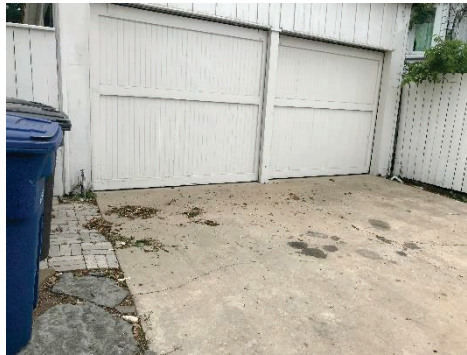
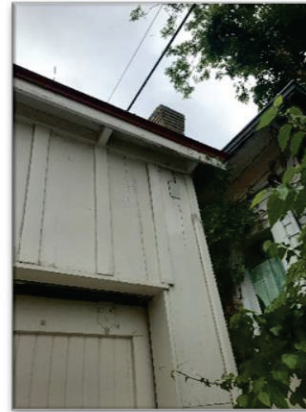
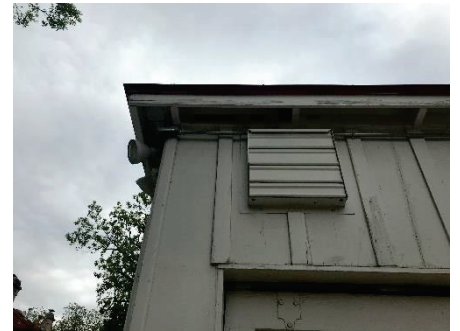
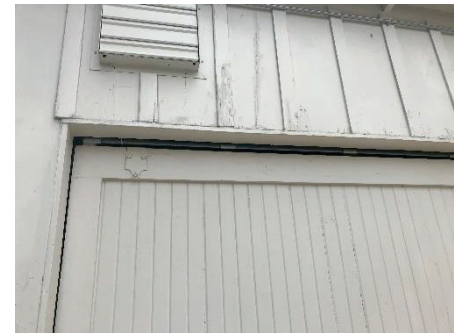
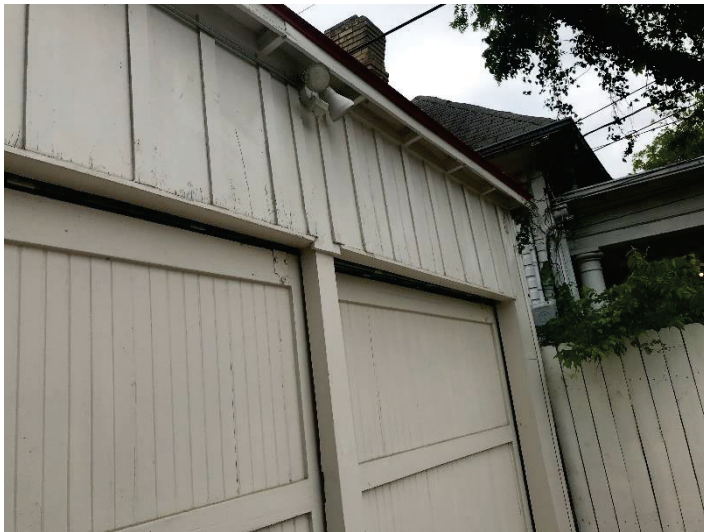
134 W Mistletoe – Garage  
Existing Front Side

Having inspected the accessory garage structure, it is a liability rather than an asset to the owner. In order to render the existing structure safe and useful, the following repairs at a minimum would be required: a new roof; structural reinforcement especially at the primary vehicular entrance; new garage doors; new pedestrian door; new siding on all sides; ventilation repair; new gutters; and adjacent landscape drainage to prevent future wood rot at base. These repairs would cost at a minimum \$50,000 and amount to completely rebuilding a historically insignificant structure. Safely demolishing the current garage would cost approximately \$20,000 and would allow the owner to replace the structure with a more appropriate accessory structure. The difference in costs and lack of historical significance demonstrate an unreasonable economic hardship for the property owner.
