# HISTORIC AND DESIGN REVIEW COMMISSION

**HDRC CASE NO:** 2021-310  
**ADDRESS:** 311 MUNCEY  
**LEGAL DESCRIPTION:** NCB 1657 BLK E LOT N 51 FT OF 15&16  
**ZONING:** R-5, H  
**CITY COUNCIL DIST.:** 2  
**DISTRICT:** Dignowity Hill Historic District  
**APPLICANT:** AEONIUM INVESTMENTS LLC  
**OWNER:** AEONIUM INVESTMENTS LLC  
**TYPE OF WORK:** Installation of porch railing  
**APPLICATION RECEIVED:** June 14, 2021  
**60-DAY REVIEW:** Not applicable due to City Council Emergency Orders  
**CASE MANAGER:** Edward Hall

The applicant is requesting a Certificate of Appropriateness for approval to install porch and porch step railing at 311 Muncey, located within the Dignowity Hill Historic District.

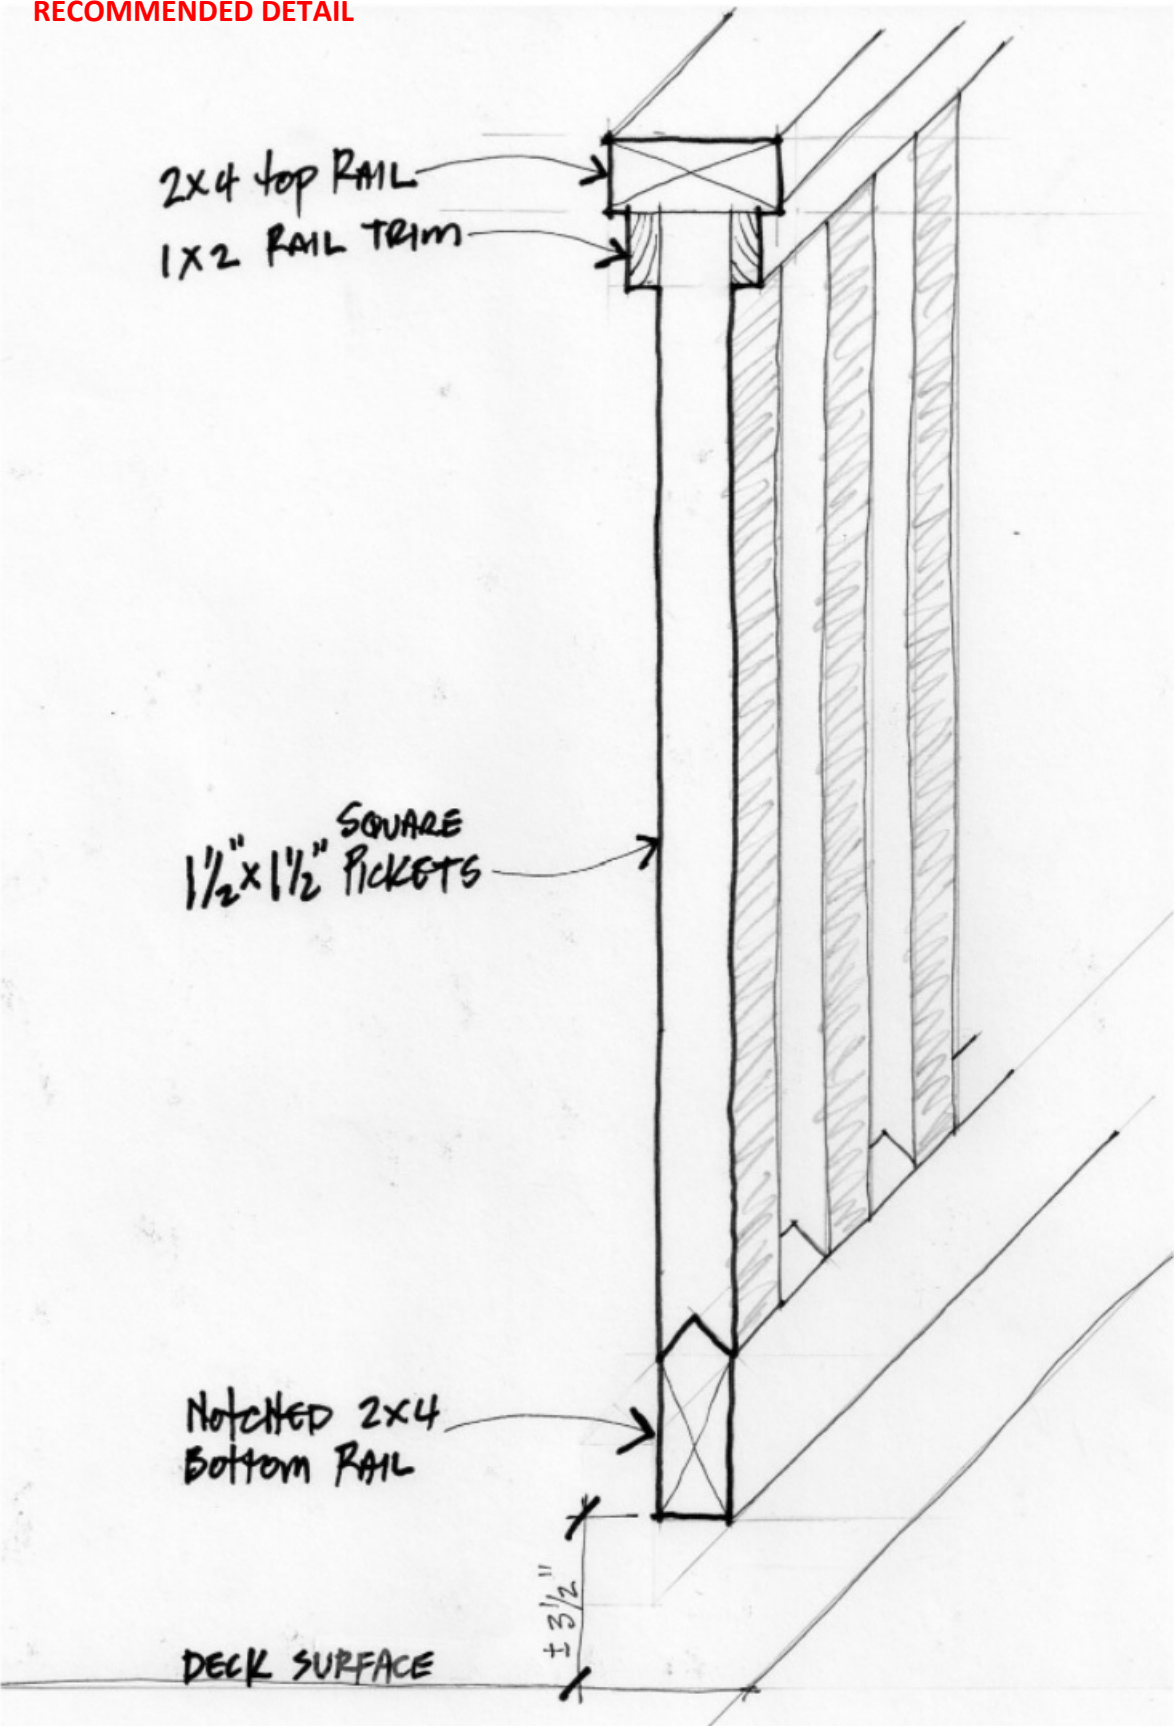
RECOMMENDED DETAIL

2x4 top RAIL

1x2 RAIL TRIM

SQUARE  
 $1\frac{1}{2}" \times 1\frac{1}{2}"$  PICKETS

NOTCHED 2x4  
Bottom RAIL

DECK SURFACE

$\pm 3\frac{1}{2}"$

- d. PORCH RAILING – The applicant has proposed to install porch and porch step railing. Generally, staff finds the installation of porch railing to be appropriate; however, it should be designed in a manner that is architecturally appropriate with both the design of the historic Craftsman house and the Historic District. Staff has included an example of architecturally appropriate porch railing in the exhibits.

Staff does recommends approval based on findings a through d with the stipulation that porch railings with an appropriate profile be installed, as noted in finding d. A detailed drawing has been included in the exhibits for reference.

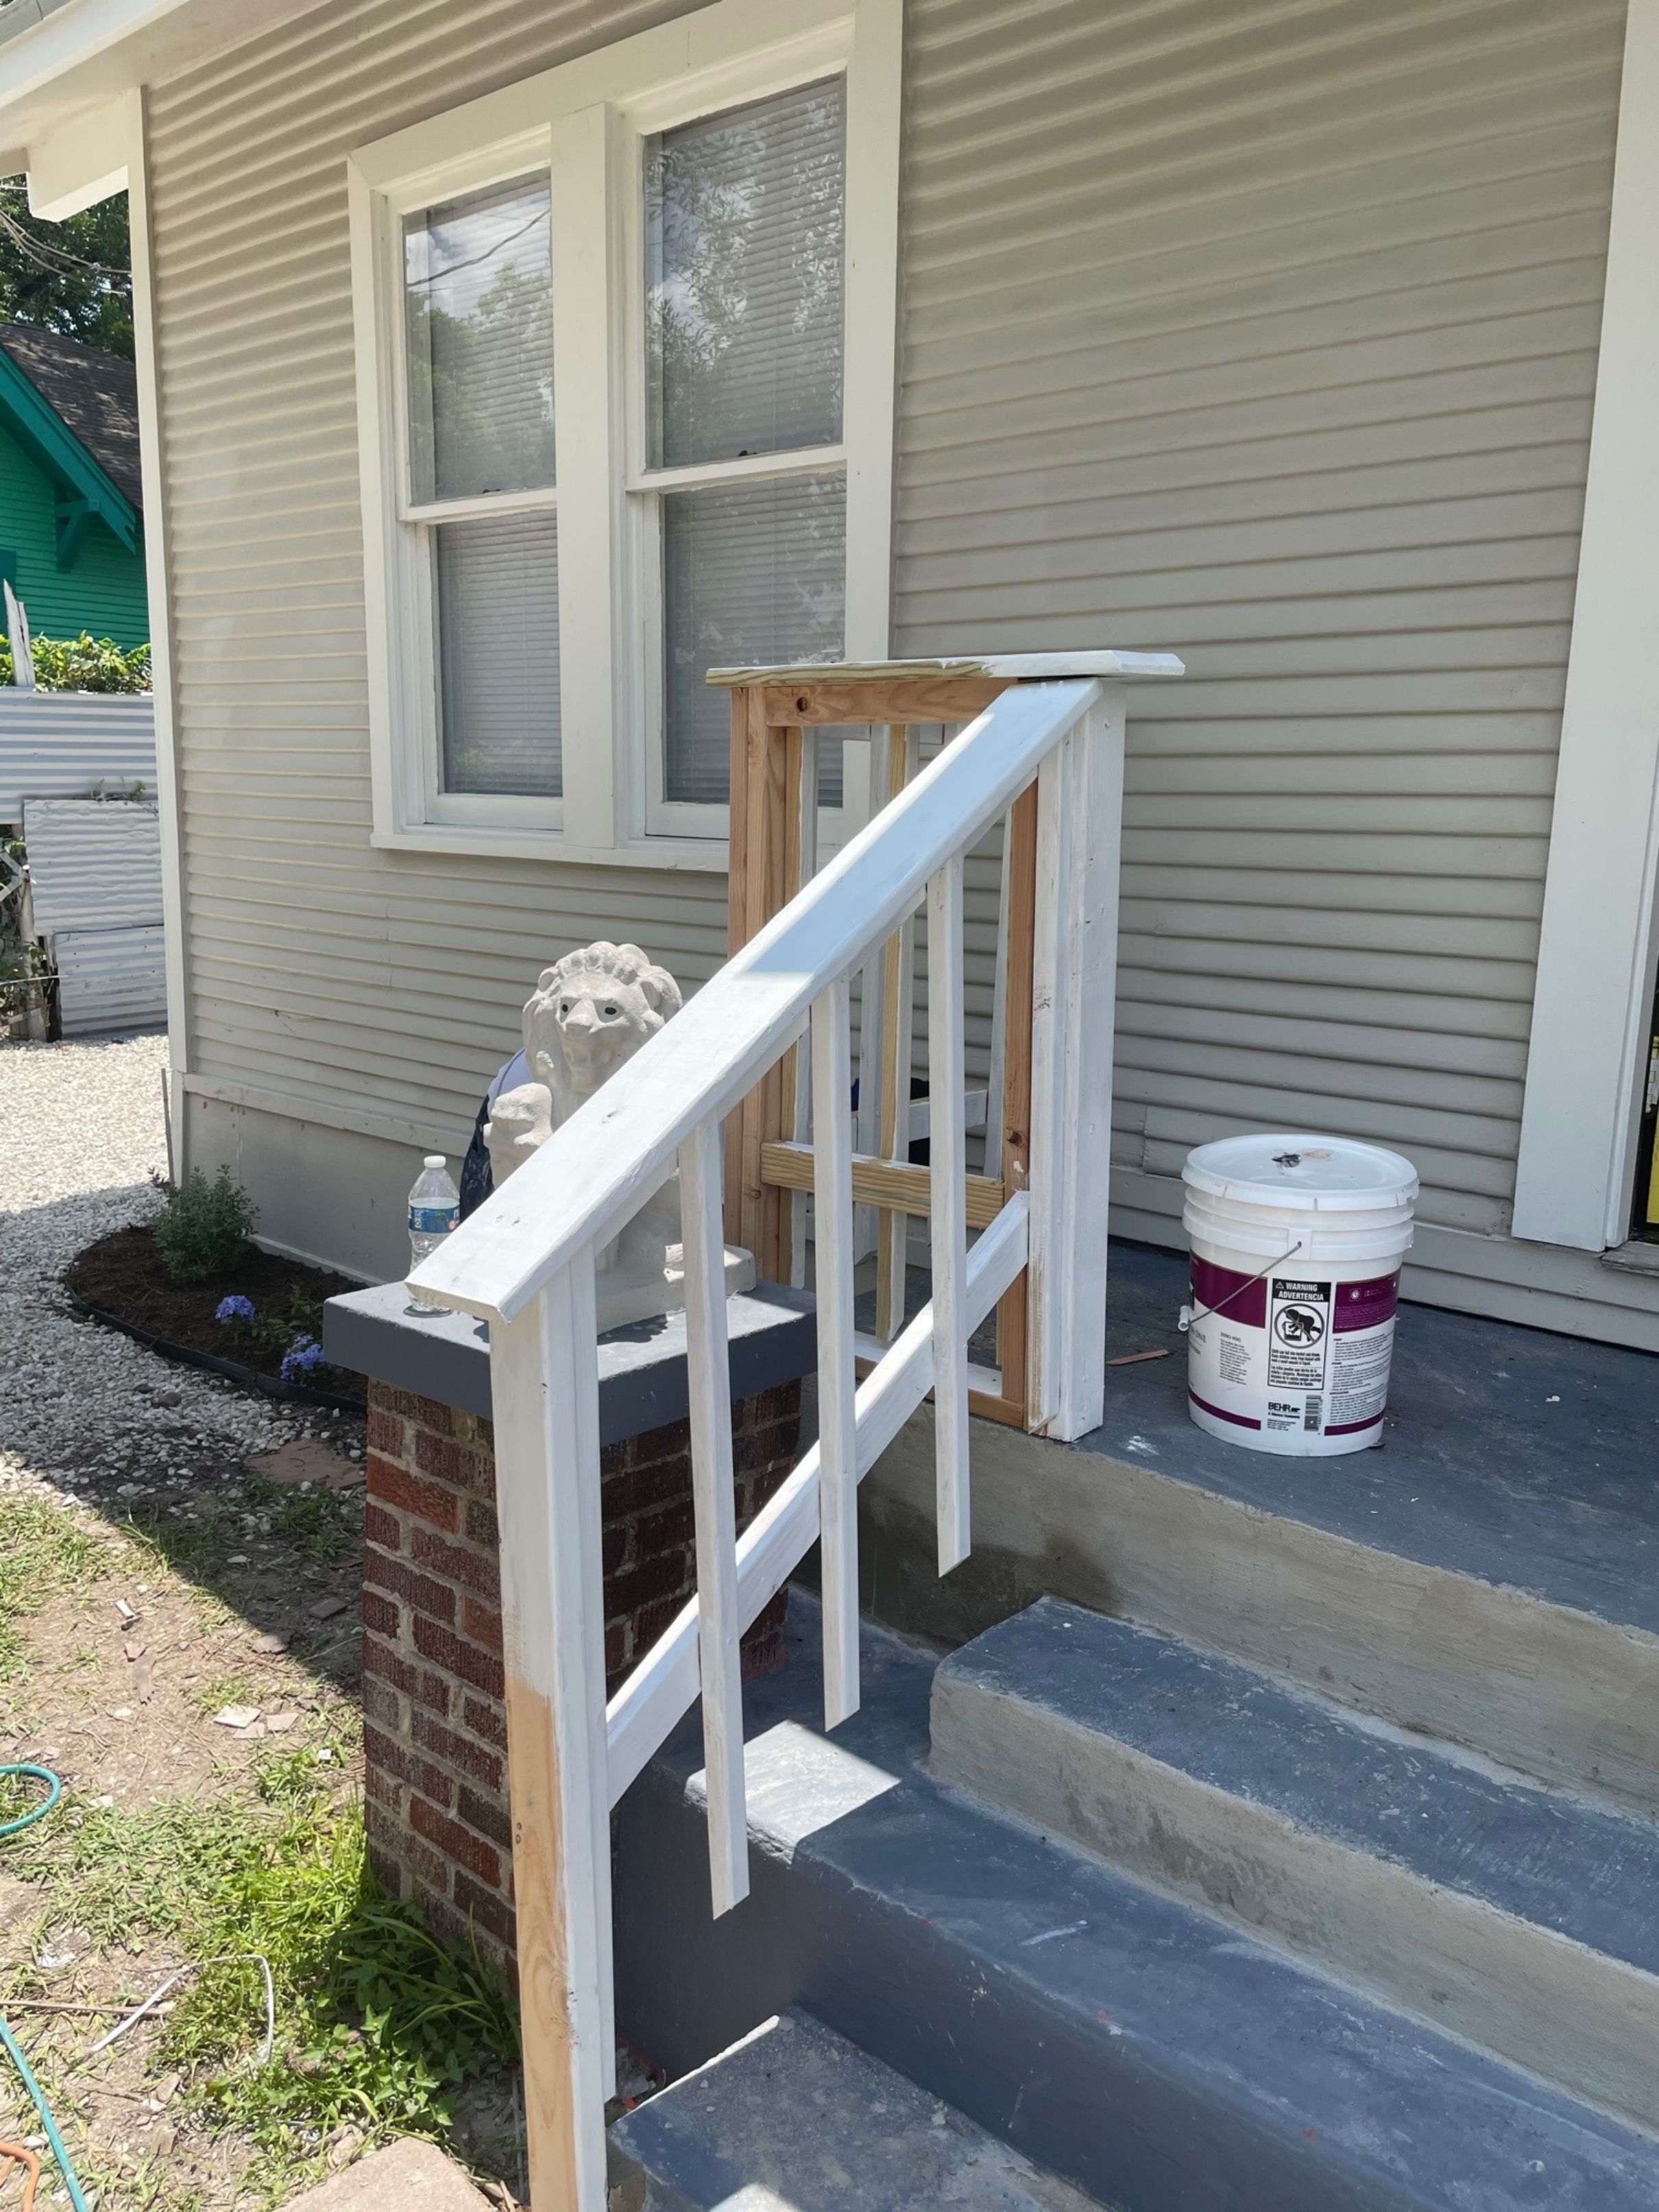
June 25, 2021 at 9:51 AM  
311 Muncey St  
San Antonio TX 78202  
United States

- c. VIOLATION – The installation of front porch and porch step railing began on June 14, 2021. OHP staff notified the applicant of the process for obtaining approval for the proposed scope of work, and noted that all work was to stop until a COA had been issued. On June 25, 2021, OHP staff issued a violation notice for the completion of the porch and porch step railing without a COA.

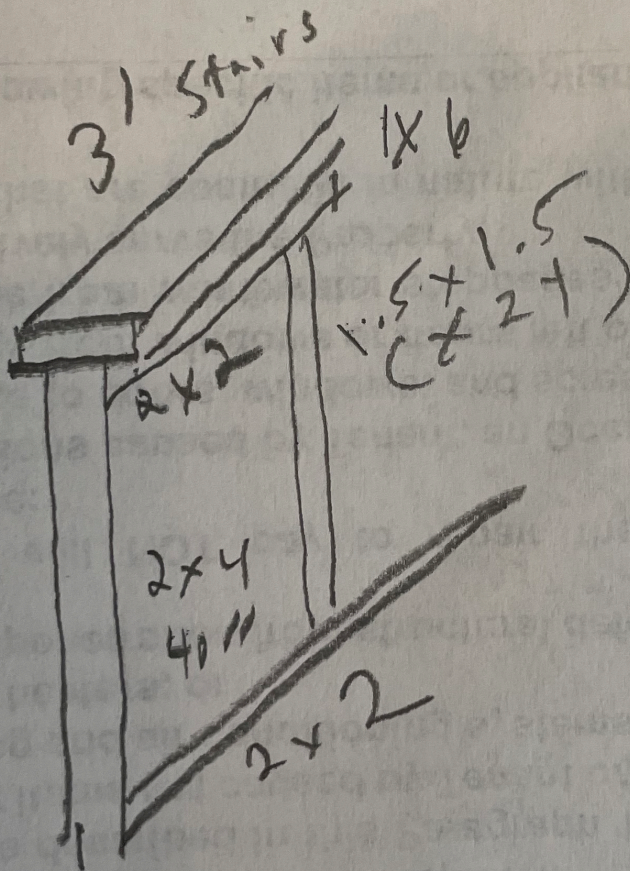
311 Manc 7

2' landing
