# HISTORIC AND DESIGN REVIEW COMMISSION

**HDRC CASE NO:** 2021-335  
**ADDRESS:** 216 N MESQUITE ST  
**LEGAL DESCRIPTION:** NCB 583 BLK 8 LOT 12  
**ZONING:** RM-4, H  
**CITY COUNCIL DIST.:** 2  
**DISTRICT:** Dignowity Hill Historic District  
**APPLICANT:** Ofelia Delgado  
**OWNER:** Ofelia Delgado  
**TYPE OF WORK:** Front porch column replacement  
**APPLICATION RECEIVED:** July 02, 2021  
**60-DAY REVIEW:** Not applicable due to City Council Emergency Orders  
**CASE MANAGER:** Edward Hall

The applicant is requesting a Certificate of Appropriateness for approval to replace the existing, four, wrought iron columns with four, round columns.

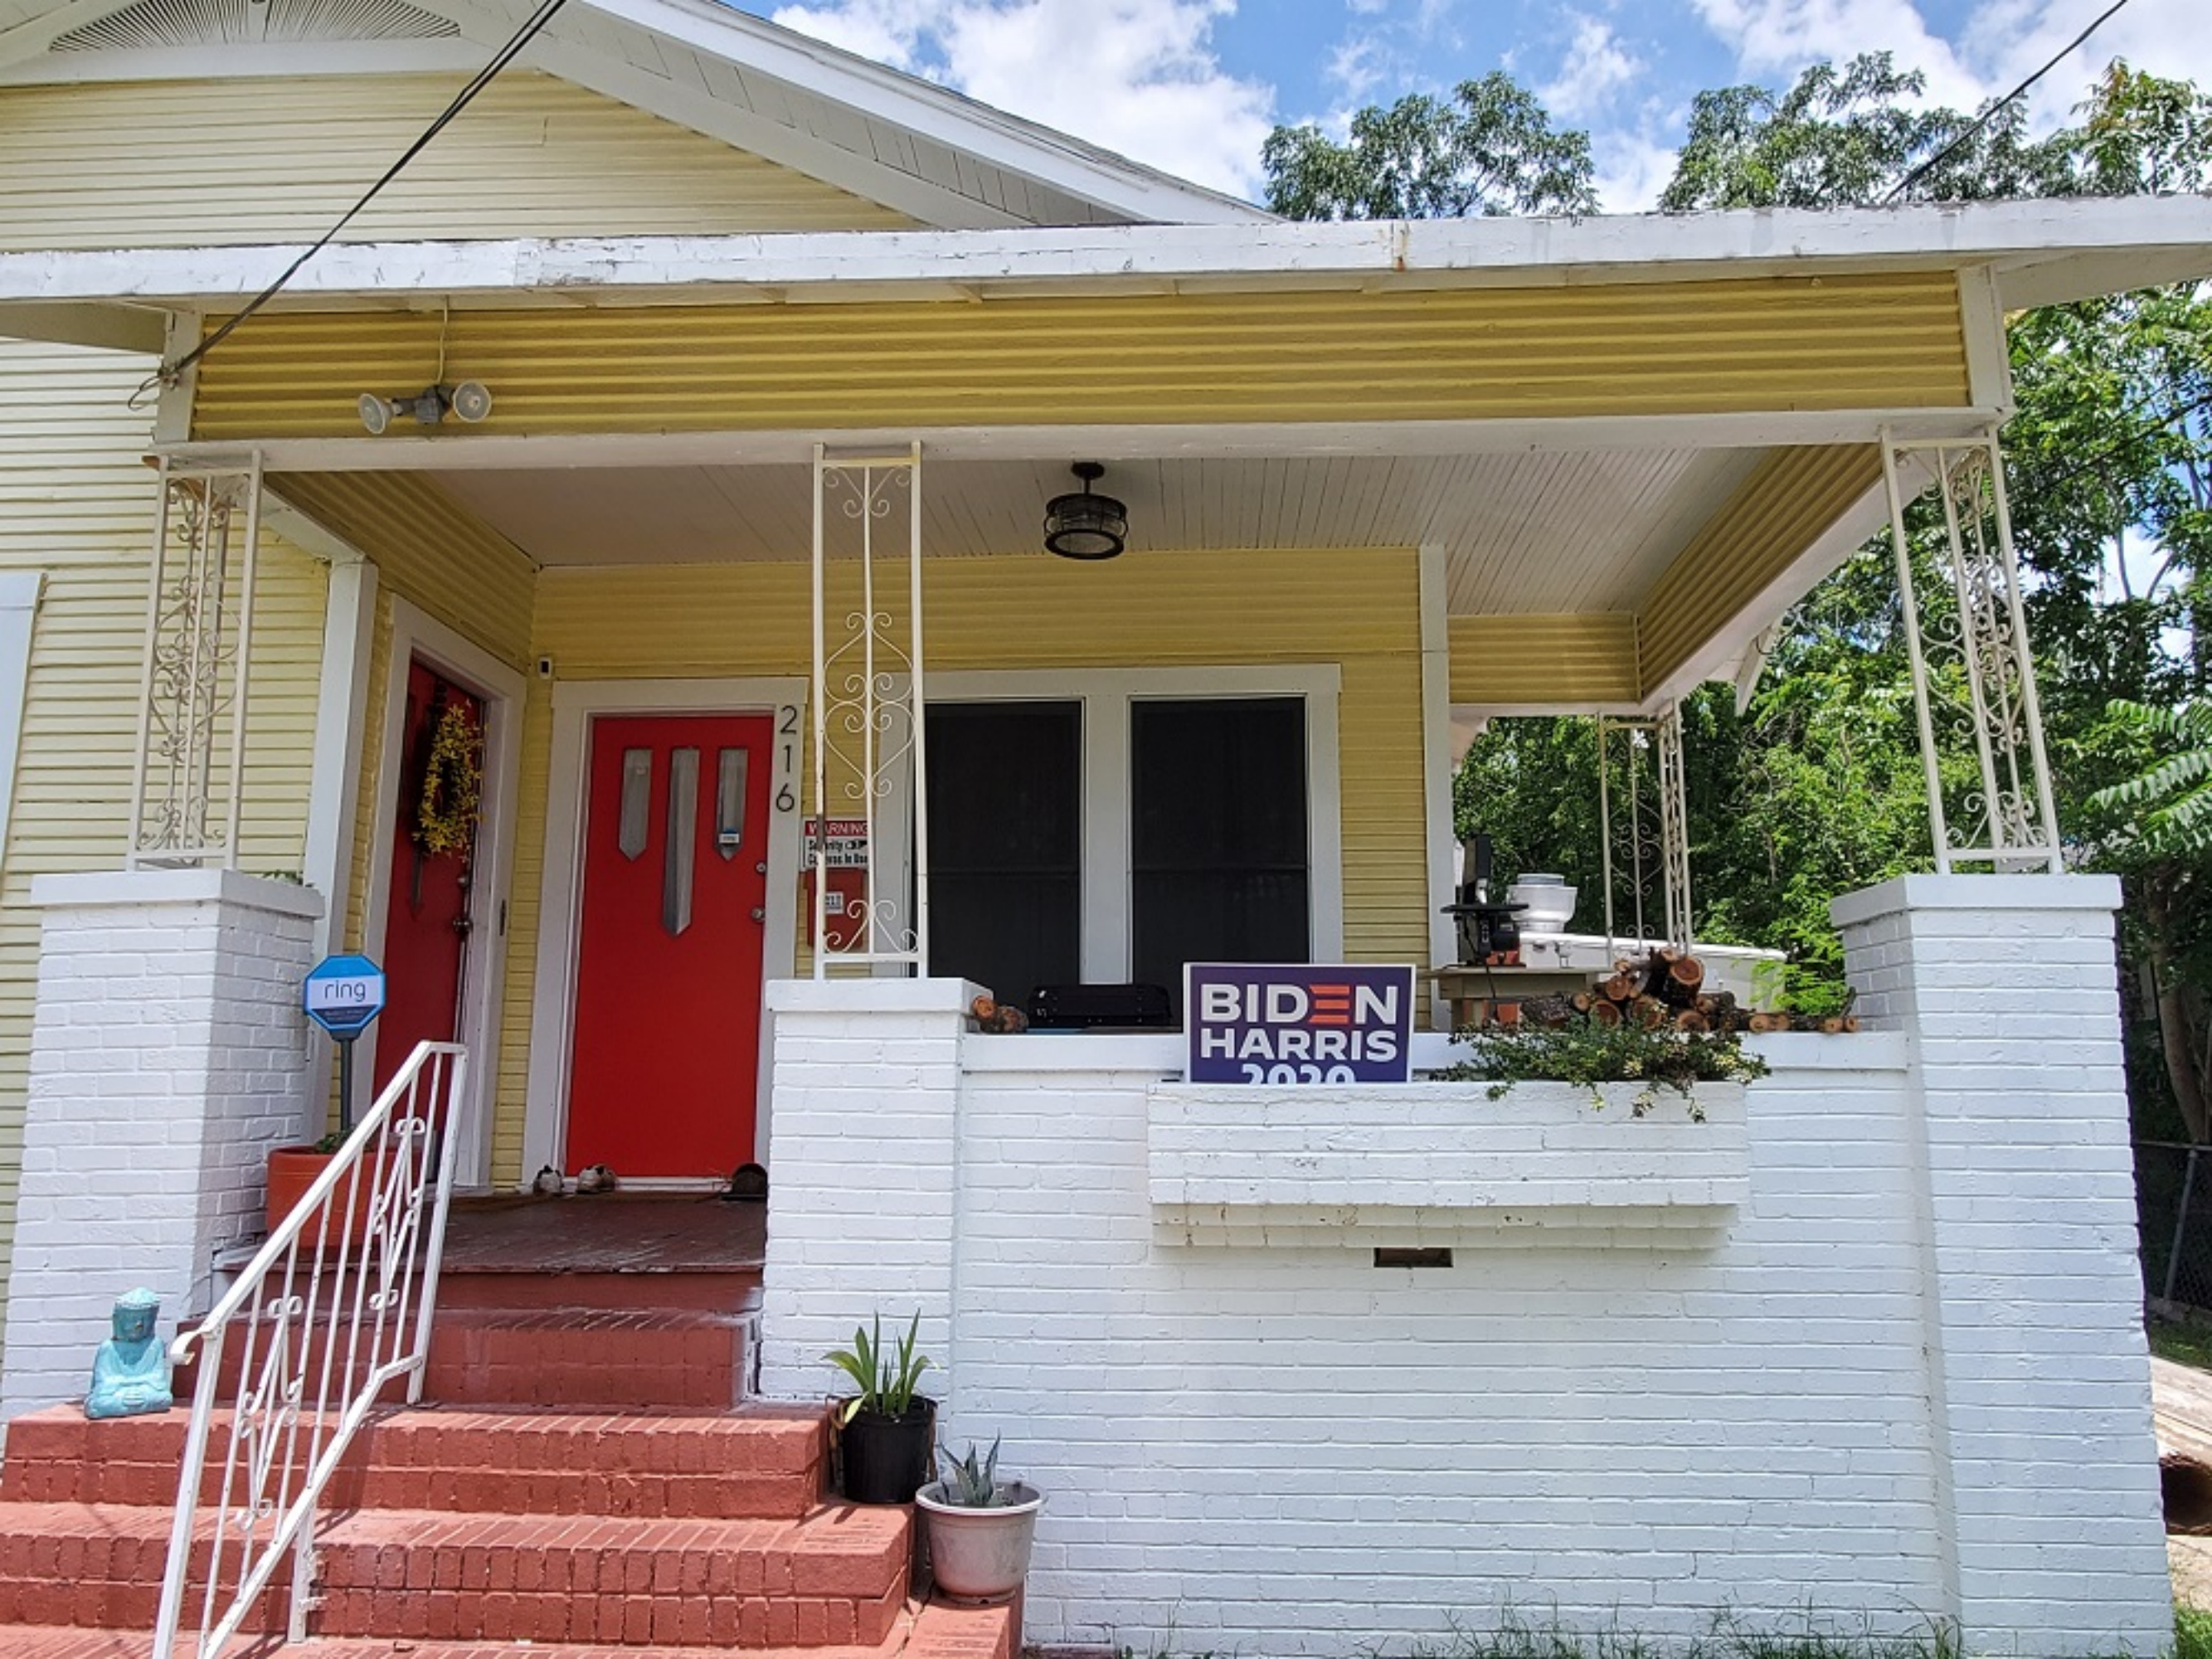
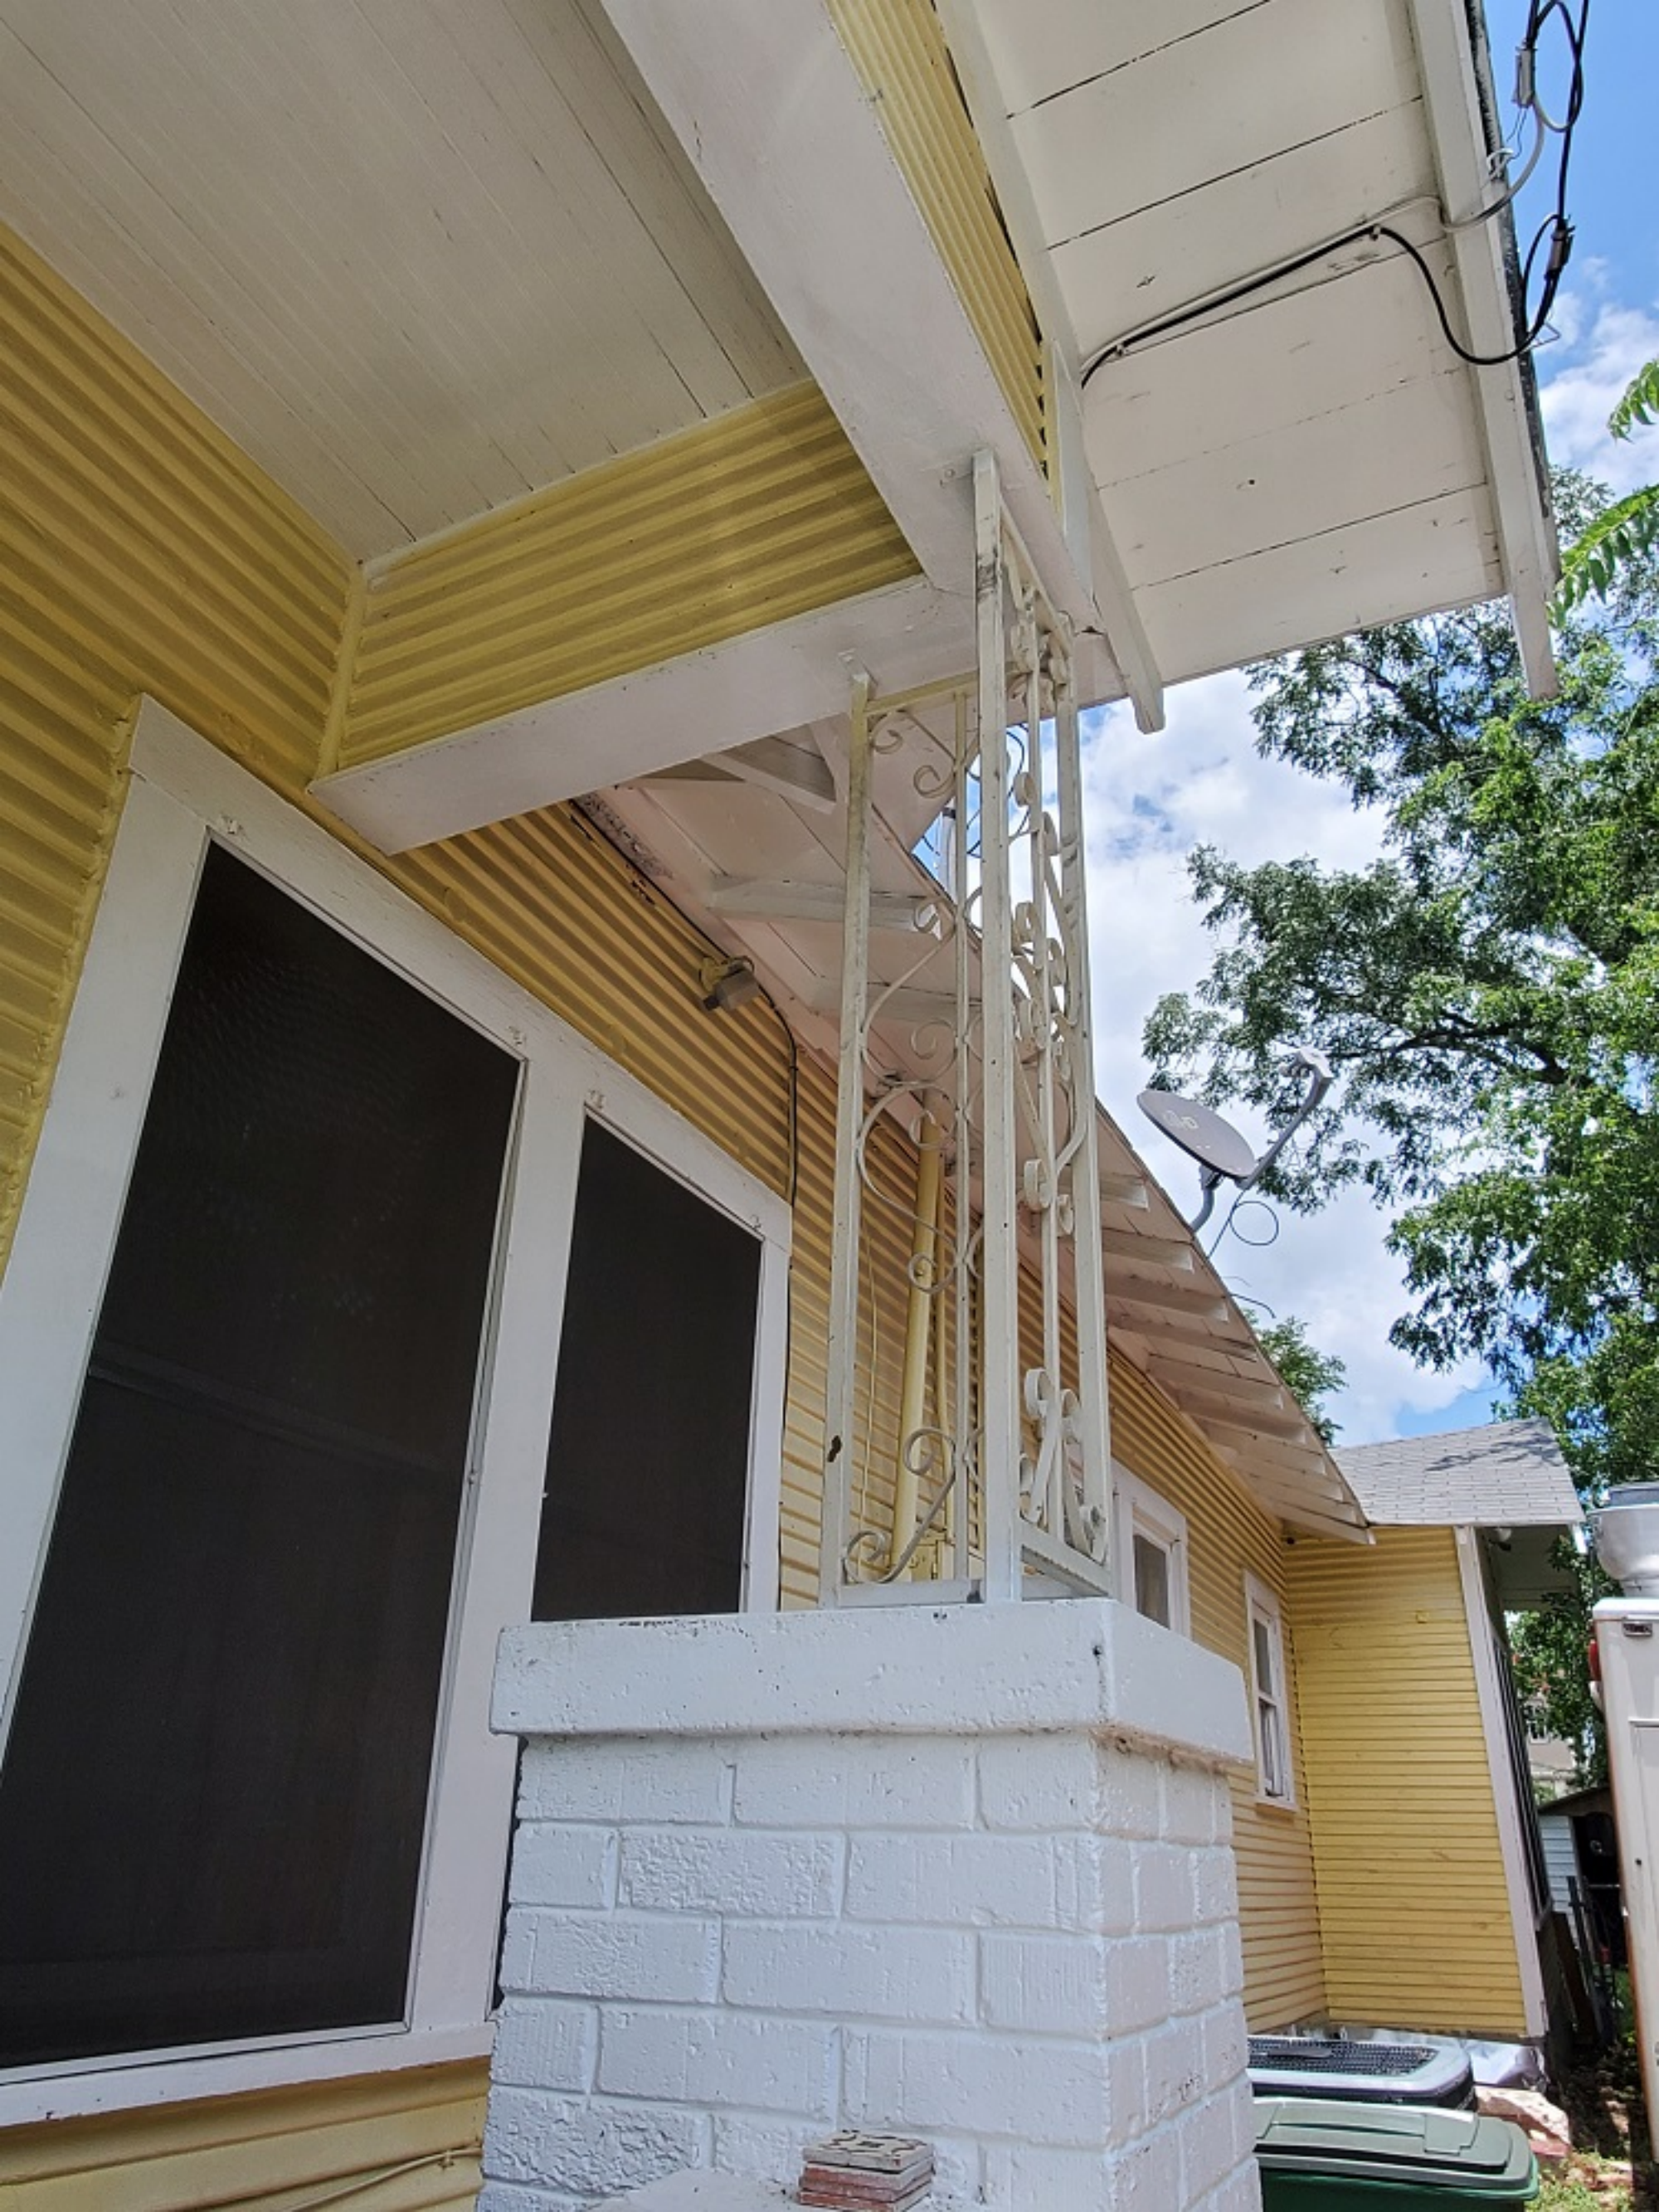
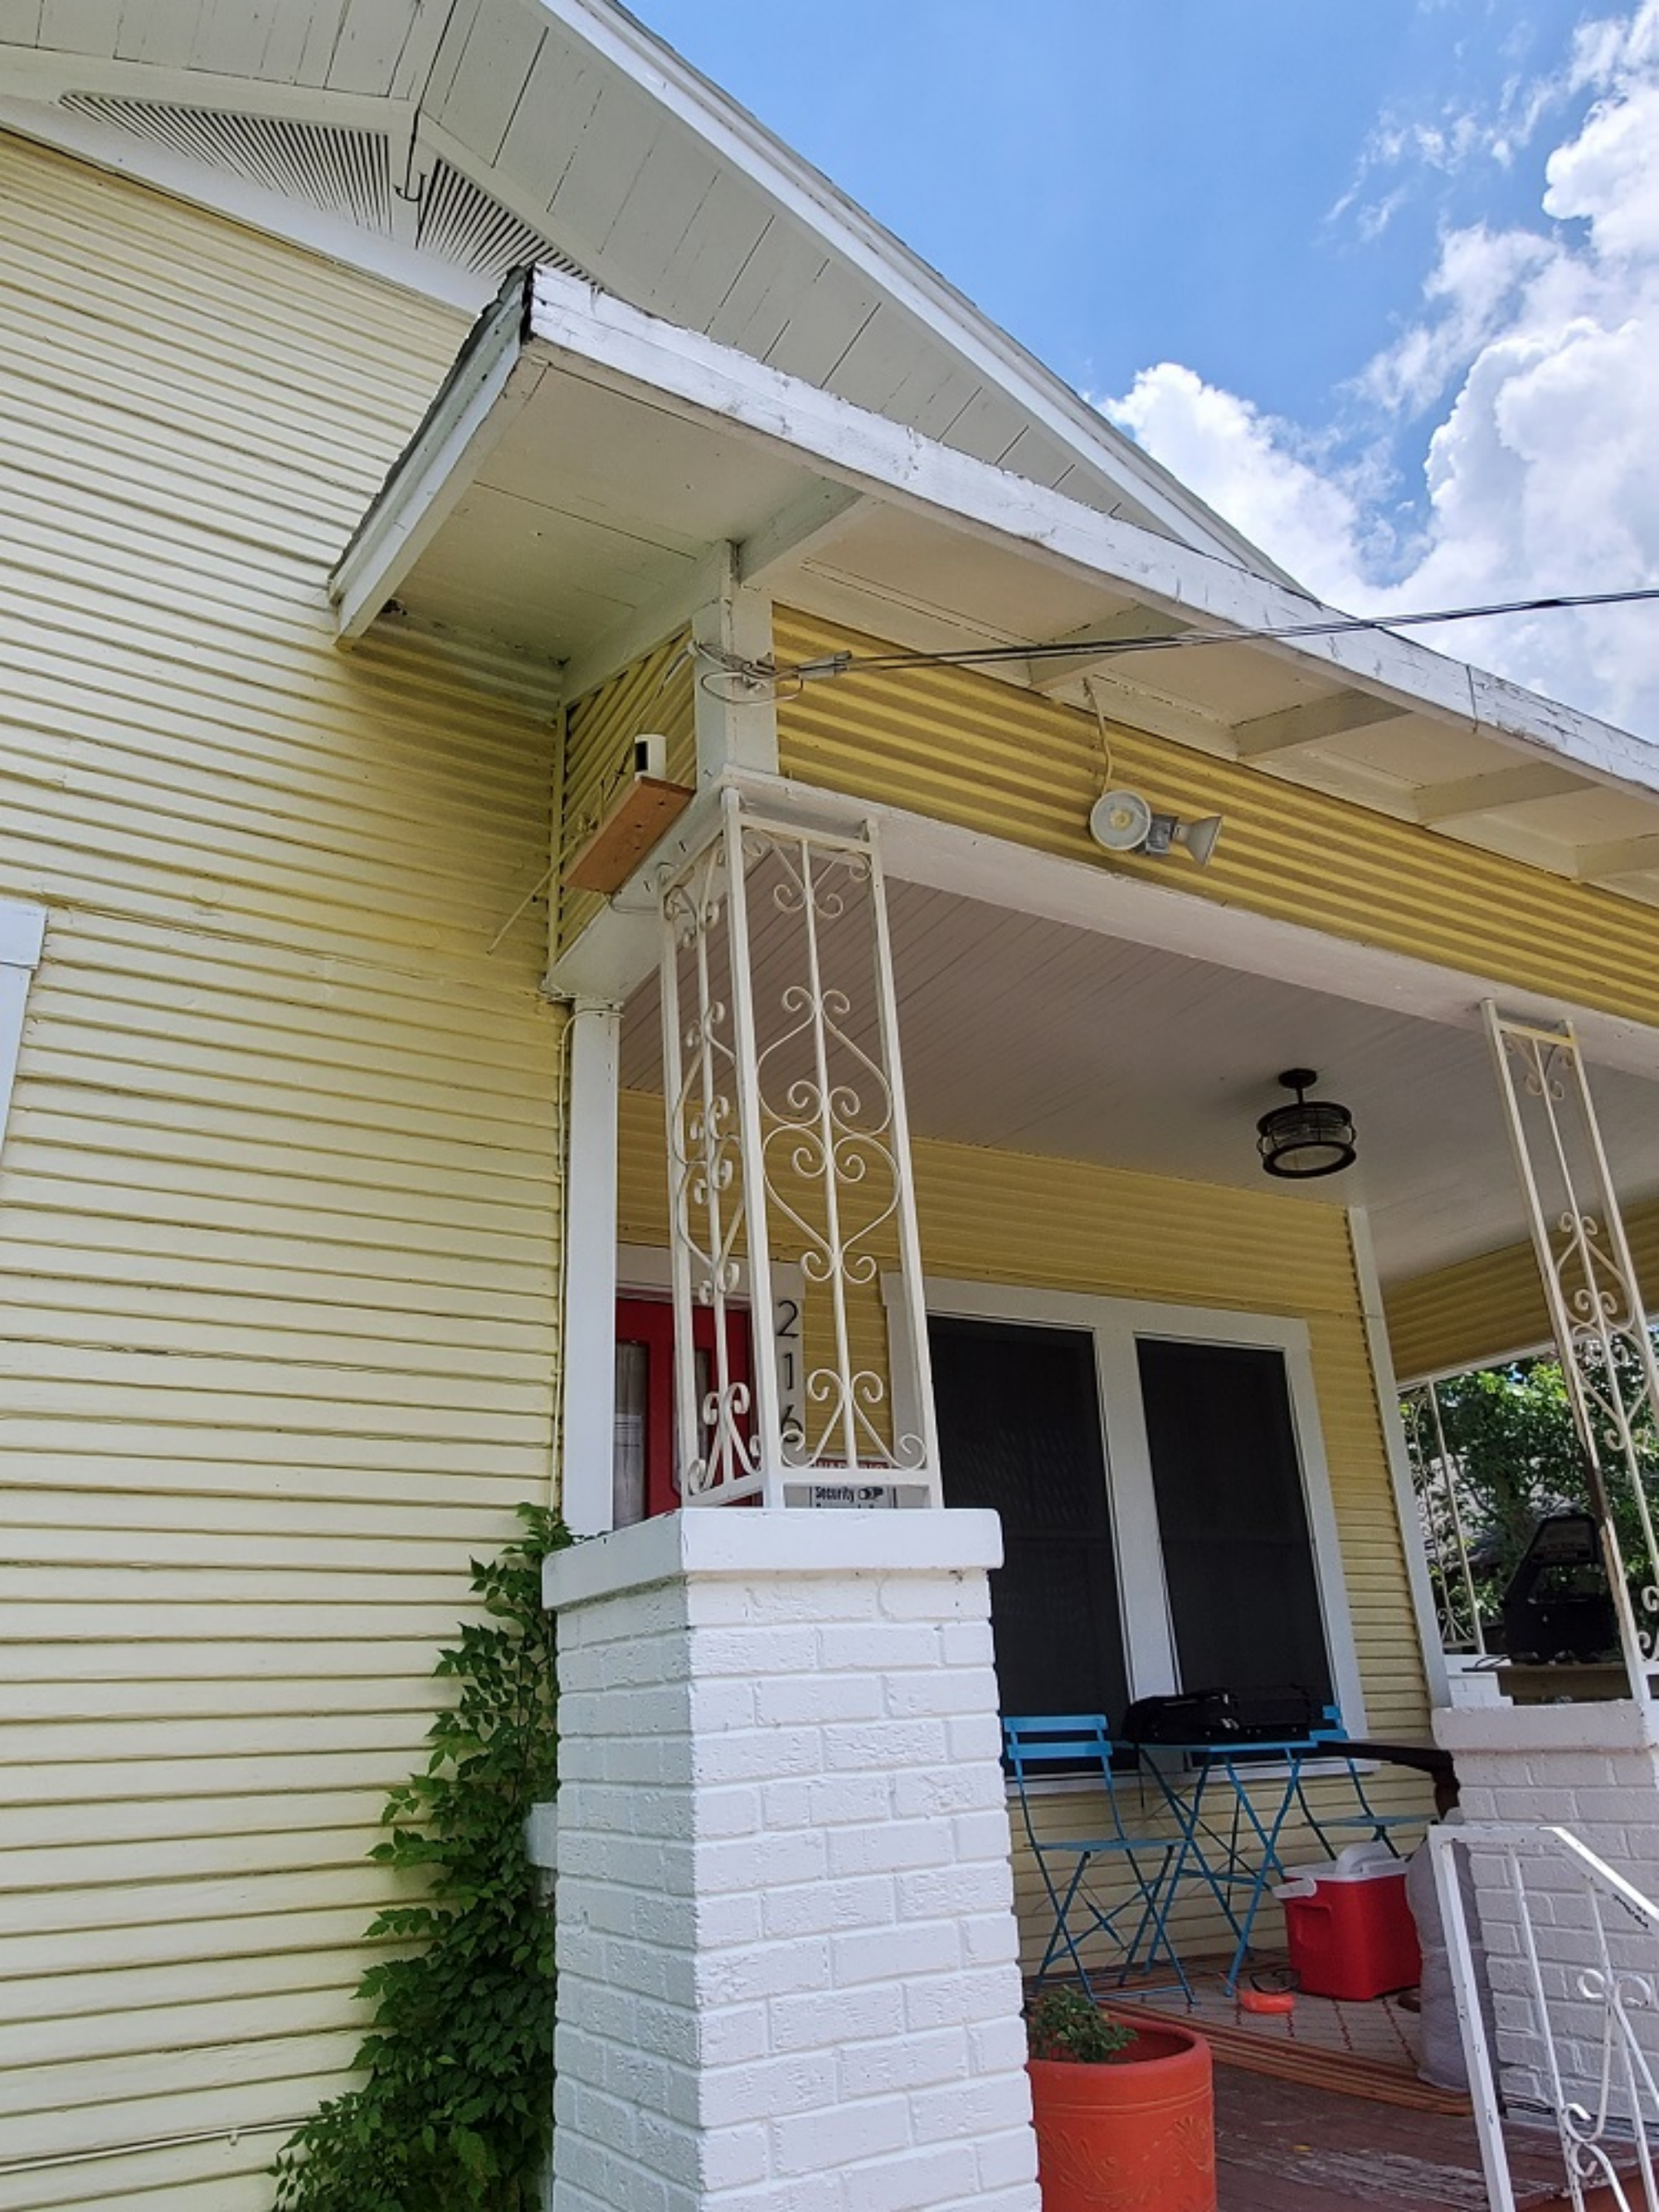
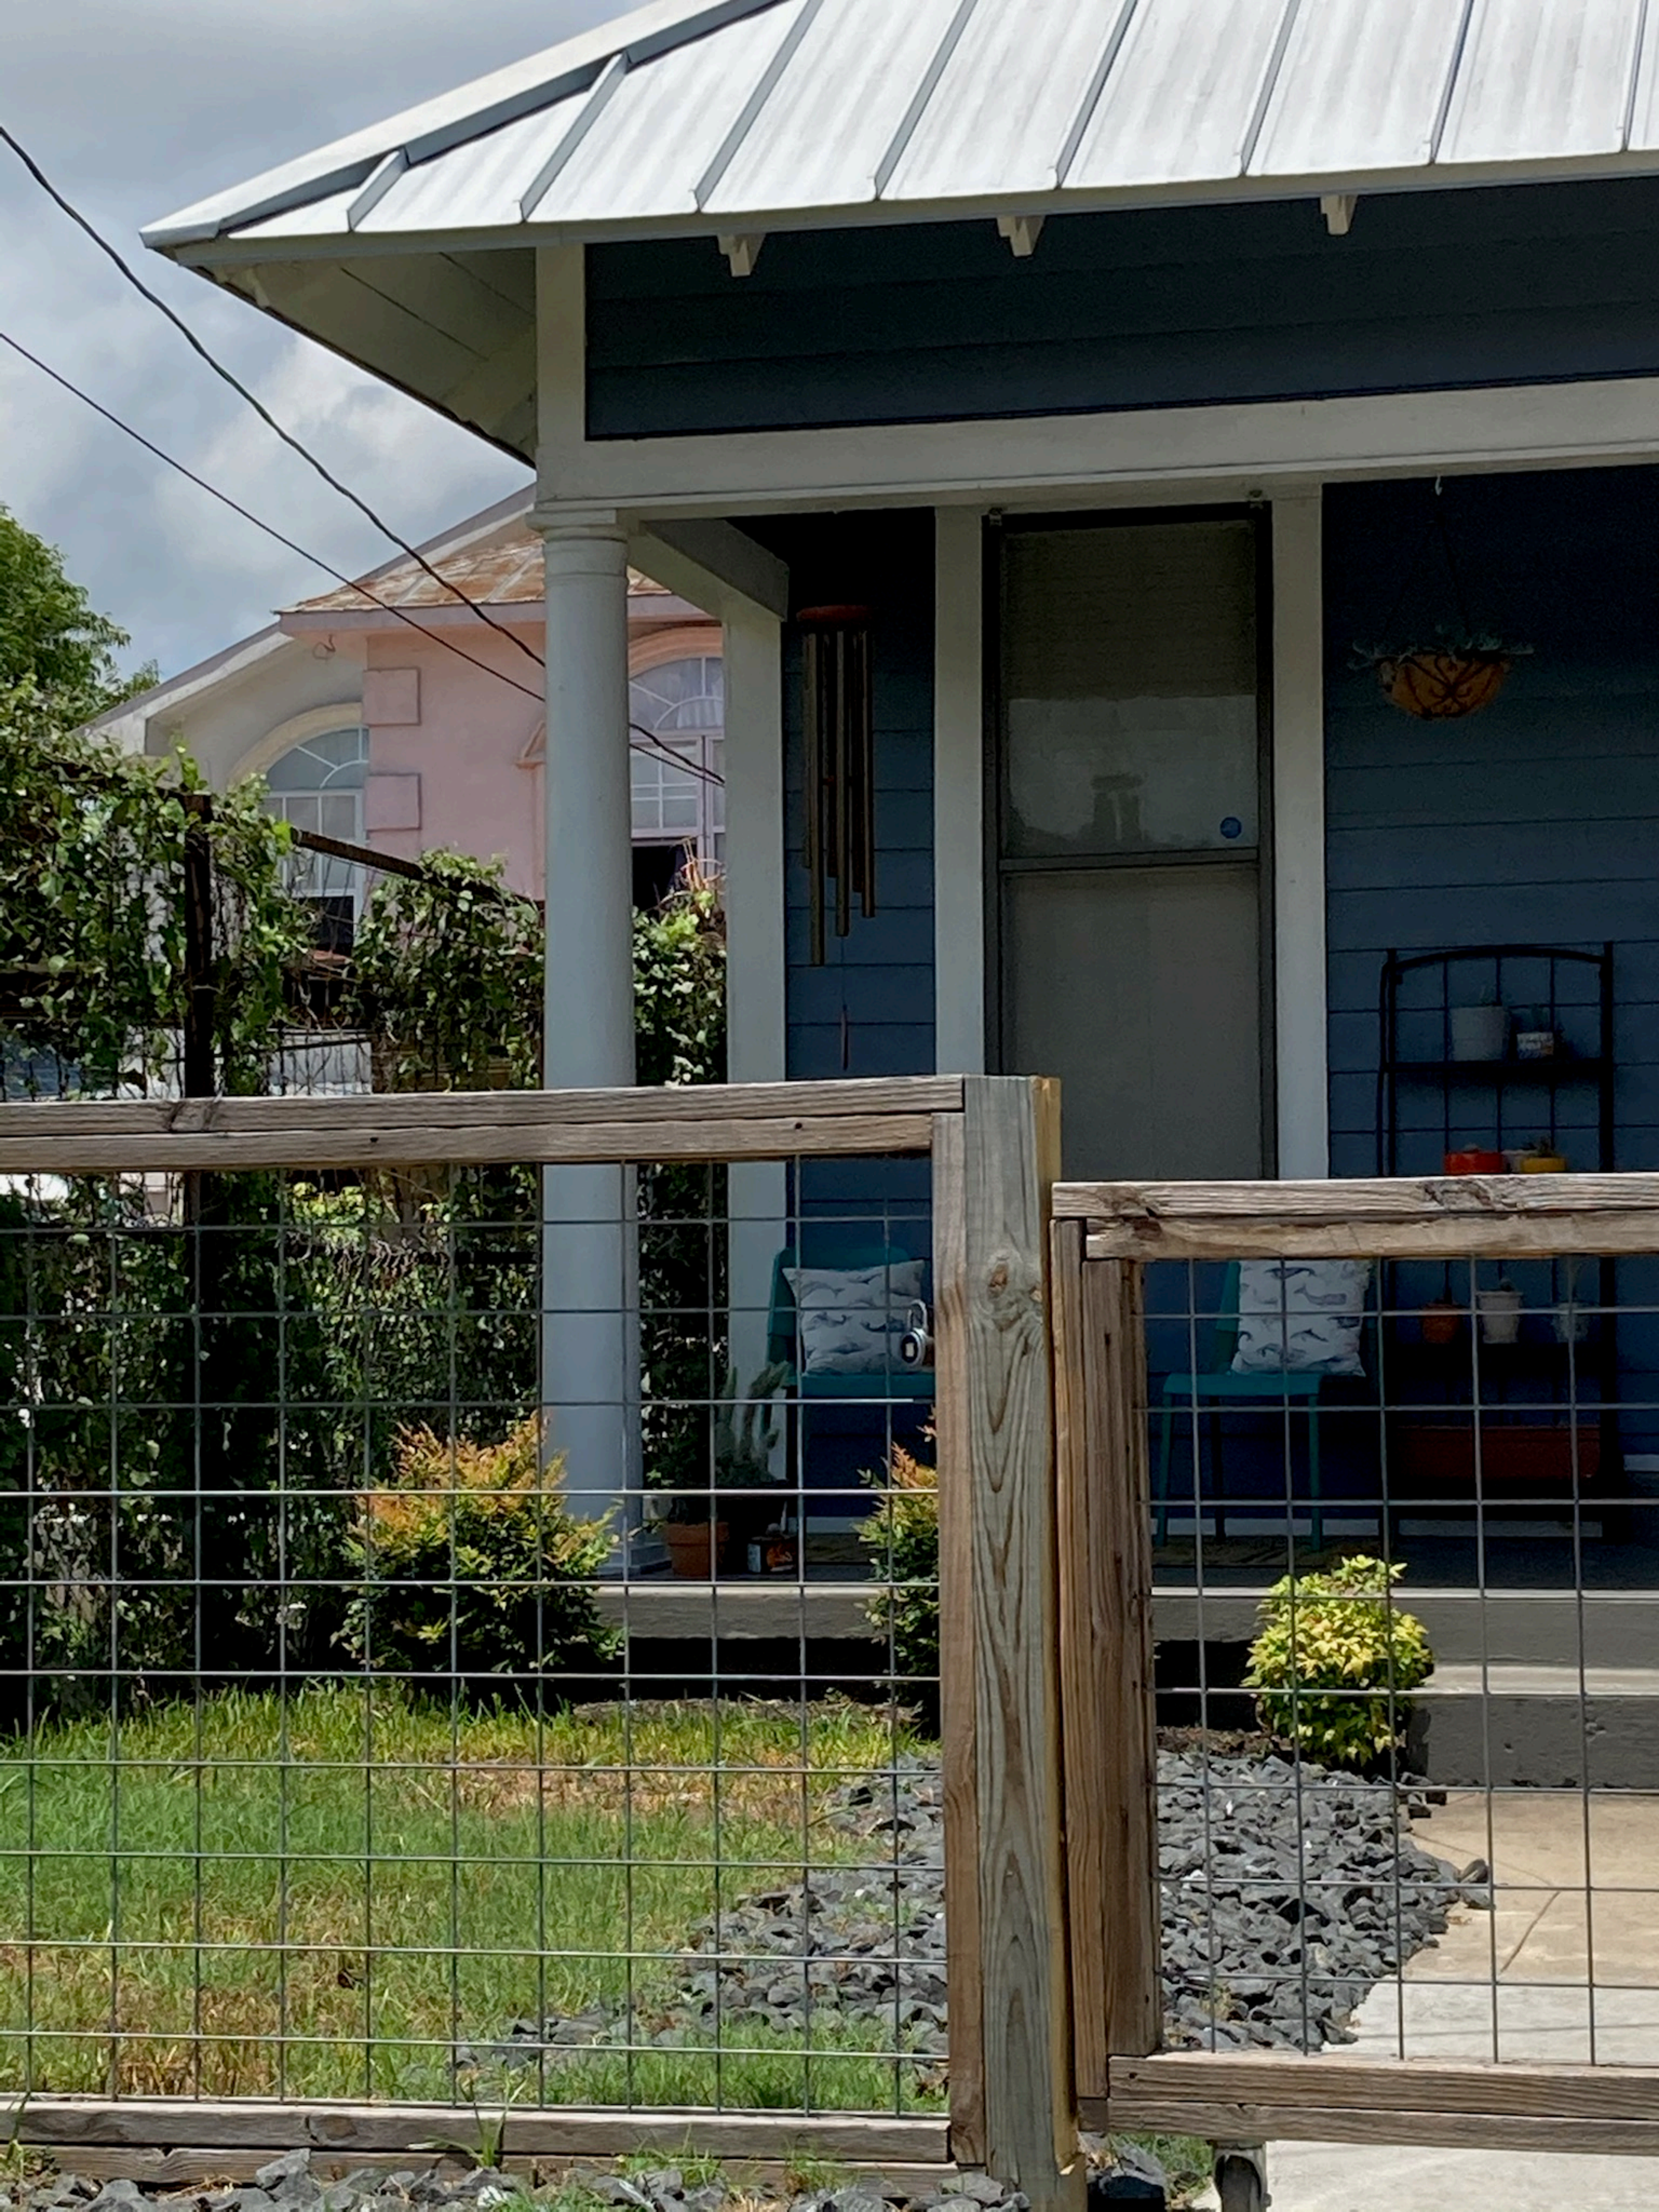
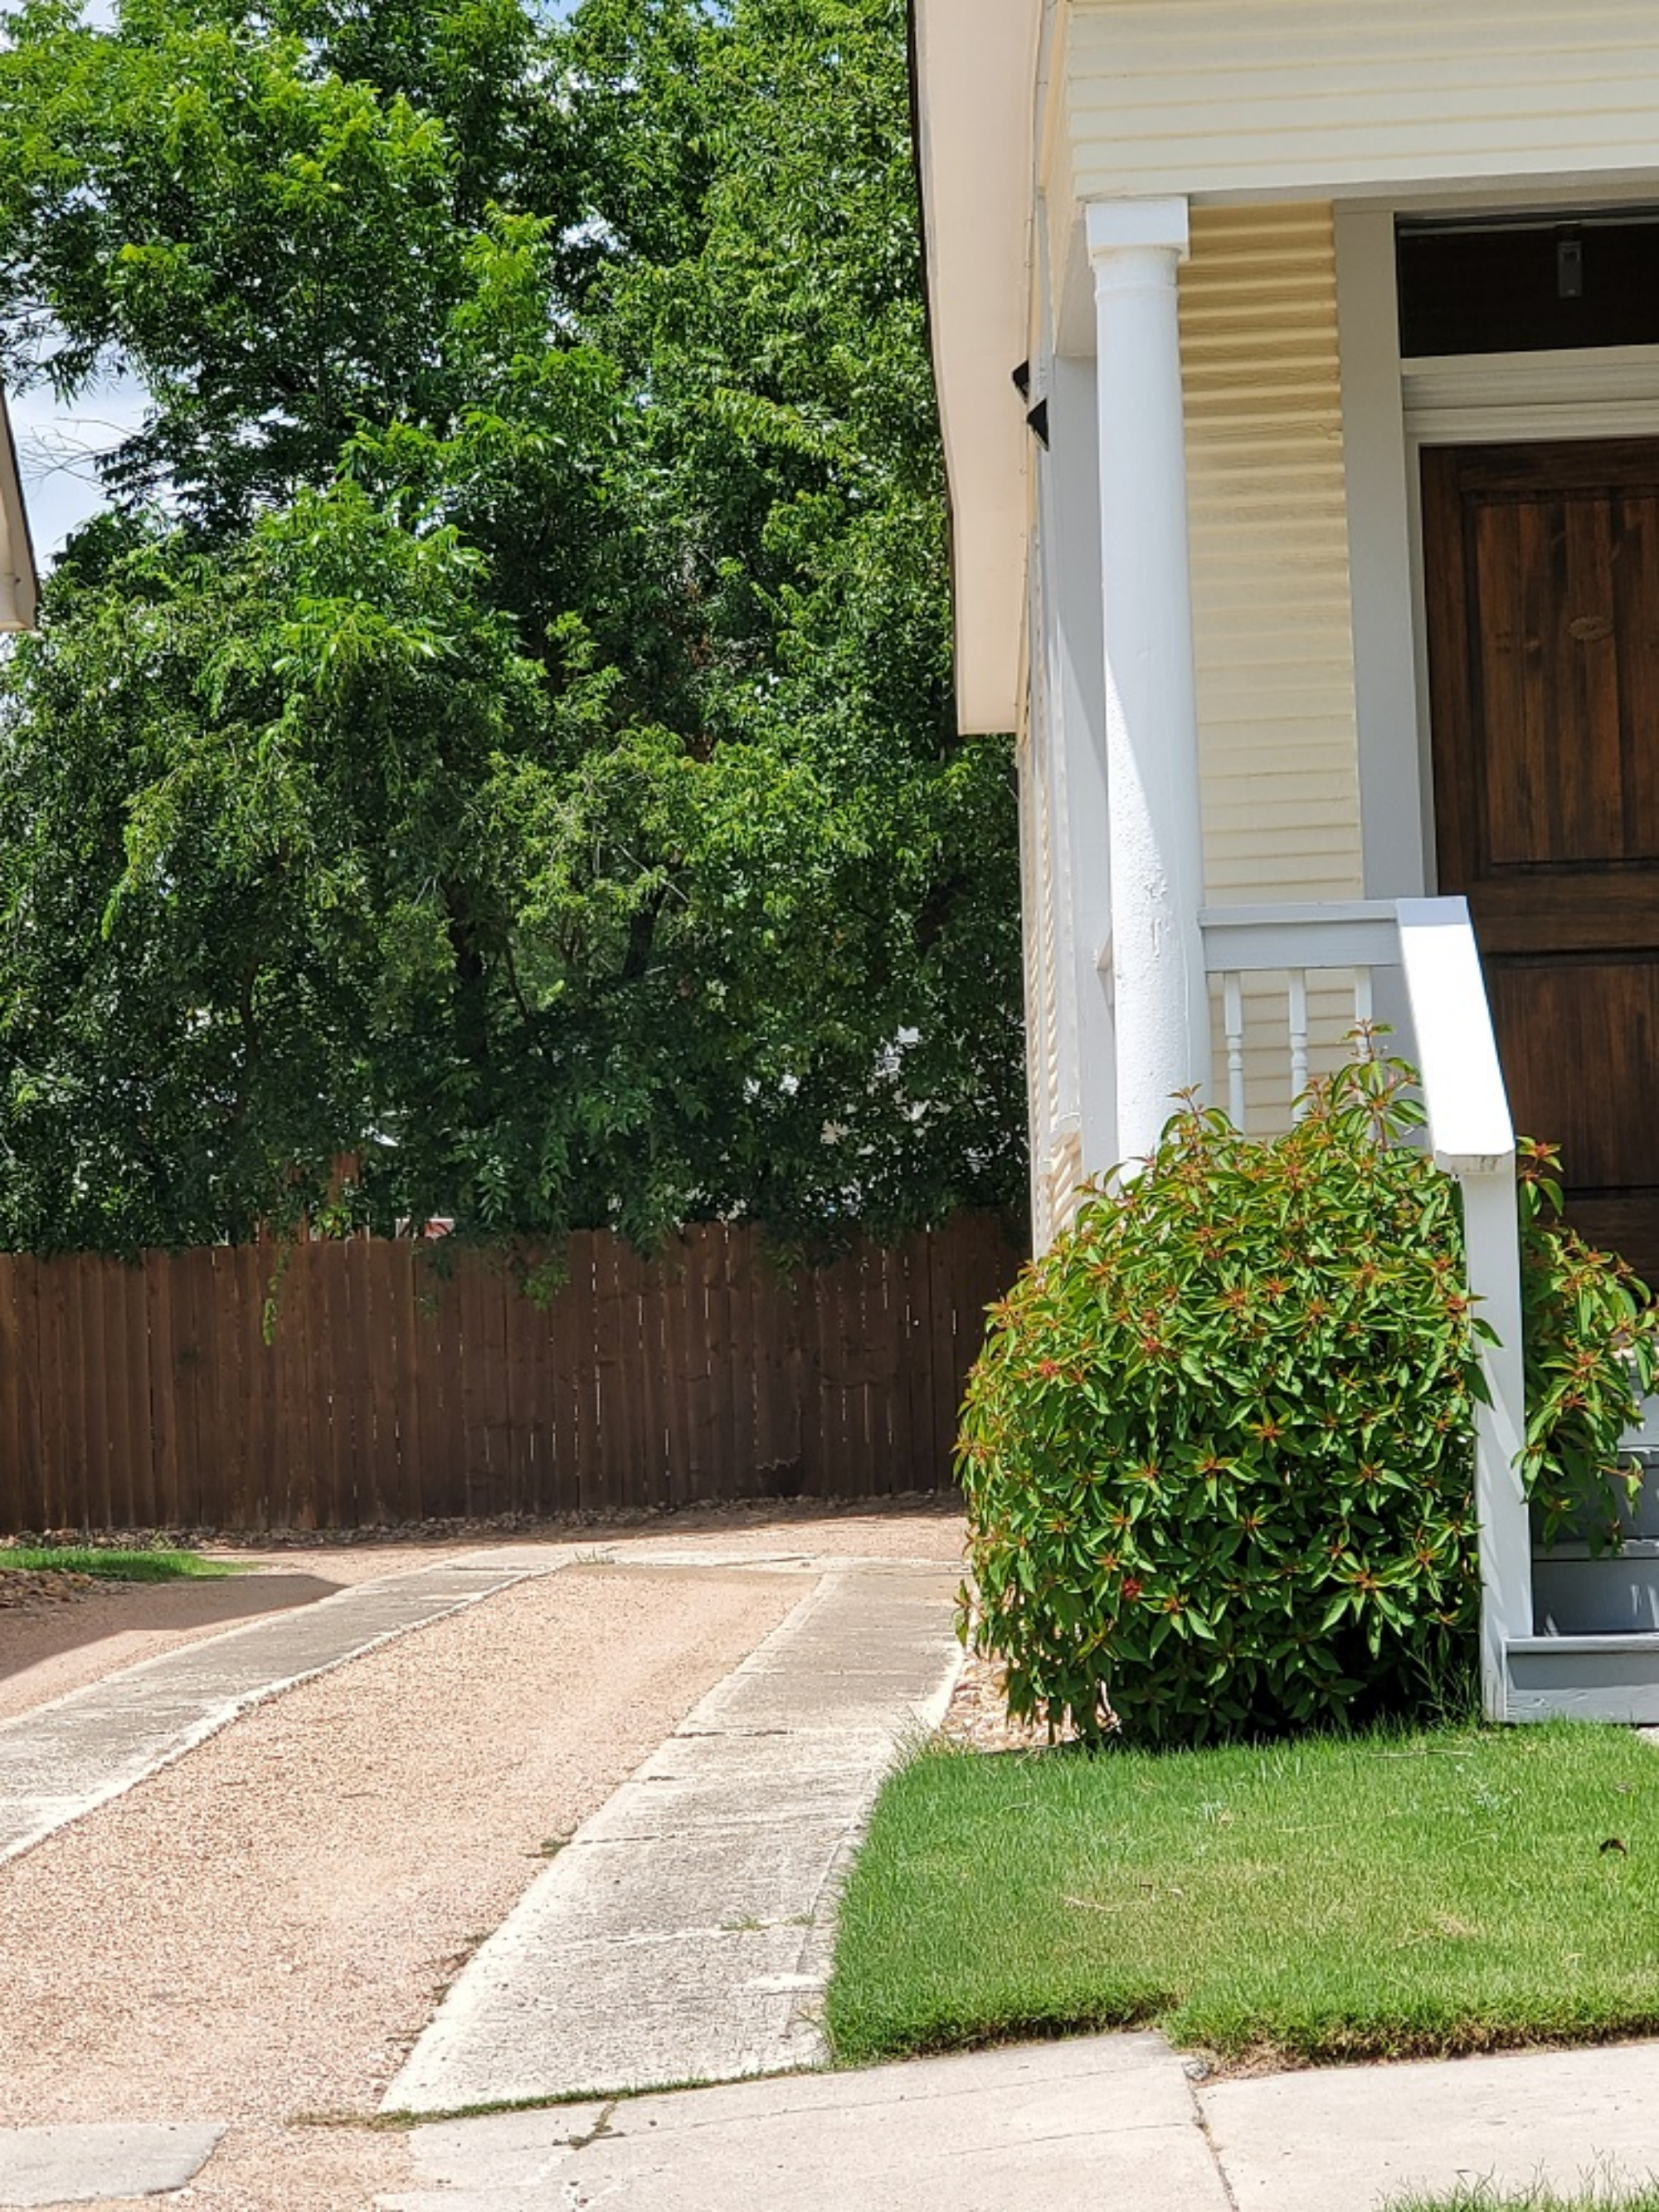
- a. The historic structure at 216 N Mesquite was constructed circa 1910 in the Craftsman style, and first appears on the 1912 Sanborn Map. At this time, the applicant is requesting a Certificate of Appropriateness for approval to replace the existing, four, wrought iron columns with four, round columns.
- b. COLUMN REPLACEMENT – Per the Guidelines for Exterior Maintenance and Alterations 7.B.iii., replacement elements should be designed to be simple so as to not distract from the historic character of the building. Additionally, new elements and details should not be added that create a false historic appearance. Staff finds that square tapered or square columns with capital and base trim would be most appropriate and consistent with the Guidelines.

Staff recommends column replacement with the stipulation that tapered or square columns with capital and base trim be installed. The existing, brick pediment are to remain unmodified.
