HISTORIC AND DESIGN REVIEW COMMISSION

HDRC CASE NO: 2016-016
ADDRESS: 304 E TRAVIS ST
LEGAL DESCRIPTION: NCB 415 BLK 18 LOT A-7, A- 8, A-9, P-100, P-101 & P-102
ZONING: D HE
CITY COUNCIL DIST.: 1
LANDMARK: St Anthony Hotel
APPLICANT: Brandon Raney
OWNER: BCL St. Anthony ML, LP
TYPE OF WORK: Tax Certification
REQUEST:

RE: St. Anthony Hotel Tax Certification Application

St. Anthony Hotel
Scope Summary of Exterior Rehabilitation

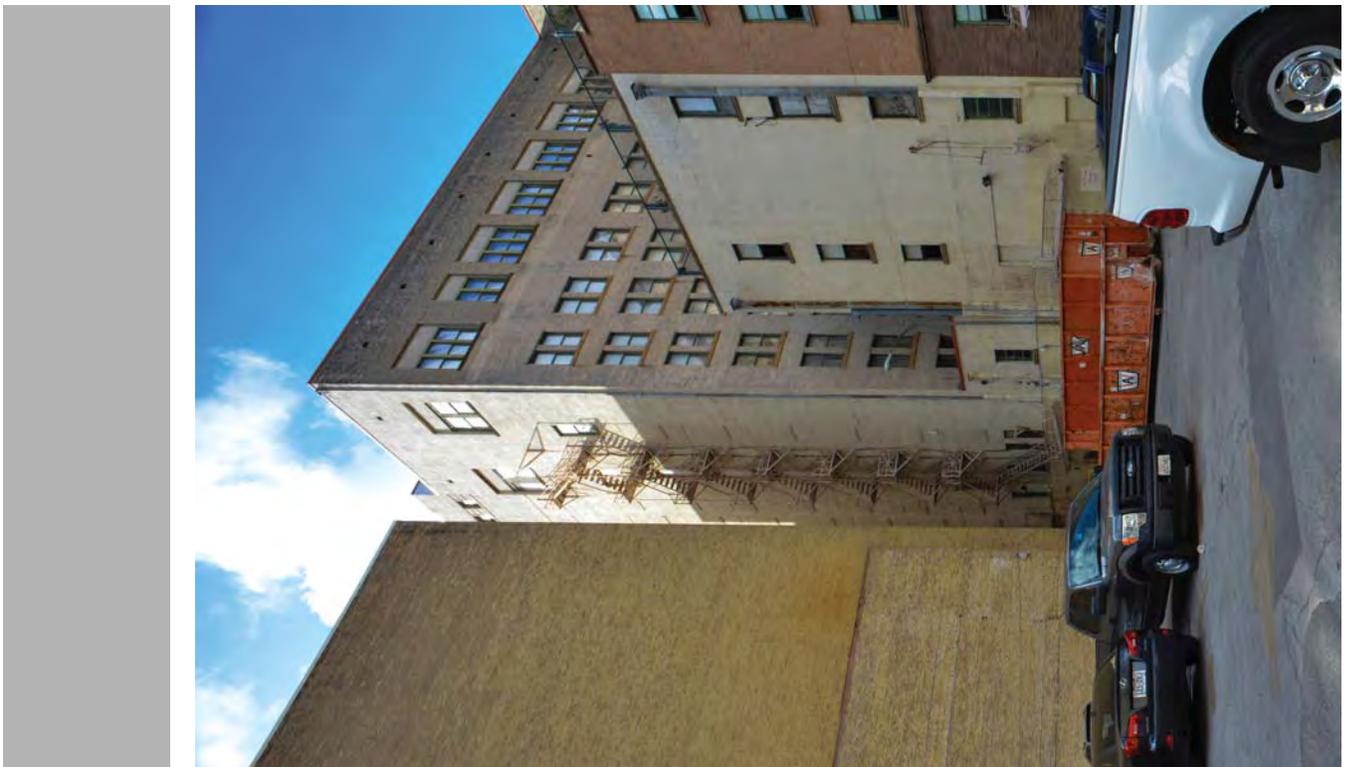
Name: Saint Anthony Hotel, 300 East Travis Street, San Antonio, Texas
View: South facade of Tower 3 from Jefferson Street looking northwest
Description: Exterior fire escape from Tower 3 to alley
Date: September 2012

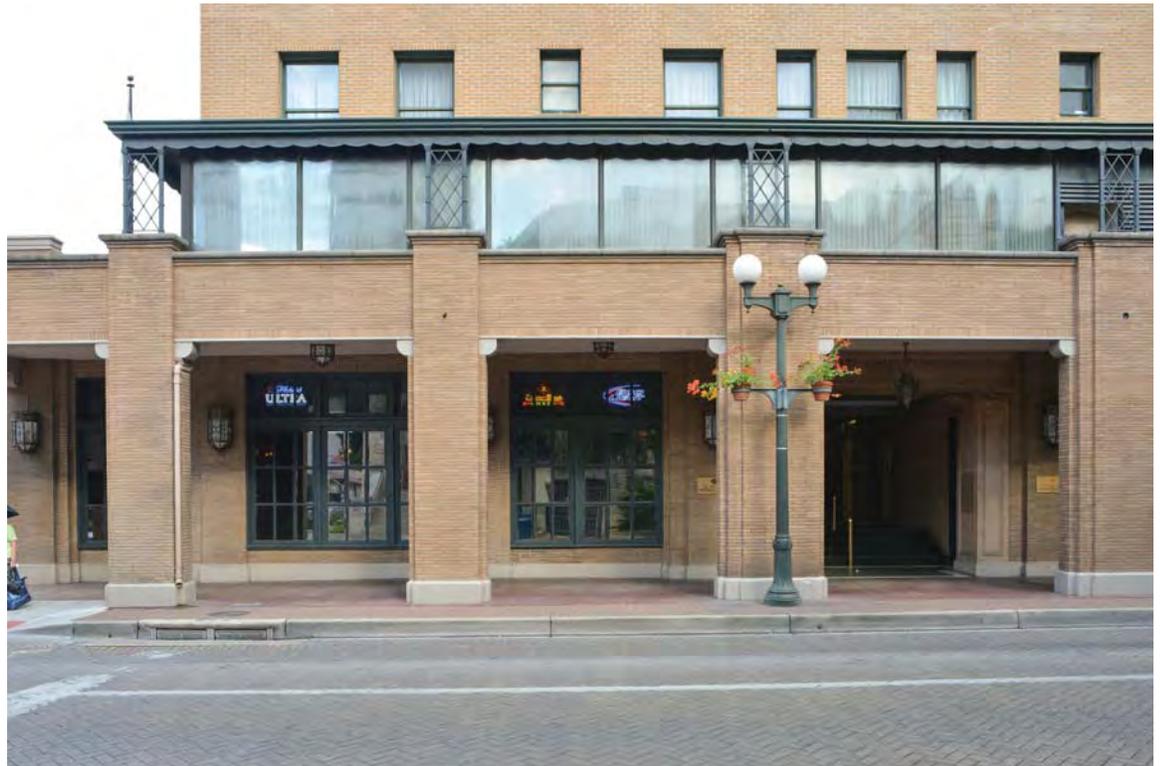
SAH-017

Name: Saint Anthony Hotel, 300 East Travis Street, San Antonio, Texas
View: West facade at Navarro Street entrance, looking east
Description: Navarro Street arcade and terrace with non-historic glazing system
Date: September 2012

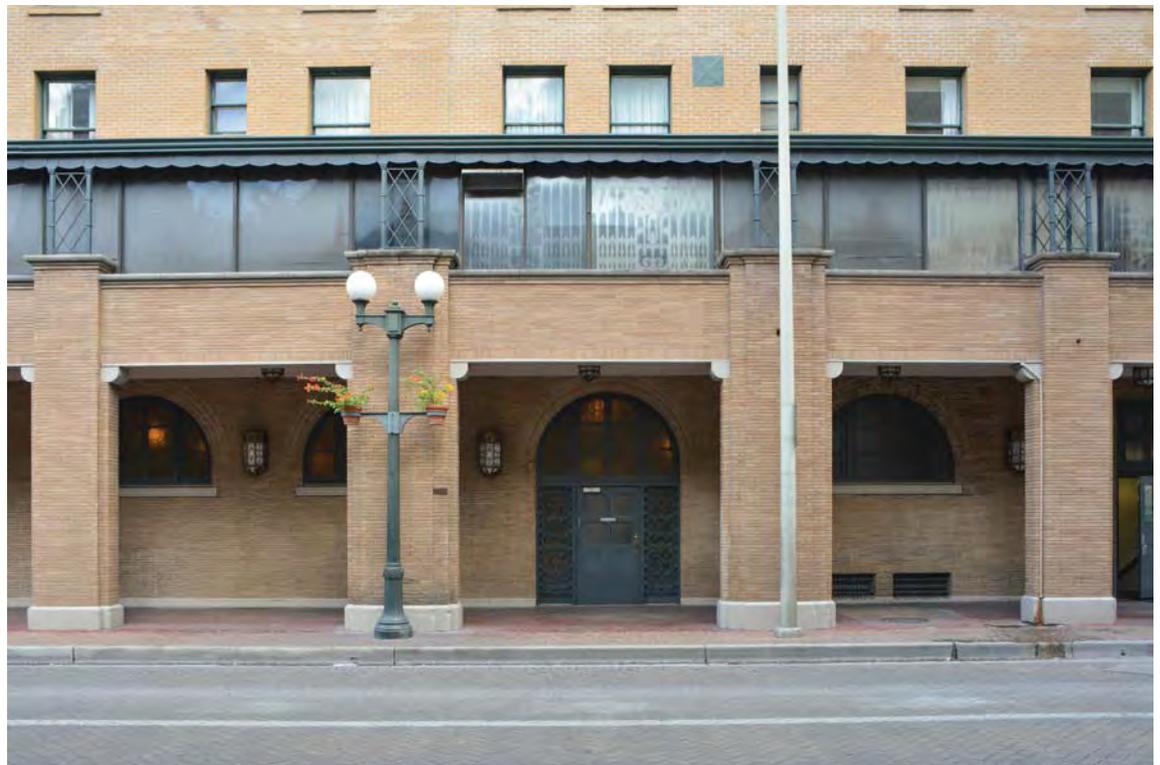
SAH-018

Name: Saint Anthony Hotel, 300 East Travis Street, San Antonio, Texas
View: West facade at restaurant street entrance, looking east
Description: Navarro Street arcade and terrace with non-historic glazing system
Date: September 2012

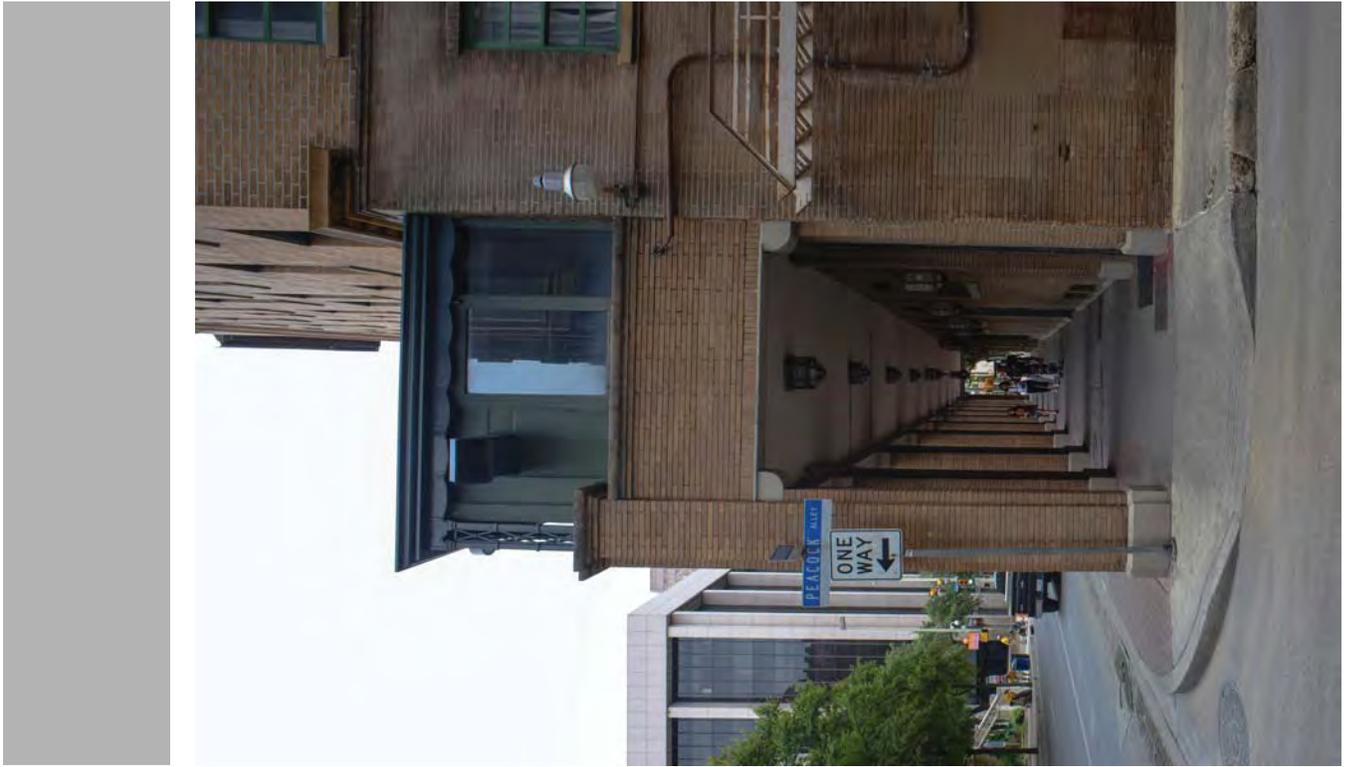
Name: Saint Anthony Hotel, 300 East Travis Street, San Antonio, Texas
View: South facade of west arcade and terrace at Navarro Street and alley
Description: Non-historic glazing system at terrace to be removed
Date: September 2012

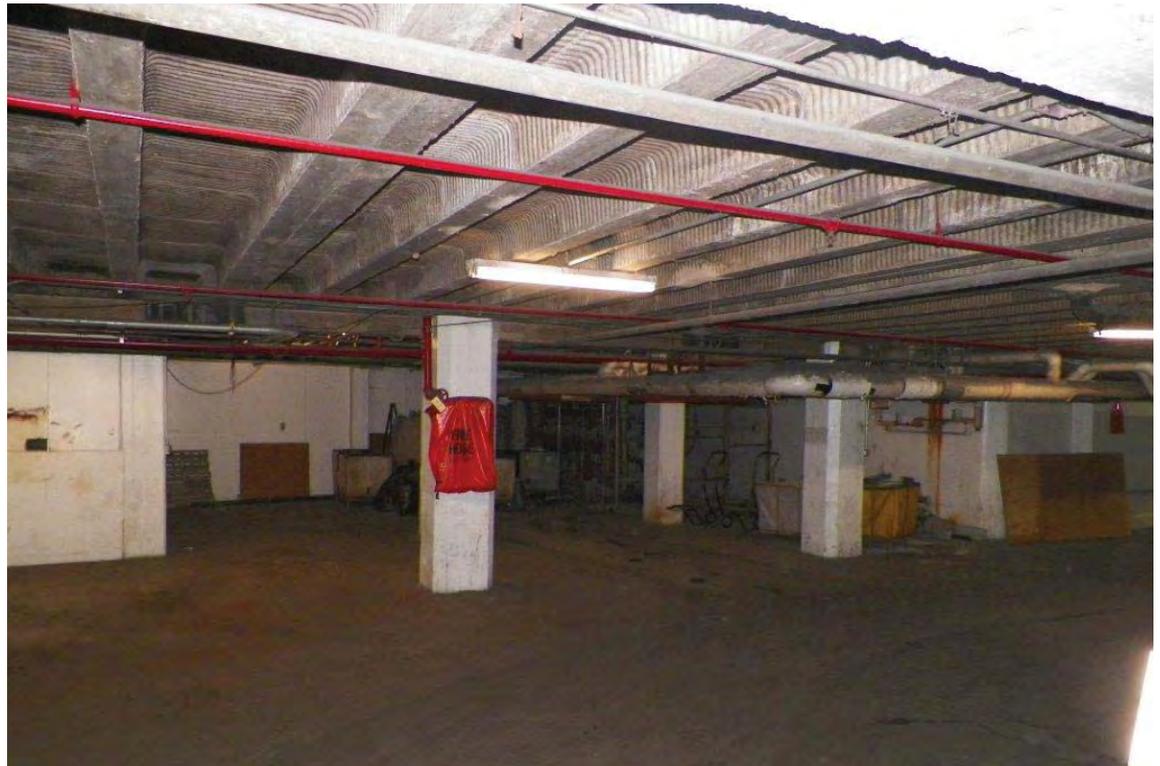
Name: Saint Anthony Hotel, 300 East Travis Street, San Antonio, Texas
View: Typical interior view of parking garage
Description: Concrete & masonry cleaning, lighting upgrades, & ventilation required
Date: September 2012

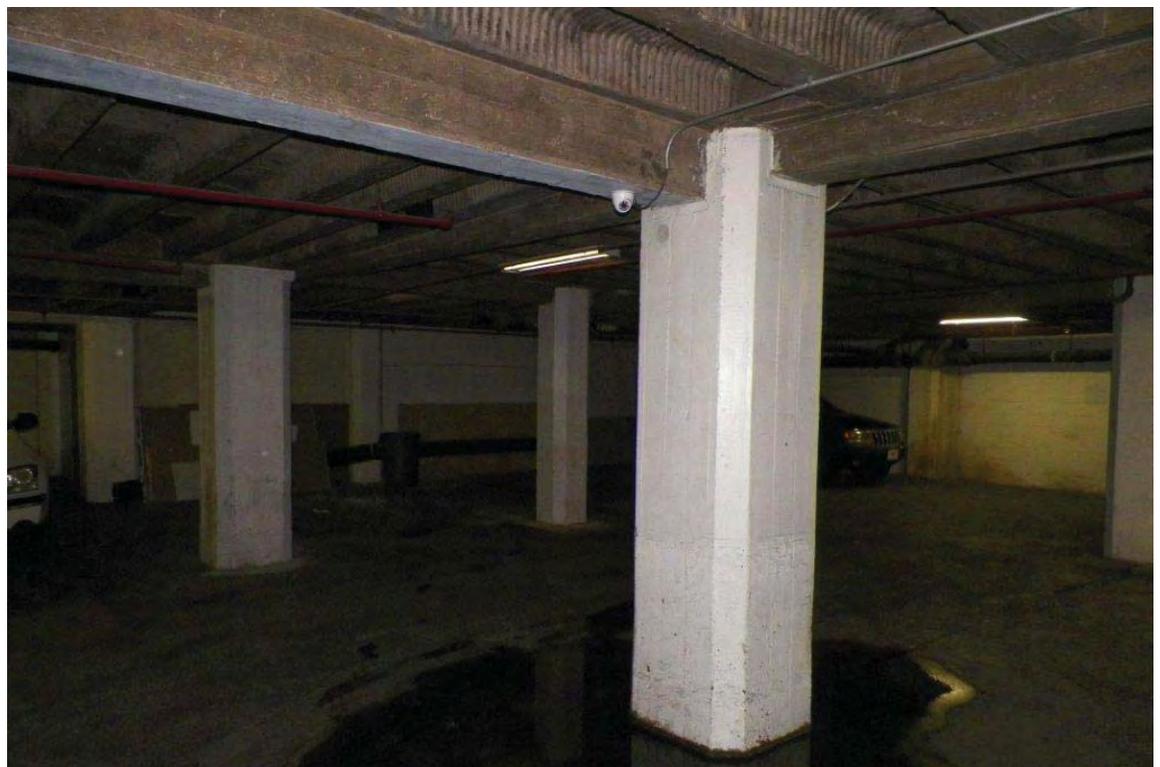
SAH-045

Name: Saint Anthony Hotel, 300 East Travis Street, San Antonio, Texas
View: Typical interior view of parking garage
Description: Concrete & masonry cleaning, lighting upgrades, & ventilation required
Date: September 2012

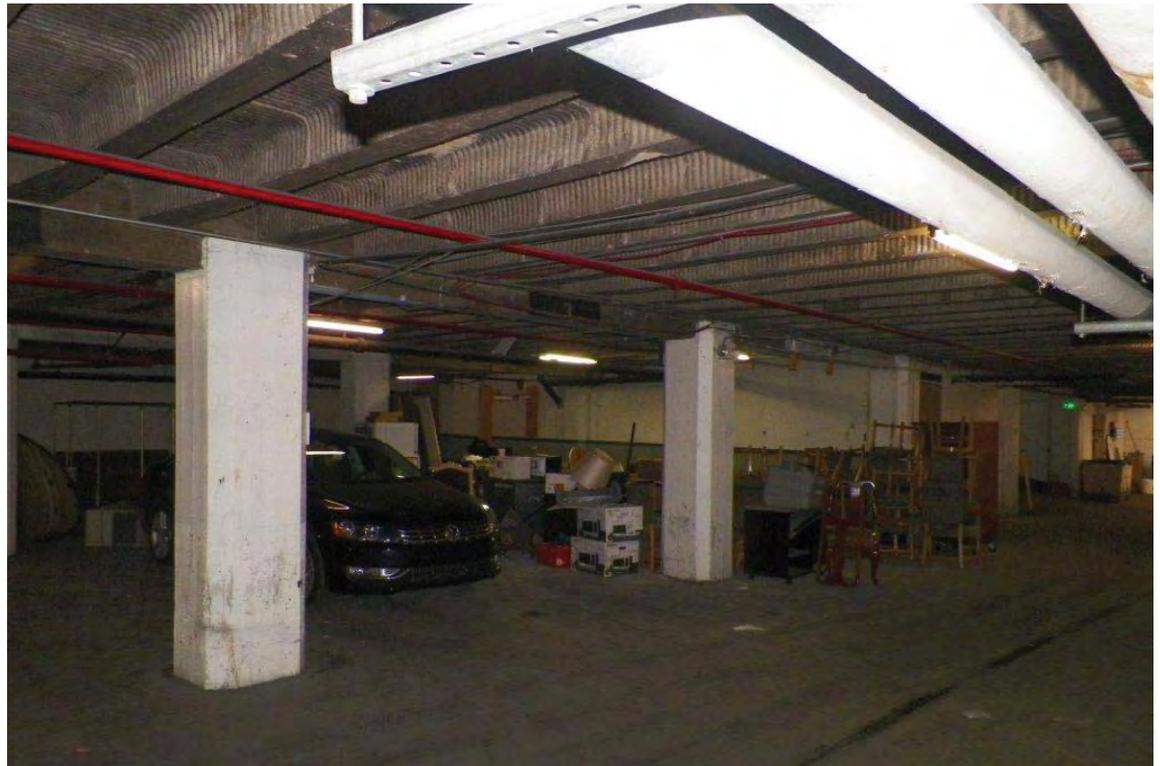
SAH-046

Name: Saint Anthony Hotel, 300 East Travis Street, San Antonio, Texas
View: Typical interior view of parking garage
Description: Concrete & masonry cleaning, lighting upgrades, & ventilation required
Date: September 2012

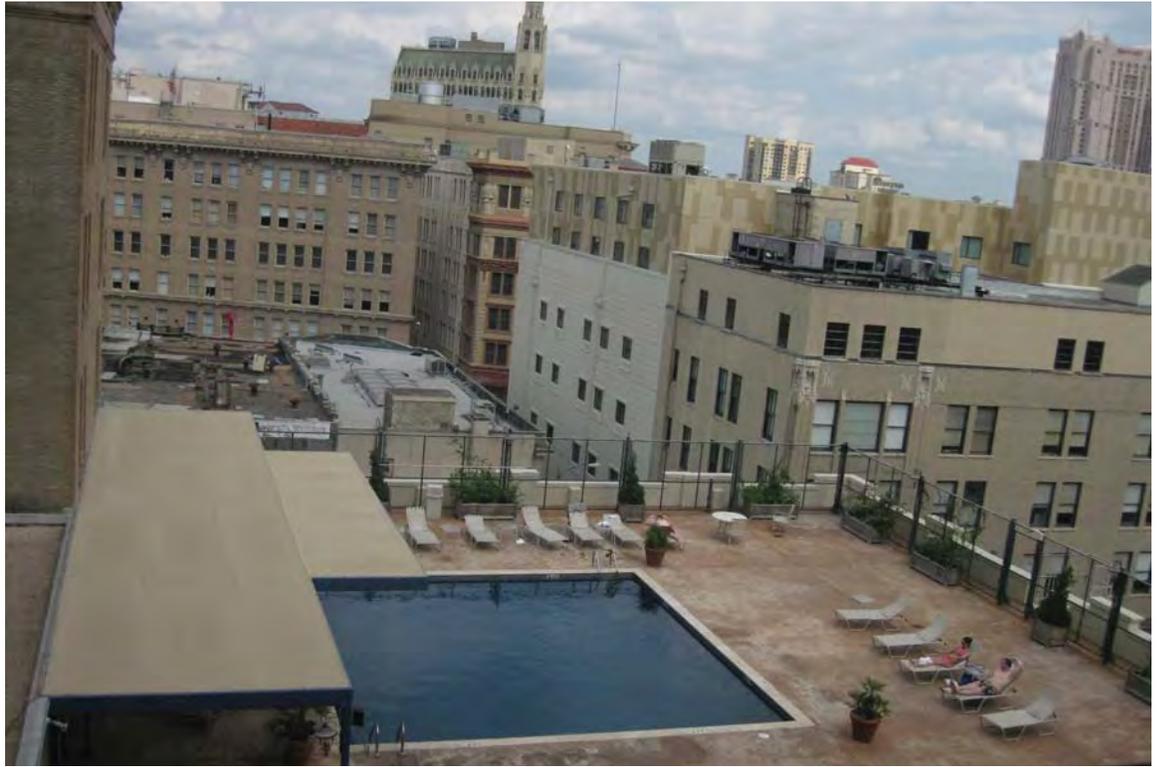
SAH-048

Name: Saint Anthony Hotel, 300 East Travis Street, San Antonio, Texas
View: Sixth floor pool terrace as seen from 8th floor, looking east-southeast
Description: General view of pool terrace, perimeter fencing and canopy structures
Date: September 2012

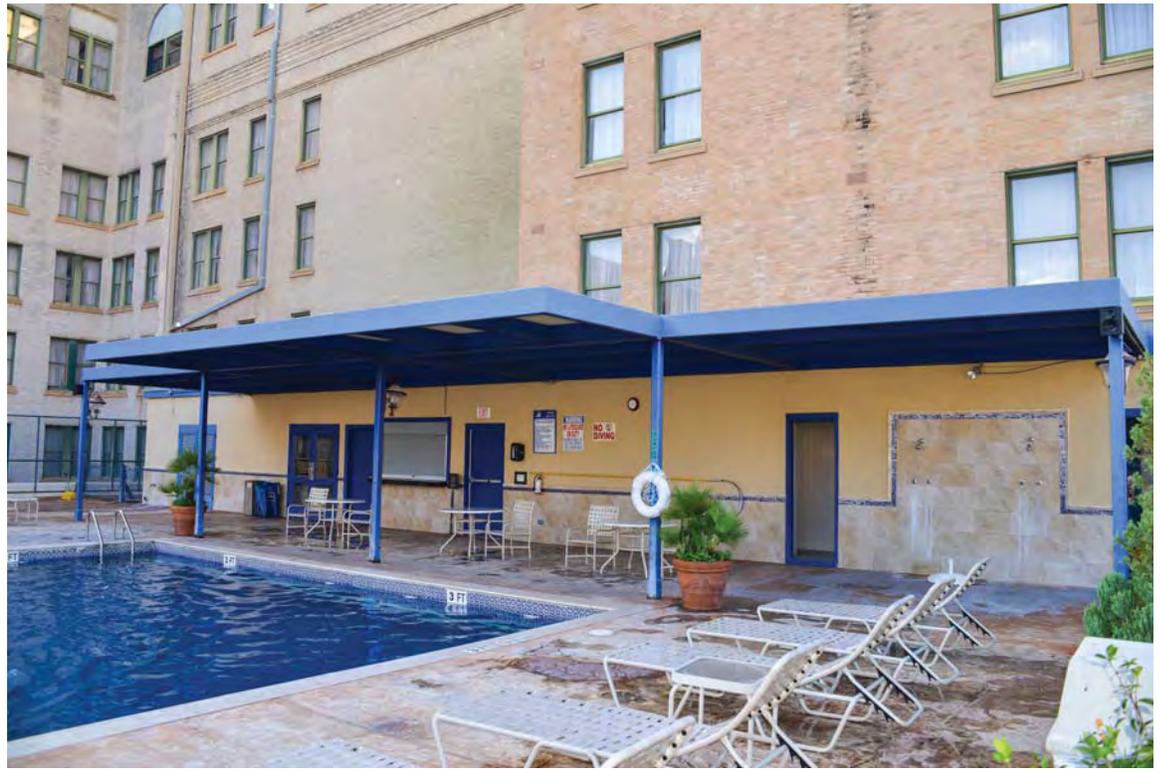
Photograph No.
SAH-060

Name: Saint Anthony Hotel, 300 East Travis Street, San Antonio, Texas
View: Sixth floor pool terrace, looking northwest at Tower 4 south facade
Description: Pool concession addition and canopy structure
Date: September 2012

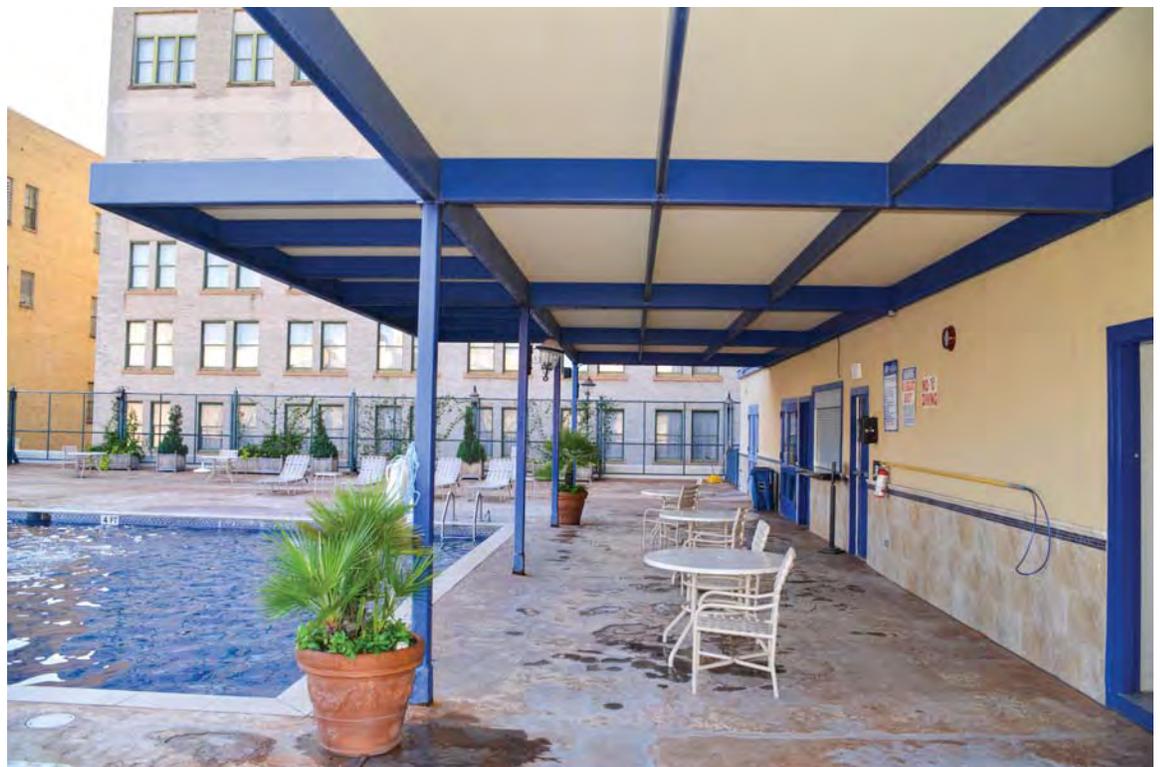
Photograph No.
SAH-061

Name: Saint Anthony Hotel, 300 East Travis Street, San Antonio, Texas
View: Sixth floor pool terrace, looking west toward Tower 3
Description: Pool concession addition and canopy structure
Date: September 2012

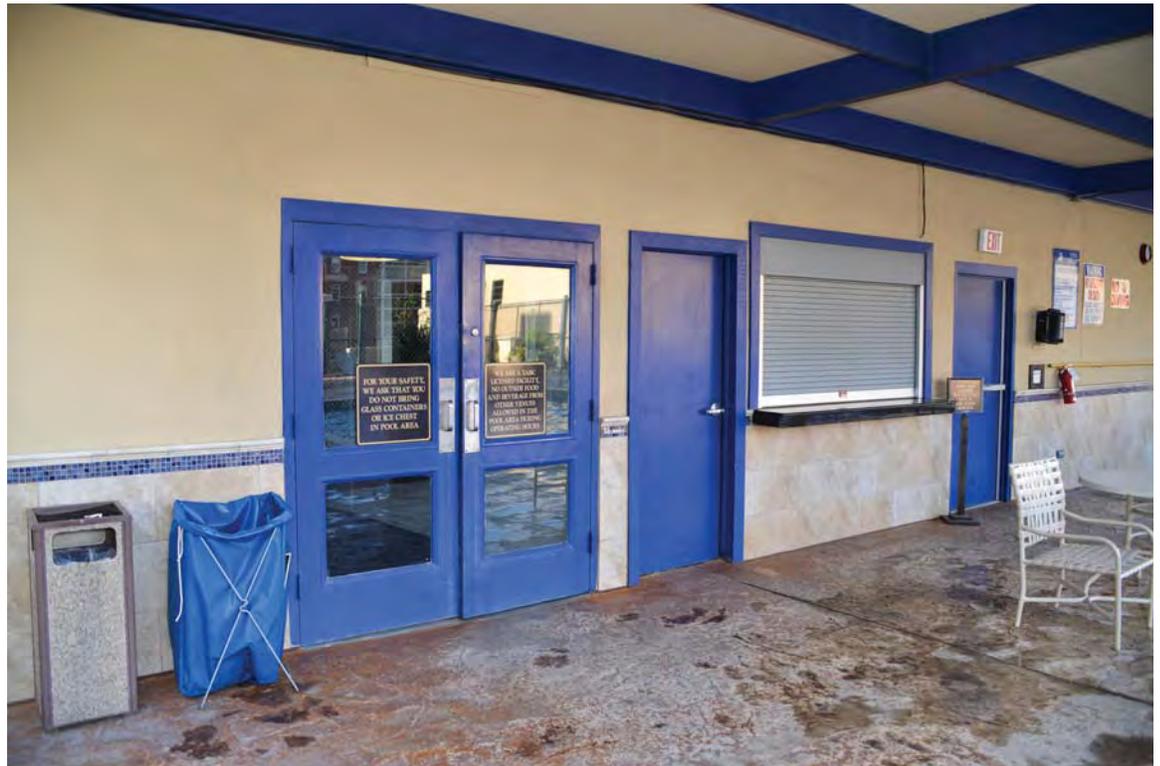
Photograph No.
SAH-062

Name: Saint Anthony Hotel, 300 East Travis Street, San Antonio, Texas
View: Sixth floor pool terrace, looking northeast at Tower 4 south facade
Description: Pool concession serving window and pool terrace entry
Date: September 2012

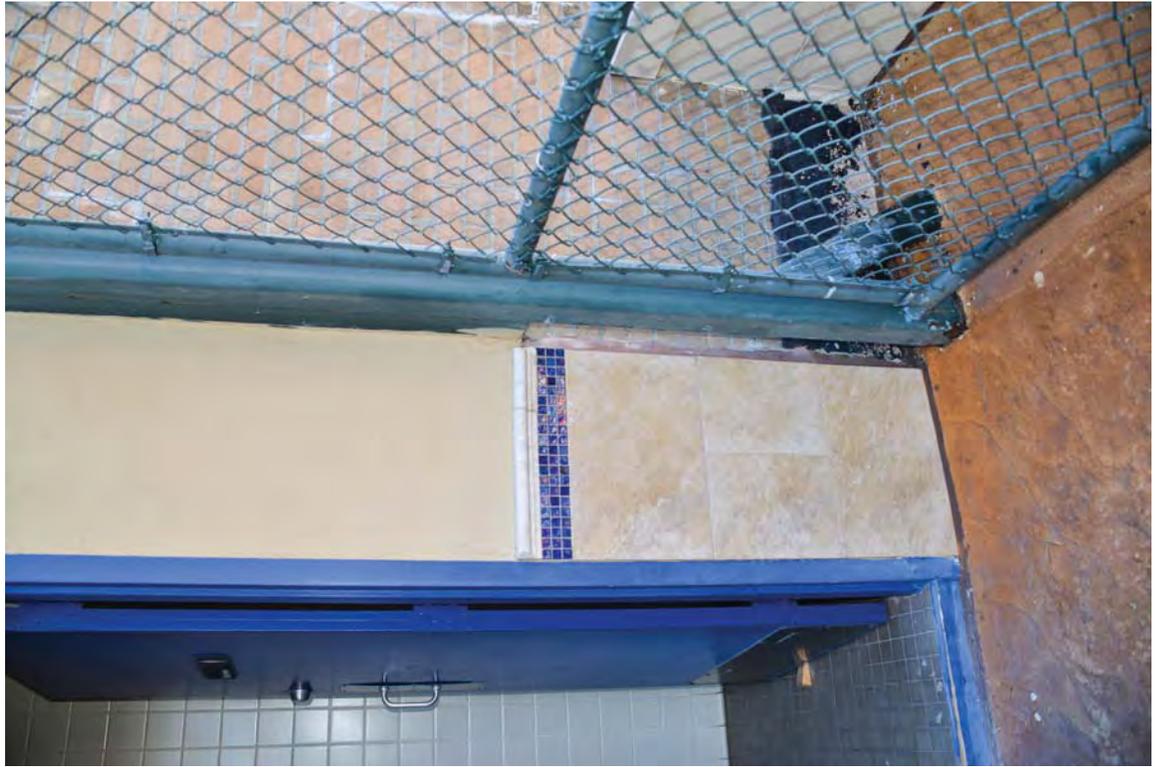
SAH-064

Name: Saint Anthony Hotel, 300 East Travis Street, San Antonio, Texas
View: Sixth floor pool terrace, looking north at Tower 4 south facade
Description: Detail of stucco and tile finishes added to historic brick masonry
Date: September 2012

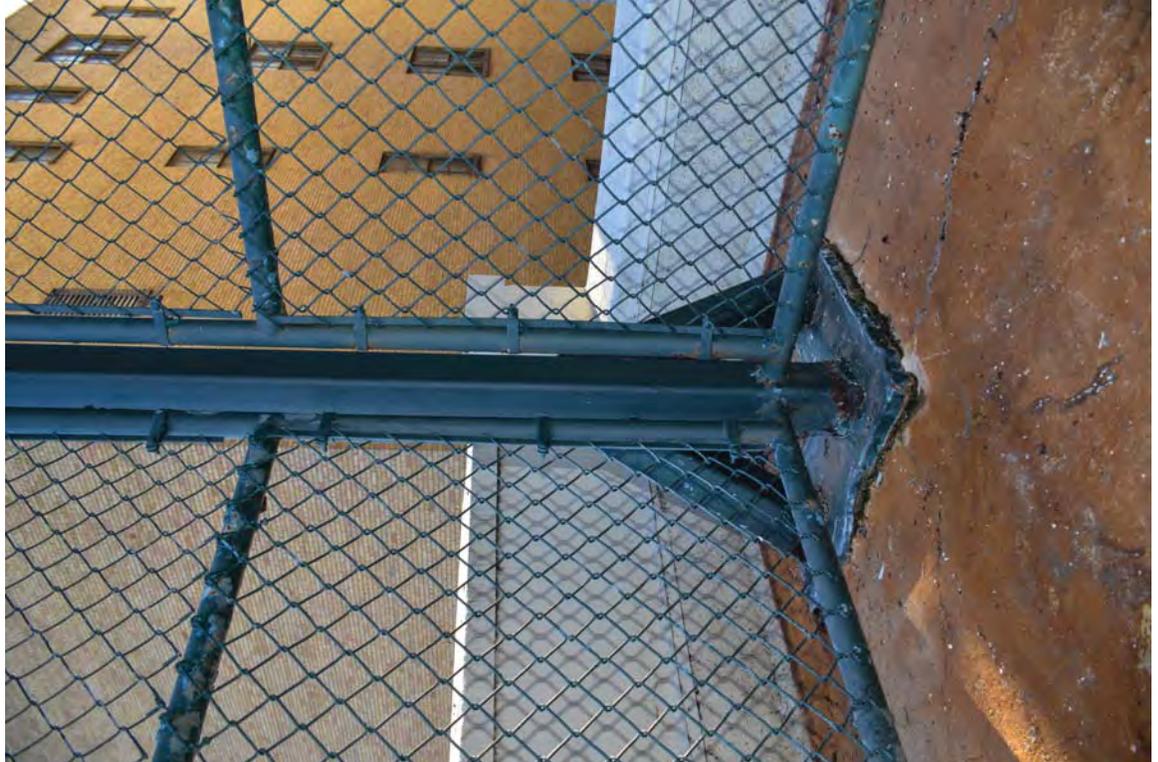
SAH-065

Name: Saint Anthony Hotel, 300 East Travis Street, San Antonio, Texas
View: Sixth floor pool terrace, looking southwest at terrace corner
Description: Detail of steel post and perimeter fencing
Date: September 2012

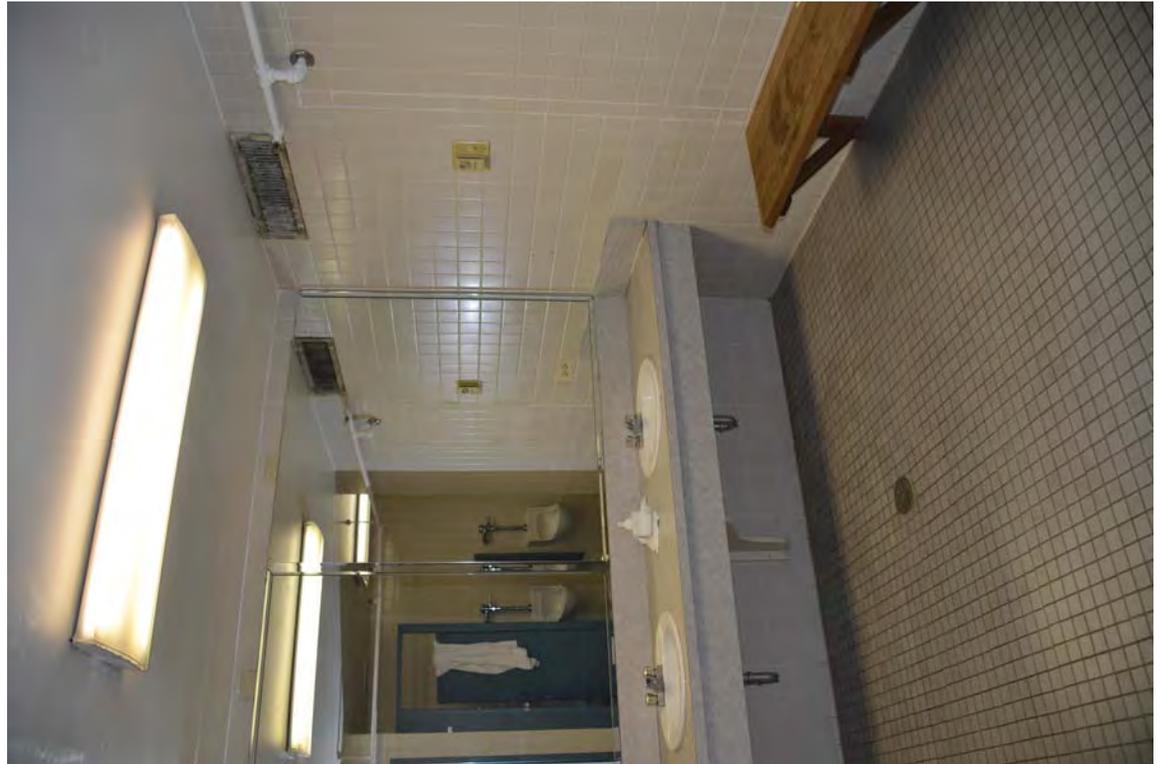
SAH-068

Name: Saint Anthony Hotel, 300 East Travis Street, San Antonio, Texas
View: Sixth floor men's pool changing room interior, looking west
Description: Lavatories in changing room
Date: September 2012

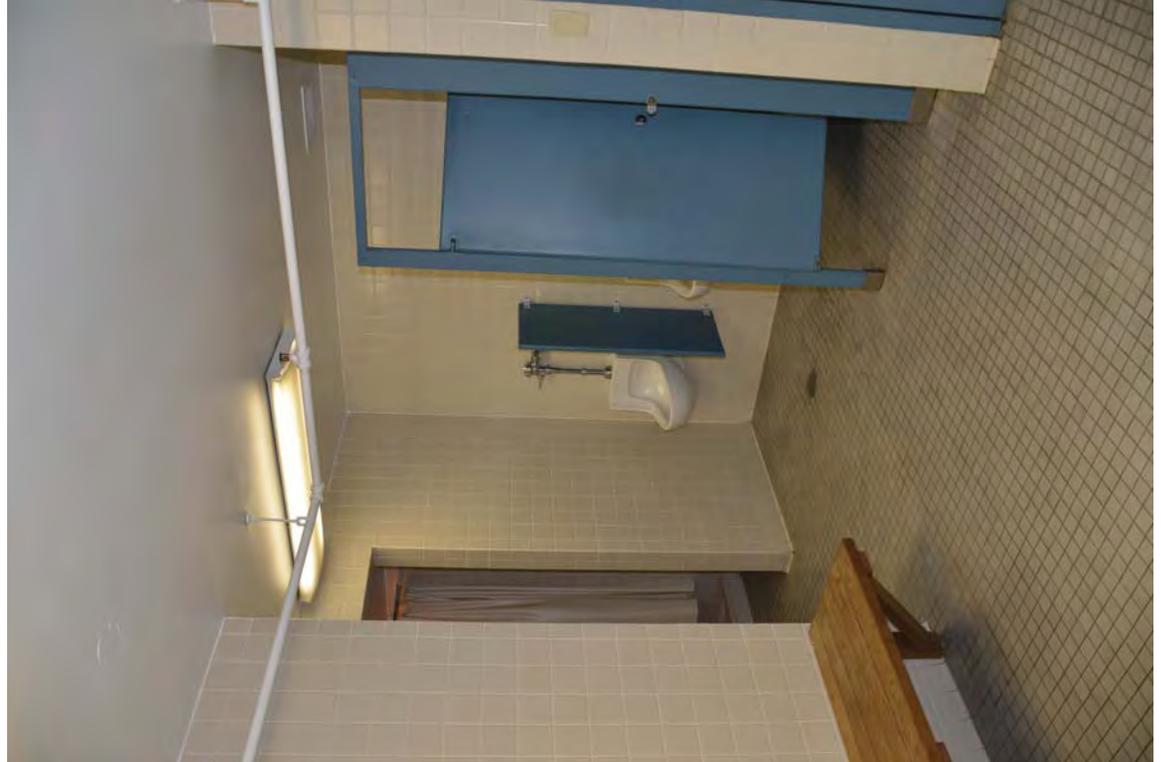
Photograph No.
SAH-069

Name: Saint Anthony Hotel, 300 East Travis Street, San Antonio, Texas
View: Sixth floor men's pool changing room interior, looking northeast
Description: Toilet, urinals and showers in changing room
Date: September 2012

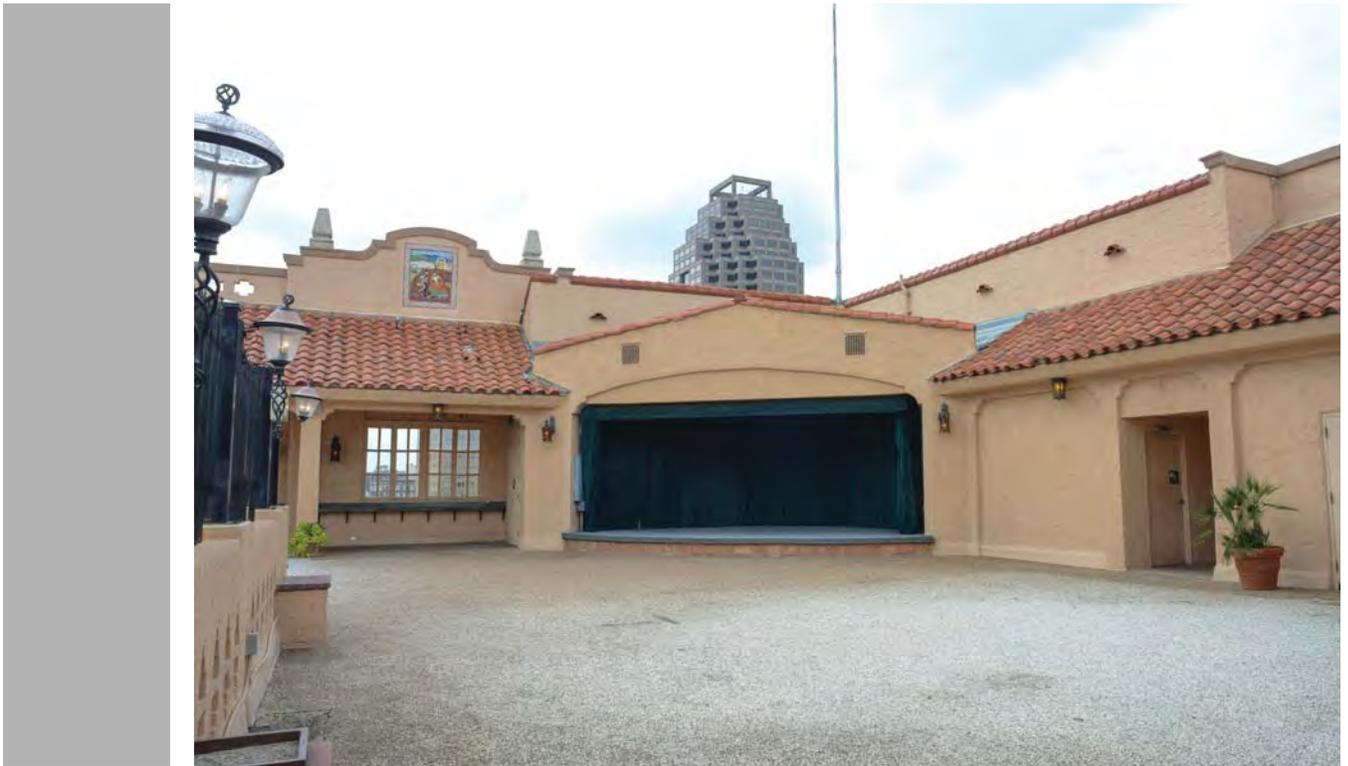
Photograph No.
SAH-070

Name: Saint Anthony Hotel, 300 East Travis Street, San Antonio, Texas
View: Tenth floor Starlight Terrace, looking northwest
Description: Proscenium and platform with non-historic restroom addition beyond
Date: September 2012

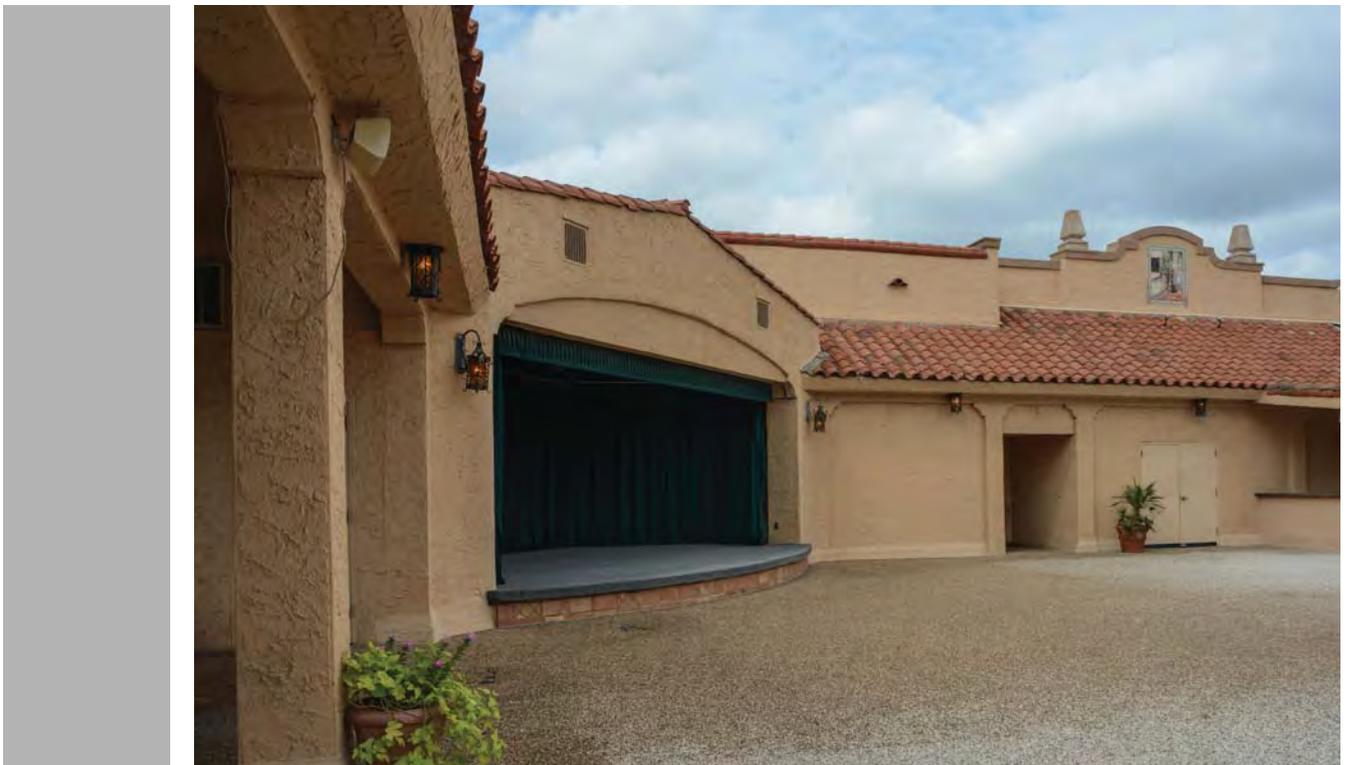
SAH-071

Name: Saint Anthony Hotel, 300 East Travis Street, San Antonio, Texas
View: Tenth floor Starlight Terrace, looking north
Description: Proscenium and platform with non-historic restroom addition beyond
Date: September 2012

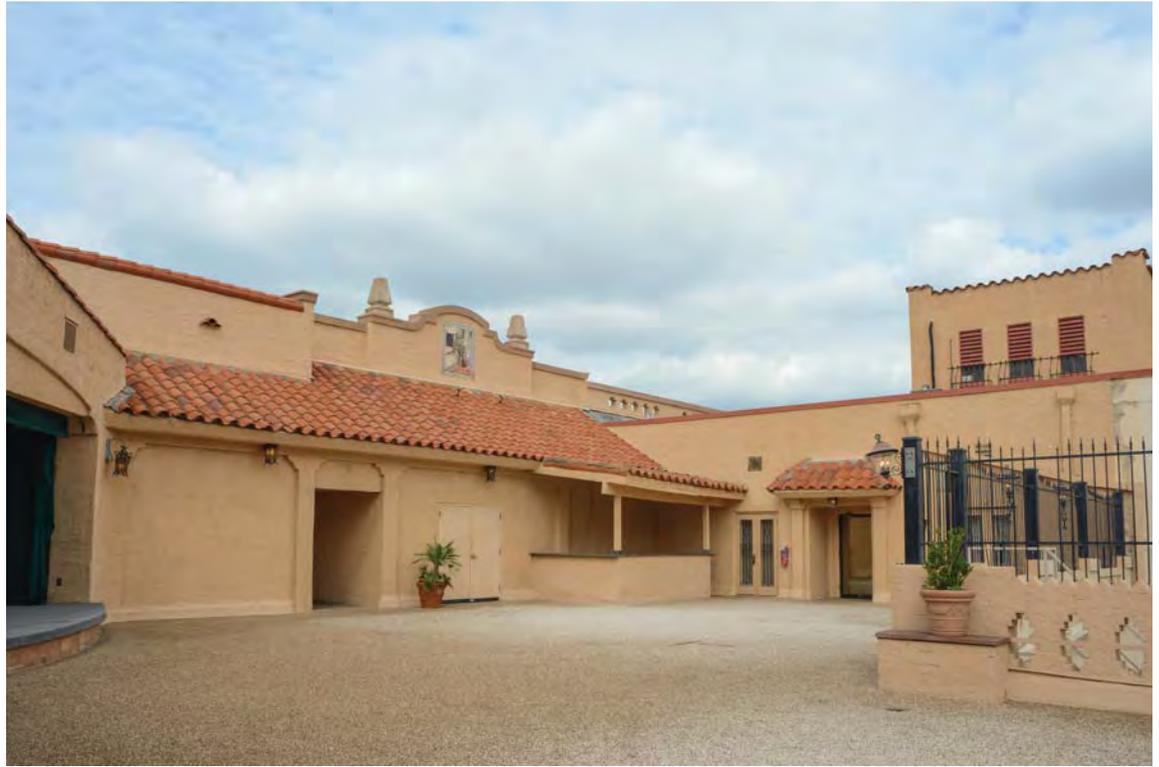
SAH-072

Name: Saint Anthony Hotel, 300 East Travis Street, San Antonio, Texas
View: Tenth floor Starlight Terrace, looking northeast
Description: Tile roof and stucco colonnade with non-historic additions & infills
Date: September 2012

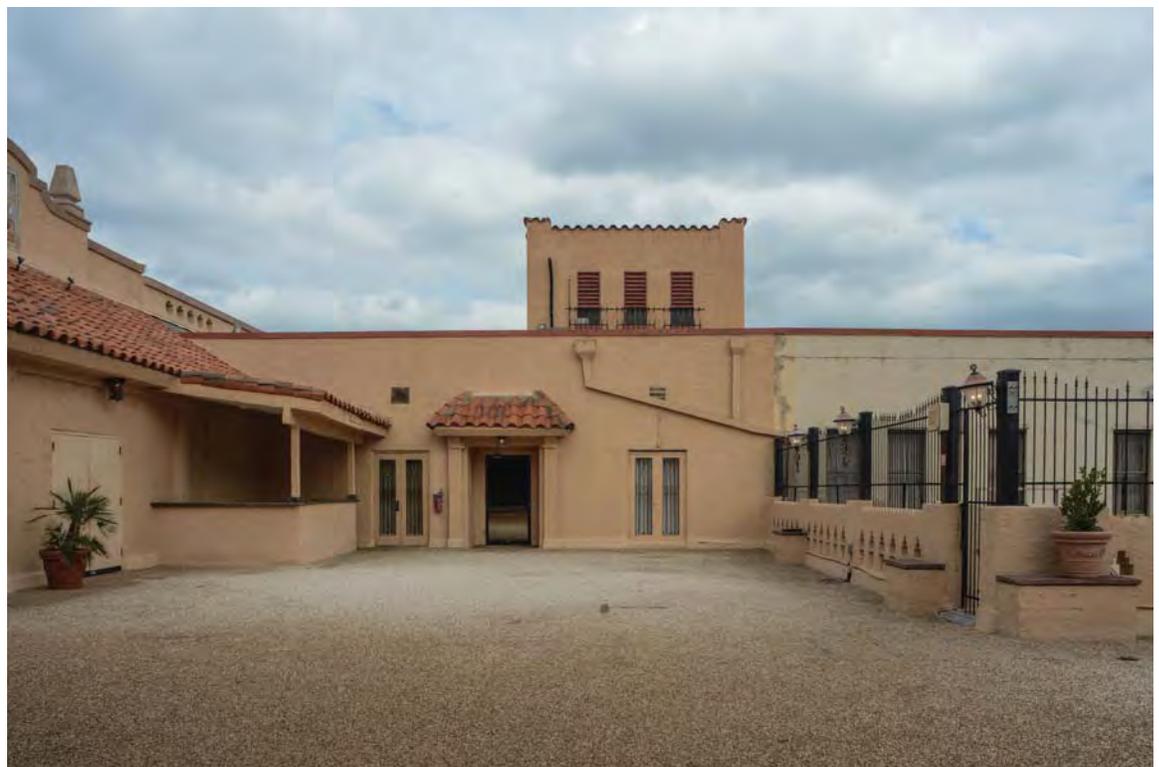
SAH-073

Name: Saint Anthony Hotel, 300 East Travis Street, San Antonio, Texas
View: Tenth floor Starlight Terrace, looking east at west facade of Tower 3
Description: Non-historic bar and storage room additions
Date: September 2012

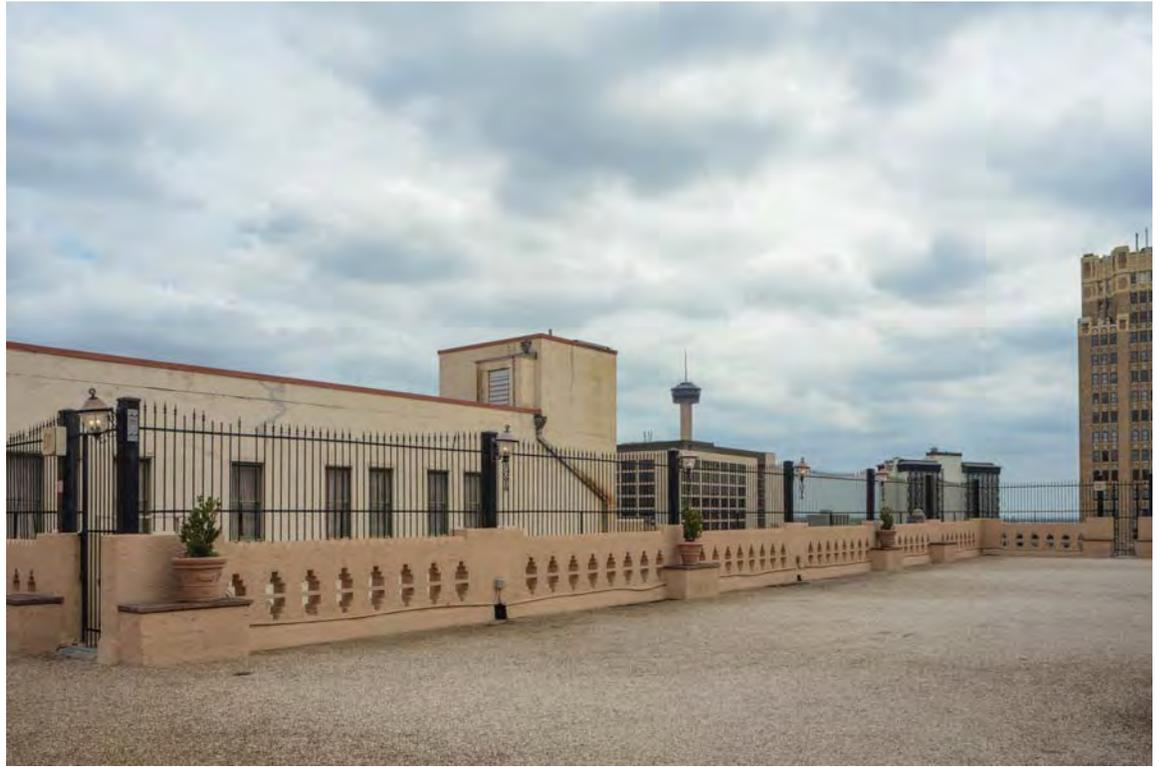
SAH-074

Name: Saint Anthony Hotel, 300 East Travis Street, San Antonio, Texas
View: Tenth floor Starlight Terrace, looking southeast at parapet wall
Description: Inappropriately scaled, non-historic guardrail on historic parapet wall
Date: September 2012

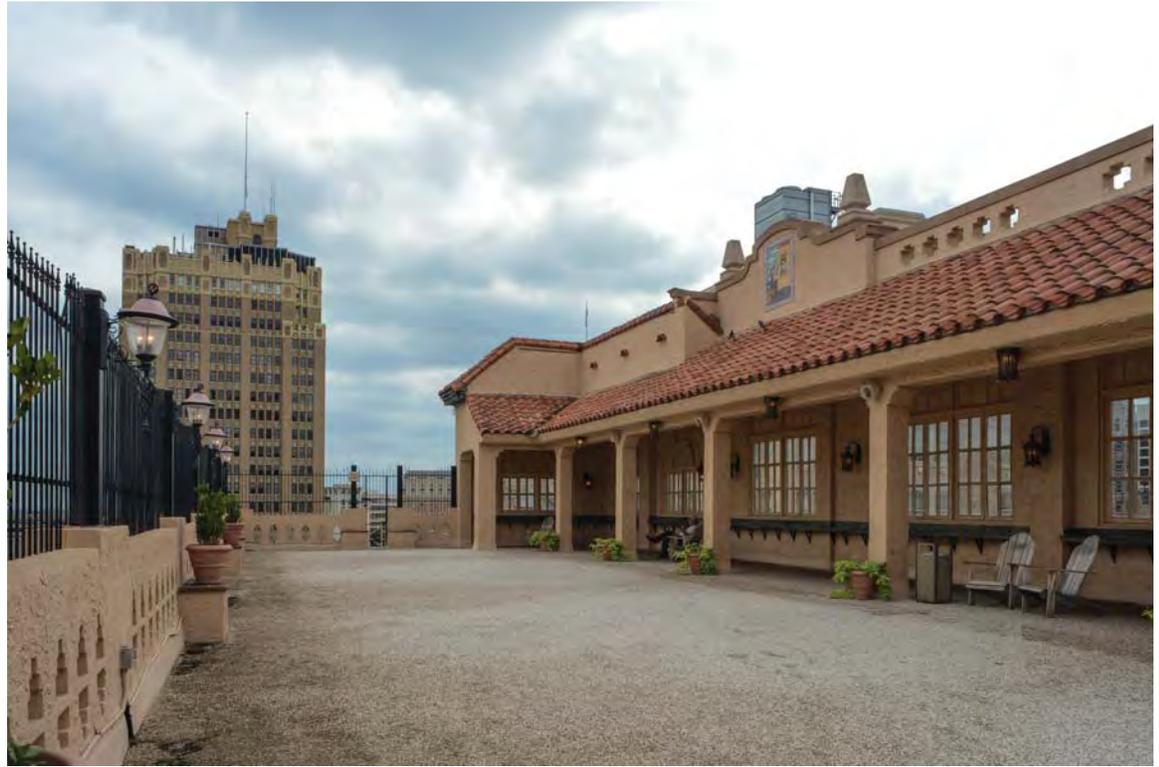
SAH-076

Name: Saint Anthony Hotel, 300 East Travis Street, San Antonio, Texas
View: Tenth floor Starlight Terrace, looking south
Description: Non-historic guardrail on historic parapet wall; tile roof & colonnade
Date: September 2012

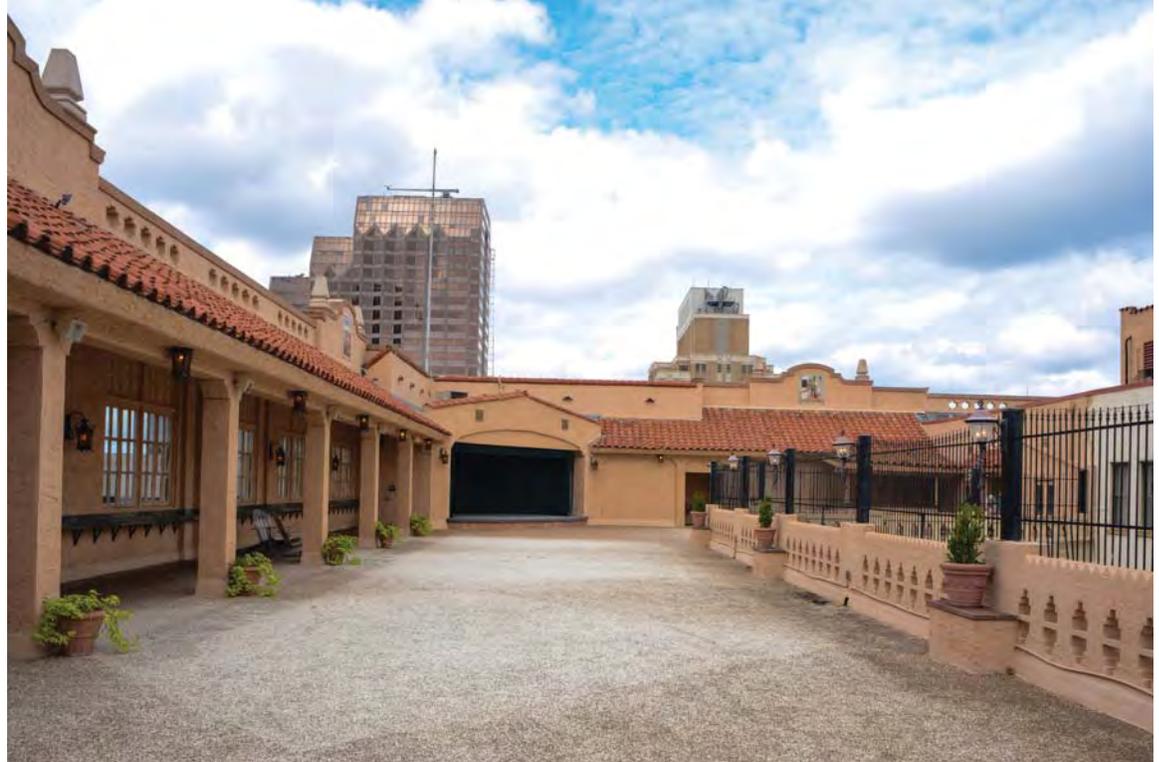
SAH-077

Name: Saint Anthony Hotel, 300 East Travis Street, San Antonio, Texas
View: Tenth floor Starlight Terrace, looking north
Description: Non-historic guardrail on historic parapet wall; tile roof & colonnade
Date: September 2012

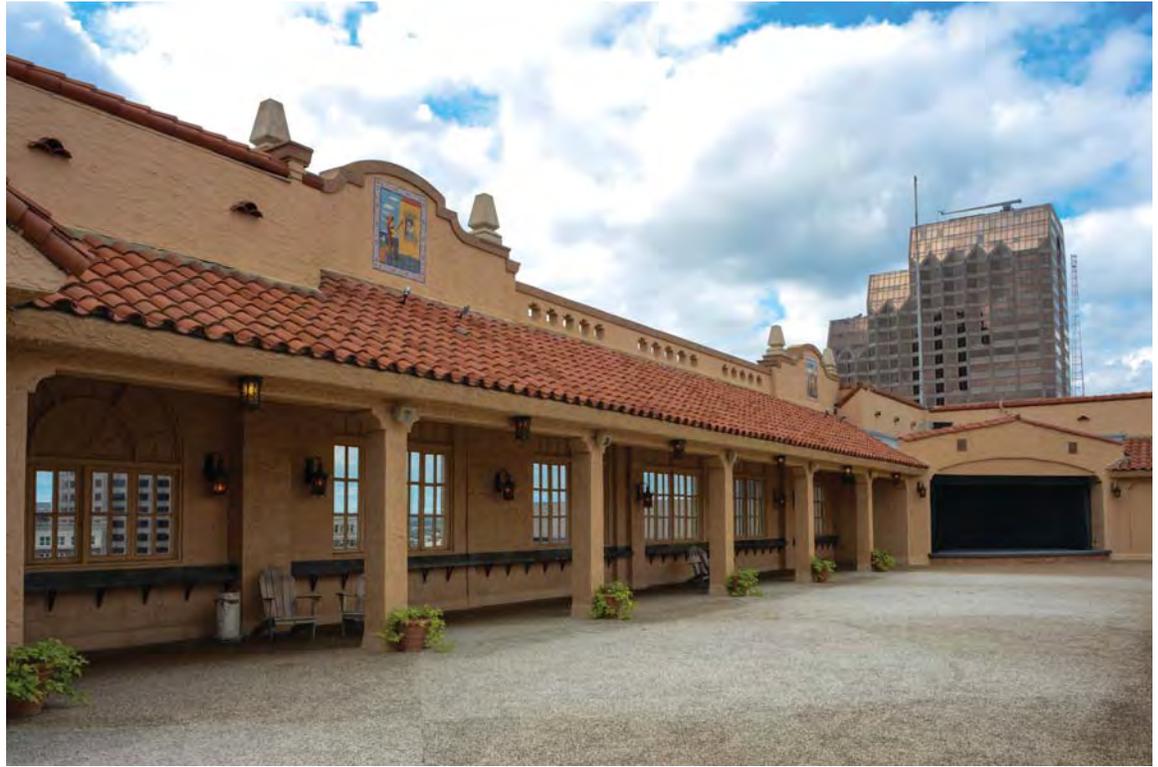
SAH-078

Name: Saint Anthony Hotel, 300 East Travis Street, San Antonio, Texas
View: Tenth floor Starlight Terrace, looking northwest
Description: Tile roof & colonnade with wood windows and transoms
Date: September 2012
