HISTORIC AND DESIGN REVIEW COMMISSION

HDRC CASE NO: 2016-016
ADDRESS: 304 E TRAVIS ST
LEGAL DESCRIPTION: NCB 415 BLK 18 LOT A-7, A- 8, A-9, P-100, P-101 & P-102
ZONING: D HE
CITY COUNCIL DIST.: 1
LANDMARK: St Anthony Hotel
APPLICANT: Brandon Raney
OWNER: BCL St. Anthony ML, LP
TYPE OF WORK: Tax Certification
REQUEST:

RE: St. Anthony Hotel Tax Certification Application

St. Anthony Hotel
Scope Summary of Exterior Rehabilitation

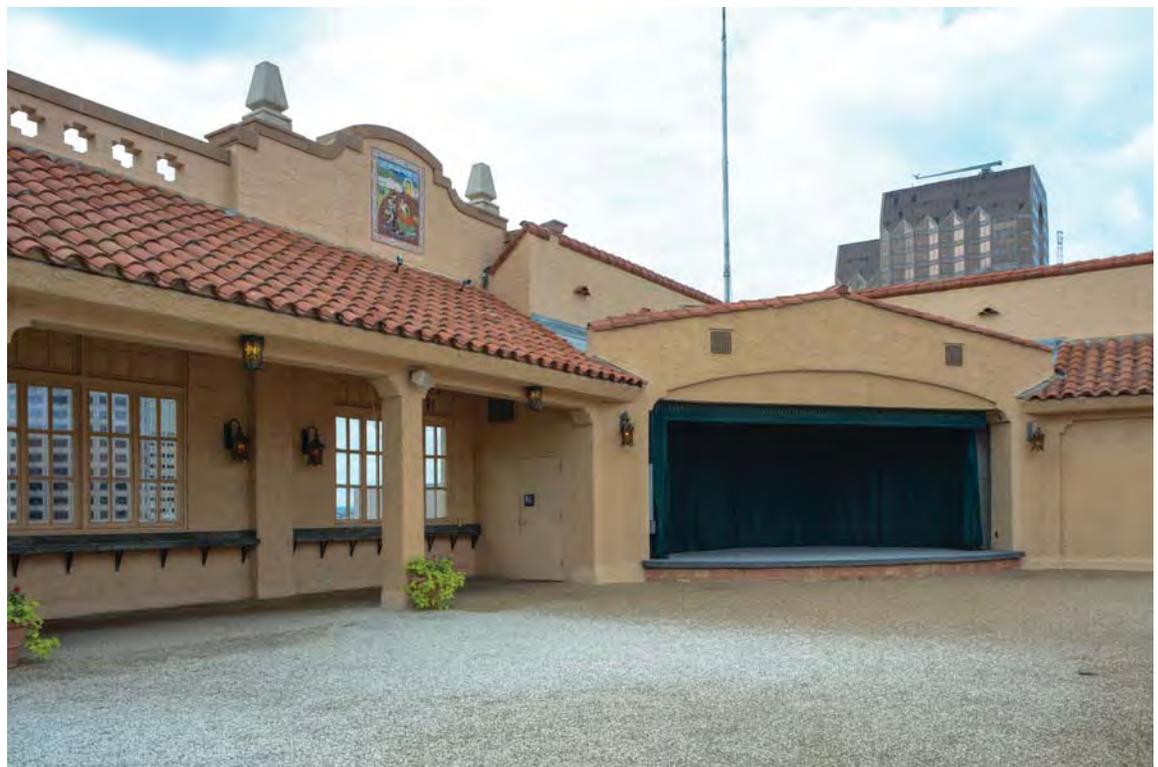
SAH-079

Name: Saint Anthony Hotel, 300 East Travis Street, San Antonio, Texas
View: Tenth floor Starlight Terrace, looking northwest
Description: Proscenium and platform with non-historic restroom addition beyond
Date: September 2012

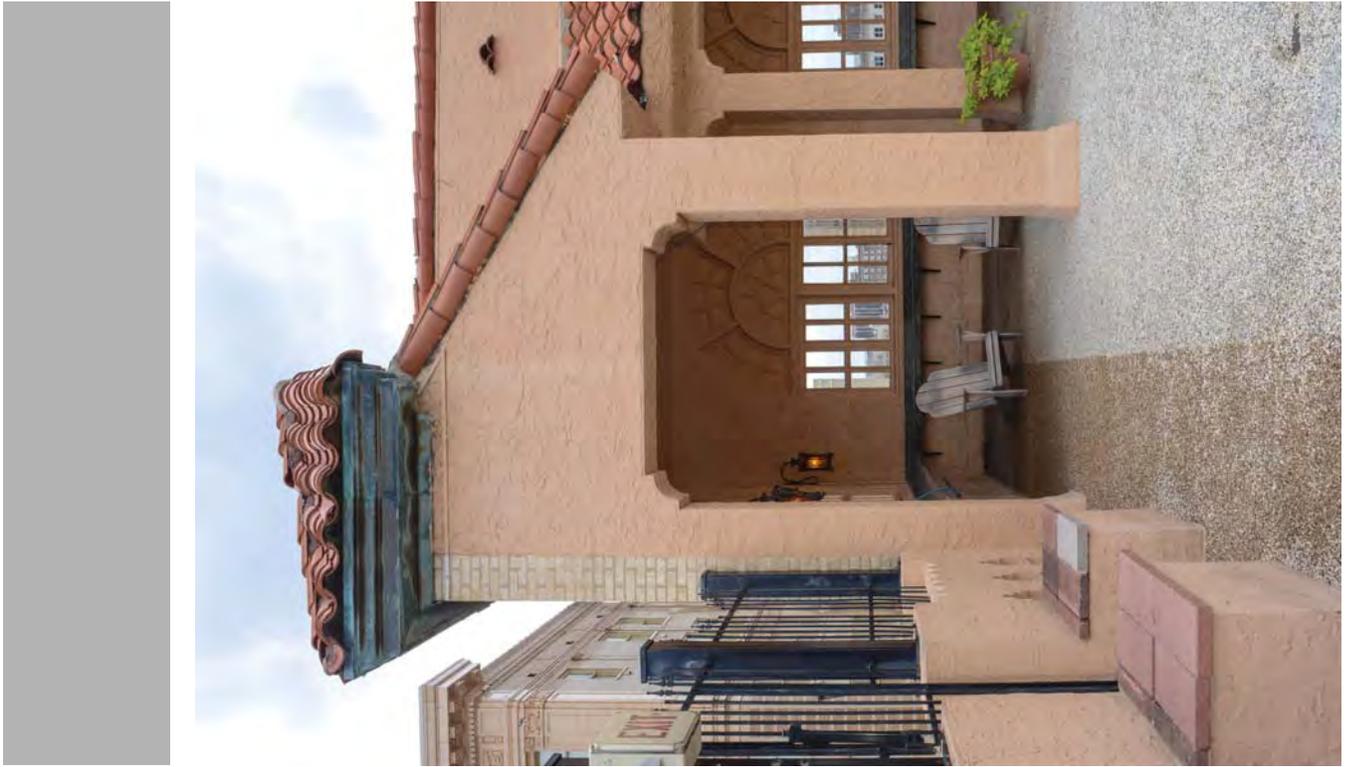
SAH-080

Name: Saint Anthony Hotel, 300 East Travis Street, San Antonio, Texas
View: Tenth floor Starlight Terrace, looking west
Description: South bay of west colonnade with tile roof and copper gutter
Date: September 2012

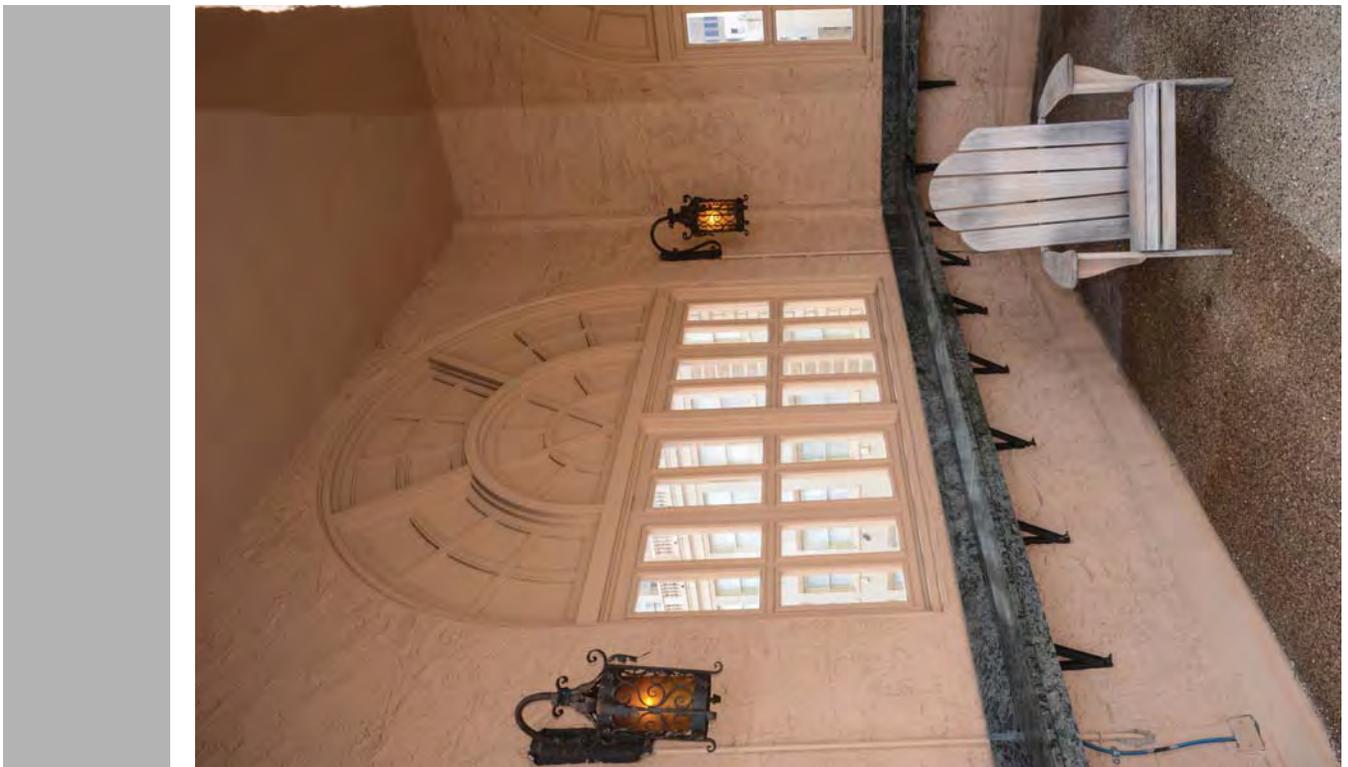
SAH-081

Name: Saint Anthony Hotel, 300 East Travis Street, San Antonio, Texas
View: Tenth floor Starlight Terrace, looking southwest at window
Description: Wood window with painted transom arch; historic light fixtures
Date: September 2012

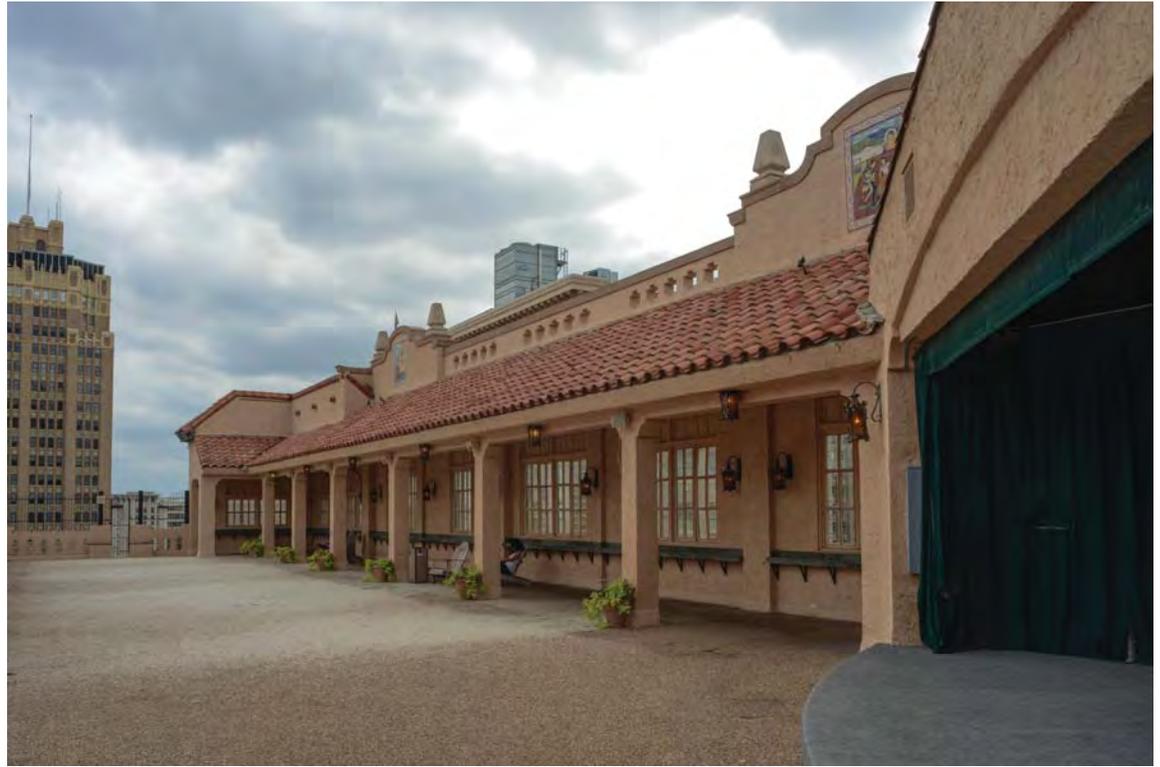
SAH-082

Name: Saint Anthony Hotel, 300 East Travis Street, San Antonio, Texas
View: Tenth floor Starlight Terrace, looking southwest at west colonnade
Description: Tile roof & colonnade with wood windows and transoms
Date: September 2012

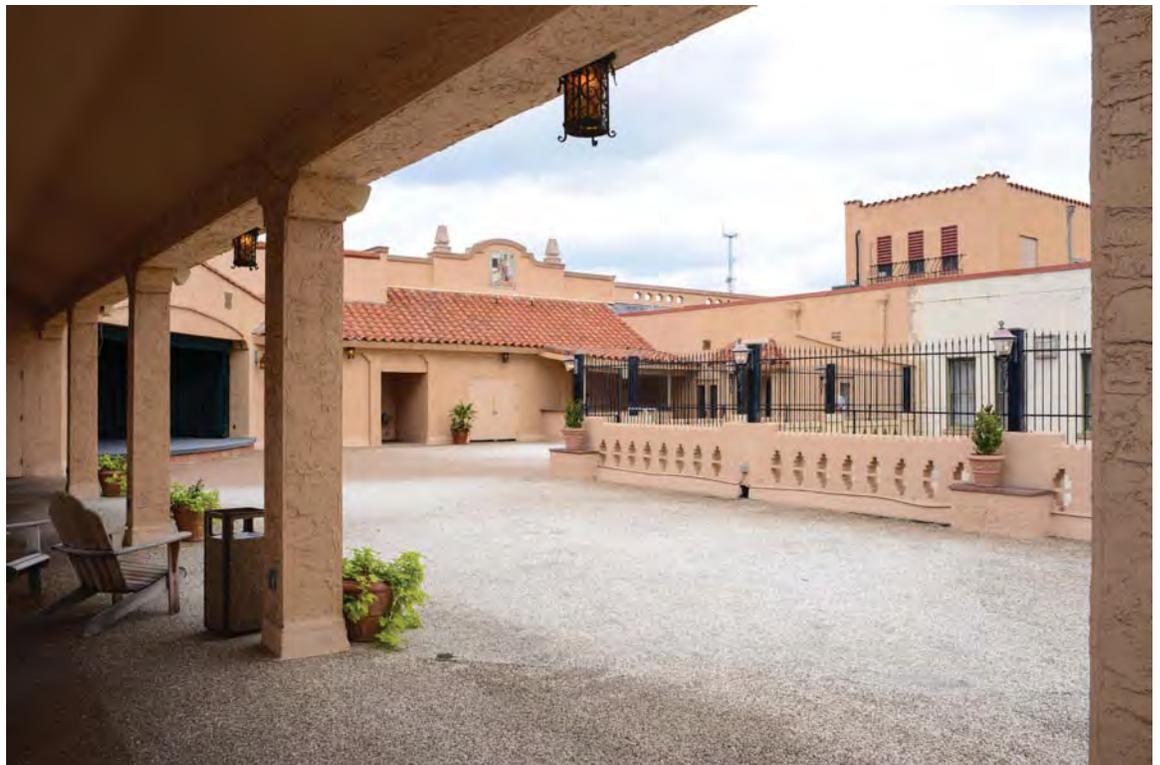
Photograph No.
SAH-083

Name: Saint Anthony Hotel, 300 East Travis Street, San Antonio, Texas
View: Tenth floor Starlight Terrace, looking northeast from west colonnade
Description: General view of terrace features
Date: September 2012

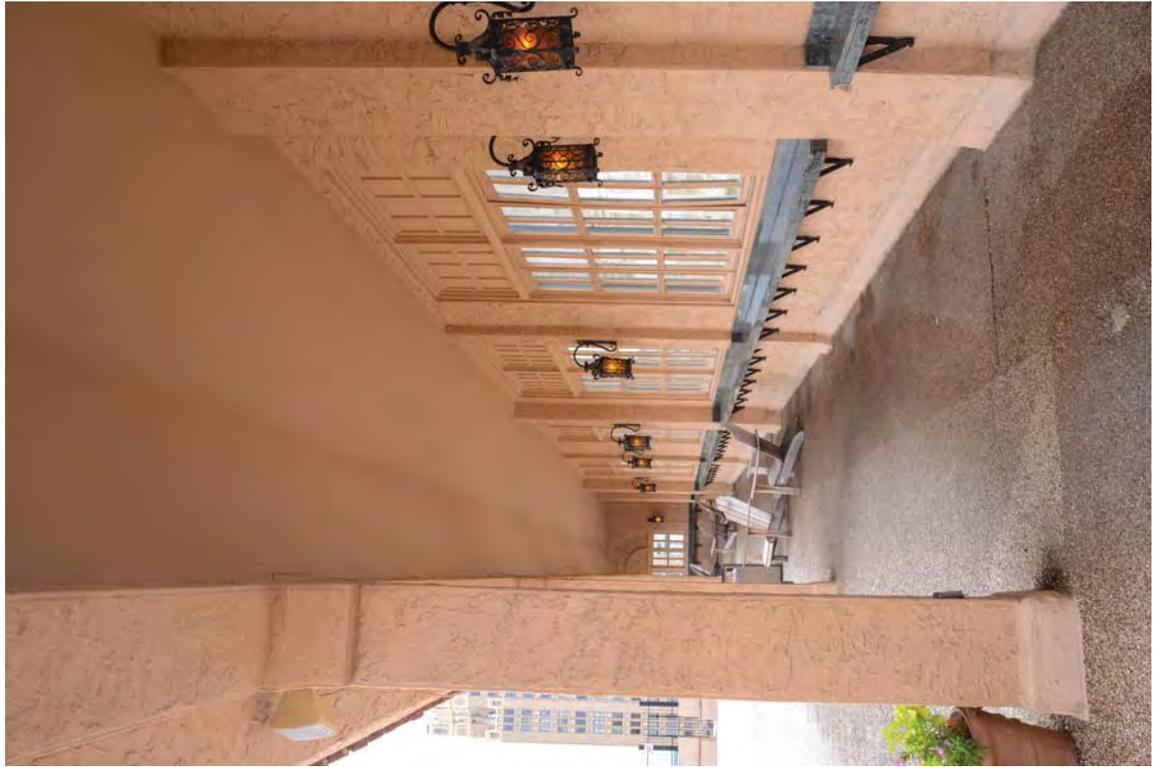
Photograph No.
SAH-084

Name: Saint Anthony Hotel, 300 East Travis Street, San Antonio, Texas
View: Tenth floor Starlight Terrace, looking south at west colonnade
Description: Stucco columns, wood windows with transoms, & historic fixtures
Date: September 2012

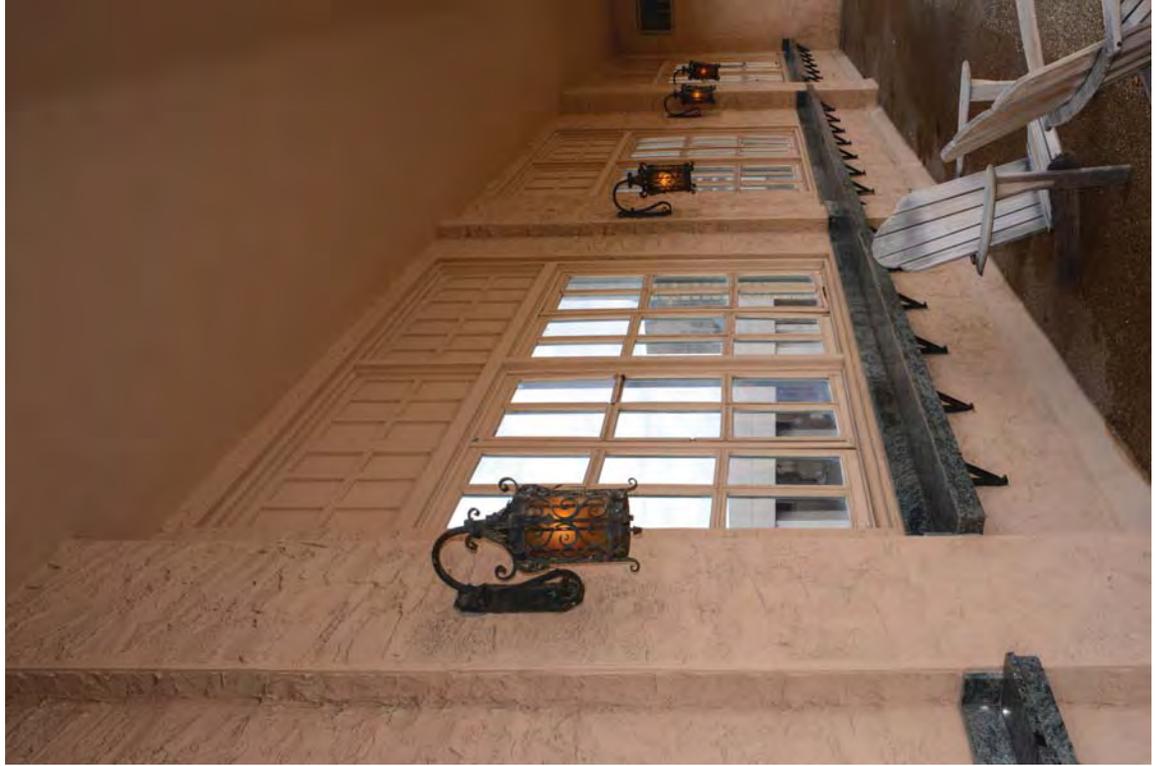
Photograph No.
SAH-085

Name: Saint Anthony Hotel, 300 East Travis Street, San Antonio, Texas
View: Tenth floor Starlight Terrace, looking north at west colonnade
Description: Stucco columns, wood windows with transoms, & historic fixtures
Date: September 2012

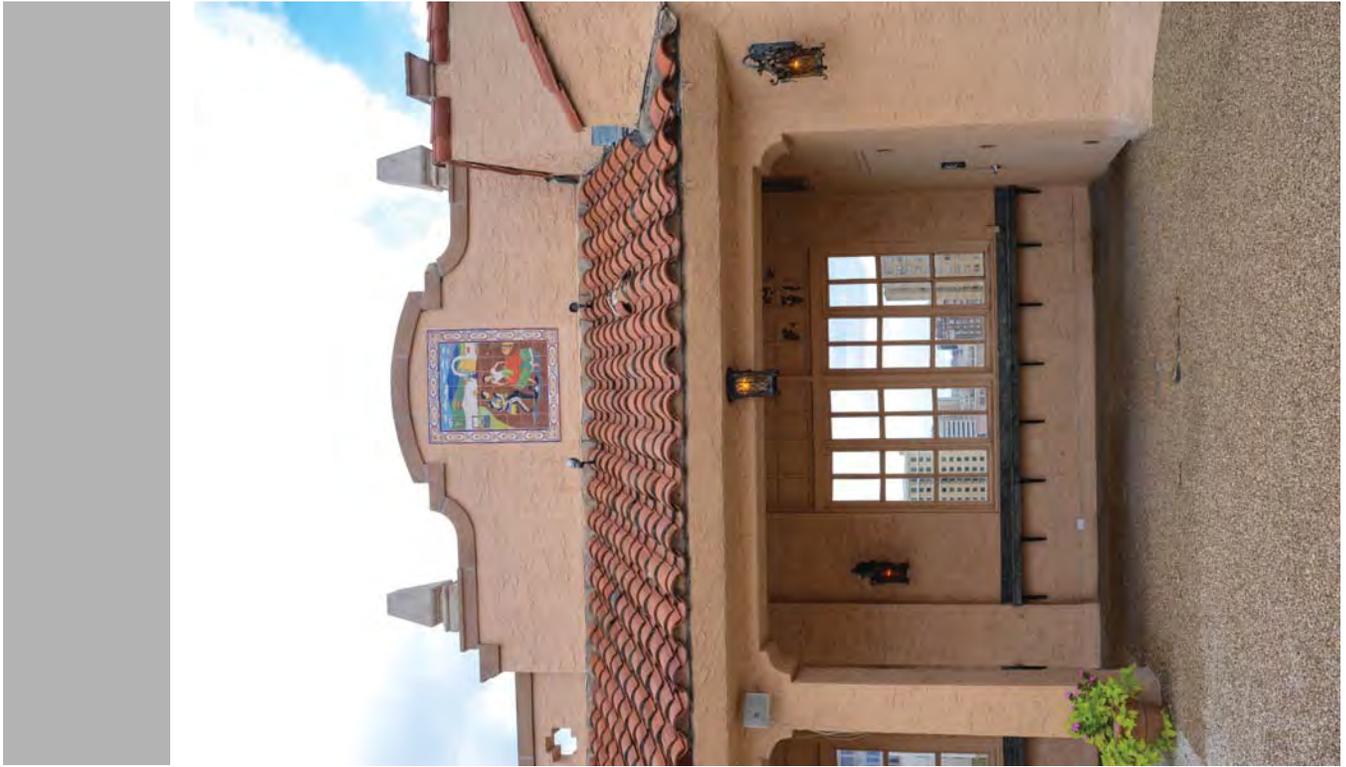
Photograph No.
SAH-086

Name: Saint Anthony Hotel, 300 East Travis Street, San Antonio, Texas
View: Tenth floor Starlight Terrace, looking west at west colonnade
Description: Tile parapet mural above tile roof and stucco colonnade
Date: September 2012

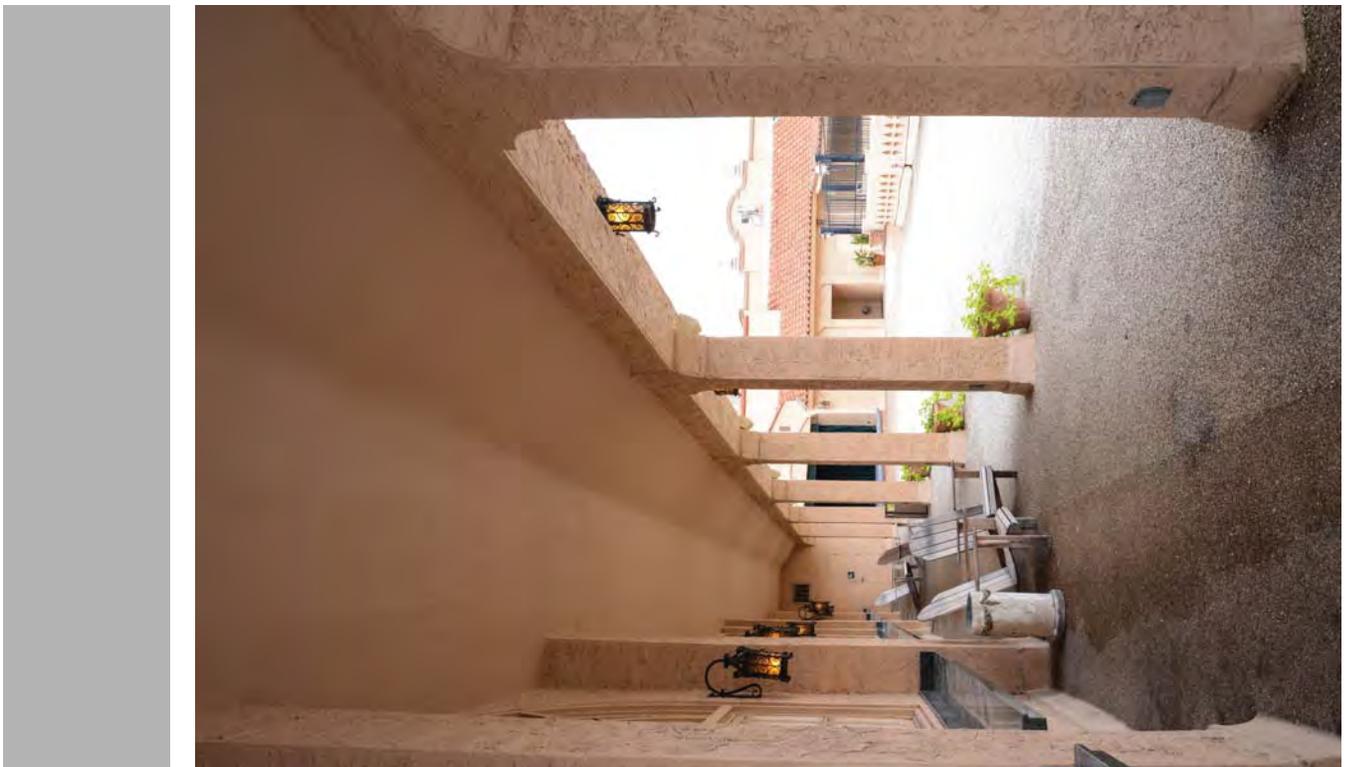
SAH-087

Name: Saint Anthony Hotel, 300 East Travis Street, San Antonio, Texas
View: Tenth floor Starlight Terrace, looking north at west colonnade
Description: Stucco columns, wood windows with transoms, & historic fixtures
Date: September 2012

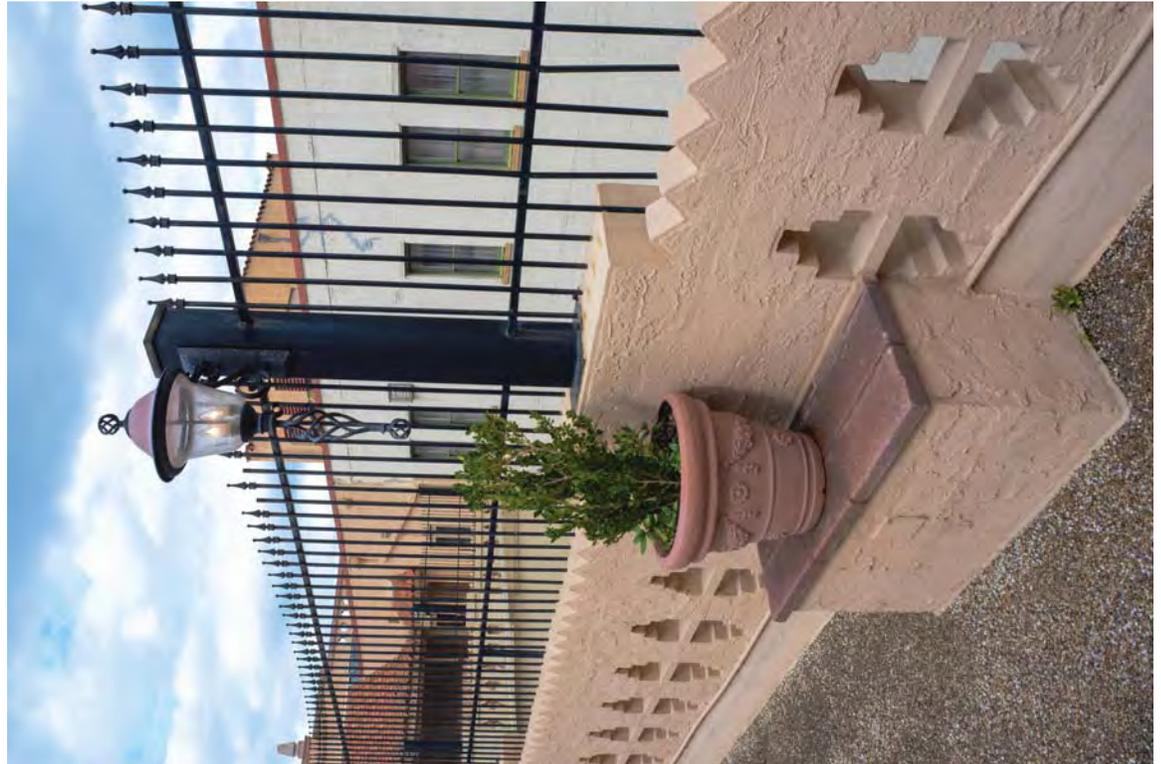
SAH-088

Name: Saint Anthony Hotel, 300 East Travis Street, San Antonio, Texas
View: Tenth floor Starlight Terrace parapet and guardrail
Description: Detail view of inappropriately scaled guardrail & non-historic podium
Date: September 2012

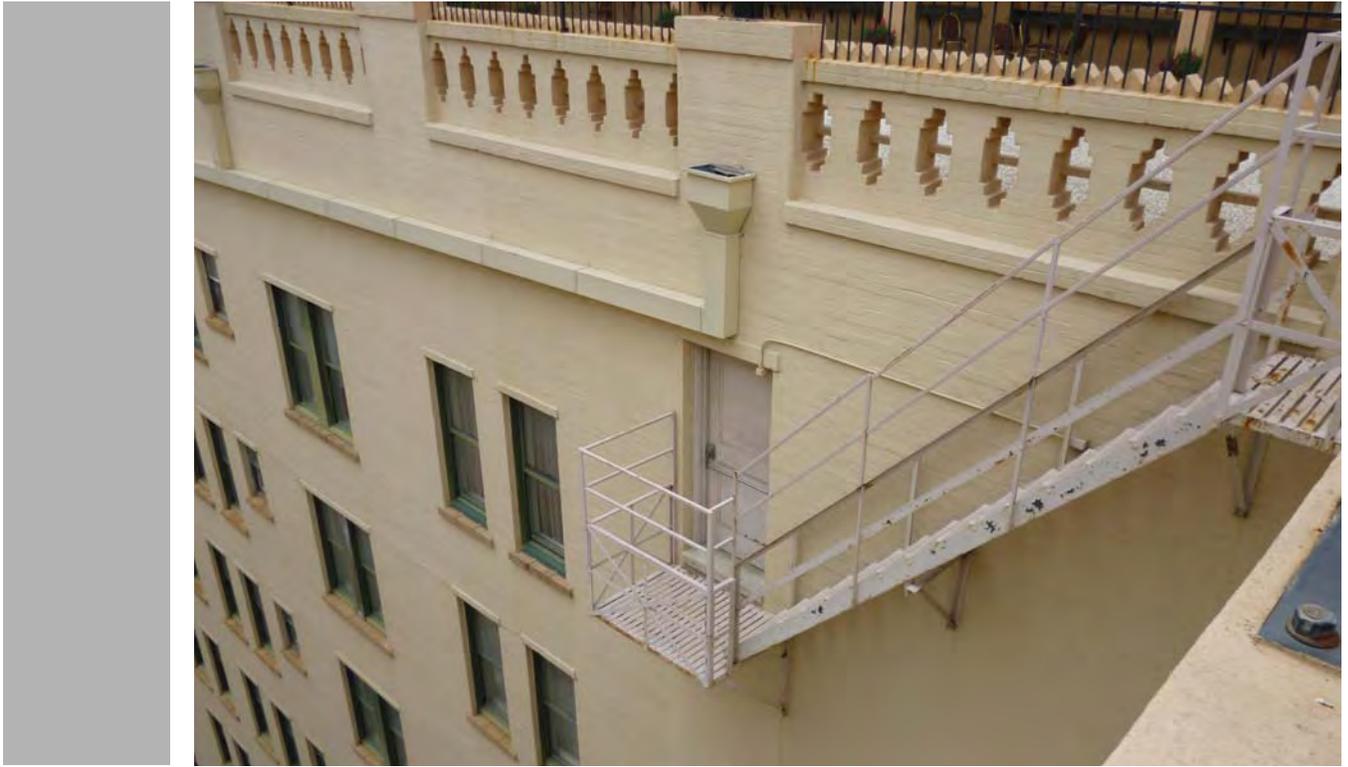
SAH-090

Name: Saint Anthony Hotel, 300 East Travis Street, San Antonio, Texas
View: East facade of Tower 1, as seen from tenth floor Starlight Terrace
Description: Starlight Terrace fire escape and crenelated brick parapet
Date: September 2012

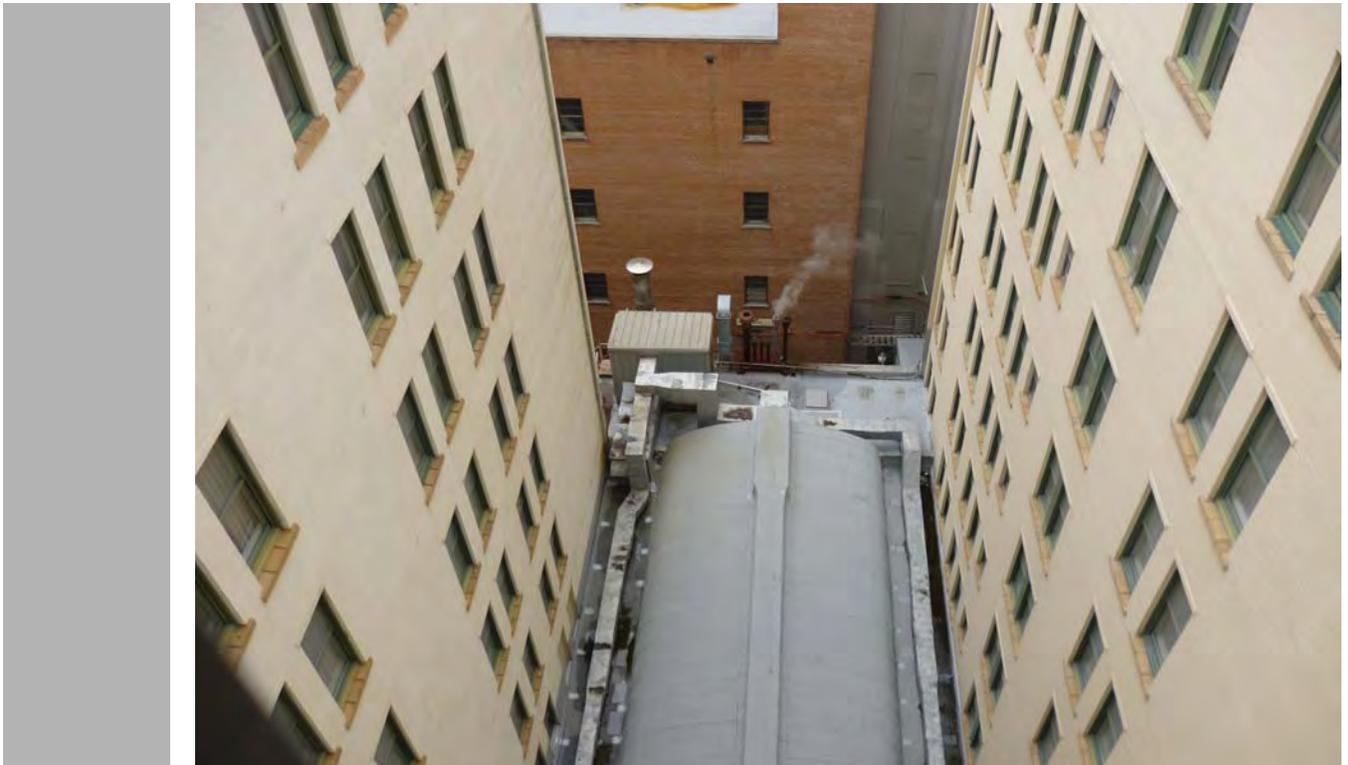
SAH-091

Name: Saint Anthony Hotel, 300 East Travis Street, San Antonio, Texas
View: Roof of Travis Room, as seen from tenth floor Starlight Terrace
Description: Coated masonry walls, terra-cotta sills, mechanical equipment & ducts
Date: September 2012

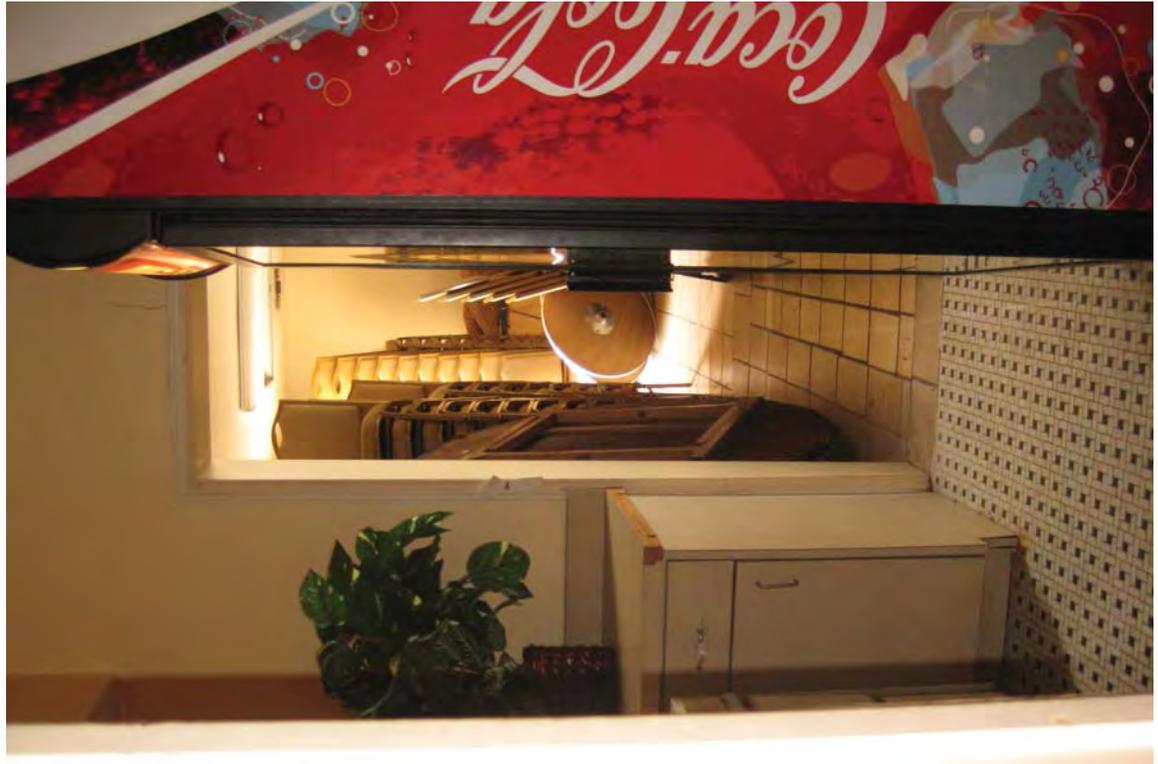
SAH-092

Name: Saint Anthony Hotel, 300 East Travis Street, San Antonio, Texas
View: Tenth floor Starlight Terrace storage room interior, looking west
Description: Non-historic infill addition at north colonnade to be demolished
Date: September 2012

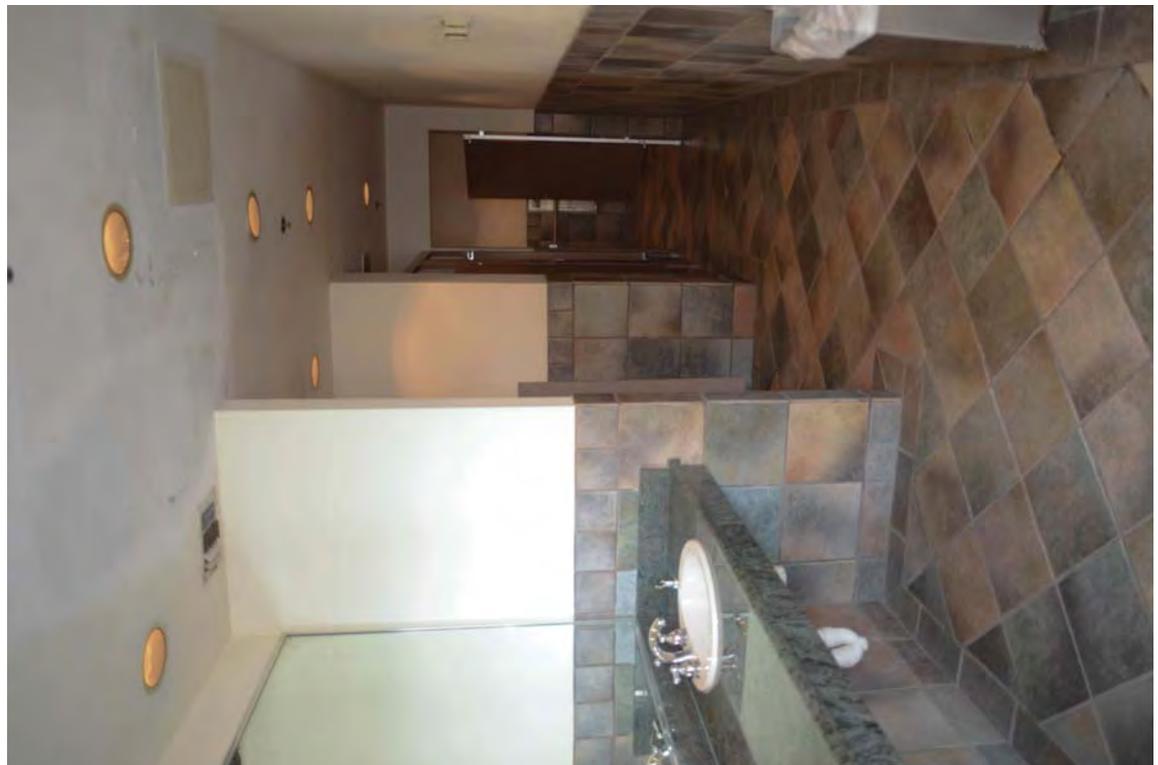
SAH-093

Name: Saint Anthony Hotel, 300 East Travis Street, San Antonio, Texas
View: Tenth floor Starlight Terrace restroom interior, looking north
Description: Non-historic infill addition behind stage to be demolished
Date: September 2012

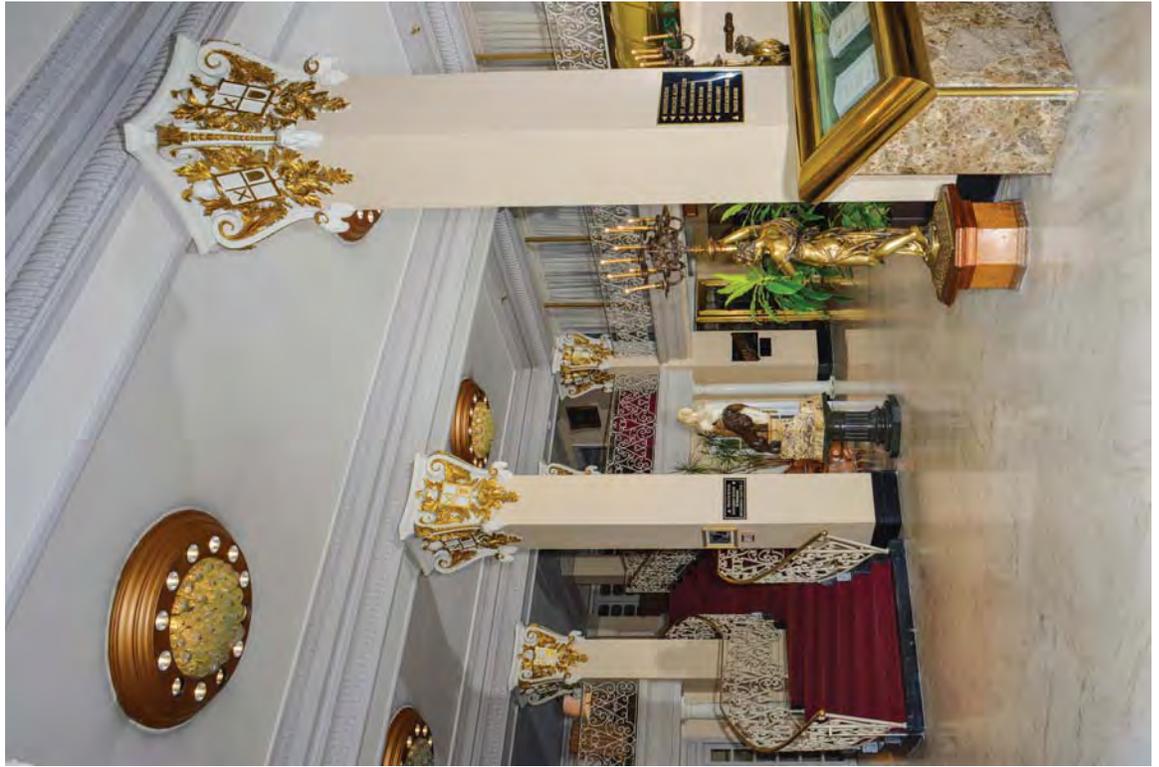
SAH-094

Name: Saint Anthony Hotel, 300 East Travis Street, San Antonio, Texas
View: First floor Grand Lobby interior, looking southwest
Description: General view of Grand Lobby's significant features
Date: September 2012

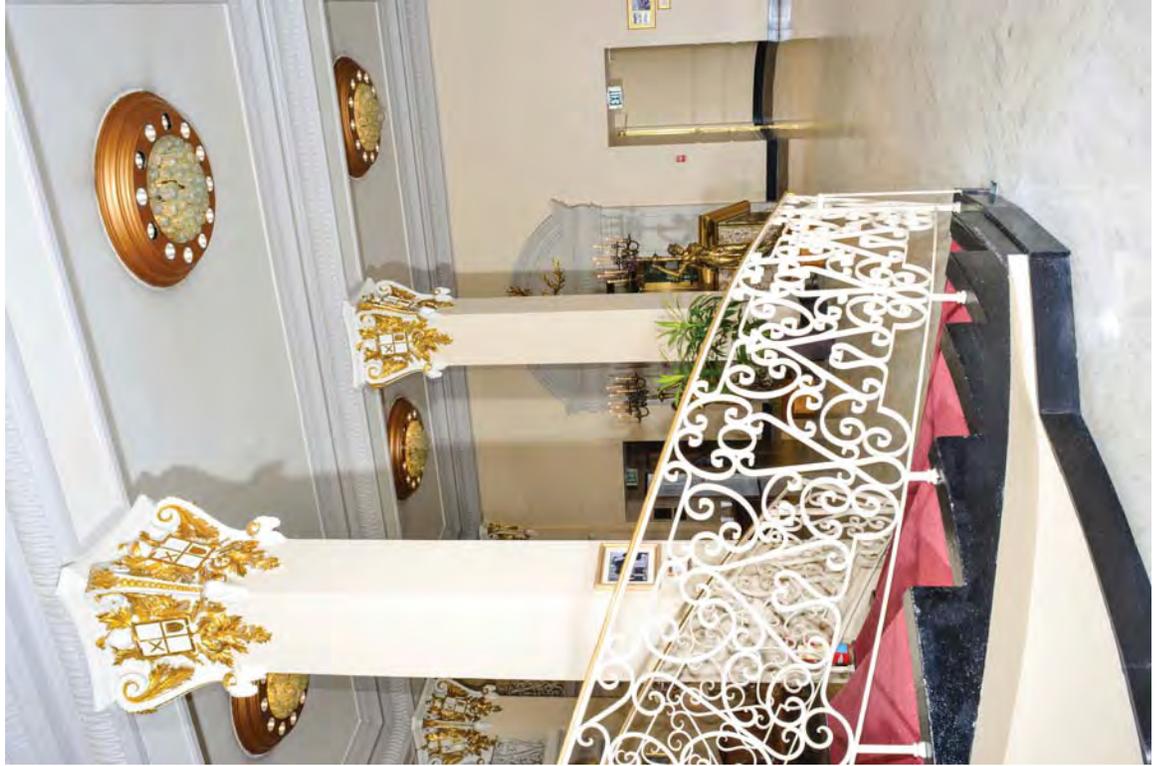
Photograph No.
SAH-095

Name: Saint Anthony Hotel, 300 East Travis Street, San Antonio, Texas
View: First floor Grand Lobby interior, looking north
Description: Non-historic serpentine stair to be demolished
Date: September 2012

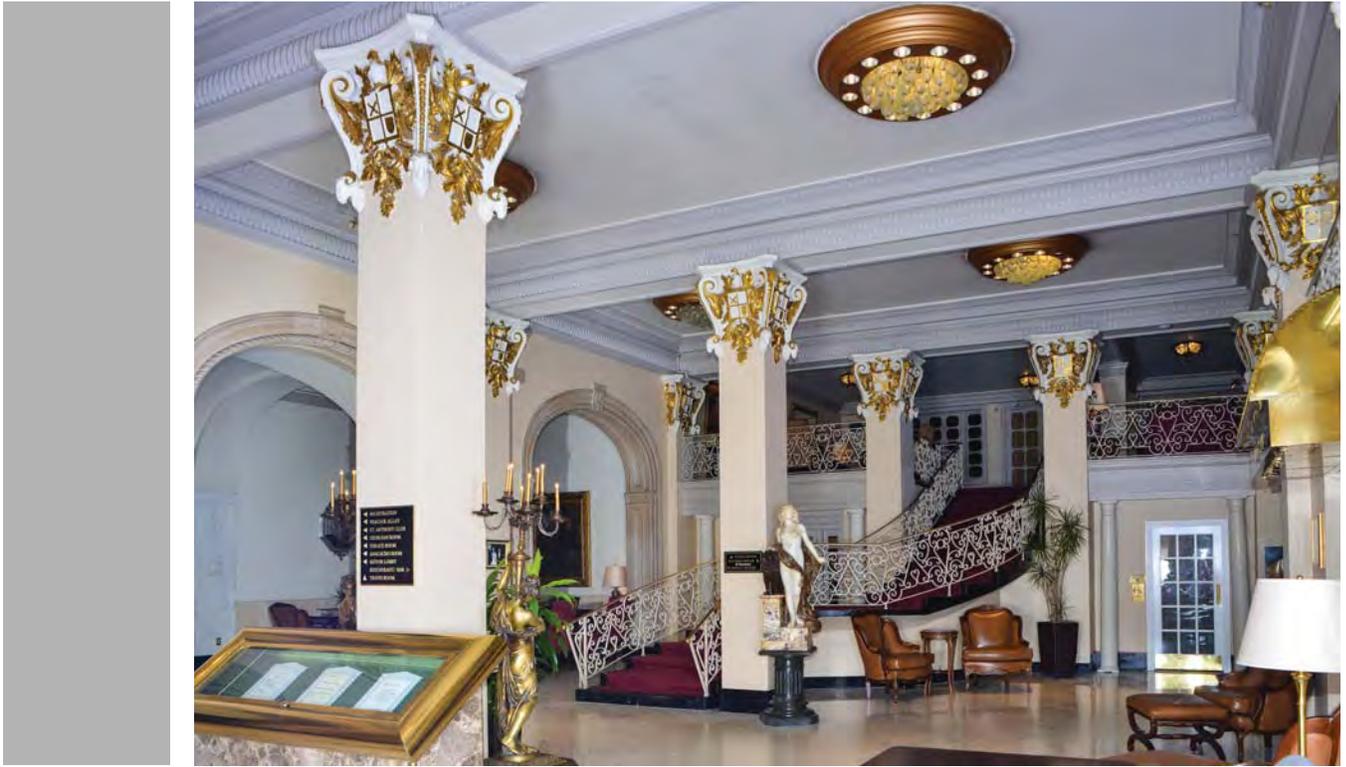
Photograph No.
SAH-096

Name: Saint Anthony Hotel, 300 East Travis Street, San Antonio, Texas
View: First floor Grand Lobby interior, looking southeast
Description: General view of Grand Lobby's significant features
Date: September 2012

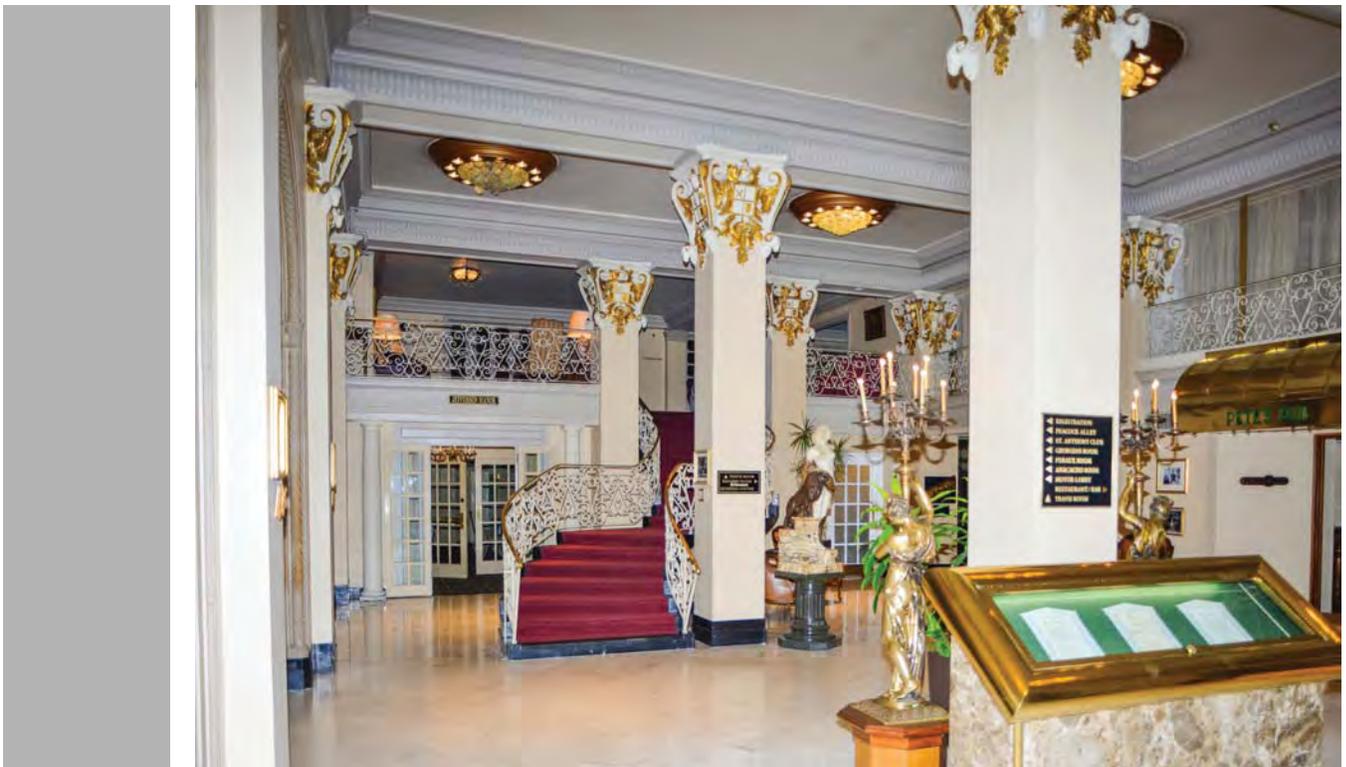
SAH-097

Name: Saint Anthony Hotel, 300 East Travis Street, San Antonio, Texas
View: First floor Grand Lobby interior, looking south-southwest
Description: General view of Grand Lobby's significant features
Date: September 2012

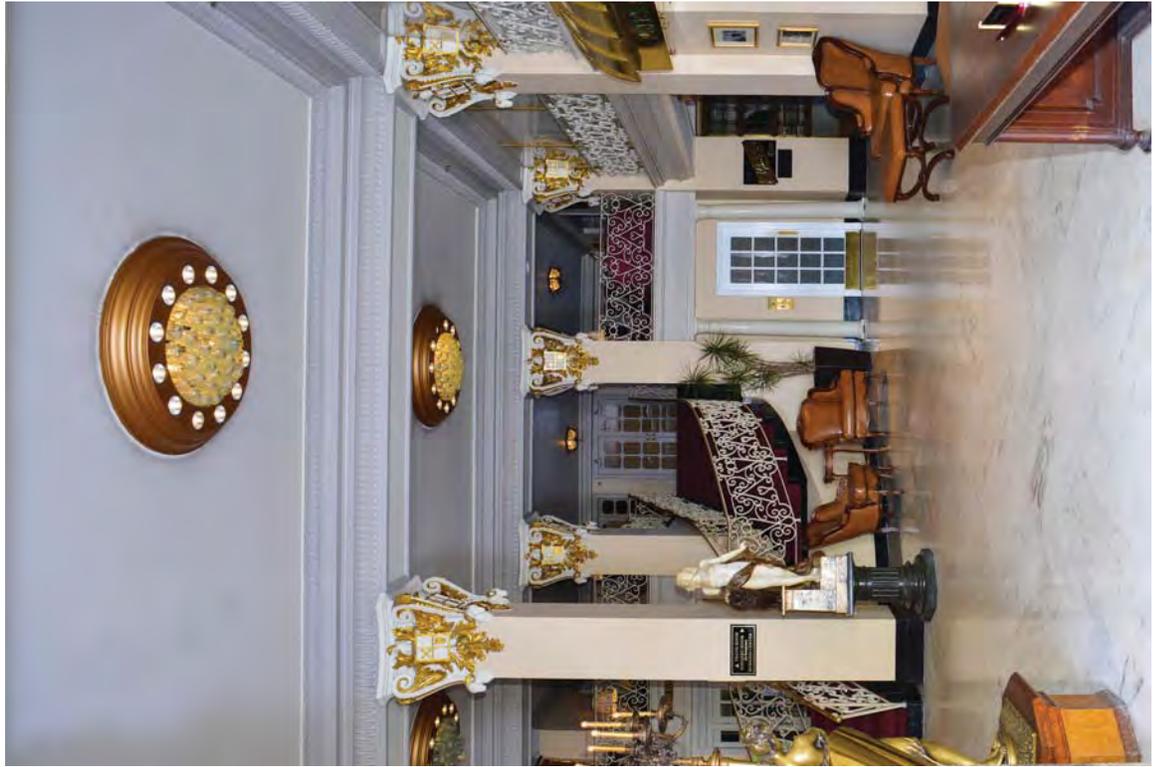
SAH-098

Name: Saint Anthony Hotel, 300 East Travis Street, San Antonio, Texas
View: First floor Grand Lobby interior, looking south
Description: General view of Grand Lobby's significant features
Date: September 2012

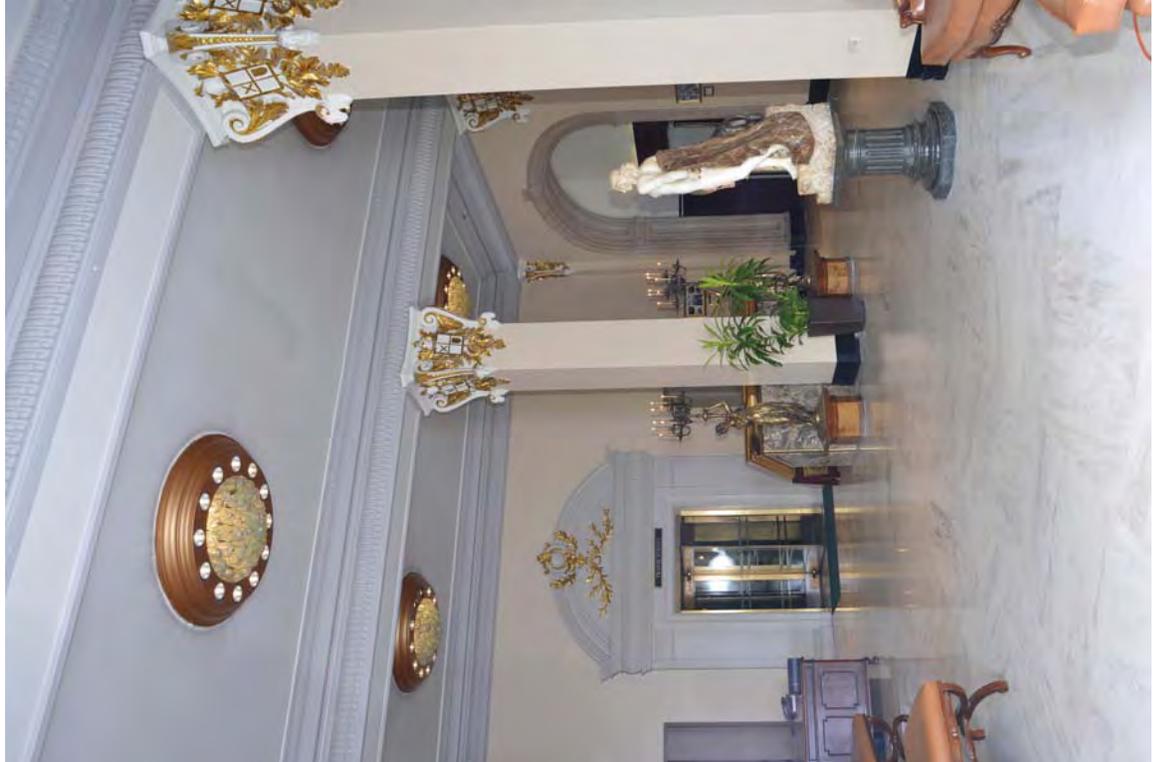
Photograph No.
SAH-099

Name: Saint Anthony Hotel, 300 East Travis Street, San Antonio, Texas
View: First floor Grand Lobby interior, looking northeast (portrait format)
Description: Travis Street entrance with brass revolving door & decorative surround
Date: September 2012

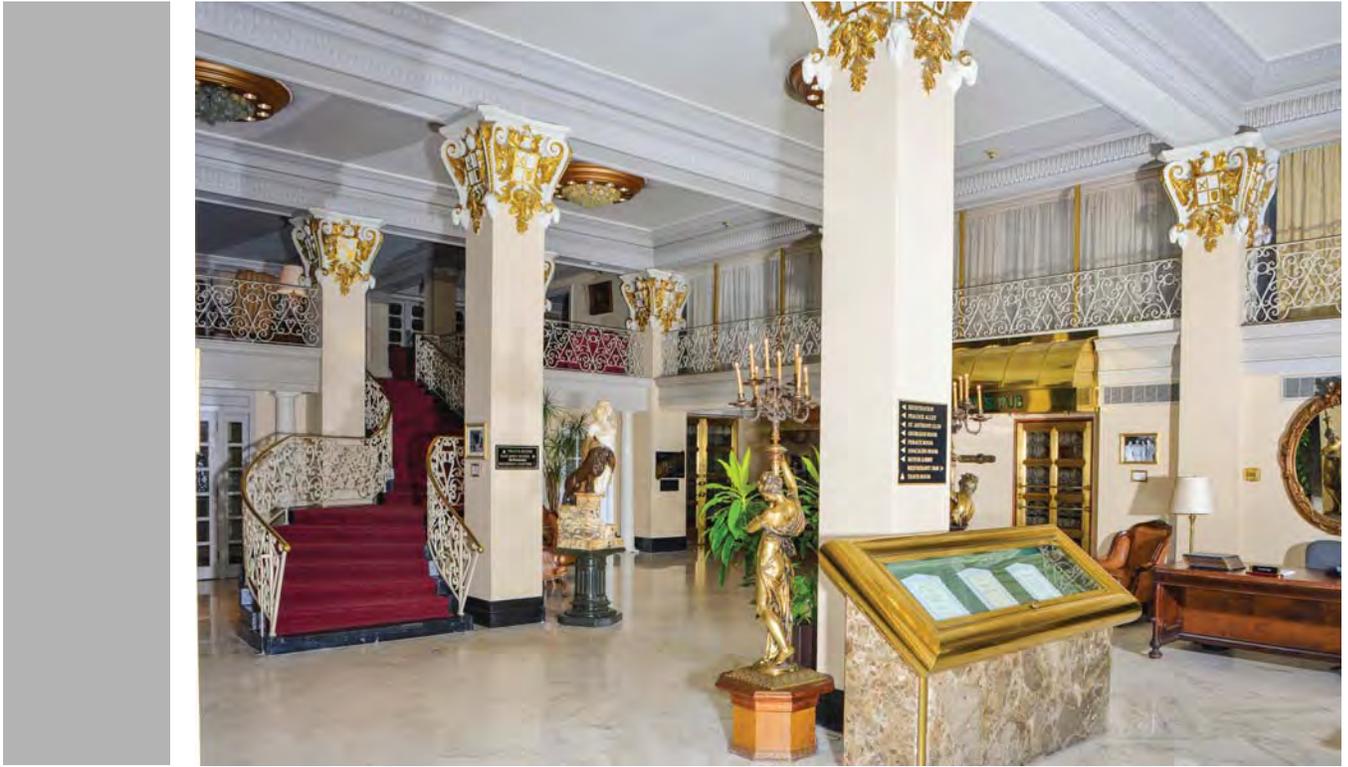
Photograph No.
SAH-100

Name: Saint Anthony Hotel, 300 East Travis Street, San Antonio, Texas
View: First floor Grand Lobby interior, looking southwest
Description: General view of Grand Lobby significant features
Date: September 2012

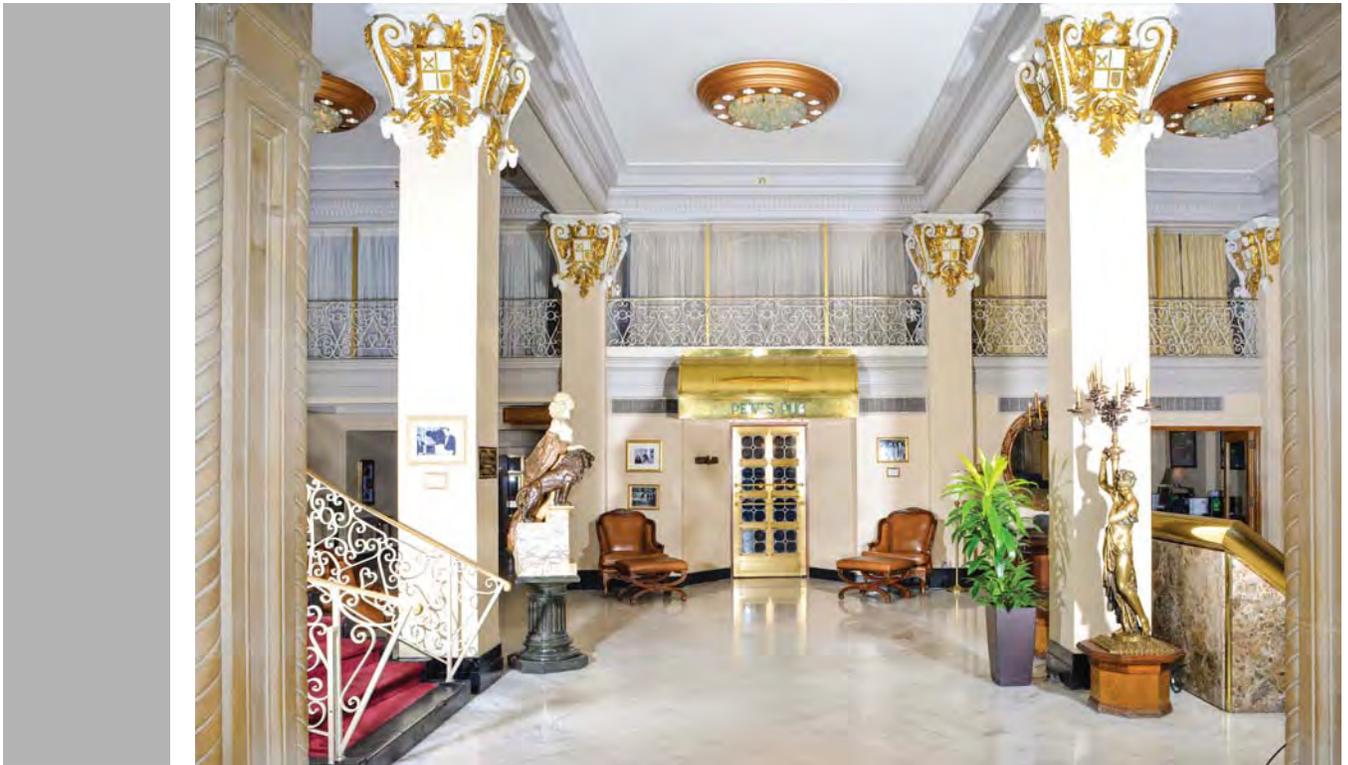
Photograph No.
SAH-101

Name: Saint Anthony Hotel, 300 East Travis Street, San Antonio, Texas
View: First floor Grand Lobby interior, looking west
Description: Plexiglas panels at mezzanine, brass canopy and historic door
Date: September 2012
