HISTORIC AND DESIGN REVIEW COMMISSION

HDRC CASE NO: 2016-016
ADDRESS: 304 E TRAVIS ST
LEGAL DESCRIPTION: NCB 415 BLK 18 LOT A-7, A- 8, A-9, P-100, P-101 & P-102
ZONING: D HE
CITY COUNCIL DIST.: 1
LANDMARK: St Anthony Hotel
APPLICANT: Brandon Raney
OWNER: BCL St. Anthony ML, LP
TYPE OF WORK: Tax Certification
REQUEST:

RE: St. Anthony Hotel Tax Certification Application

St. Anthony Hotel
Scope Summary of Exterior Rehabilitation

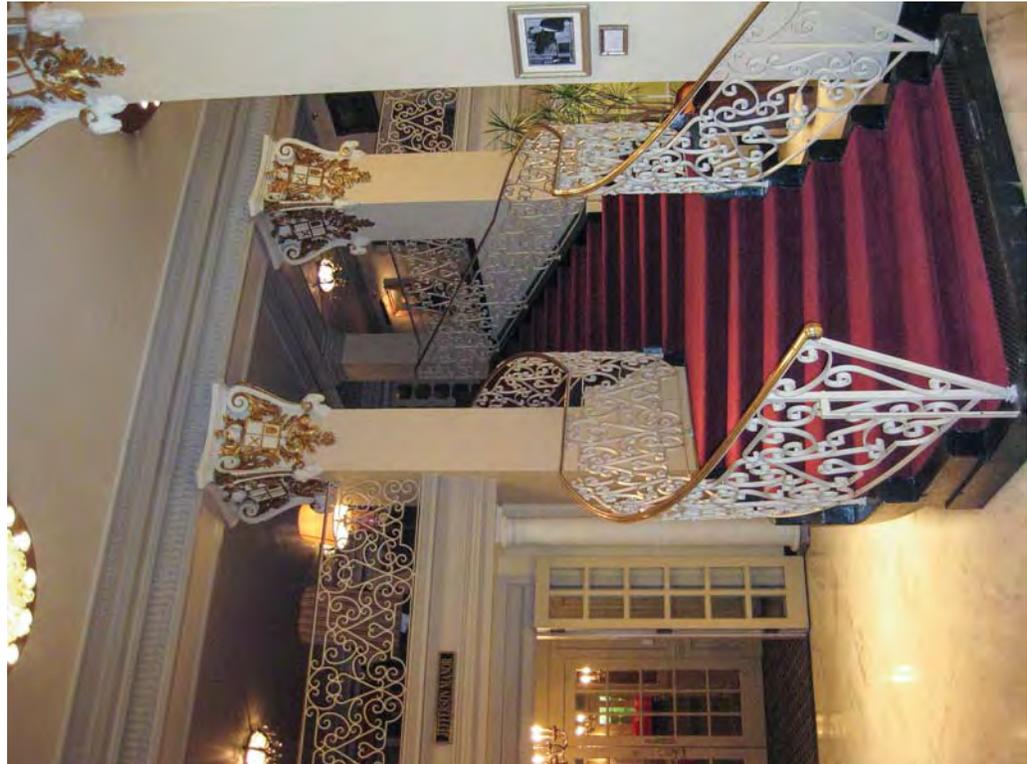
Photograph No.
SAH-102

Name: Saint Anthony Hotel, 300 East Travis Street, San Antonio, Texas
View: First floor Grand Lobby interior, looking south
Description: Non-historic serpentine stair, historic column (left), faux column (right)
Date: September 2012

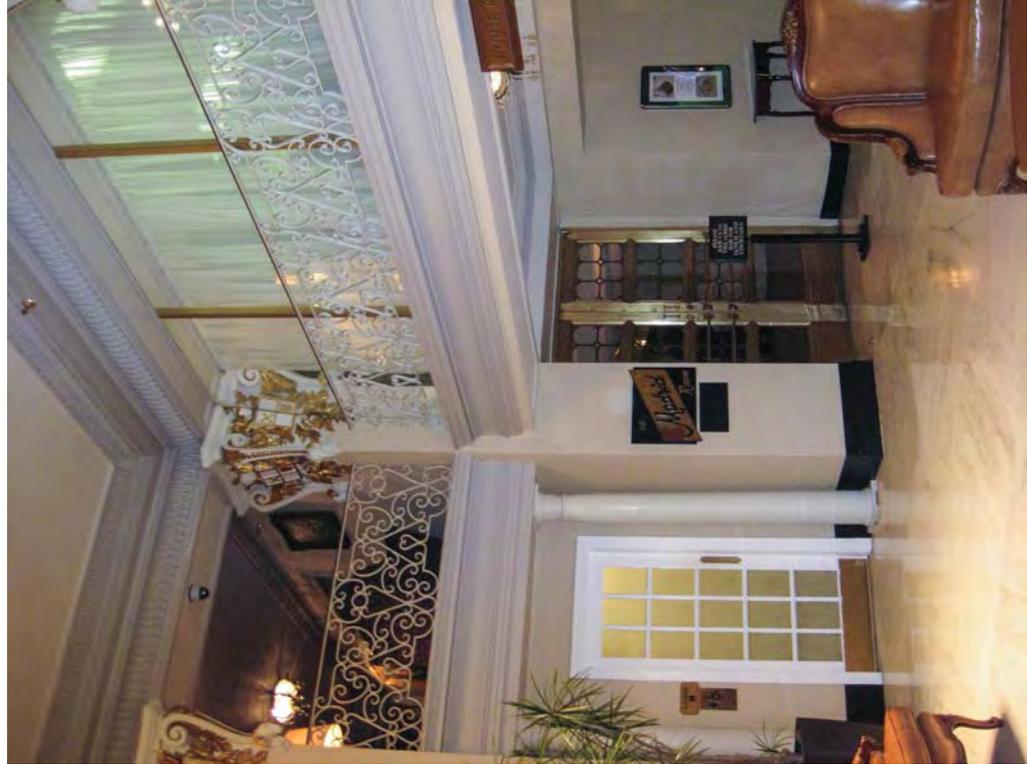
Photograph No.
SAH-103

Name: Saint Anthony Hotel, 300 East Travis Street, San Antonio, Texas
View: First floor Grand Lobby interior, looking at southwest corner
Description: Historic brass restaurant doors; non-historic plexiglass and railing
Date: September 2012

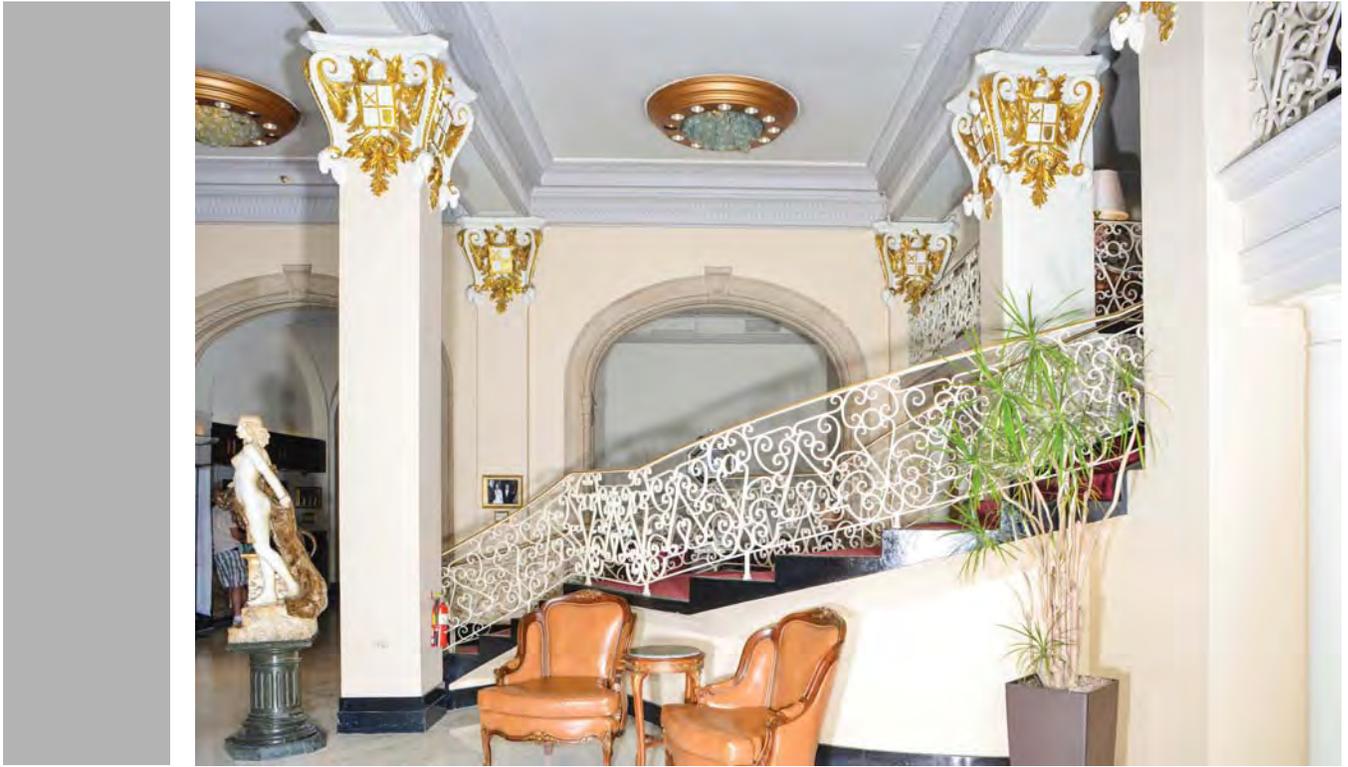
Photograph No.
SAH-104

Name: Saint Anthony Hotel, 300 East Travis Street, San Antonio, Texas
View: First floor Grand Lobby interior, looking east at stair
Description: Non-historic serpentine stair, plaster columns and cast stone arches
Date: September 2012

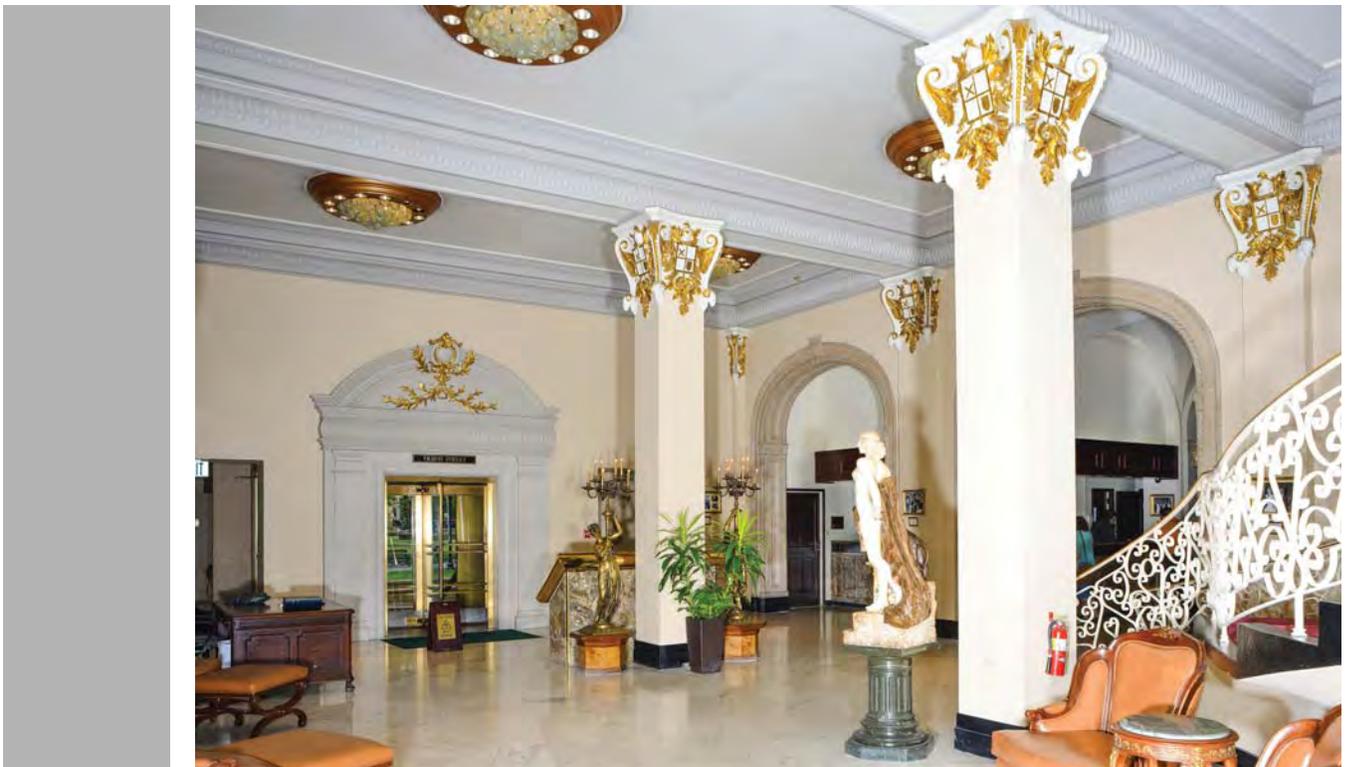
SAH-105

Name: Saint Anthony Hotel, 300 East Travis Street, San Antonio, Texas
View: First floor Grand Lobby interior, looking northeast (landscape format)
Description: Travis Street entrance with brass revolving door & decorative surround
Date: September 2012

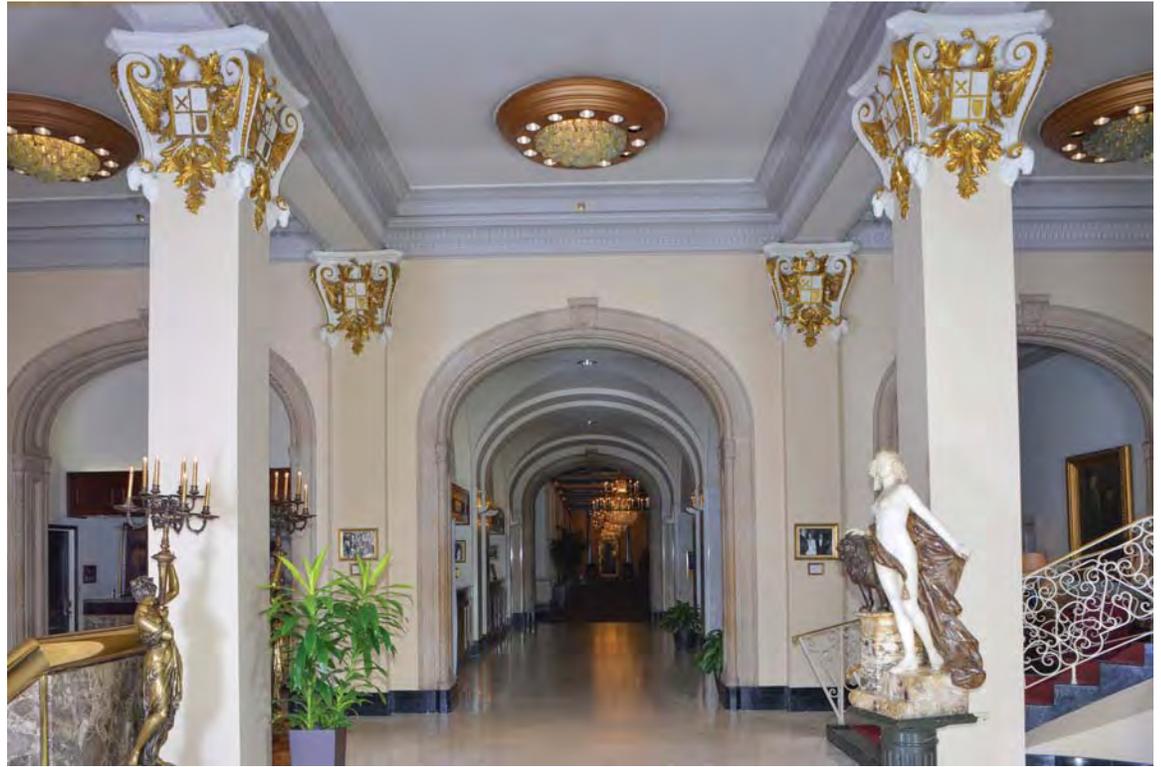
SAH-106

Name: Saint Anthony Hotel, 300 East Travis Street, San Antonio, Texas
View: First floor Grand Lobby interior, looking east toward reception lobby
Description: Gypsum plaster columns and beam moldings; cast stone arches
Date: September 2012

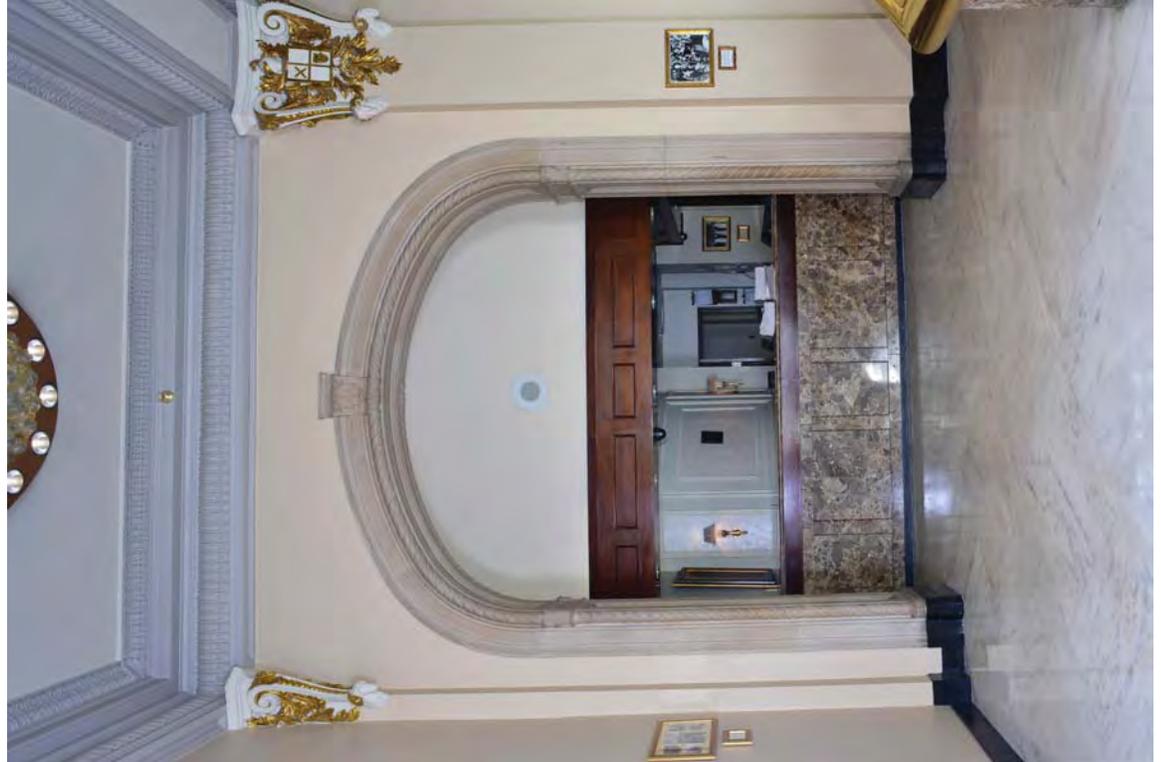
SAH-107

Name: Saint Anthony Hotel, 300 East Travis Street, San Antonio, Texas
View: First floor Grand Lobby interior, looking east at reception desk
Description: Cast stone arch & non-historic reception desk
Date: September 2012

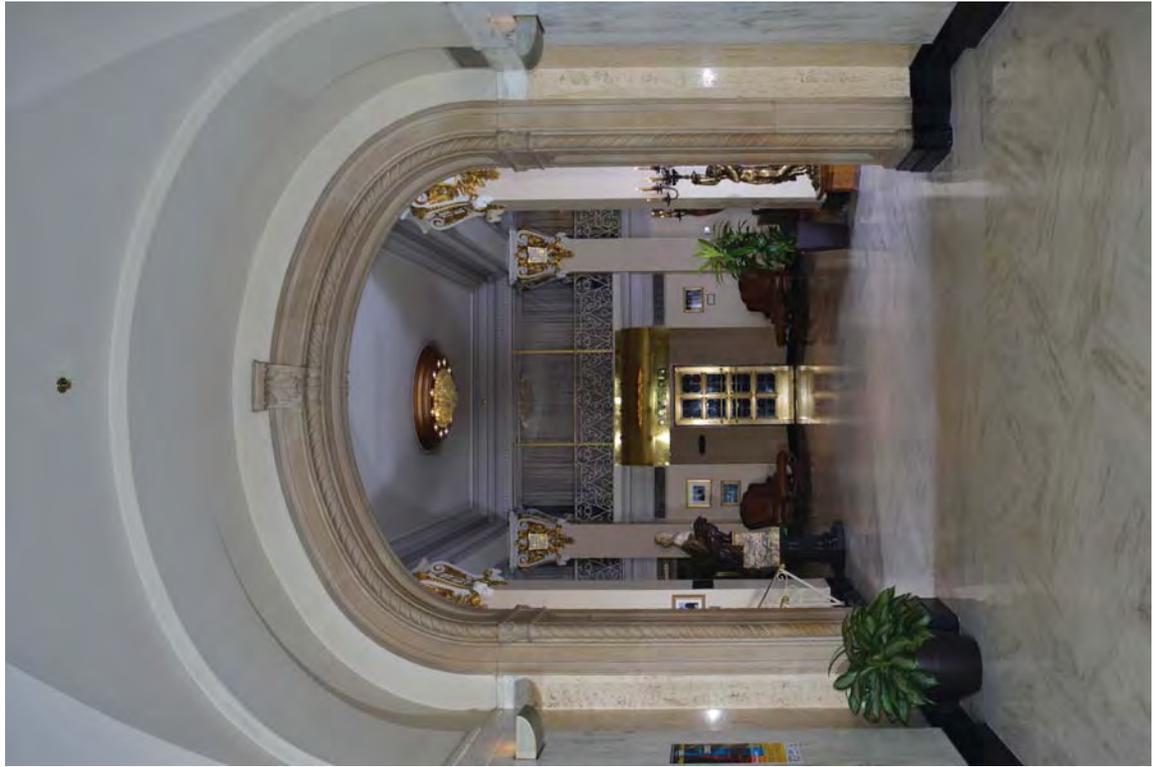
SAH-108

Name: Saint Anthony Hotel, 300 East Travis Street, San Antonio, Texas
View: First floor reception lobby interior, looking west toward Grand Lobby
Description: Plaster groin vault ceiling & cast stone arch
Date: September 2012

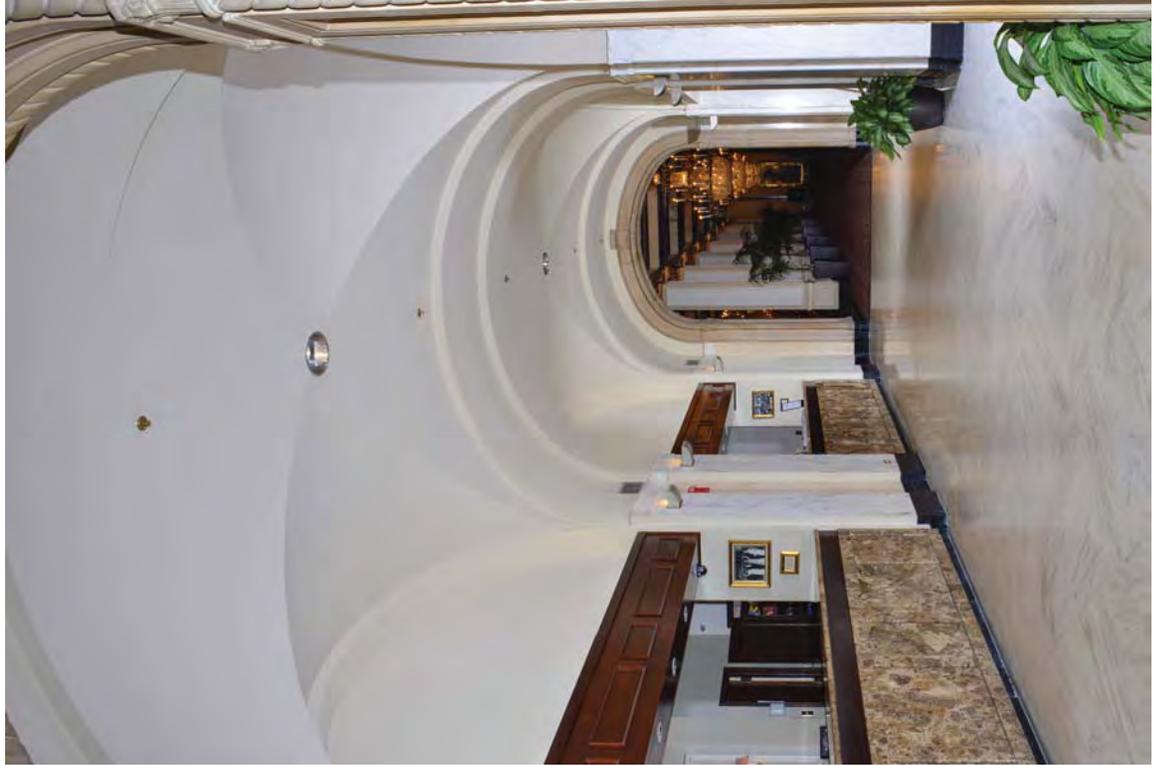
Photograph No.
SAH-109

Name: Saint Anthony Hotel, 300 East Travis Street, San Antonio, Texas
View: First floor reception lobby interior, looking east toward Peacock Alley
Description: Plaster groin vault ceiling & reception desk
Date: September 2012

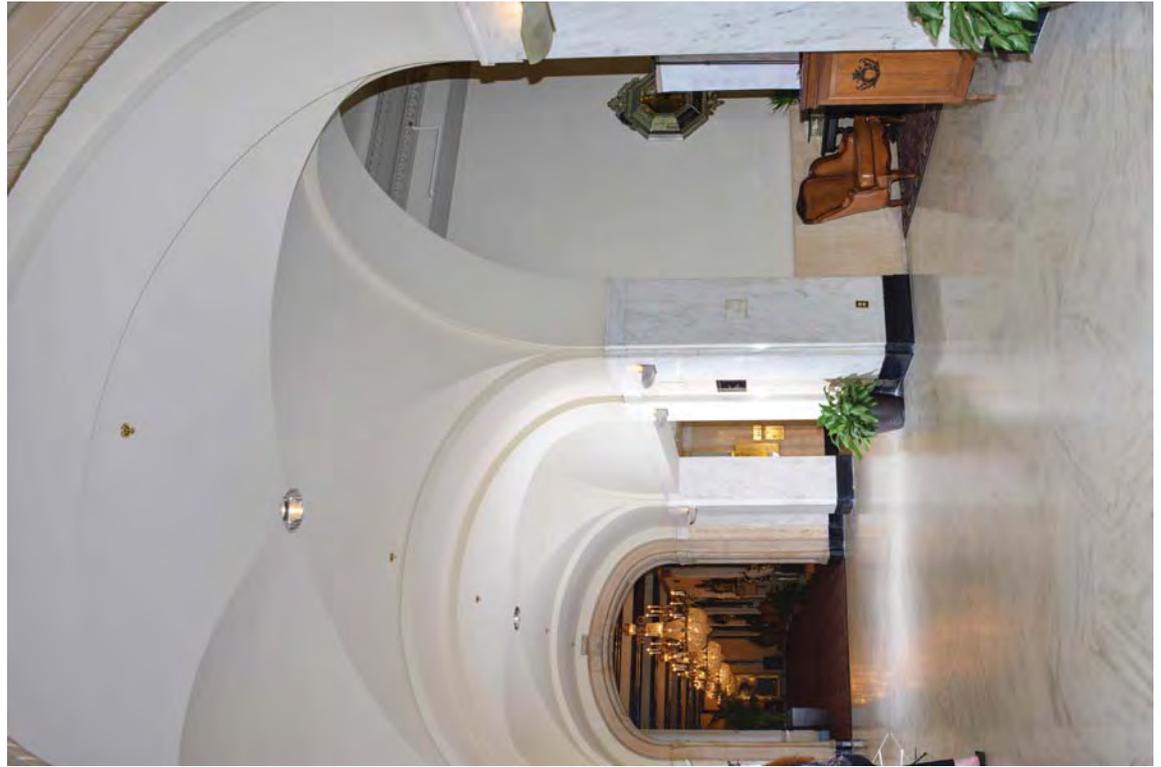
Photograph No.
SAH-110

Name: Saint Anthony Hotel, 300 East Travis Street, San Antonio, Texas
View: First floor reception lobby interior, looking east toward Peacock Alley
Description: Plaster groin vault ceiling & elevator lobby
Date: September 2012

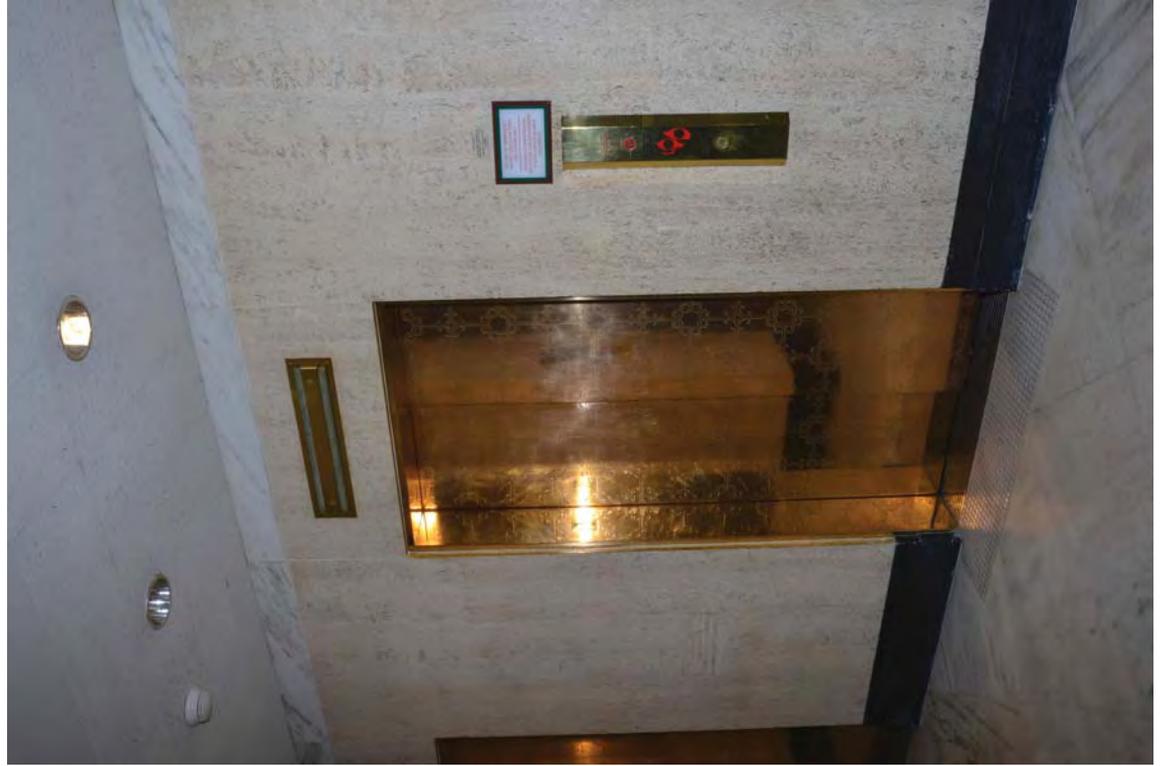
Photograph No.
SAH-111

Name: Saint Anthony Hotel, 300 East Travis Street, San Antonio, Texas
View: First floor elevator lobby interior, looking southeast
Description: Non-historic, engraved brass elevator doors and call buttons
Date: September 2012

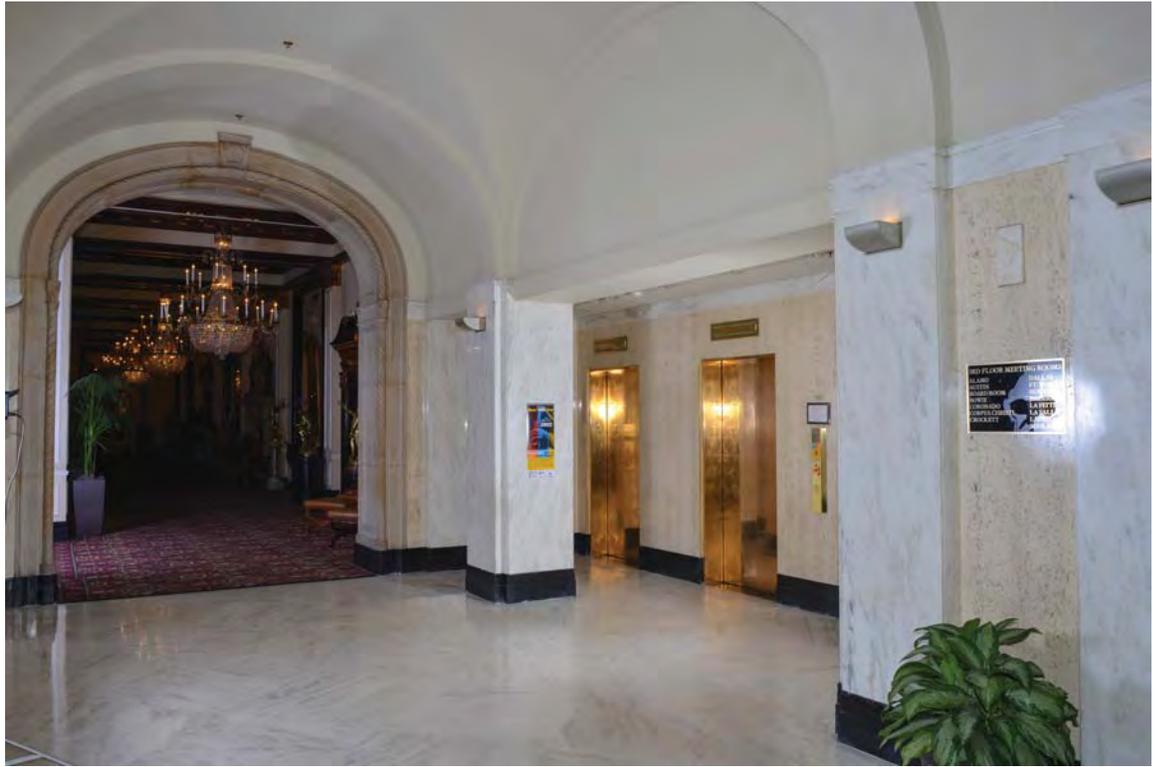
Photograph No.
SAH-112

Name: Saint Anthony Hotel, 300 East Travis Street, San Antonio, Texas
View: First floor reception lobby interior, looking east toward Peacock Alley
Description: Plaster groin vault ceiling & elevator lobby
Date: September 2012

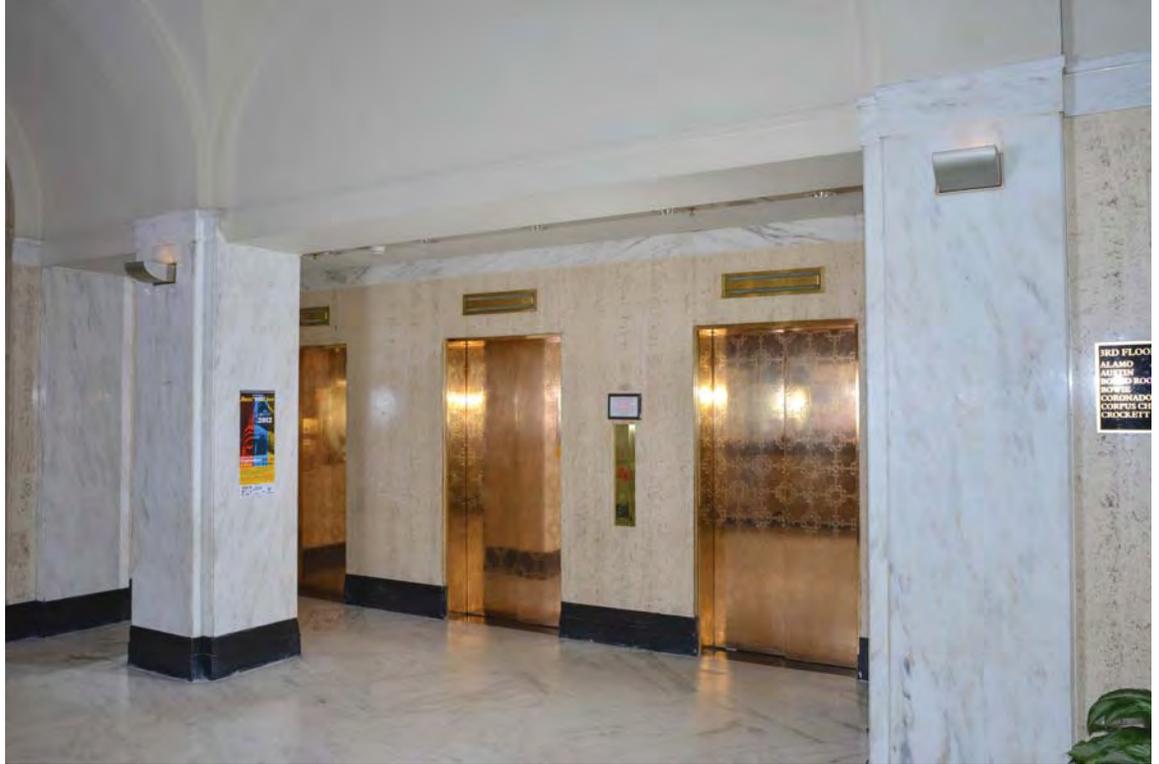
SAH-113

Name: Saint Anthony Hotel, 300 East Travis Street, San Antonio, Texas
View: First floor elevator lobby interior, looking southeast
Description: Non-historic, engraved brass elevator doors and call buttons
Date: September 2012

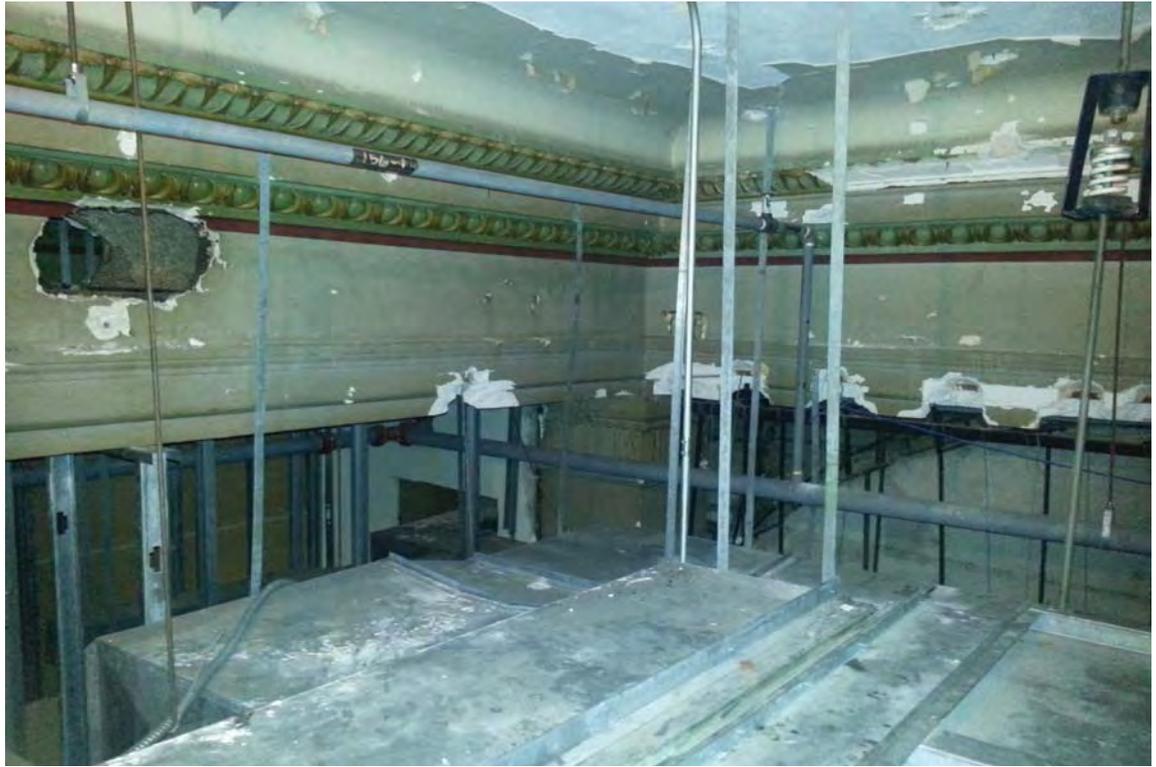
SAH-114

Name: Saint Anthony Hotel, 300 East Travis Street, San Antonio, Texas
View: First floor reception lobby interior, view above plaster groin vaults
Description: Mechanical equipment and remnants of original plaster ceiling
Date: September 2012

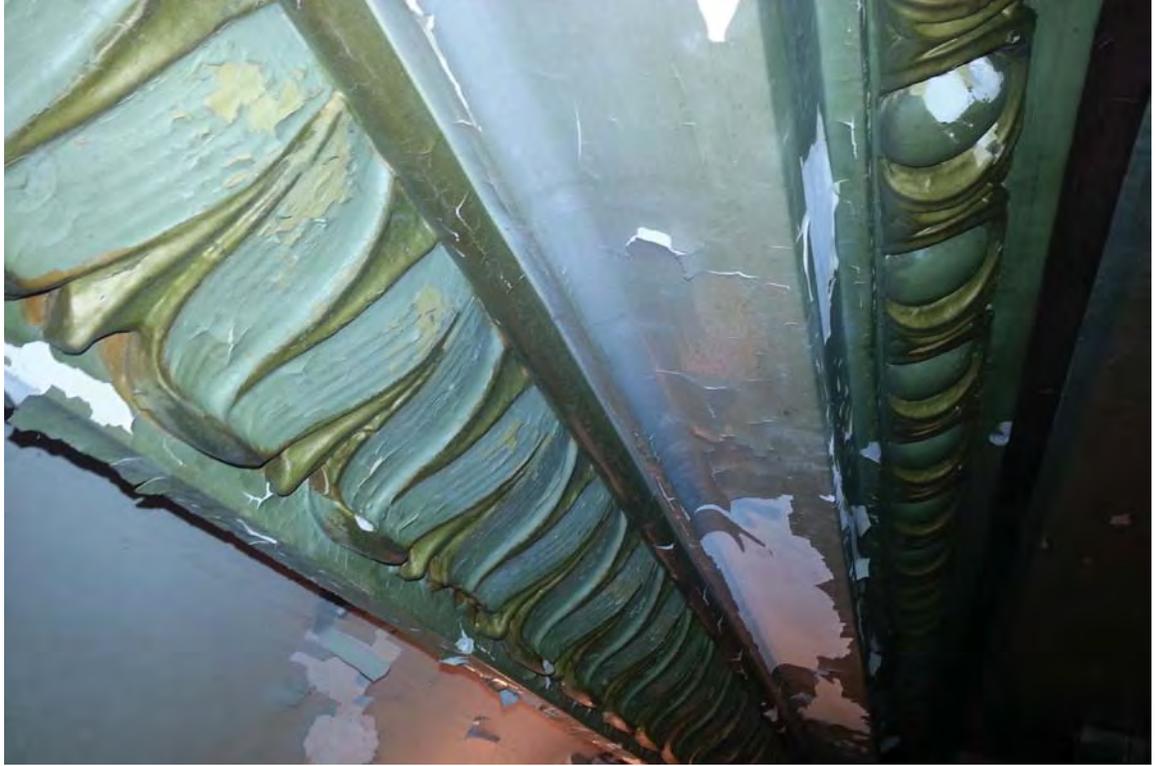
Photograph No.
SAH-115

Name: Saint Anthony Hotel, 300 East Travis Street, San Antonio, Texas
View: First floor reception lobby interior, view above plaster groin vaults
Description: Detail of remnants of original plaster ceiling molding and paint
Date: September 2012

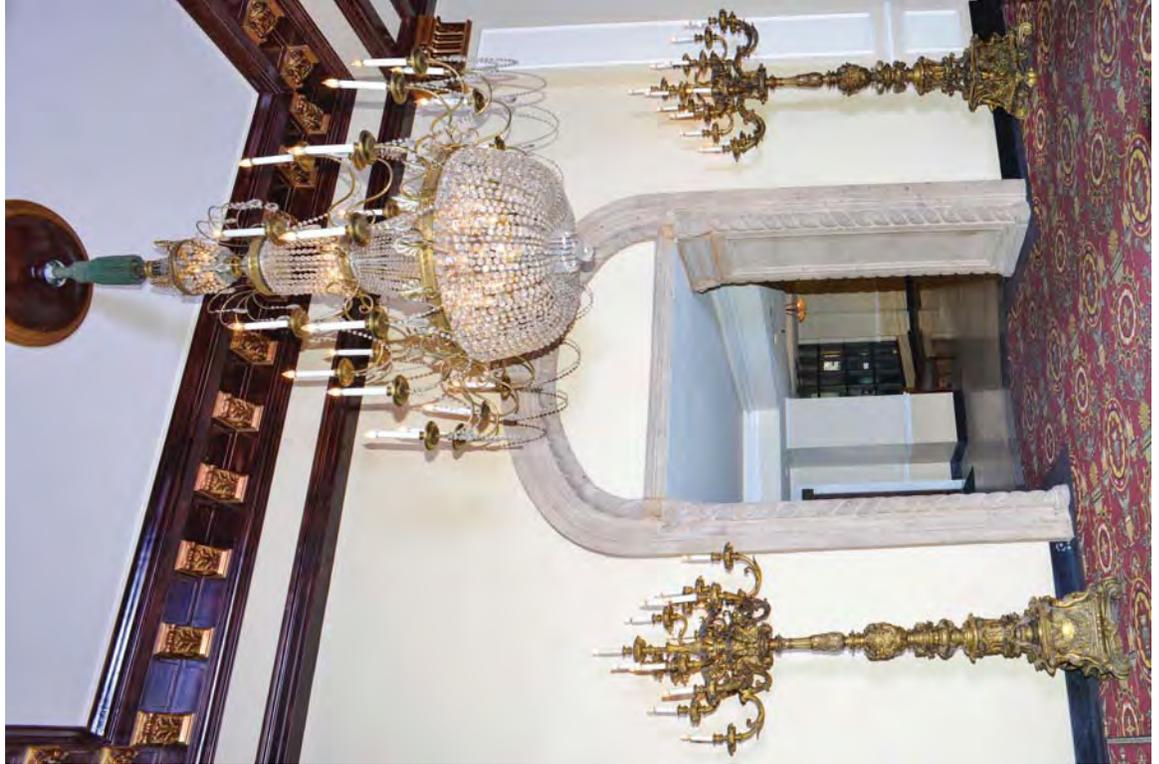
Photograph No.
SAH-131

Name: Saint Anthony Hotel, 300 East Travis Street, San Antonio, Texas
View: First floor Peacock Alley interior, looking east toward motor lobby
Description: Non-historic canterra stone arch
Date: September 2012

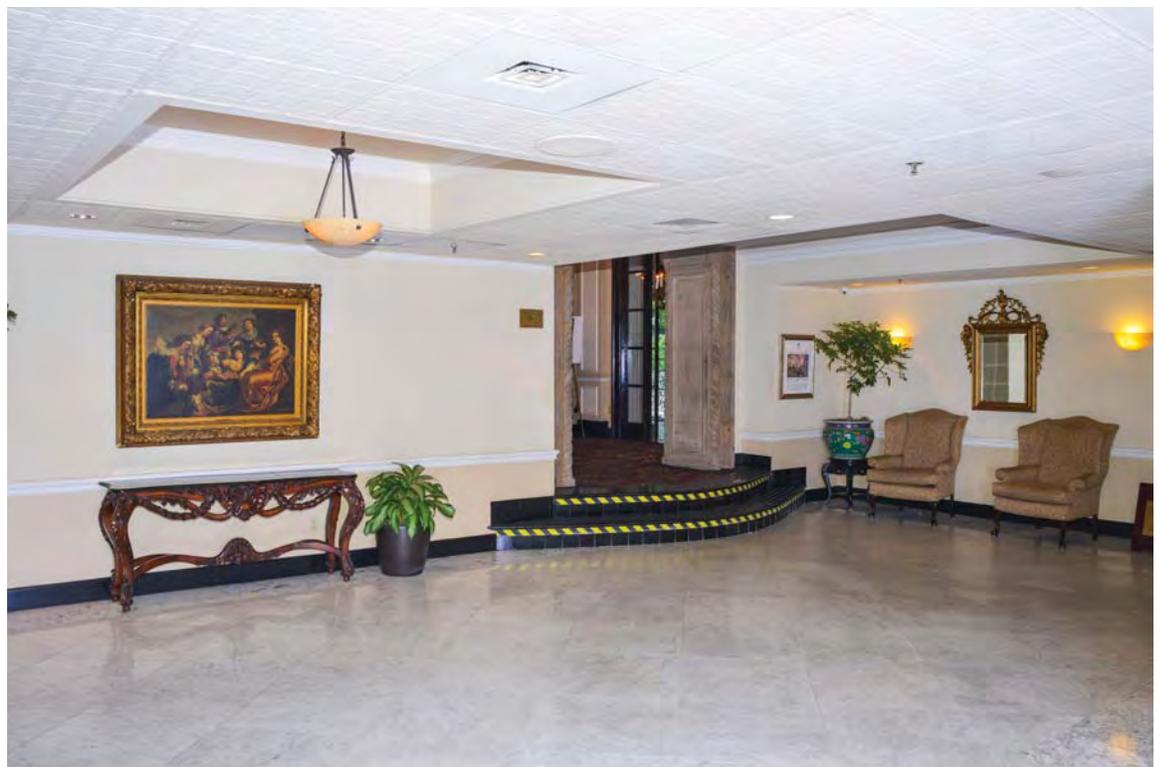
SAH-137

Name: Saint Anthony Hotel, 300 East Travis Street, San Antonio, Texas
View: First floor Motor Lobby interior, looking northwest
Description: Non-historic steps, canterra stone arch, marble flooring and ceiling
Date: September 2012

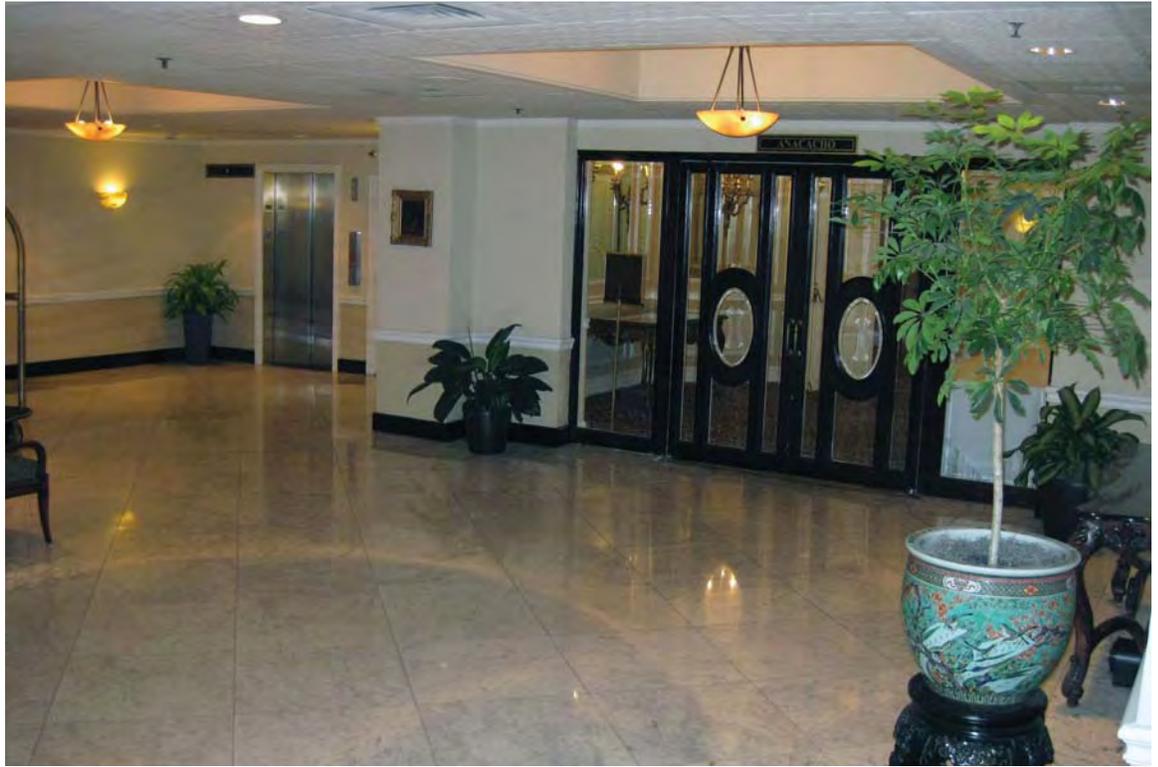
SAH-138

Name: Saint Anthony Hotel, 300 East Travis Street, San Antonio, Texas
View: First floor Motor Lobby interior, looking southeast at elevator
Description: Non-historic vestibule doors, marble flooring and ceiling
Date: September 2012

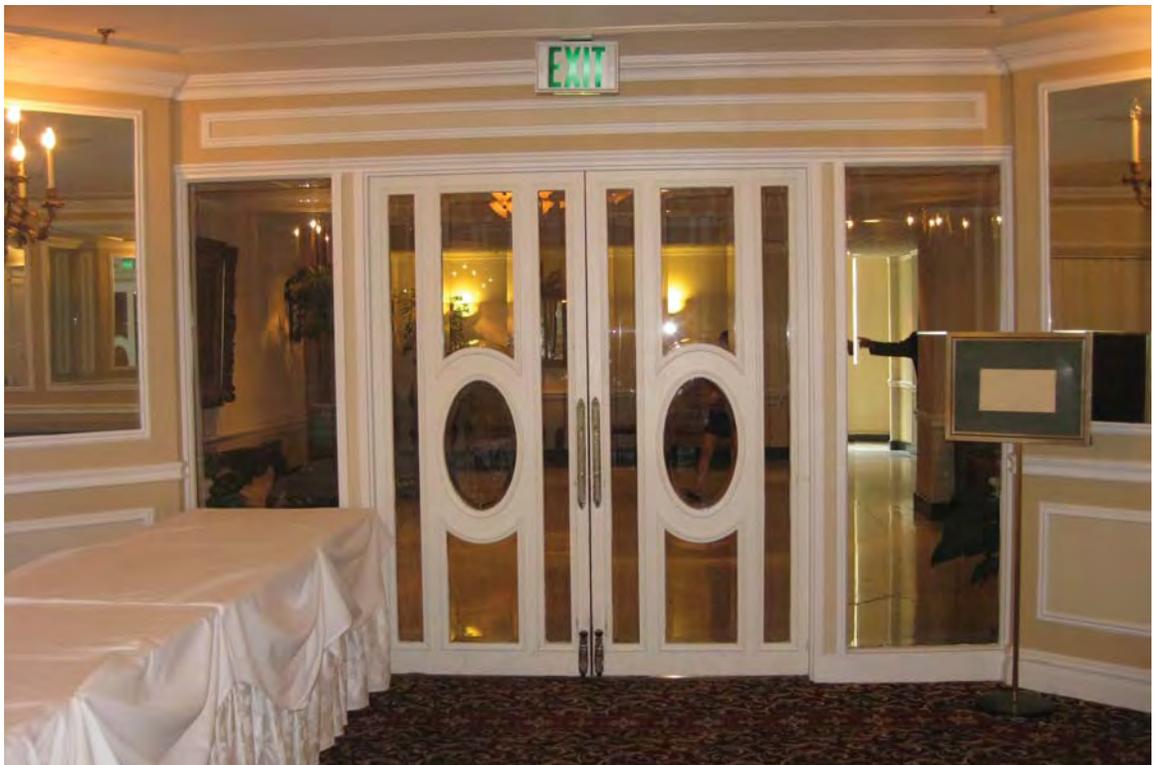
SAH-139

Name: Saint Anthony Hotel, 300 East Travis Street, San Antonio, Texas
View: First floor Anacacho pre-function interior, looking north
Description: Non-historic vestibule finishes and doors
Date: September 2012

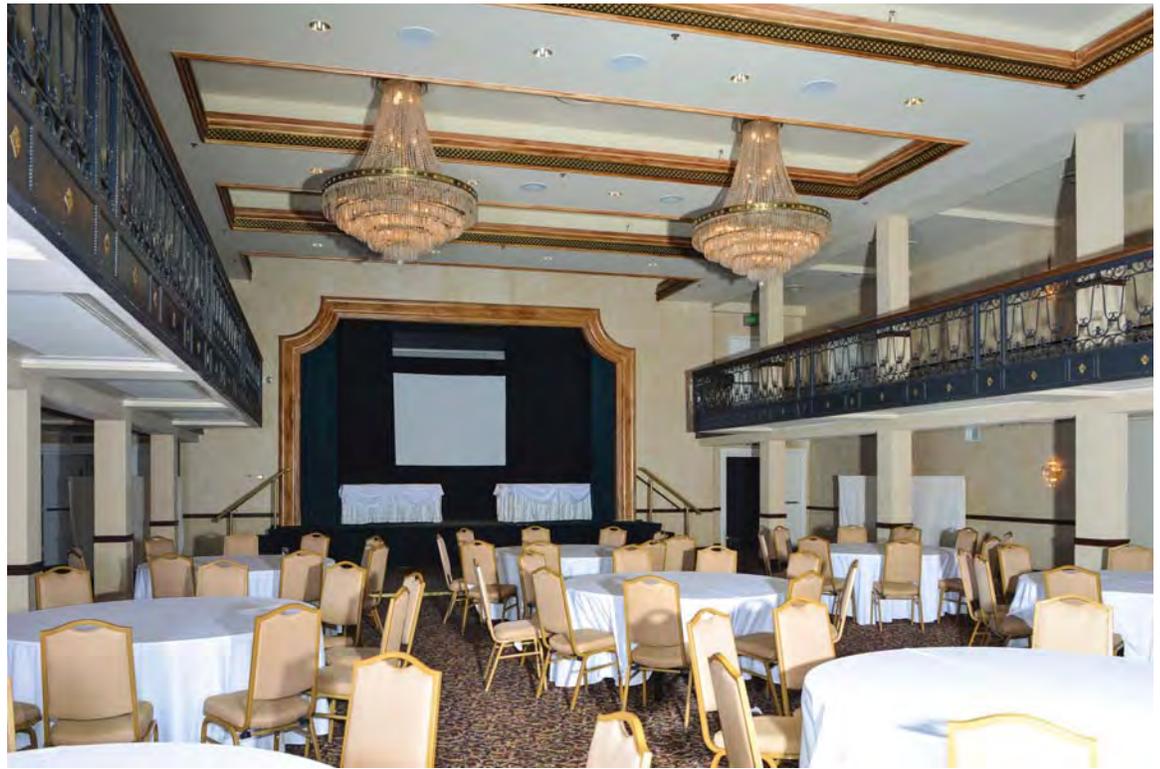
SAH-142

Name: Saint Anthony Hotel, 300 East Travis Street, San Antonio, Texas
View: First floor Anacacho Room interior, looking southwest toward stage
Description: Coffered ceiling with plaster moldings, metal railings & chandeliers
Date: September 2012

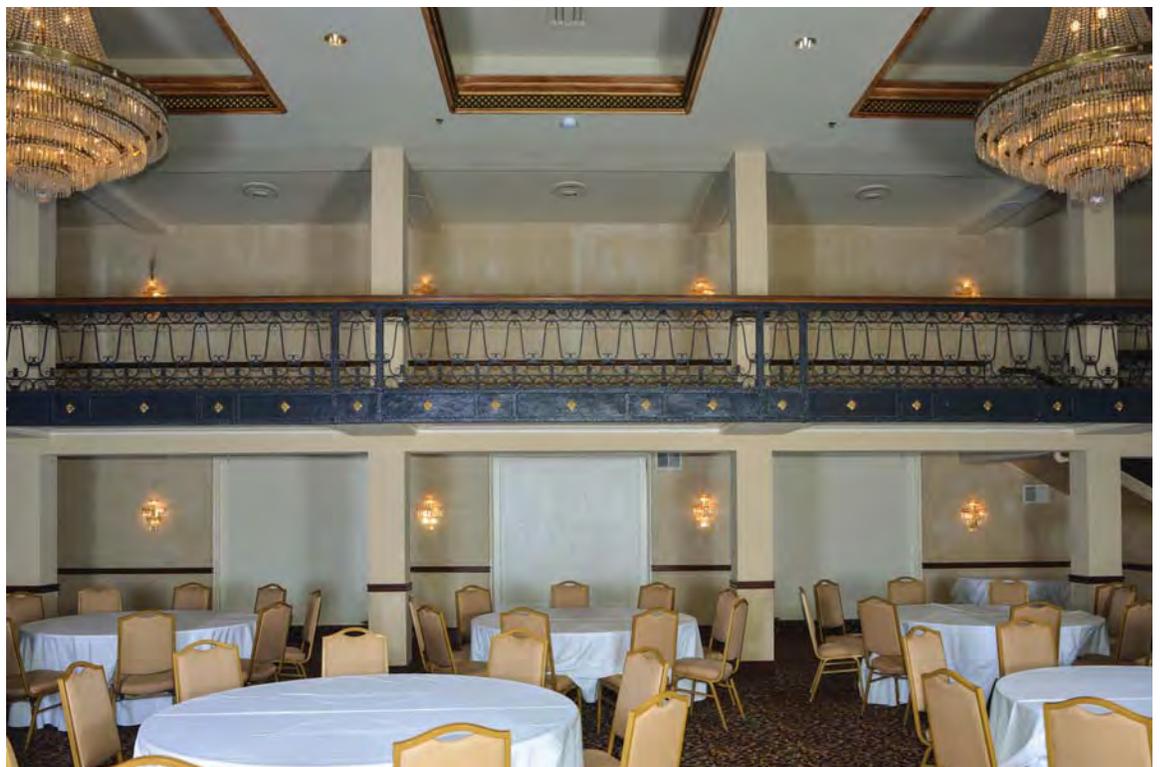
SAH-143

Name: Saint Anthony Hotel, 300 East Travis Street, San Antonio, Texas
View: First floor Anacacho Room interior, looking west toward mezzanine
Description: Coffered ceiling with plaster moldings, metal railings & chandeliers
Date: September 2012

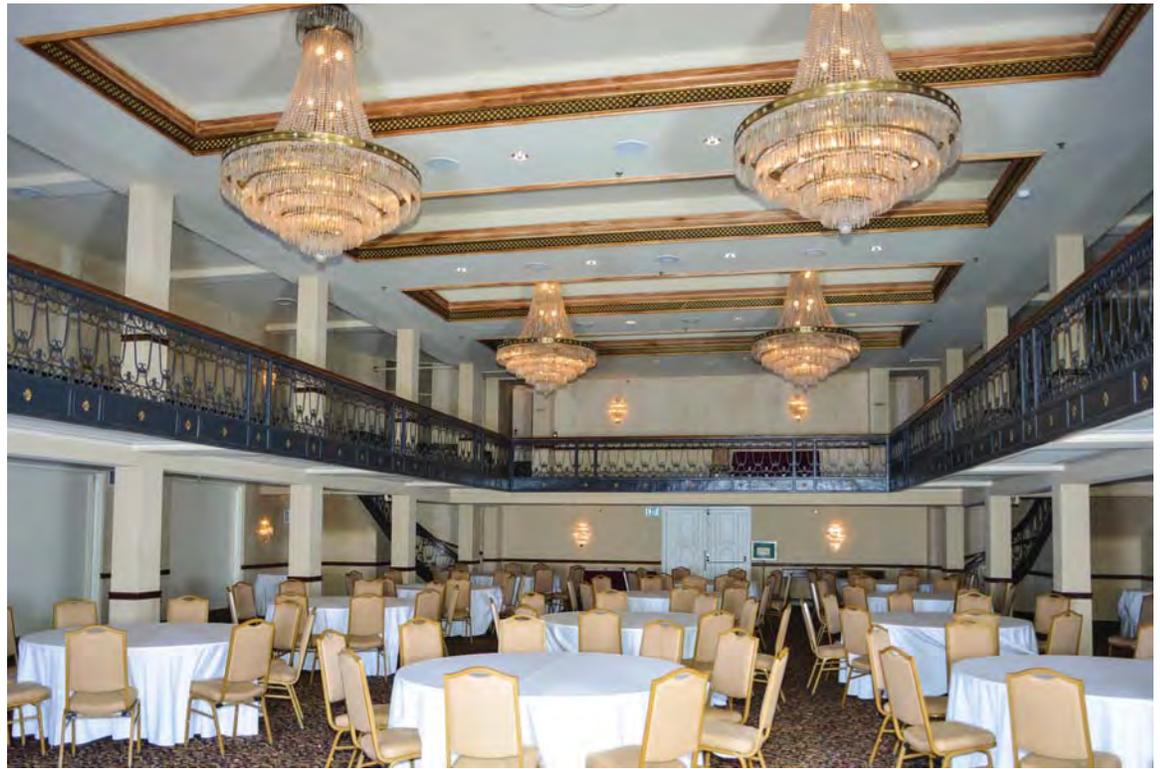
SAH-144

Name: Saint Anthony Hotel, 300 East Travis Street, San Antonio, Texas
View: First floor Anacacho Room interior, looking northwest toward entry
Description: Coffered ceiling with plaster moldings, metal railings & chandelieres
Date: September 2012

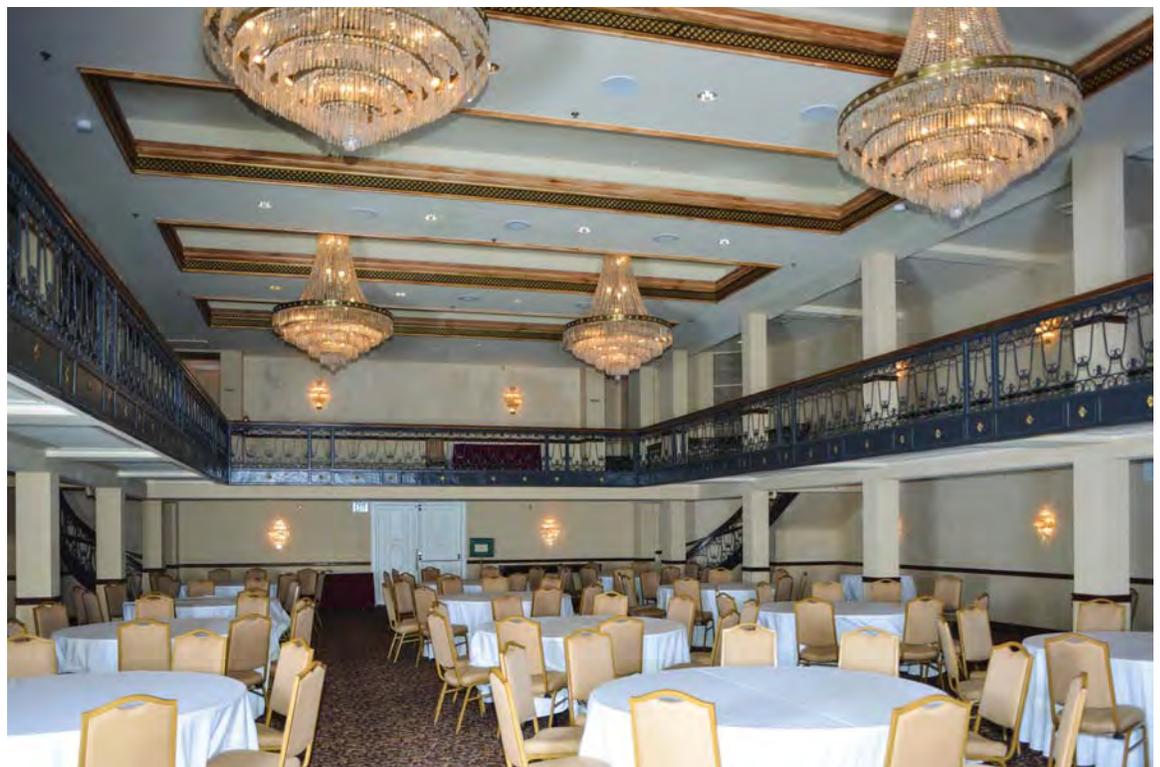
SAH-145

Name: Saint Anthony Hotel, 300 East Travis Street, San Antonio, Texas
View: First floor Anacacho Room interior, looking northeast toward entry
Description: Coffered ceiling with plaster moldings, metal railings & chandelieres
Date: September 2012

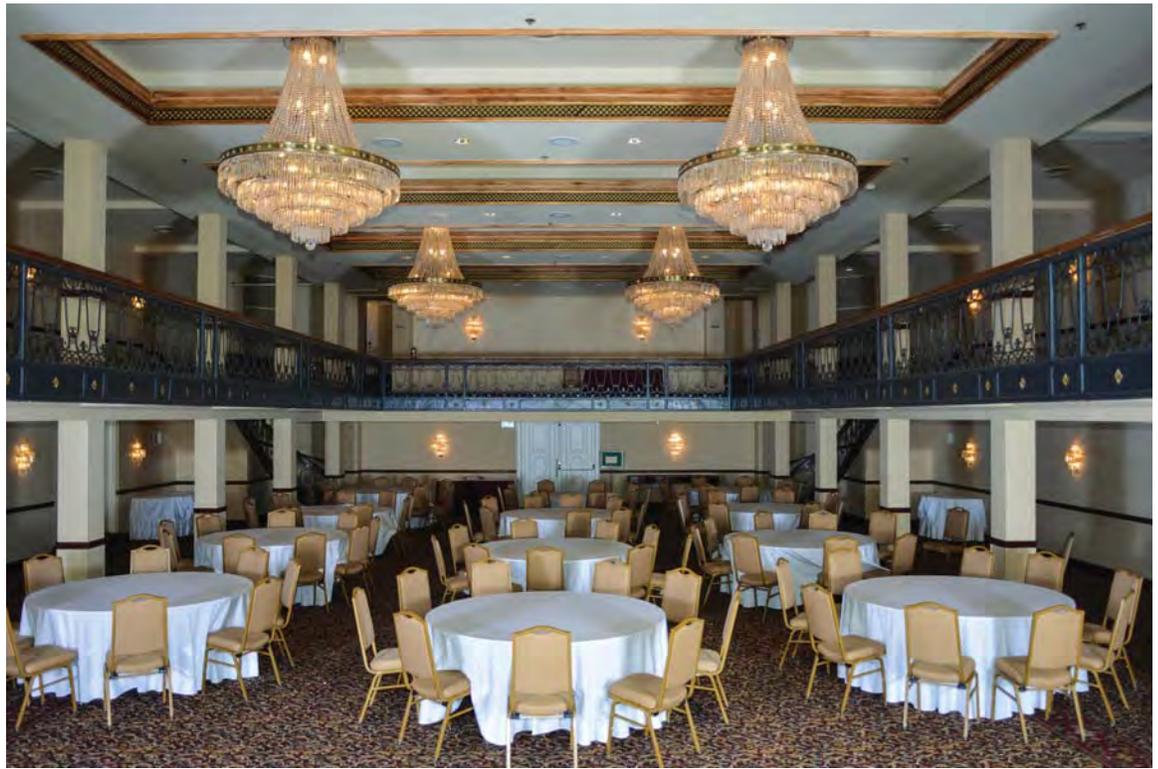
SAH-146

Name: Saint Anthony Hotel, 300 East Travis Street, San Antonio, Texas
View: First floor Anacacho Room interior, from stage looking north
Description: Coffered ceiling with plaster moldings, metal railings & chandelieres
Date: September 2012

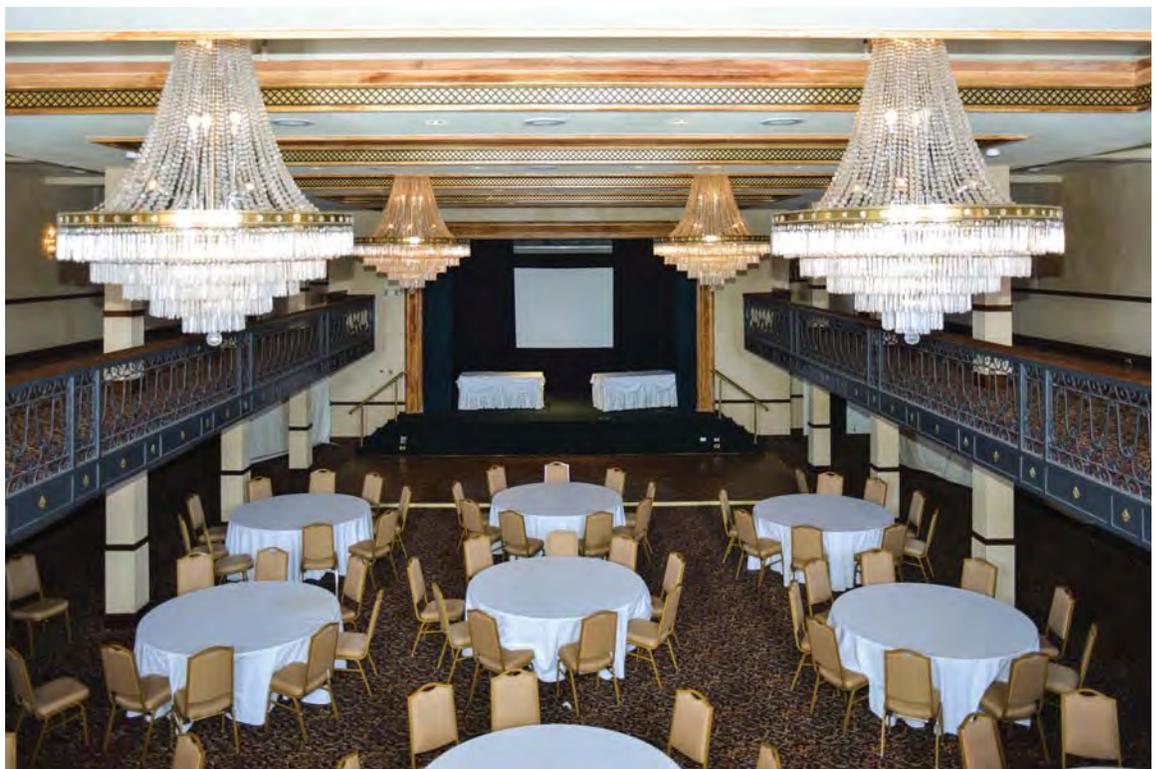
Photograph No.
SAH-147

Name: Saint Anthony Hotel, 300 East Travis Street, San Antonio, Texas
View: Mezzanine level Anacacho Room interior, looking south toward stage
Description: Coffered ceiling with plaster moldings, metal railings & chandelieres
Date: September 2012
