HISTORIC AND DESIGN REVIEW COMMISSION

HDRC CASE NO: 2016-016
ADDRESS: 304 E TRAVIS ST
LEGAL DESCRIPTION: NCB 415 BLK 18 LOT A-7, A- 8, A-9, P-100, P-101 & P-102
ZONING: D HE
CITY COUNCIL DIST.: 1
LANDMARK: St Anthony Hotel
APPLICANT: Brandon Raney
OWNER: BCL St. Anthony ML, LP
TYPE OF WORK: Tax Certification
REQUEST:

RE: St. Anthony Hotel Tax Certification Application

St. Anthony Hotel
Scope Summary of Exterior Rehabilitation

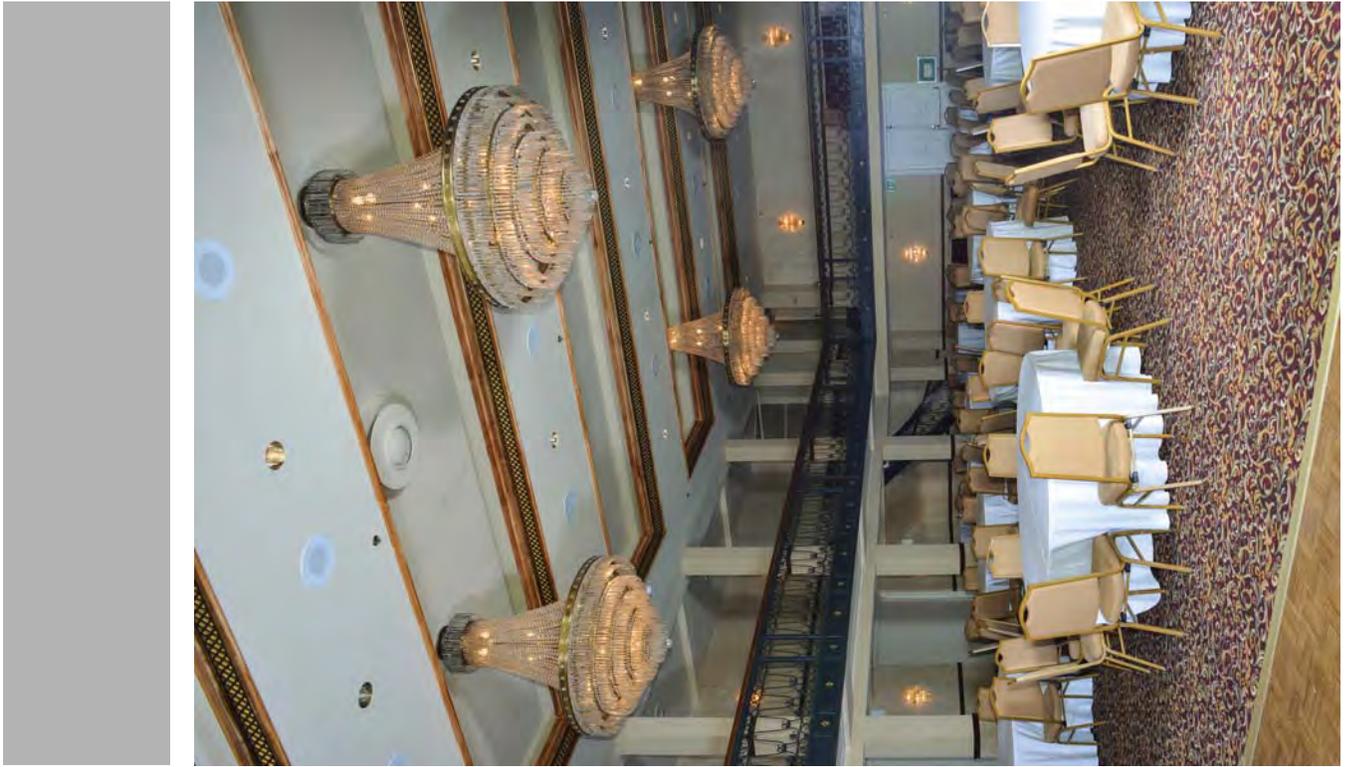
Photograph No.
SAH-148

Name: Saint Anthony Hotel, 300 East Travis Street, San Antonio, Texas
View: First floor Anacacho Room interior, looking northwest toward entry
Description: Coffered ceiling with plaster moldings, metal railings & chandelieres
Date: September 2012

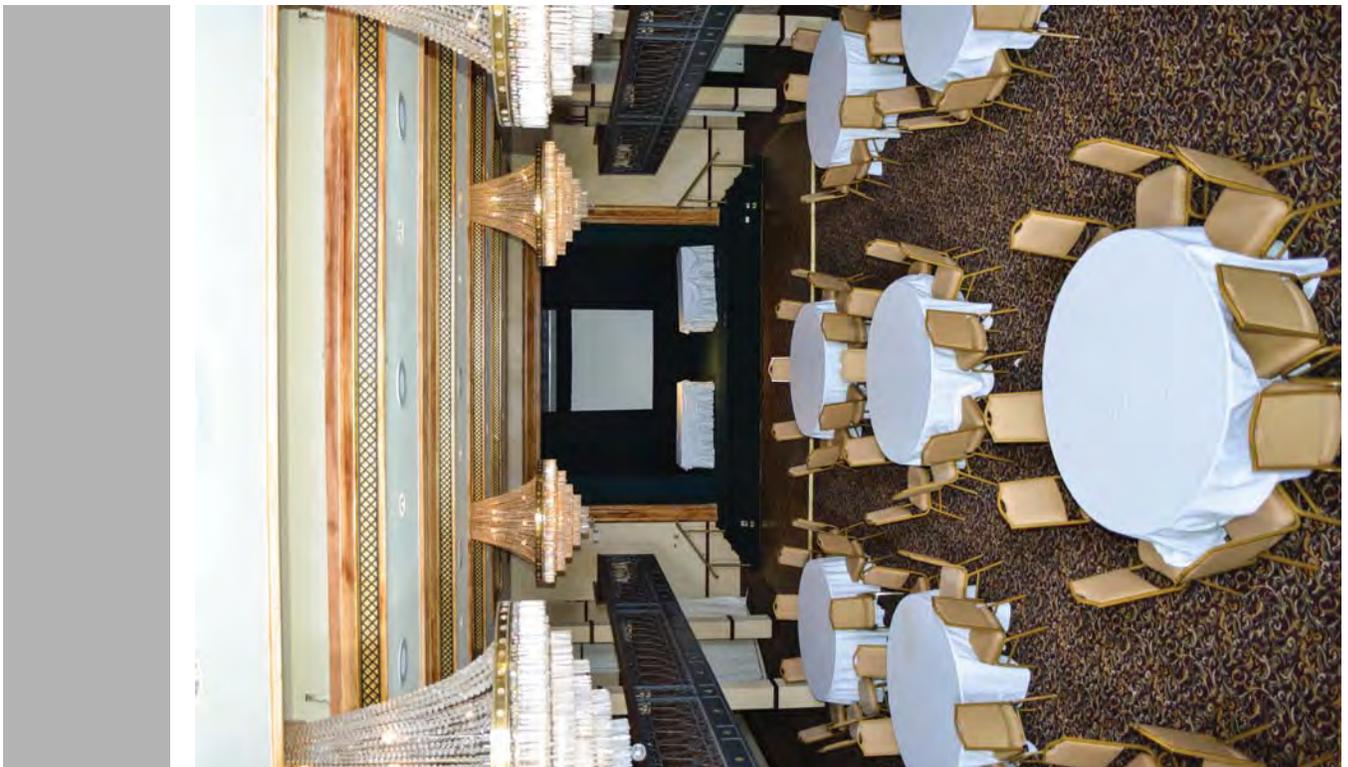
SAH-149

Name: Saint Anthony Hotel, 300 East Travis Street, San Antonio, Texas
View: Mezzanine level Anacacho Room interior, looking south toward stage
Description: Coffered ceiling with plaster moldings, metal railings & chandelieres
Date: September 2012

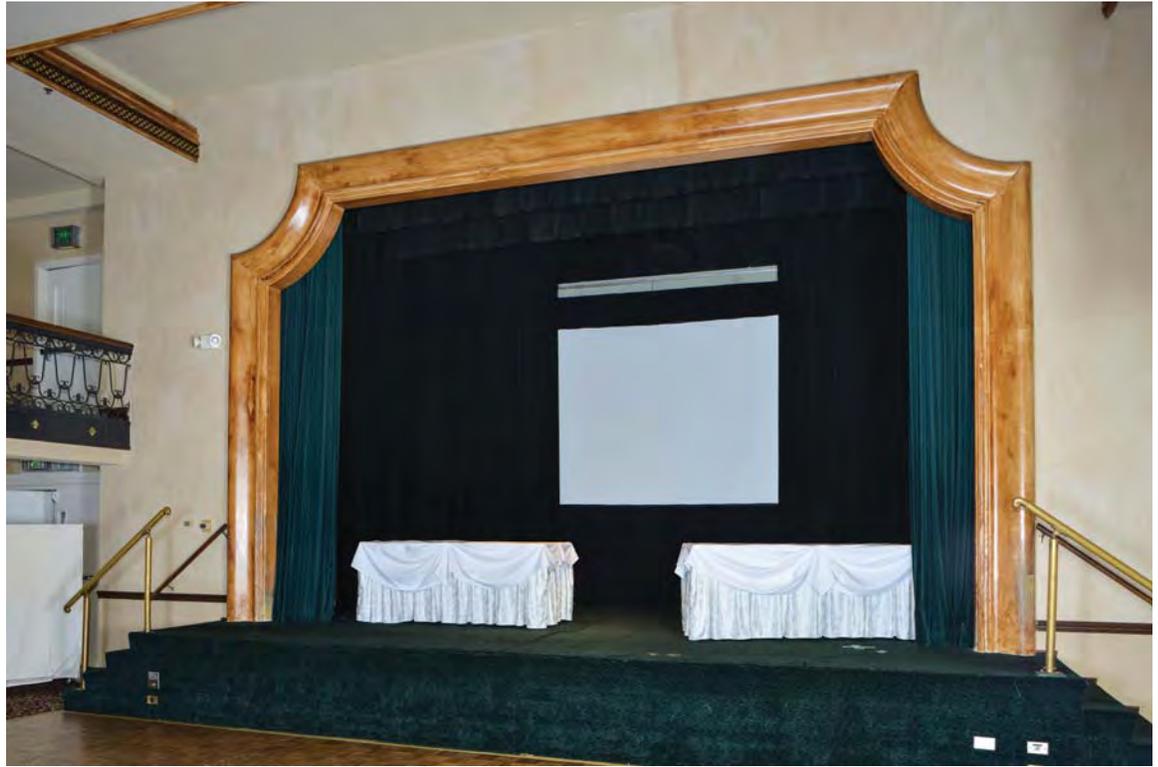
SAH-150

Name: Saint Anthony Hotel, 300 East Travis Street, San Antonio, Texas
View: First floor Anacacho Room interior, looking south at stage
Description: Stage proscenium of molded gypsum plaster
Date: September 2012

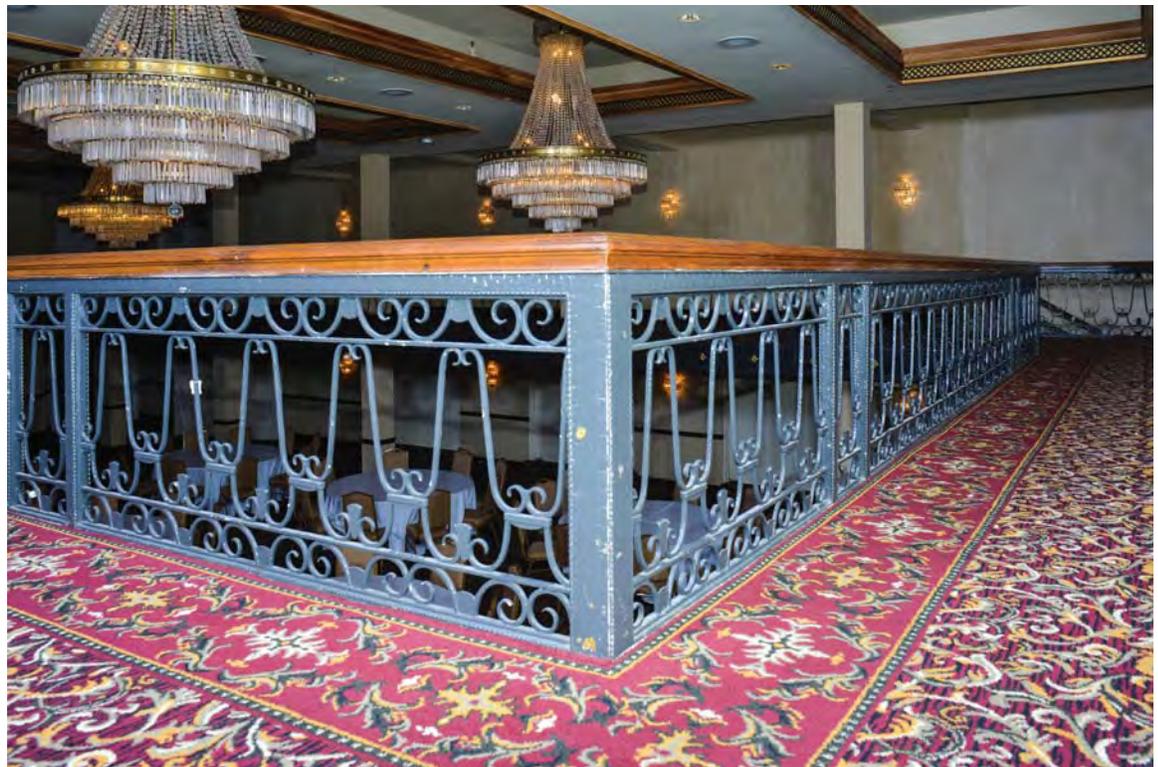
Photograph No.
SAH-151

Name: Saint Anthony Hotel, 300 East Travis Street, San Antonio, Texas
View: Mezzanine level Anacacho Room interior, looking west
Description: Corner detail of wrought iron railing with wood hand rail
Date: September 2012

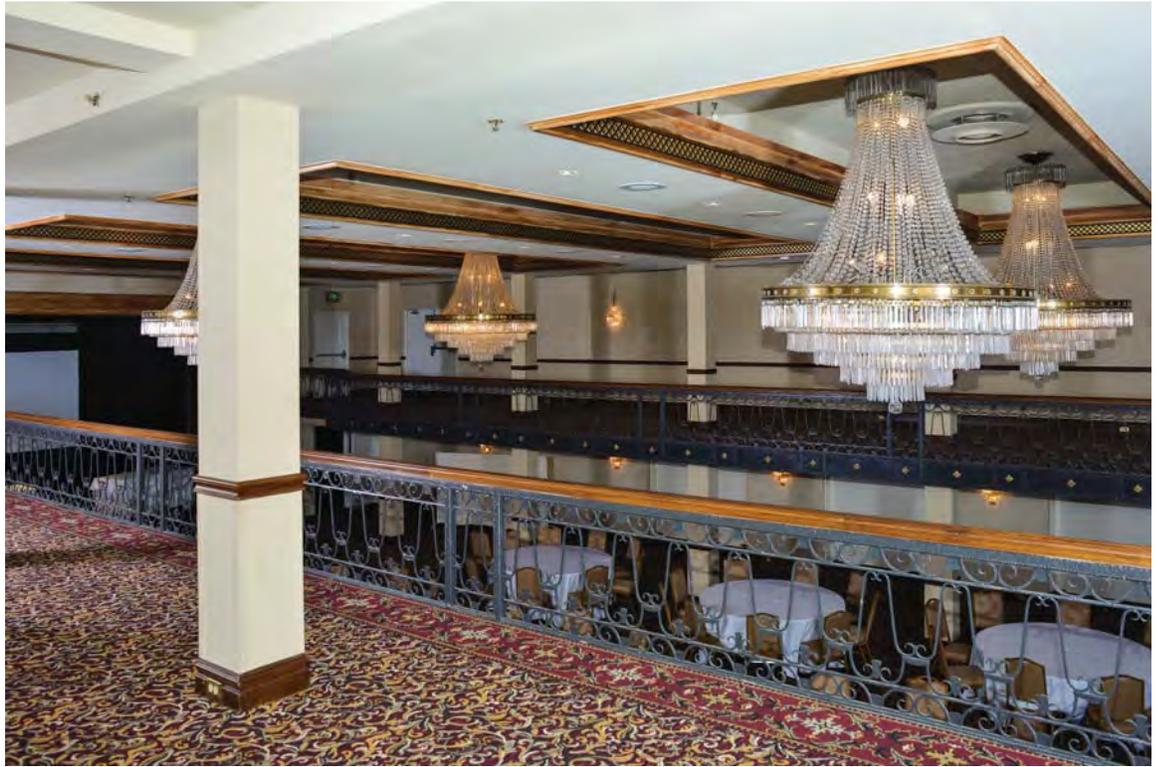
Photograph No.
SAH-152

Name: Saint Anthony Hotel, 300 East Travis Street, San Antonio, Texas
View: Mezzanine level Anacacho Room interior, looking southwest
Description: Wrought iron railing with wood hand rail; mezzanine column
Date: September 2012

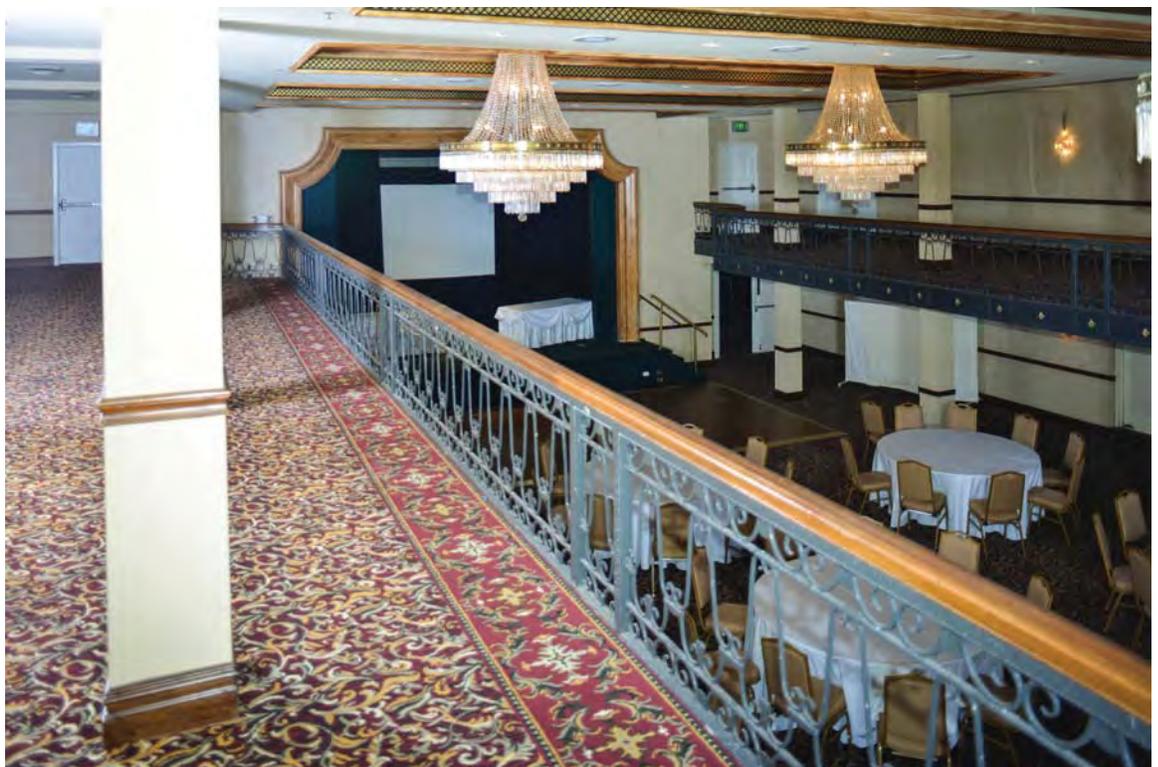
SAH-153

Name: Saint Anthony Hotel, 300 East Travis Street, San Antonio, Texas
View: Mezzanine level Anacacho Room interior, looking south
Description: Wrought iron railing with wood hand rail; mezzanine column
Date: September 2012

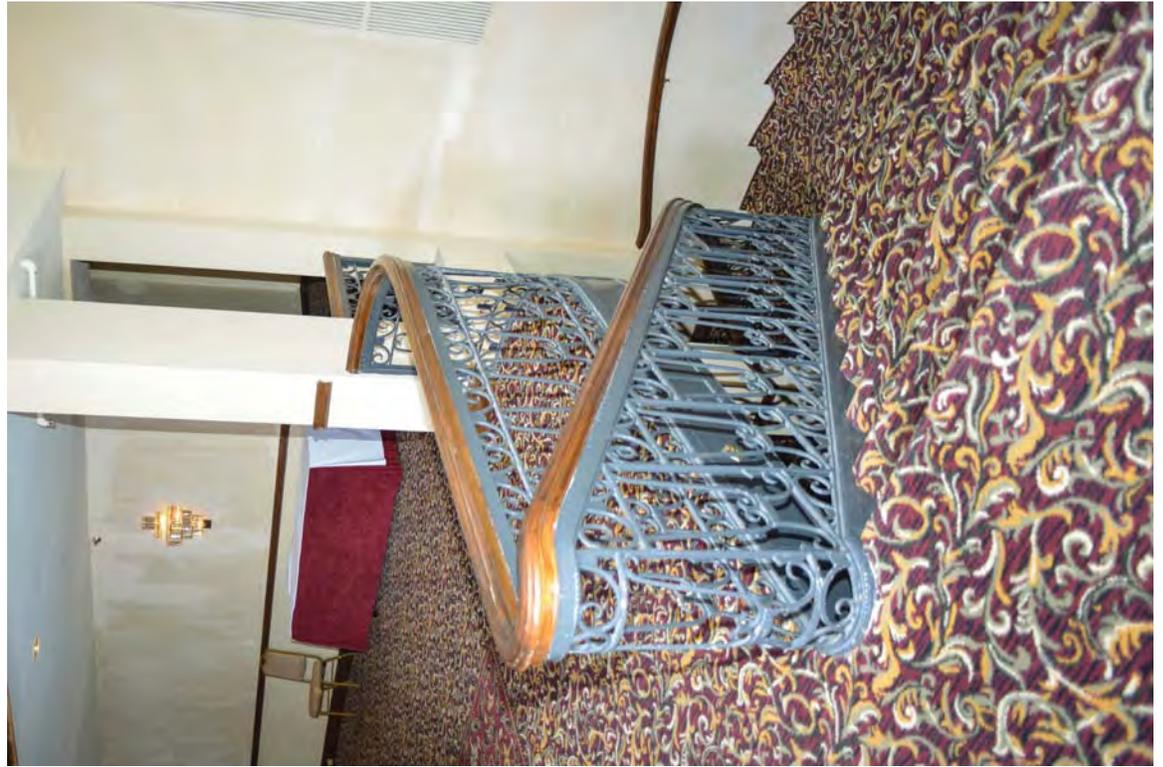
SAH-154

Name: Saint Anthony Hotel, 300 East Travis Street, San Antonio, Texas
View: Mezzanine level Anacacho Room interior at top of east stair
Description: Wrought iron stair railing with wood hand rail
Date: September 2012

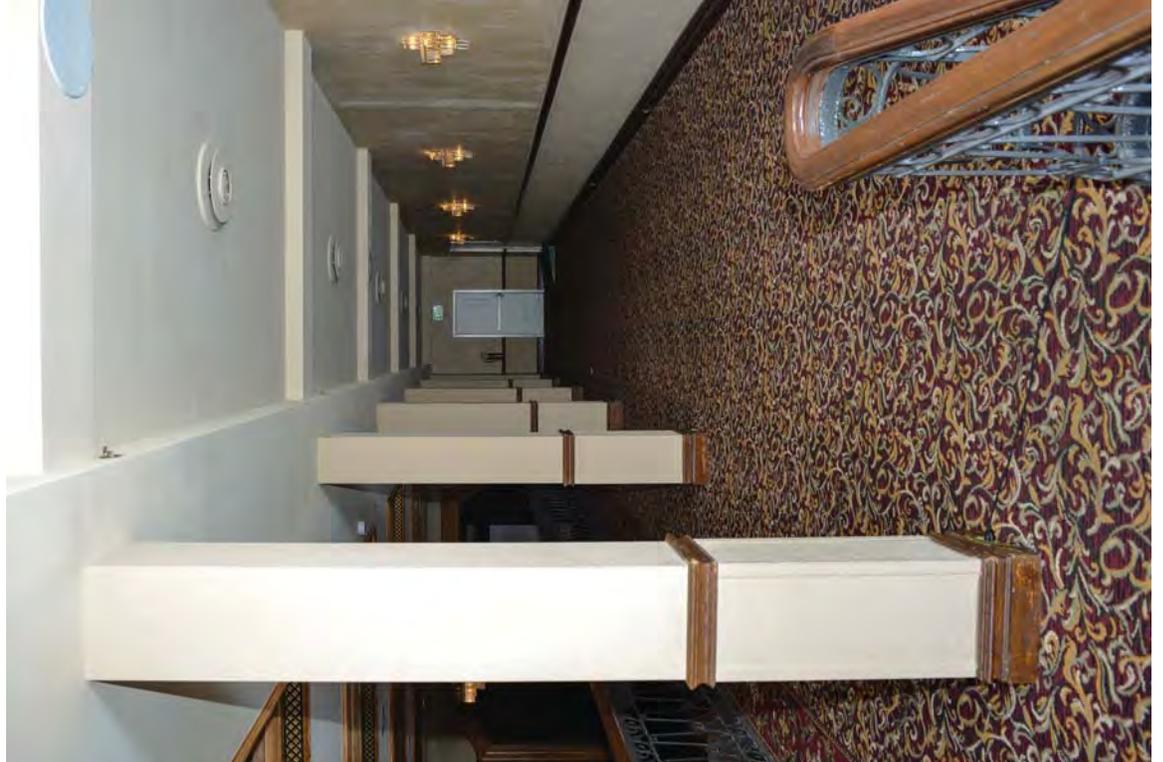
SAH-155

Name: Saint Anthony Hotel, 300 East Travis Street, San Antonio, Texas
View: Mezzanine level Anacacho Room interior, looking south
Description: Plaster finished structural steel columns at west side of mezzanine
Date: September 2012

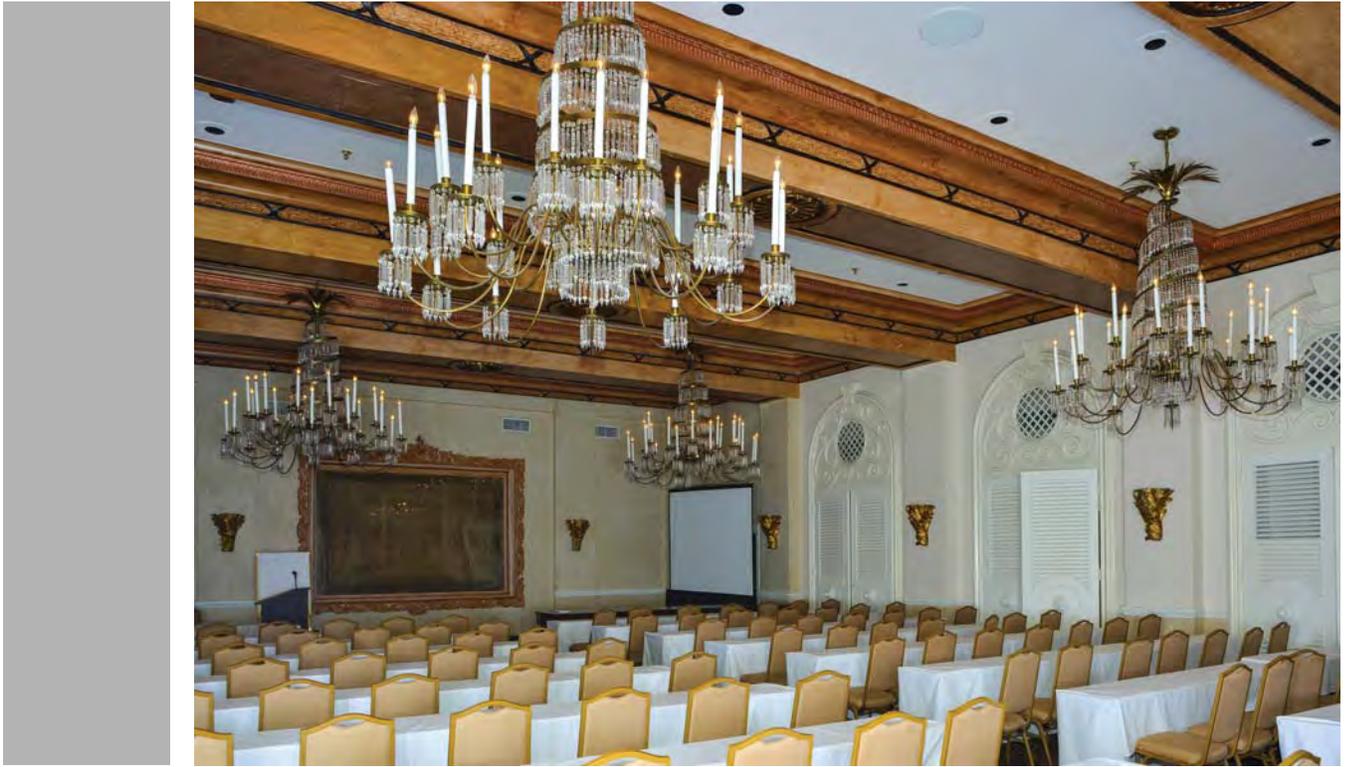
SAH-156

Name: Saint Anthony Hotel, 300 East Travis Street, San Antonio, Texas
View: First floor Peraus Room interior, looking southwest
Description: Coffered ceiling with plaster moldings, historic tapastry & chandeliers
Date: September 2012

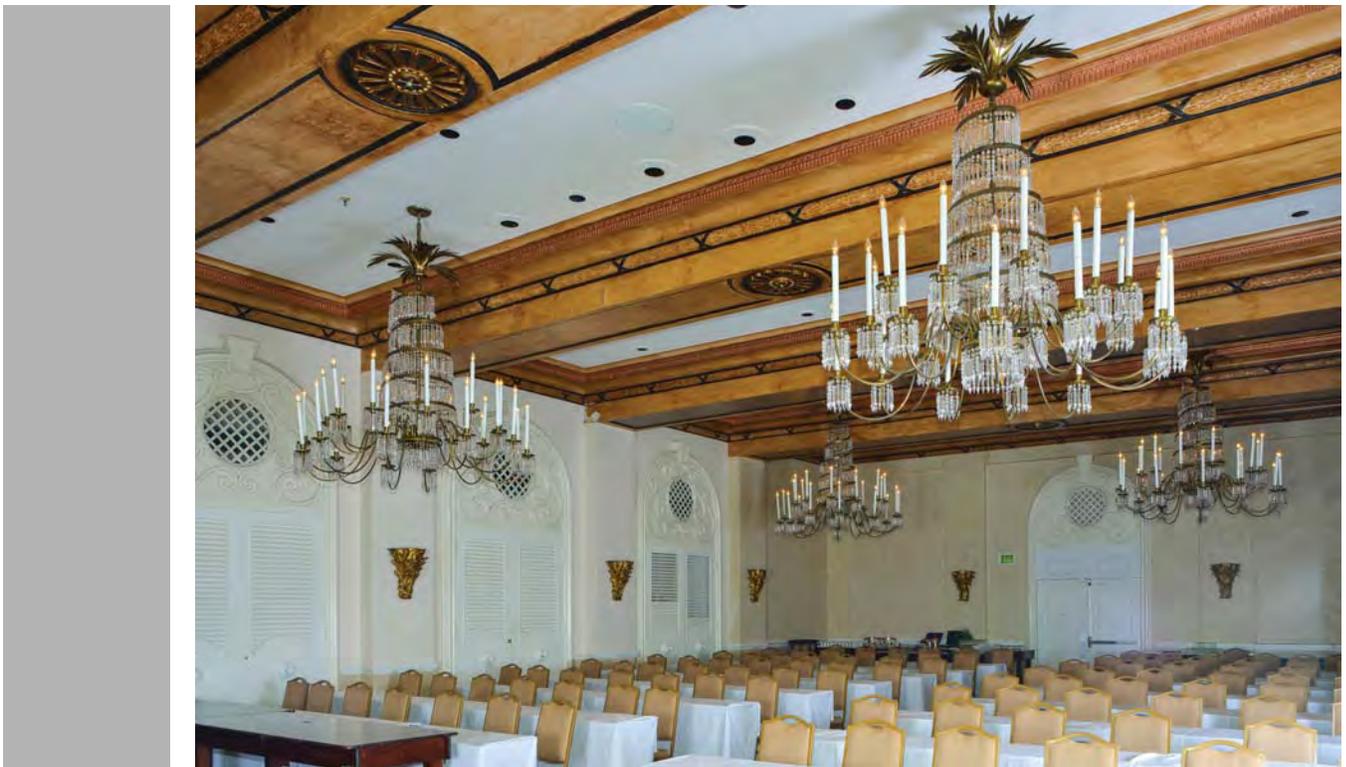
SAH-157

Name: Saint Anthony Hotel, 300 East Travis Street, San Antonio, Texas
View: First floor Anacacho Room interior, looking northwest
Description: Coffered ceiling with plaster moldings, louvered doors & chandeliers
Date: September 2012

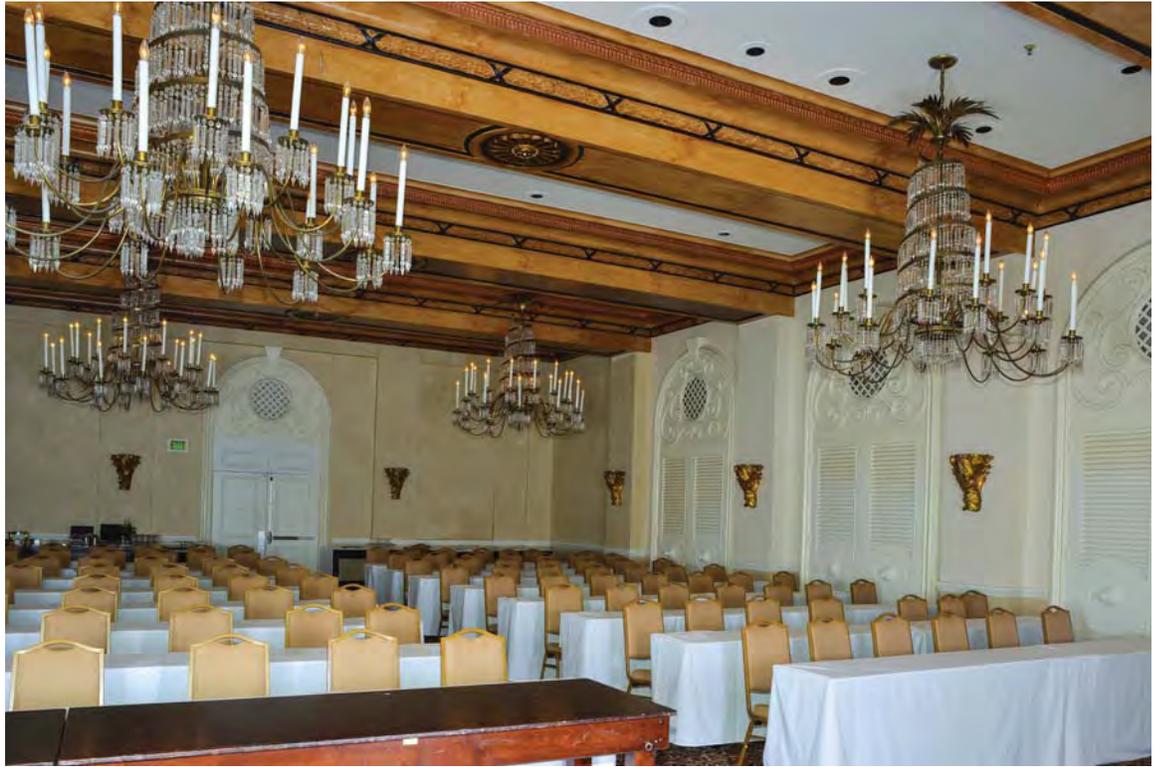
SAH-158

Name: Saint Anthony Hotel, 300 East Travis Street, San Antonio, Texas
View: First floor Peraus Room interior, looking northeast
Description: Coffered ceiling with plaster moldings, louvered doors & chandeliers
Date: September 2012

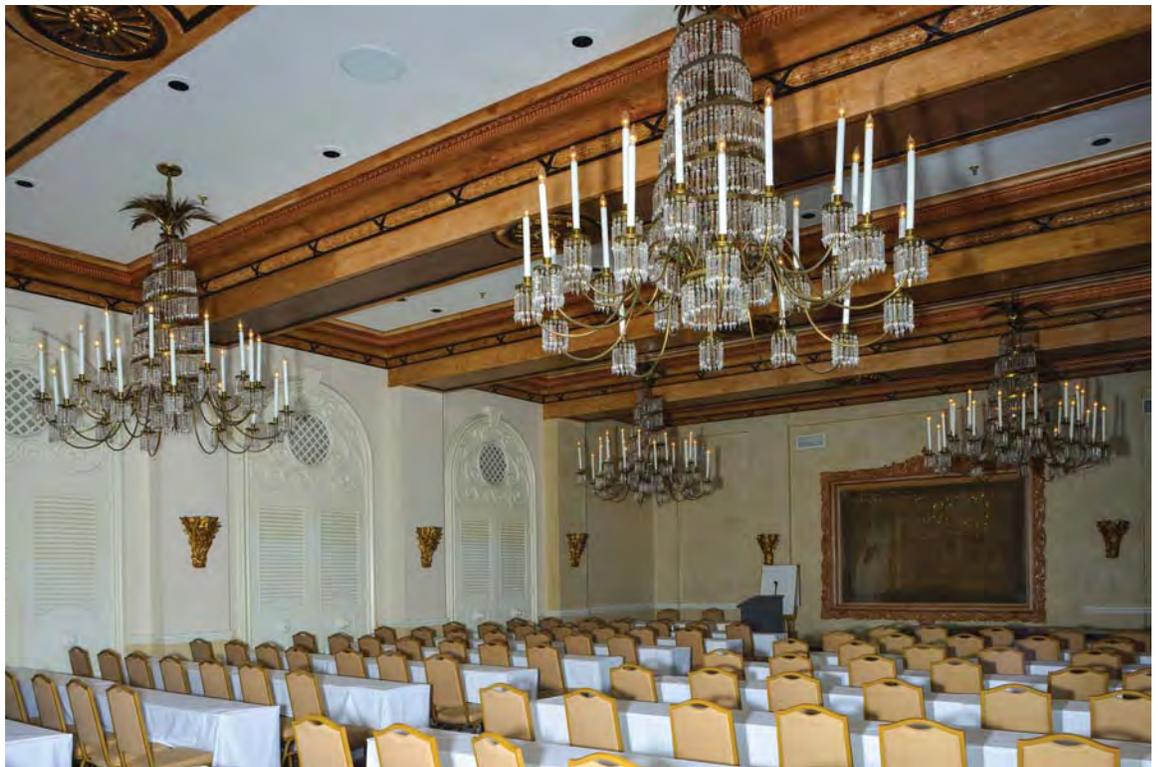
SAH-159

Name: Saint Anthony Hotel, 300 East Travis Street, San Antonio, Texas
View: First floor Peraus Room interior, looking southeast
Description: Coffered ceiling with plaster moldings, historic tapastry & chandeliers
Date: September 2012

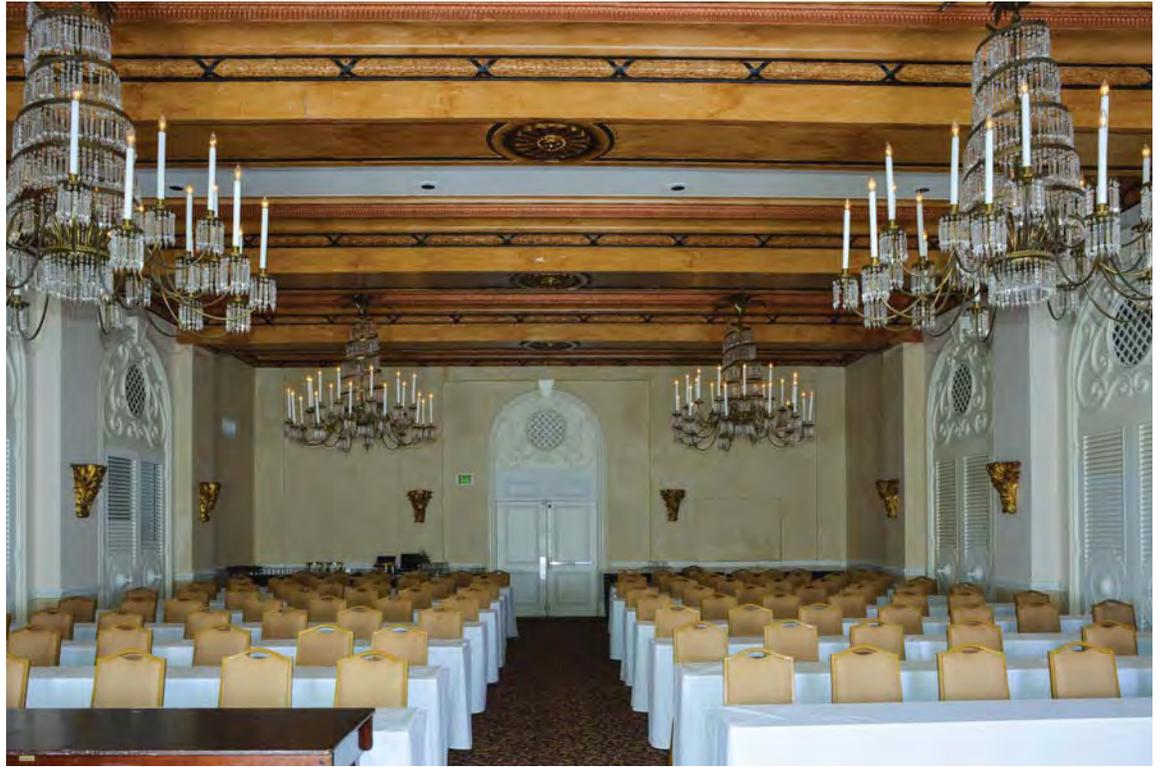
SAH-160

Name: Saint Anthony Hotel, 300 East Travis Street, San Antonio, Texas
View: First floor Peraux Room interior, looking north
Description: Coffered ceiling with plaster moldings, louvered doors & chandeliers
Date: September 2012

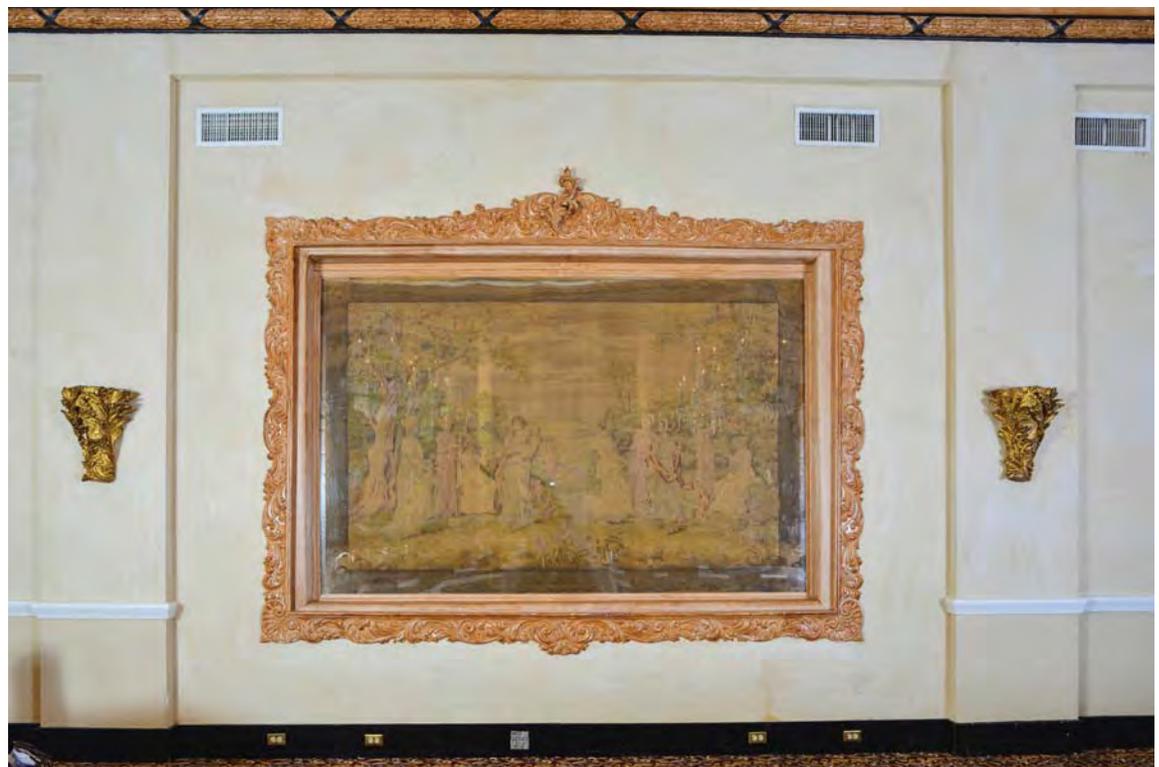
SAH-161

Name: Saint Anthony Hotel, 300 East Travis Street, San Antonio, Texas
View: First floor Peraux Room interior, looking south
Description: Historic tapastry in molded gypsum plaster frame and plexiglas
Date: September 2012

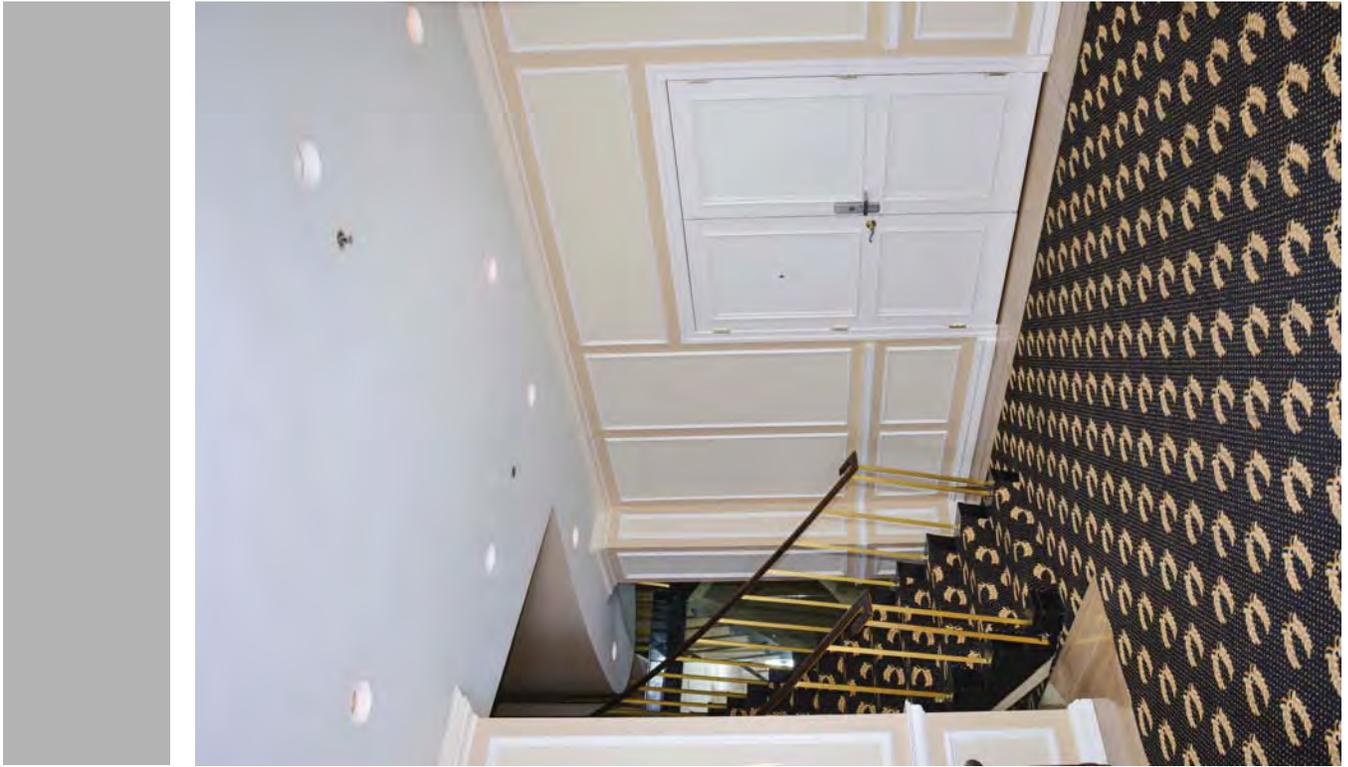
SAH-162

Name: Saint Anthony Hotel, 300 East Travis Street, San Antonio, Texas
View: First floor St. Anthony Club Foyer interior, looking southeast
Description: Club entry doors and mezzanine stair
Date: September 2012

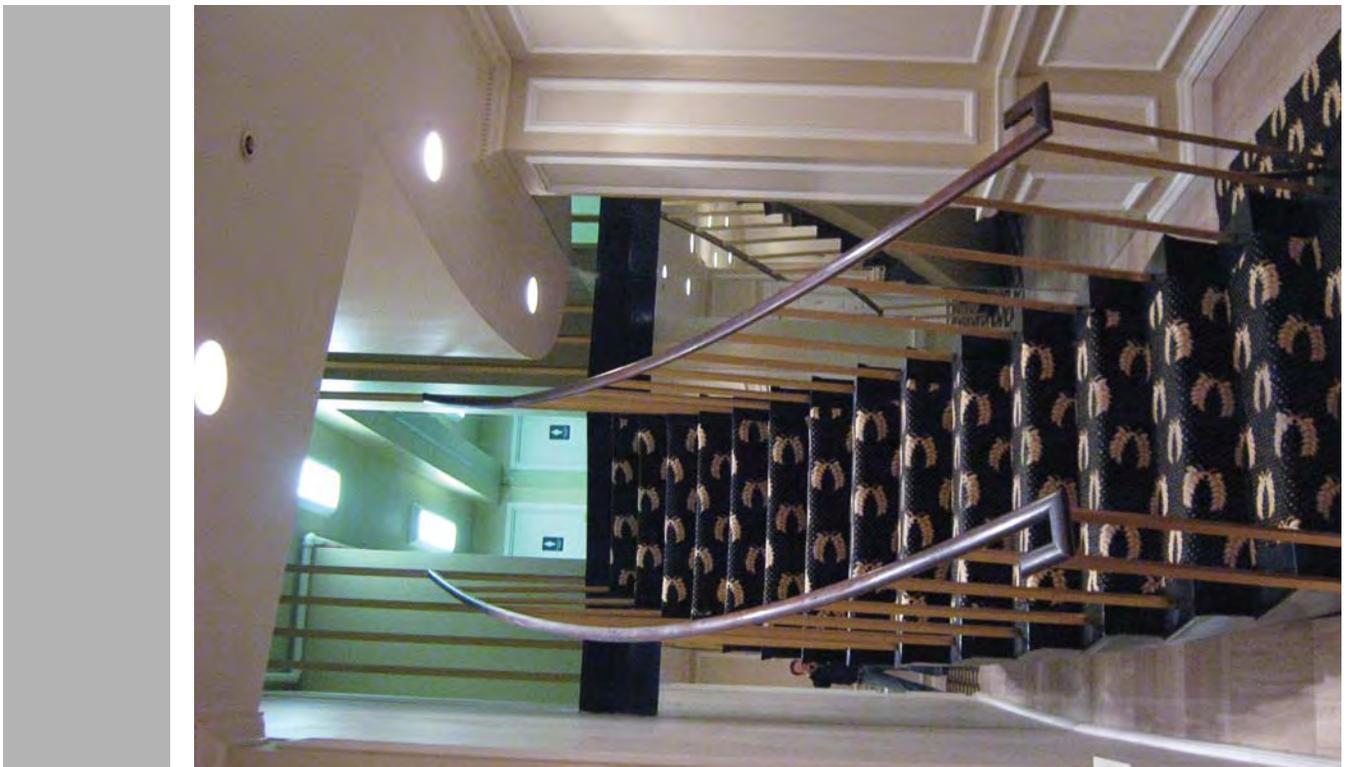
SAH-163

Name: Saint Anthony Hotel, 300 East Travis Street, San Antonio, Texas
View: First floor St. Anthony Club Foyer interior, looking east
Description: Mezzanine stair and mirrored walls
Date: September 2012

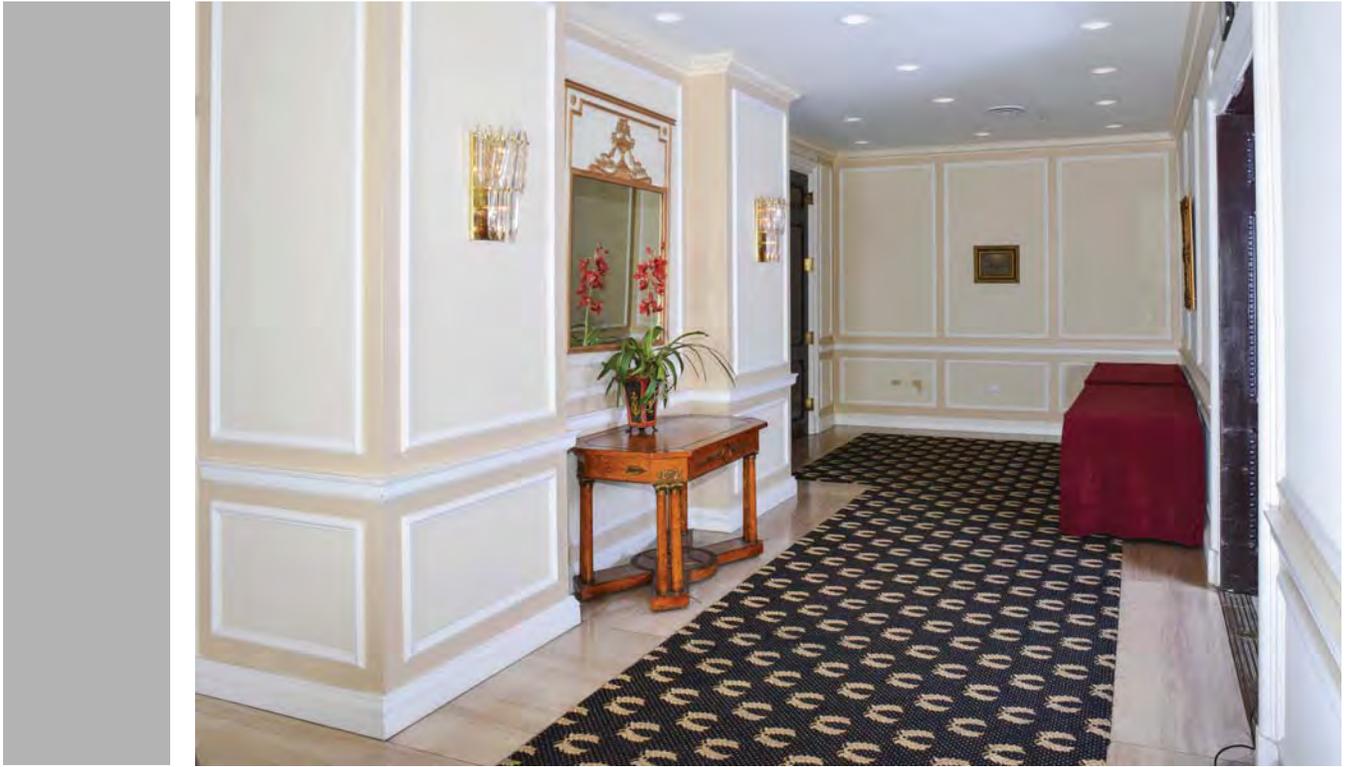
SAH-164

Name: Saint Anthony Hotel, 300 East Travis Street, San Antonio, Texas
View: First floor St. Anthony Club Foyer interior, looking west
Description: Georgian Room entry doors, Niche, wainscot, wood trim and crown molding
Date: September 2012

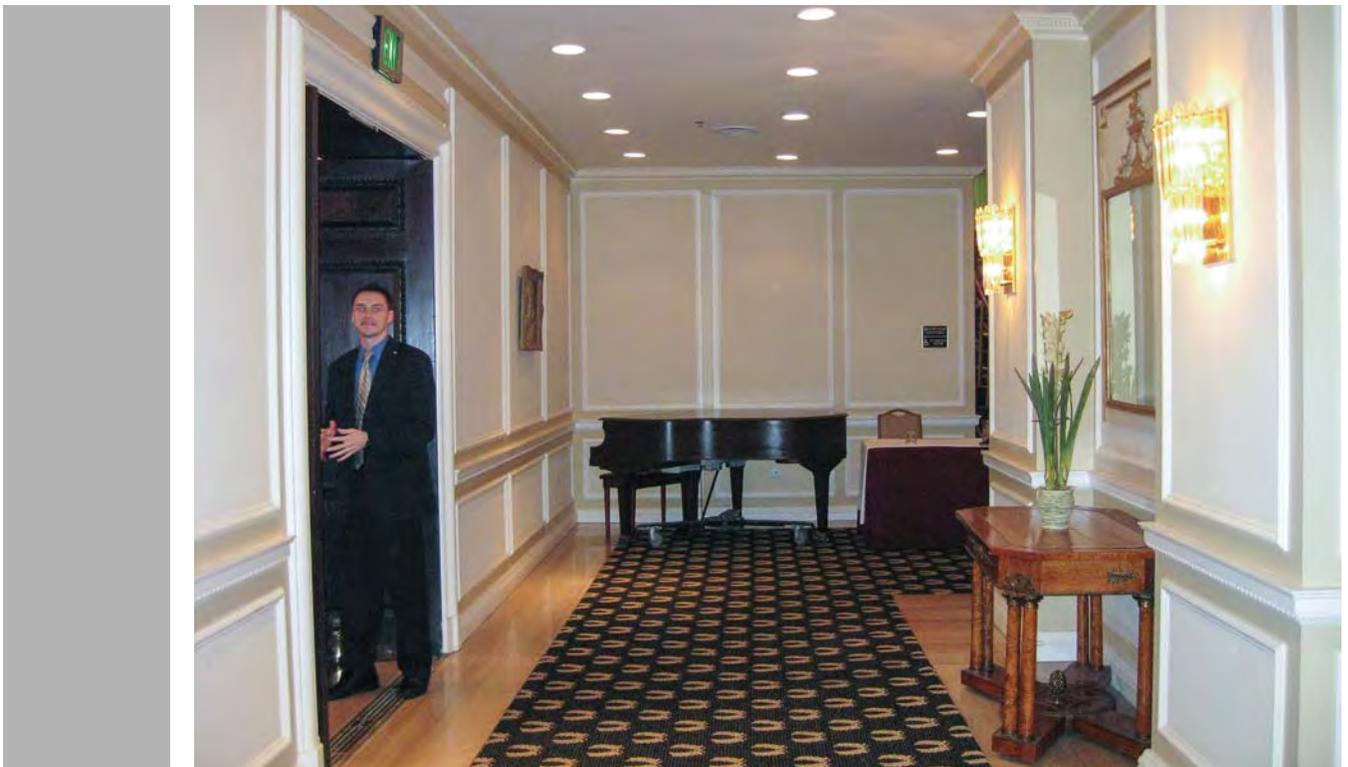
SAH-165

Name: Saint Anthony Hotel, 300 East Travis Street, San Antonio, Texas
View: First floor St. Anthony Club Foyer interior, looking east
Description: Doors to Peacock Alley (left), niche, wainscot, wood trim and crown molding
Date: September 2012

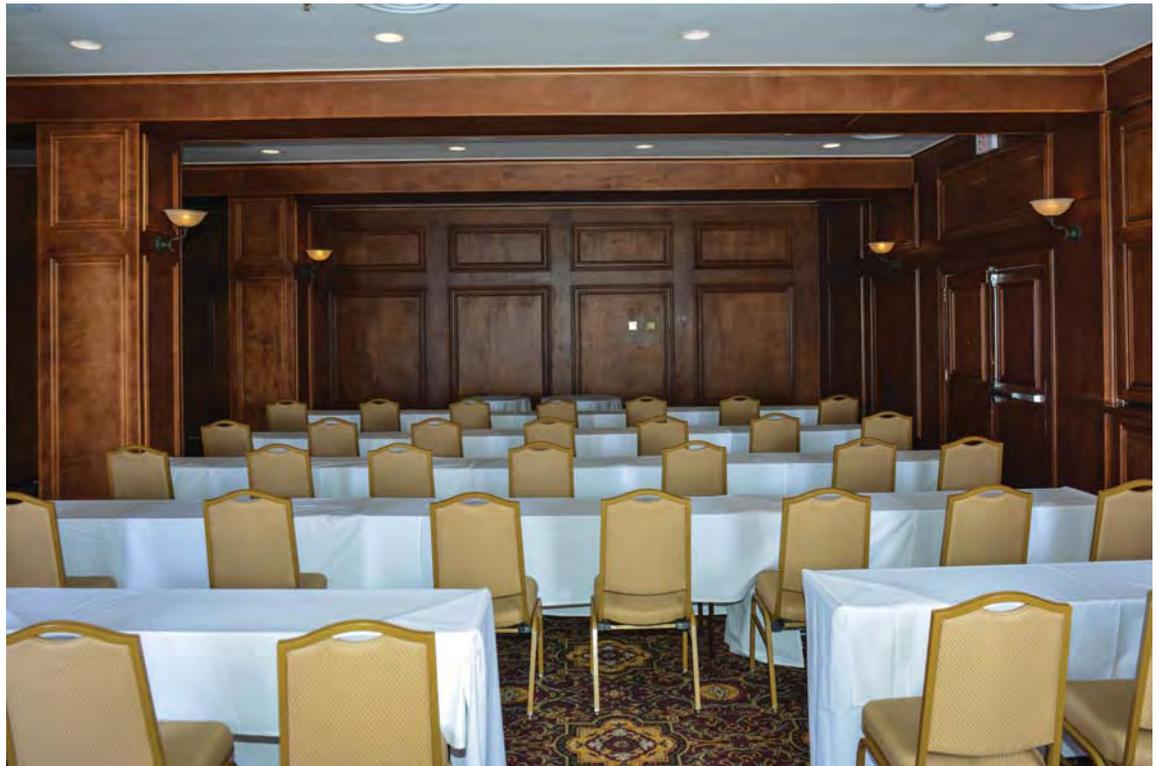
SAH-166

Name: Saint Anthony Hotel, 300 East Travis Street, San Antonio, Texas
View: First floor St. Anthony Club interior, looking south
Description: Wood paneling, beams, columns, and sconce light fixtures
Date: September 2012

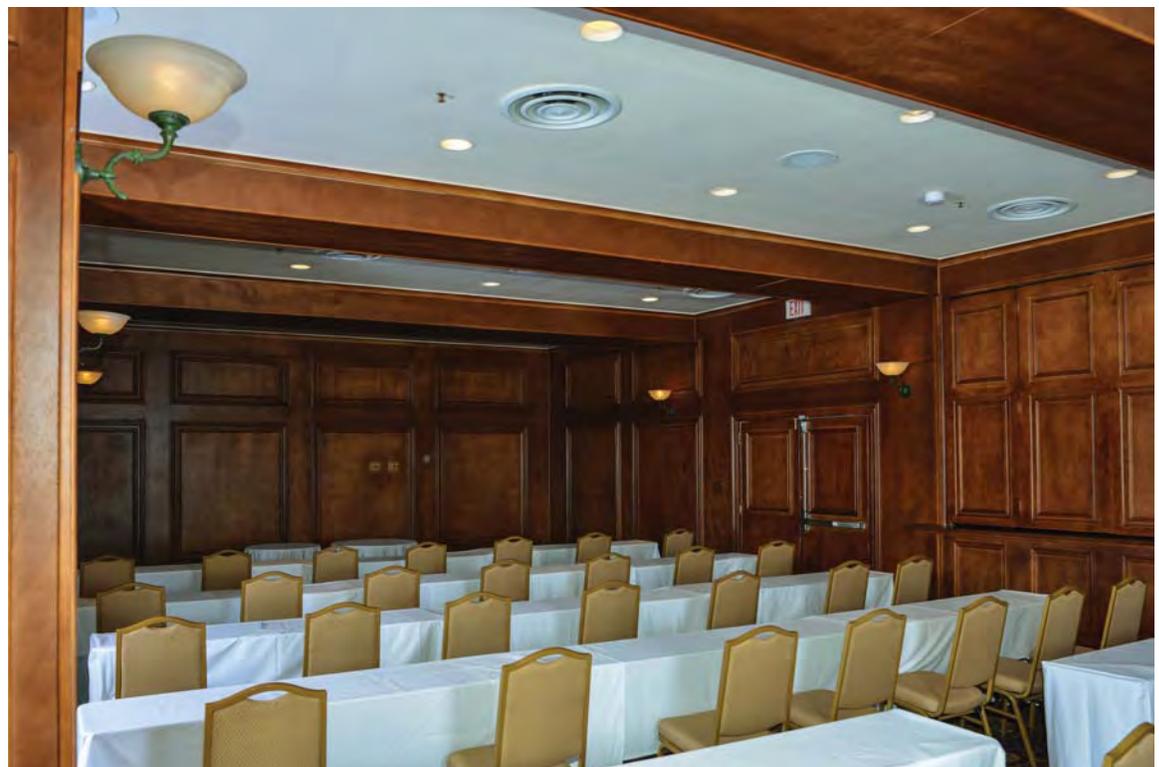
SAH-167

Name: Saint Anthony Hotel, 300 East Travis Street, San Antonio, Texas
View: First floor St. Anthony Club interior, looking southwest
Description: Wood paneling, beams, columns, sconce light fixtures, service doors to kitchen
Date: September 2012

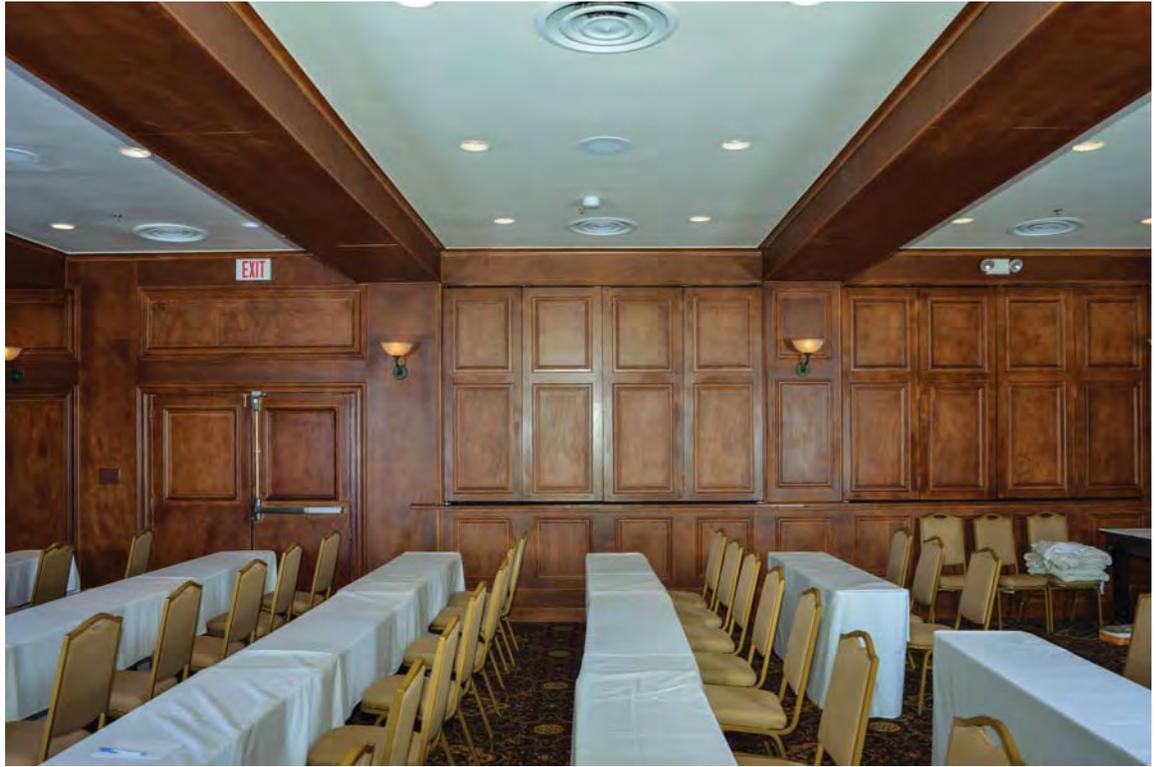
SAH-168

Name: Saint Anthony Hotel, 300 East Travis Street, San Antonio, Texas
View: First floor St. Anthony Club interior, looking west
Description: Wood paneling, beams, columns, sconce light fixtures, & folding panels at bar
Date: September 2012

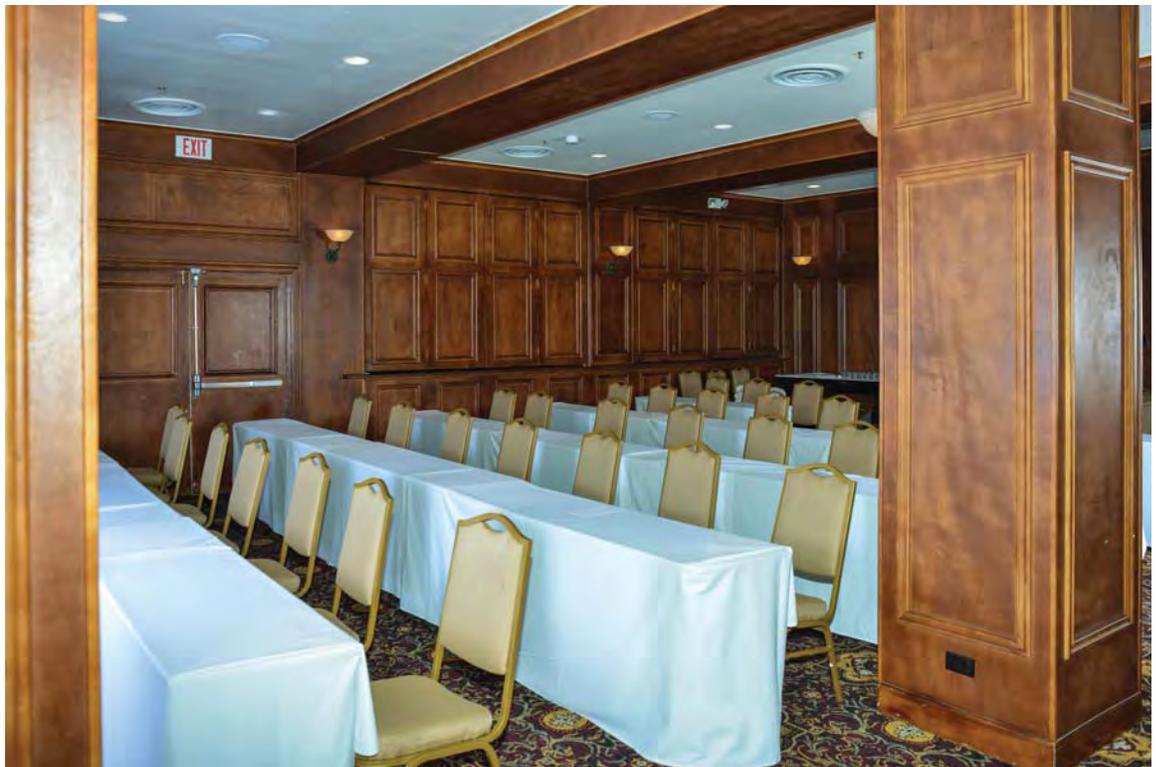
SAH-169

Name: Saint Anthony Hotel, 300 East Travis Street, San Antonio, Texas
View: First floor St. Anthony Club interior, looking northwest
Description: Wood paneling, beams, columns, sconce light fixtures, & folding panels at bar
Date: September 2012

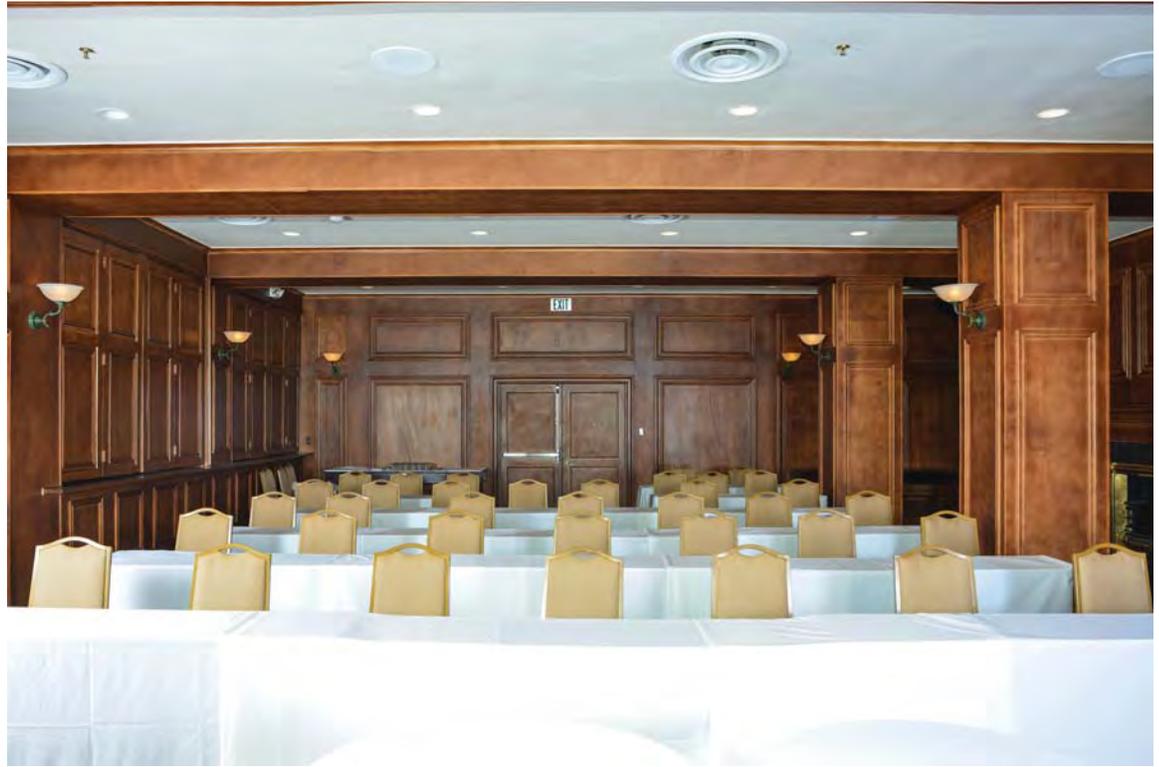
SAH-170

Name: Saint Anthony Hotel, 300 East Travis Street, San Antonio, Texas
View: First floor St. Anthony Club interior, looking north
Description: Wood paneling, beams, columns, sconce light fixtures, and entry doors to foyer
Date: September 2012
