HISTORIC AND DESIGN REVIEW COMMISSION

HDRC CASE NO: 2016-016
ADDRESS: 304 E TRAVIS ST
LEGAL DESCRIPTION: NCB 415 BLK 18 LOT A-7, A- 8, A-9, P-100, P-101 & P-102
ZONING: D HE
CITY COUNCIL DIST.: 1
LANDMARK: St Anthony Hotel
APPLICANT: Brandon Raney
OWNER: BCL St. Anthony ML, LP
TYPE OF WORK: Tax Certification
REQUEST:

RE: St. Anthony Hotel Tax Certification Application

St. Anthony Hotel
Scope Summary of Exterior Rehabilitation

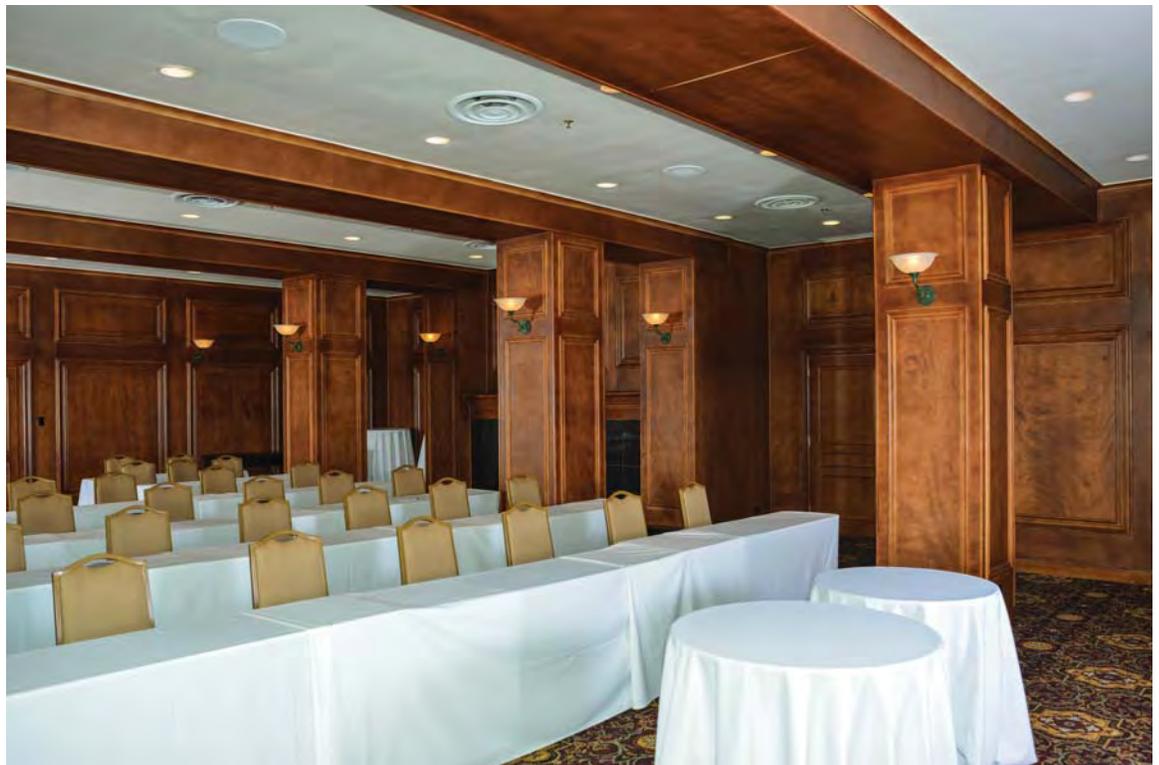
SAH-171

Name: Saint Anthony Hotel, 300 East Travis Street, San Antonio, Texas
View: First floor St. Anthony Club interior, looking northeast
Description: Wood paneling, beams, columns, sconce light fixtures, and fireplace
Date: September 2012

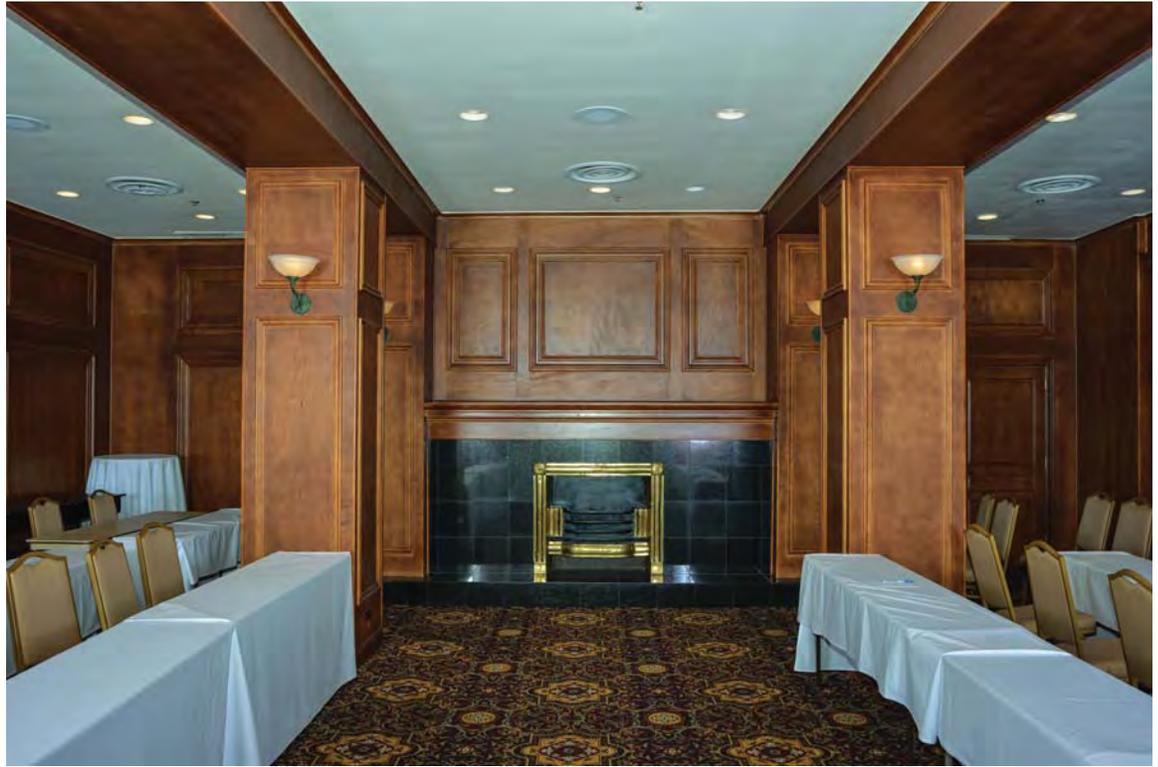
SAH-172

Name: Saint Anthony Hotel, 300 East Travis Street, San Antonio, Texas
View: First floor St. Anthony Club interior, looking east
Description: Wood paneling, beams, columns, sconce light fixtures, and fireplace
Date: September 2012

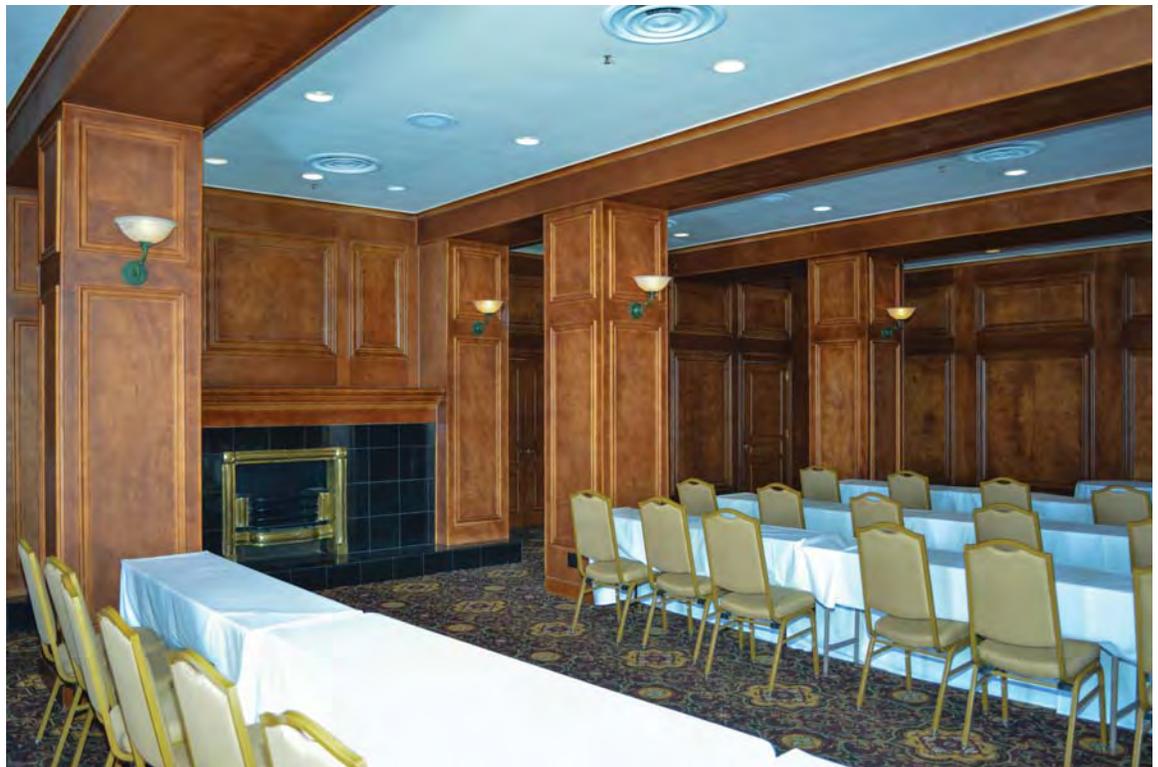
SAH-173

Name: Saint Anthony Hotel, 300 East Travis Street, San Antonio, Texas
View: First floor St. Anthony Club interior, looking east-southeast
Description: Wood paneling, beams, columns, sconce light fixtures, and fireplace
Date: September 2012

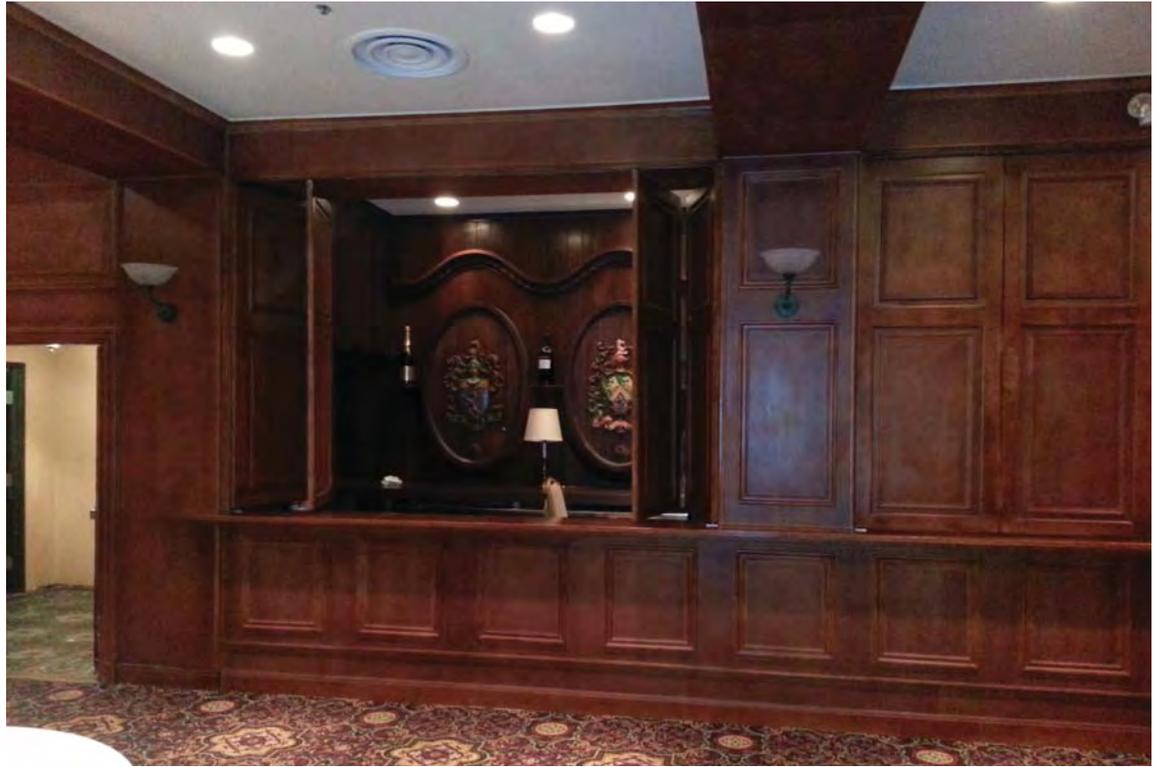
SAH-174

Name: Saint Anthony Hotel, 300 East Travis Street, San Antonio, Texas
View: First floor St. Anthony Club interior, looking west
Description: Folding panels at bar partially open revealing faux casks at back bar beyond
Date: September 2012

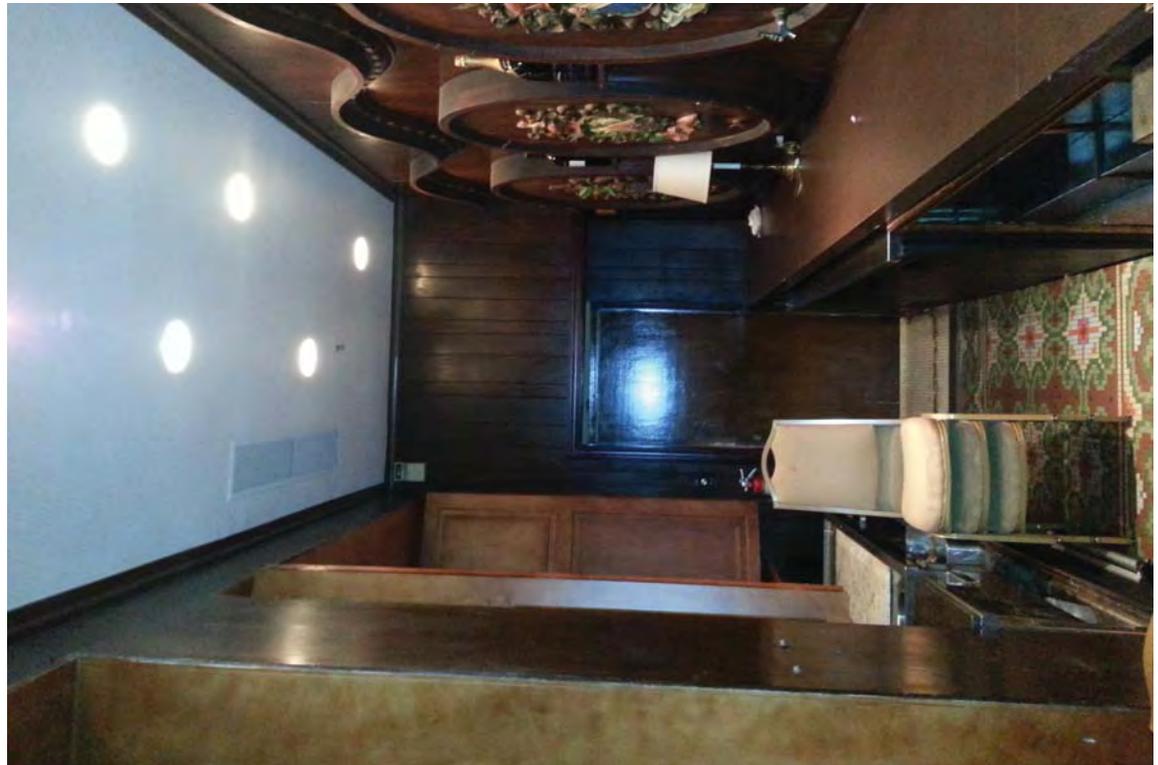
SAH-175

Name: Saint Anthony Hotel, 300 East Travis Street, San Antonio, Texas
View: First floor St. Anthony Club bar interior, looking south
Description: Folding panels (left) and faux casks at back bar (right)
Date: September 2012

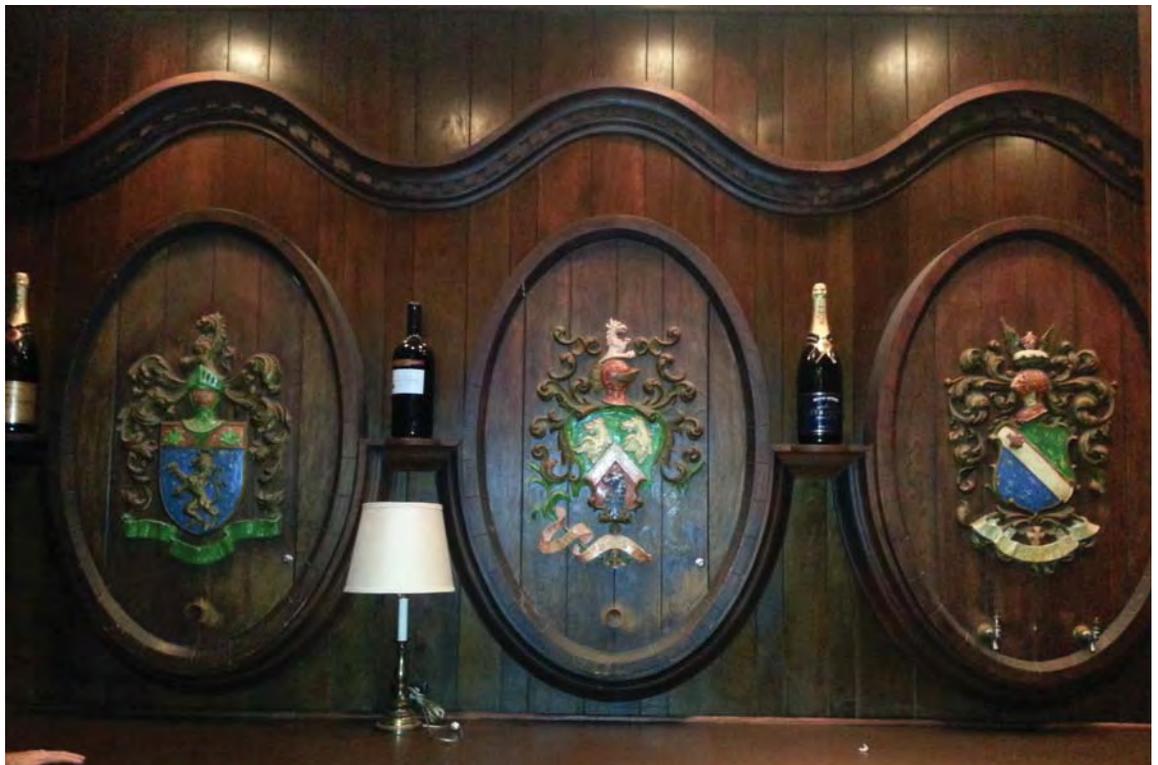
SAH-177

Name: Saint Anthony Hotel, 300 East Travis Street, San Antonio, Texas
View: First floor St. Anthony Club bar interior, looking west
Description: Faux casks with heraldic crests at back bar
Date: September 2012

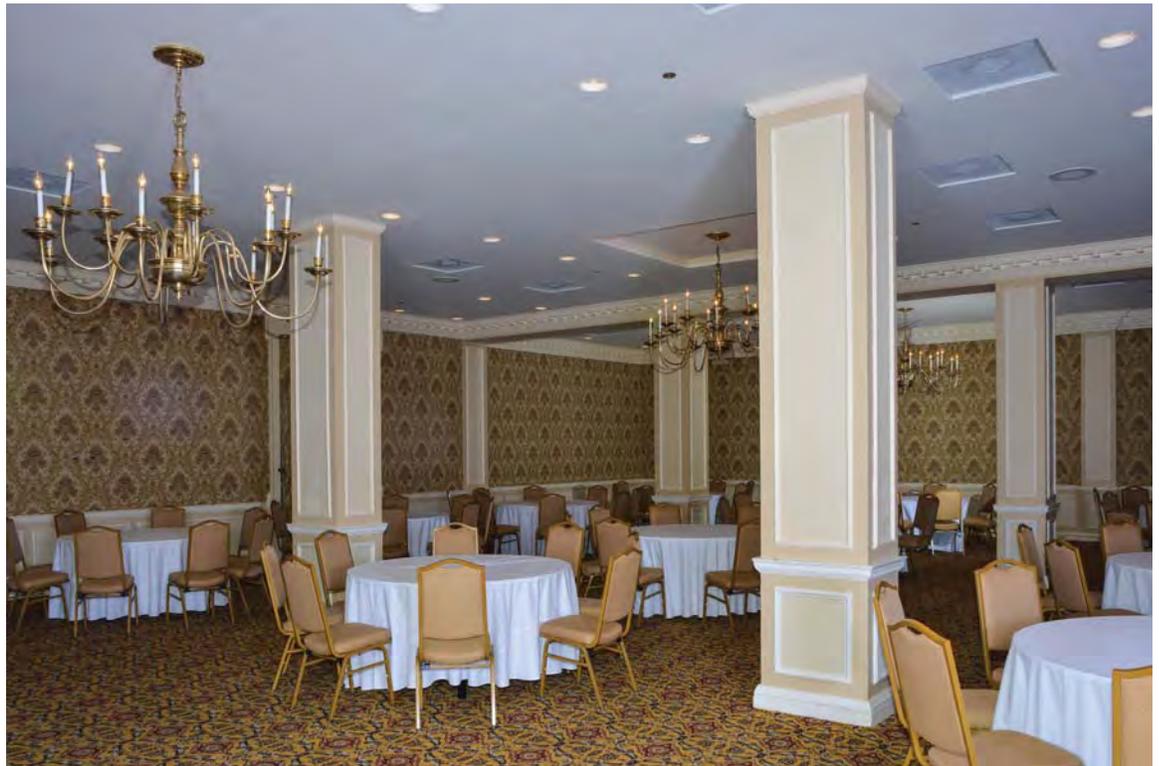
SAH-178

Name: Saint Anthony Hotel, 300 East Travis Street, San Antonio, Texas
View: First floor Georgian Room interior, looking southwest
Description: Wood wainscot, columns, beams, crown, wall fabric, & brass chandeliers
Date: September 2012

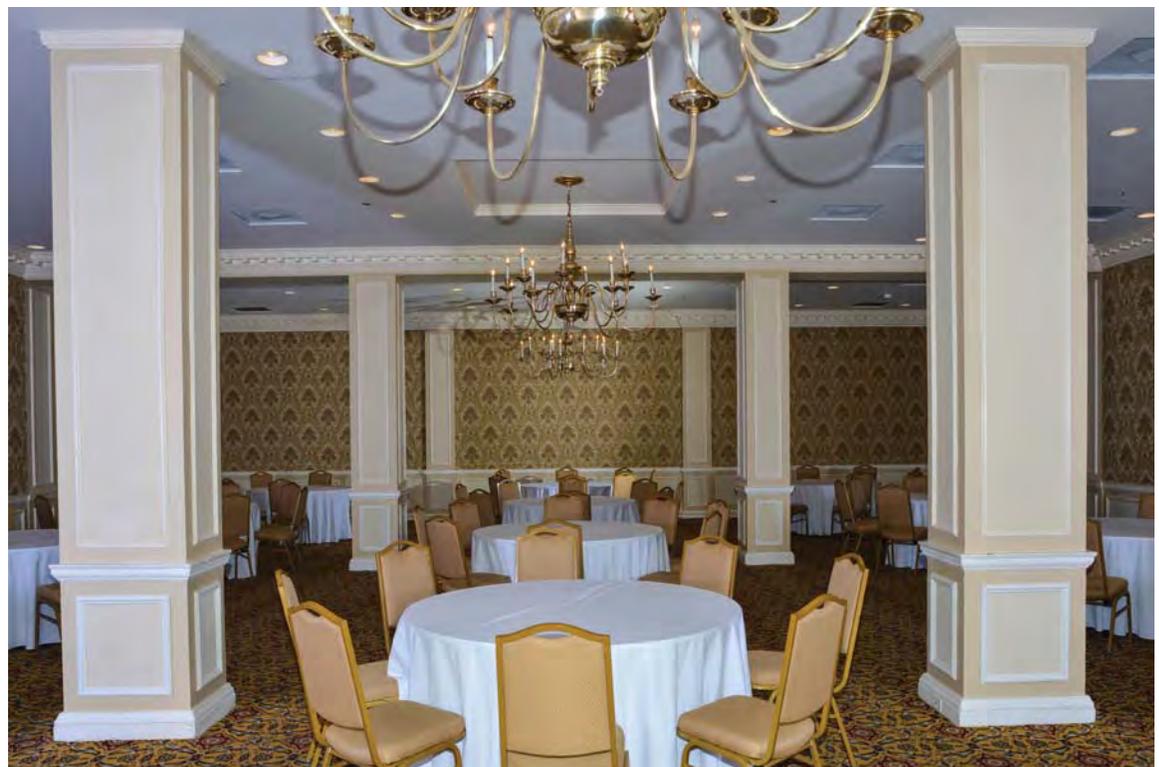
SAH-179

Name: Saint Anthony Hotel, 300 East Travis Street, San Antonio, Texas
View: First floor Georgian Room interior, looking west
Description: Wood wainscot, columns, beams, crown, wall fabric, & brass chandeliers
Date: September 2012

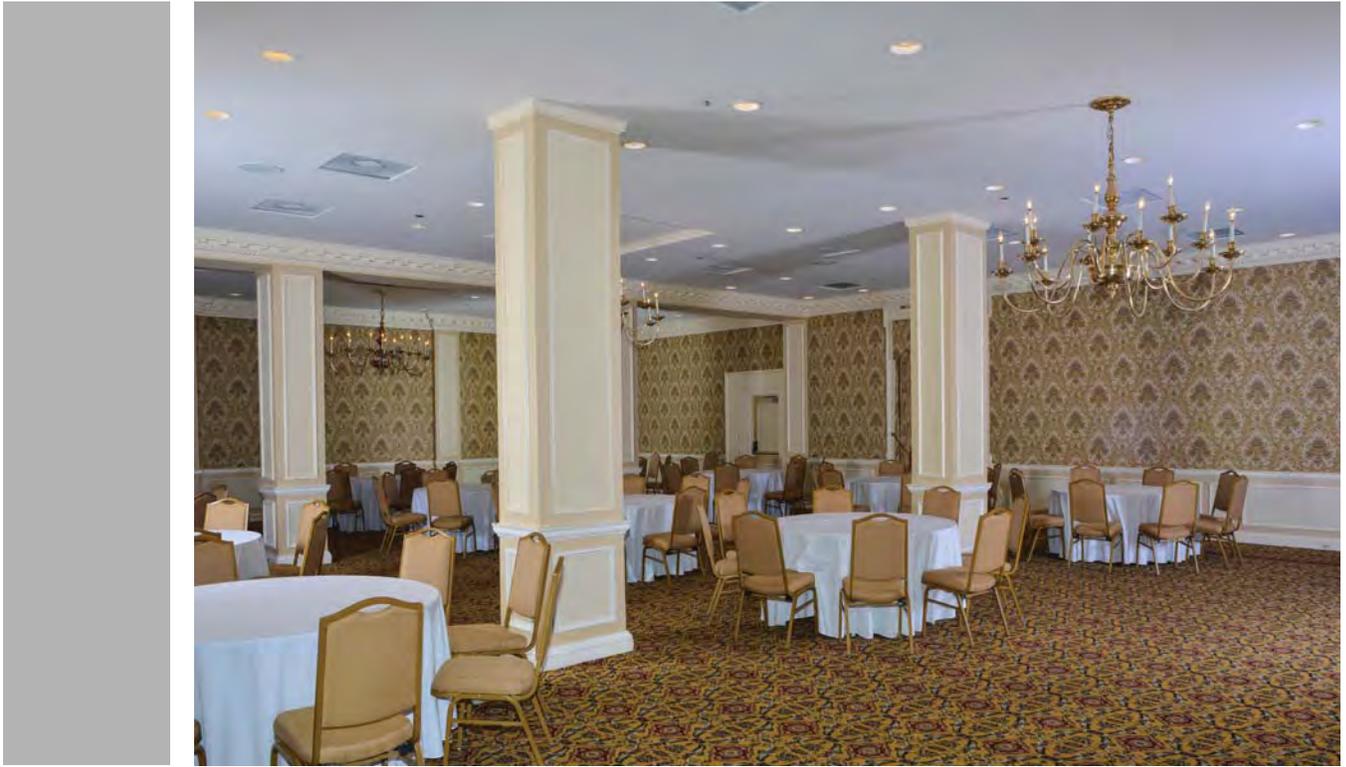
SAH-180

Name: Saint Anthony Hotel, 300 East Travis Street, San Antonio, Texas
View: First floor Georgian Room interior, looking northwest
Description: Wood wainscot, columns, beams, crown, wall fabric, & brass chandeliers
Date: September 2012

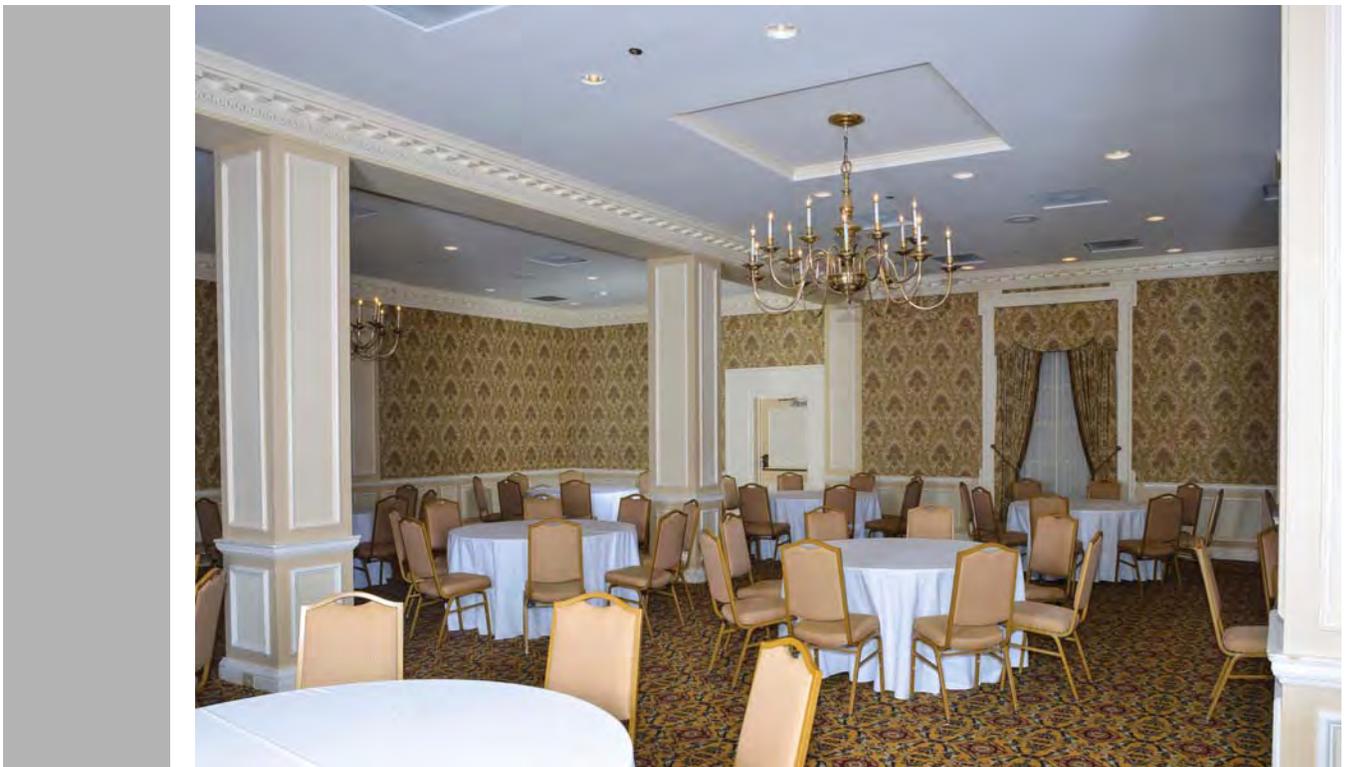
SAH-181

Name: Saint Anthony Hotel, 300 East Travis Street, San Antonio, Texas
View: First floor Georgian Room interior, looking north-northwest
Description: Wood wainscot, columns, beams, crown, wall fabric, exit door & faux window
Date: September 2012

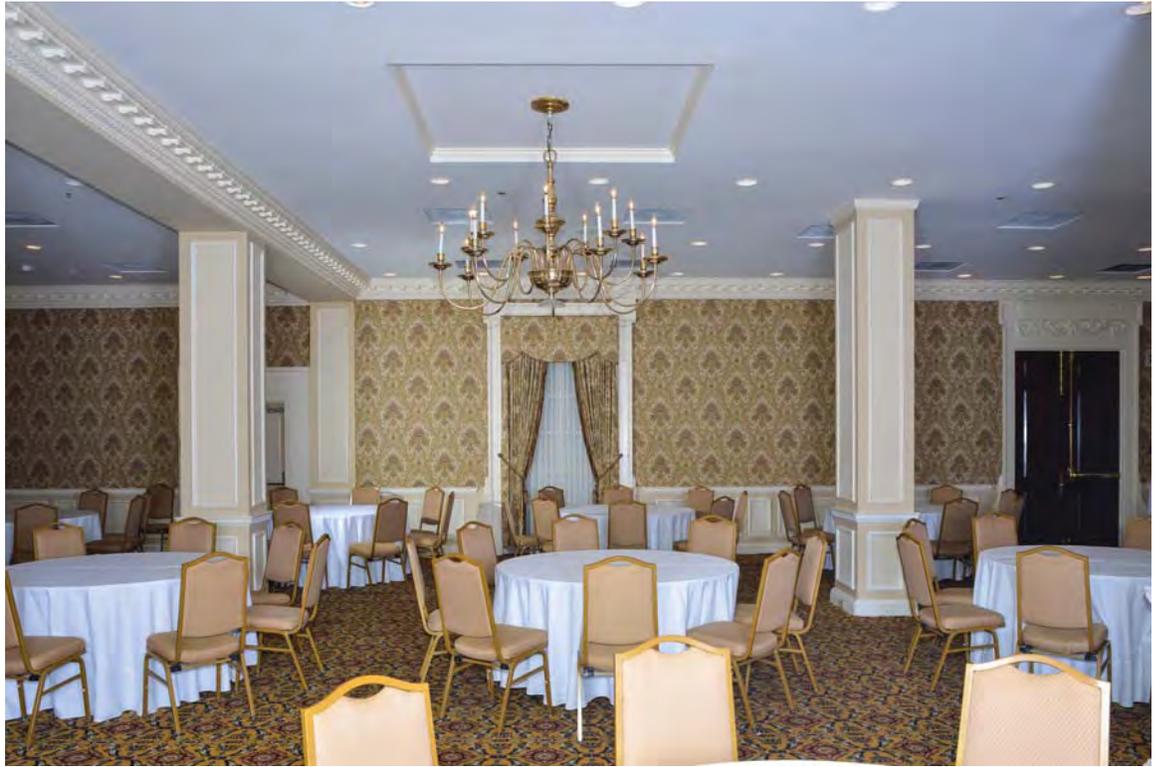
SAH-182

Name: Saint Anthony Hotel, 300 East Travis Street, San Antonio, Texas
View: First floor Georgian Room interior, looking north
Description: Wood wainscot, columns, beams, crown, wall fabric, chandelier & faux window
Date: September 2012

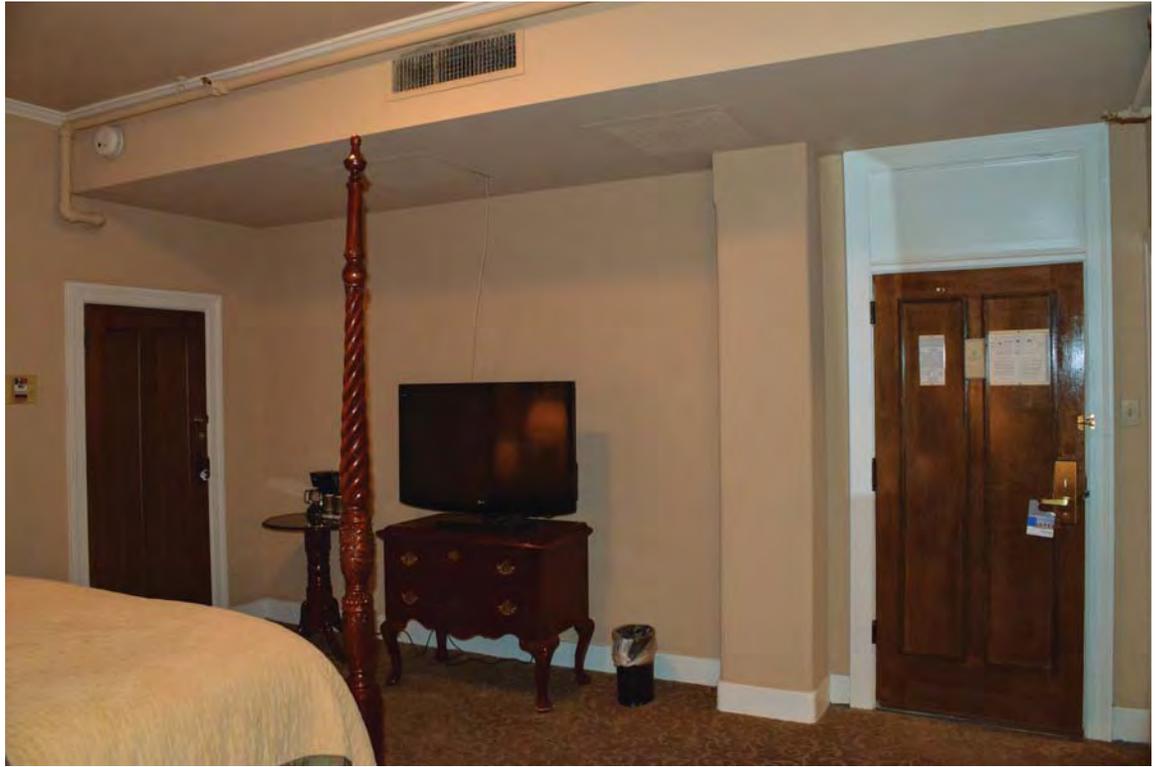
SAH-240

Name: Saint Anthony Hotel, 300 East Travis Street, San Antonio, Texas
View: Typical guest room with single king-sized bed
Description: Mechanical furr down & exposed sprinkler piping; entry door w/ transom panel
Date: September 2012

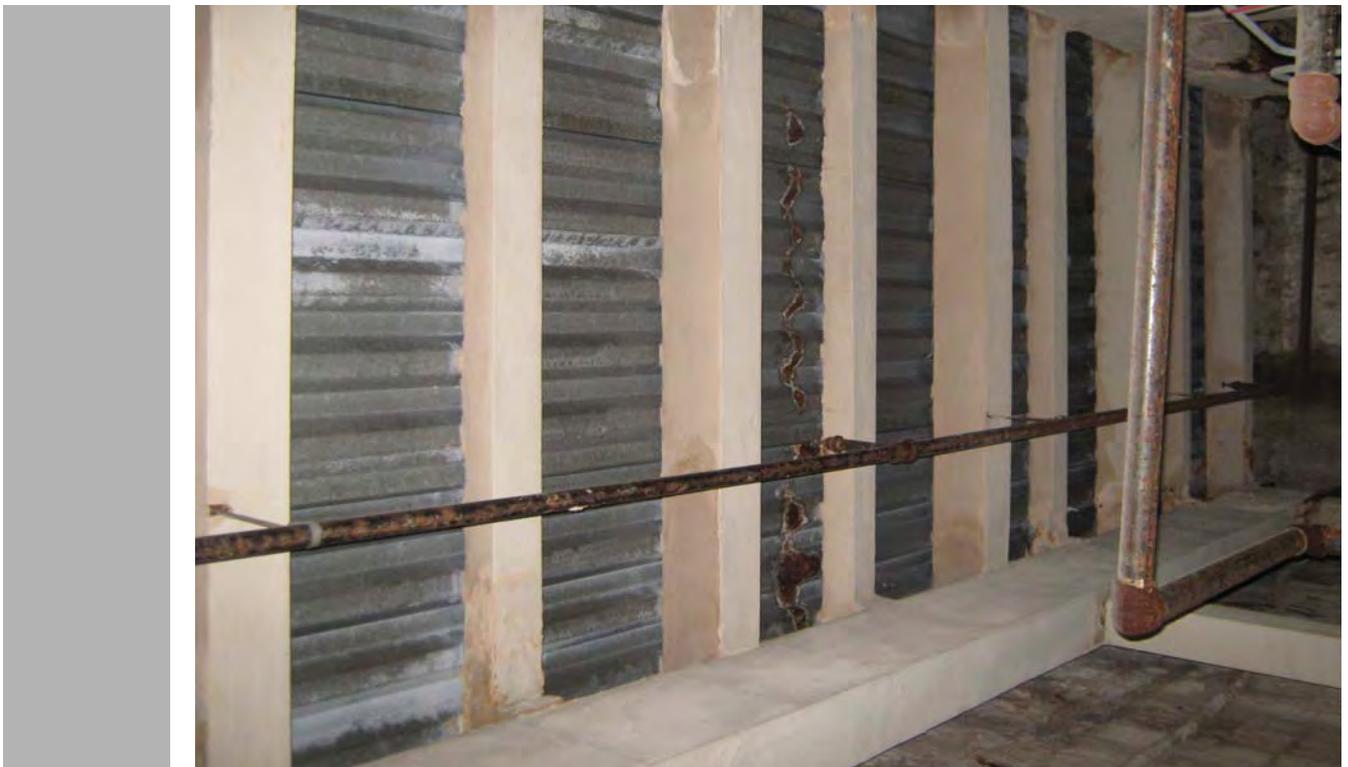
SAH-263

Name: Saint Anthony Hotel, 300 East Travis Street, San Antonio, Texas
View: Basement level mechanical room
Description: Concrete and metal decking to be removed for construction access
Date: September 2012

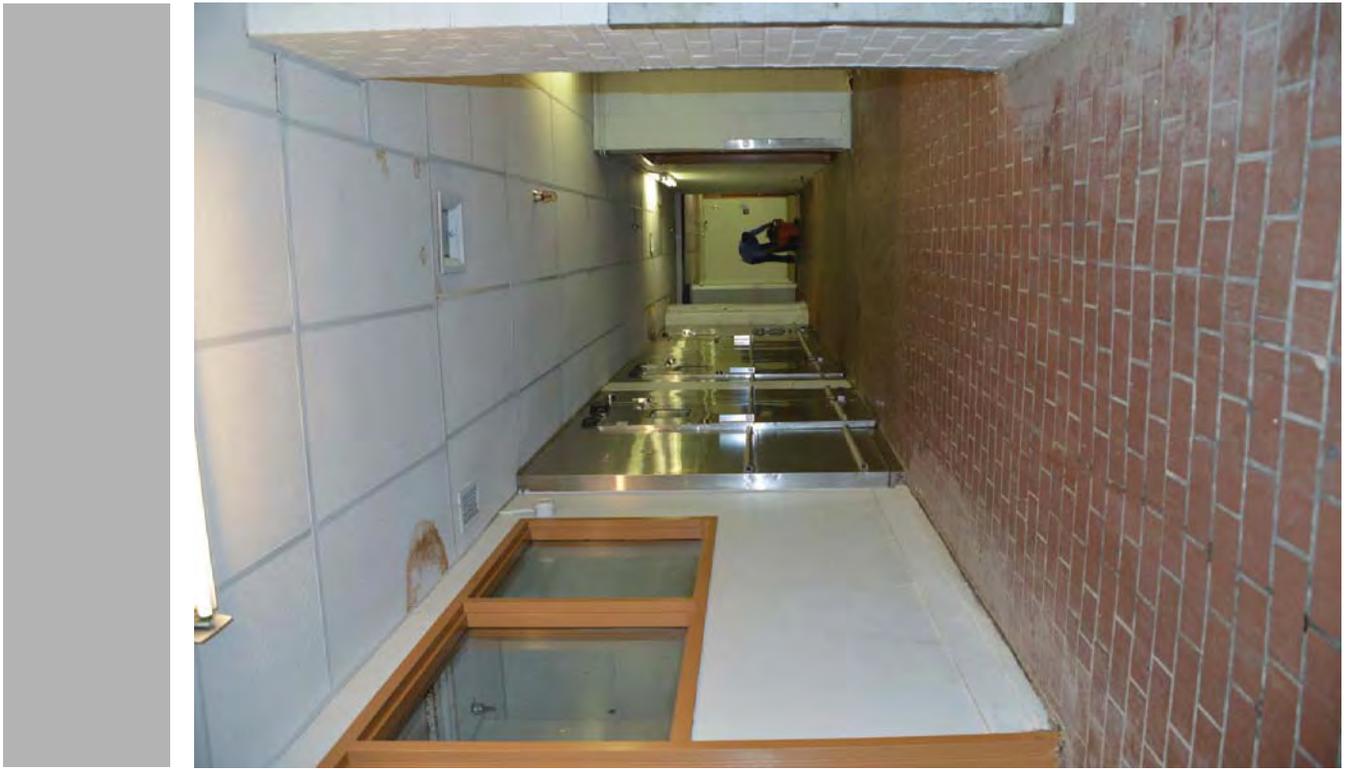
SAH-276

Name: Saint Anthony Hotel, 300 East Travis Street, San Antonio, Texas
View: Basement view of typical service corridor
Description: Non-historic, non-character-defining features to be renovated
Date: November 2012

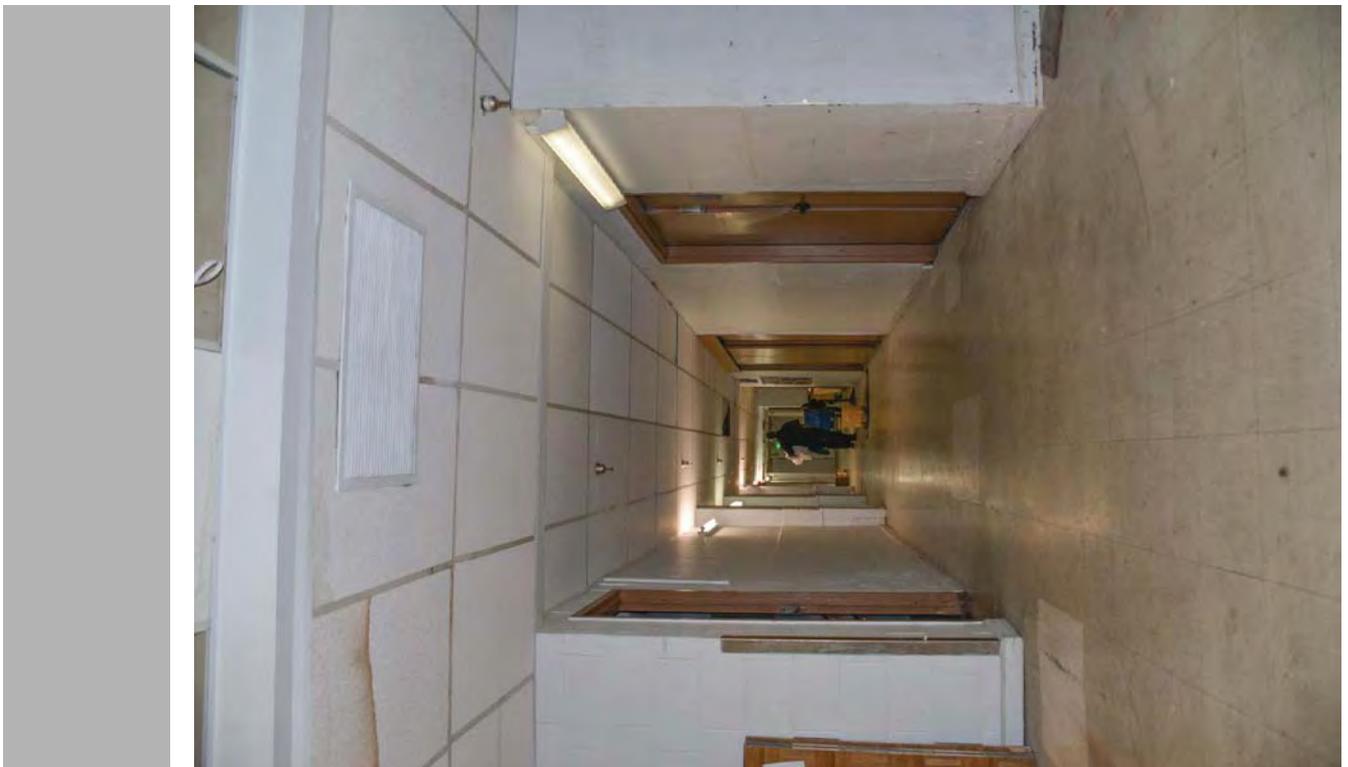
SAH-277

Name: Saint Anthony Hotel, 300 East Travis Street, San Antonio, Texas
View: Basement view of typical service corridor
Description: Non-historic, non-character-defining features to be renovated
Date: November 2012

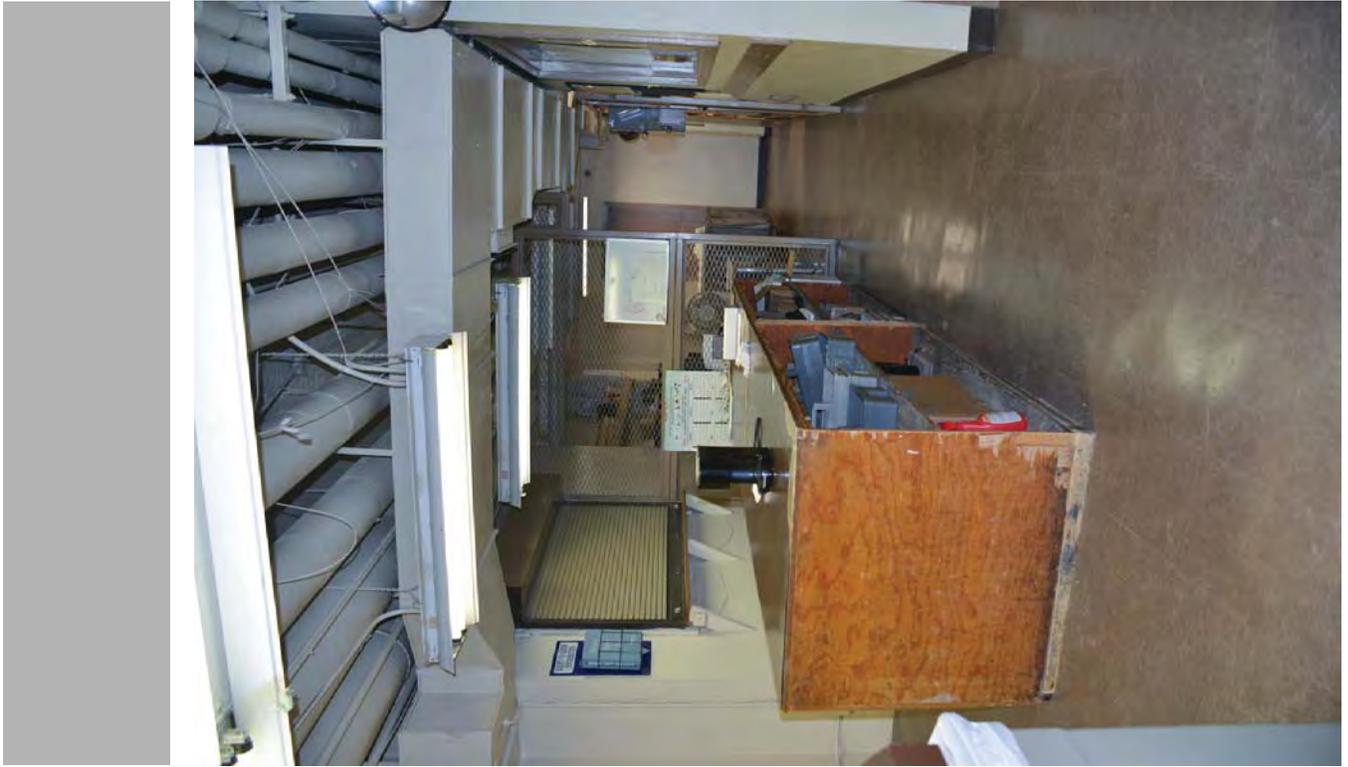
SAH-278

Name: Saint Anthony Hotel, 300 East Travis Street, San Antonio, Texas
View: Basement view of typical work area
Description: Non-historic, non-character-defining features to be renovated
Date: November 2012

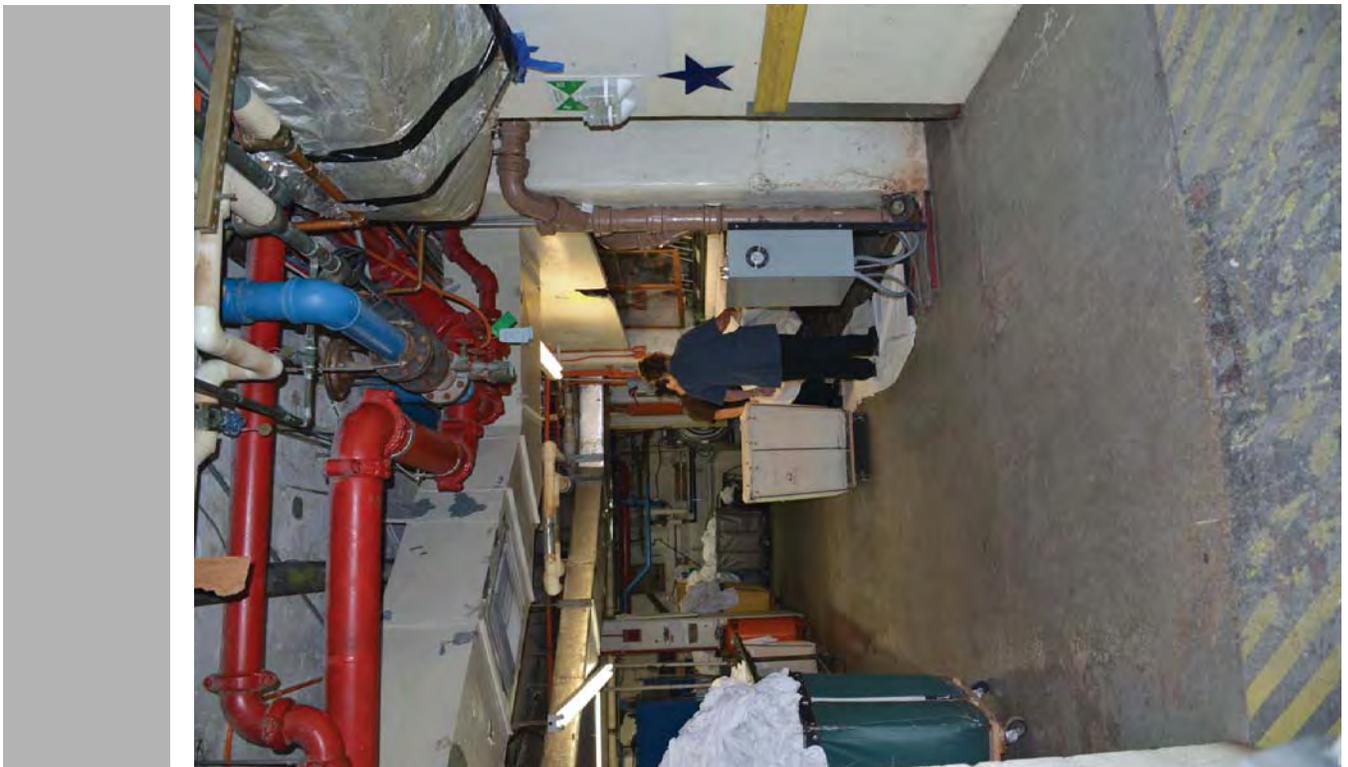
SAH-279

Name: Saint Anthony Hotel, 300 East Travis Street, San Antonio, Texas
View: Basement view of laundry facilities
Description: Non-historic, non-character-defining features to be renovated
Date: November 2012

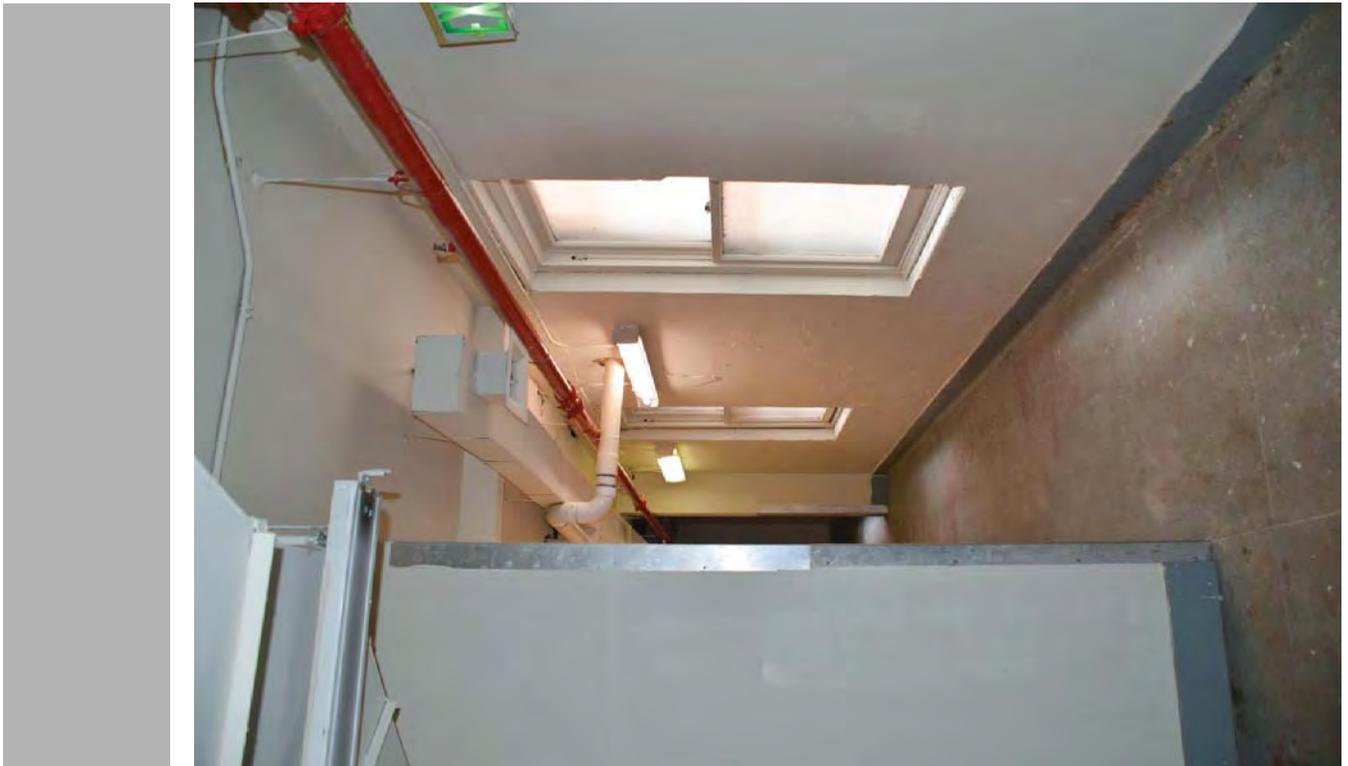
SAH-280

Name: Saint Anthony Hotel, 300 East Travis Street, San Antonio, Texas
View: View of typical back-of-house service corridor at Mezzanine Level
Description: Areas to receive routine maintenance, repairs & life safety upgrades
Date: November 2012

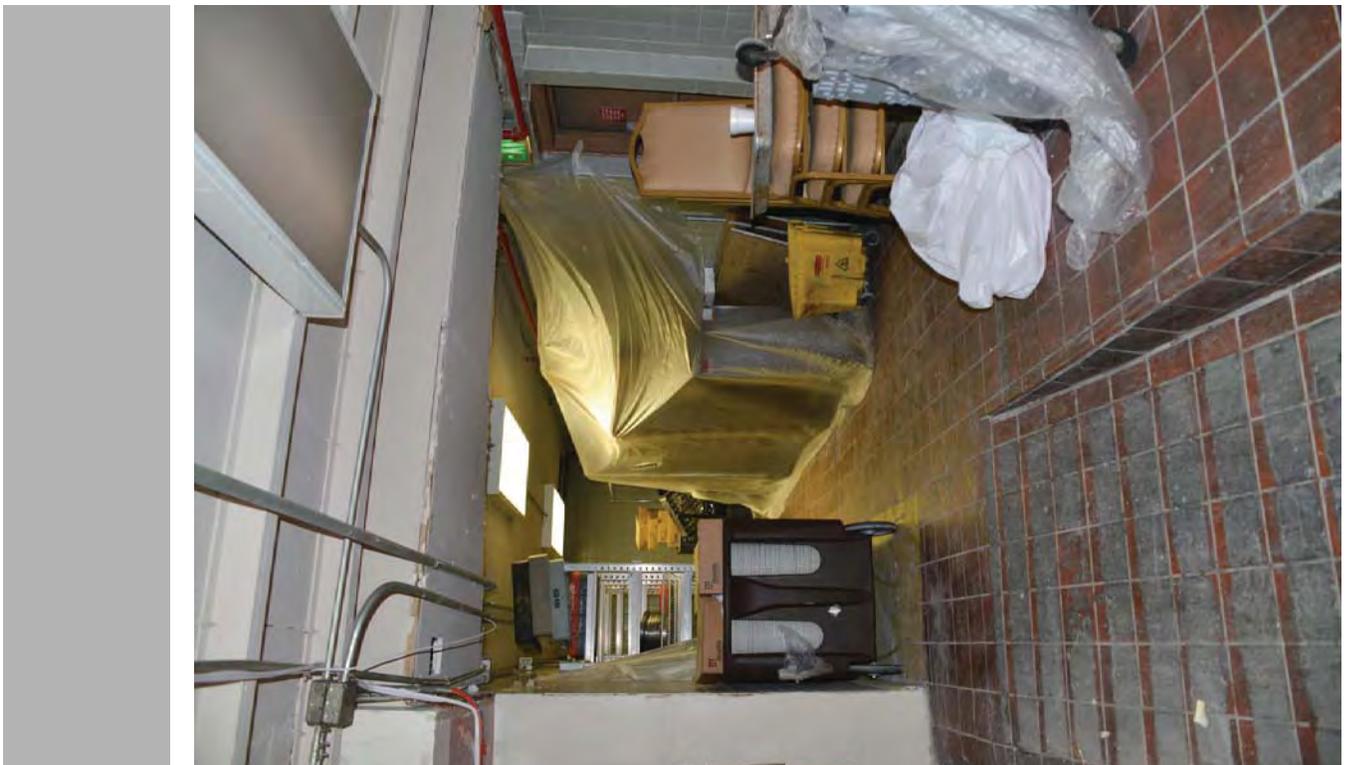
SAH-281

Name: Saint Anthony Hotel, 300 East Travis Street, San Antonio, Texas
View: View of typical back-of-house storage area at Mezzanine Level
Description: Areas to receive routine maintenance, repairs & life safety upgrades
Date: November 2012

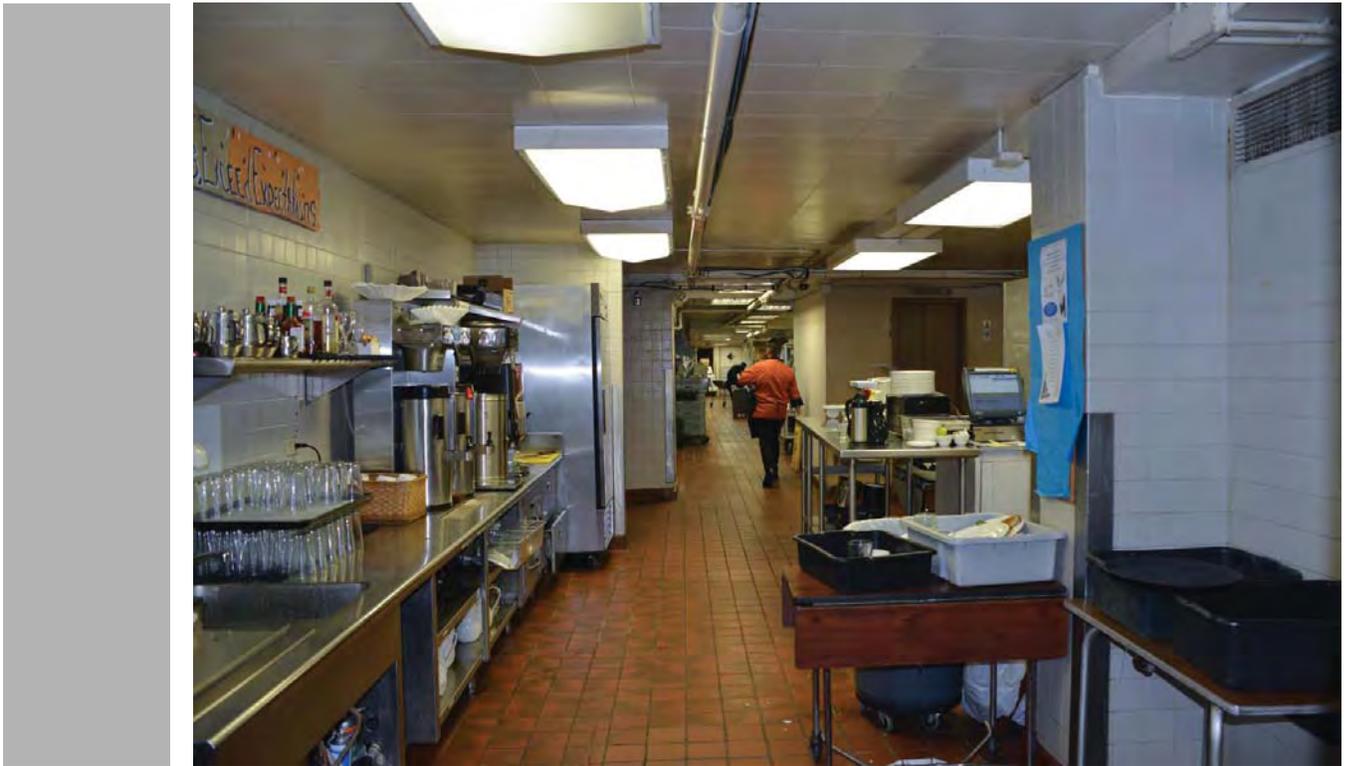
SAH-282

Name: Saint Anthony Hotel, 300 East Travis Street, San Antonio, Texas
View: Typical view of main kitchen looking east w/ non-historic finishes
Description: Kitchen to be renovated and modernized with new finishes and equipment
Date: November 2012

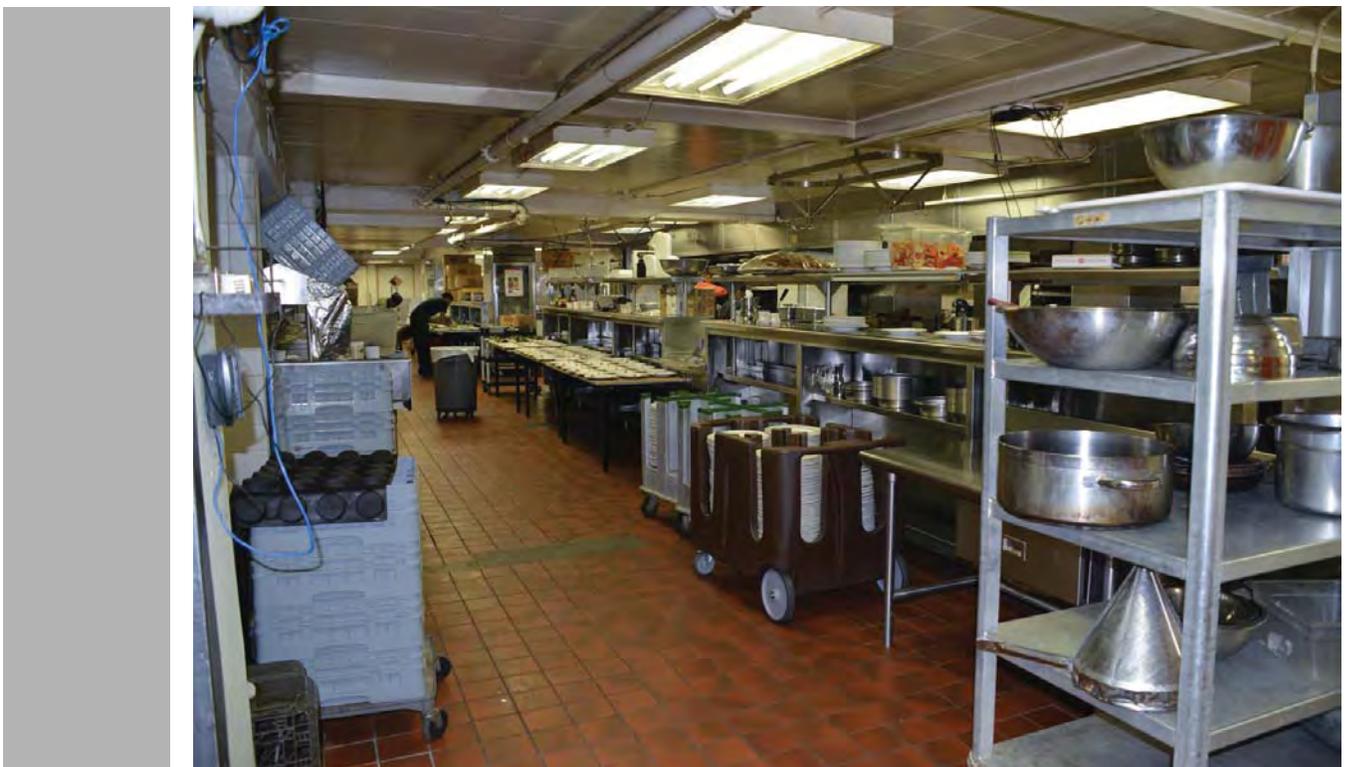
SAH-283

Name: Saint Anthony Hotel, 300 East Travis Street, San Antonio, Texas
View: Typical view of main kitchen looking east w/ non-historic finishes
Description: Kitchen to be renovated and modernized with new finishes and equipment
Date: November 2012

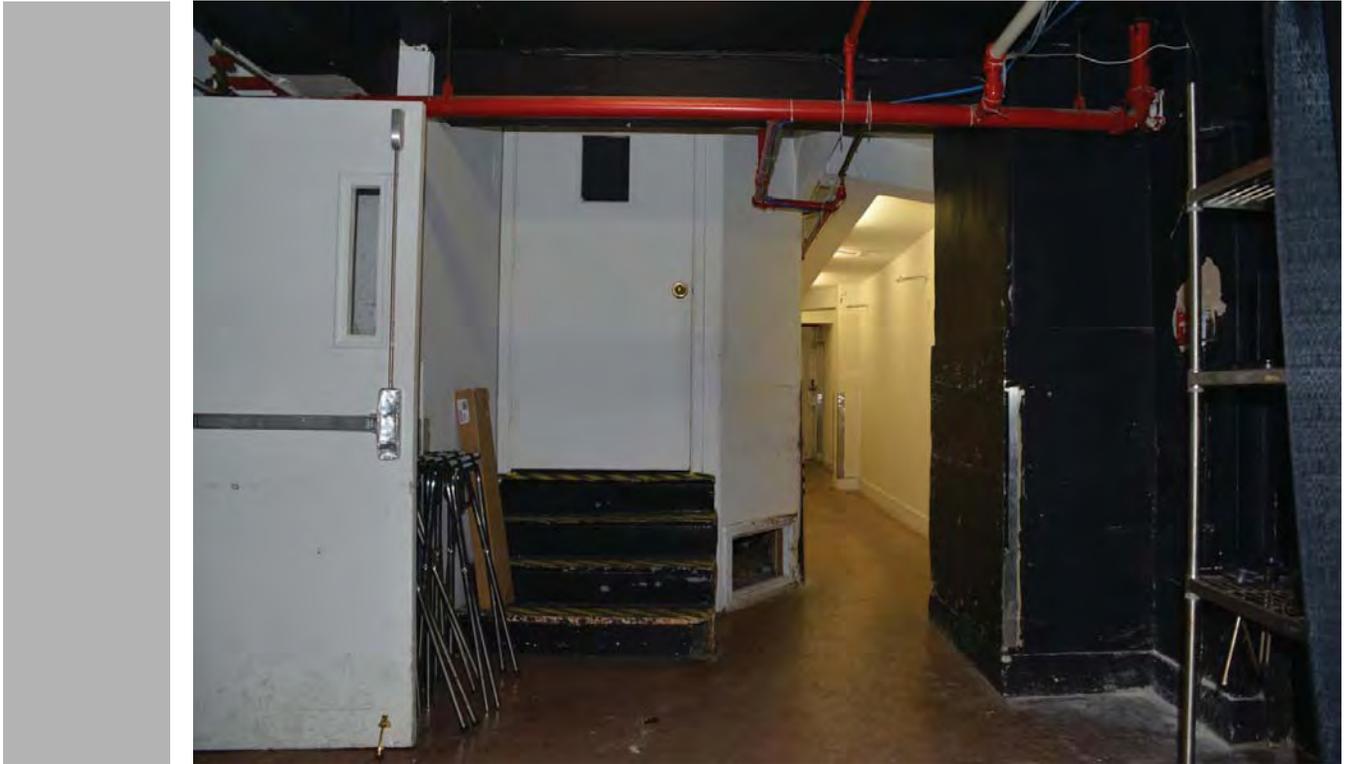
SAH-284

Name: Saint Anthony Hotel, 300 East Travis Street, San Antonio, Texas
View: Anacacho Room First Floor Level back stage area looking east
Description: Area to receive routine maintenance, repairs & life safety upgrades
Date: November 2012
