HISTORIC AND DESIGN REVIEW COMMISSION

HDRC CASE NO: 2016-016
ADDRESS: 304 E TRAVIS ST
LEGAL DESCRIPTION: NCB 415 BLK 18 LOT A-7, A- 8, A-9, P-100, P-101 & P-102
ZONING: D HE
CITY COUNCIL DIST.: 1
LANDMARK: St Anthony Hotel
APPLICANT: Brandon Raney
OWNER: BCL St. Anthony ML, LP
TYPE OF WORK: Tax Certification
REQUEST:

RE: St. Anthony Hotel Tax Certification Application

St. Anthony Hotel
Scope Summary of Exterior Rehabilitation

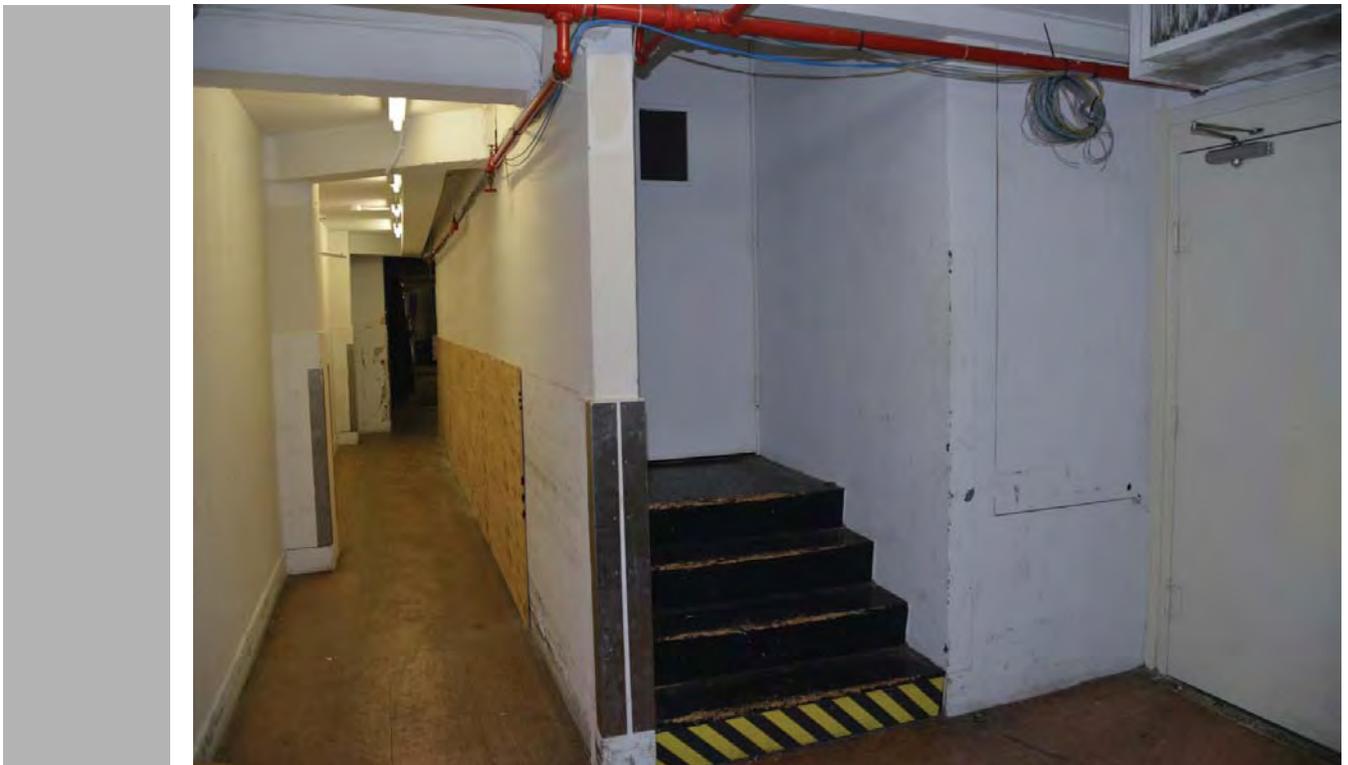
SAH-285

Name: Saint Anthony Hotel, 300 East Travis Street, San Antonio, Texas
View: Anacacho Room First Floor Level back stage area looking west
Description: Area to receive routine maintenance, repairs & life safety upgrades
Date: November 2012

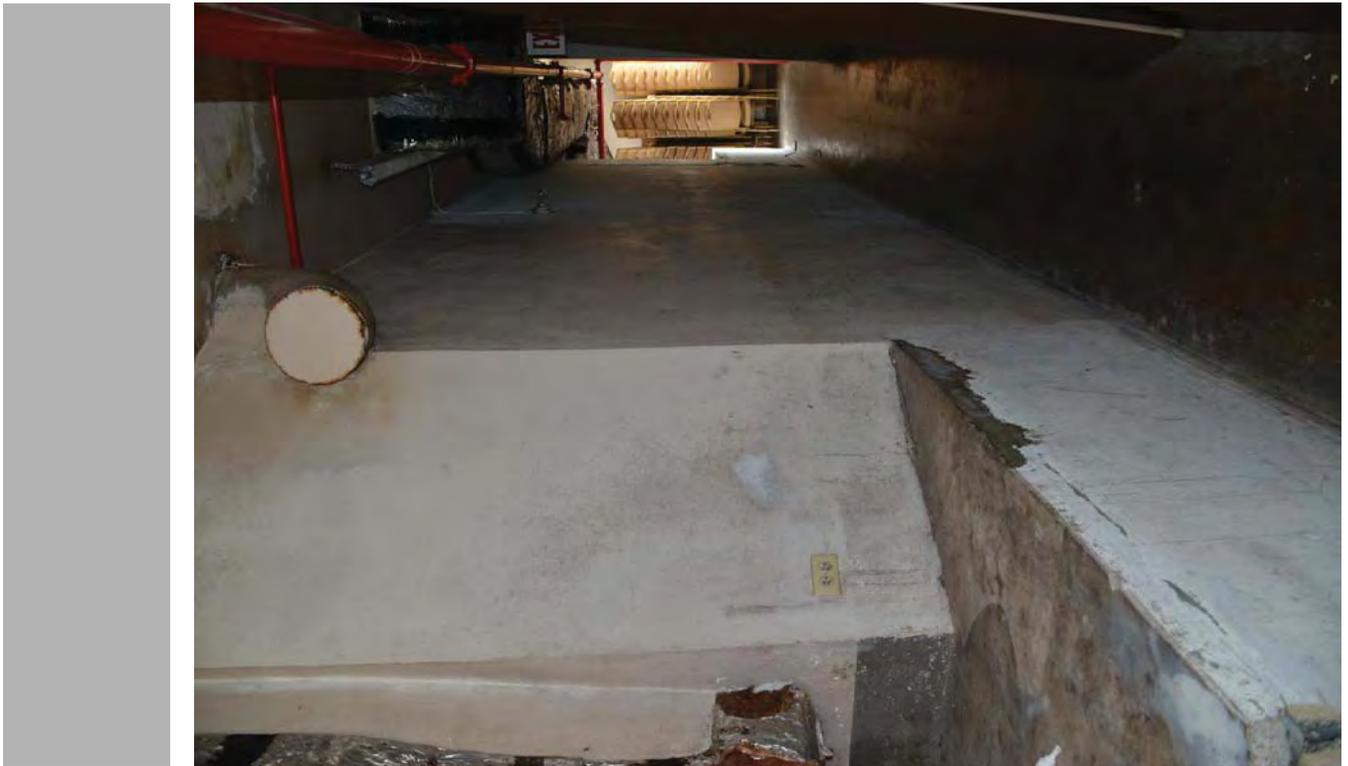
SAH-286

Name: Saint Anthony Hotel, 300 East Travis Street, San Antonio, Texas
View: Anacacho Room Mezzanine Level back stage area looking east
Description: Area to receive routine maintenance, repairs & life safety upgrades
Date: November 2012

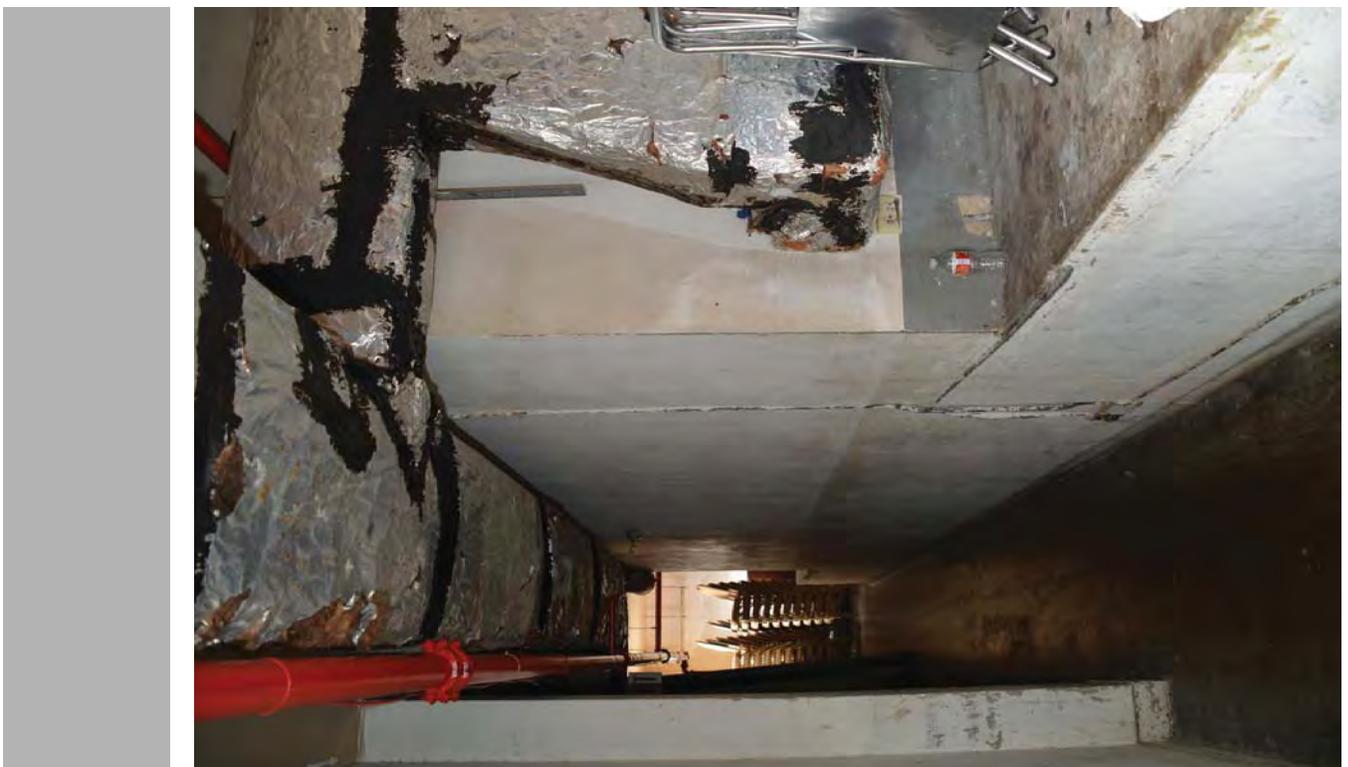
SAH-287

Name: Saint Anthony Hotel, 300 East Travis Street, San Antonio, Texas
View: Anacacho Room Mezzanine Level back stage area looking west
Description: Area to receive routine maintenance, repairs & life safety upgrades
Date: November 2012

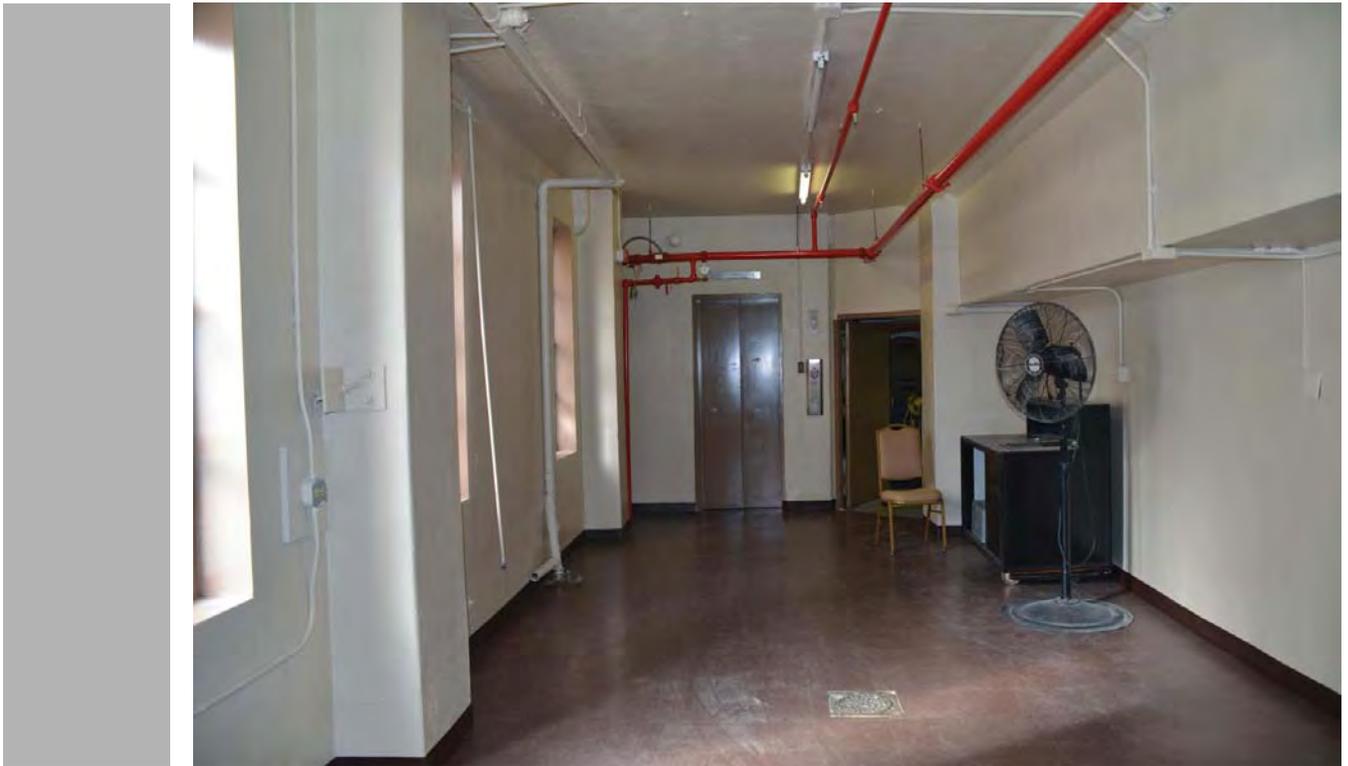
SAH-288

Name: Saint Anthony Hotel, 300 East Travis Street, San Antonio, Texas
View: Mezzanine Level typical back-of-house space looking west toward elevator
Description: Area to receive routine maintenance, repairs & life safety upgrades
Date: November 2012

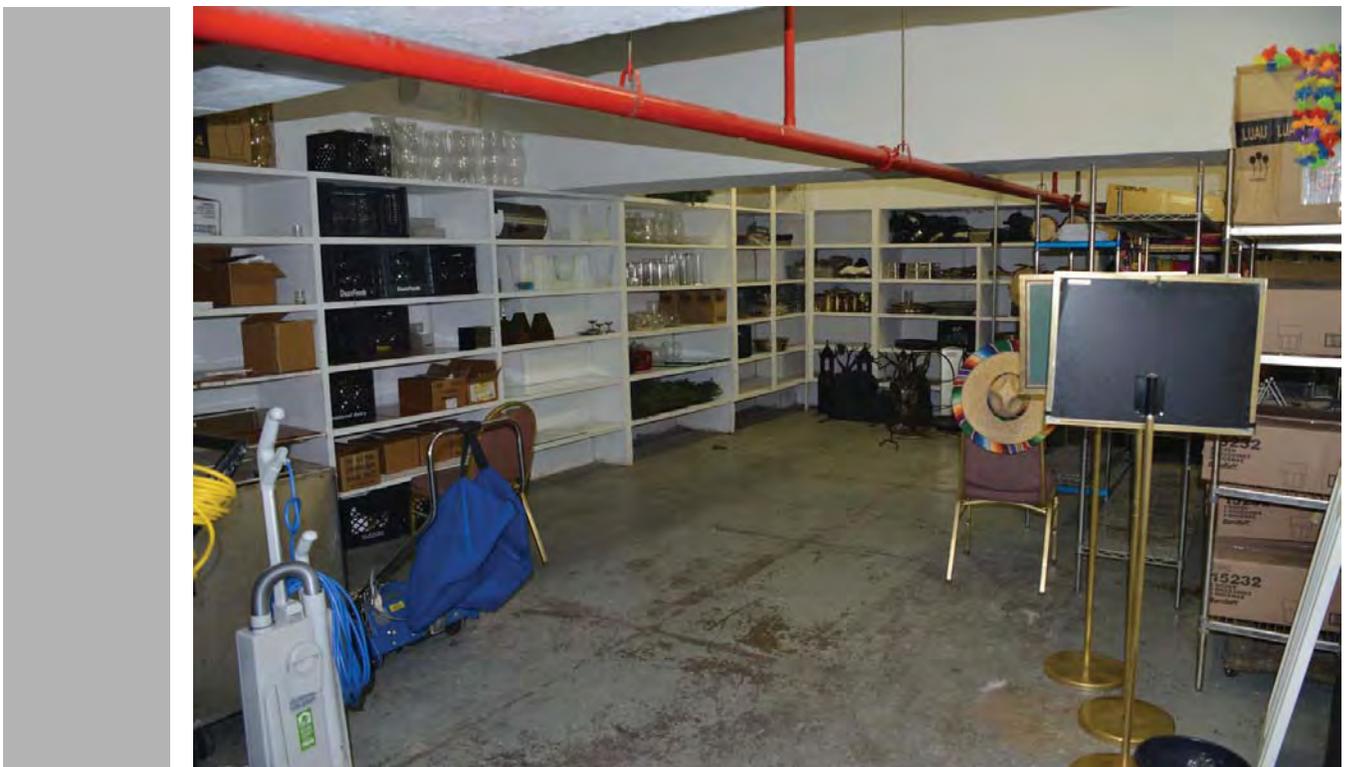
SAH-289

Name: Saint Anthony Hotel, 300 East Travis Street, San Antonio, Texas
View: Mezzanine Level back-of-house storage space looking southwest
Description: Area to receive routine maintenance, repairs & life safety upgrades
Date: November 2012

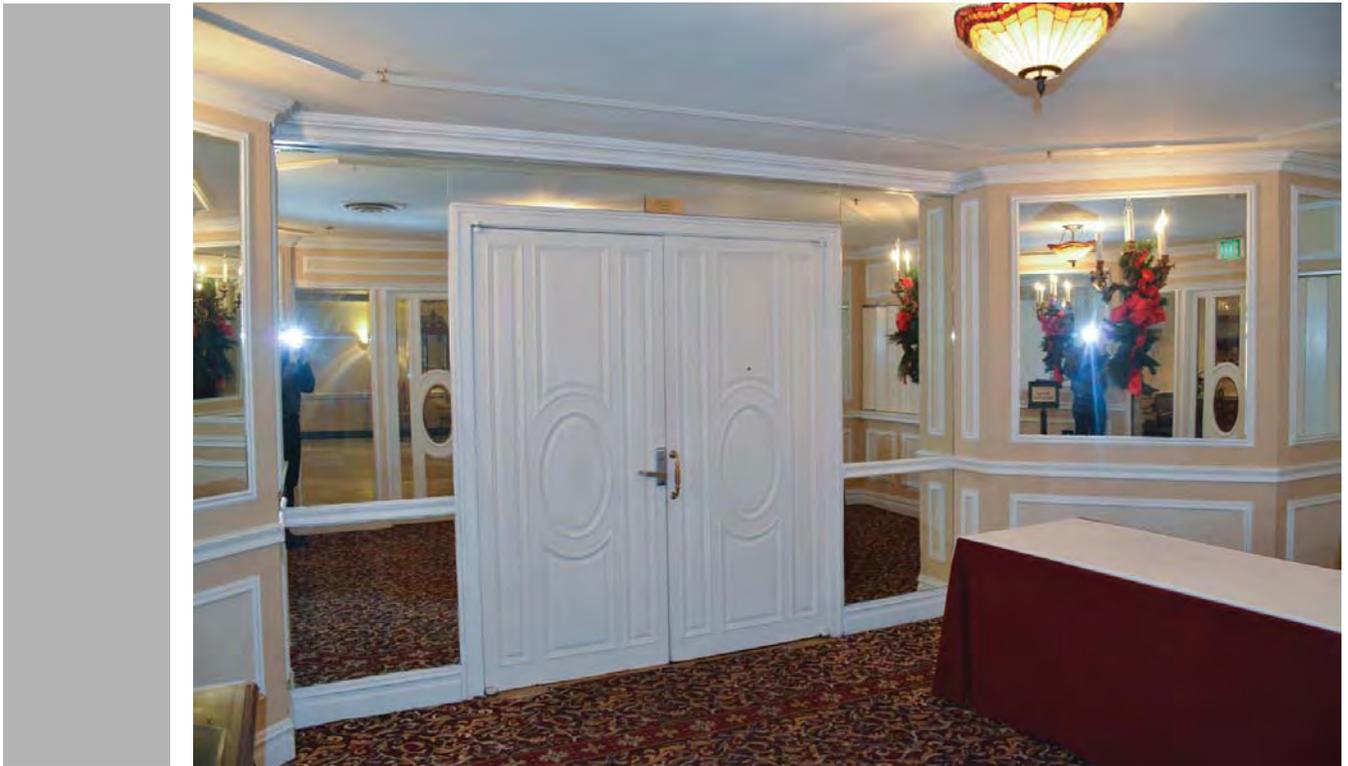
SAH-290

Name: Saint Anthony Hotel, 300 East Travis Street, San Antonio, Texas
View: First Floor Anacacho Pre-function Vestibule, looking southwest
Description: Non-historic (1983) vestibule space to be reconfigured with Motor Lobby
Date: November 2012

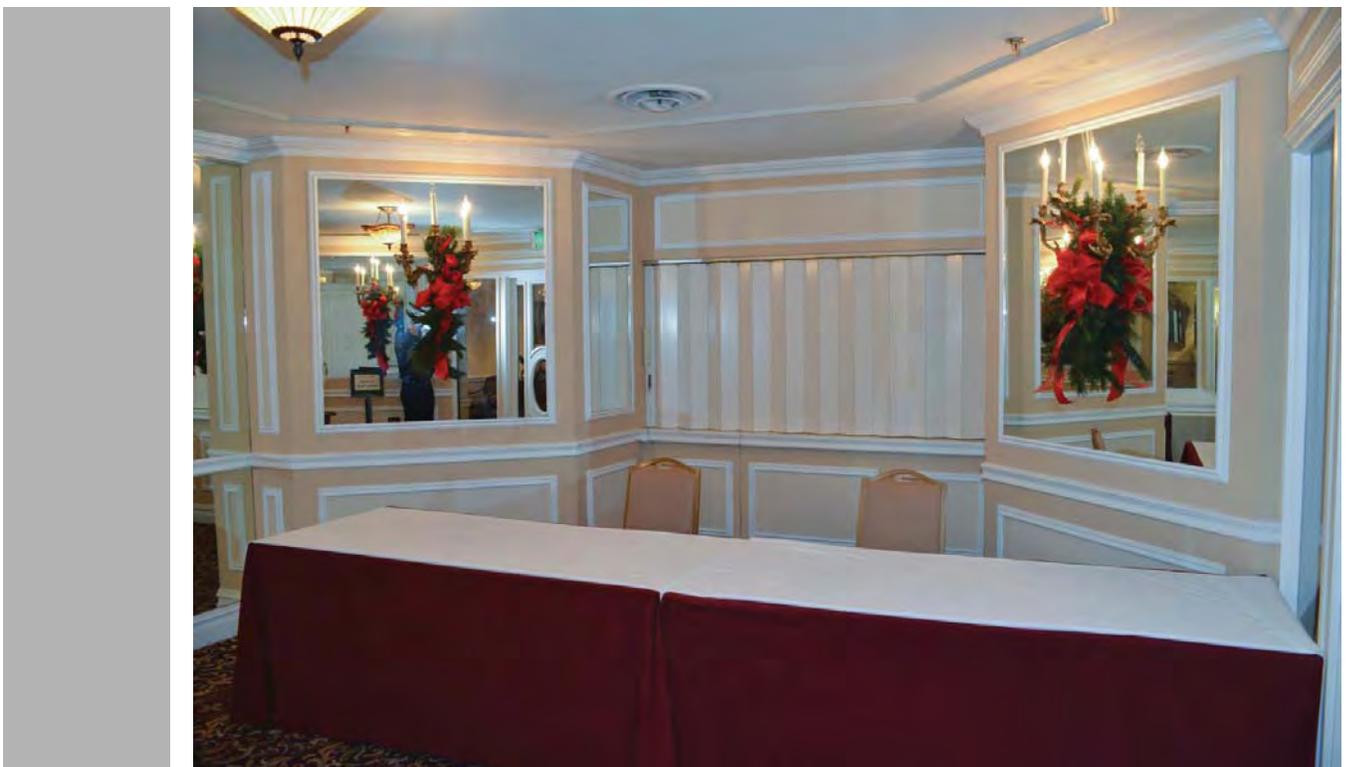
SAH-291

Name: Saint Anthony Hotel, 300 East Travis Street, San Antonio, Texas
View: First Floor Anacacho Pre-function Vestibule, looking west
Description: Non-historic (1983) coat check to be demolished to re-create corridor
Date: November 2012

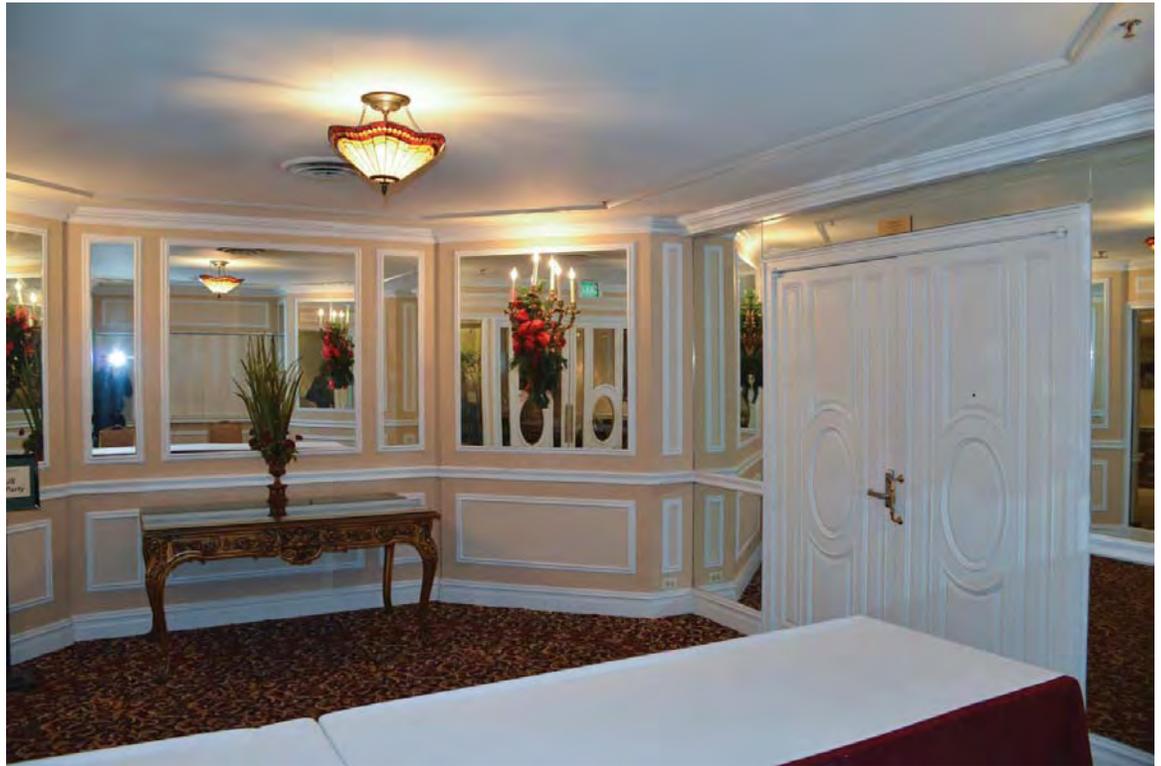
SAH-292

Name: Saint Anthony Hotel, 300 East Travis Street, San Antonio, Texas
View: First Floor Anacacho Pre-function Vestibule, looking east southeast
Description: Non-historic (1983) vestibule space to be reconfigured with Motor Lobby
Date: November 2012

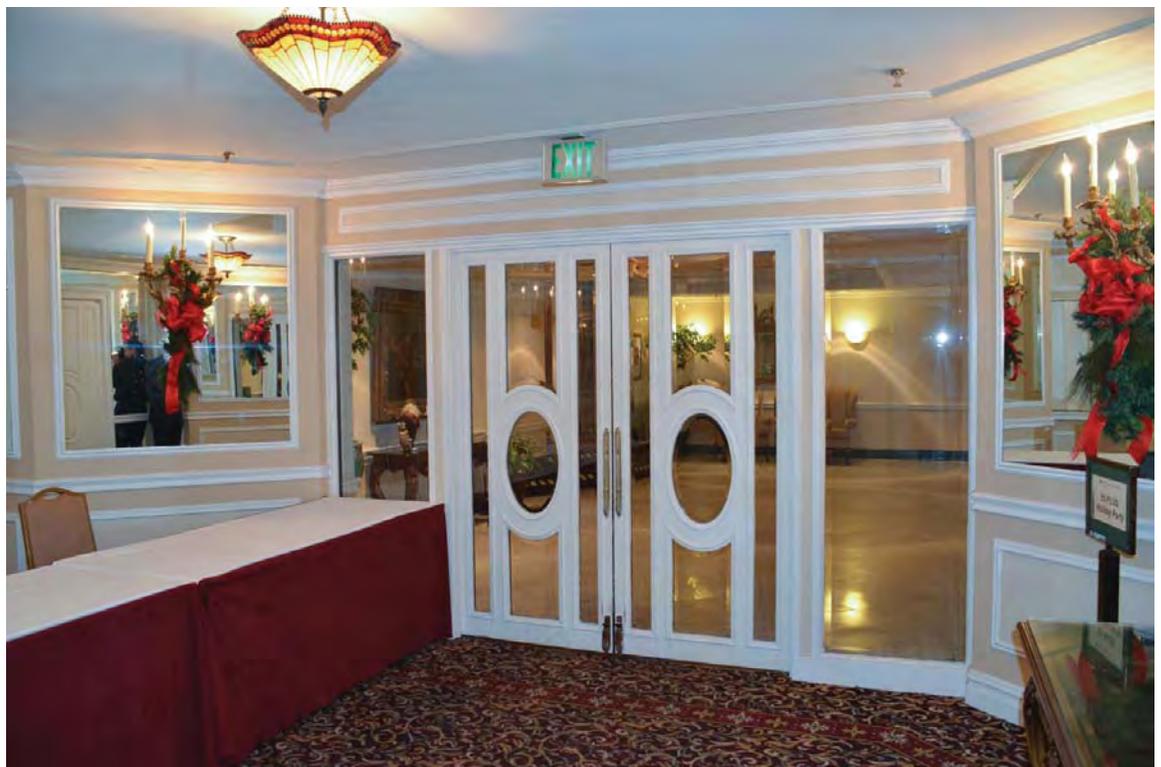
SAH-293

Name: Saint Anthony Hotel, 300 East Travis Street, San Antonio, Texas
View: First Floor Anacacho Pre-function Vestibule, looking north toward Motor Lobby
Description: Non-historic (1983) vestibule space to be reconfigured with Motor Lobby
Date: November 2012

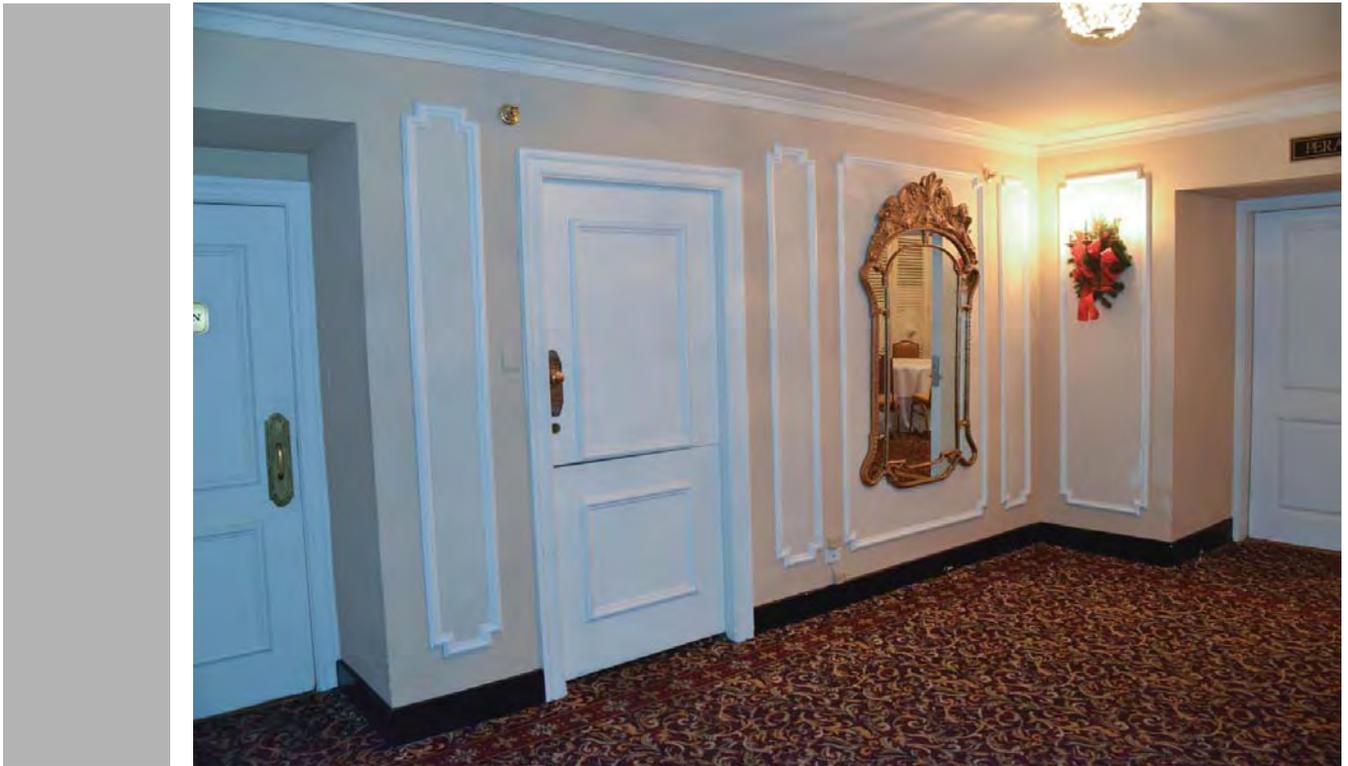
SAH-294

Name: Saint Anthony Hotel, 300 East Travis Street, San Antonio, Texas
View: First Floor Peraux Pre-function Vestibule, looking southeast at coat check door
Description: Non-historic (mid-1960s, 1983) walls and finishes to be removed & renovated
Date: November 2012

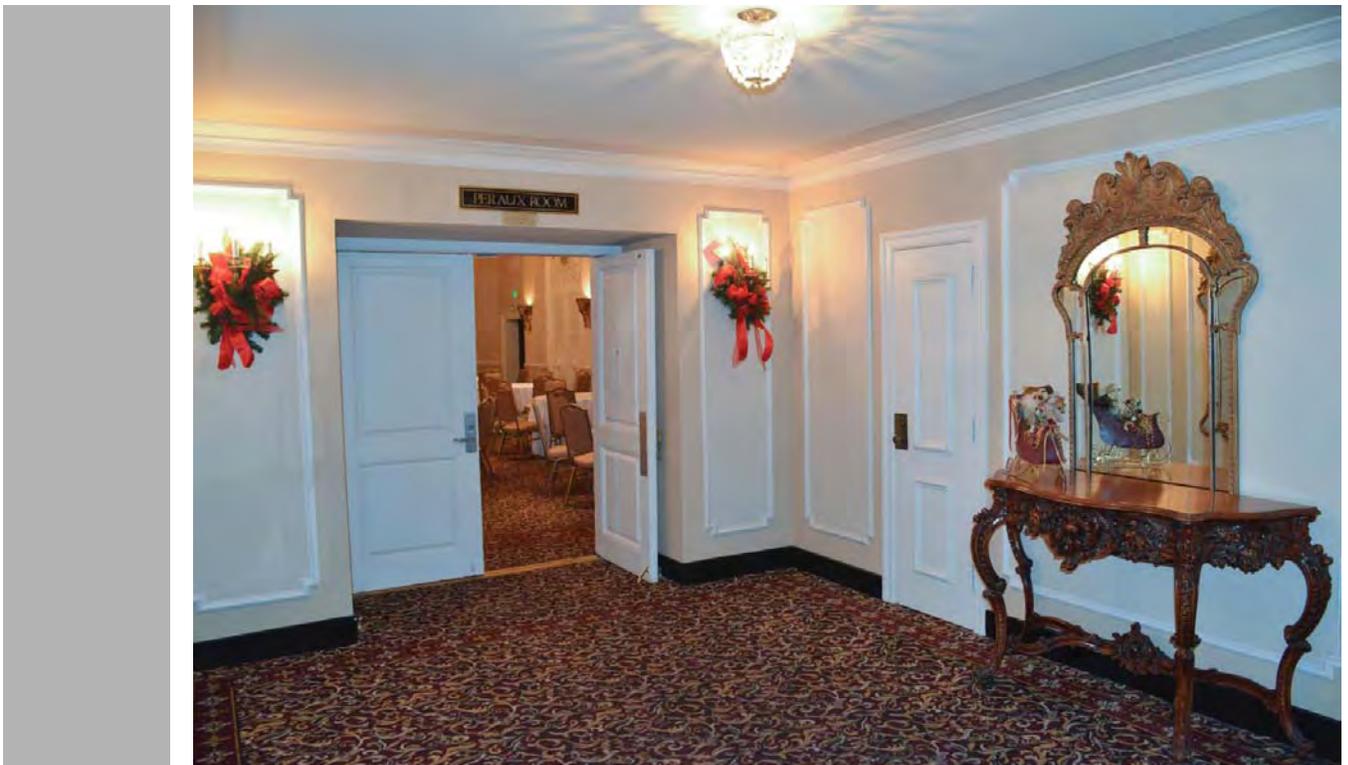
SAH-295

Name: Saint Anthony Hotel, 300 East Travis Street, San Antonio, Texas
View: First Floor Peraux Pre-function Vestibule, looking south at Peraux Room entry
Description: Non-historic (mid-1960s, 1983) walls and finishes to be removed & renovated
Date: November 2012

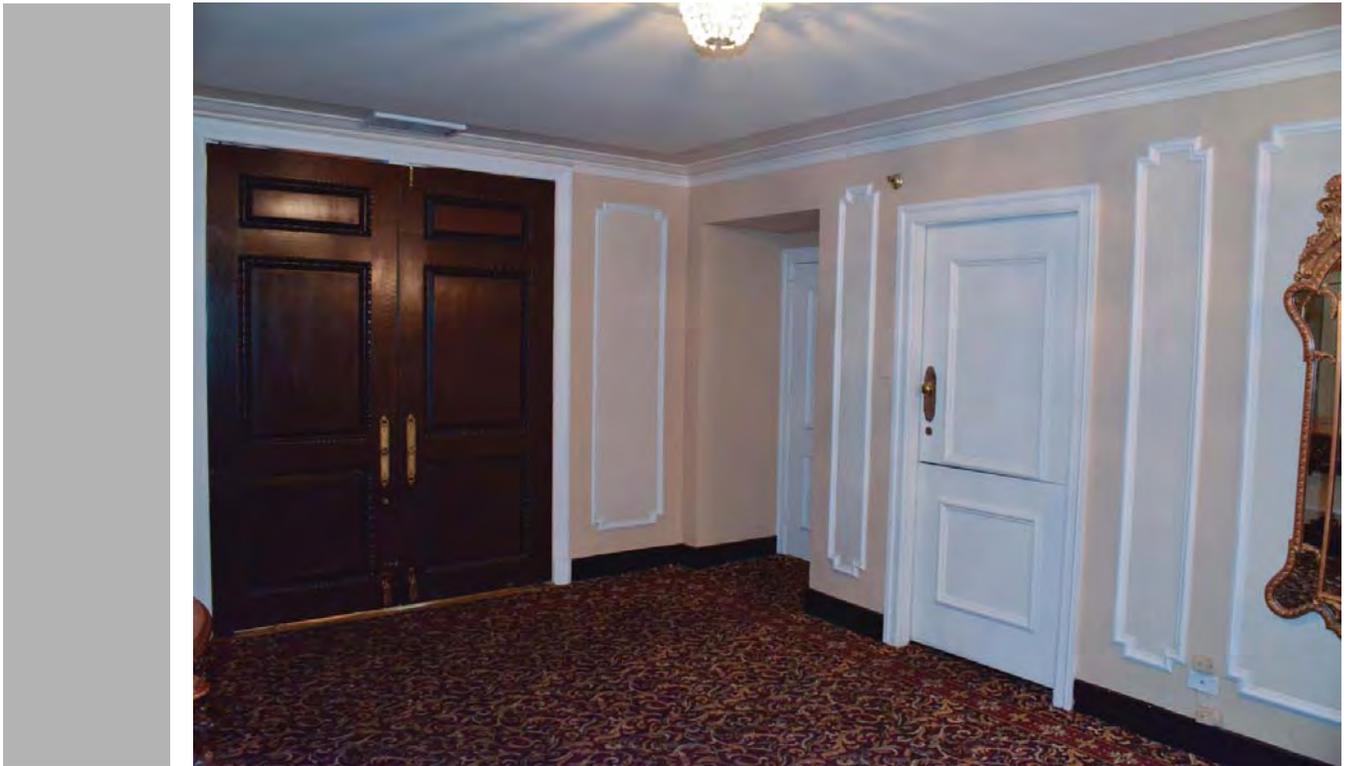
SAH-296

Name: Saint Anthony Hotel, 300 East Travis Street, San Antonio, Texas
View: First Floor Peraux Pre-function Vestibule, looking northeast
Description: Non-historic (mid-1960s, 1983) walls and finishes to be removed & renovated
Date: November 2012

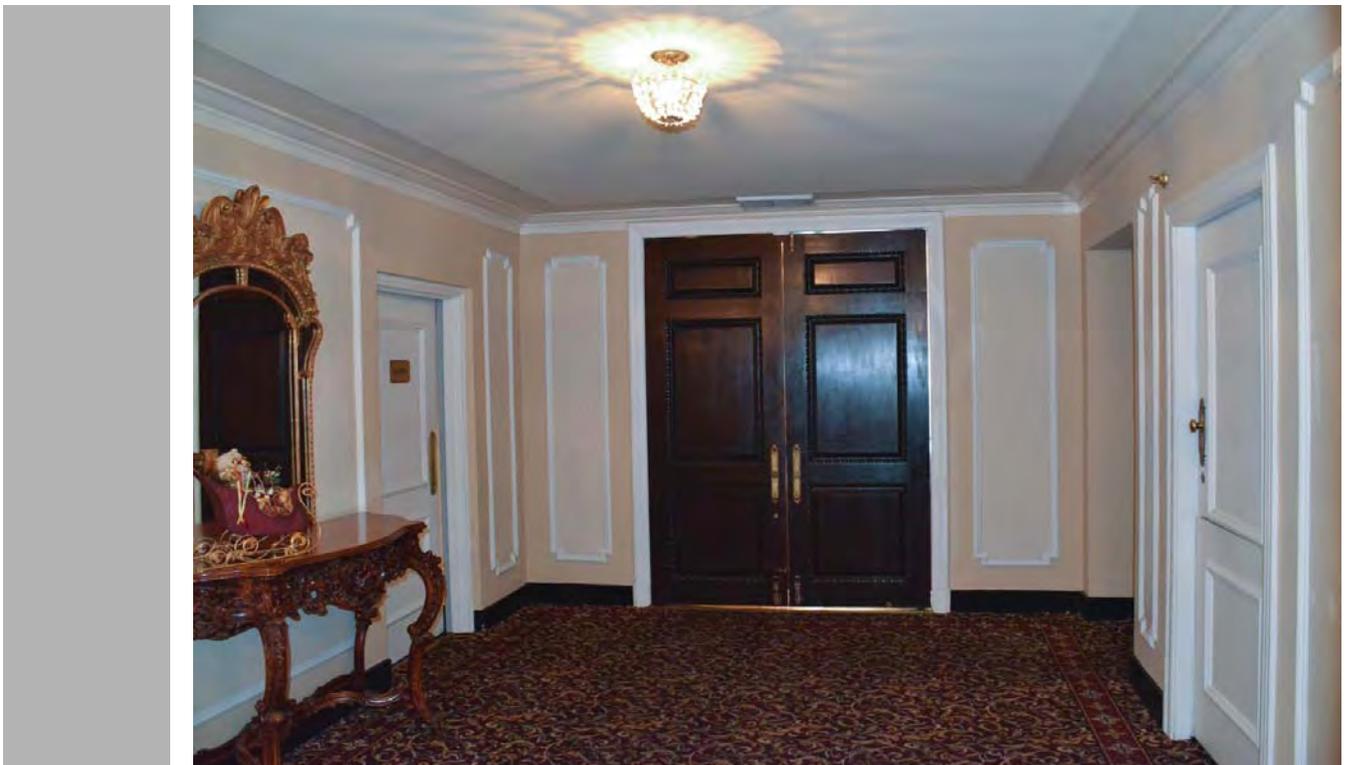
SAH-297

Name: Saint Anthony Hotel, 300 East Travis Street, San Antonio, Texas
View: First Floor Peraux Pre-function Vestibule, looking north at Peacock Alley door
Description: Historic door to remain *in situ*, non-historic finishes renovated
Date: November 2012

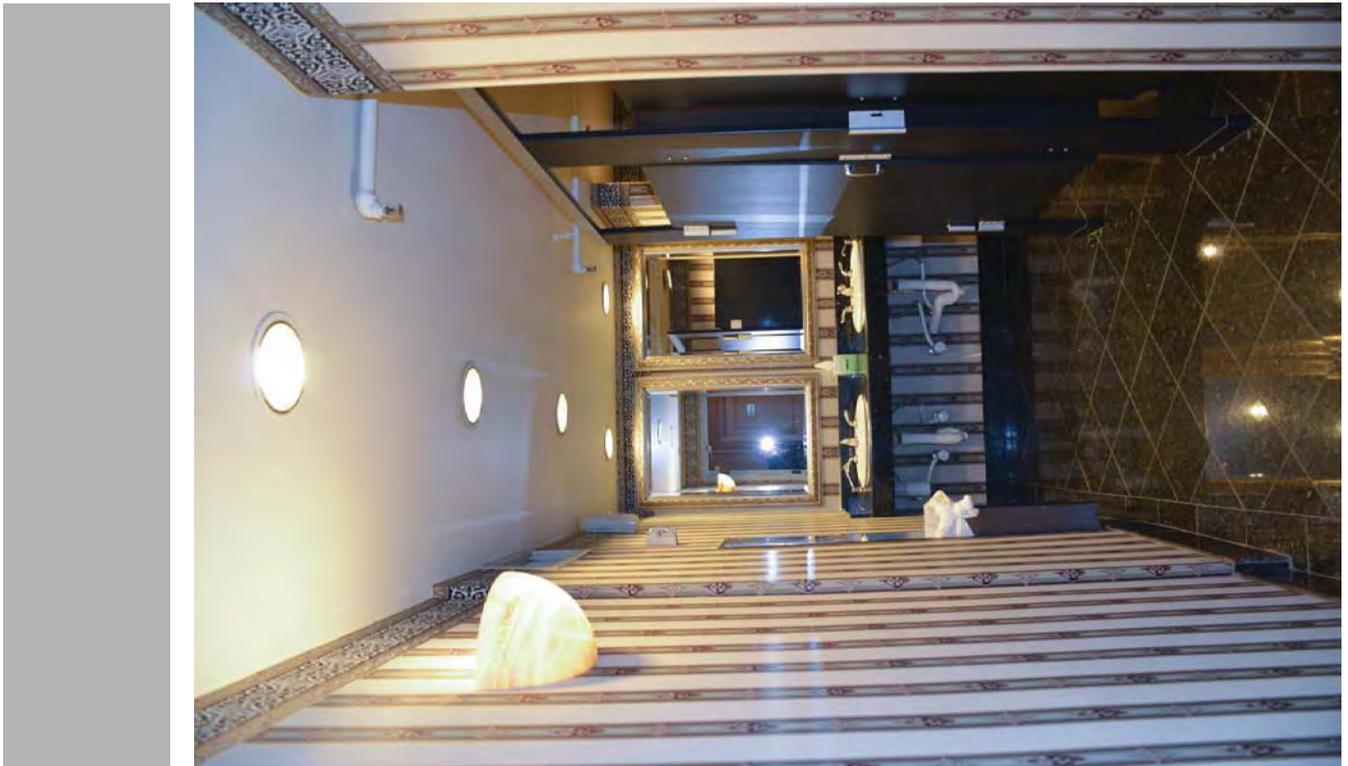
SAH-298

Name: Saint Anthony Hotel, 300 East Travis Street, San Antonio, Texas
View: First Floor Peraux Pre-function Mens Restroom, looking east
Description: Non-historic (mid-1960s, 1983) walls, finishes & fixtures to be removed
Date: November 2012

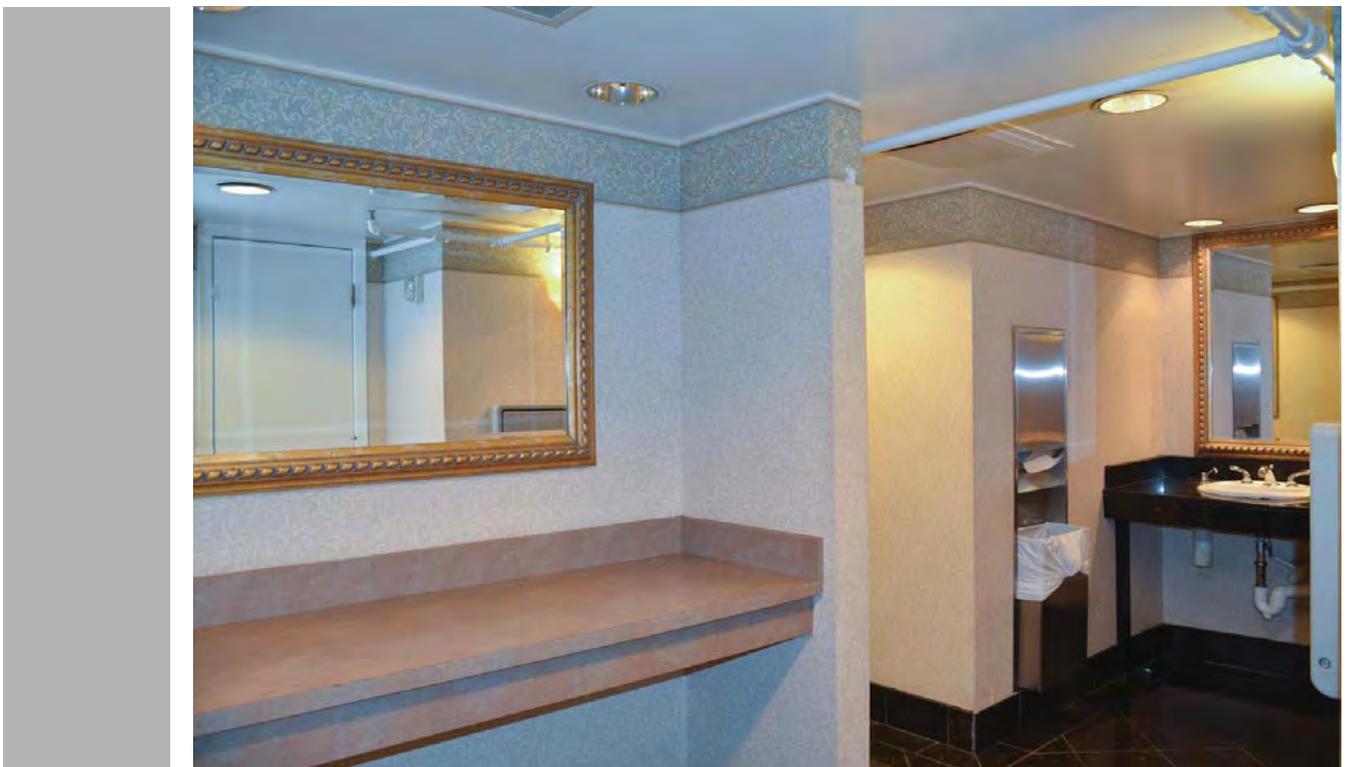
SAH-299

Name: Saint Anthony Hotel, 300 East Travis Street, San Antonio, Texas
View: First Floor Peraux Pre-function Womens Restroom, looking southwest
Description: Non-historic (mid-1960s, 1983) walls, finishes & fixtures to be removed
Date: November 2012

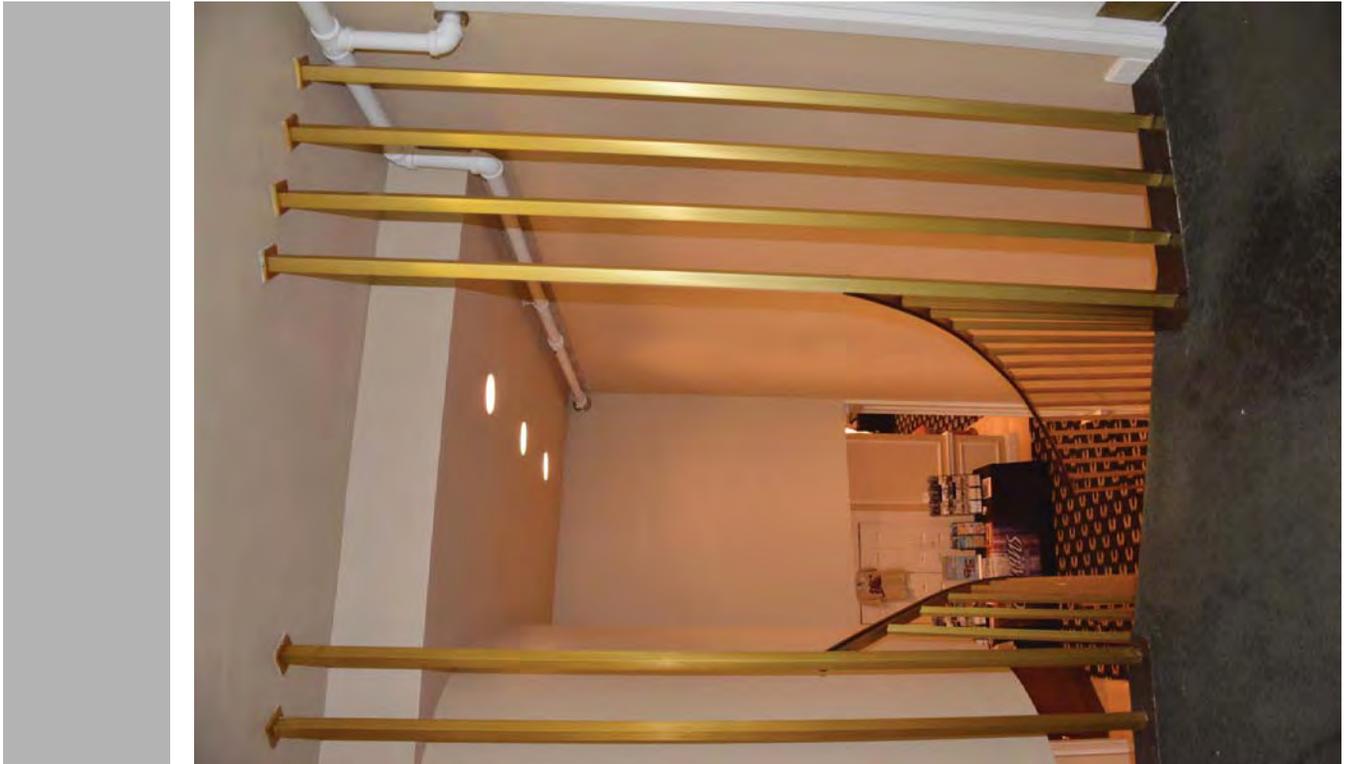
SAH-300

Name: Saint Anthony Hotel, 300 East Travis Street, San Antonio, Texas
View: Mezzanine Level above Peraux Pre-function, looking at St. Anthony Bar Vestibule
Description: Non-historic (1983, 2000) finishes to be removed & partial demolition of floor slab
Date: November 2012

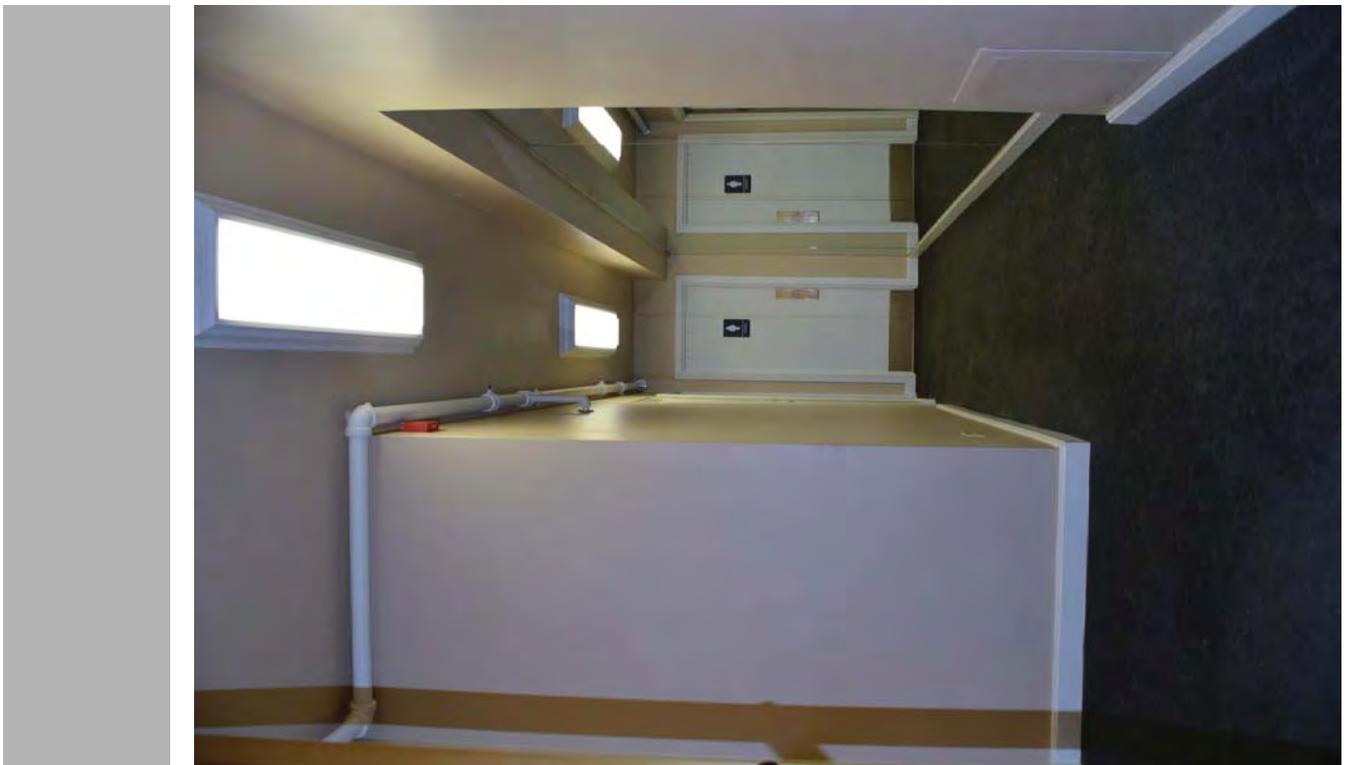
SAH-301

Name: Saint Anthony Hotel, 300 East Travis Street, San Antonio, Texas
View: Mezzanine Level above Peraux Pre-function, looking at Womens Restroom door
Description: Non-historic (1983, 2000) walls, finishes & fixtures to be removed
Date: November 2012

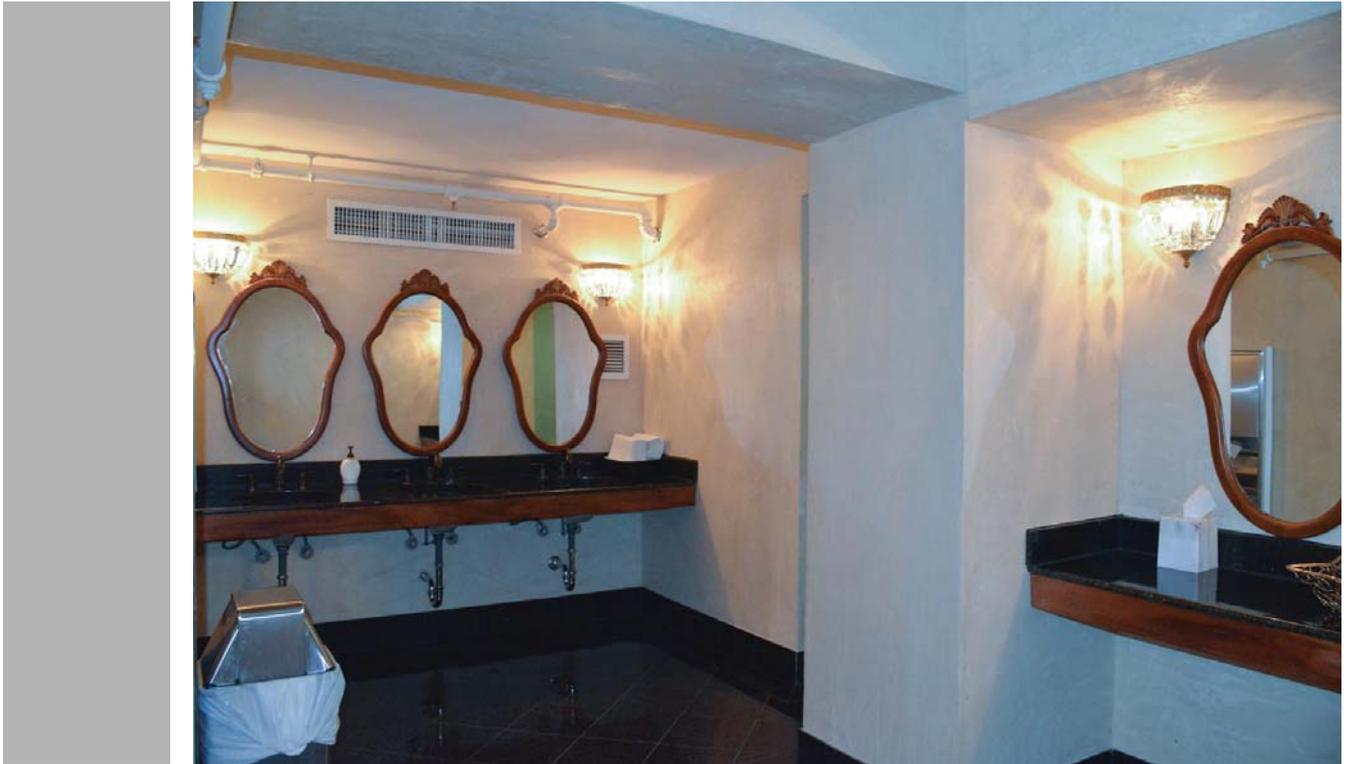
SAH-302

Name: Saint Anthony Hotel, 300 East Travis Street, San Antonio, Texas
View: Mezzanine Level above Peraux Pre-function, looking at Womens Restroom
Description: Non-historic (1983, 2000) walls, finishes & fixtures to be removed
Date: November 2012

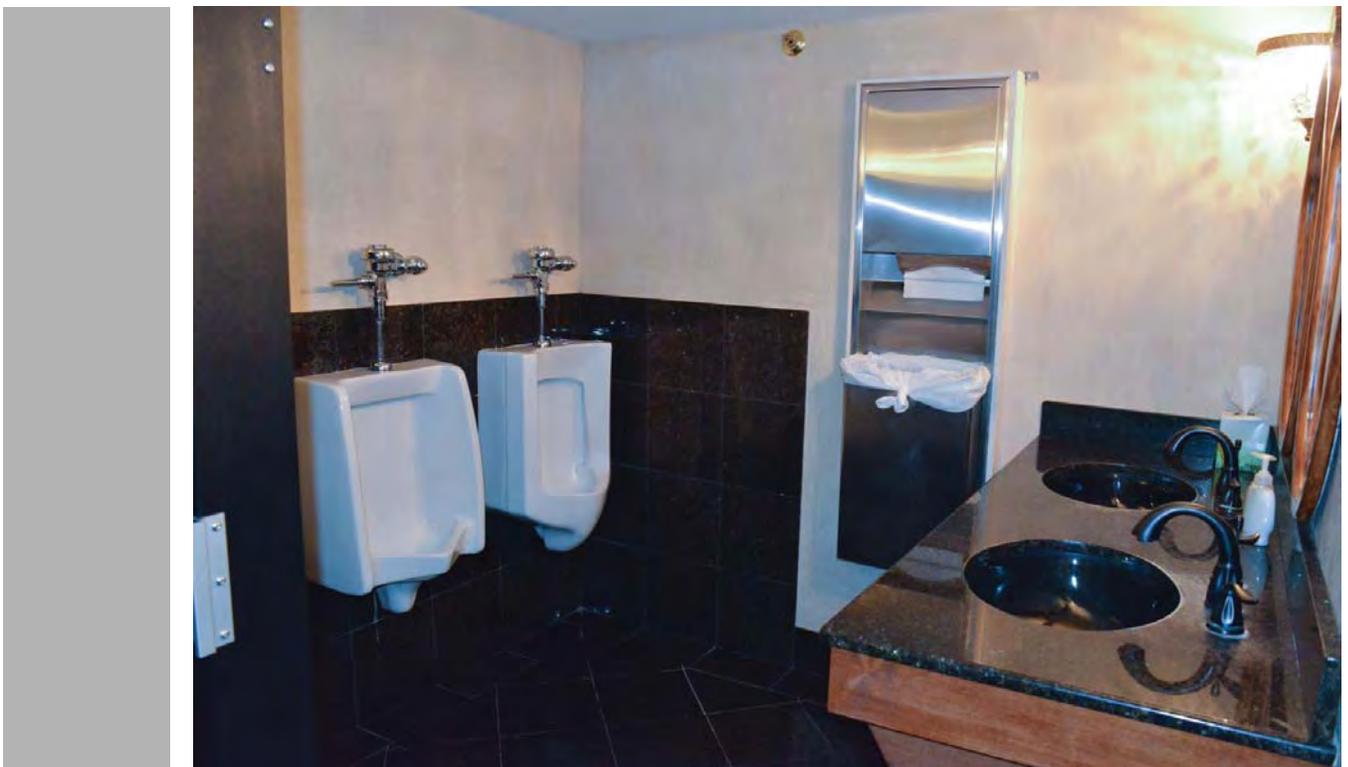
SAH-303

Name: Saint Anthony Hotel, 300 East Travis Street, San Antonio, Texas
View: Mezzanine Level above Peraux Pre-function, looking at Mens Restroom
Description: Non-historic (1983, 2000) walls, finishes & fixtures to be removed
Date: November 2012

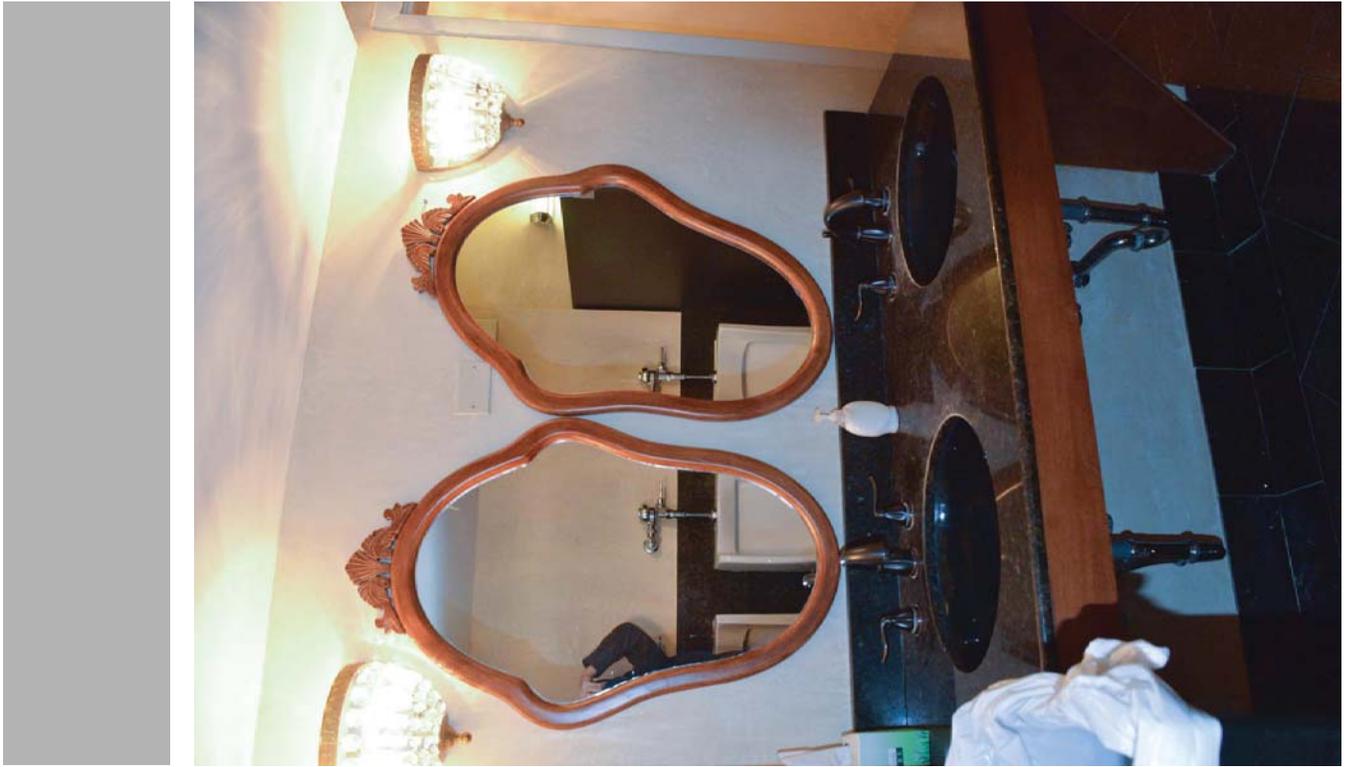
SAH-304

Name: Saint Anthony Hotel, 300 East Travis Street, San Antonio, Texas
View: Mezzanine Level above Peraux Pre-function, looking at Mens Restroom
Description: Non-historic (1983, 2000) walls, finishes & fixtures to be removed
Date: November 2012

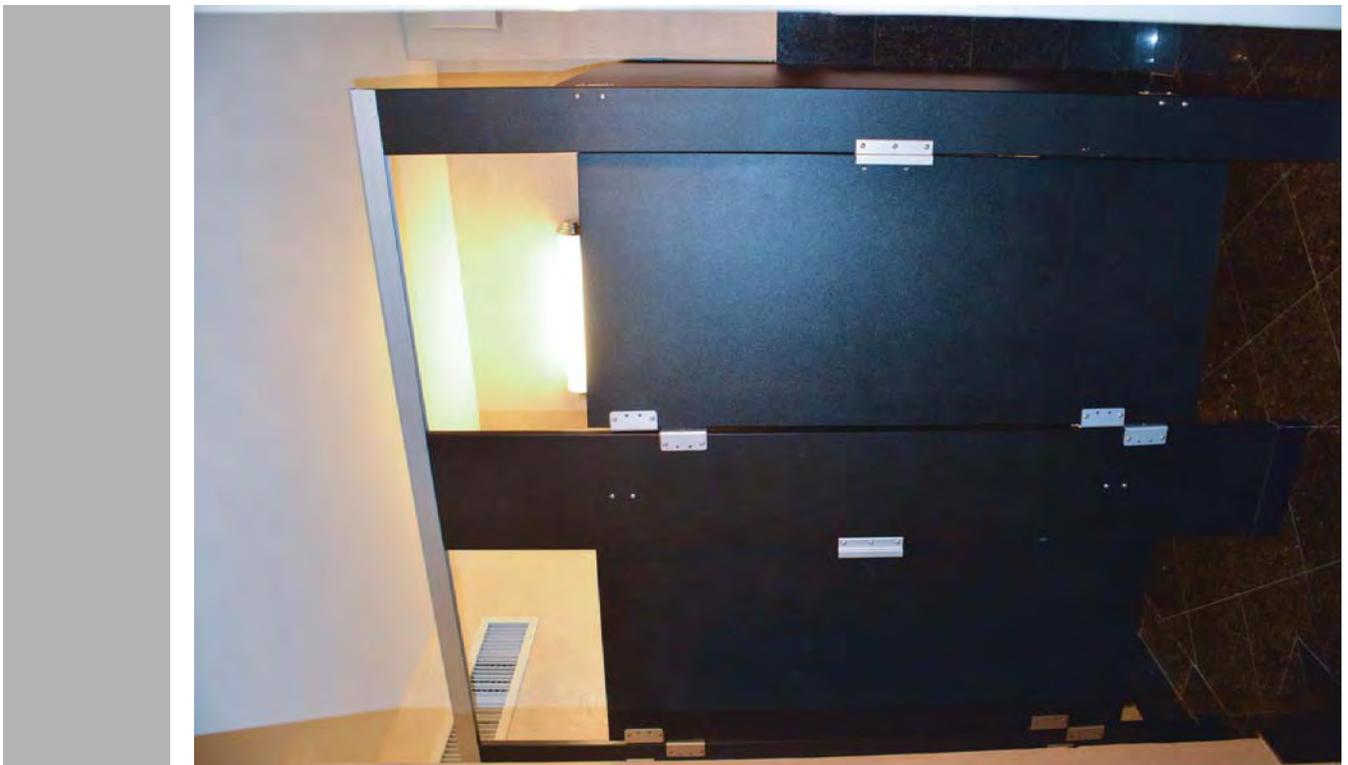
SAH-305

Name: Saint Anthony Hotel, 300 East Travis Street, San Antonio, Texas
View: Mezzanine Level above Peraux Pre-function, looking at Mens Restroom
Description: Non-historic (1983, 2000) walls, finishes & fixtures to be removed
Date: November 2012
