HISTORIC AND DESIGN REVIEW COMMISSION

HDRC CASE NO: 2016-016
ADDRESS: 304 E TRAVIS ST
LEGAL DESCRIPTION: NCB 415 BLK 18 LOT A-7, A- 8, A-9, P-100, P-101 & P-102
ZONING: D HE
CITY COUNCIL DIST.: 1
LANDMARK: St Anthony Hotel
APPLICANT: Brandon Raney
OWNER: BCL St. Anthony ML, LP
TYPE OF WORK: Tax Certification
REQUEST:

RE: St. Anthony Hotel Tax Certification Application

St. Anthony Hotel
Scope Summary of Exterior Rehabilitation

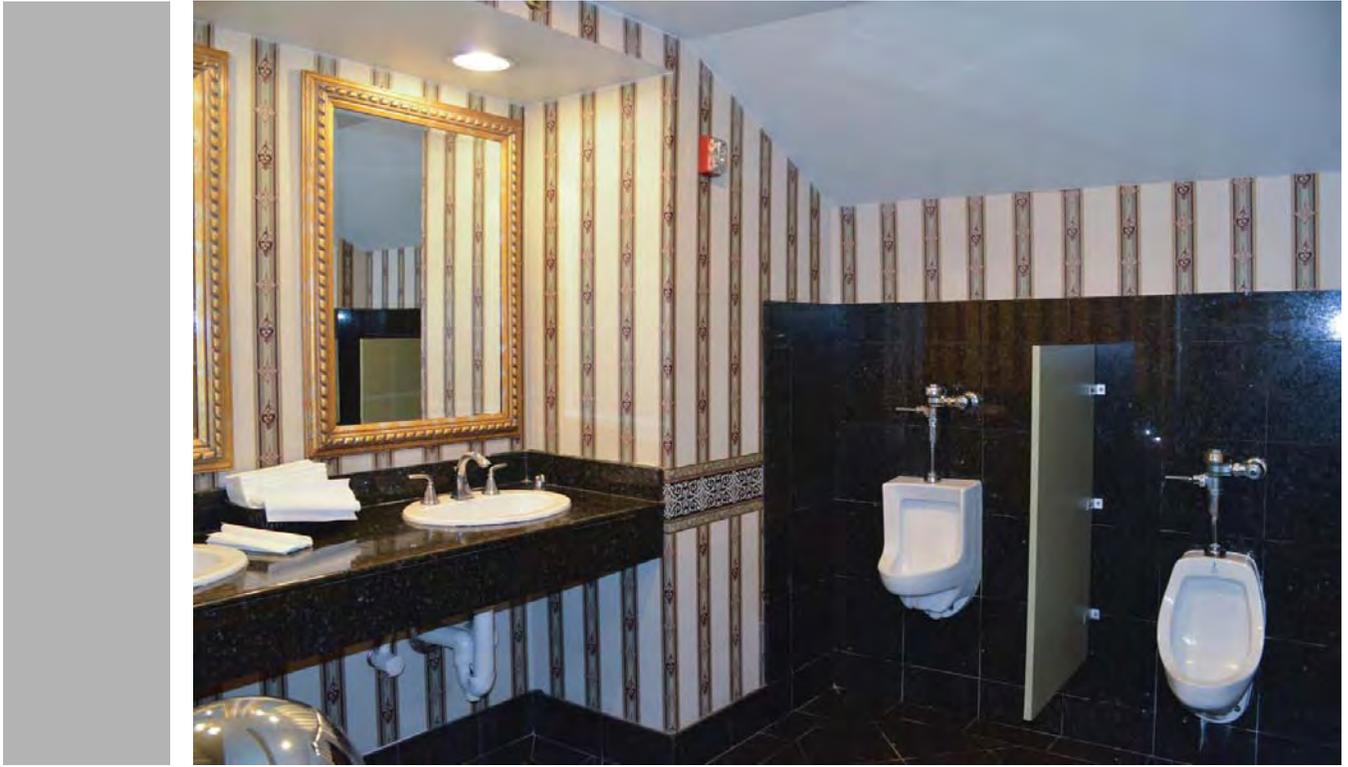
SAH-306

Name: Saint Anthony Hotel, 300 East Travis Street, San Antonio, Texas
View: First Level Lobby Mens Restroom, looking northwest at lavatory & urinals
Description: Non-historic (2000) walls, finishes & fixtures to be removed
Date: November 2012

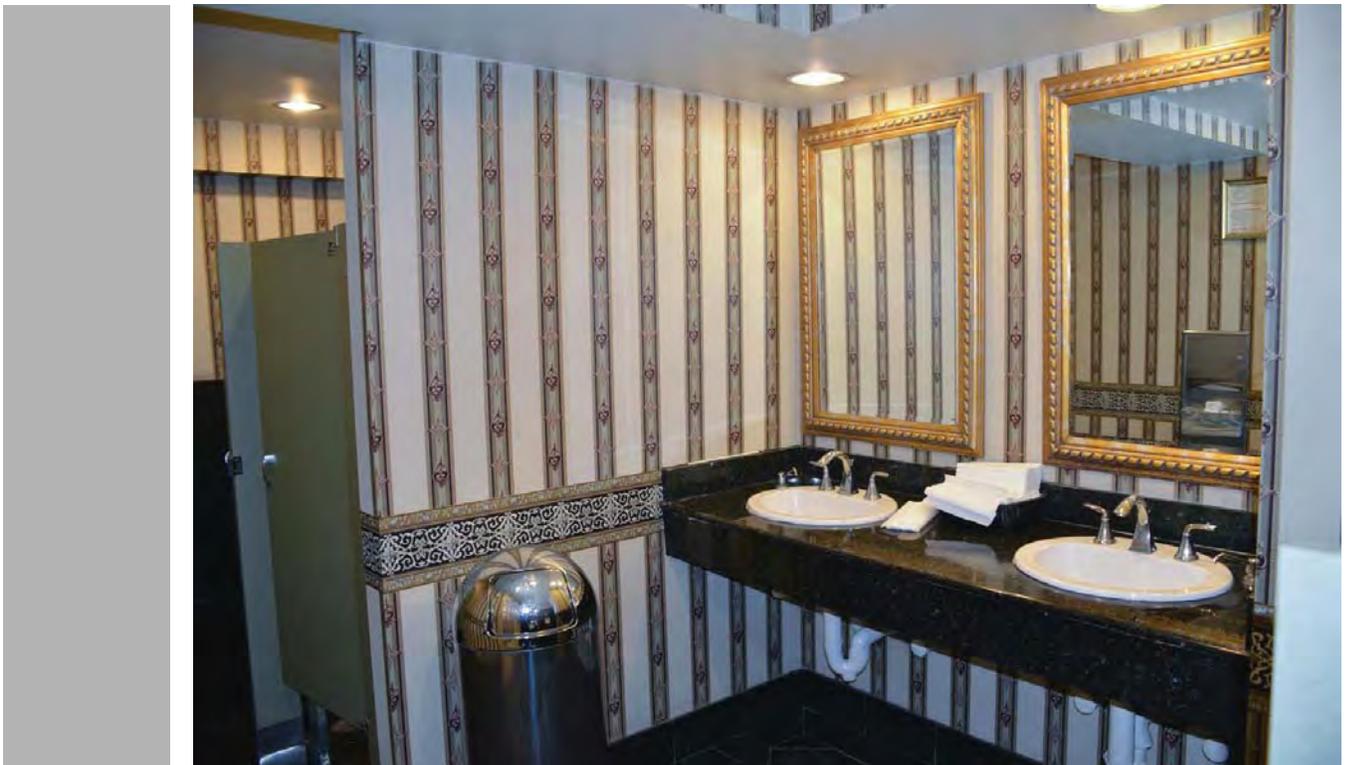
SAH-307

Name: Saint Anthony Hotel, 300 East Travis Street, San Antonio, Texas
View: First Level Lobby Mens Restroom, looking southwest at lavatory & stalls
Description: Non-historic (2000) walls, finishes & fixtures to be removed
Date: November 2012

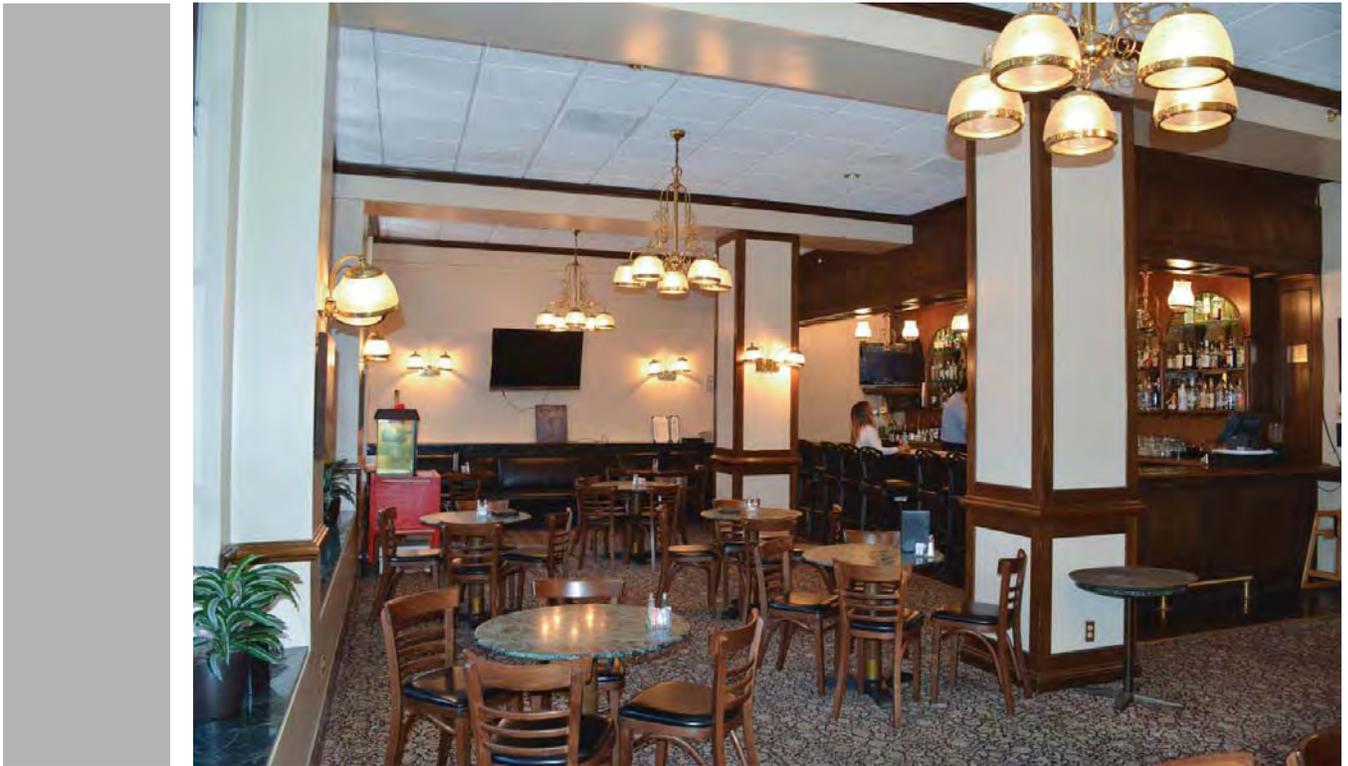
SAH-308

Name: Saint Anthony Hotel, 300 East Travis Street, San Antonio, Texas
View: First Level at Pete's Pub, looking north at bar
Description: Non-historic (1983) finishes & fixtures to be removed & pub renovated
Date: November 2012

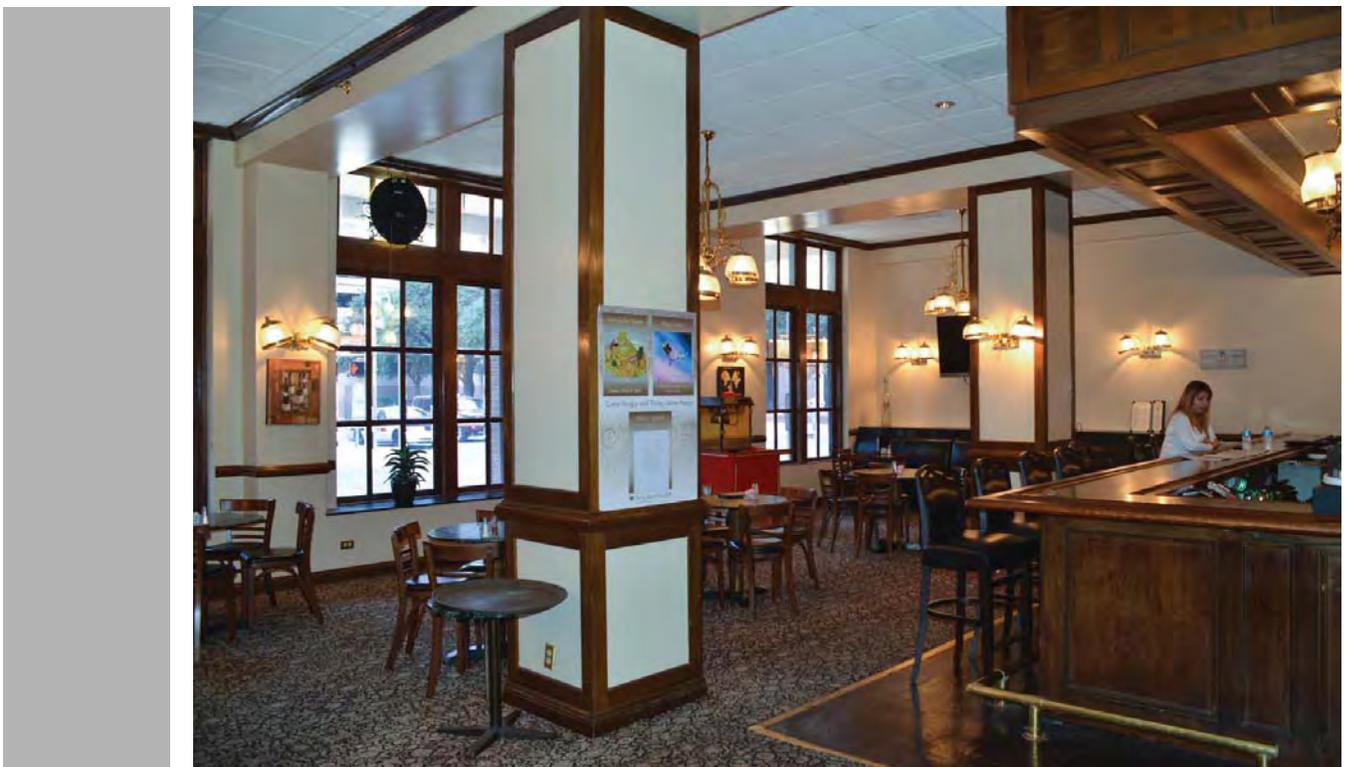
SAH-309

Name: Saint Anthony Hotel, 300 East Travis Street, San Antonio, Texas
View: First Level at Pete's Pub, looking northwest at exterior wall & windows
Description: Historic windows & structure to remain *in situ*, pub renovated
Date: November 2012

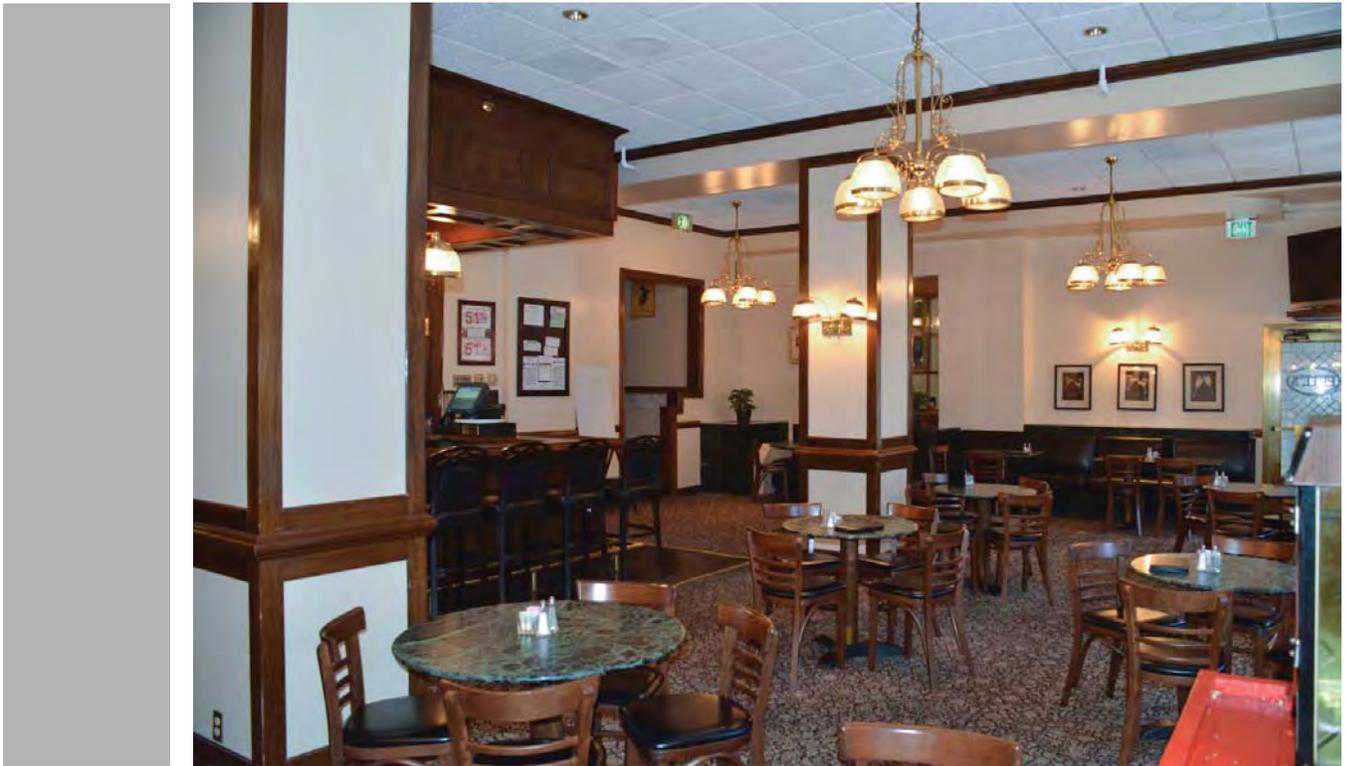
SAH-310

Name: Saint Anthony Hotel, 300 East Travis Street, San Antonio, Texas
View: First Level at Pete's Pub, looking southeast at bar and lobby entry
Description: Non-historic (1983) finishes & fixtures to be removed & pub renovated
Date: November 2012

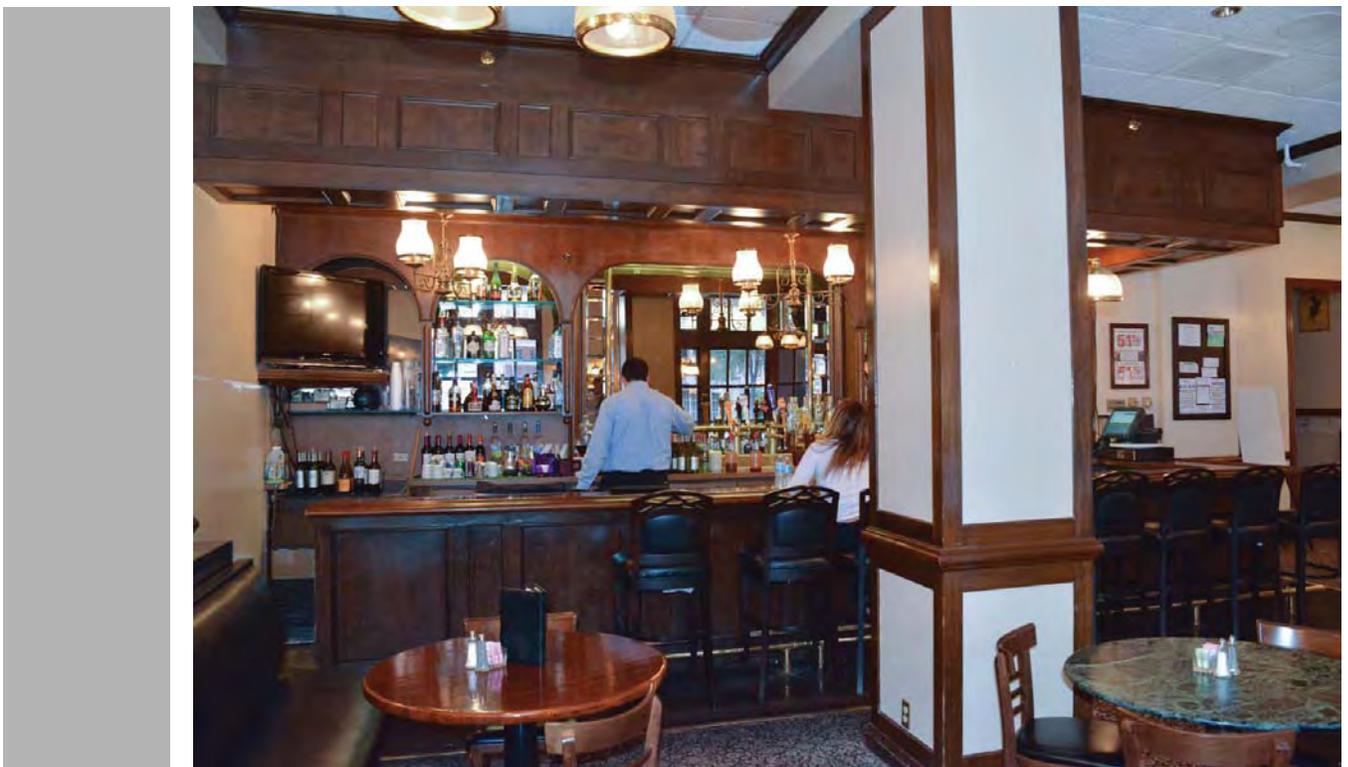
SAH-311

Name: Saint Anthony Hotel, 300 East Travis Street, San Antonio, Texas
View: First Level at Pete's Pub, looking east at bar
Description: Non-historic (1983) finishes & fixtures to be removed & pub renovated
Date: November 2012

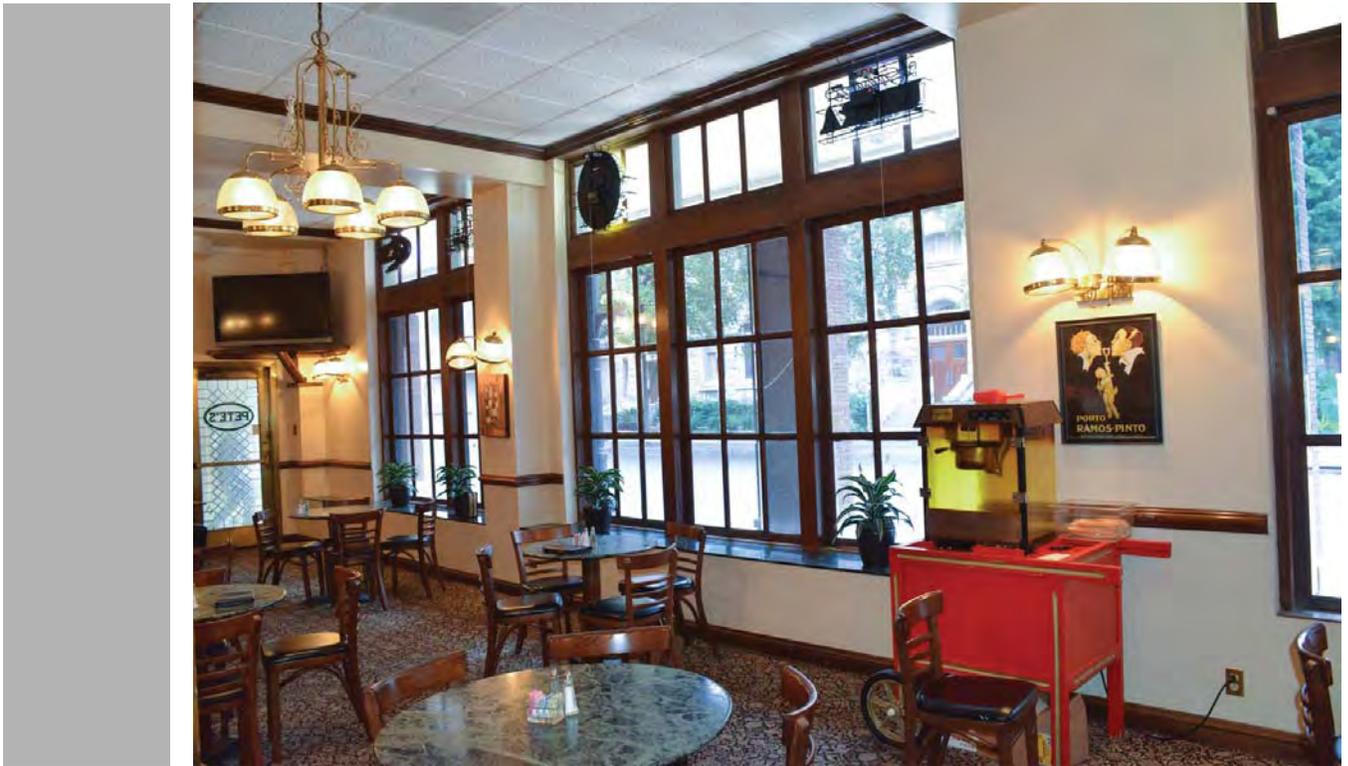
SAH-312

Name: Saint Anthony Hotel, 300 East Travis Street, San Antonio, Texas
View: First Level at Pete's Pub, looking southwest at exterior walls, windows & entry
Description: Historic windows, structure and door to remain *in situ*, pub renovated
Date: November 2012

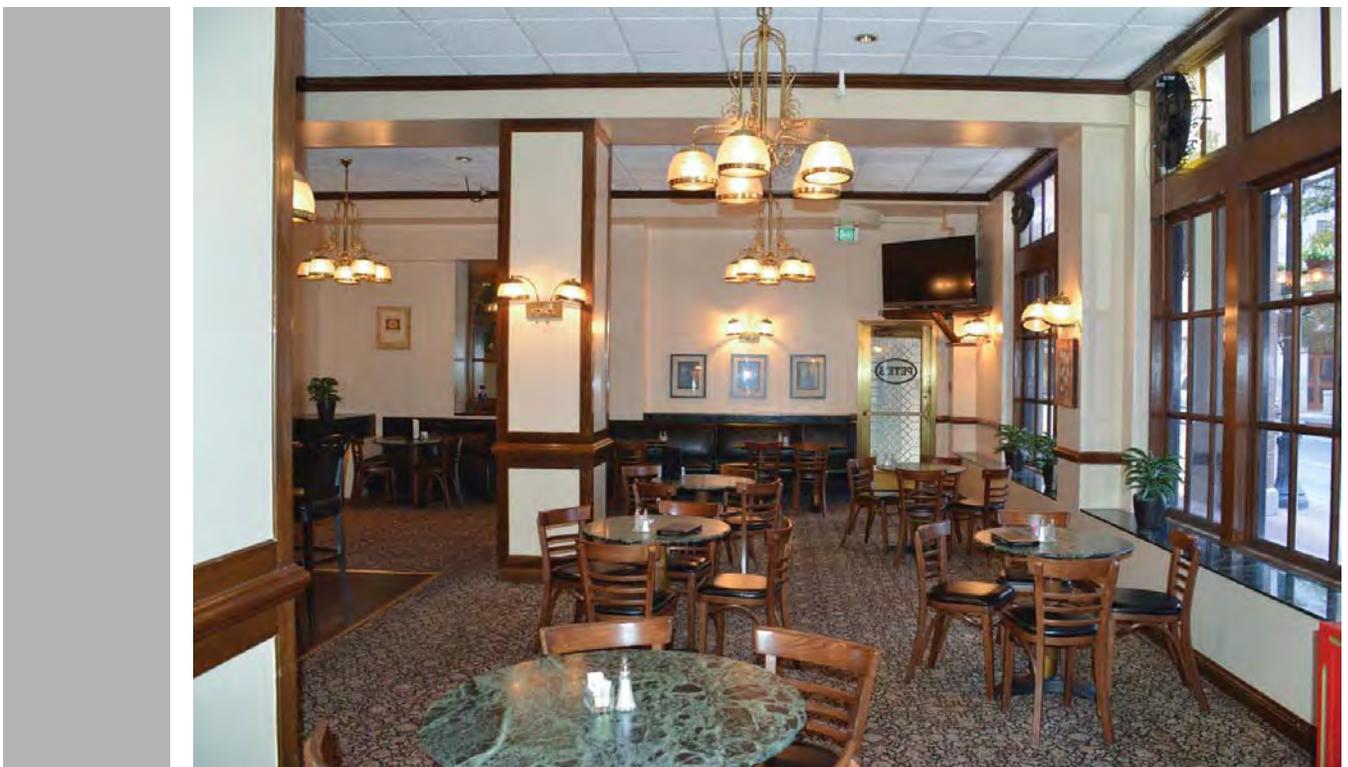
SAH-313

Name: Saint Anthony Hotel, 300 East Travis Street, San Antonio, Texas
View: First Level at Pete's Pub, looking south at exterior walls, windows & entry
Description: New pub entry to Navarro Street Lobby to re-establish historic relationship
Date: November 2012

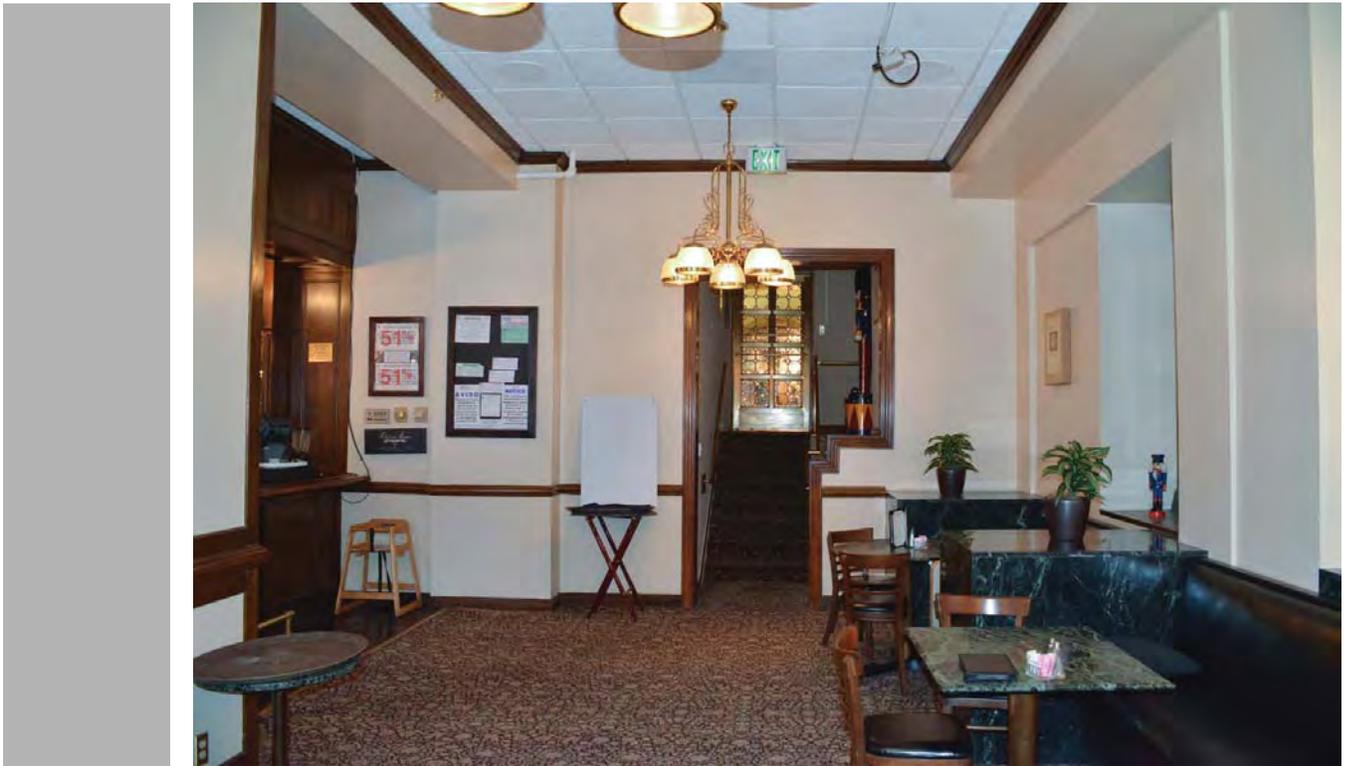
SAH-314

Name: Saint Anthony Hotel, 300 East Travis Street, San Antonio, Texas
View: First Level at Pete's Pub, looking east at stair to Main Lobby pub entry
Description: Historic door salvaged and reused; non-historic stair removed
Date: November 2012

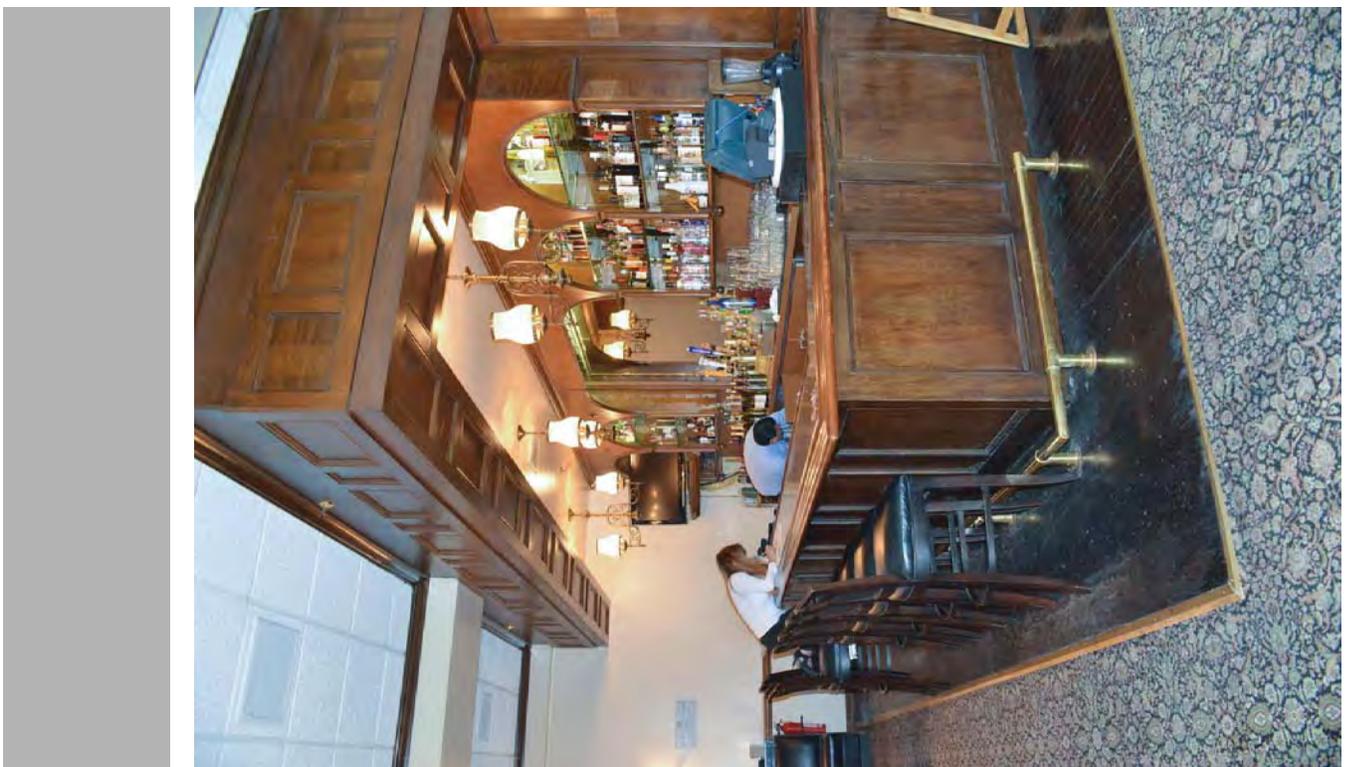
SAH-315

Name: Saint Anthony Hotel, 300 East Travis Street, San Antonio, Texas
View: First Level at Pete's Pub, looking north at bar
Description: Non-historic (1983) finishes & fixtures to be removed & pub renovated
Date: November 2012

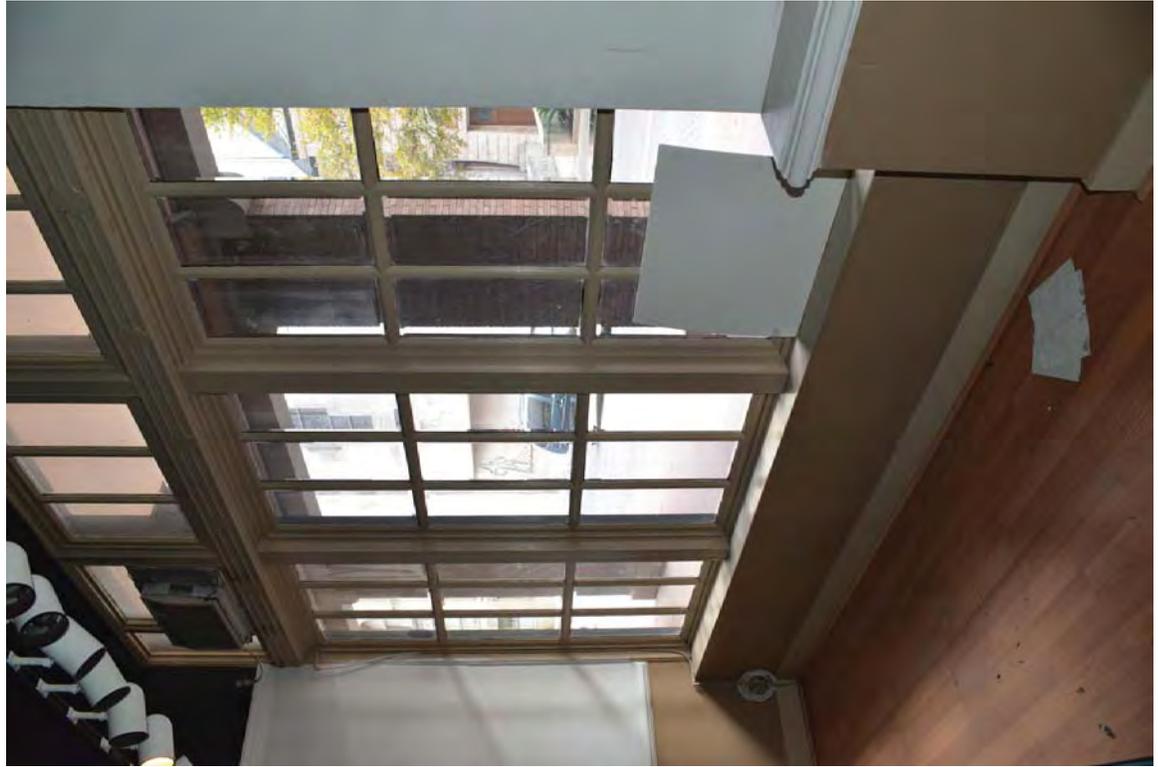
SAH-316

Name: Saint Anthony Hotel, 300 East Travis Street, San Antonio, Texas
View: First Level Retail Space, looking southwest at exterior wall and windows
Description: Historic windows retained *in situ*; creation of ADA access elevator lobby
Date: November 2012

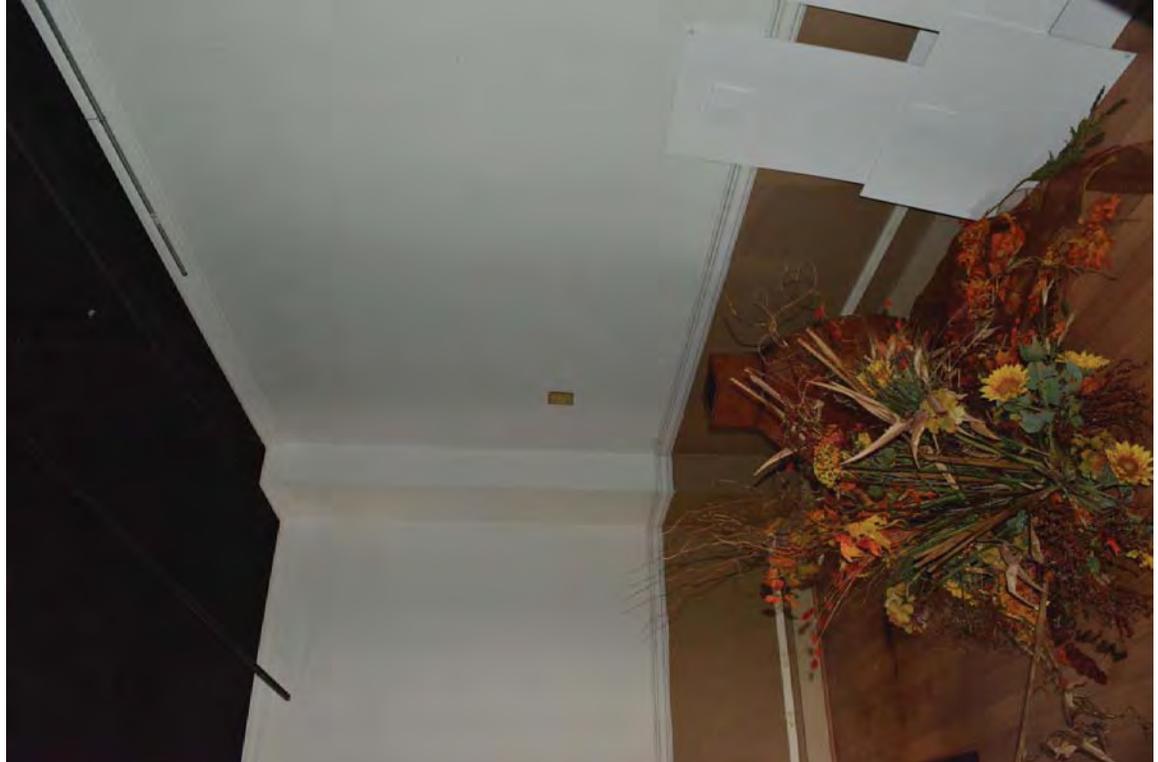
SAH-317

Name: Saint Anthony Hotel, 300 East Travis Street, San Antonio, Texas
View: First Level Retail Space, looking northeast at corner of interior walls
Description: Creation of ADA accessible elevator and small lobby space
Date: November 2012

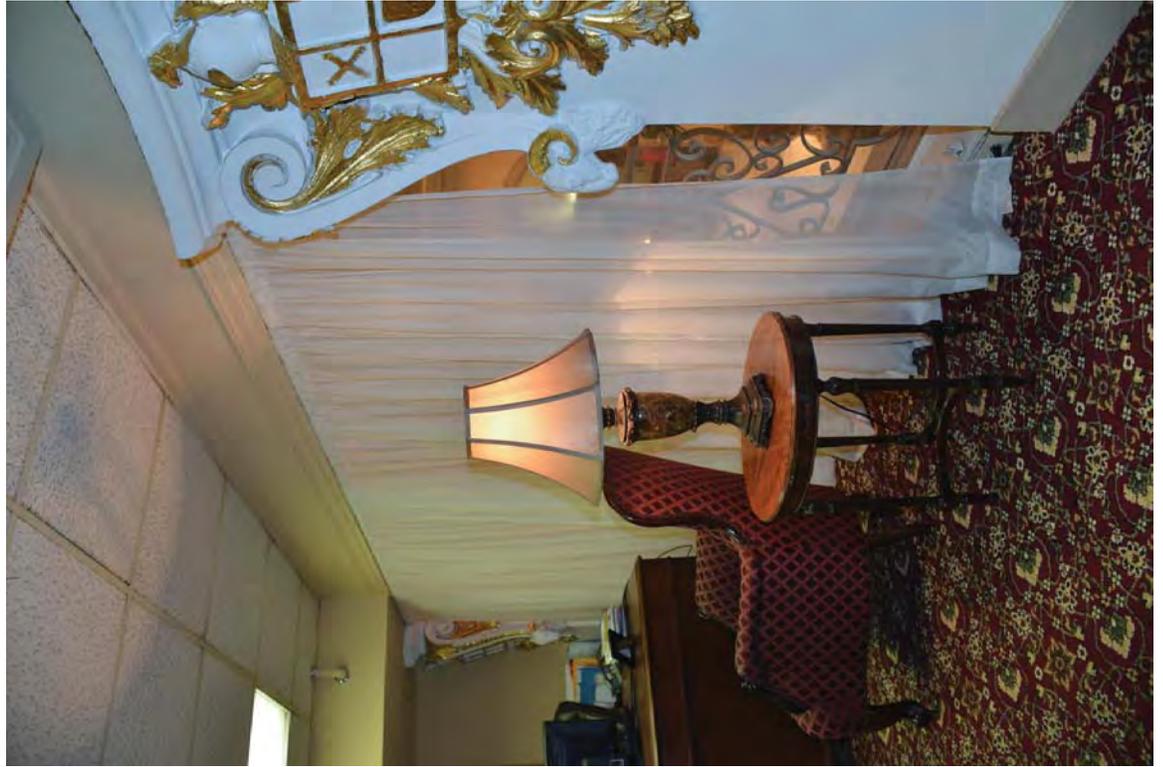
SAH-318

Name: Saint Anthony Hotel, 300 East Travis Street, San Antonio, Texas
View: Mezzanine Level Admin. Offices, looking northeast from reception area
Description: Non-historic ceiling, walls and plexi-glass panels to be removed
Date: November 2012

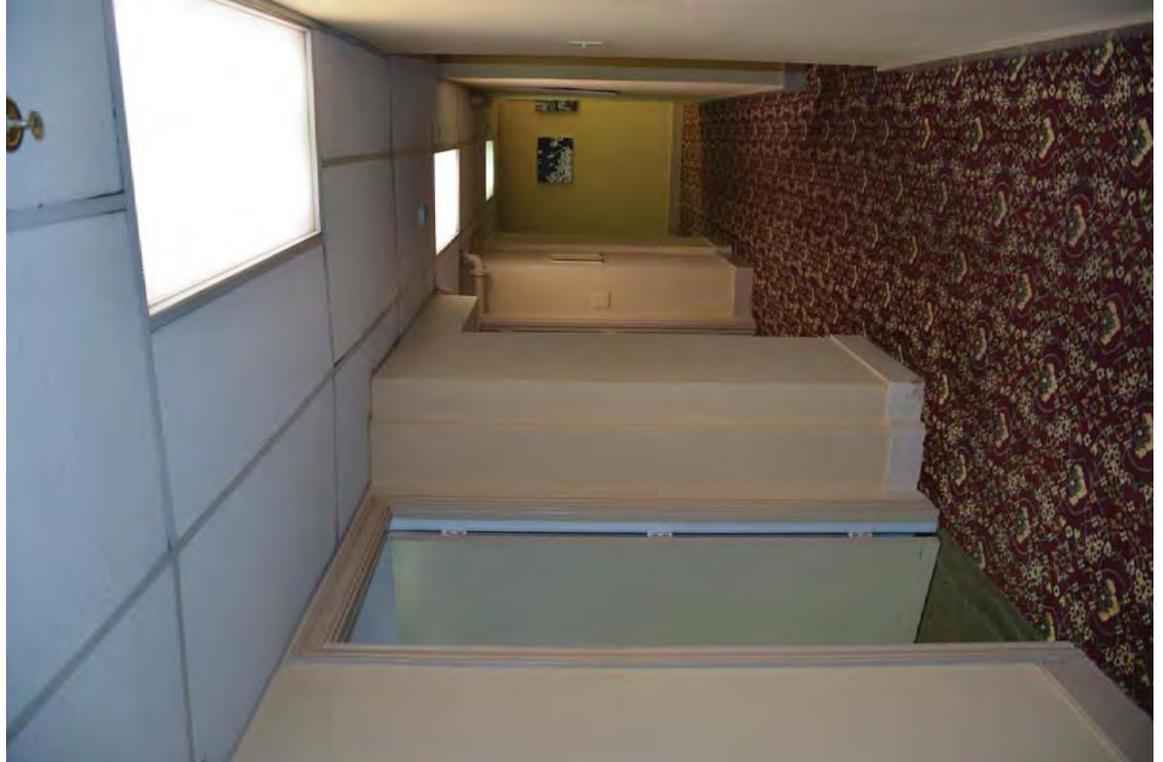
SAH-319

Name: Saint Anthony Hotel, 300 East Travis Street, San Antonio, Texas
View: Mezzanine Level Admin. Offices, looking east in corridor
Description: Non-historic ceiling & walls to be removed; historic columns & beams to remain
Date: November 2012

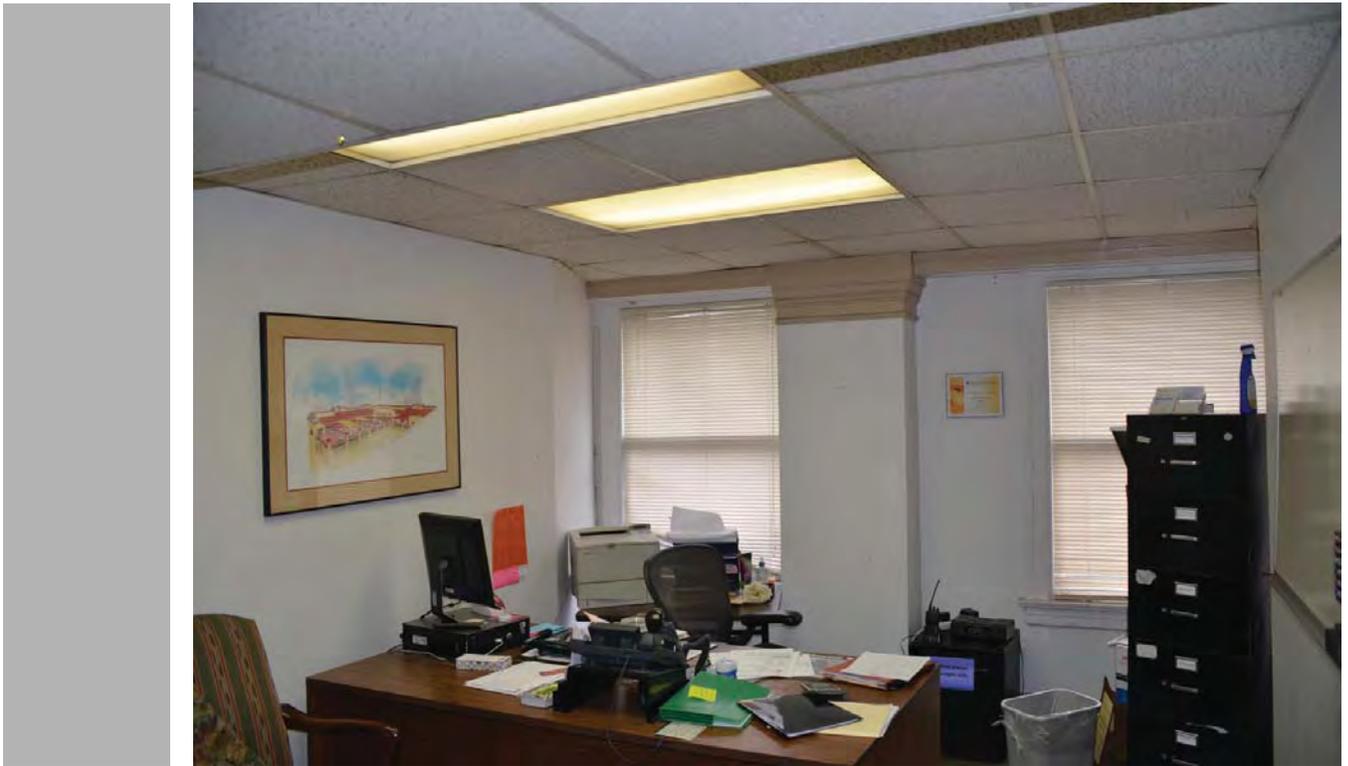
SAH-320

Name: Saint Anthony Hotel, 300 East Travis Street, San Antonio, Texas
View: Mezzanine Level Admin. Offices, looking north toward exterior wall in office
Description: Non-historic ceiling & walls to be removed; historic pilaster & beams to remain
Date: November 2012

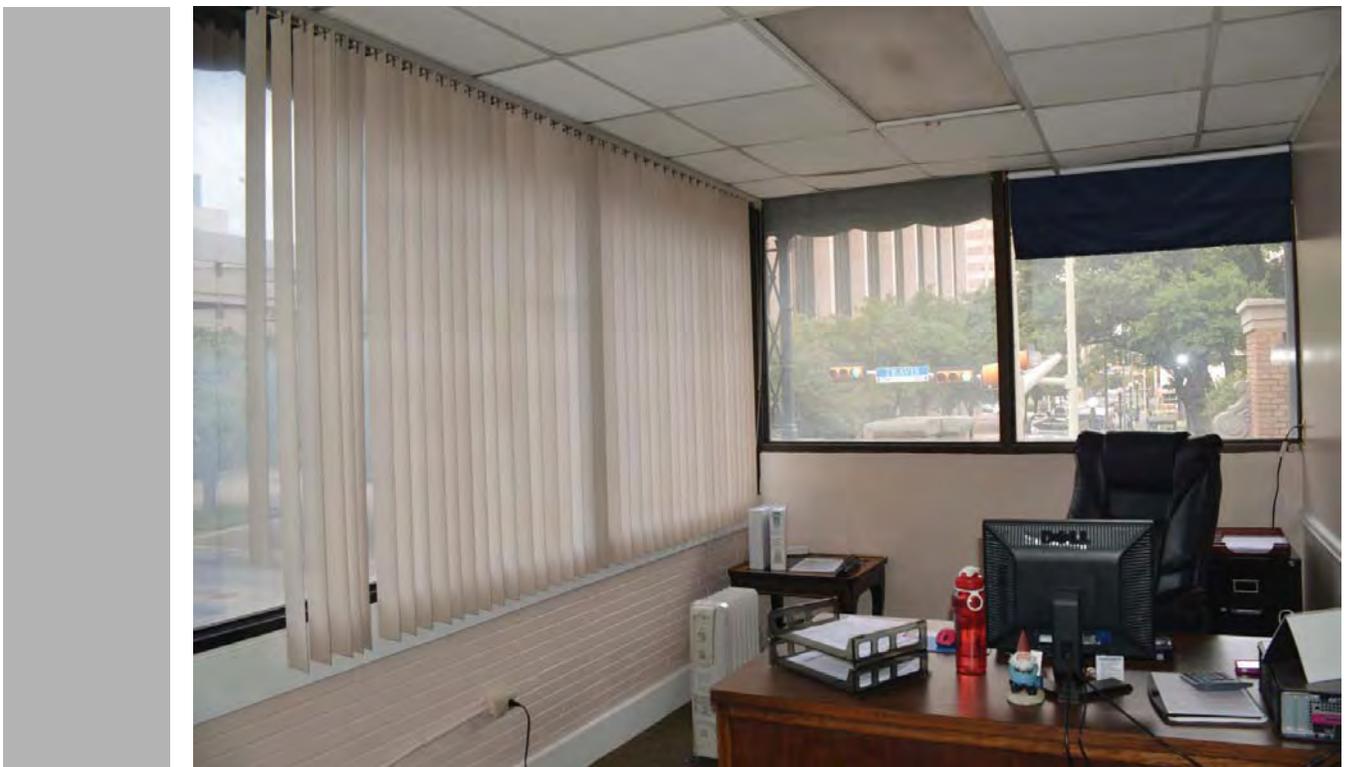
SAH-321

Name: Saint Anthony Hotel, 300 East Travis Street, San Antonio, Texas
View: Mezzanine Level Admin. Offices at Terrace, looking north end of terrace
Description: Non-historic glazing, walls & finishes to be removed; exterior terrace restored
Date: November 2012

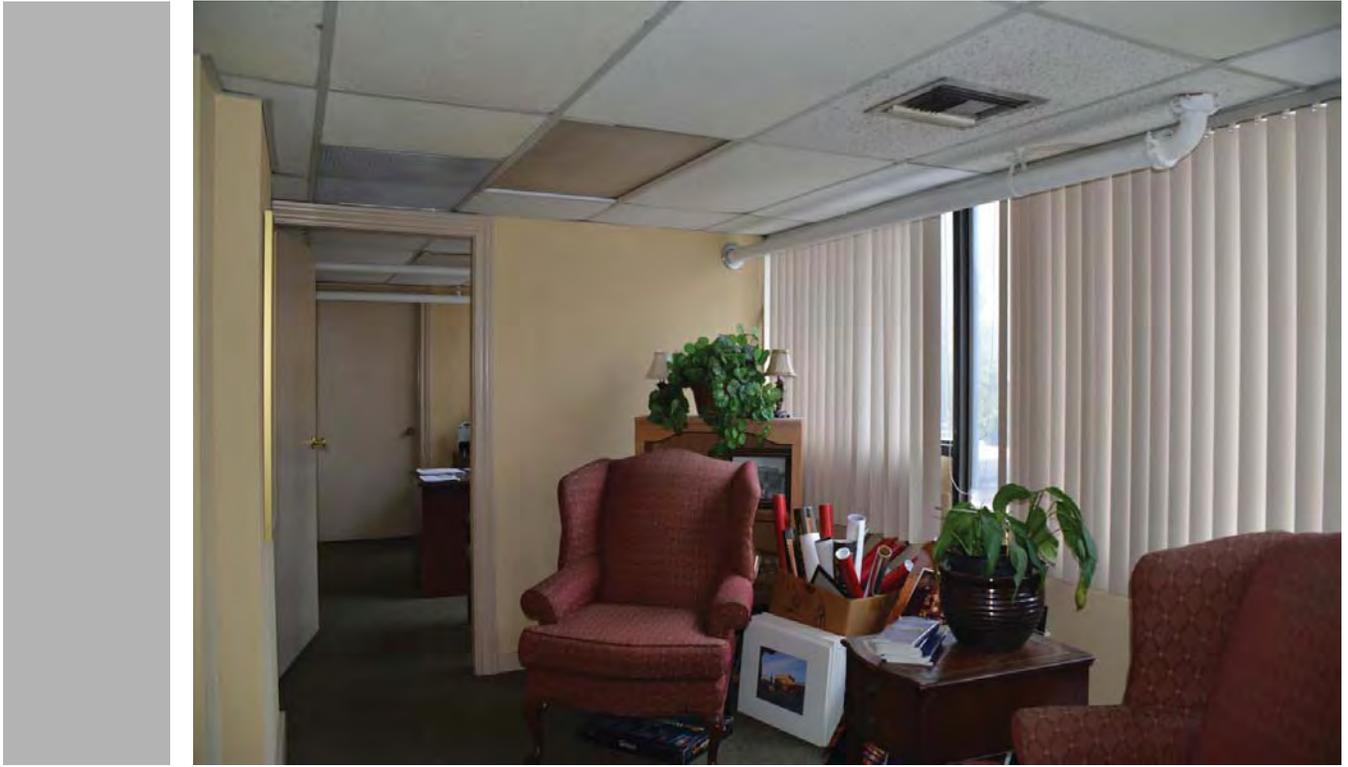
SAH-322

Name: Saint Anthony Hotel, 300 East Travis Street, San Antonio, Texas
View: Mezzanine Level Admin. Offices at Terrace, looking south southwest
Description: Non-historic glazing, walls, ceilings, finishes & piping to be removed
Date: November 2012

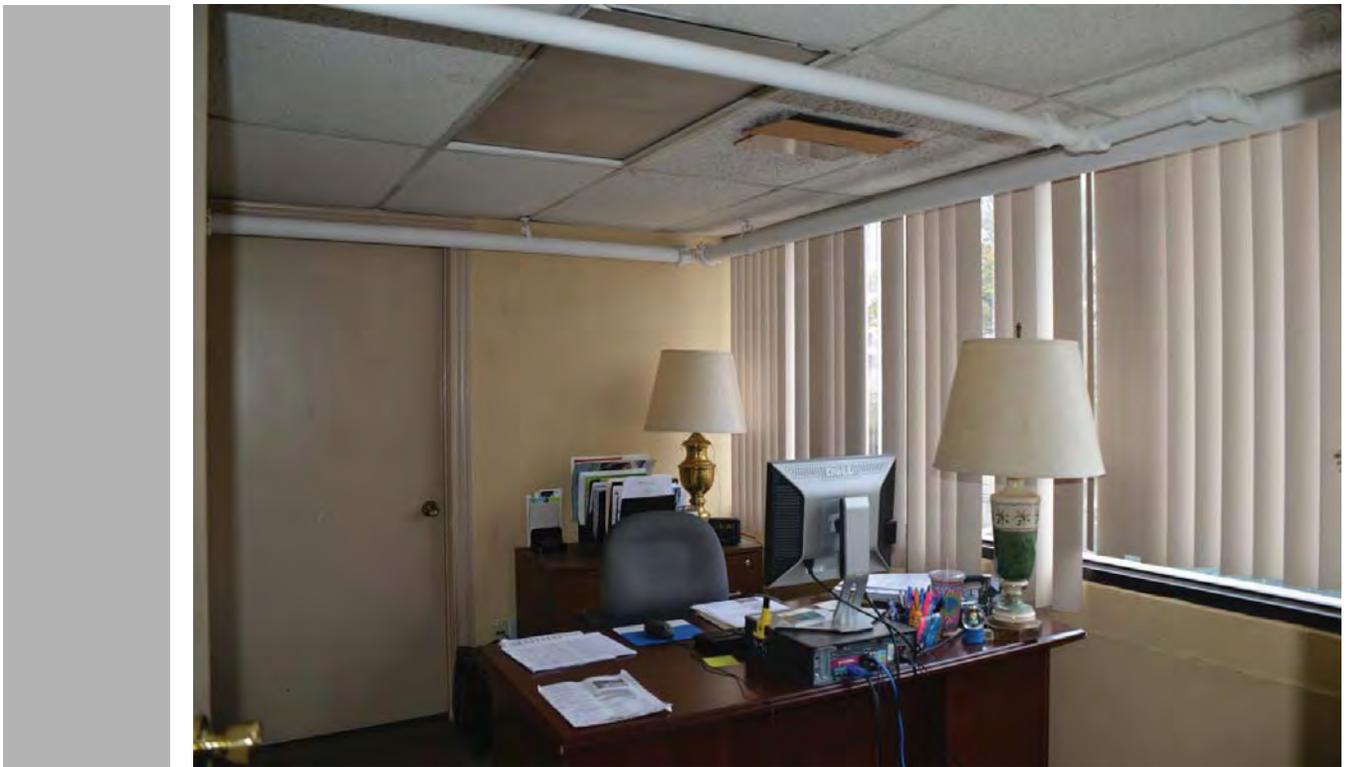
Photograph No.
SAH-323

Name: Saint Anthony Hotel, 300 East Travis Street, San Antonio, Texas
View: Mezzanine Level Admin. Offices at Terrace, looking south southwest
Description: Non-historic glazing, walls, ceilings, finishes & piping to be removed
Date: November 2012

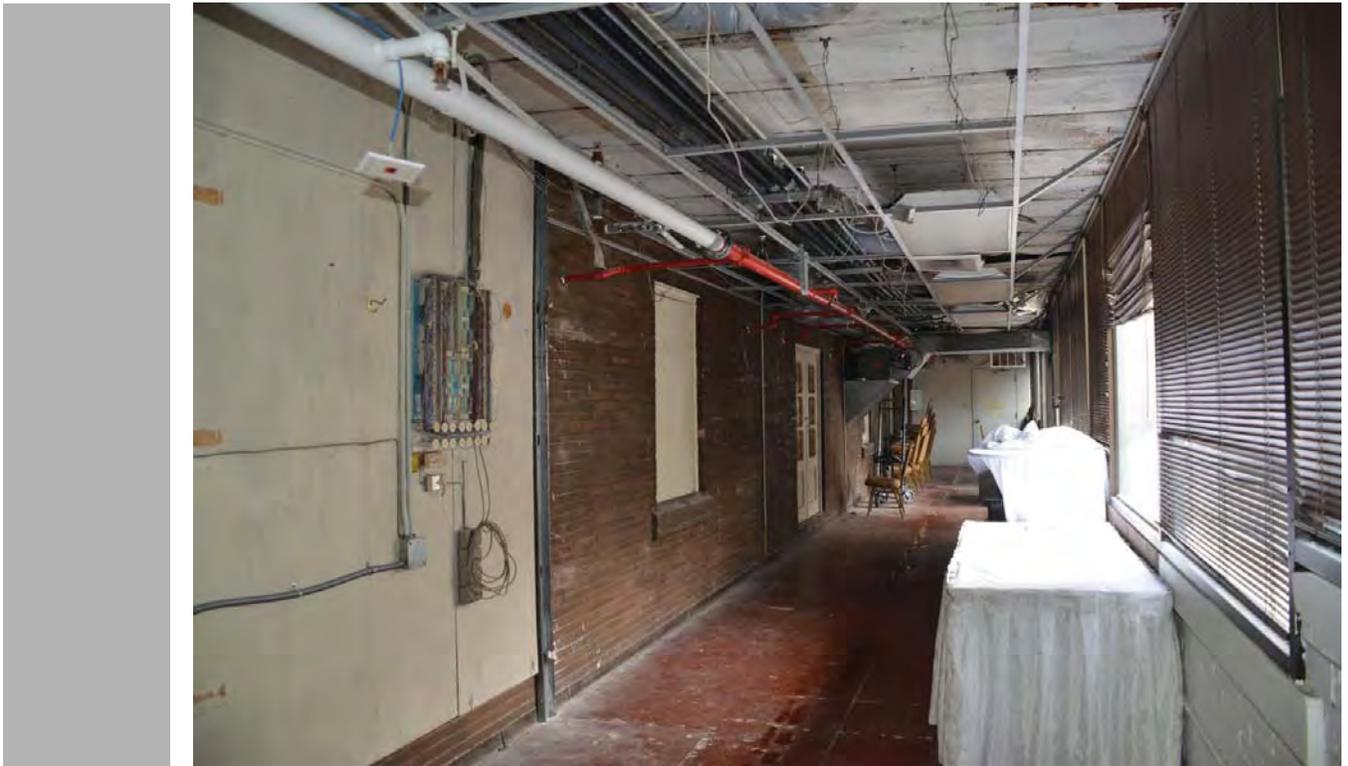
Photograph No.
SAH-324

Name: Saint Anthony Hotel, 300 East Travis Street, San Antonio, Texas
View: Mezzanine Level Storage at Terrace, looking south southeast
Description: Non-historic glazing, walls, ceilings, finishes, piping & mech. to be removed
Date: November 2012

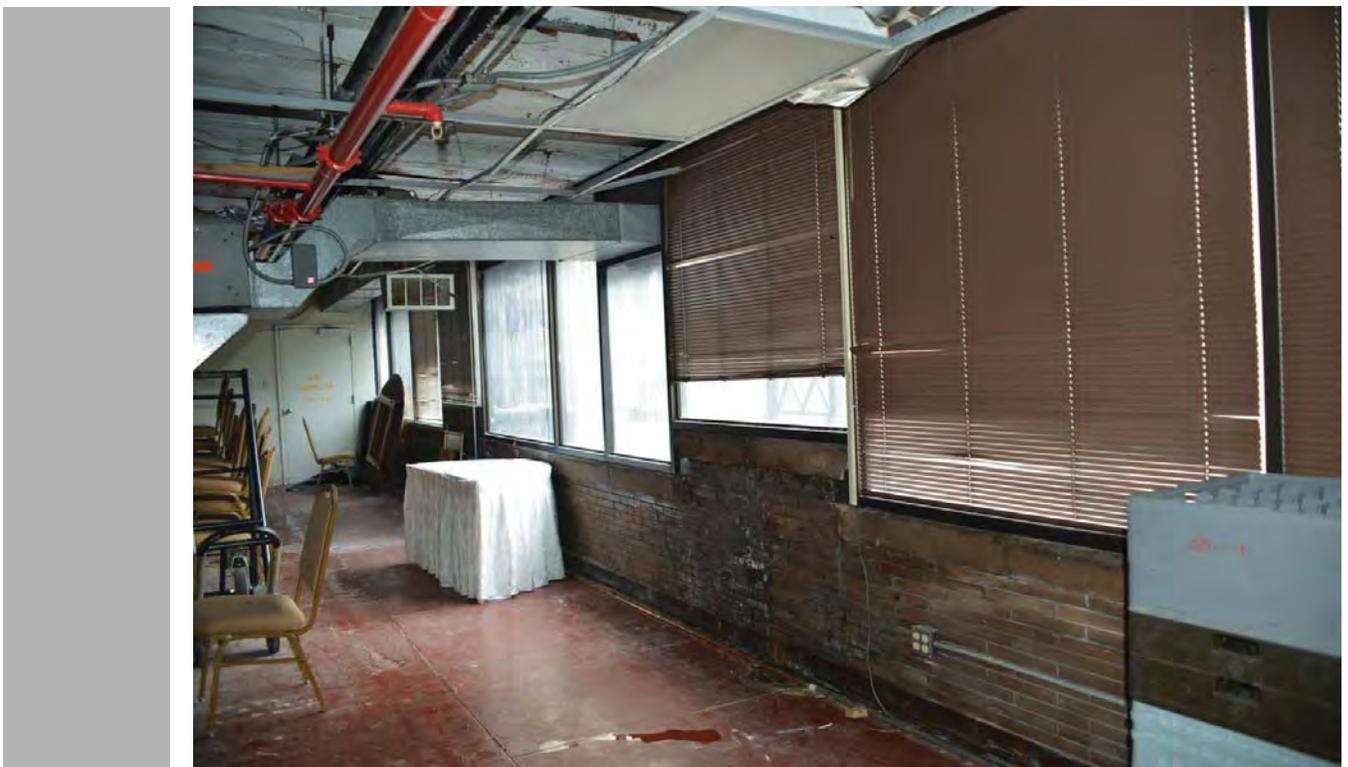
SAH-325

Name: Saint Anthony Hotel, 300 East Travis Street, San Antonio, Texas
View: Mezzanine Level Storage at Terrace, looking south southwest
Description: Non-historic glazing, walls, ceilings, finishes, piping & mech. to be removed
Date: November 2012

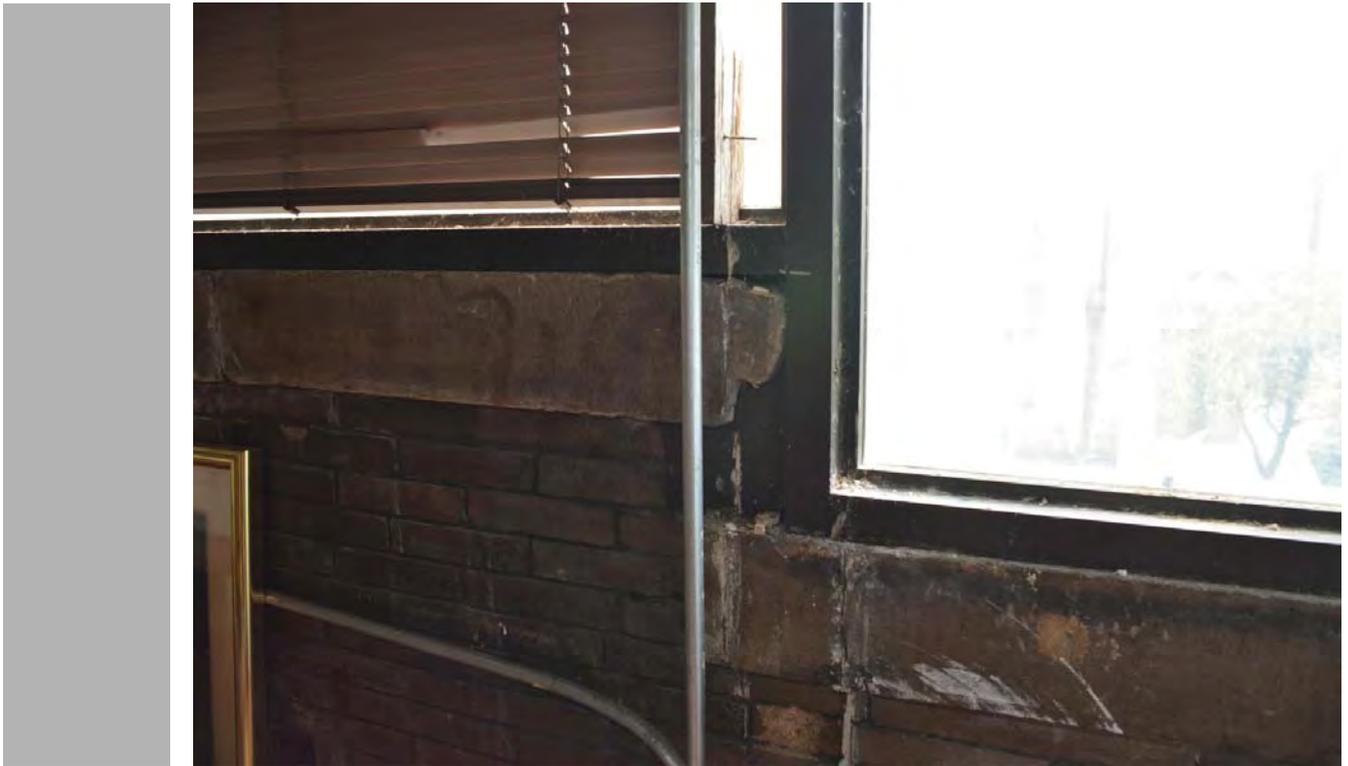
SAH-326

Name: Saint Anthony Hotel, 300 East Travis Street, San Antonio, Texas
View: Mezzanine Level Storage at Terrace, detail of parapet and alum. window
Description: Non-historic (1970s) window to be removed and masonry restored
Date: November 2012
