HISTORIC AND DESIGN REVIEW COMMISSION

HDRC CASE NO: 2016-016
ADDRESS: 304 E TRAVIS ST
LEGAL DESCRIPTION: NCB 415 BLK 18 LOT A-7, A- 8, A-9, P-100, P-101 & P-102
ZONING: D HE
CITY COUNCIL DIST.: 1
LANDMARK: St Anthony Hotel
APPLICANT: Brandon Raney
OWNER: BCL St. Anthony ML, LP
TYPE OF WORK: Tax Certification
REQUEST:

RE: St. Anthony Hotel Tax Certification Application

St. Anthony Hotel
Scope Summary of Exterior Rehabilitation

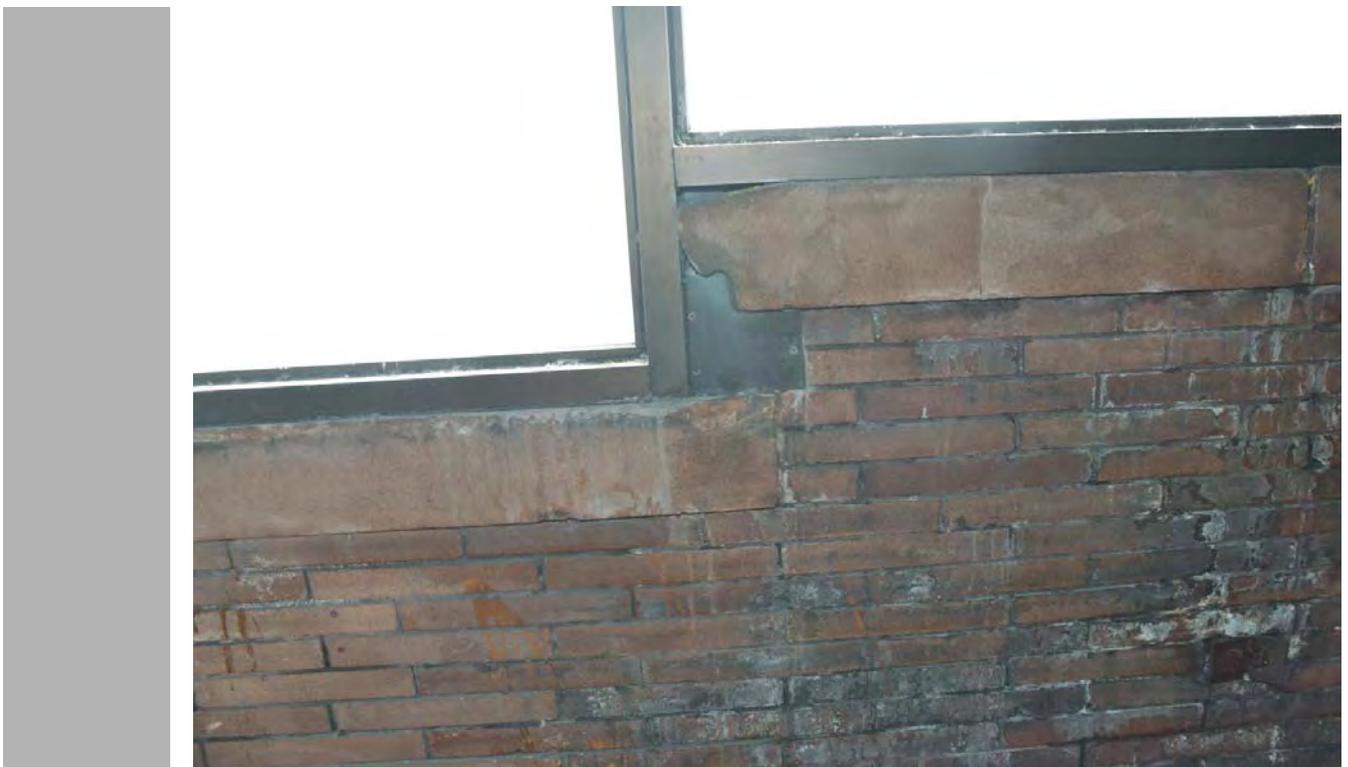
SAH-327

Name: Saint Anthony Hotel, 300 East Travis Street, San Antonio, Texas
View: Mezzanine Level Storage at Terrace, detail of parapet and alum. window
Description: Non-historic (1970s) window to be removed and masonry restored
Date: November 2012

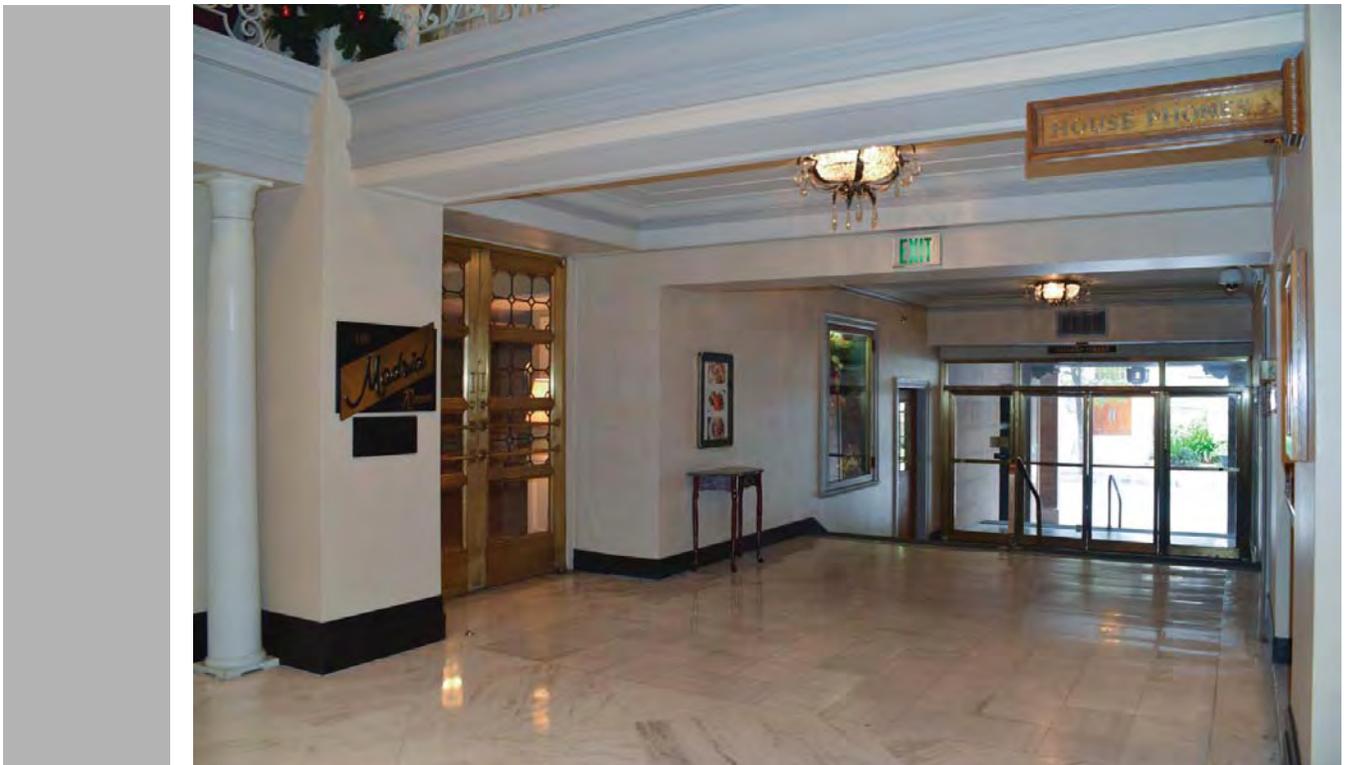
SAH-329

Name: Saint Anthony Hotel, 300 East Travis Street, San Antonio, Texas
View: First Floor Navarro Street entry lobby, looking west at Madrid Rm. entry doors
Description: Historic doors to be salvaged and reused; new entry to restaurant
Date: November 2012

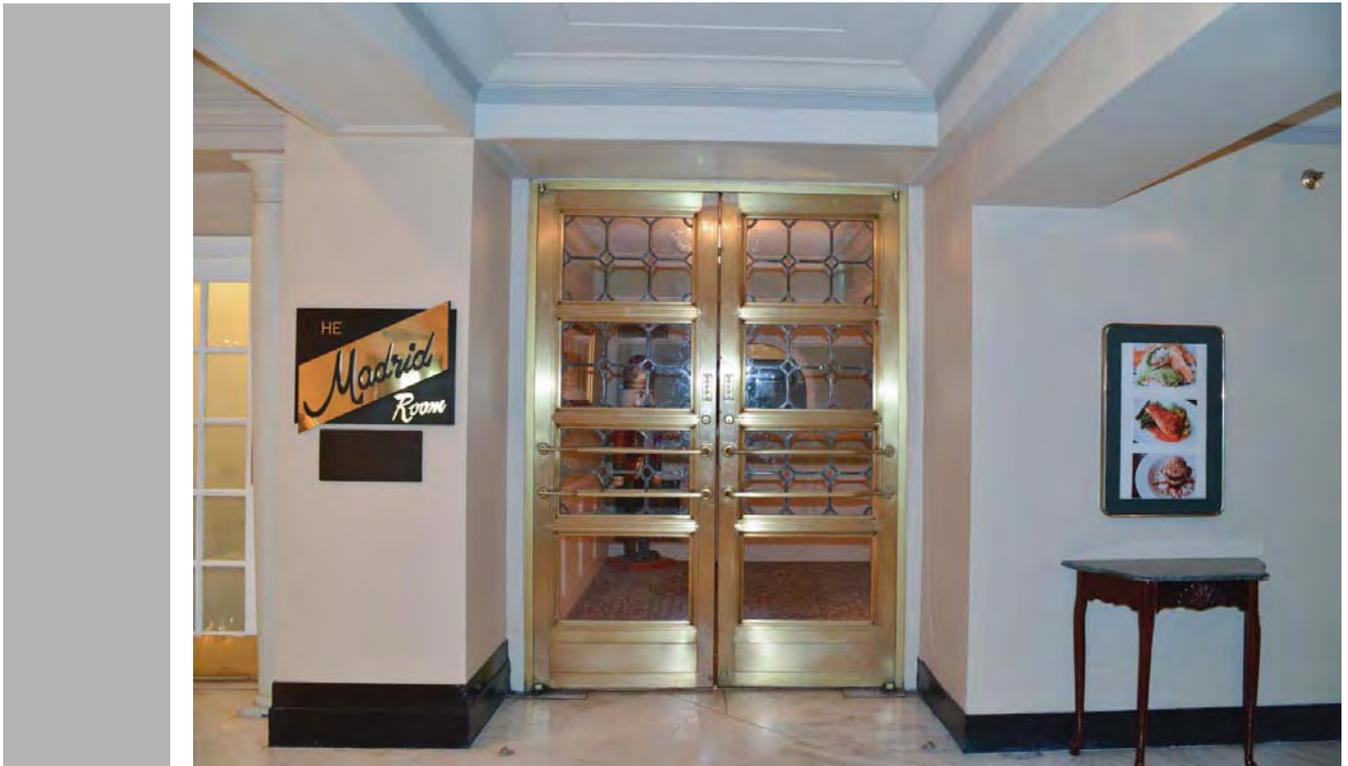
SAH-330

Name: Saint Anthony Hotel, 300 East Travis Street, San Antonio, Texas
View: First Floor Navarro Street entry lobby, detail of historic doors
Description: Historic doors to be salvaged and reused (not original to this location)
Date: November 2012

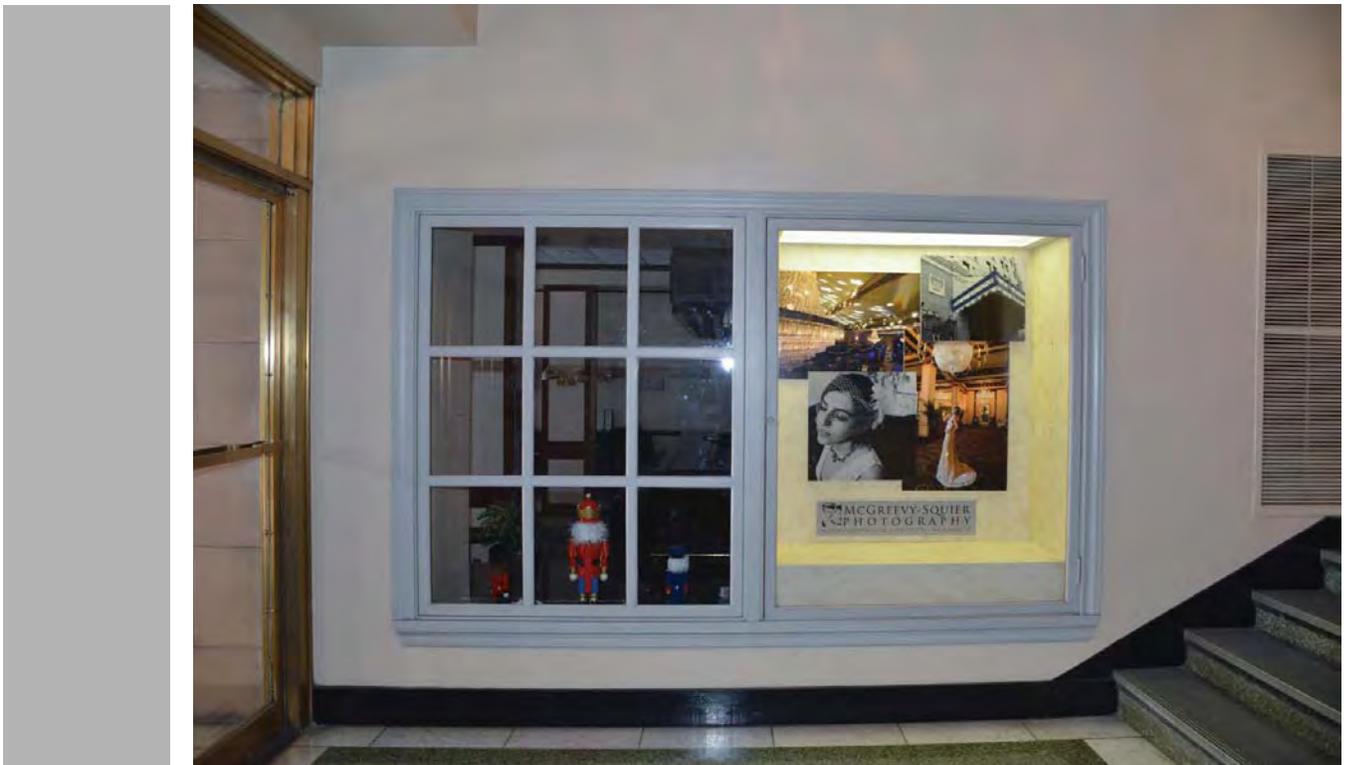
SAH-331

Name: Saint Anthony Hotel, 300 East Travis Street, San Antonio, Texas
View: First Floor Navarro Street entry lobby, detail of non-historic display case
Description: Display case to be removed; location of new (original) entry to Pete's Pub
Date: November 2012

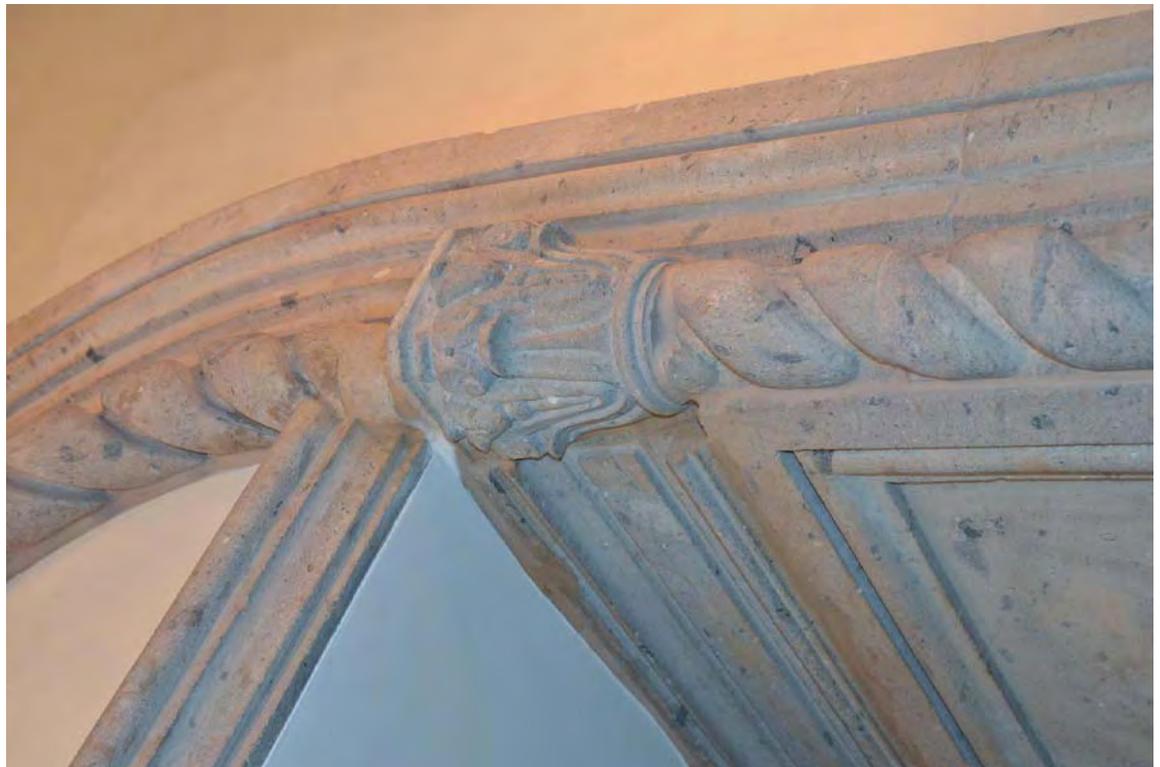
Photograph No.
SAH-334

Name: Saint Anthony Hotel, 300 East Travis Street, San Antonio, Texas
View: First Floor Peacock Alley, detail of historic cast stone arch casing
Description: Historic feature exhibiting high degree of craftsmanship & refined details
Date: November 2012

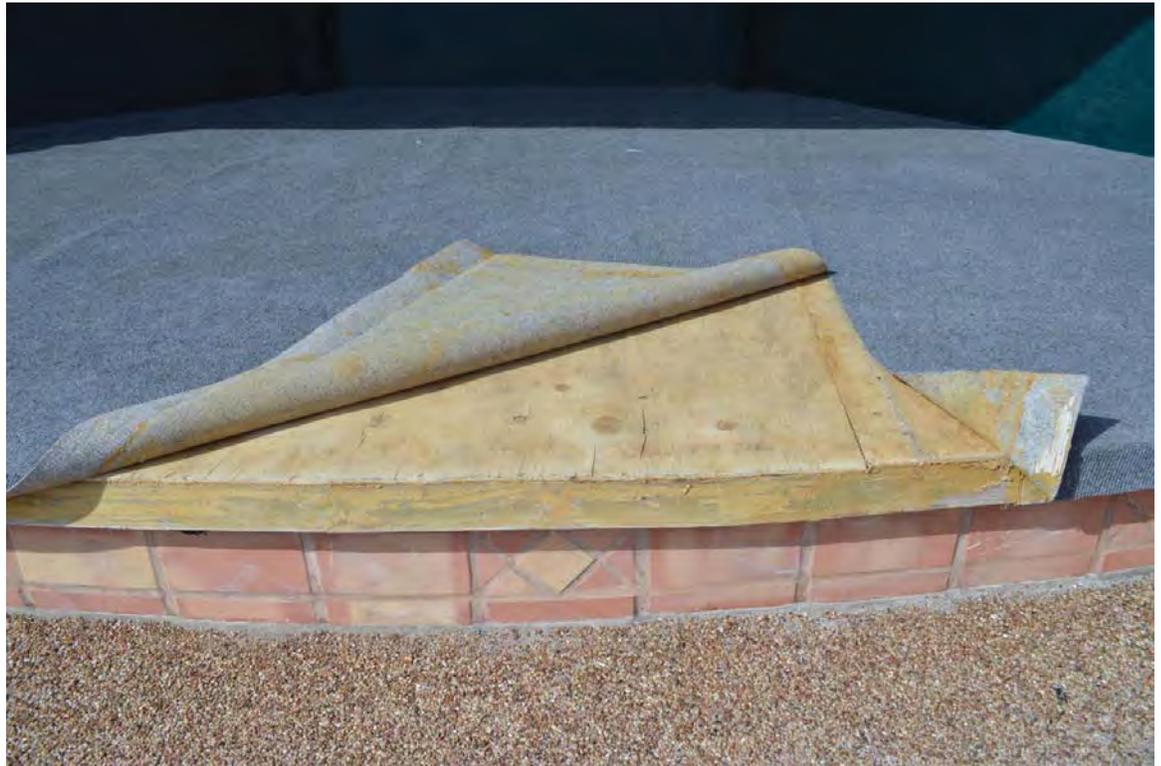
SAH-337

Name: Saint Anthony Hotel, 300 East Travis Street, San Antonio, Texas
View: Tenth Floor Starlight Terrace, detail at back wall of stage revealing construction
Description: Contemporary cementitious walls partially concealing historic steel structure
Date: November 2012

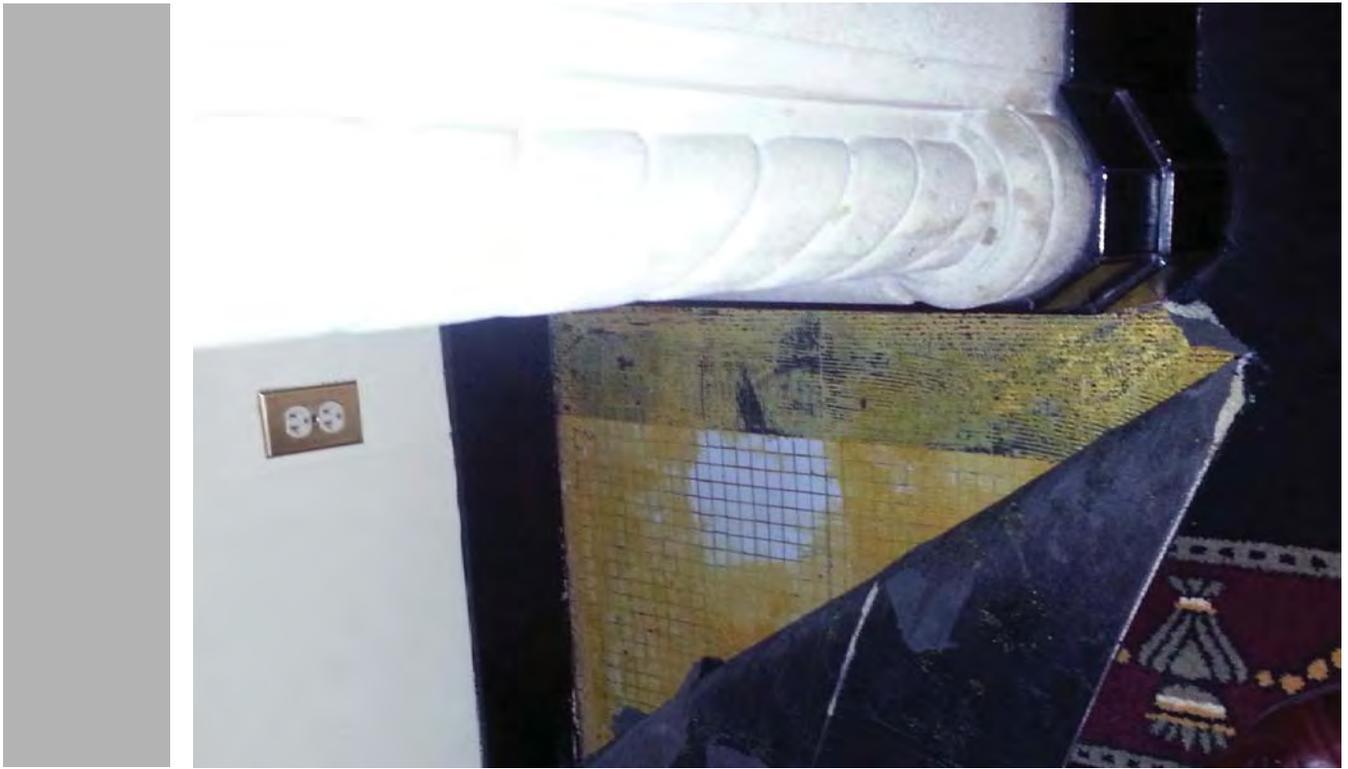
SAH-339

Name: Saint Anthony Hotel, 300 East Travis Street, San Antonio, Texas
View: First Floor Peacock Alley, detail of historic tile beneath existing carpet
Description: Carpet to be removed and tile cleaned of mastic and rehabilitated
Date: November 2012

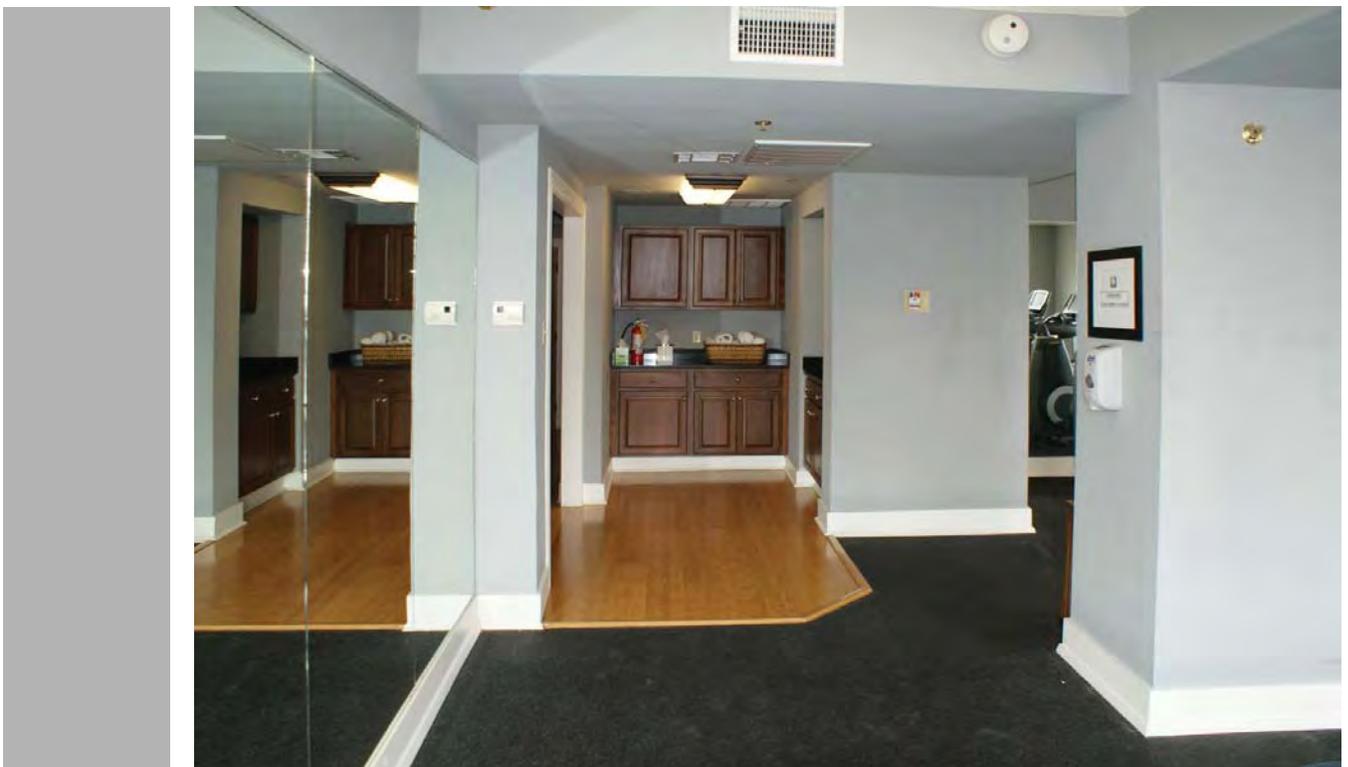
Photograph No.
SAH-346

Name: Saint Anthony Hotel, 300 East Travis Street, San Antonio, Texas
View: Tenth Level Starlight Terrace Event Room, looking southwest
Description: Non-historic finishes renovated; historic relationship to terrace re-established
Date: November 2012

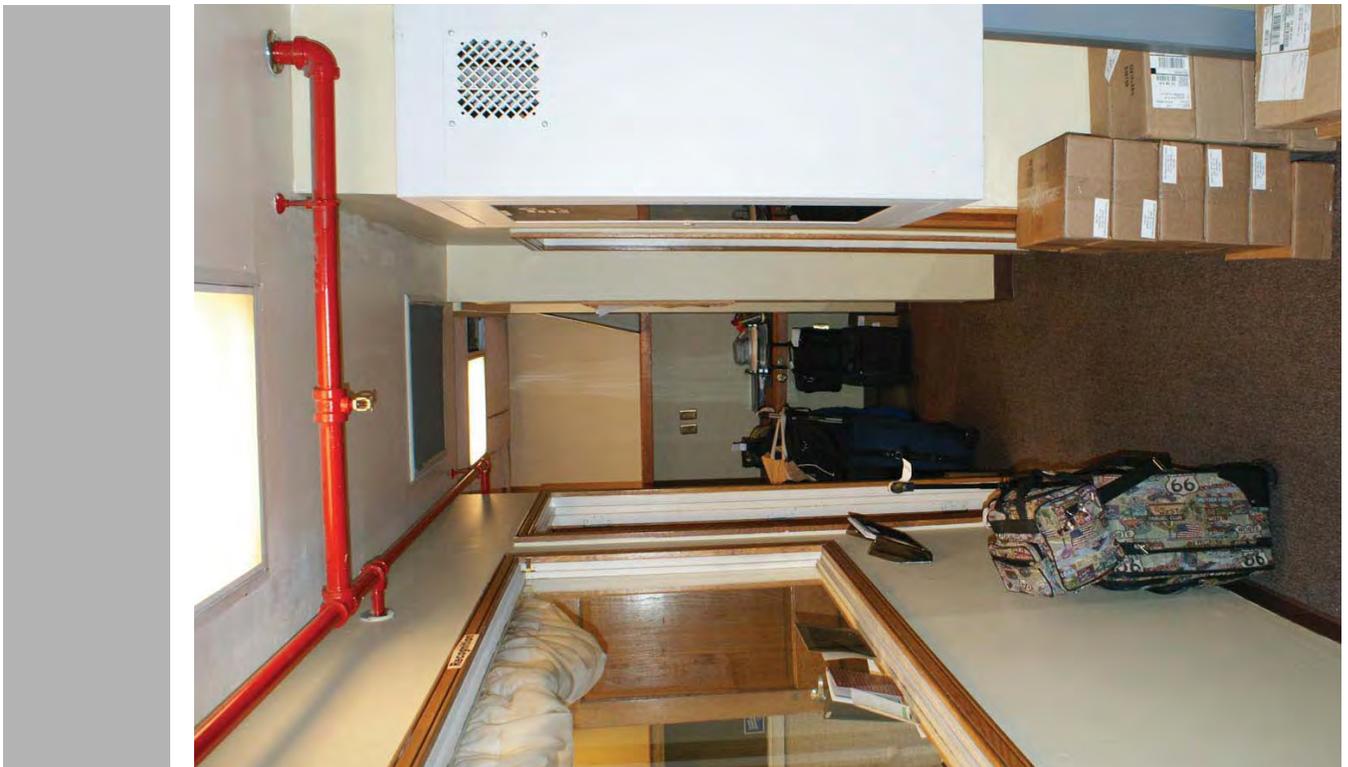
SAH-350

Name: Saint Anthony Hotel, 300 East Travis Street, San Antonio, Texas
View: First Level Concierge Office, looking southwest
Description: Non-historic finishes (1983 or later) renovated to create boutique
Date: November 2012

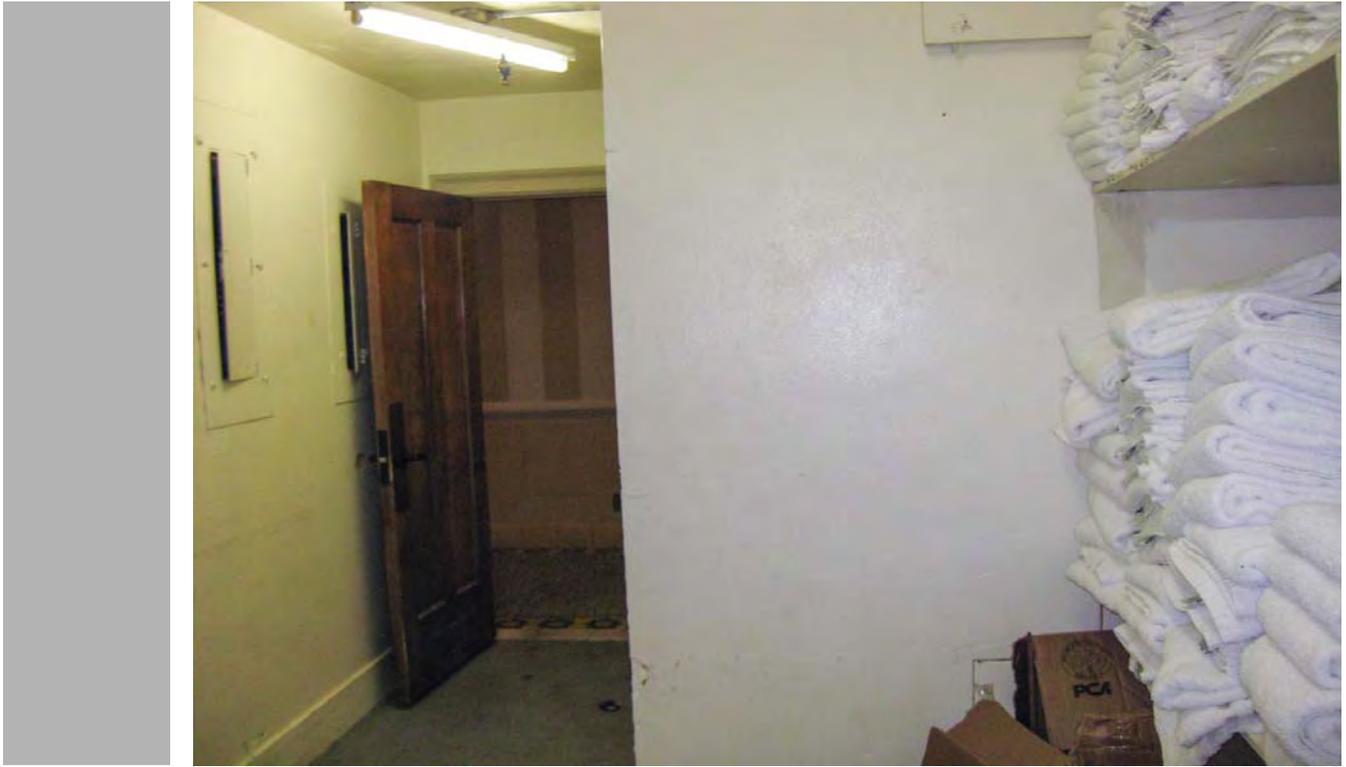
SAH-355

Name: Saint Anthony Hotel, 300 East Travis Street, San Antonio, Texas
View: First Level Front Desk back offices, looking east
Description: Area to receive routine maintenance, repairs & life safety upgrades
Date: November 2012
