HISTORIC AND DESIGN REVIEW COMMISSION

HDRC CASE NO: 2016-051
ADDRESS: 304 E TRAVIS ST
LEGAL DESCRIPTION: NCB 415 BLK 18 LOT A-7, A- 8, A-9, P-100, P-101 & P-102
ZONING: D HE
CITY COUNCIL DIST.: 1
LANDMARK: St Anthony Hotel
APPLICANT: Brandon Raney
OWNER: BCL St. Anthony ML, LP
TYPE OF WORK: Tax Verification
REQUEST:

St. Anthony Hotel
Scope Summary of Exterior Rehabilitation

ST. ANTHONY HOTEL RENOVATION
 PHOTO KEY PLAN - EXISTING 1ST FLOOR

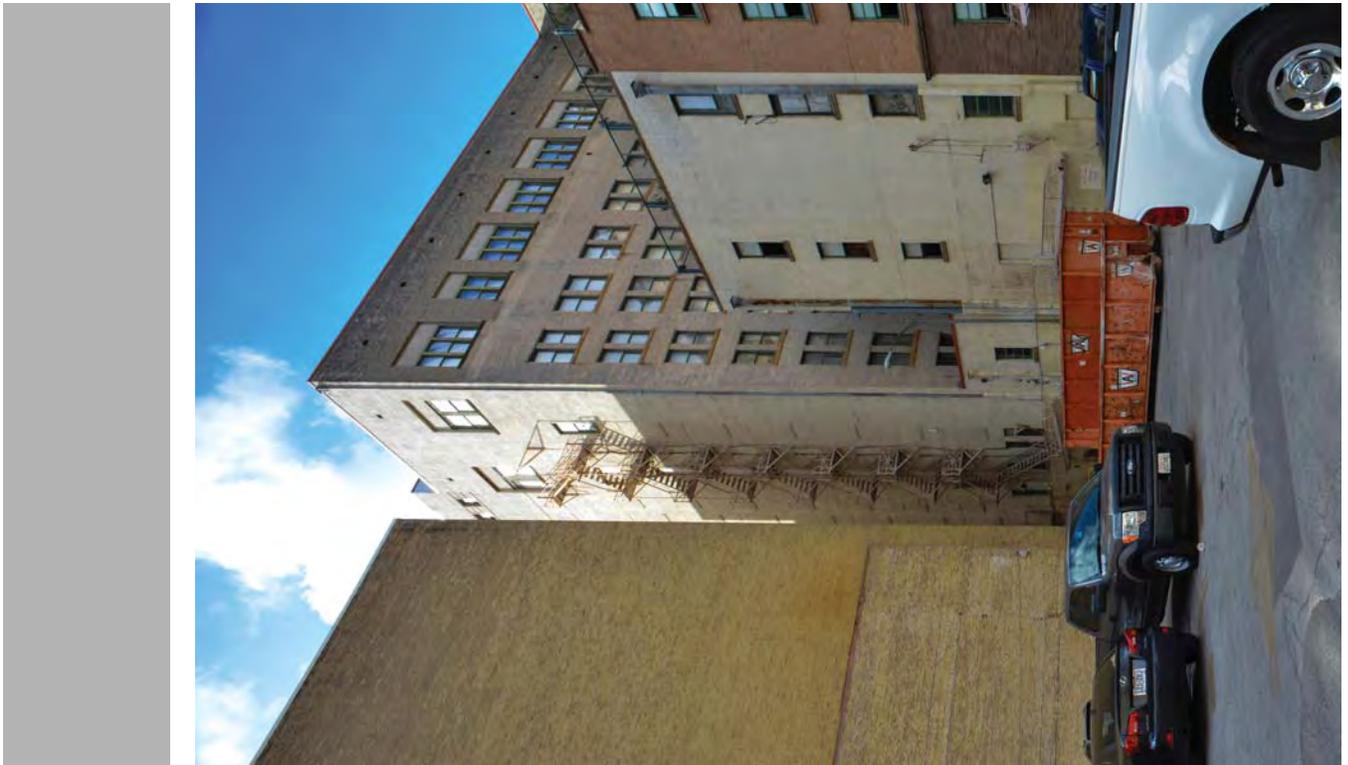
Photograph No.

Name: Saint Anthony Hotel, 300 East Travis Street, San Antonio, Texas
View: South facade of Tower 3 from Jefferson Street looking northwest
Description: Exterior fire escape from Tower 3 to alley
Date: September 2012

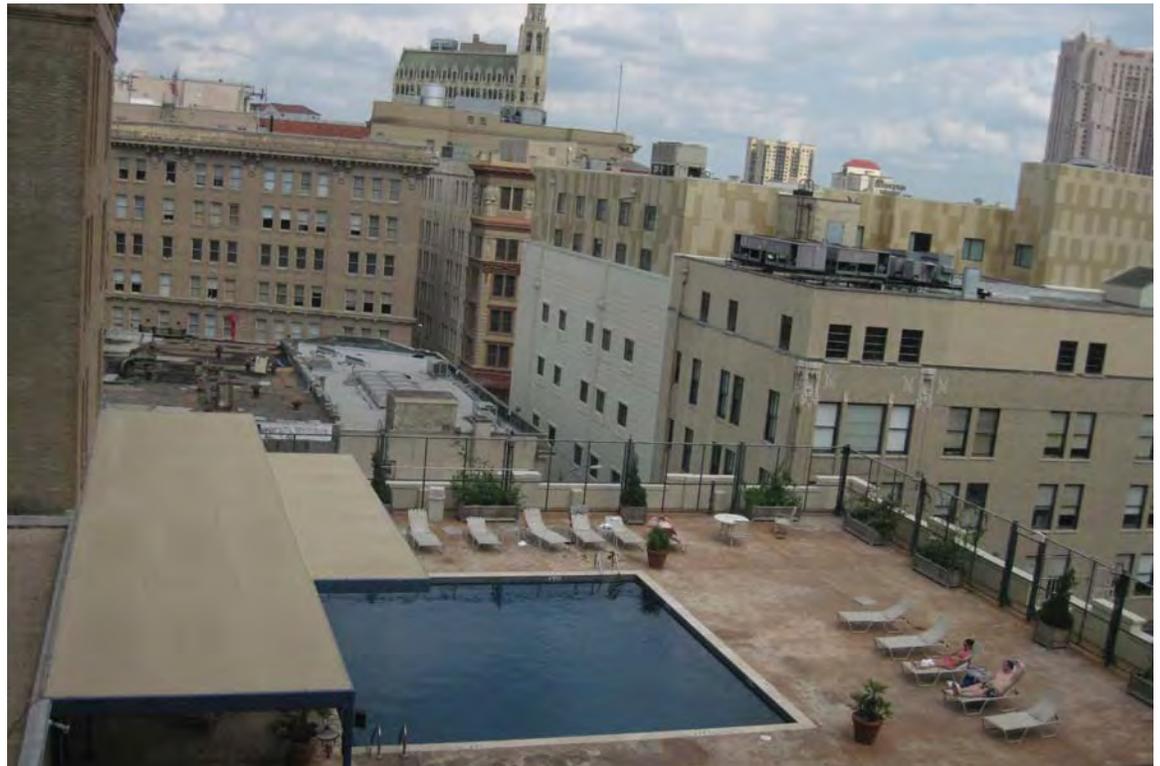
SAH-048

Name: Saint Anthony Hotel, 300 East Travis Street, San Antonio, Texas
View: Sixth floor pool terrace as seen from 8th floor, looking east-southeast
Description: General view of pool terrace, perimeter fencing and canopy structures
Date: September 2012

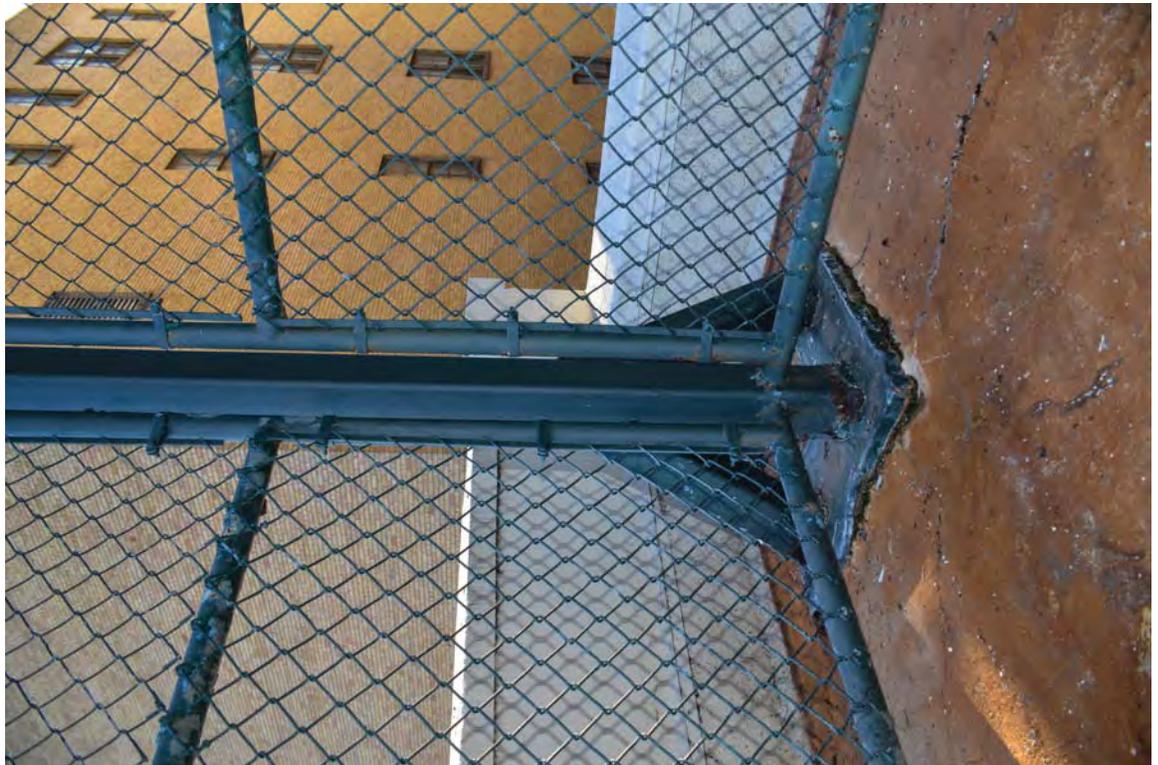
SAH-065

Name: Saint Anthony Hotel, 300 East Travis Street, San Antonio, Texas
View: Sixth floor pool terrace, looking southwest at terrace corner
Description: Detail of steel post and perimeter fencing
Date: September 2012

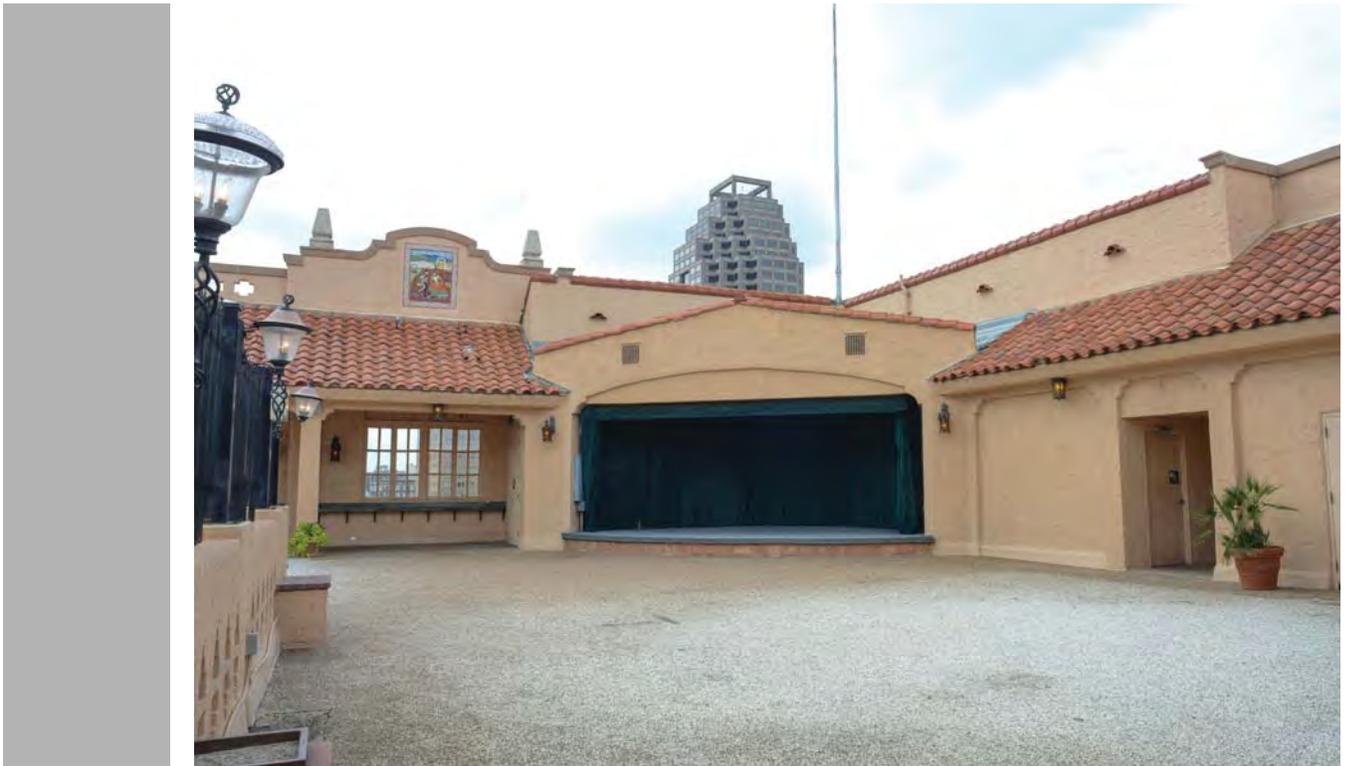
Photograph No.
SAH-070

Name: Saint Anthony Hotel, 300 East Travis Street, San Antonio, Texas
View: Tenth floor Starlight Terrace, looking northwest
Description: Proscenium and platform with non-historic restroom addition beyond
Date: September 2012

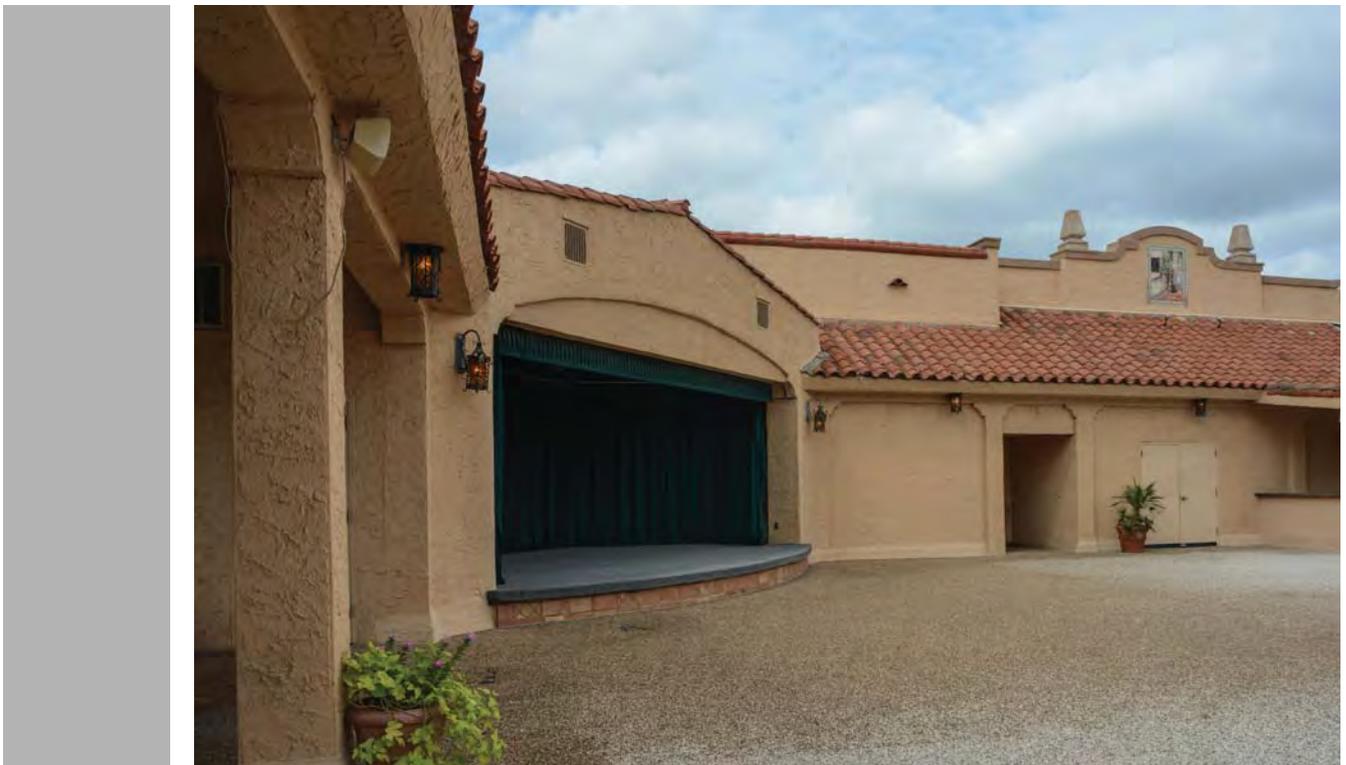
SAH-071

Name: Saint Anthony Hotel, 300 East Travis Street, San Antonio, Texas
View: Tenth floor Starlight Terrace, looking north
Description: Proscenium and platform with non-historic restroom addition beyond
Date: September 2012

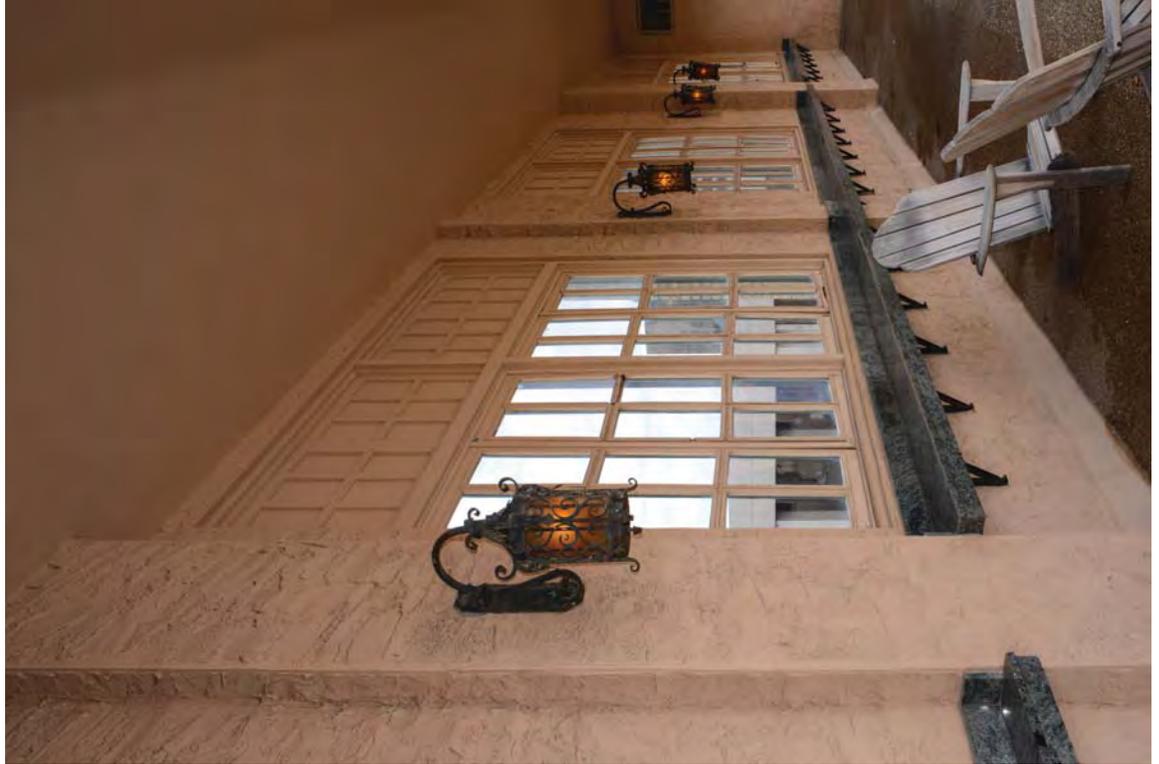
SAH-085

Name: Saint Anthony Hotel, 300 East Travis Street, San Antonio, Texas
View: Tenth floor Starlight Terrace, looking north at west colonnade
Description: Stucco columns, wood windows with transoms, & historic fixtures
Date: September 2012

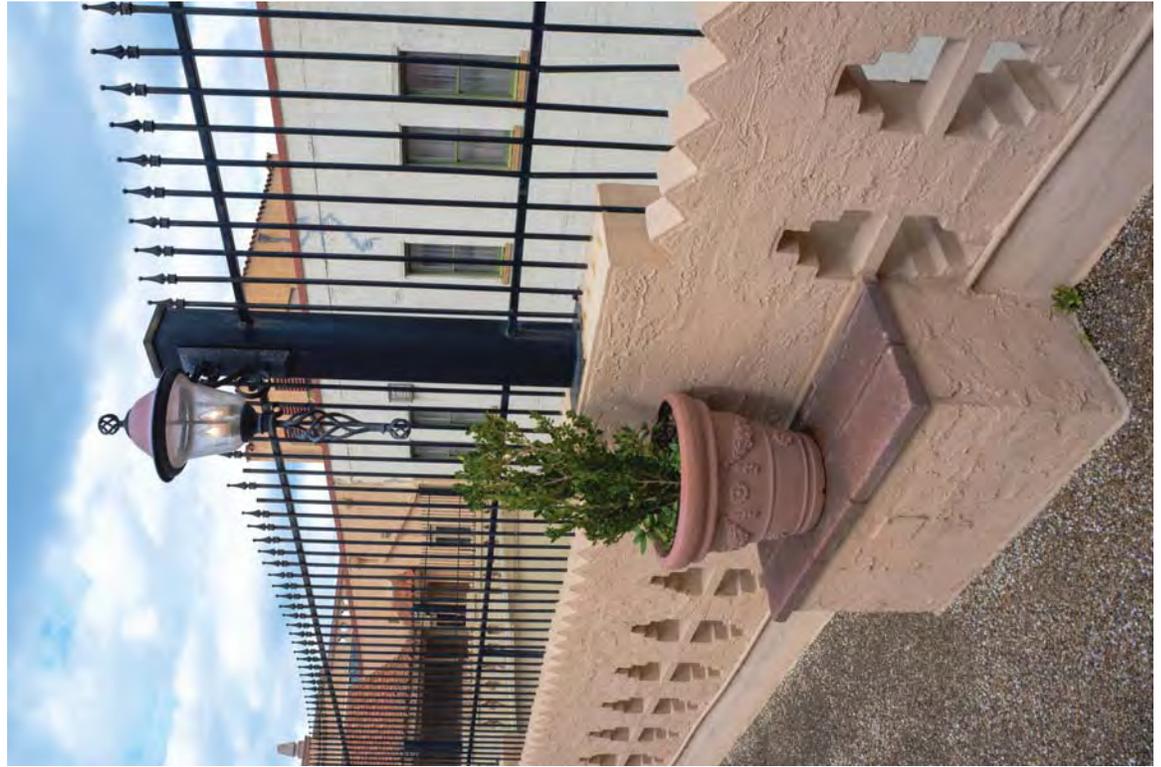
SAH-088

Name: Saint Anthony Hotel, 300 East Travis Street, San Antonio, Texas
View: Tenth floor Starlight Terrace parapet and guardrail
Description: Detail view of inappropriately scaled guardrail & non-historic podium
Date: September 2012

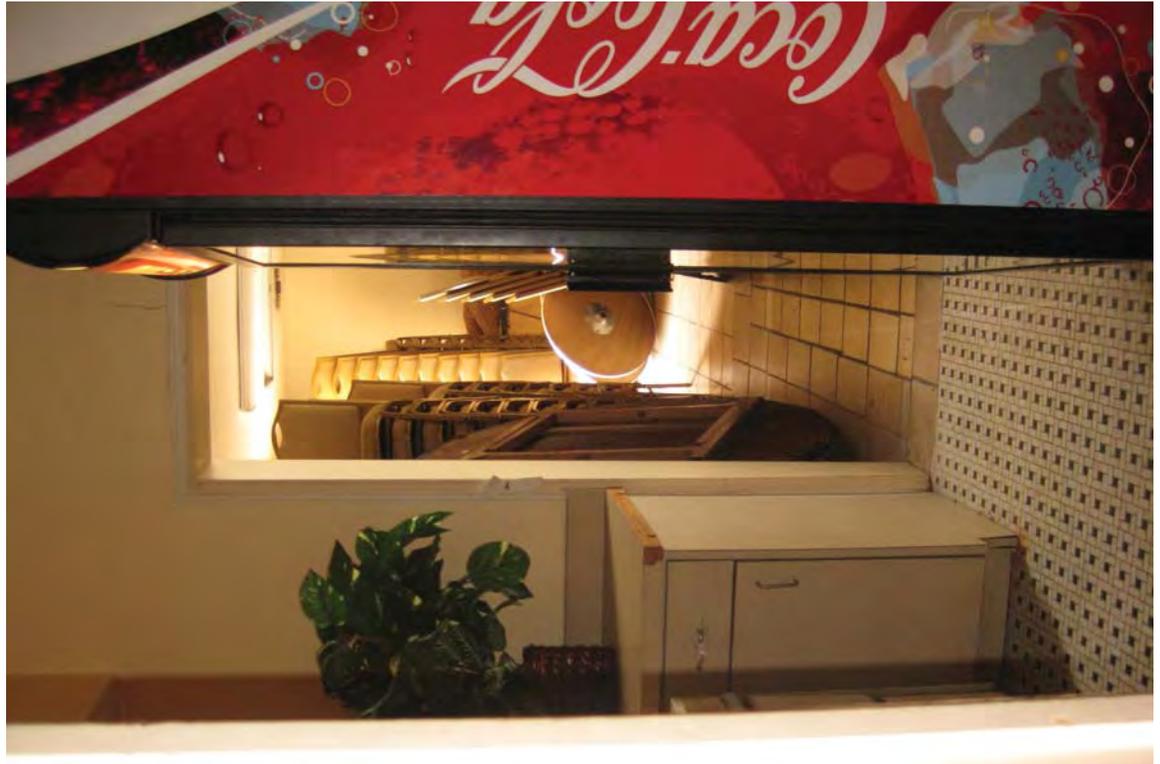
SAH-092

Name: Saint Anthony Hotel, 300 East Travis Street, San Antonio, Texas
View: Tenth floor Starlight Terrace storage room interior, looking west
Description: Non-historic infill addition at north colonnade to be demolished
Date: September 2012

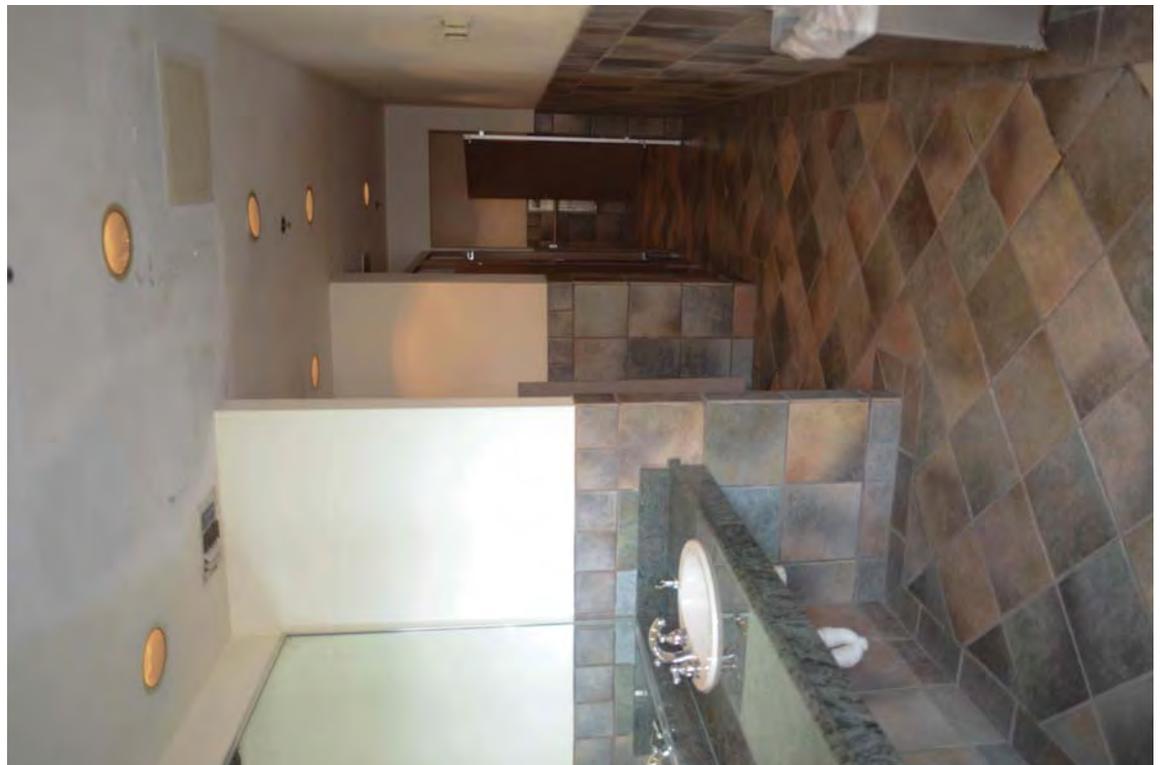
SAH-093

Name: Saint Anthony Hotel, 300 East Travis Street, San Antonio, Texas
View: Tenth floor Starlight Terrace restroom interior, looking north
Description: Non-historic infill addition behind stage to be demolished
Date: September 2012

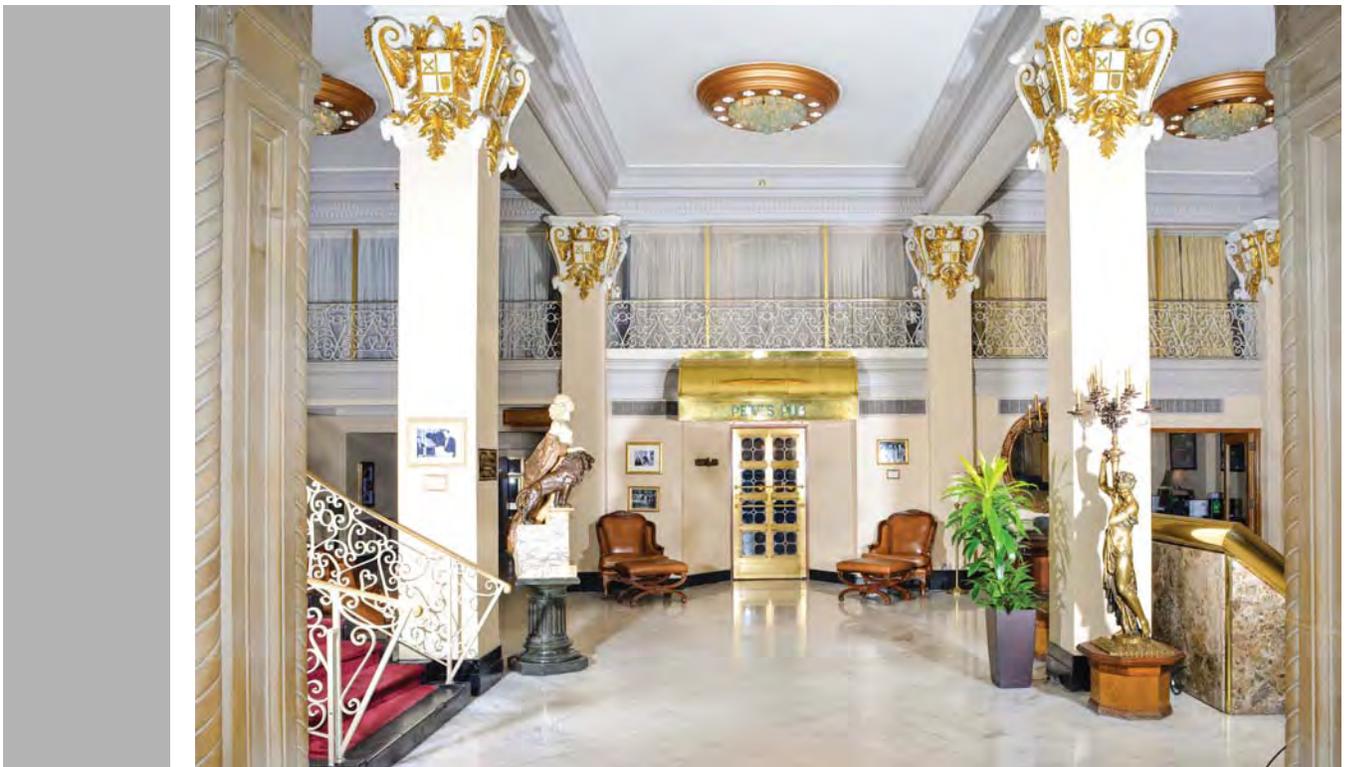
SAH-101

Name: Saint Anthony Hotel, 300 East Travis Street, San Antonio, Texas
View: First floor Grand Lobby interior, looking west
Description: Plexiglas panels at mezzanine, brass canopy and historic door
Date: September 2012

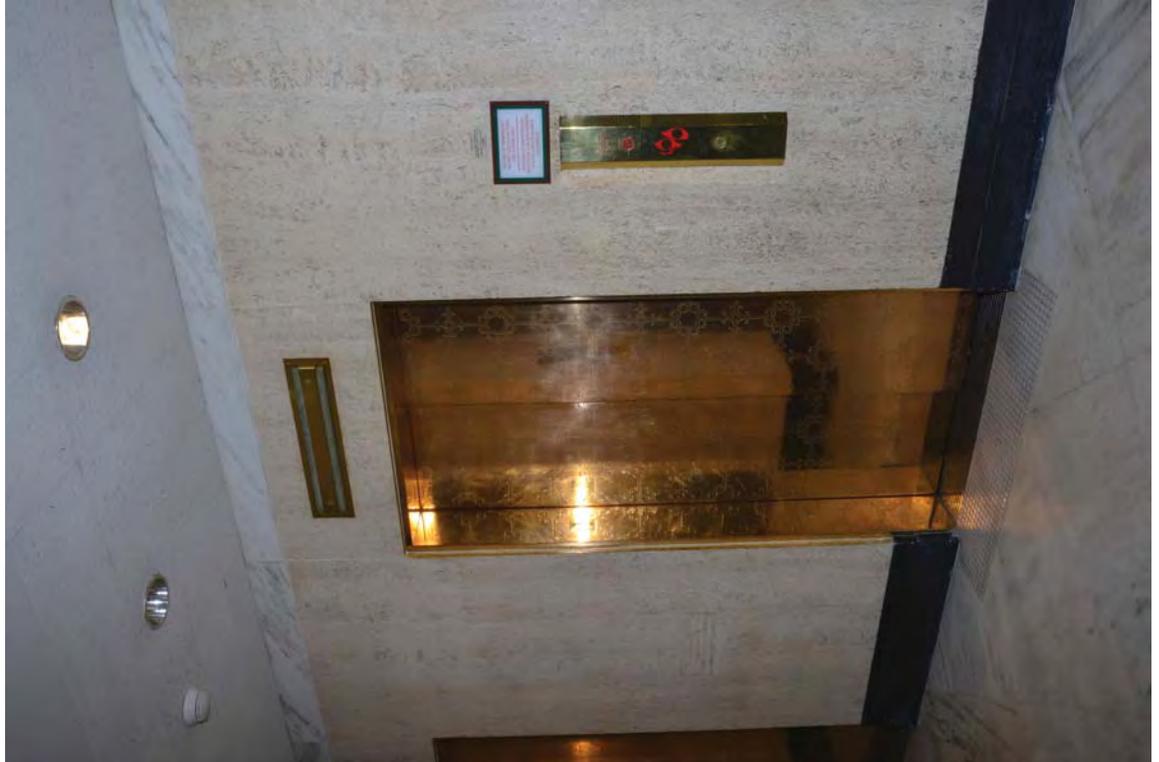
Photograph No.
SAH-111

Name: Saint Anthony Hotel, 300 East Travis Street, San Antonio, Texas
View: First floor elevator lobby interior, looking southeast
Description: Non-historic, engraved brass elevator doors and call buttons
Date: September 2012

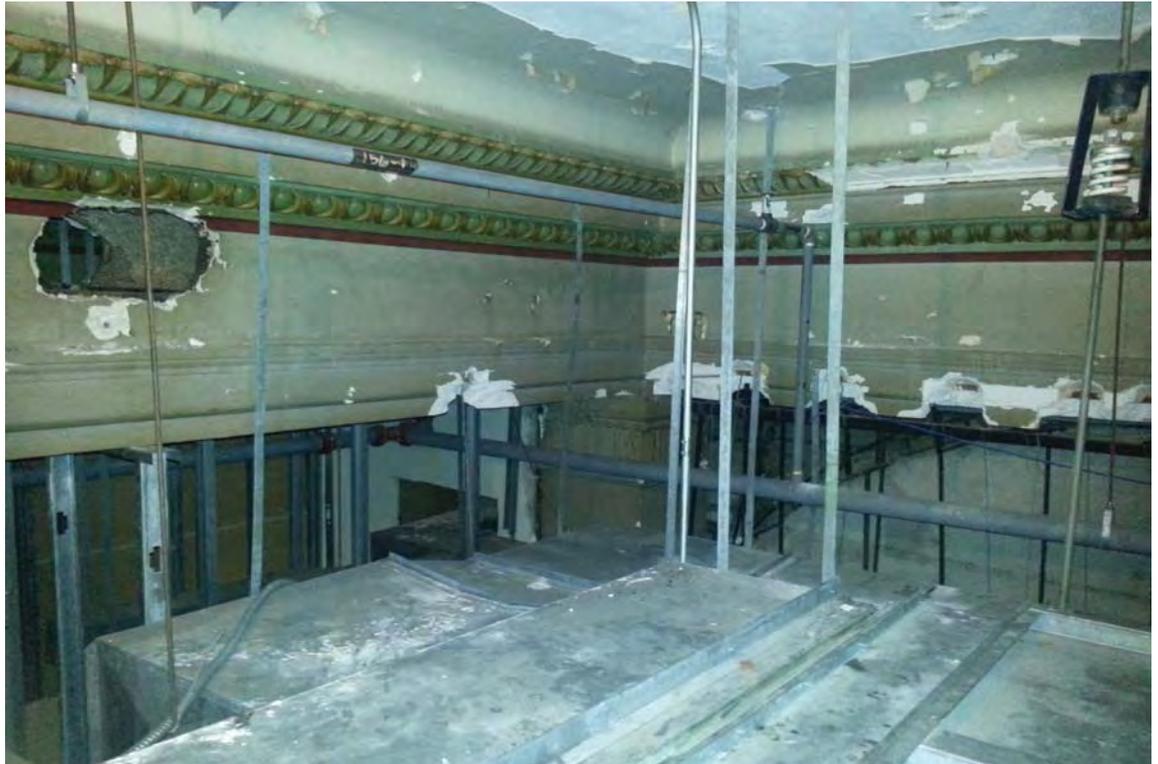
SAH-114

Name: Saint Anthony Hotel, 300 East Travis Street, San Antonio, Texas
View: First floor reception lobby interior, view above plaster groin vaults
Description: Mechanical equipment and remnants of original plaster ceiling
Date: September 2012

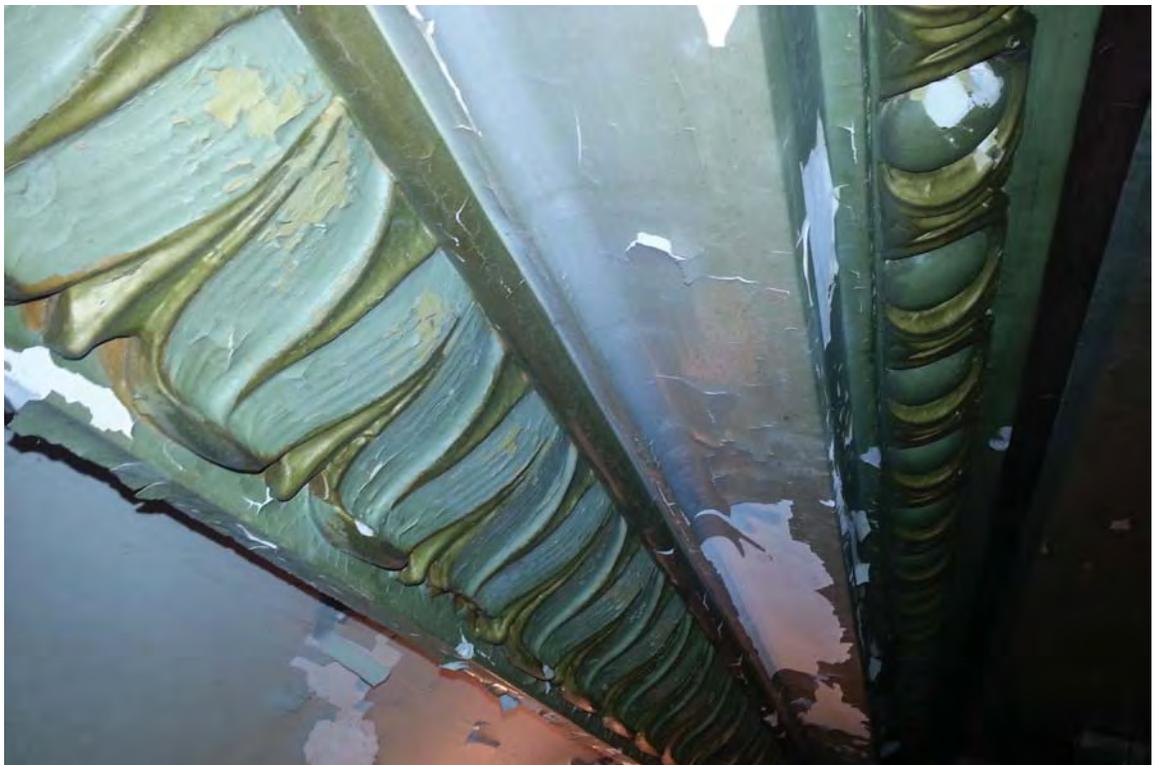
SAH-115

Name: Saint Anthony Hotel, 300 East Travis Street, San Antonio, Texas
View: First floor reception lobby interior, view above plaster groin vaults
Description: Detail of remnants of original plaster ceiling molding and paint
Date: September 2012

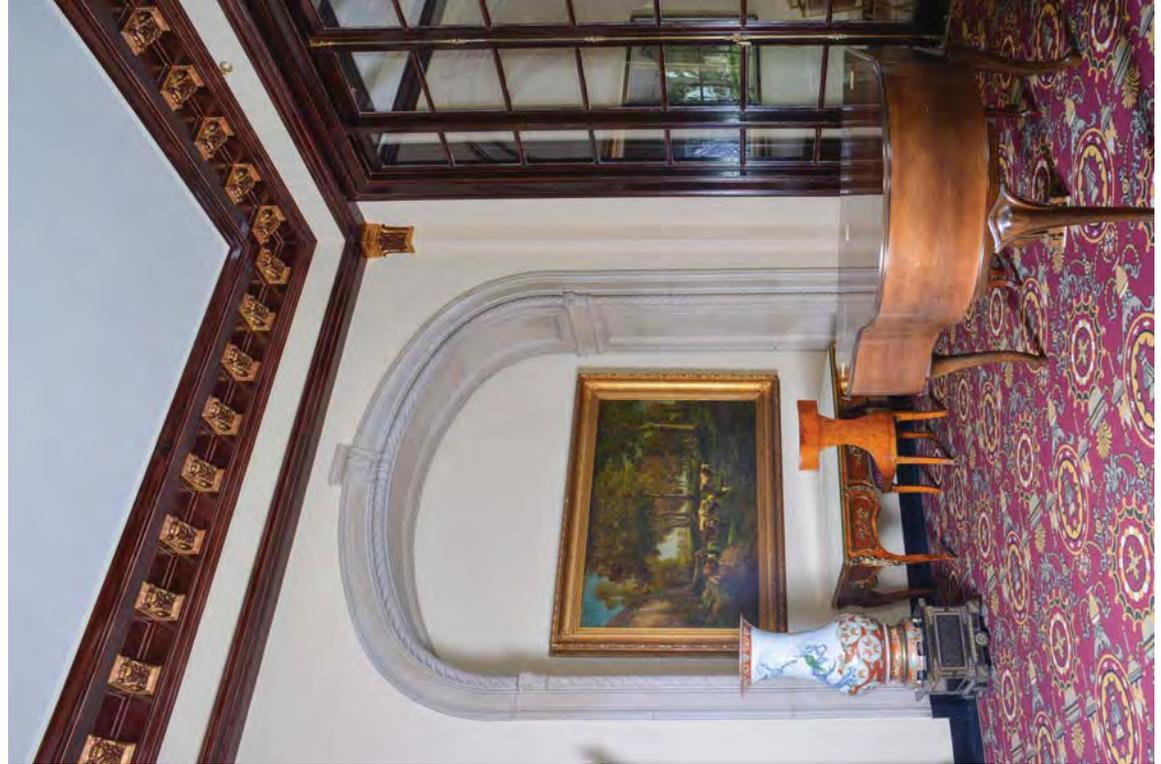
SAH-125

Name: Saint Anthony Hotel, 300 East Travis Street, San Antonio, Texas
View: First floor Peacock Alley interior, looking at northwest corner
Description: Cast stone arch with non-historic infill wall
Date: September 2012

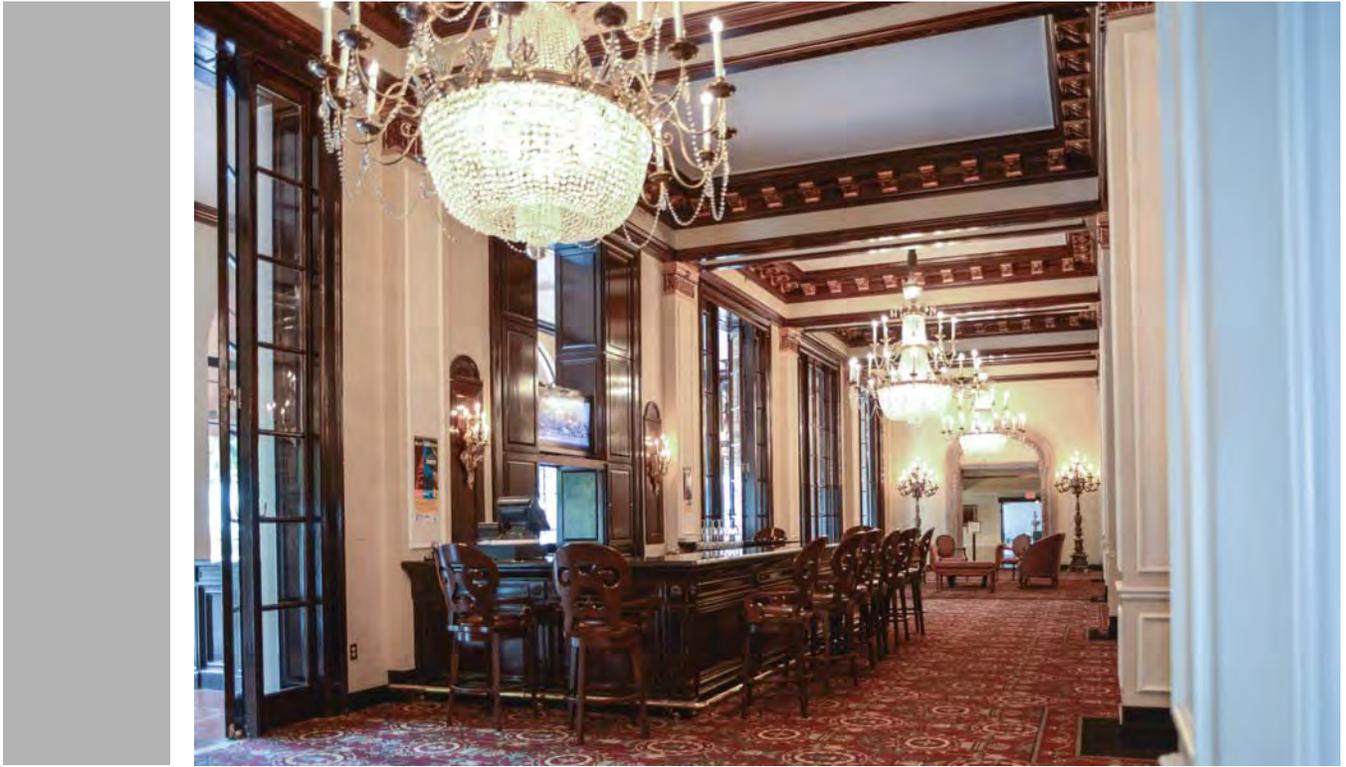
SAH-126

Name: Saint Anthony Hotel, 300 East Travis Street, San Antonio, Texas
View: First floor Peacock Alley interior, looking east at bar
Description: Non-historic bar & loggia door with solid panels
Date: September 2012

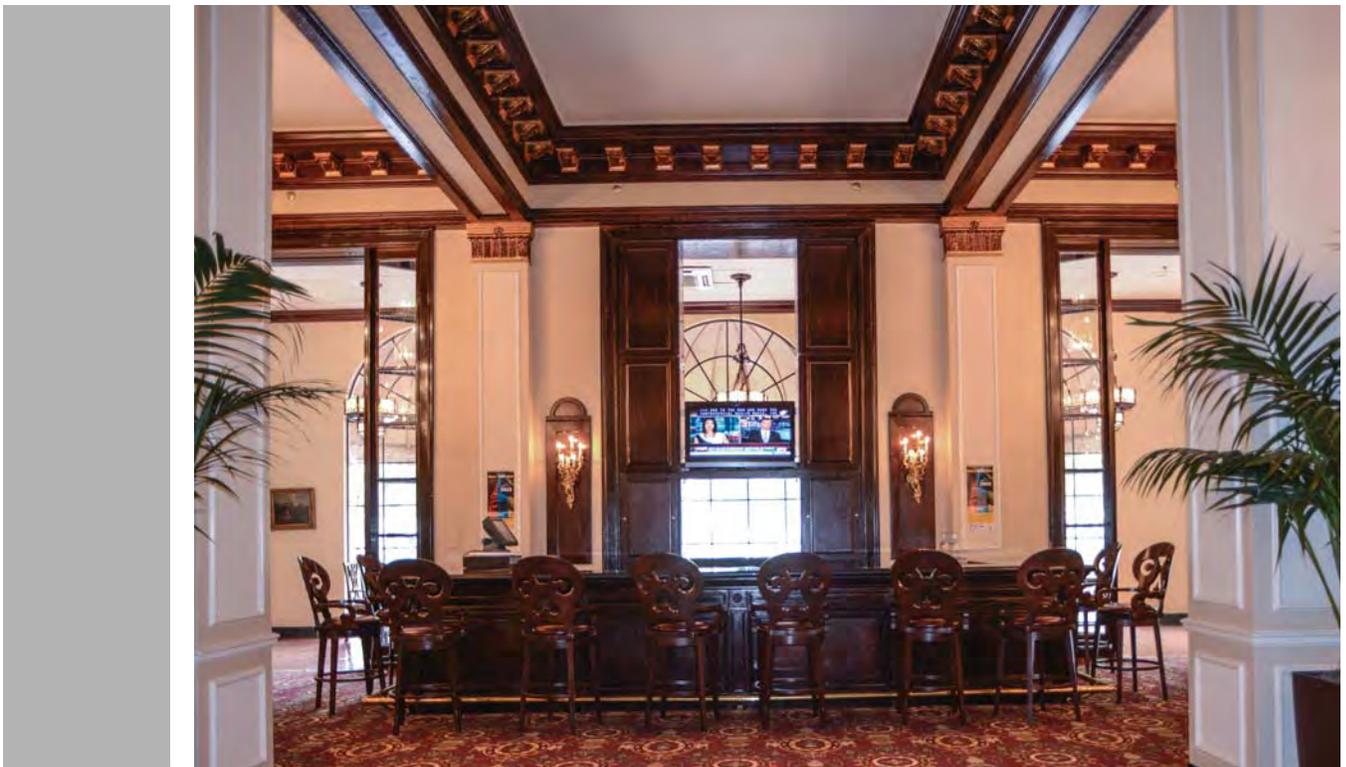
SAH-127

Name: Saint Anthony Hotel, 300 East Travis Street, San Antonio, Texas
View: First floor Peacock Alley interior, looking north at bar
Description: Non-historic bar & loggia door with solid panels
Date: September 2012

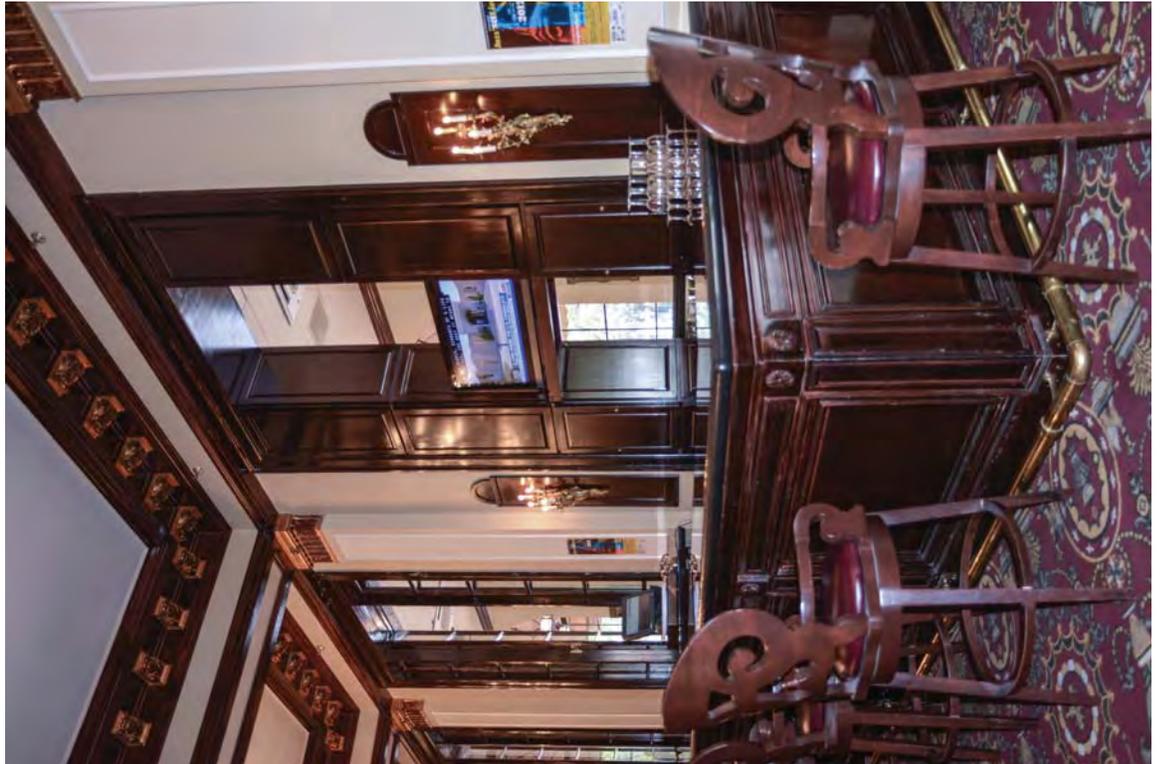
SAH-128

Name: Saint Anthony Hotel, 300 East Travis Street, San Antonio, Texas
View: First floor Peacock Alley interior, looking northwest at bar
Description: Non-historic bar & loggia door with solid panels
Date: September 2012

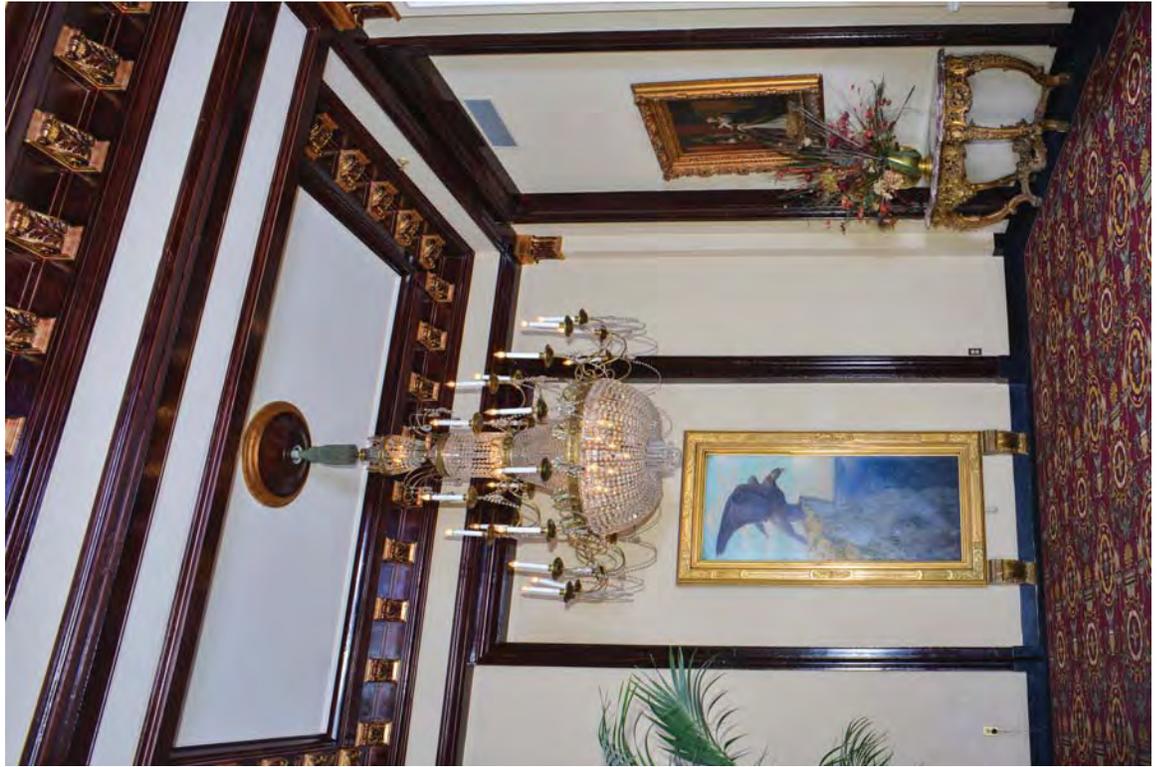
SAH-130

Name: Saint Anthony Hotel, 300 East Travis Street, San Antonio, Texas
View: First floor Peacock Alley interior, looking east
Description: Non-historic infill wall panel at east wall of Peacock Alley
Date: September 2012

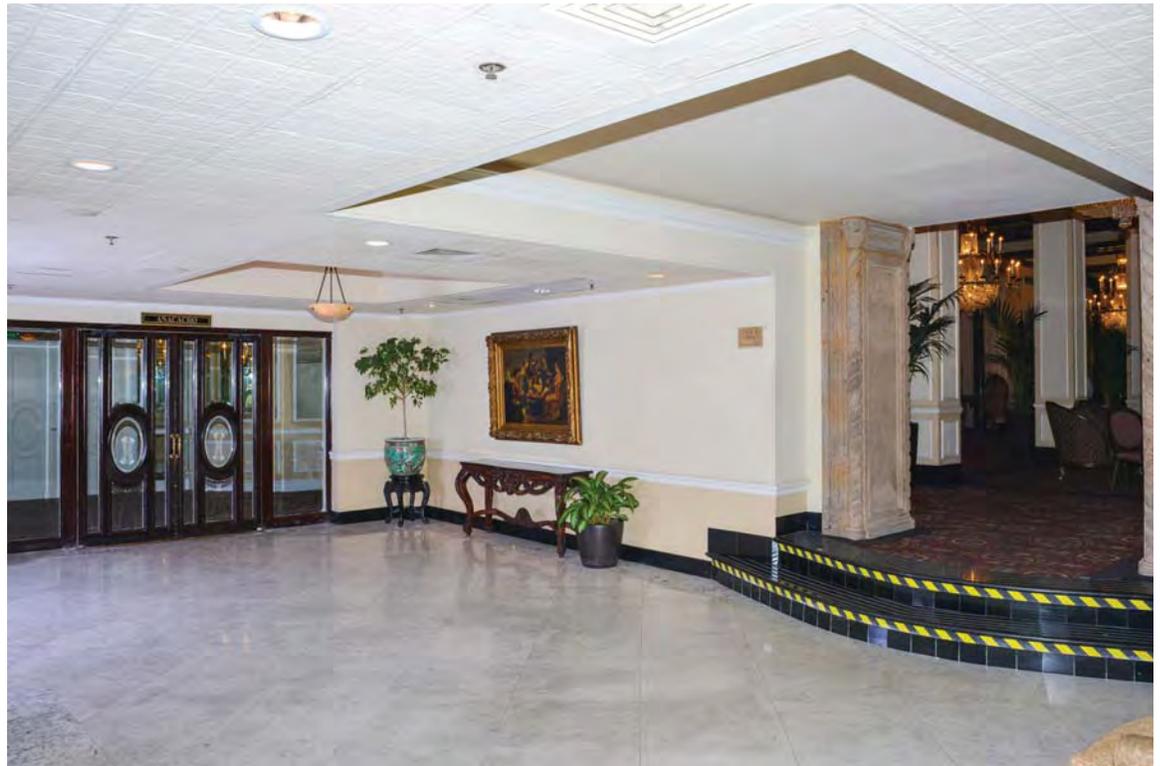
SAH-136

Name: Saint Anthony Hotel, 300 East Travis Street, San Antonio, Texas
View: First floor Motor Lobby interior, looking southwest
Description: Non-historic steps, canterra stone arch, marble flooring and ceiling
Date: September 2012

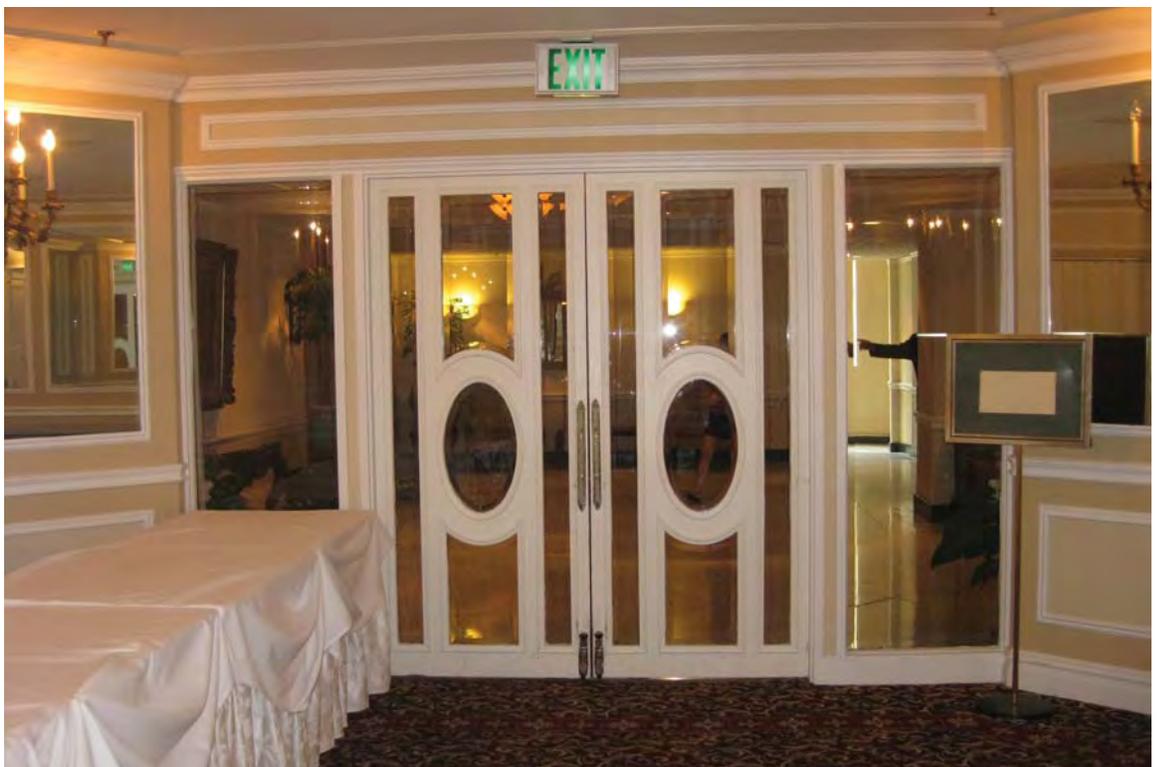
SAH-139

Name: Saint Anthony Hotel, 300 East Travis Street, San Antonio, Texas
View: First floor Anacacho pre-function interior, looking north
Description: Non-historic vestibule finishes and doors
Date: September 2012

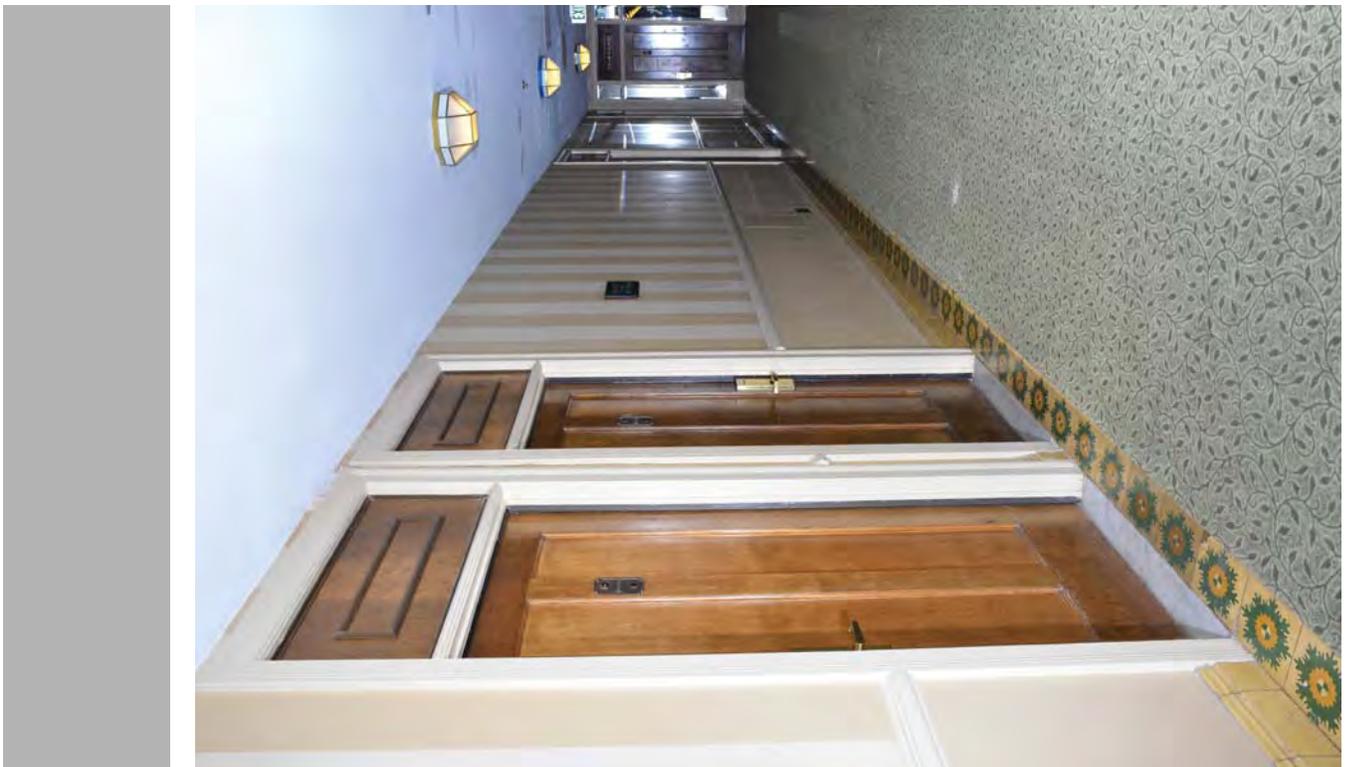
SAH-223

Name: Saint Anthony Hotel, 300 East Travis Street, San Antonio, Texas
View: Tenth floor corridor interior, looking east
Description: Typical guest level corridor with chair rail, tile border, tile base & room doors
Date: September 2012

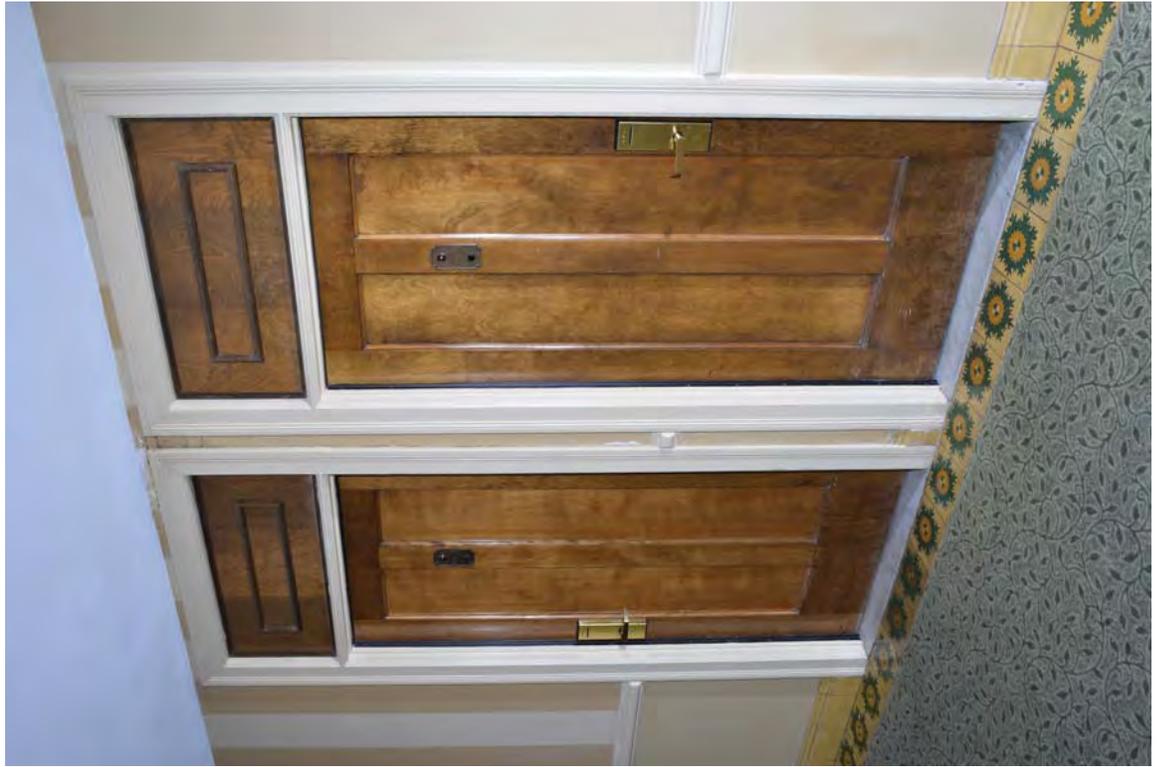
SAH-224

Name: Saint Anthony Hotel, 300 East Travis Street, San Antonio, Texas
View: Tenth floor corridor interior, looking northwest (rooms 1074 & 1076)
Description: Typical recessed panel wood doors with wood transom panel
Date: September 2012

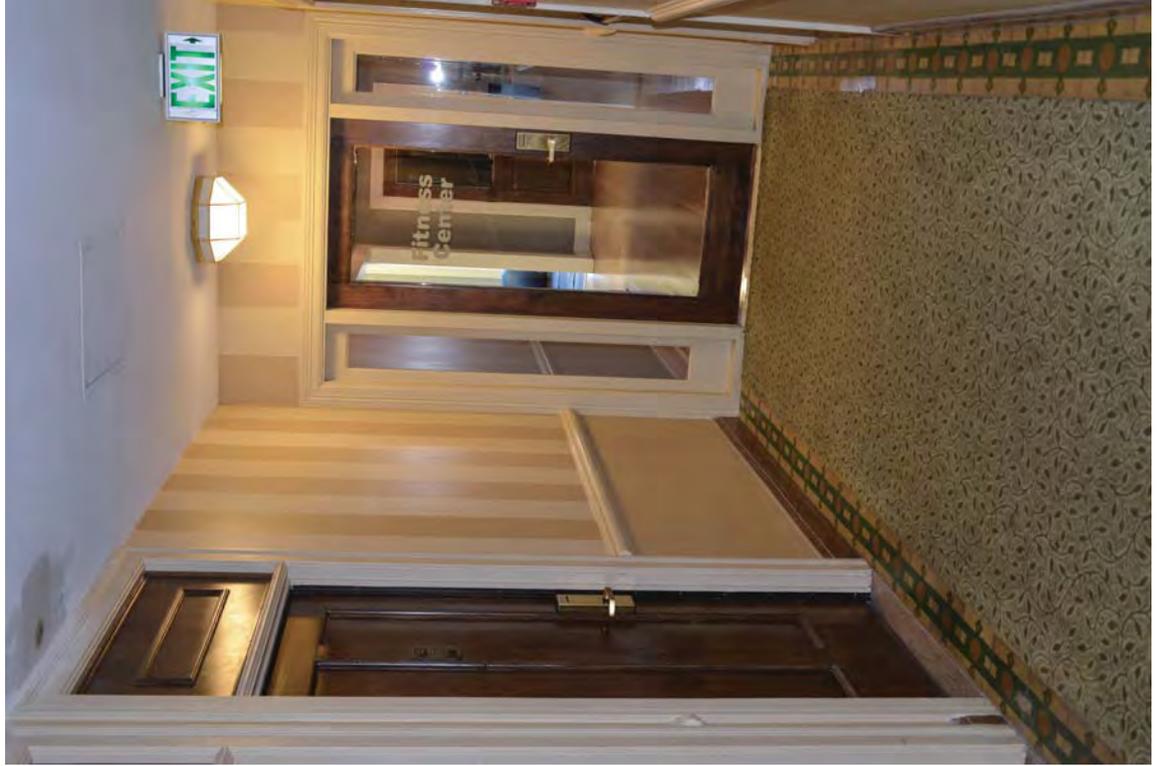
Photograph No.
SAH-225

Name: Saint Anthony Hotel, 300 East Travis Street, San Antonio, Texas
View: Sixth floor corridor interior, looking east
Description: Entry door to fitness center with mirror sidelights and beveled glass door
Date: September 2012
