HISTORIC AND DESIGN REVIEW COMMISSION

HDRC CASE NO: 2016-051
ADDRESS: 304 E TRAVIS ST
LEGAL DESCRIPTION: NCB 415 BLK 18 LOT A-7, A- 8, A-9, P-100, P-101 & P-102
ZONING: D HE
CITY COUNCIL DIST.: 1
LANDMARK: St Anthony Hotel
APPLICANT: Brandon Raney
OWNER: BCL St. Anthony ML, LP
TYPE OF WORK: Tax Verification
REQUEST:

St. Anthony Hotel
Scope Summary of Exterior Rehabilitation

ST. ANTHONY HOTEL RENOVATION
 PHOTO KEY PLAN - EXISTING 1ST FLOOR

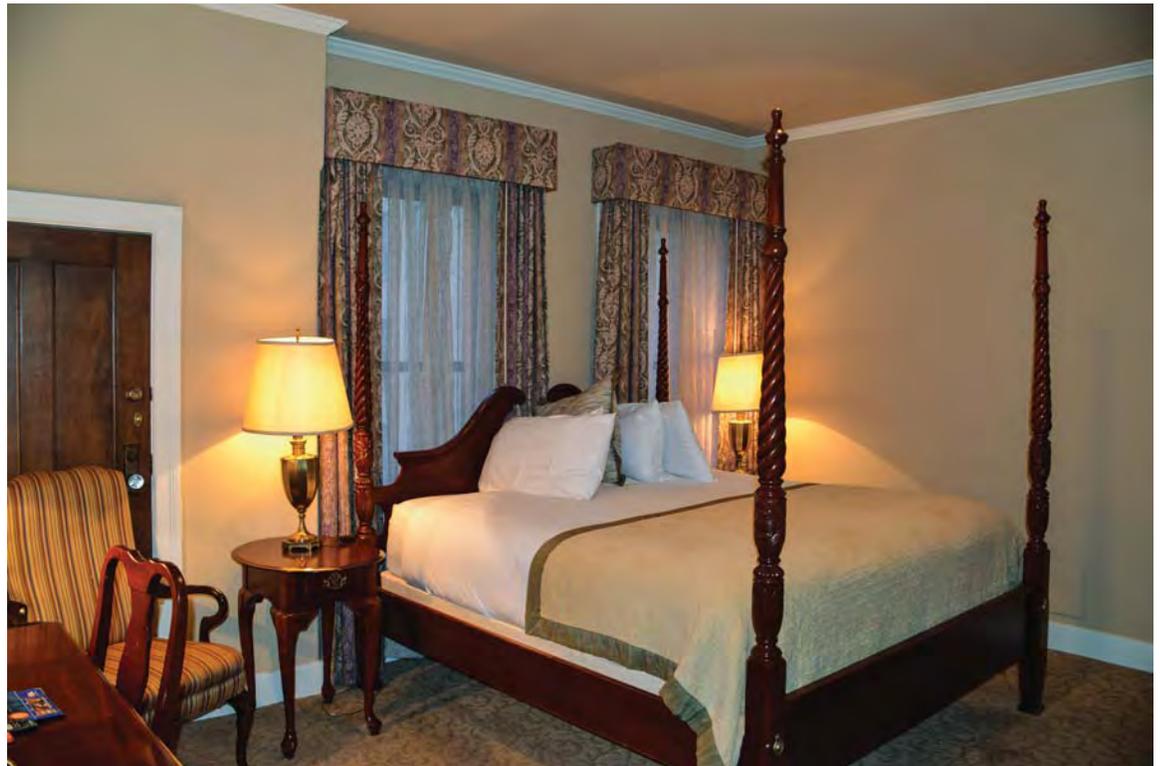
SAH-238

Name: Saint Anthony Hotel, 300 East Travis Street, San Antonio, Texas
View: Typical guest room with single king-sized bed
Description: Small, wood crown molding, and simple base; 2-inch thick plaster walls
Date: September 2012

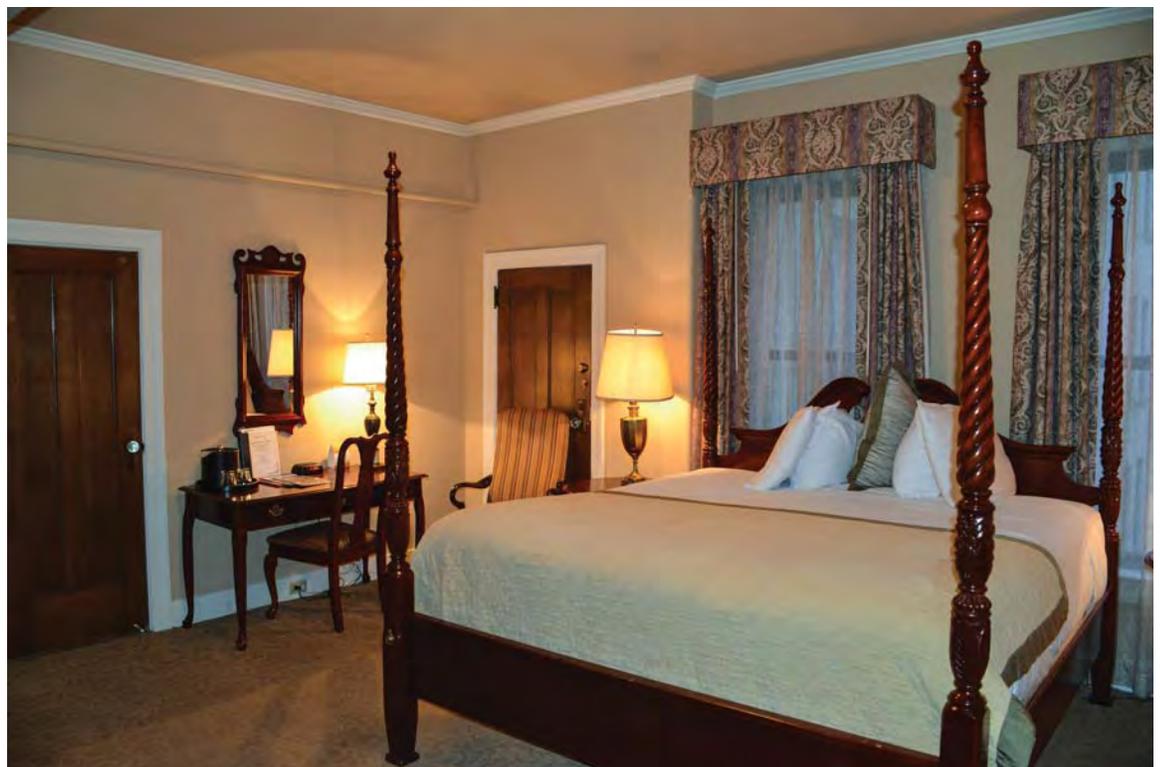
SAH-239

Name: Saint Anthony Hotel, 300 East Travis Street, San Antonio, Texas
View: Typical guest room with single king-sized bed
Description: Simple crown & door trim and recessed door panels; exposed sprinkler piping
Date: September 2012

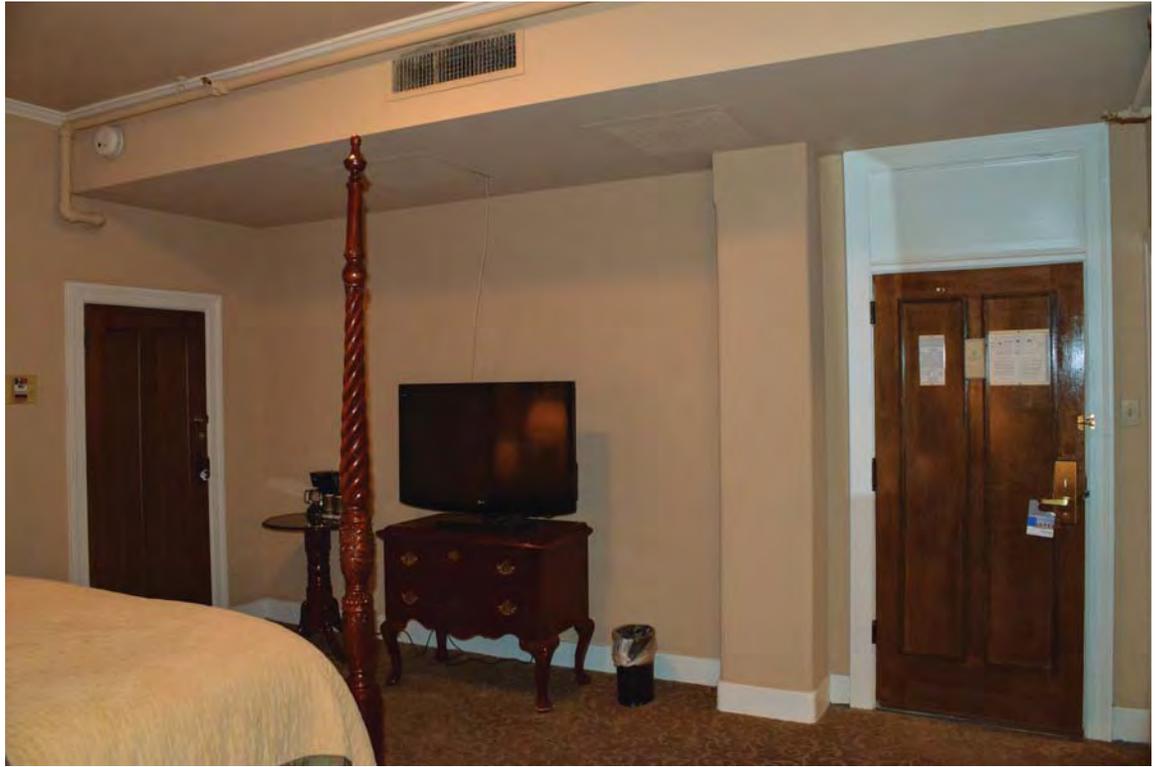
SAH-240

Name: Saint Anthony Hotel, 300 East Travis Street, San Antonio, Texas
View: Typical guest room with single king-sized bed
Description: Mechanical furr down & exposed sprinkler piping; entry door w/ transom panel
Date: September 2012

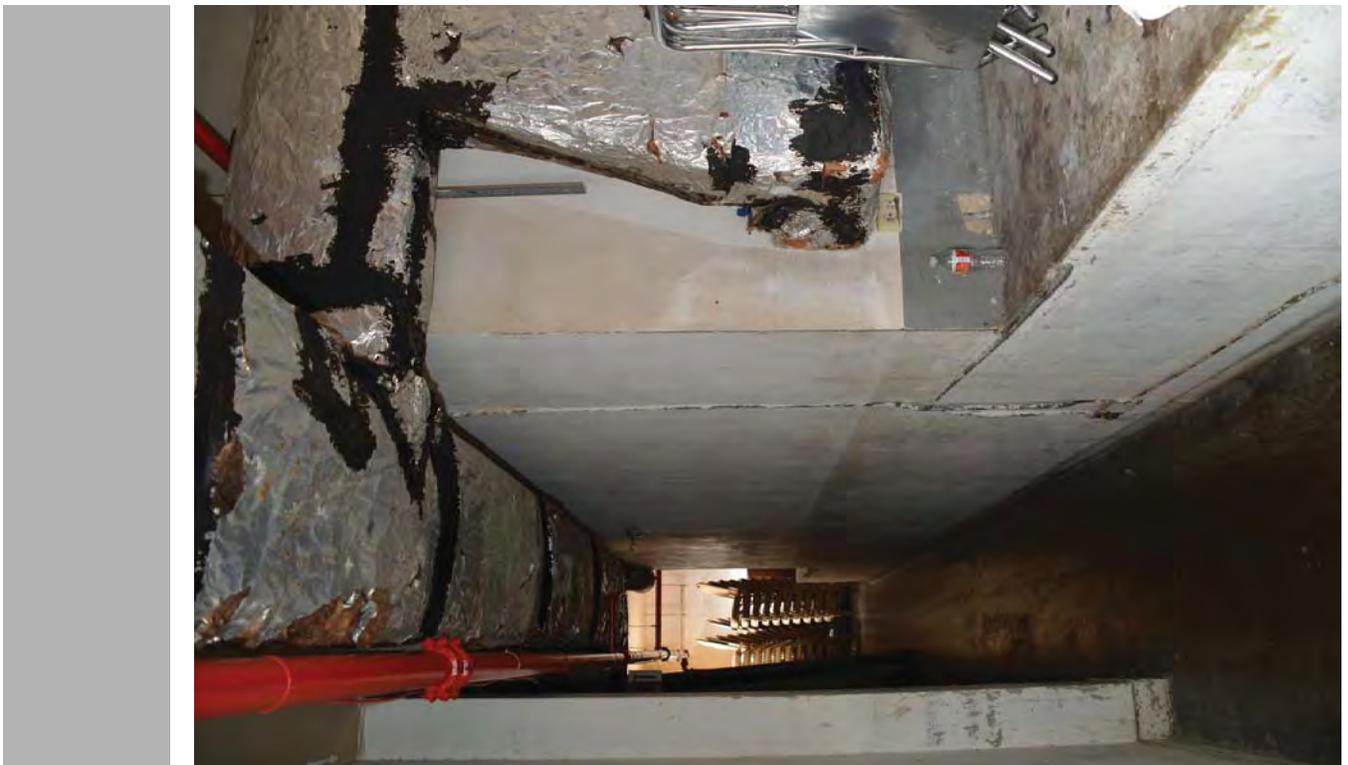
SAH-287

Name: Saint Anthony Hotel, 300 East Travis Street, San Antonio, Texas
View: Anacacho Room Mezzanine Level back stage area looking west
Description: Area to receive routine maintenance, repairs & life safety upgrades
Date: November 2012

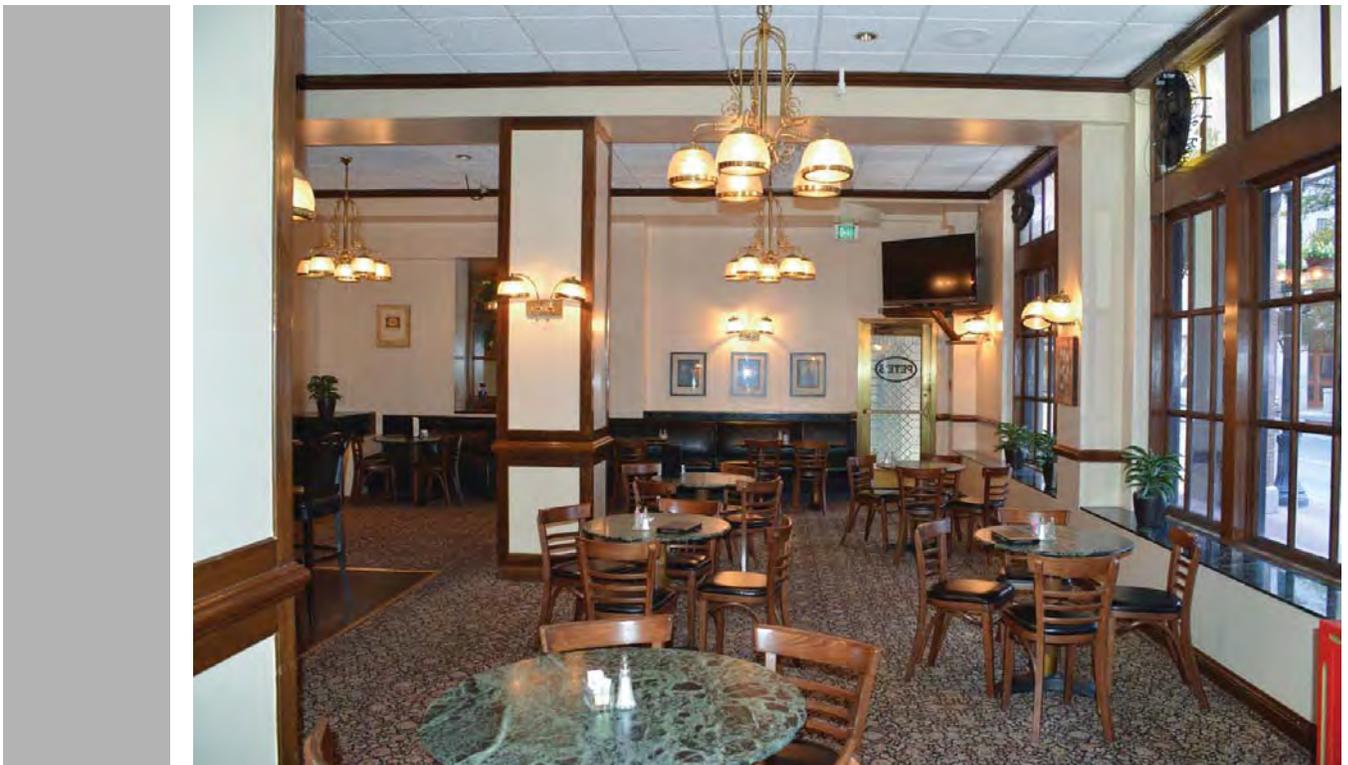
SAH-313

Name: Saint Anthony Hotel, 300 East Travis Street, San Antonio, Texas
View: First Level at Pete's Pub, looking south at exterior walls, windows & entry
Description: New pub entry to Navarro Street Lobby to re-establish historic relationship
Date: November 2012

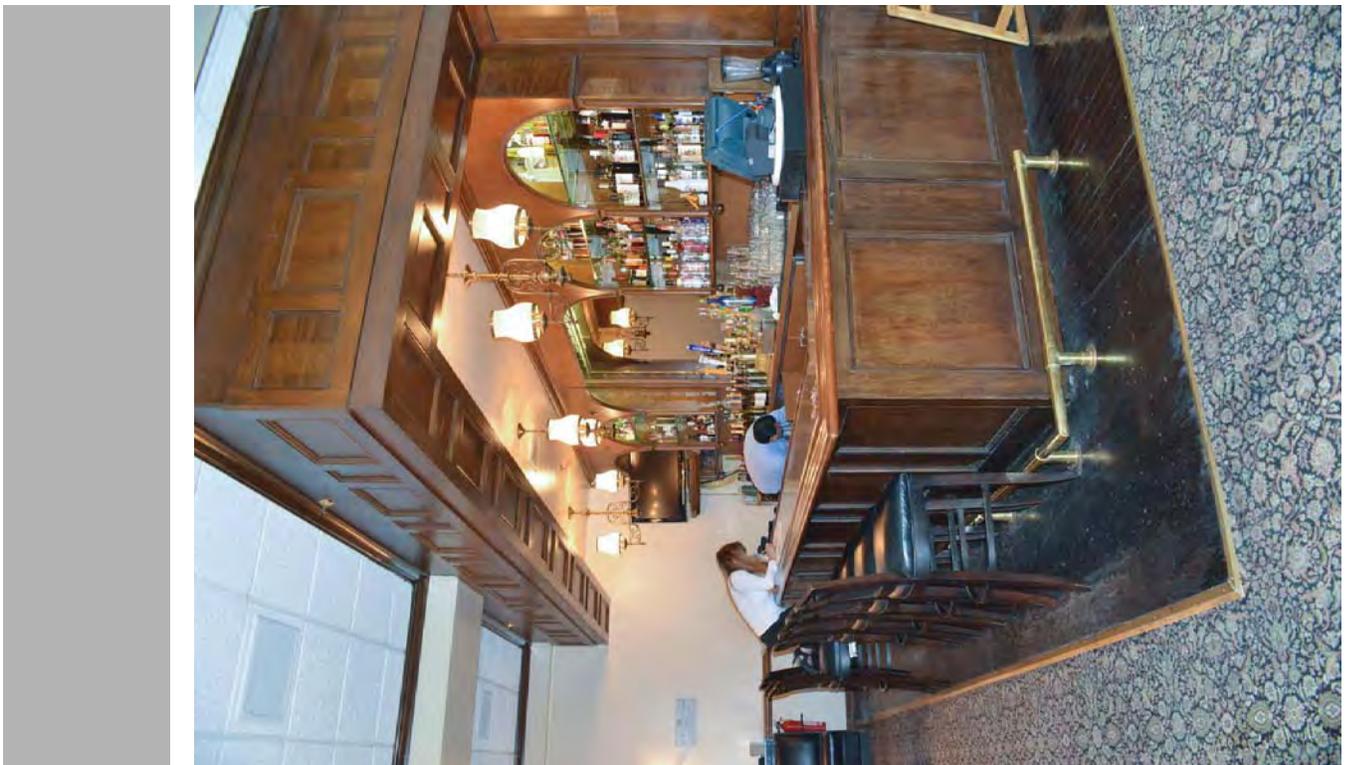
SAH-315

Name: Saint Anthony Hotel, 300 East Travis Street, San Antonio, Texas
View: First Level at Pete's Pub, looking north at bar
Description: Non-historic (1983) finishes & fixtures to be removed & pub renovated
Date: November 2012

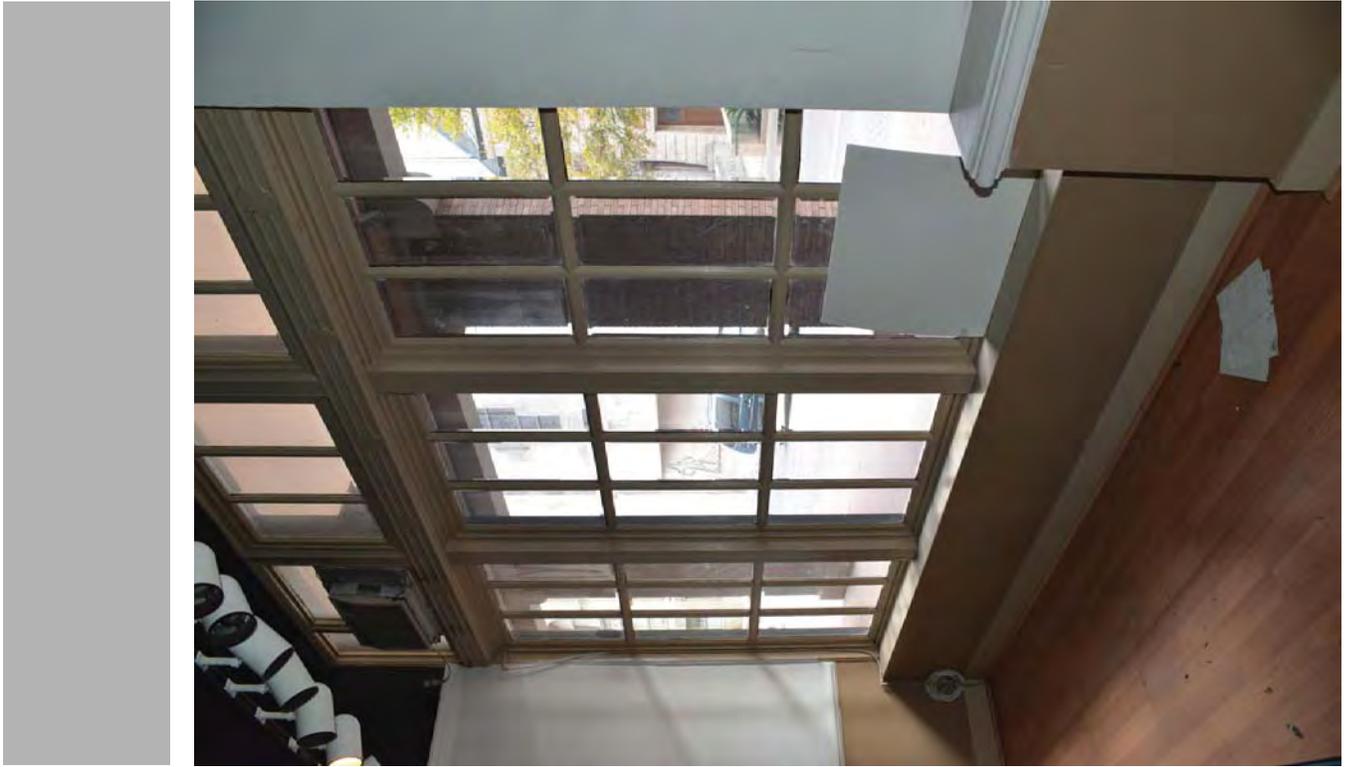
SAH-316

Name: Saint Anthony Hotel, 300 East Travis Street, San Antonio, Texas
View: First Level Retail Space, looking southwest at exterior wall and windows
Description: Historic windows retained *in situ*; creation of ADA access elevator lobby
Date: November 2012

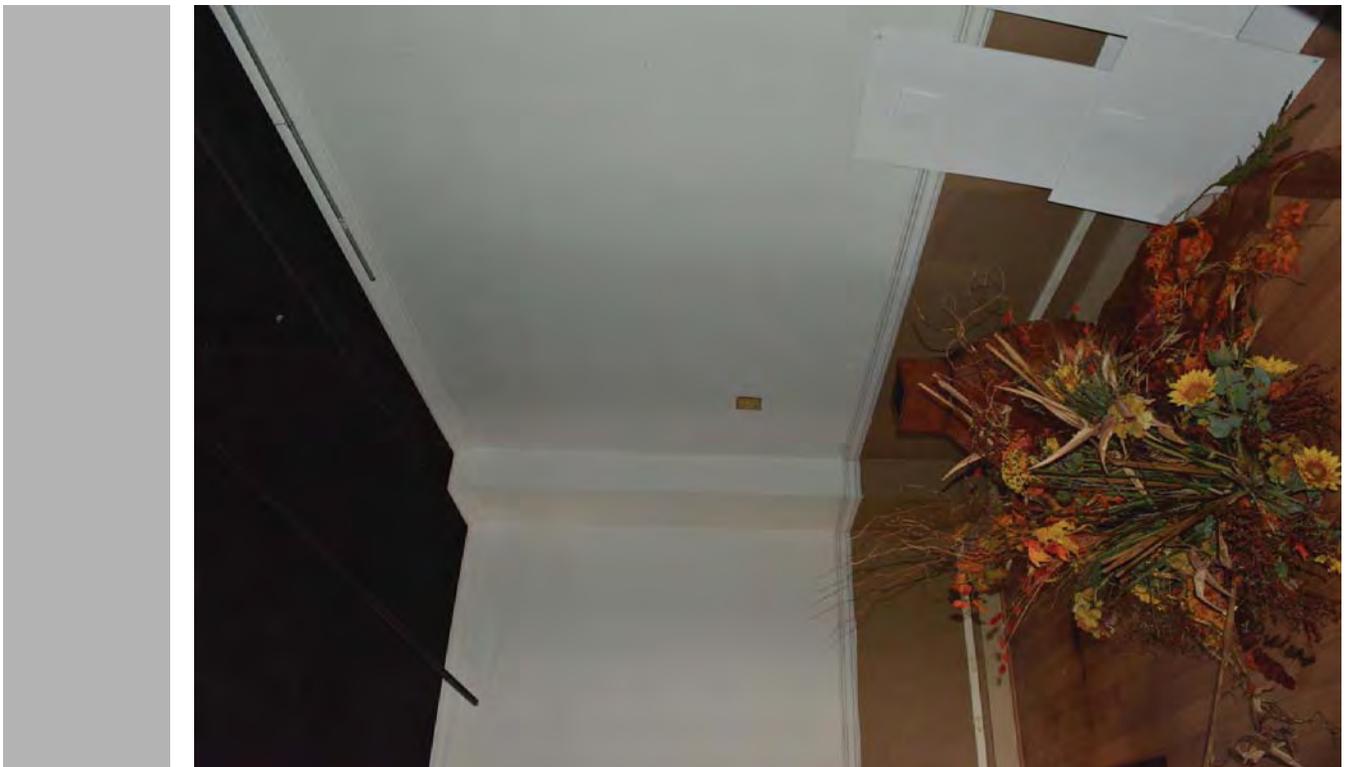
SAH-317

Name: Saint Anthony Hotel, 300 East Travis Street, San Antonio, Texas
View: First Level Retail Space, looking northeast at corner of interior walls
Description: Creation of ADA accessible elevator and small lobby space
Date: November 2012

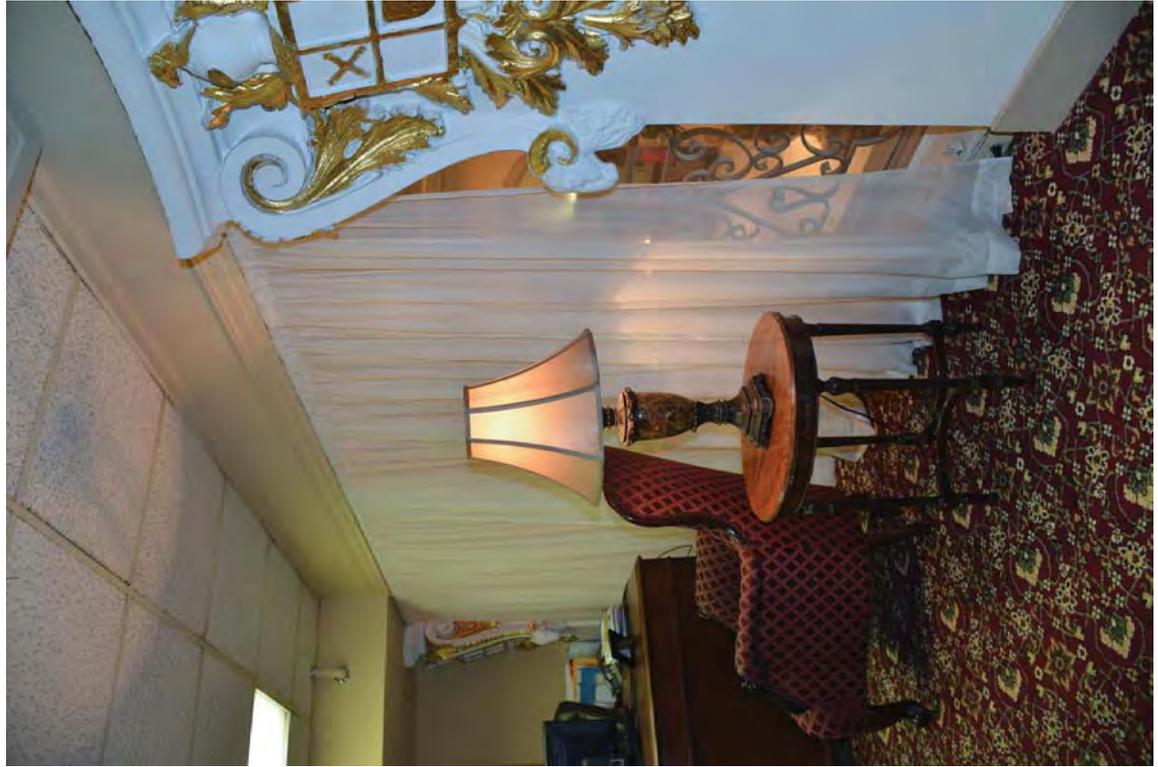
SAH-318

Name: Saint Anthony Hotel, 300 East Travis Street, San Antonio, Texas
View: Mezzanine Level Admin. Offices, looking northeast from reception area
Description: Non-historic ceiling, walls and plexi-glass panels to be removed
Date: November 2012

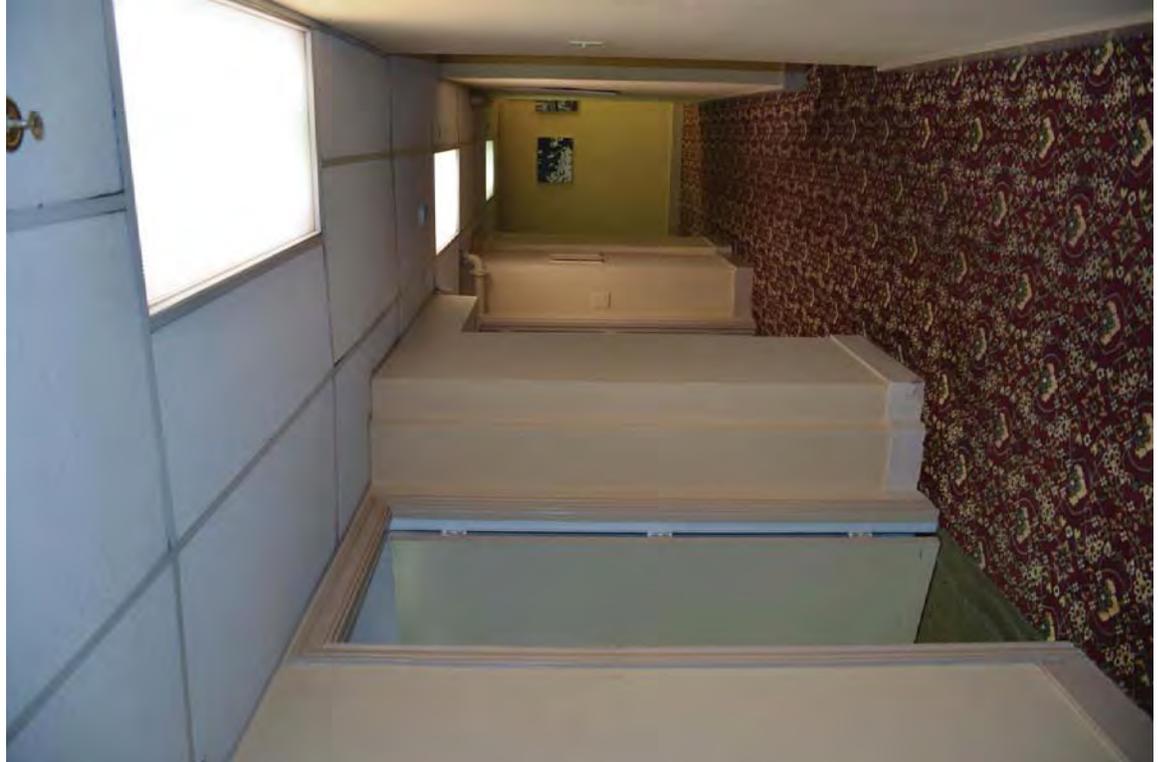
SAH-319

Name: Saint Anthony Hotel, 300 East Travis Street, San Antonio, Texas
View: Mezzanine Level Admin. Offices, looking east in corridor
Description: Non-historic ceiling & walls to be removed; historic columns & beams to remain
Date: November 2012

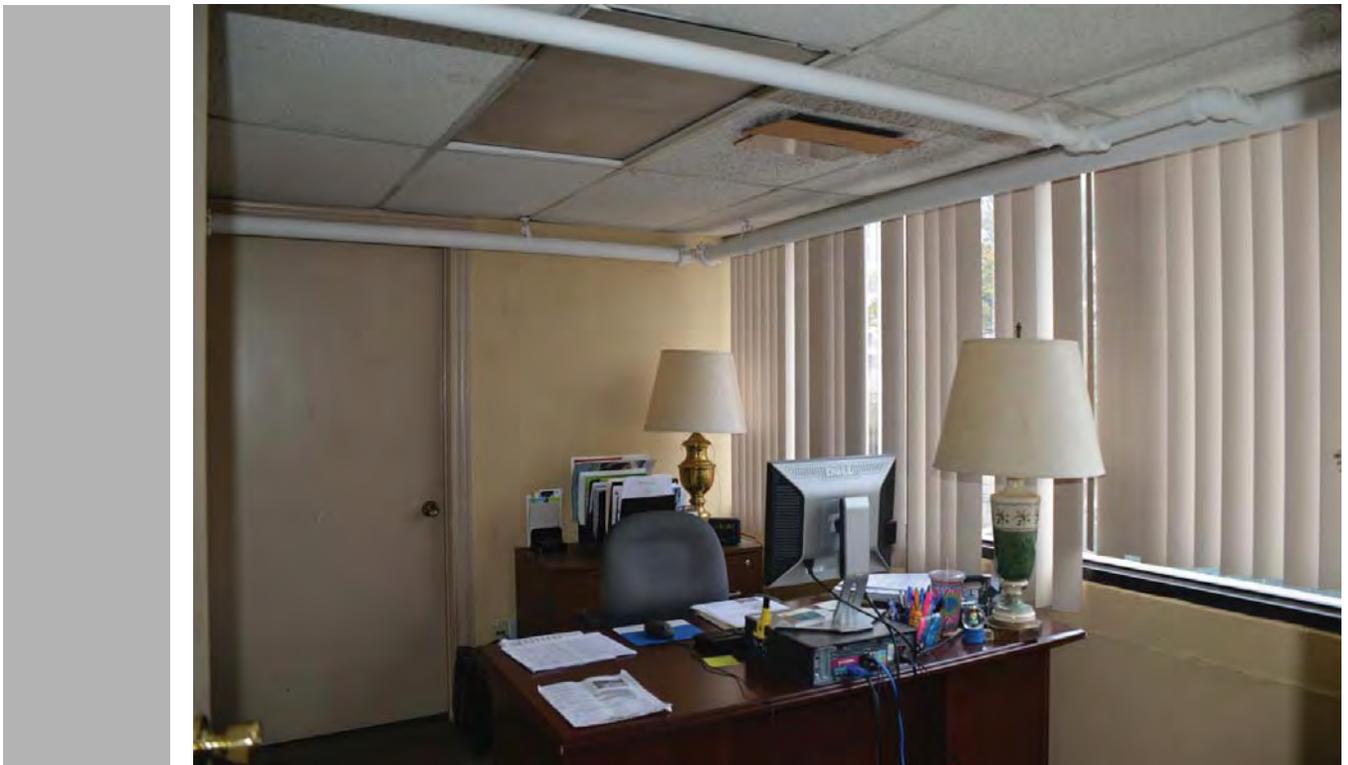
Photograph No.
SAH-323

Name: Saint Anthony Hotel, 300 East Travis Street, San Antonio, Texas
View: Mezzanine Level Admin. Offices at Terrace, looking south southwest
Description: Non-historic glazing, walls, ceilings, finishes & piping to be removed
Date: November 2012

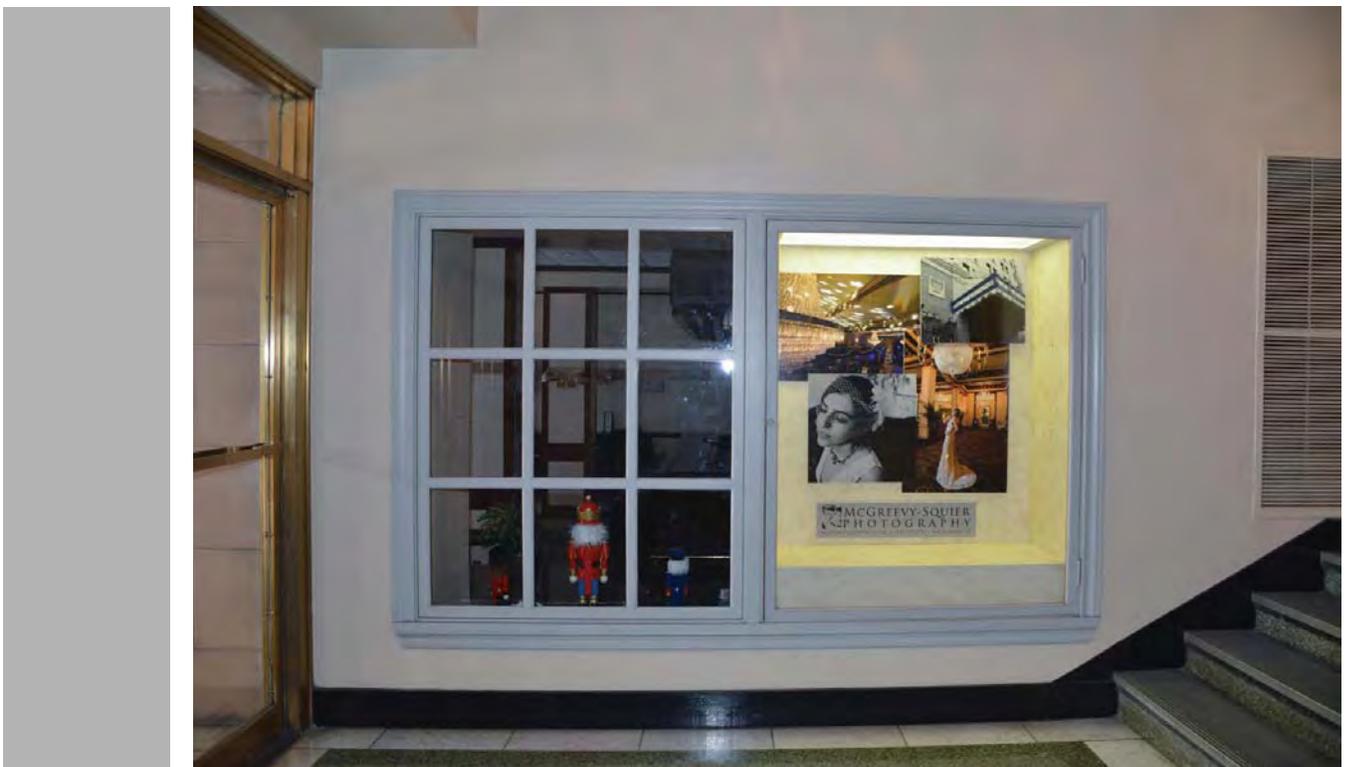
SAH-331

Name: Saint Anthony Hotel, 300 East Travis Street, San Antonio, Texas
View: First Floor Navarro Street entry lobby, detail of non-historic display case
Description: Display case to be removed; location of new (original) entry to Pete's Pub
Date: November 2012

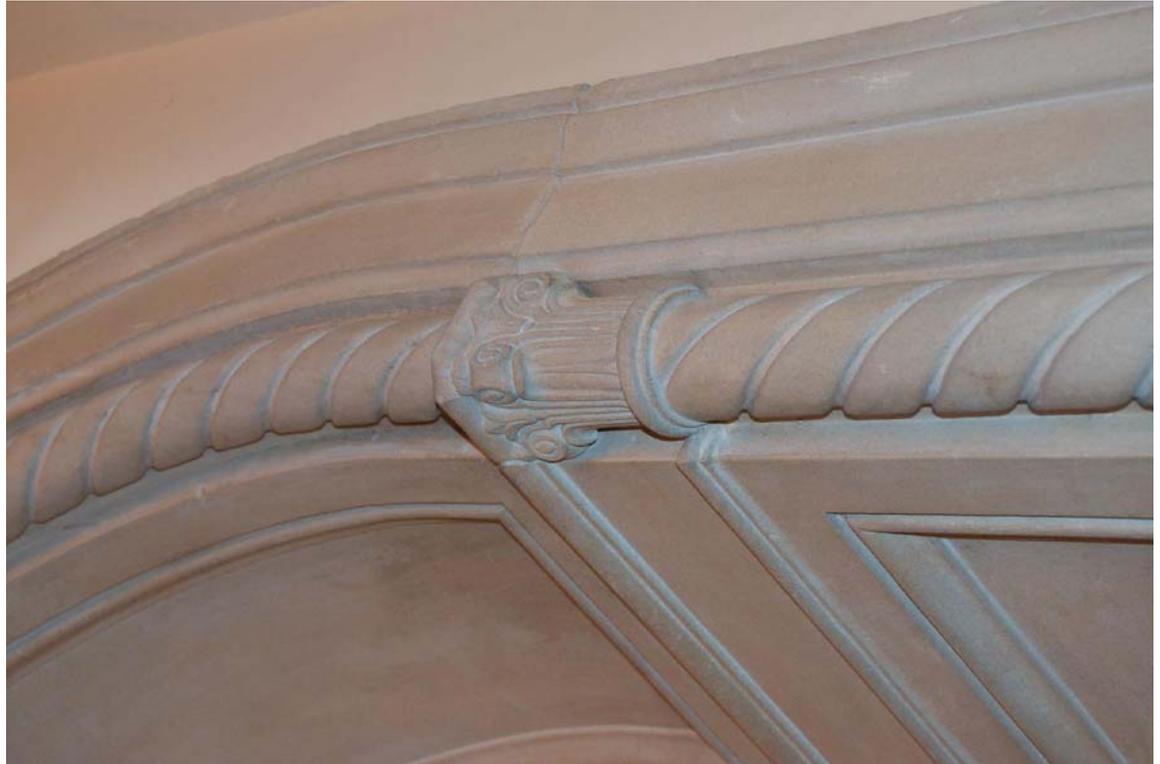
SAH-332

Name: Saint Anthony Hotel, 300 East Travis Street, San Antonio, Texas
View: First Floor Peacock Alley, detail of historic cast stone arch casing
Description: Historic feature exhibiting high degree of craftsmanship & refined details
Date: November 2012

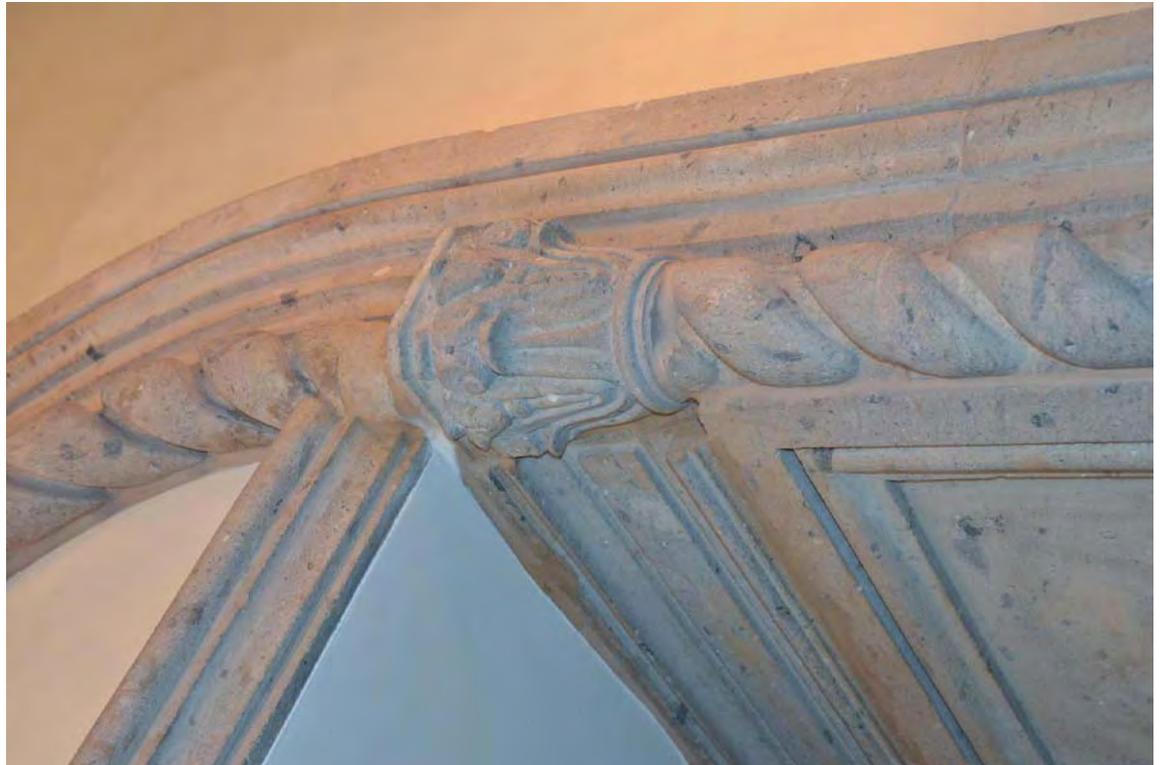
Photograph No.
SAH-333

Name: Saint Anthony Hotel, 300 East Travis Street, San Antonio, Texas
View: First Floor Peacock Alley, detail of non-historic carved Canterra stone arch casing
Description: Non-historic (after 1983) feature exhibiting crude craftsmanship & different material
Date: November 2012

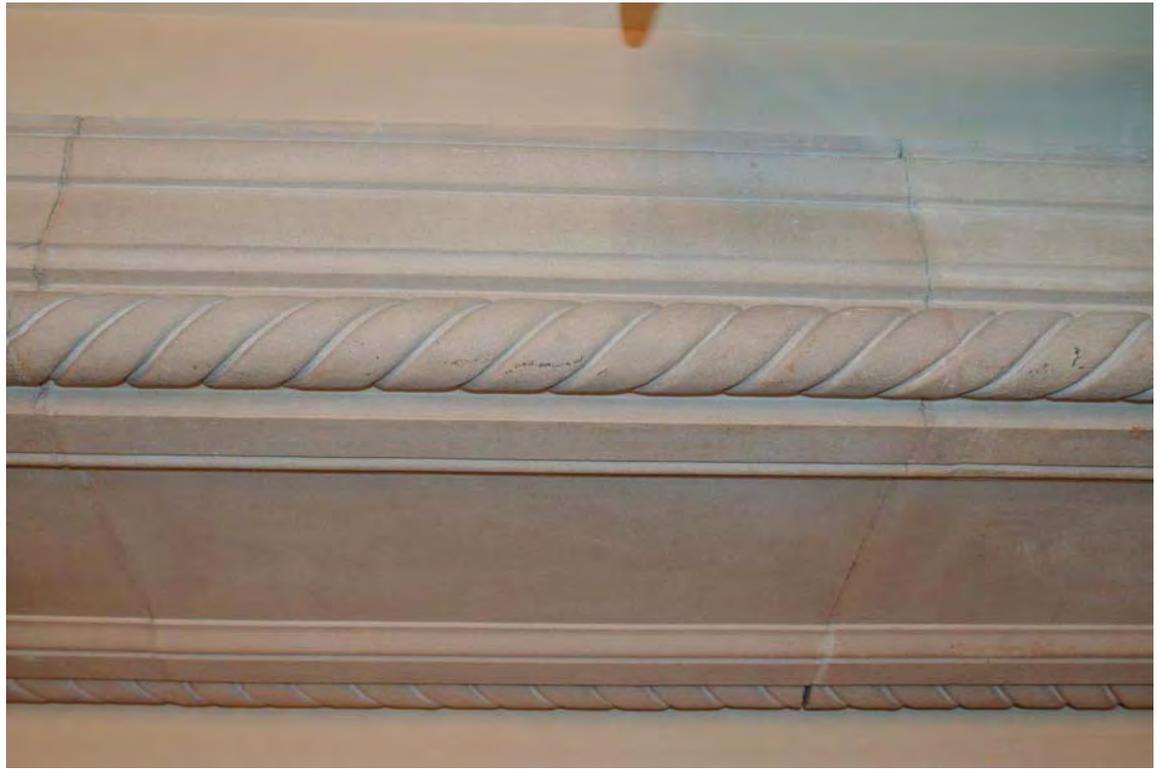
Photograph No.
SAH-334

Name: Saint Anthony Hotel, 300 East Travis Street, San Antonio, Texas
View: First Floor Peacock Alley, detail of historic cast stone arch casing
Description: Historic feature exhibiting high degree of craftsmanship & refined details
Date: November 2012

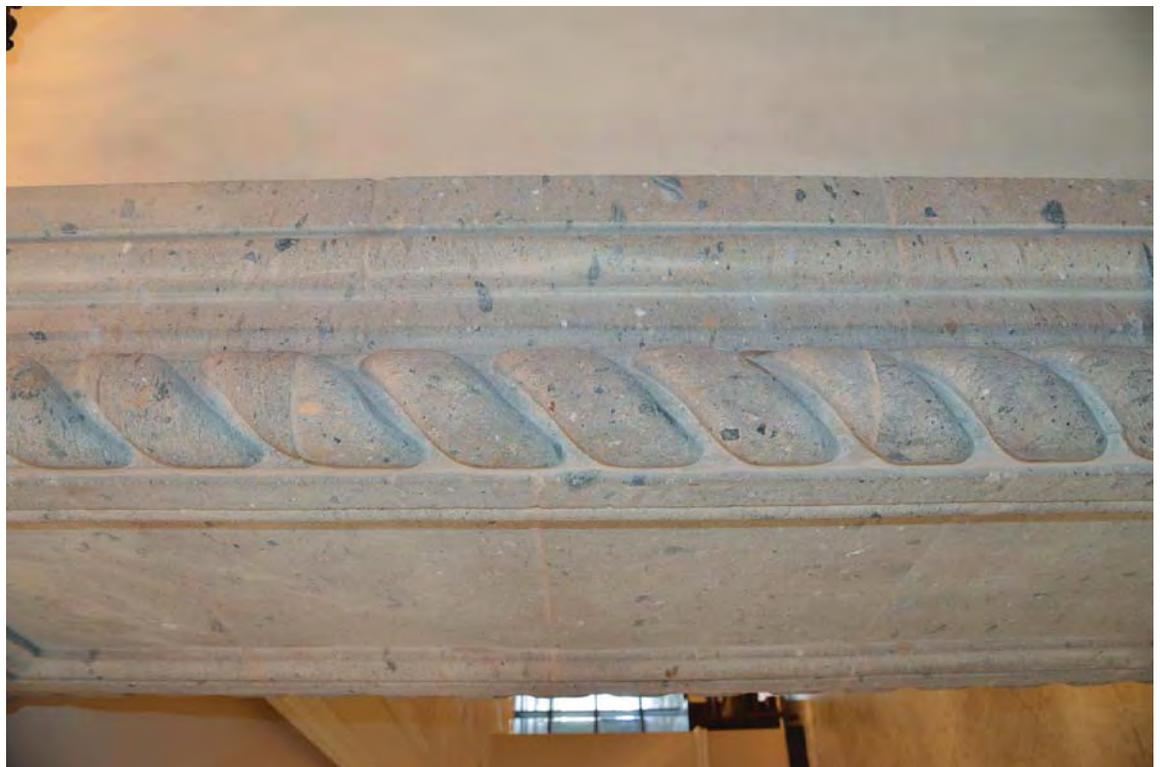
SAH-335

Name: Saint Anthony Hotel, 300 East Travis Street, San Antonio, Texas
View: First Floor Peacock Alley, detail of non-historic carved Canterra stone arch casing
Description: Non-historic (after 1983) feature exhibiting crude craftsmanship & different material
Date: November 2012

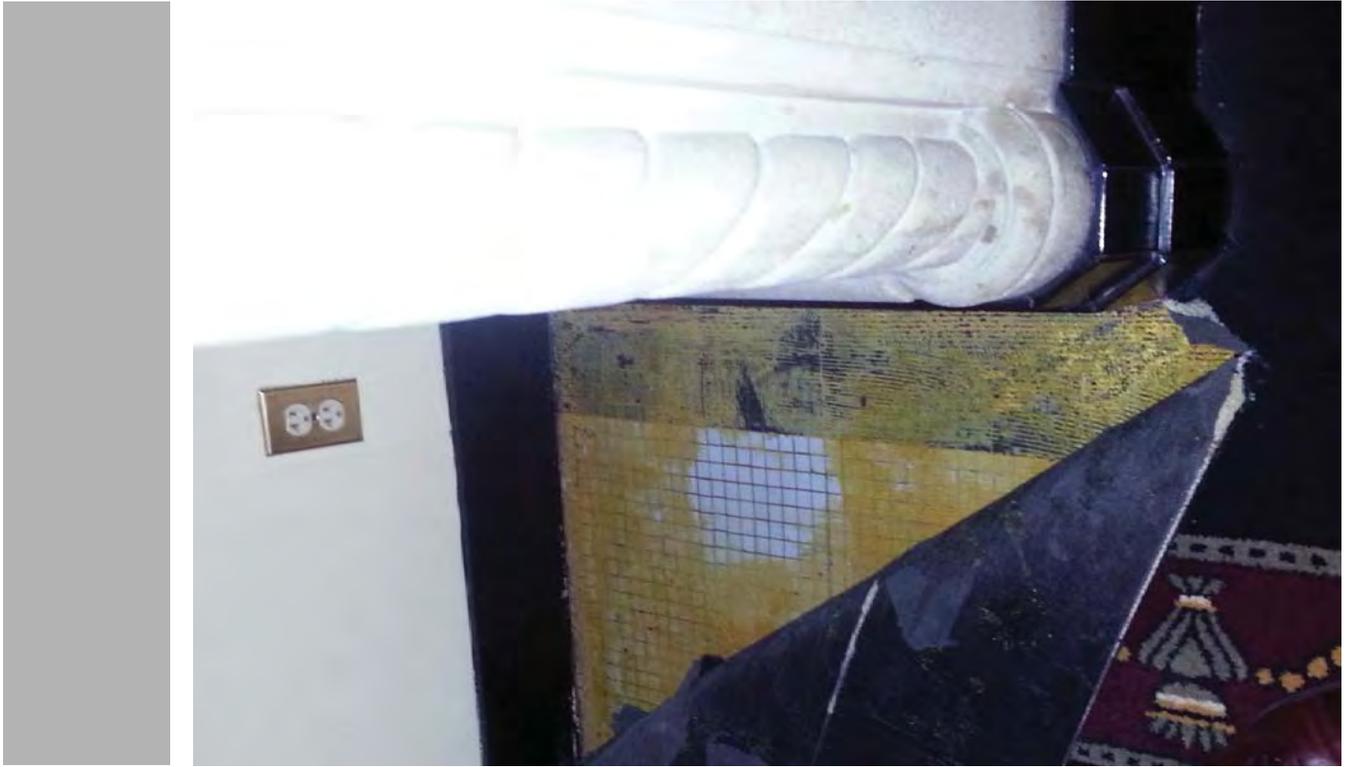
SAH-338

Name: Saint Anthony Hotel, 300 East Travis Street, San Antonio, Texas
View: First Floor Peacock Alley, detail of historic tile beneath existing carpet
Description: Carpet to be removed and tile cleaned of mastic and rehabilitated
Date: November 2012

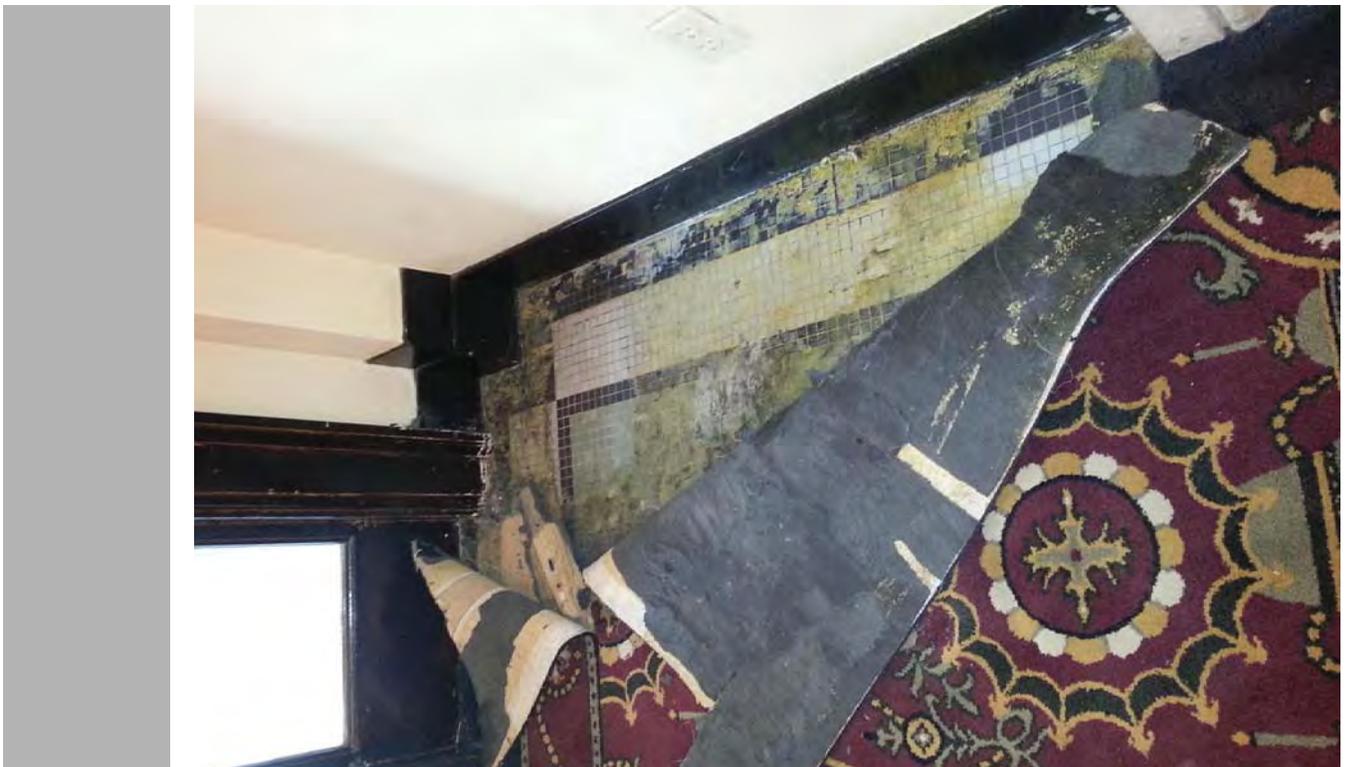
SAH-339

Name: Saint Anthony Hotel, 300 East Travis Street, San Antonio, Texas
View: First Floor Peacock Alley, detail of historic tile beneath existing carpet
Description: Carpet to be removed and tile cleaned of mastic and rehabilitated
Date: November 2012

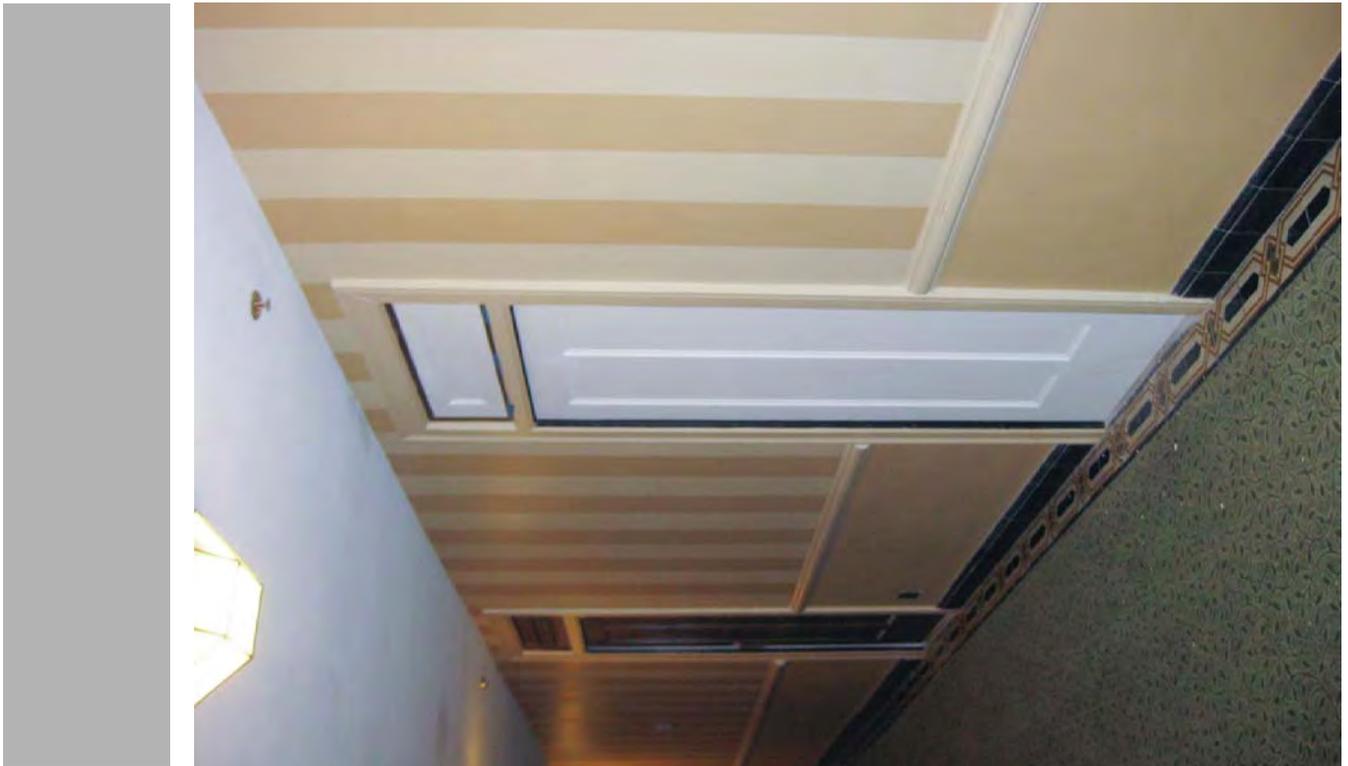
SAH-340

Name: Saint Anthony Hotel, 300 East Travis Street, San Antonio, Texas
View: Ninth Floor Tower One Corridor, view of proposed new door mockup
Description: New door in existing opening (showing primer, not finish color)
Date: December 2012

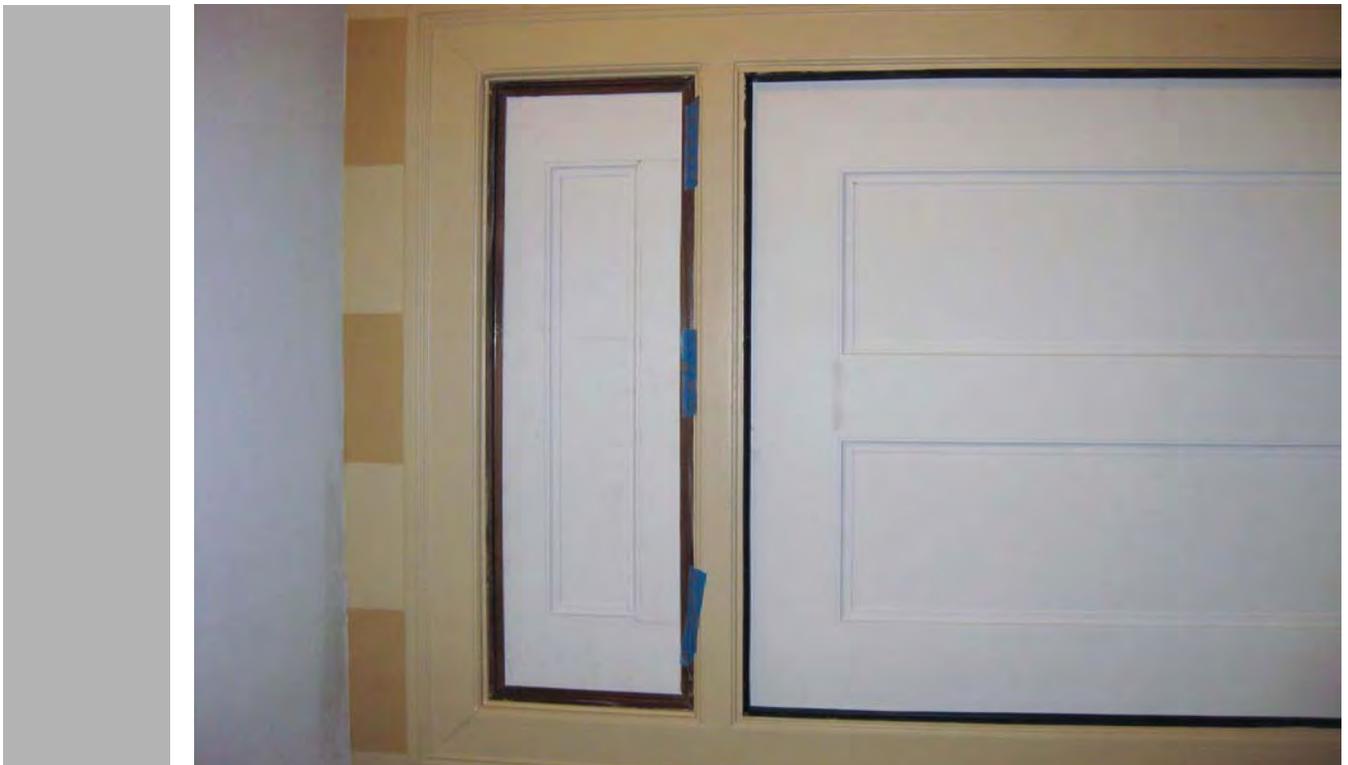
SAH-341

Name: Saint Anthony Hotel, 300 East Travis Street, San Antonio, Texas
View: Ninth Floor Tower One Corridor, view of proposed new door mockup
Description: New door in existing opening (showing primer, not finish color)
Date: December 2012

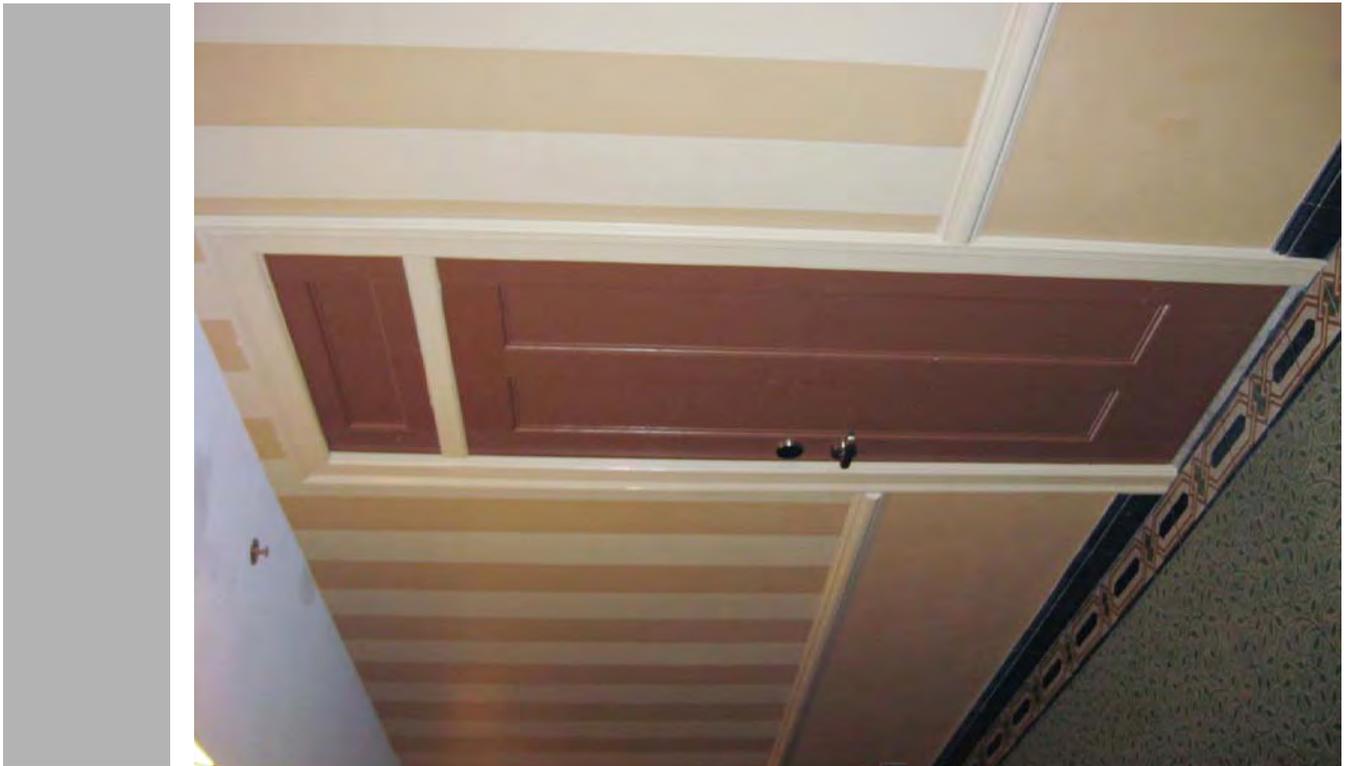
SAH-342

Name: Saint Anthony Hotel, 300 East Travis Street, San Antonio, Texas
View: Ninth Floor Tower One Corridor, view of proposed new door mockup
Description: New door w/ faux transom panel and bar for proposed new openings
Date: December 2012

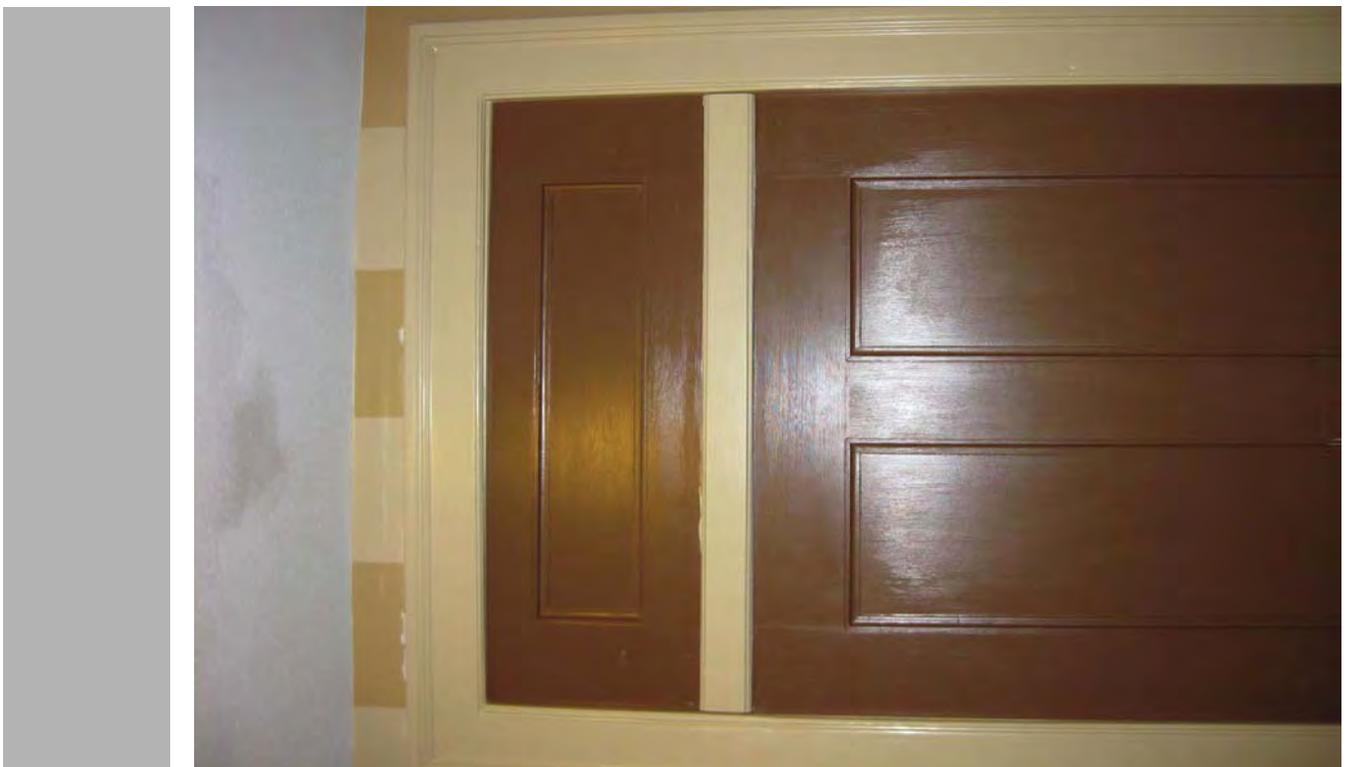
SAH-343

Name: Saint Anthony Hotel, 300 East Travis Street, San Antonio, Texas
View: Ninth Floor Tower One Corridor, view of proposed new door mockup
Description: New door w/ faux transom panel and bar for proposed new openings
Date: December 2012
